Caerus Piceance LLC
Piceance creek Unit-62S97W 10SESE
Location ID: 335696

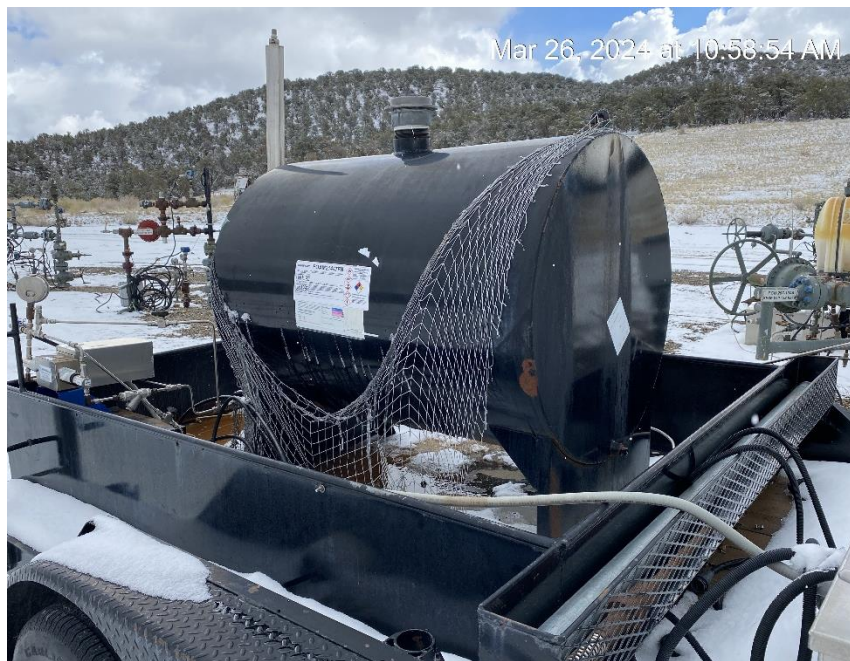
Inadequate wildlife protection

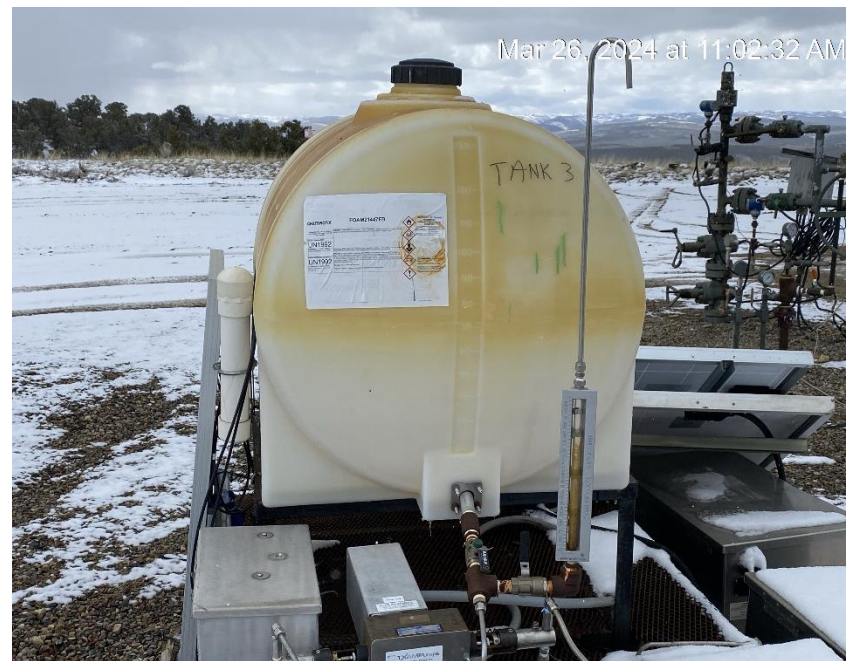
Replace label

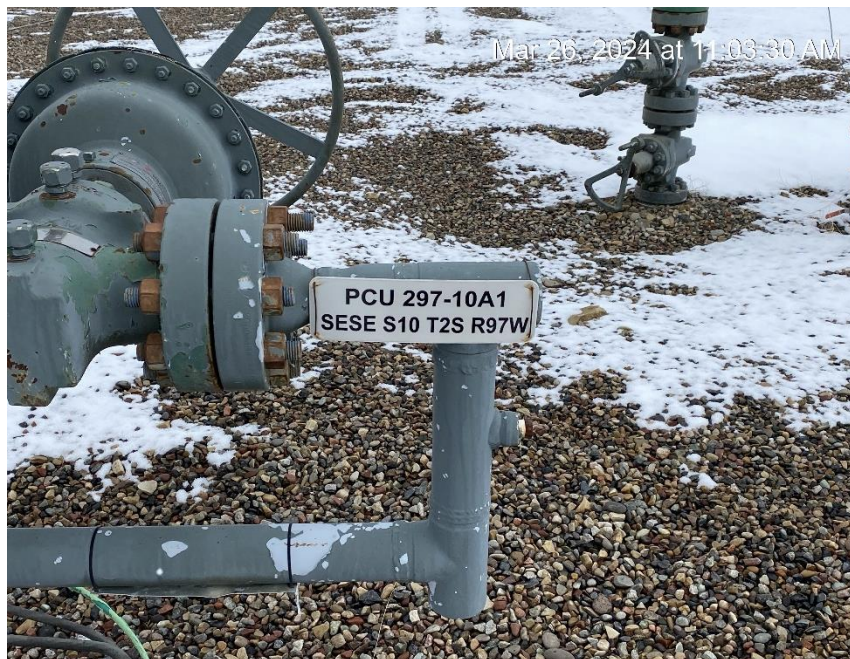
When replaced additional information is required

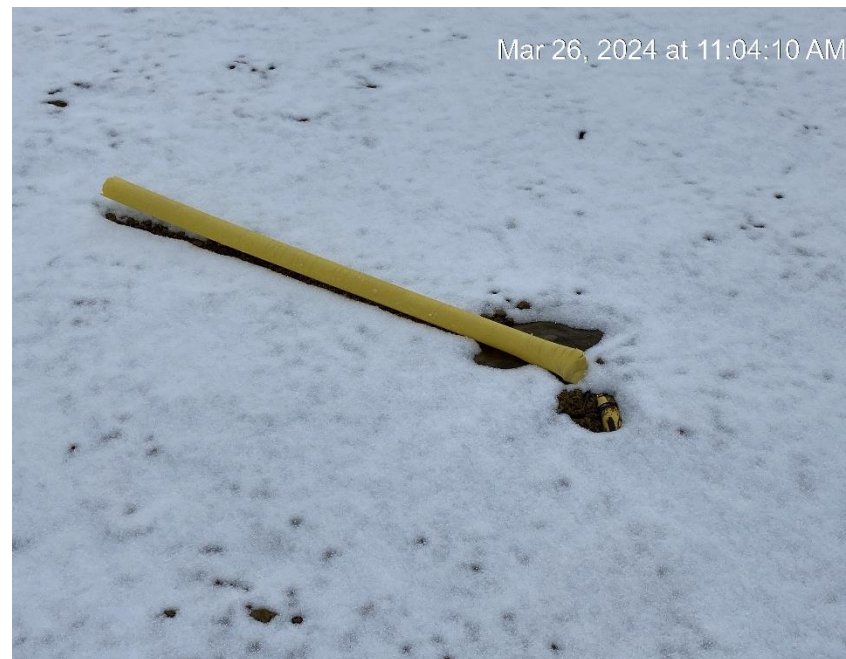
Unmarked anchor

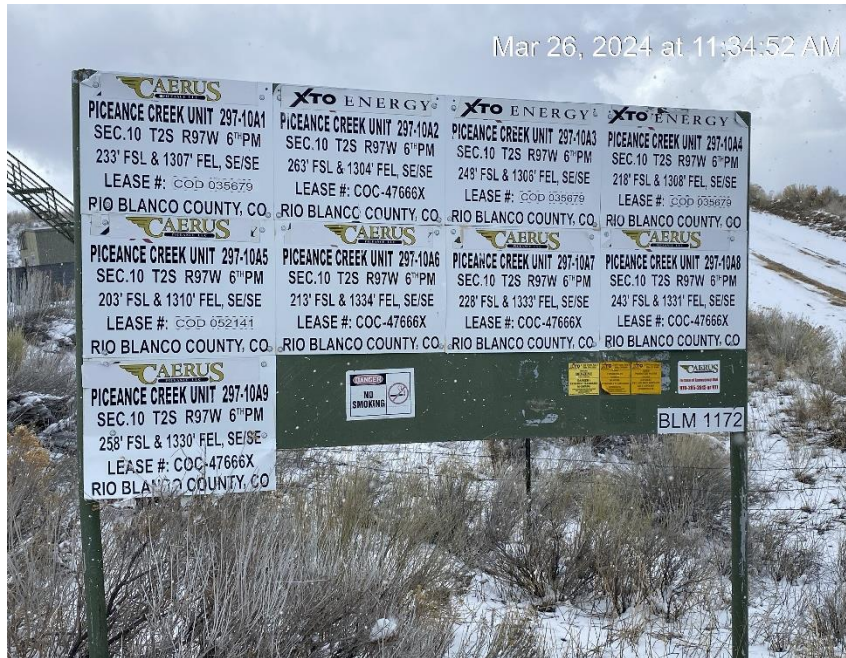
Incorrect signage

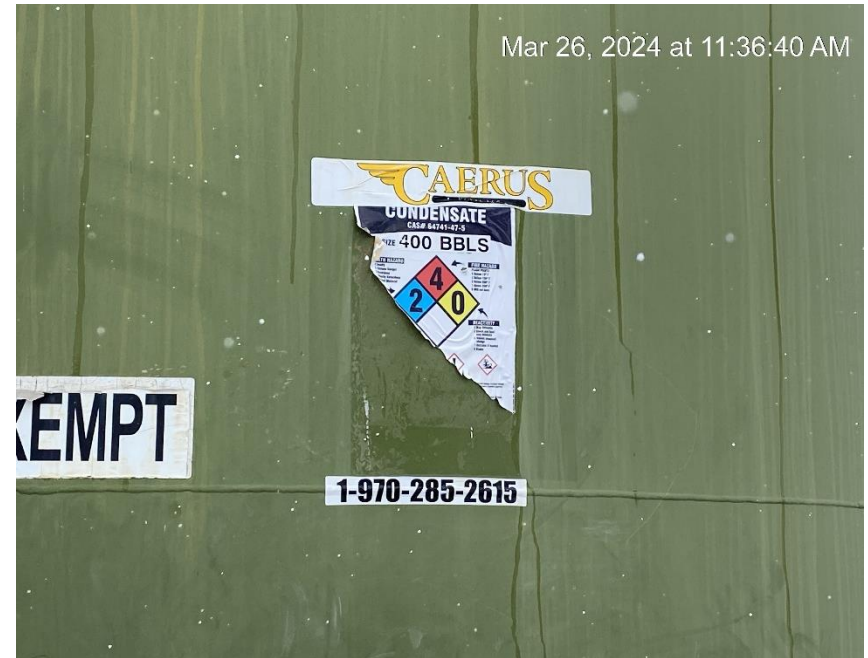
Label needs replaced

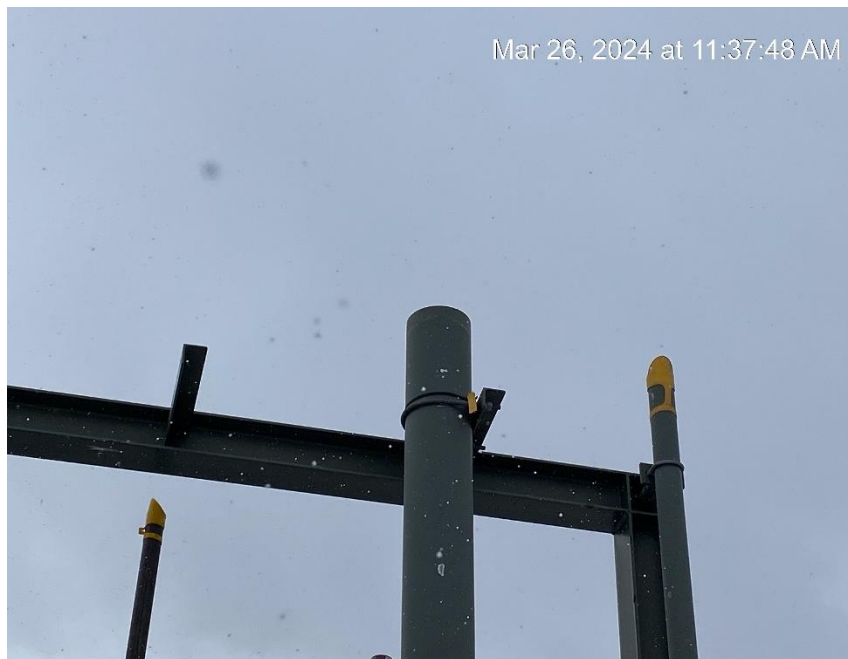
No rain protection

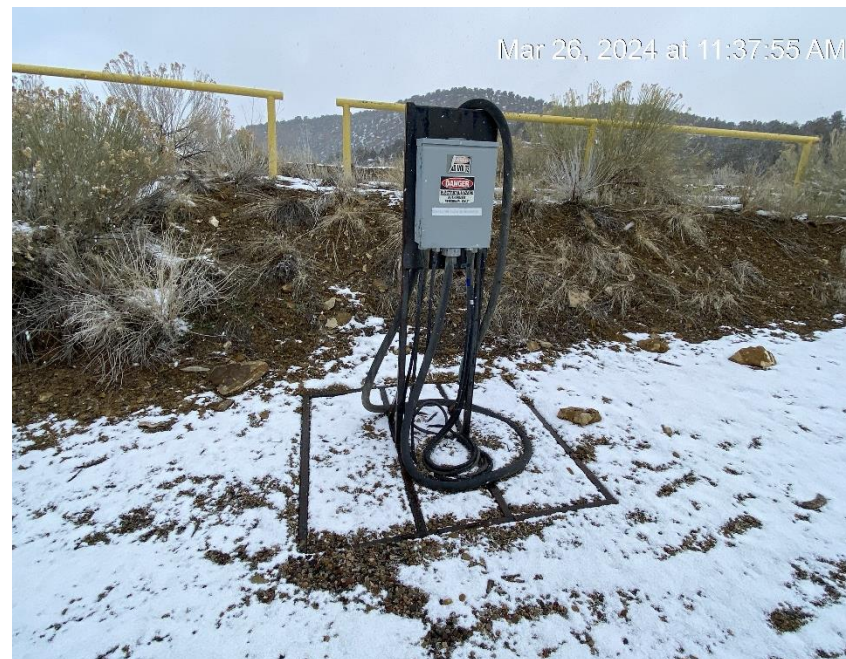
Debris

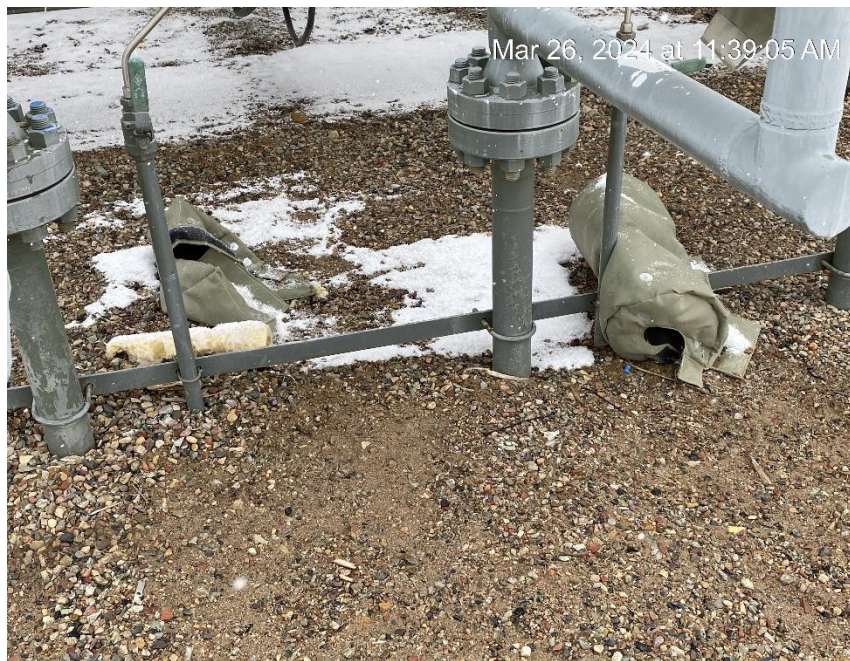
Debris

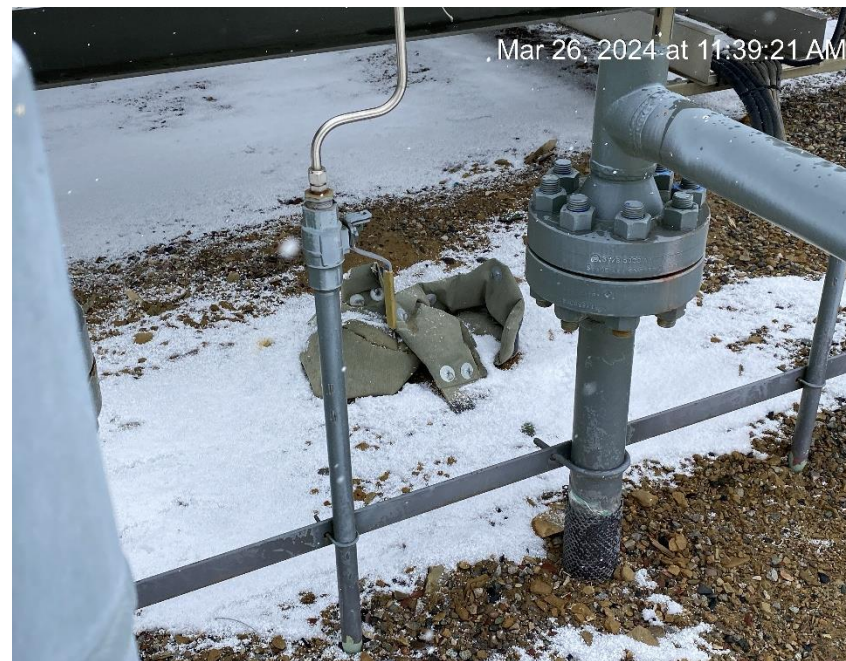
Debris

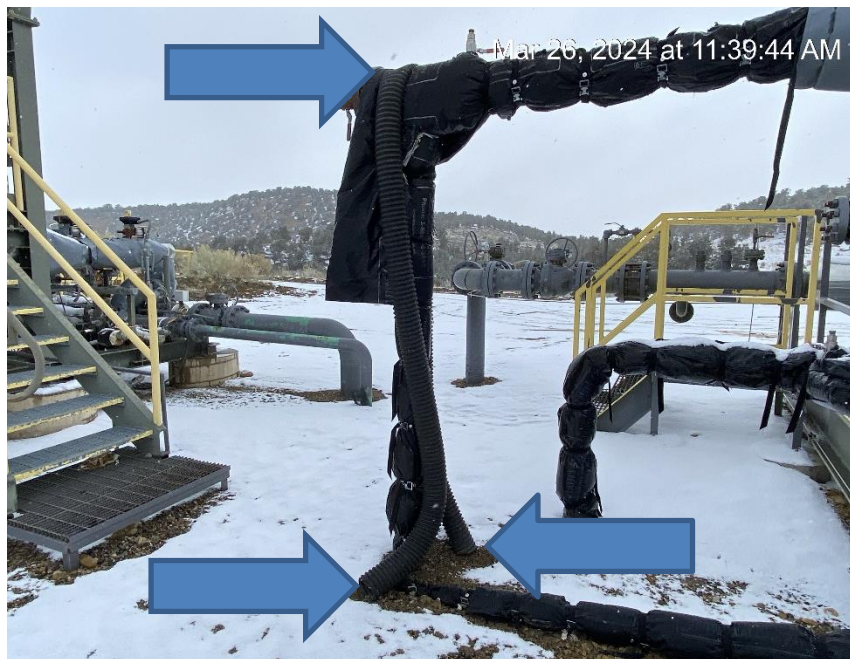
Debris. Hose hanging over flowline.

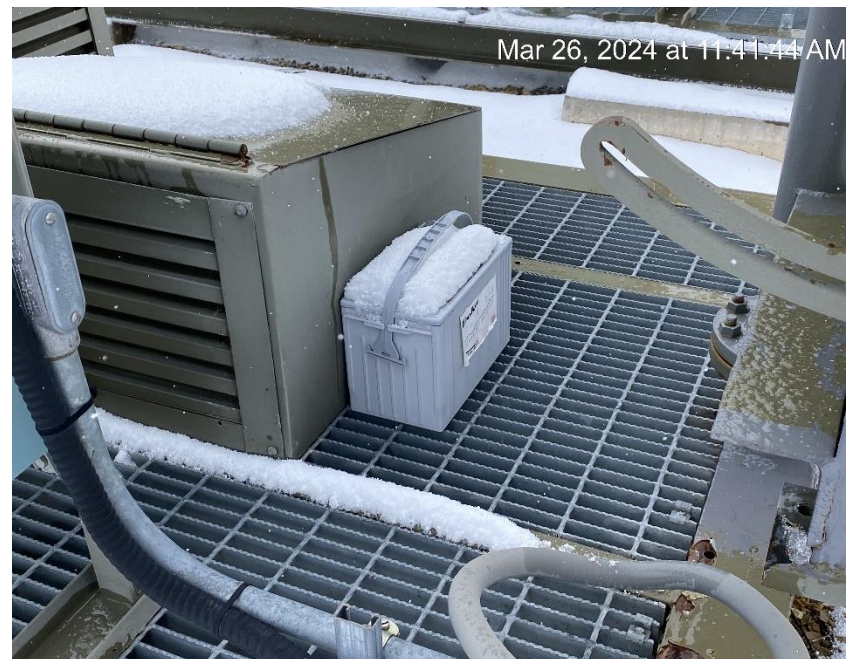
Debris

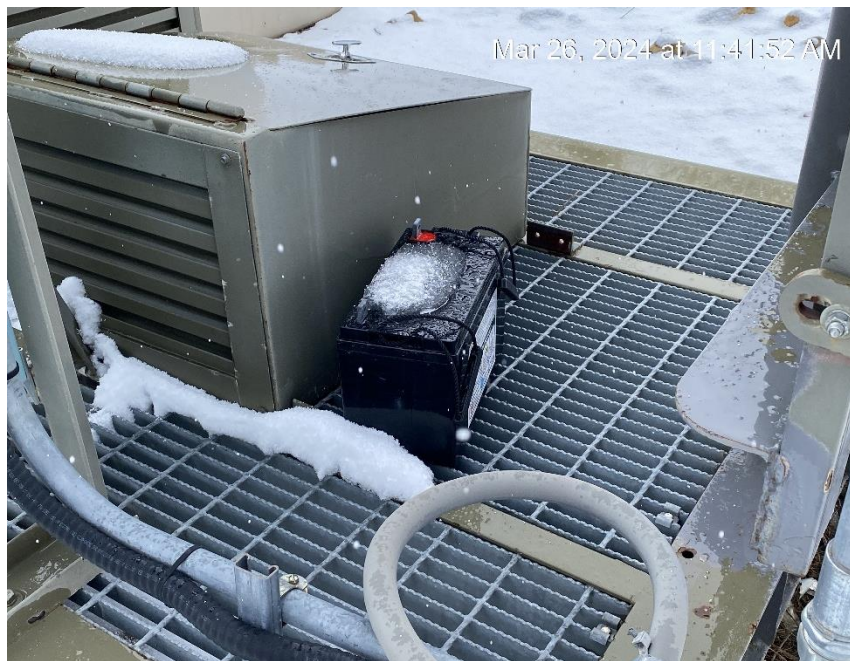
Debris

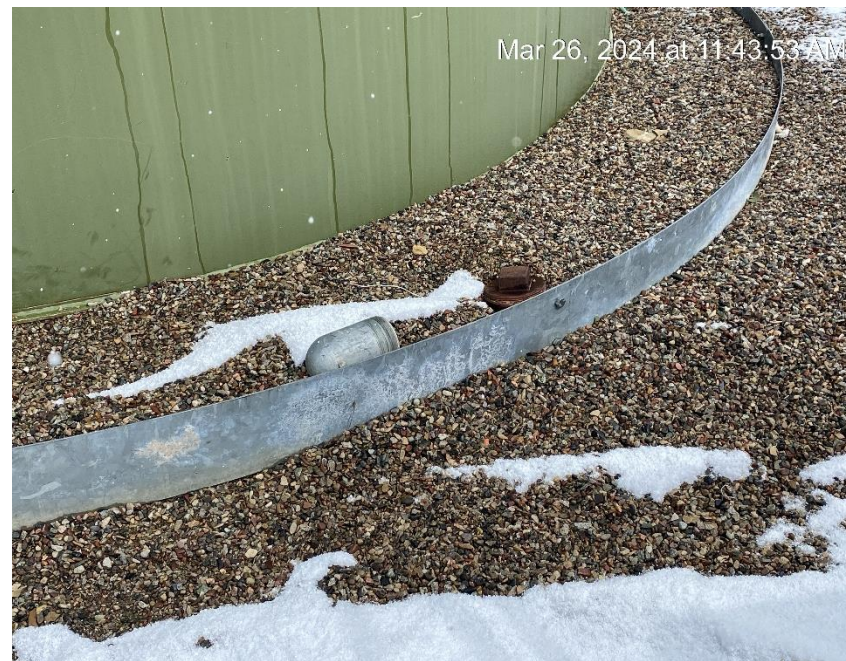
Debris
