Inspection Photos

API: 017-06629

Operator: **WILLIFORD ENERGY COMPANY**

Inspection Date: 3/26/2024

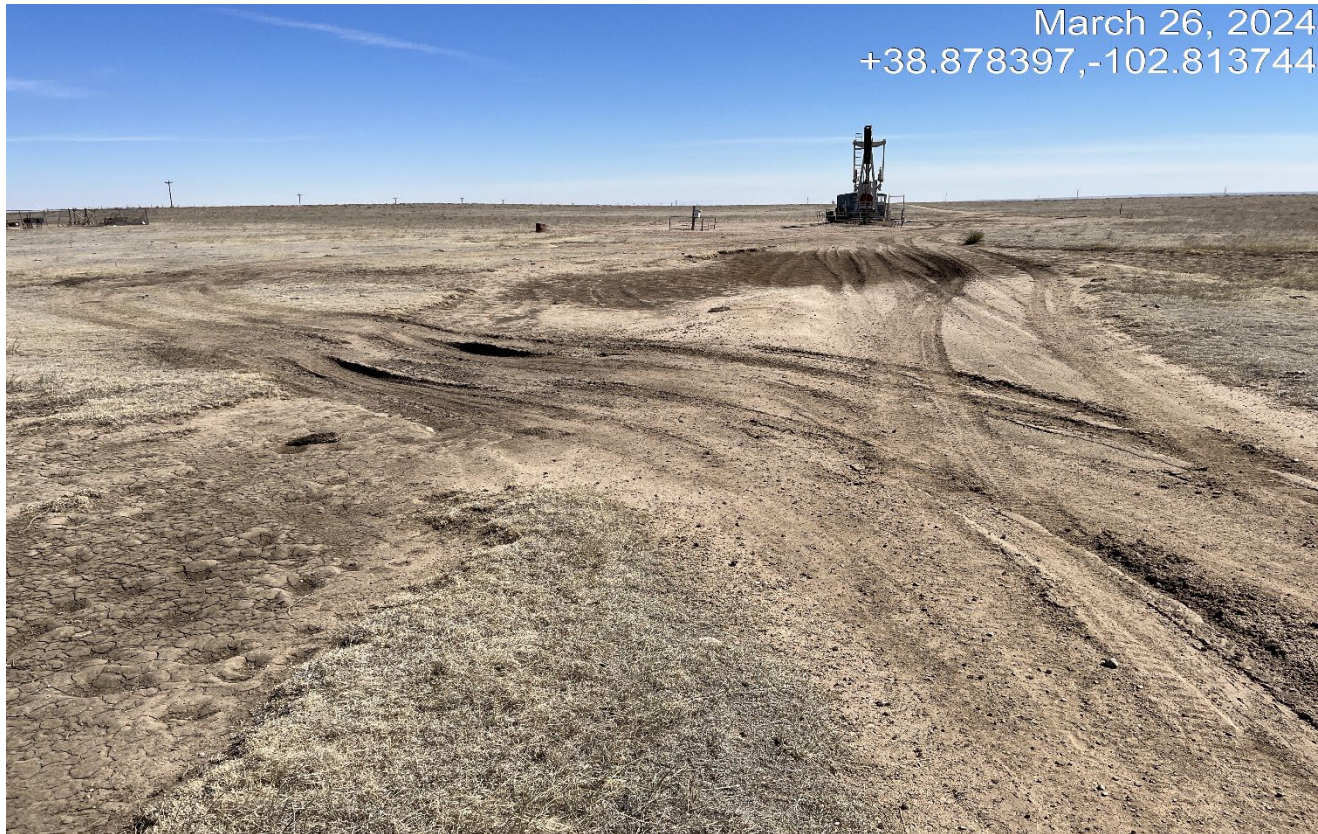
Photo 1. Facing east along the access road. Vehicles are causing unnecessary disturbance driving outside of the access road due to stormwater pooling on the road. The access road must be maintained and shall not drive outside of the access road boundary.

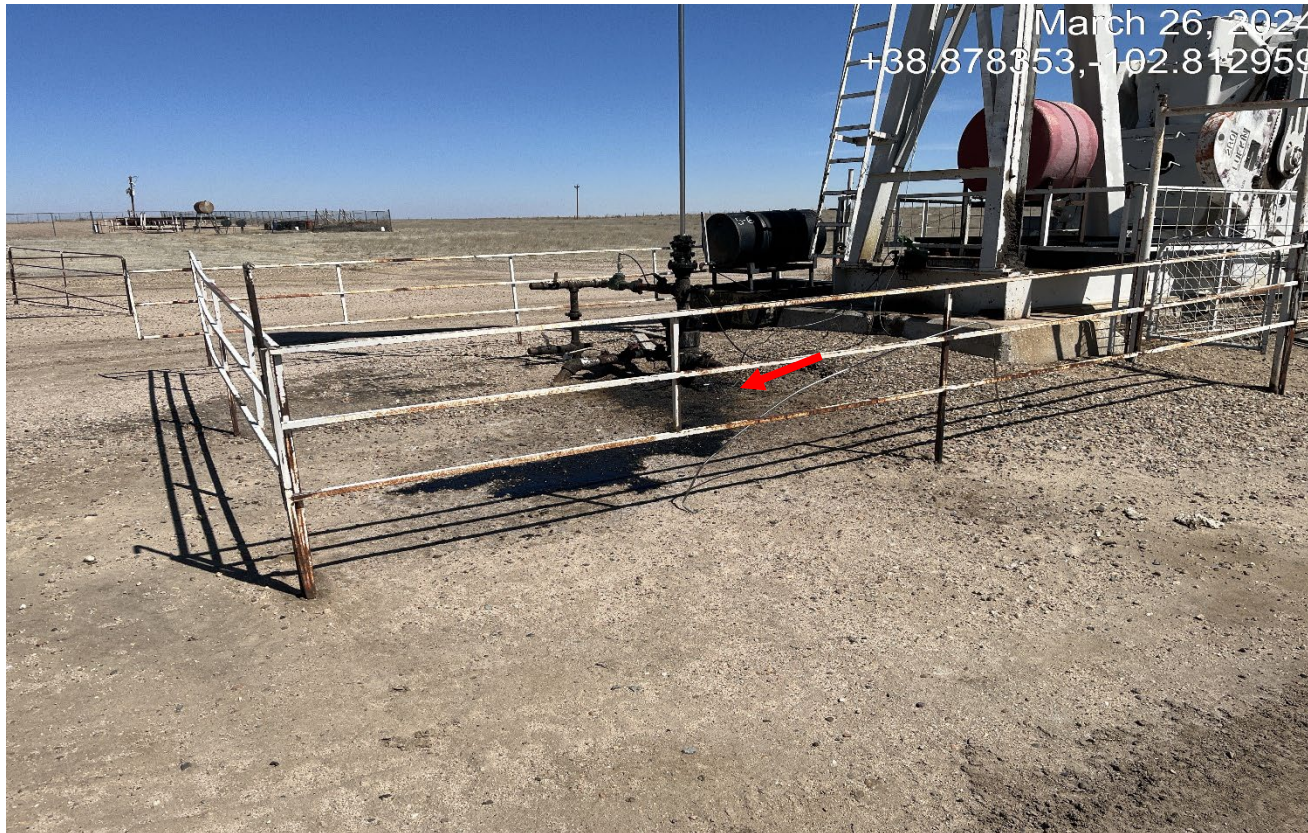
Photo 2. There is oil leaking out of the wellhead that must be controlled and cleaned up.

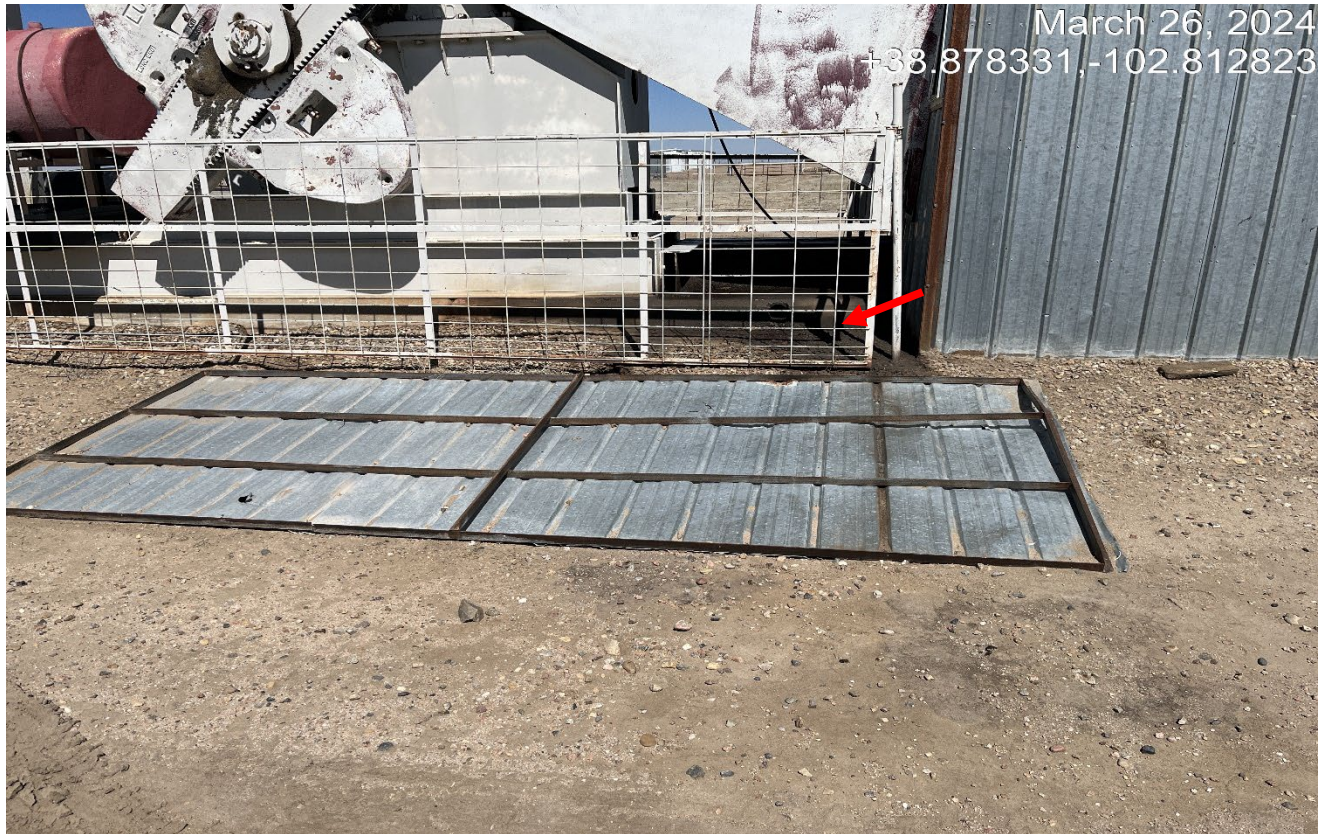
Photo 3. There is a panel laying on the ground that needs to be removed. There is oily fluids leaking out of the pumpjack at red arrow.

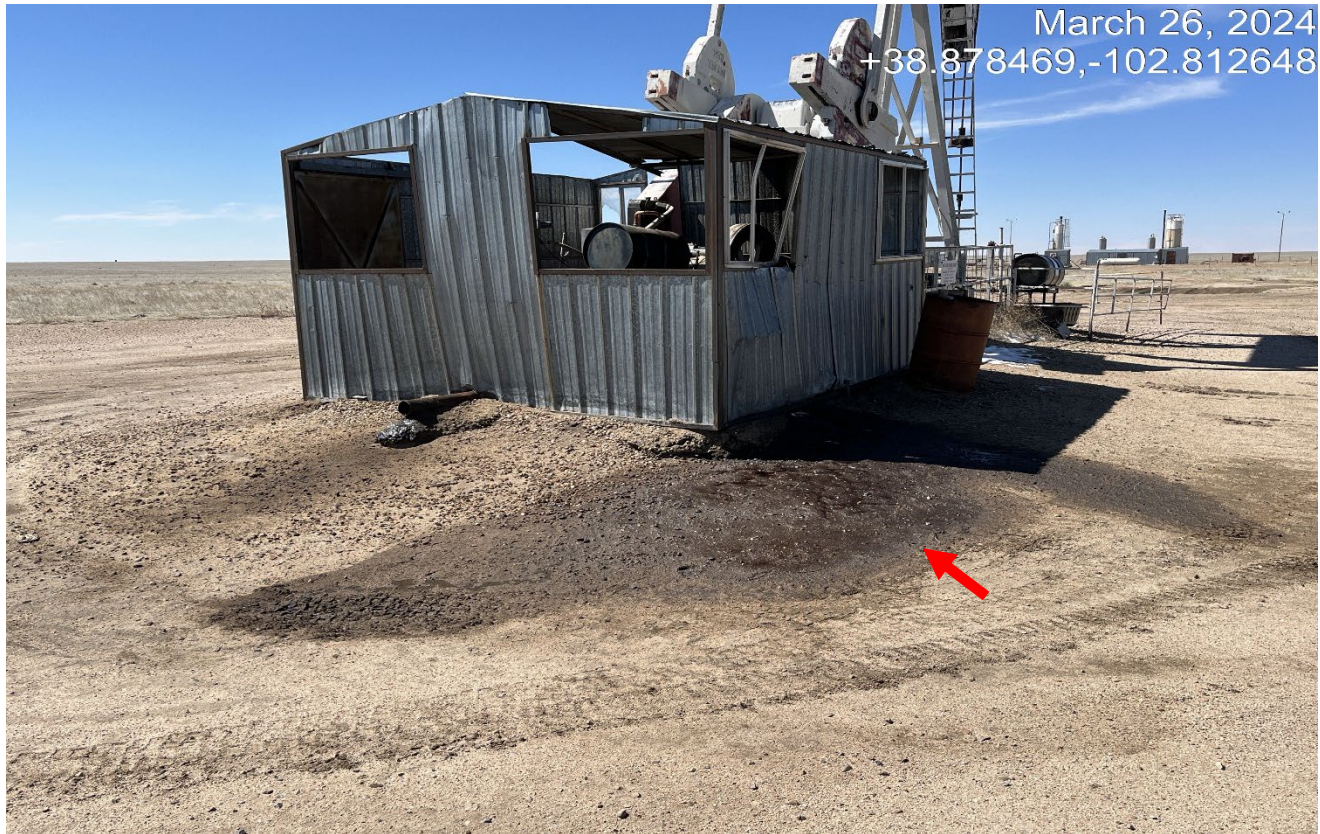
Photo 4. Facing southwest toward the engine compressor. There is oil saturated soils that have leaked out of the engine compressor. The leak must be controlled and impacted soils removed.

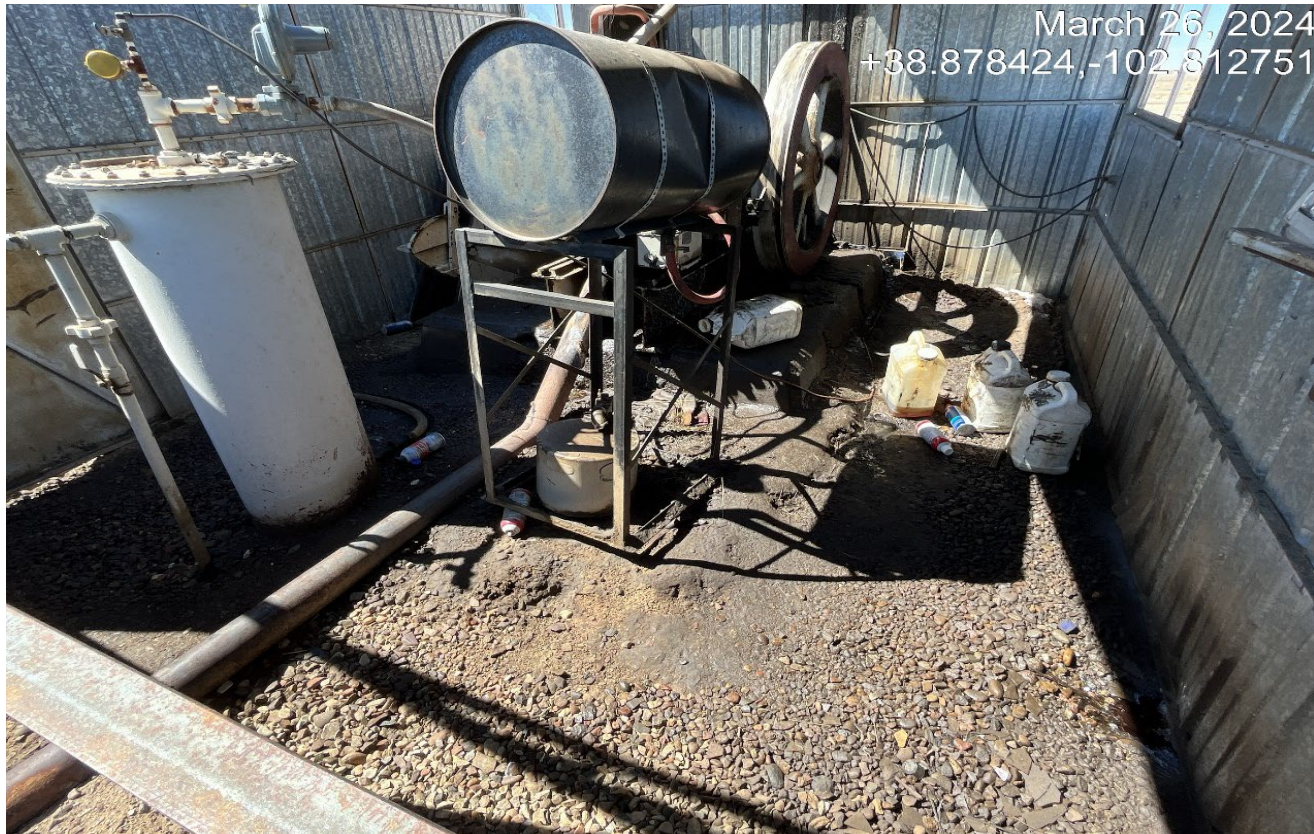
Photo 5. View of inside the shed shows oil saturated soils from the leaking engine. There is oil containers tipped over and no secondary containment.

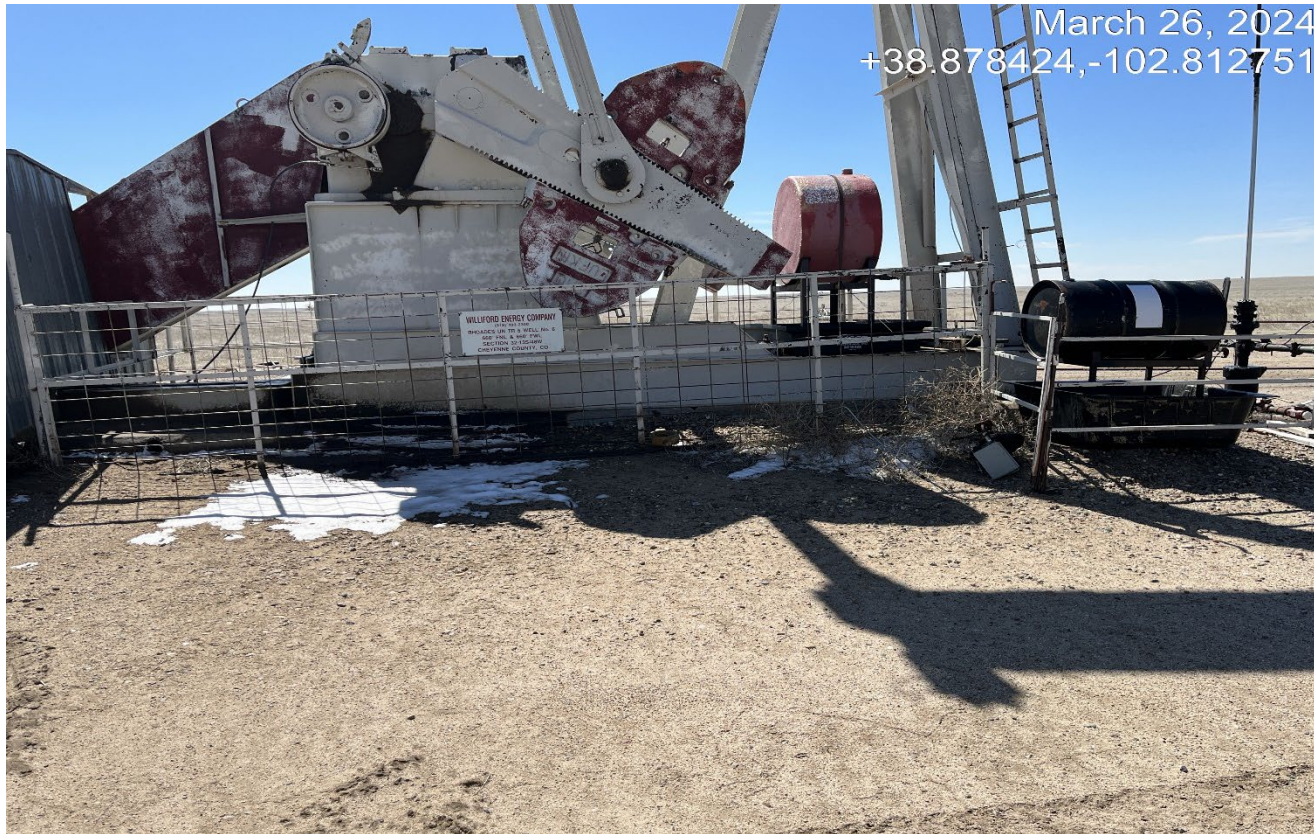
Photo 6. The well name doesn't appear to match the name of the well Rhoades 6-32.
