Inspection Photos
Location Name: Community #1 Facility
Location ID: 319888

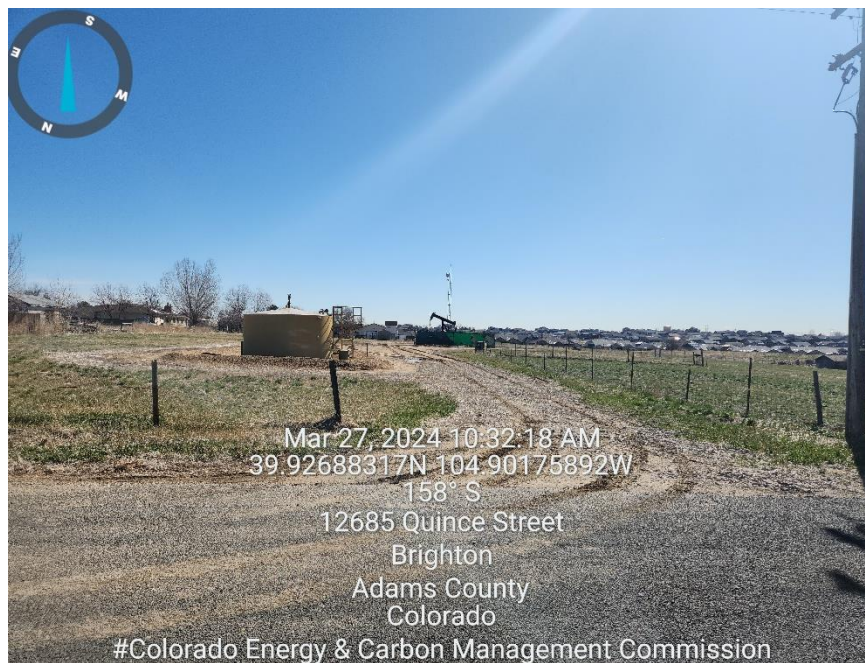
Photo 1 entrance to facility. Tracking pad impacted with sediment and being carried onto city street.

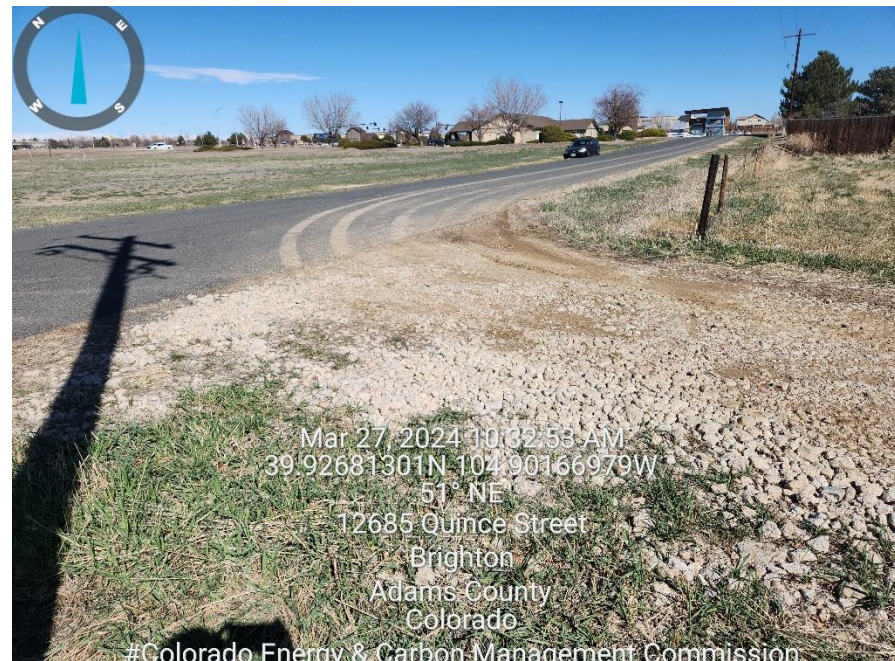
Photo 2 tracking pad in need of maintenance.

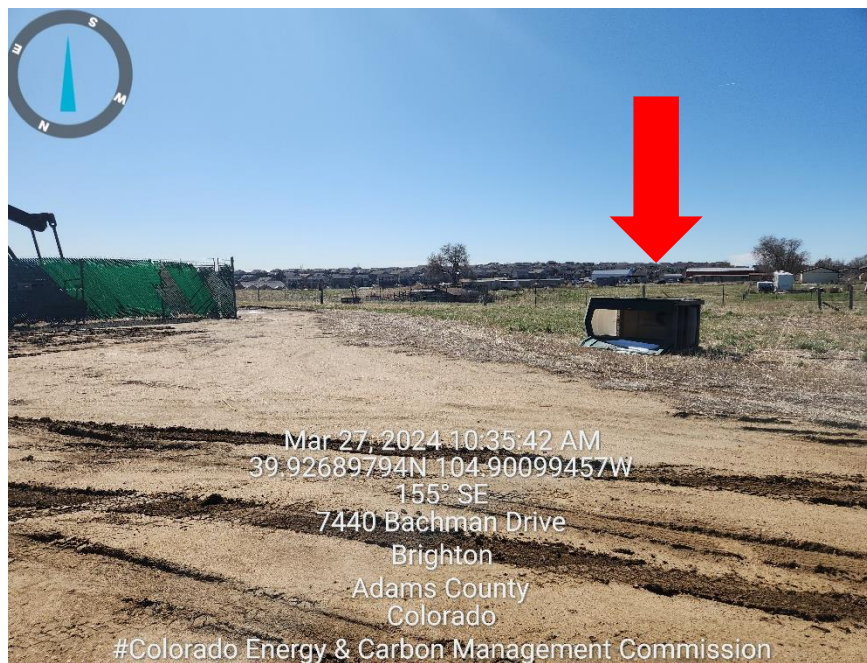
Photo 5 unused equipment port a potty

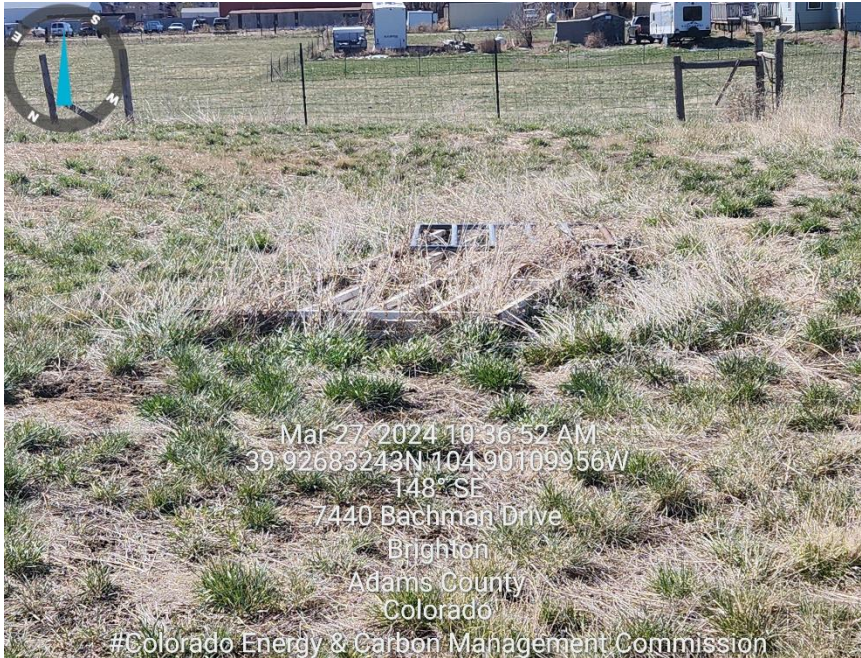
Photo 7 unused equipment (fencing)

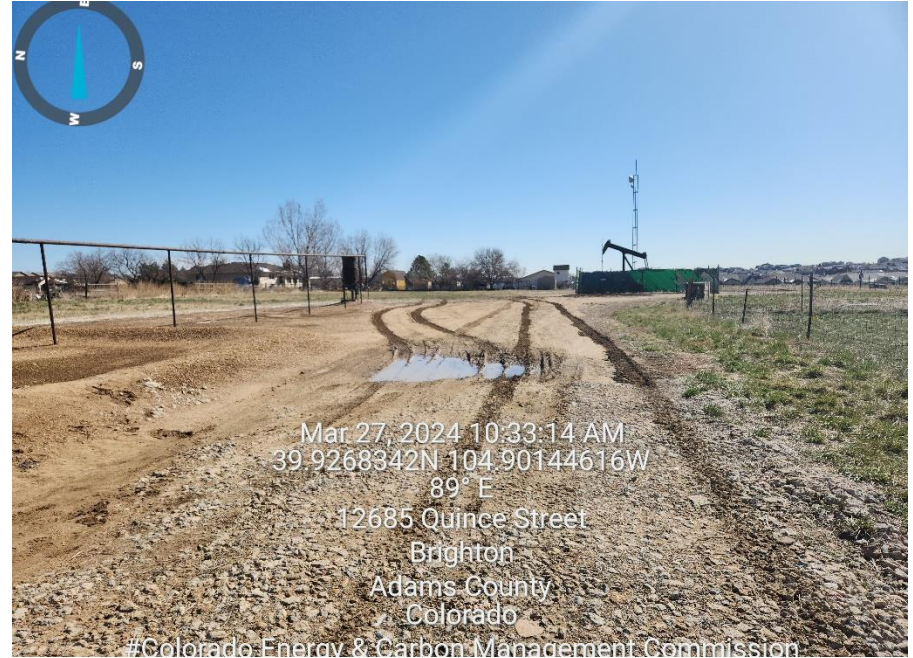
Photo 8 location not draining properly due to improper BMP's
