Inspection Photos
Location Name: Nessu 15
Location ID: 317831

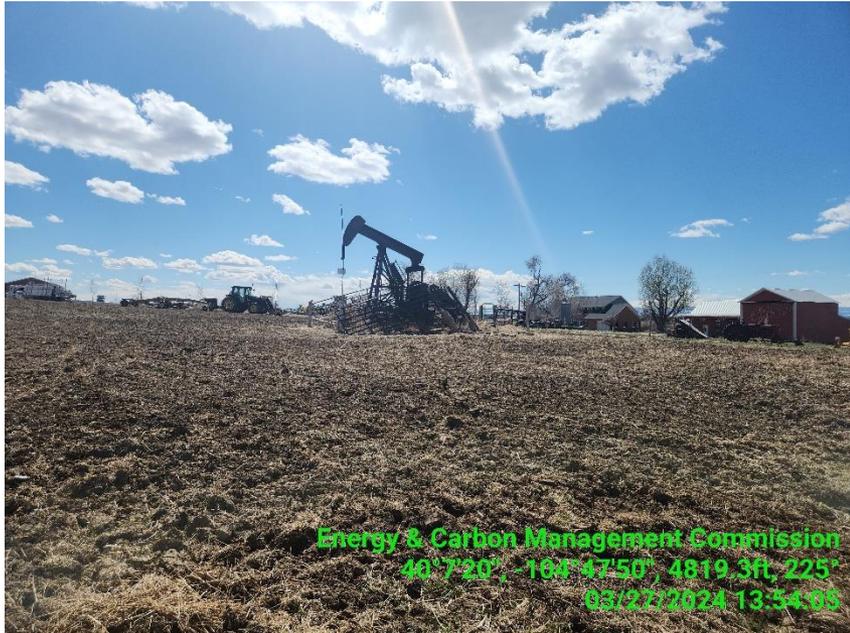
Photo 1 Location.

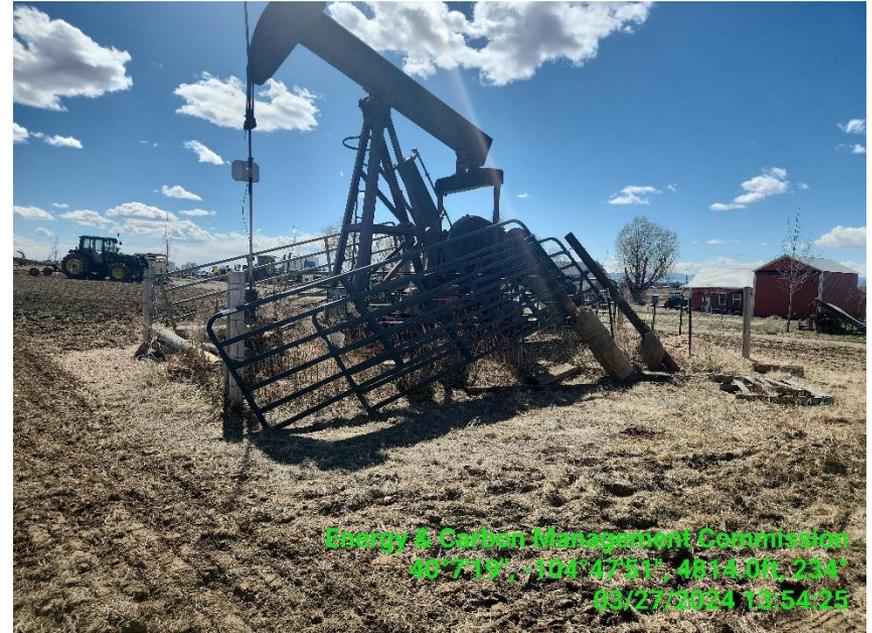
Photo 2 Wellsite.

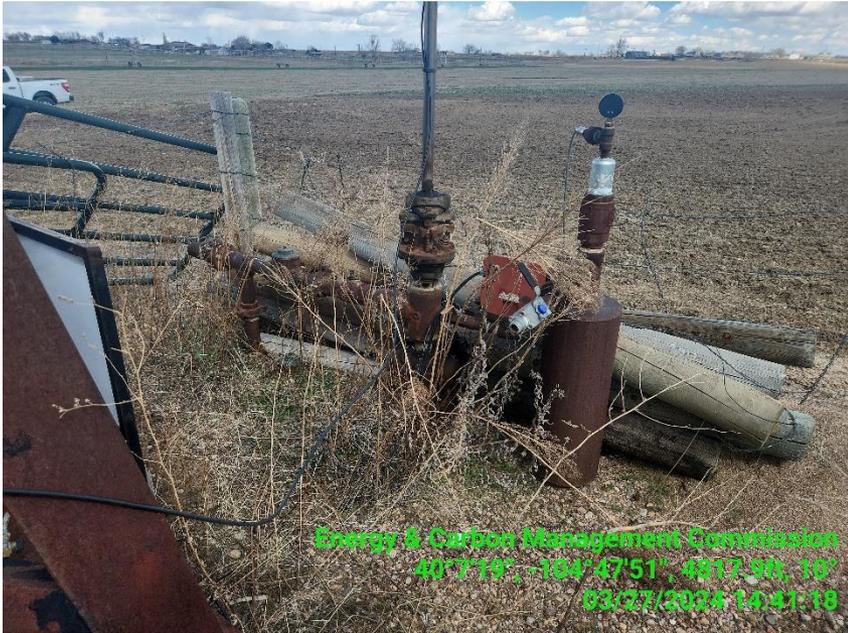
Photo 3 Debris(dead vegetation) around the WH, Land owner has fence posts stacked by the WH.

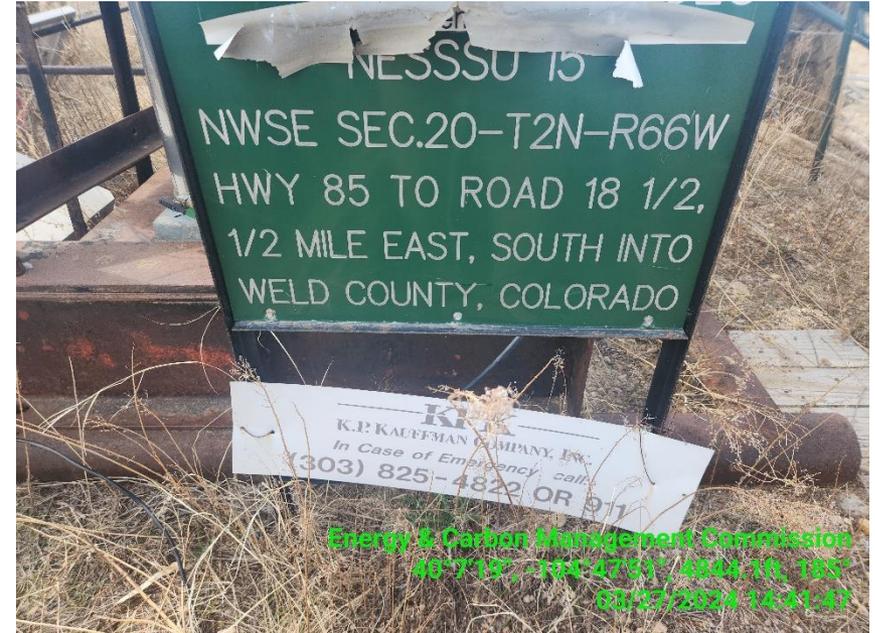
Photo 4 WH sign.

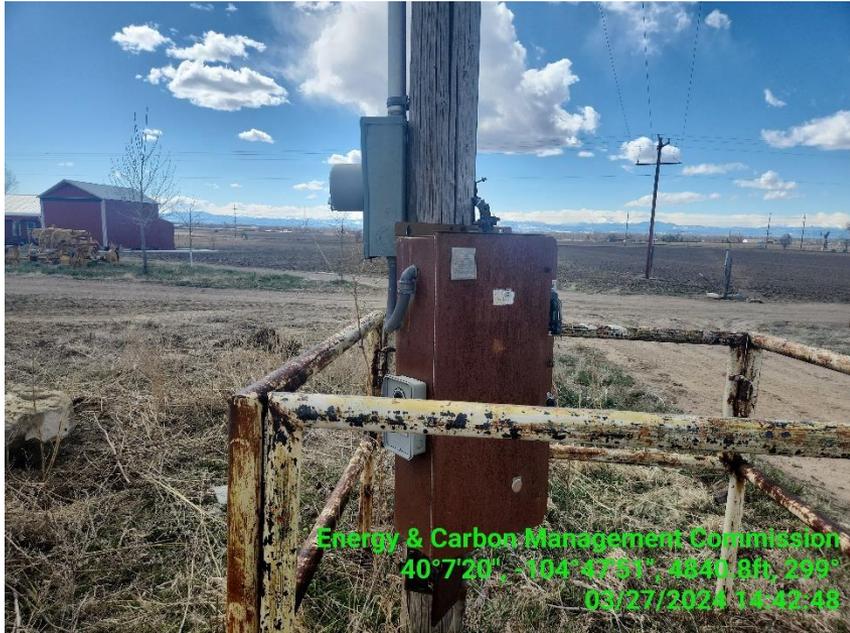
Photo 5 Ancillary equip.

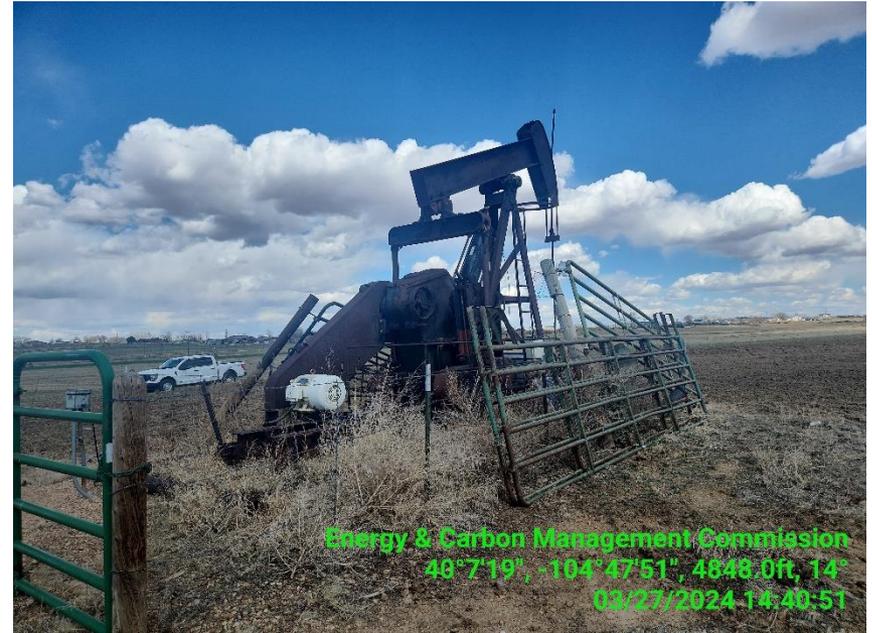
Photo 6 Debris(dead vegetation) around the Wellsite.

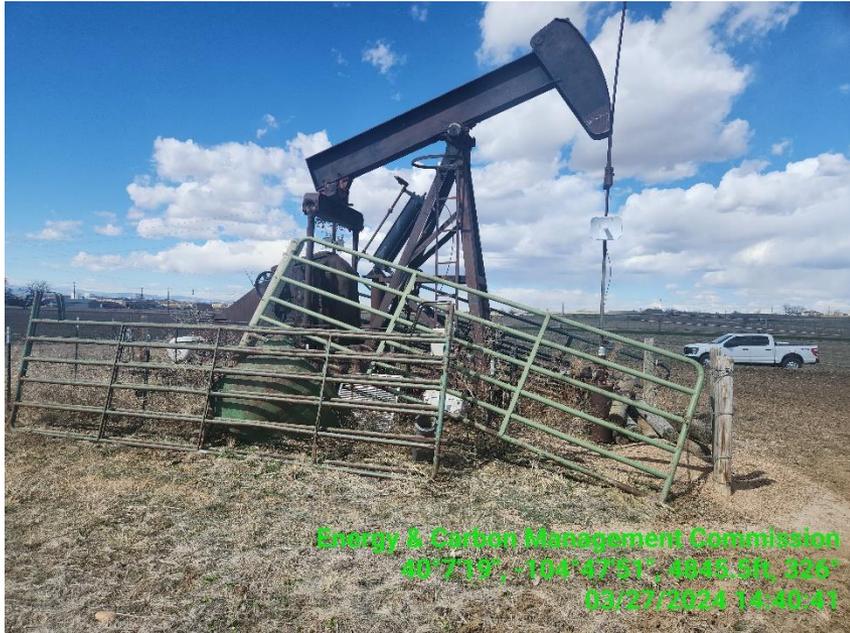
Photo 7 Land owner has AG gates stacked around the wellsite.

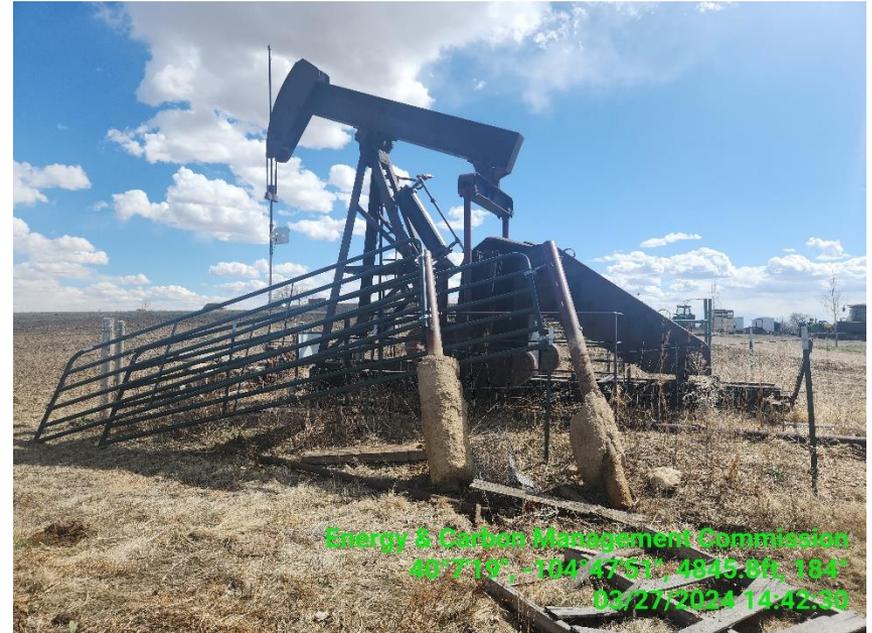
Photo 8 Land owner has AG gates stacked around the wellsite.
