Operator: EXTRACTION OIL & GAS INC

Location Name: Historic Miller 4-17J/Miller 14-17 Pit

Inspection: 714300039

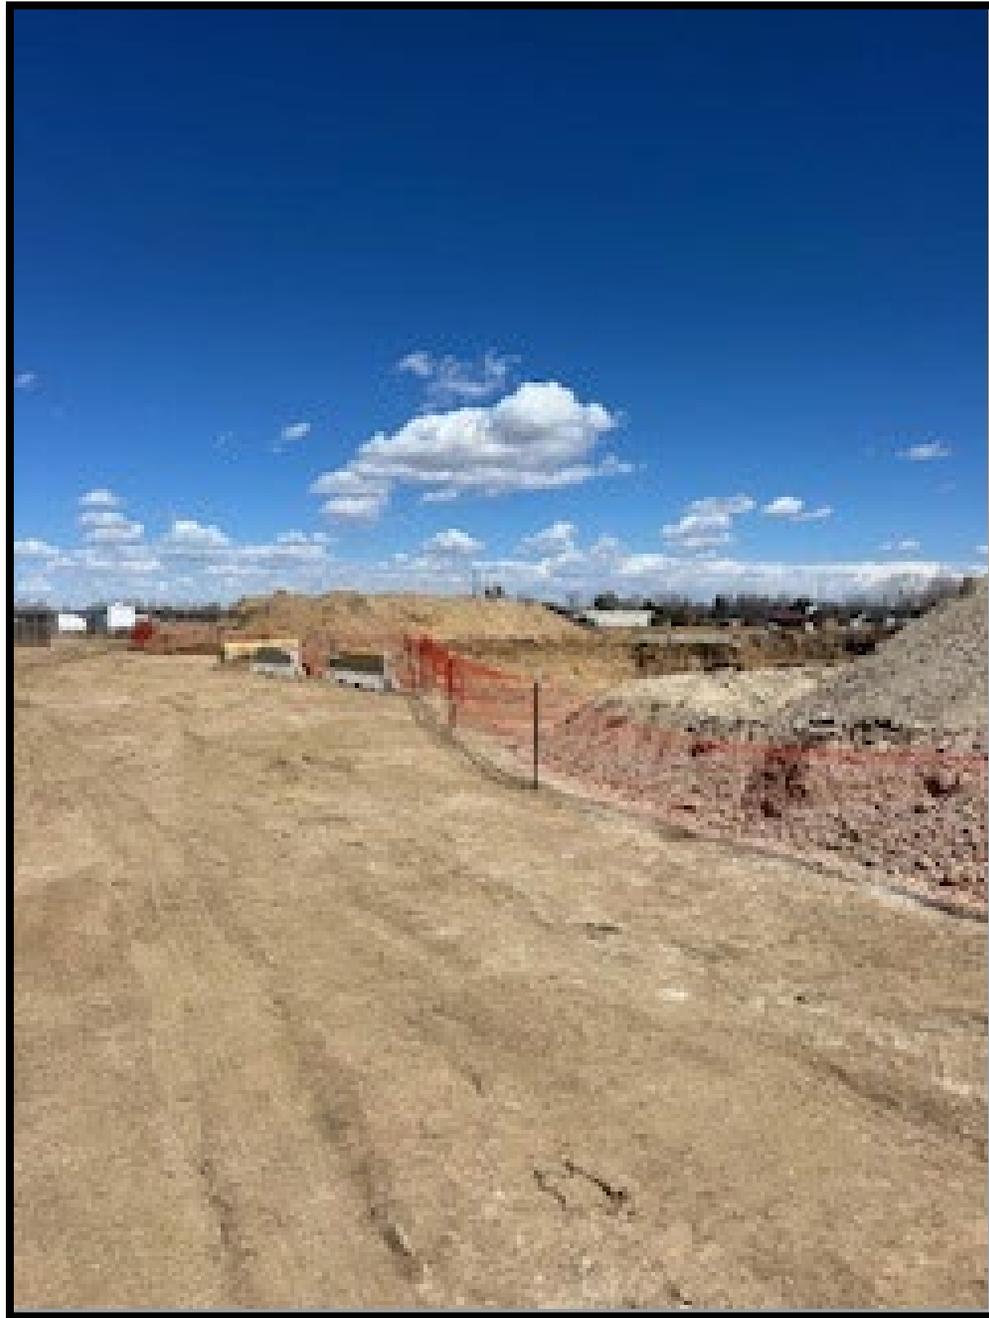
Exhibit A

CA: Fencing around the excavation is inadequate. Excavation is partly surrounded by soil berms which are inadequate for securing the excavation. Fencing is has fallen in some locations. Multiple residences are nearby the spill excavation. Secure access to excavation in compliance with Rule 913.b.(5).B.i and ECMC Guidance 913.b.(5)B i-v

CA Resolution: Operator has appropriately repaired/installed fencing to comply with Rule 913.b.(5).B.i and ECMC Guidance 913.b.(5)B i-v.
