Inspection Photos

API: 017-06622

Operator: **WILLIFORD ENERGY COMPANY**

Inspection Date: 3/26/2024

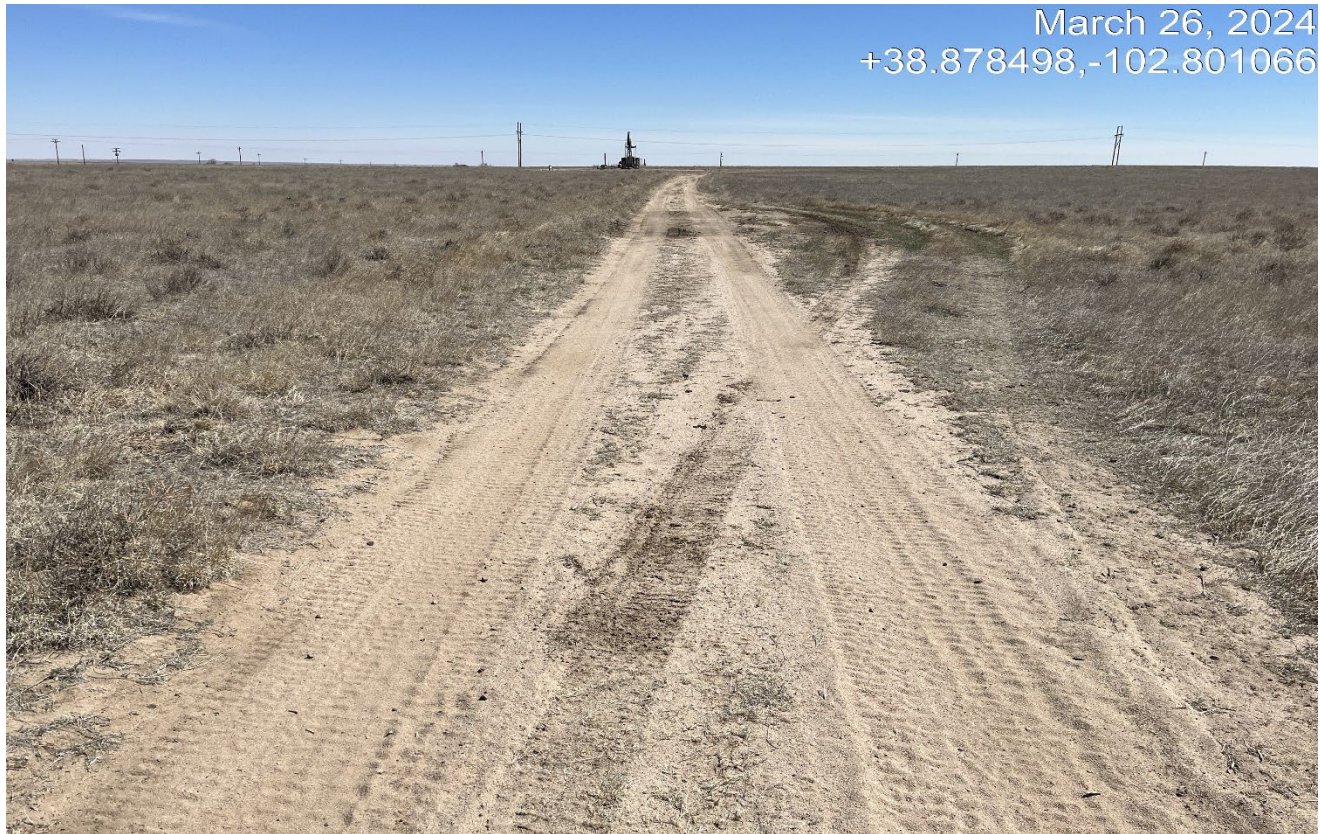
Photo 1. Facing east along the access road. Vehicles are causing unnecessary disturbance driving outside of the access road due to stormwater pooling on the road. The access road must be maintained and shall not drive outside of the access road boundary.

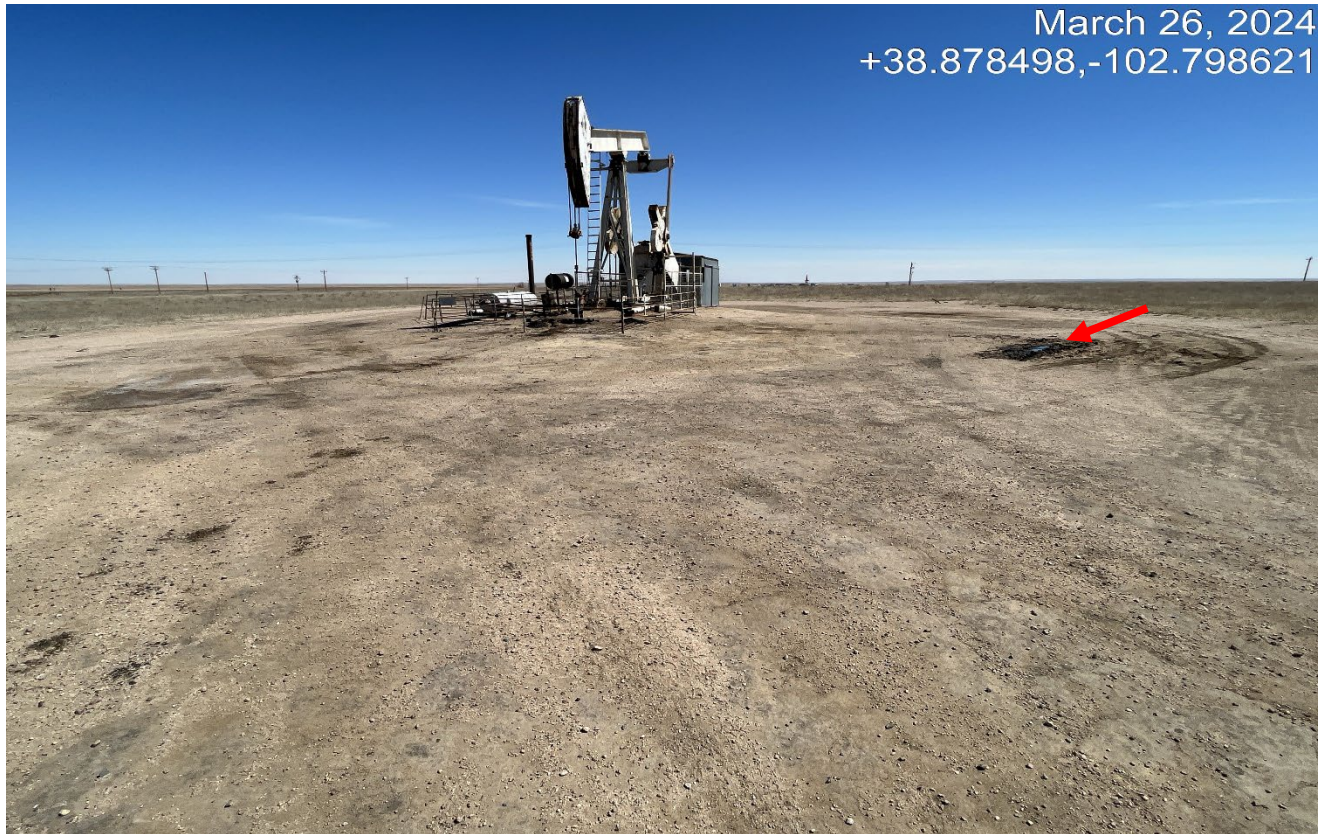
Photo 2. Facing east at the wellsite. There is oily waste pooled up on the surface shown at red arrow.

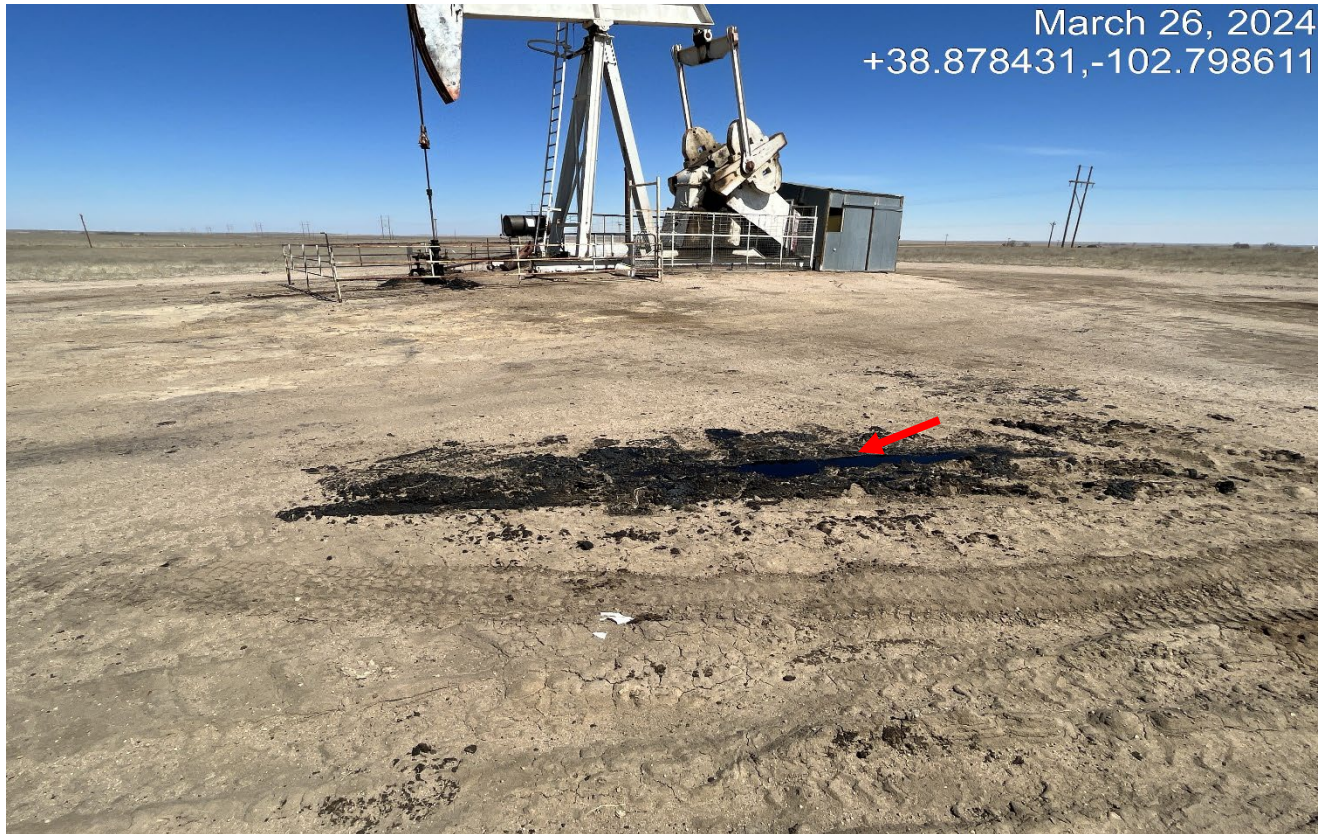
Photo 3. There is oily wasted shown at red arrow that must be cleaned up and properly disposed.

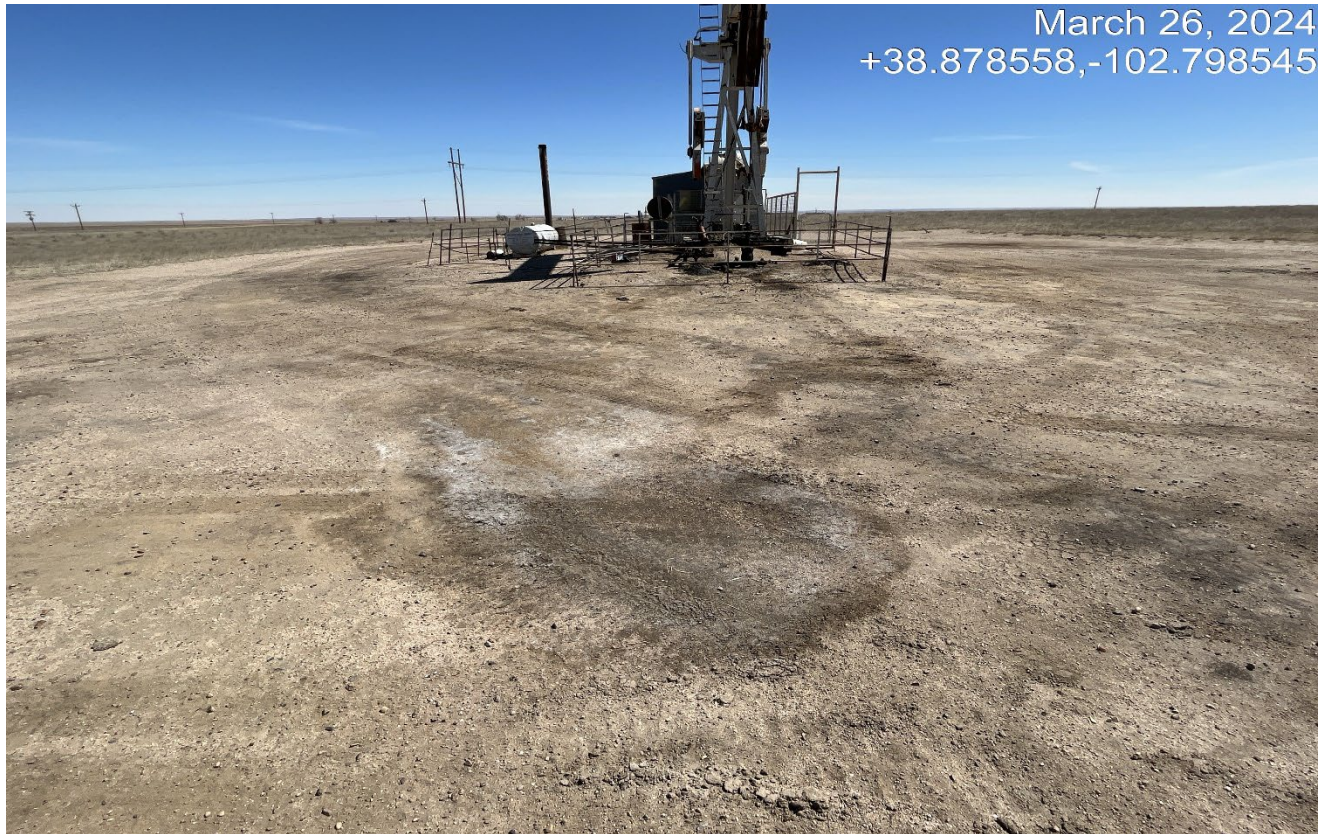
Photo 4. Facing east toward the well. There is signs the a spill occurred at the wellsite that spread out west and south of the well with an undetermined amount spilled which will require a spill report.

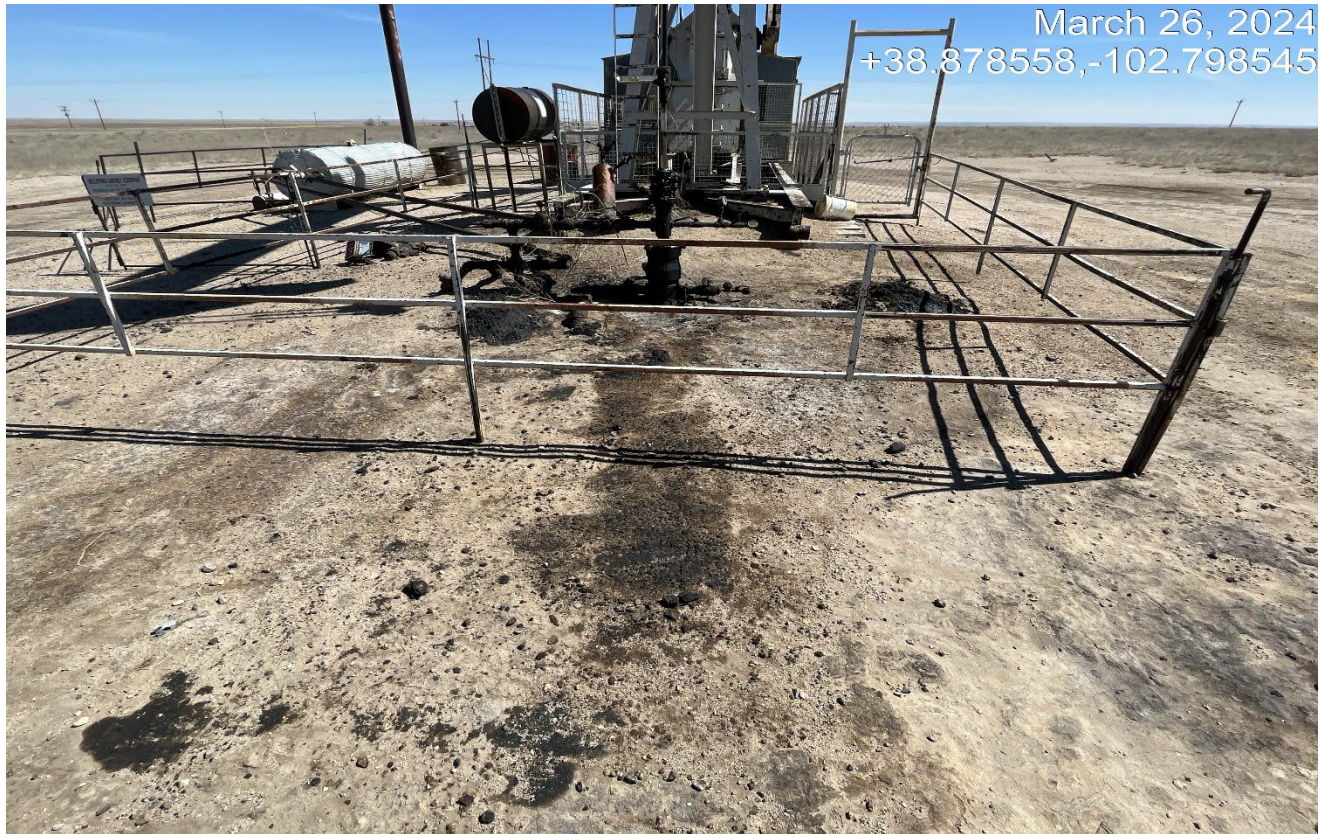
Photo 5. There is a spill that occurred at the wellhead with an undetermined amount spilled which will require a spill report.

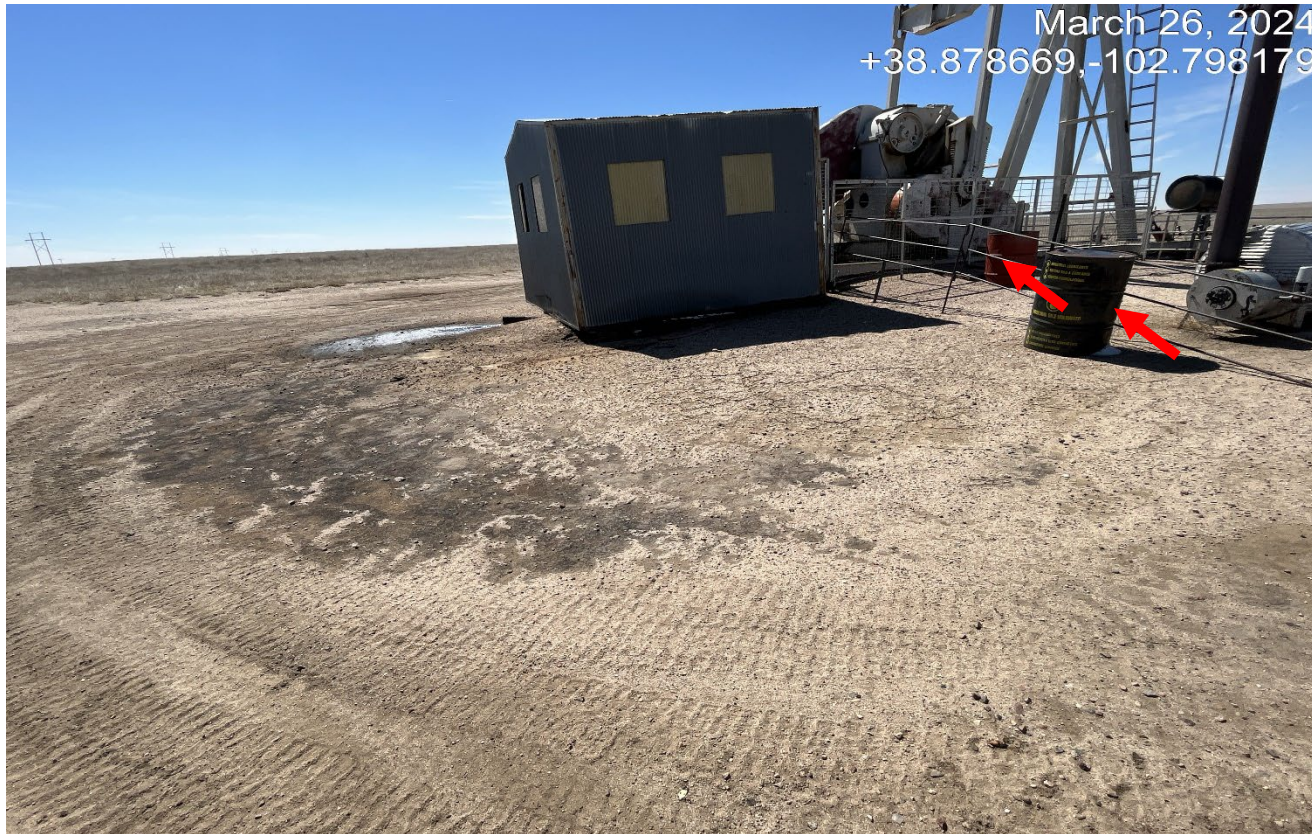
Photo 6. There are chemical barrels with no secondary containment. There are blackened stain soils around the equipment.

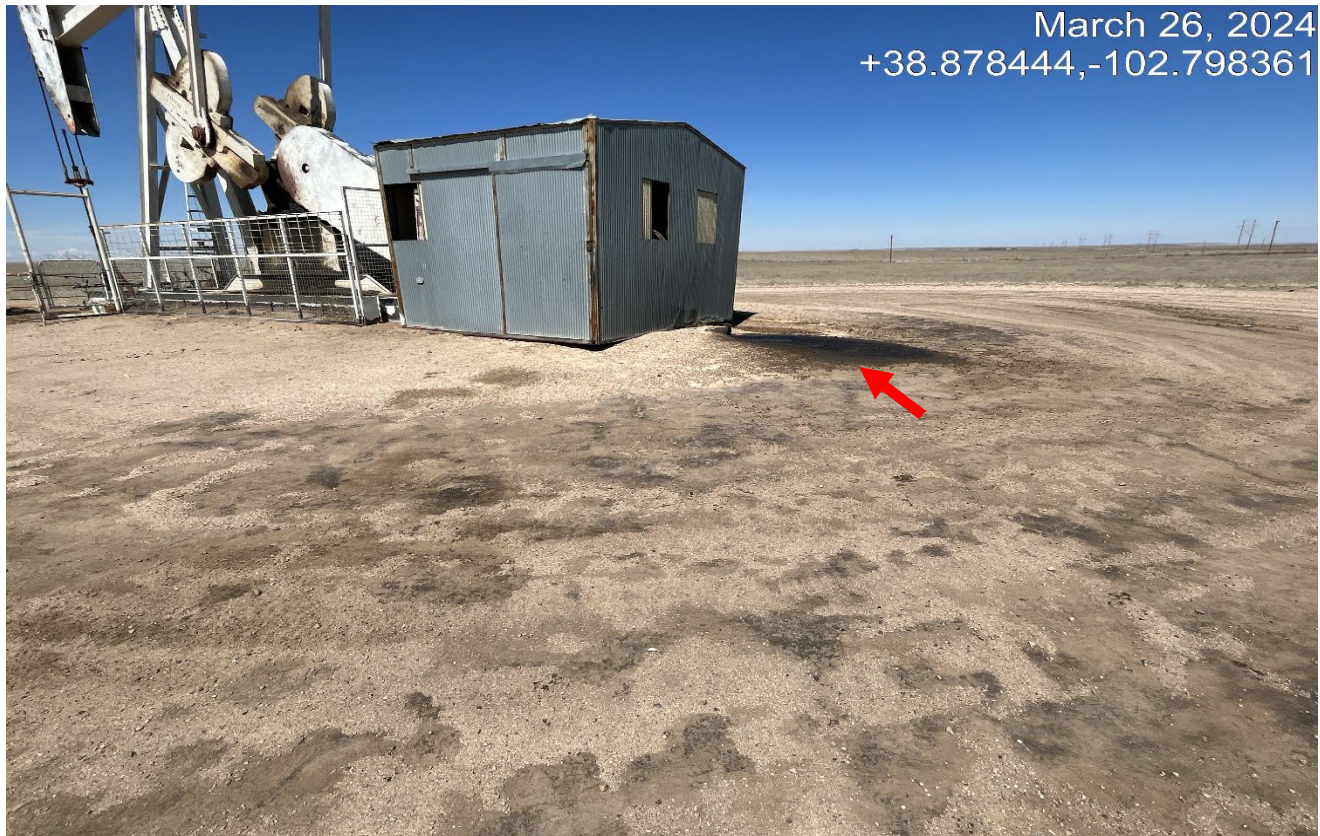
Photo 7. There is oil coming out of the exhaust pipe which is staining the soil and needs to be cleaned up.

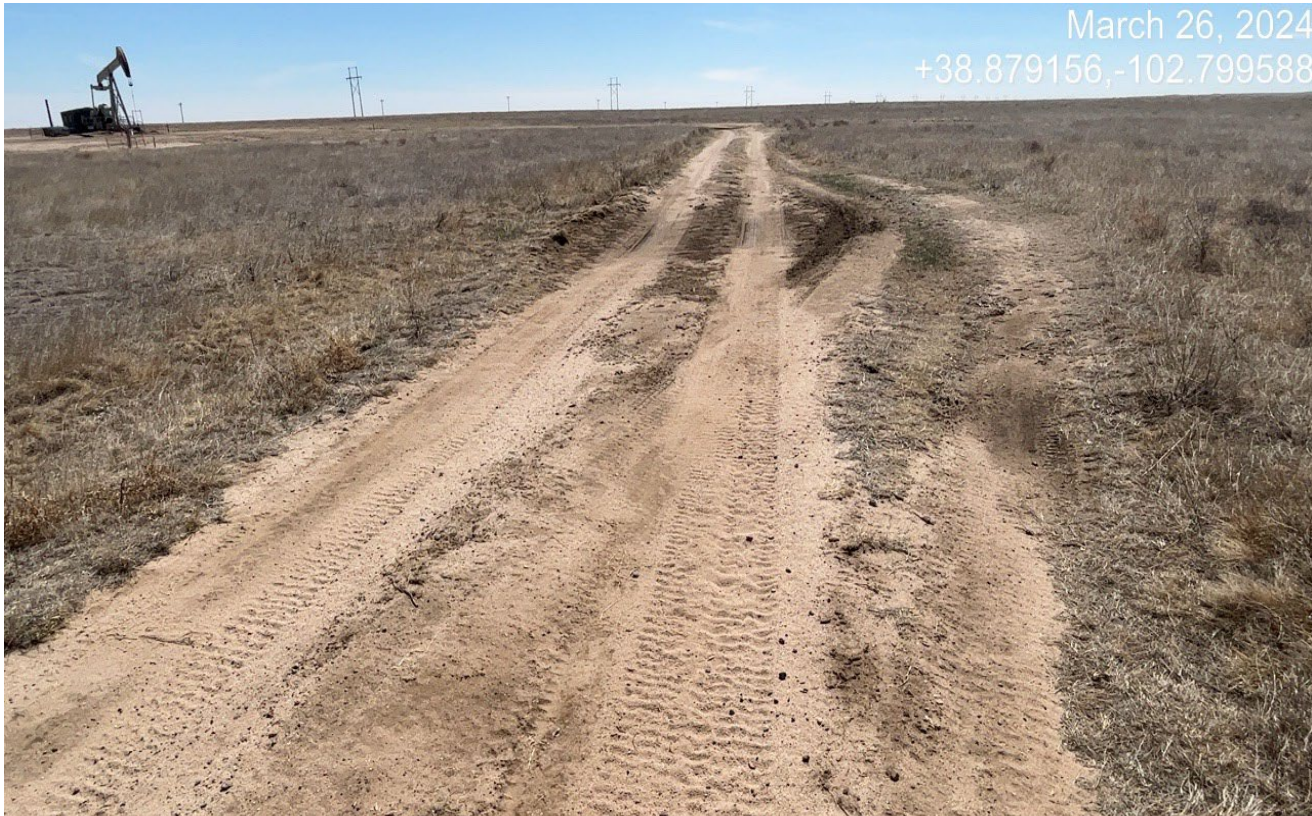
Photo 8. Facing south along the access road. Vehicles are causing unnecessary disturbance driving outside of the access road due to stormwater pooling on the road. The access road must be maintained and shall not drive outside of the access road boundary.

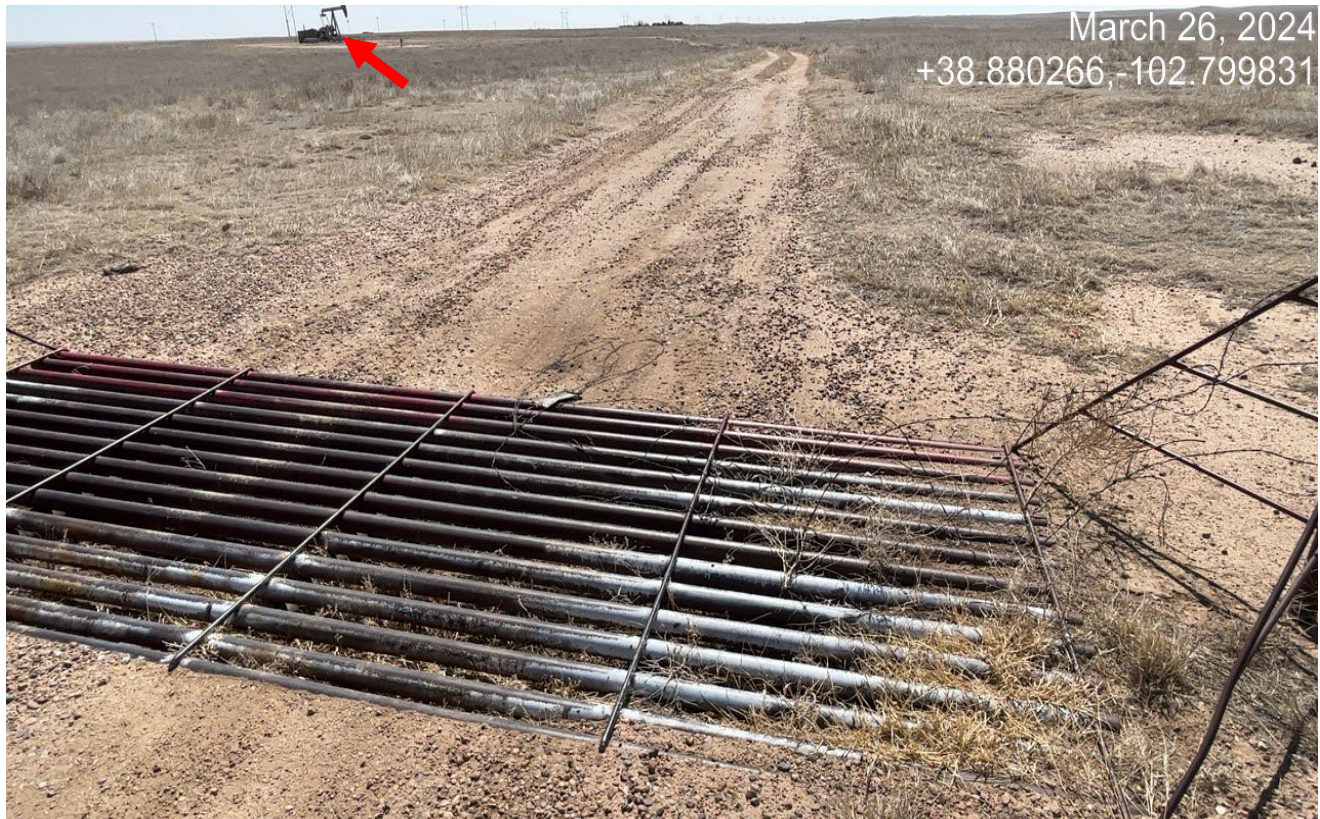
Photo 9. The cattleguard at the beginning of the access road is filled in with sediment and needs to be cleaned out and maintained.
