Inspection Photos

API: 017-06636

Operator: **WILLIFORD ENERGY COMPANY**

Inspection Date: 3/26/2024

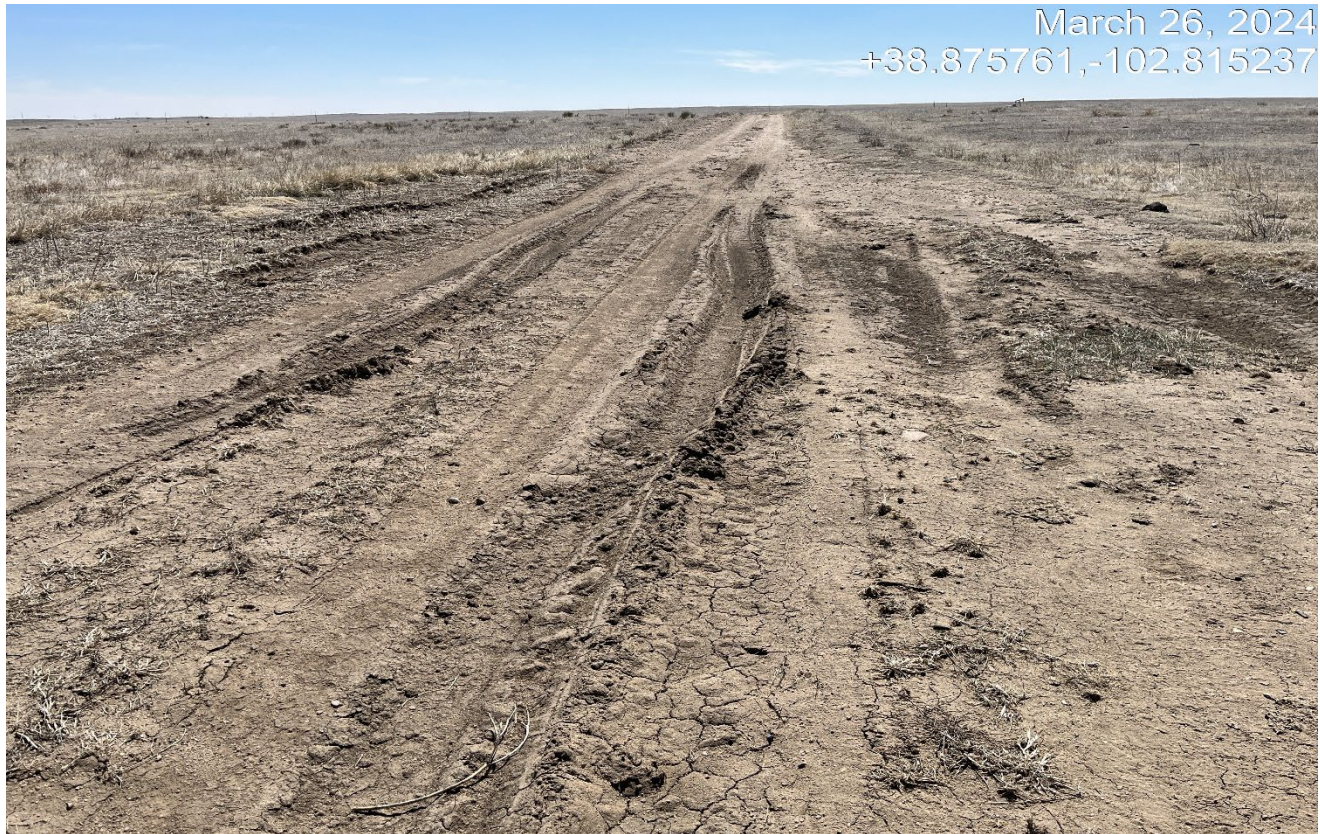
Photo 1. Facing east along the access road. Vehicles are causing unnecessary disturbance driving outside of the access road due to stormwater pooling on the road. The access road must be maintained and shall not drive outside of the access road boundary.

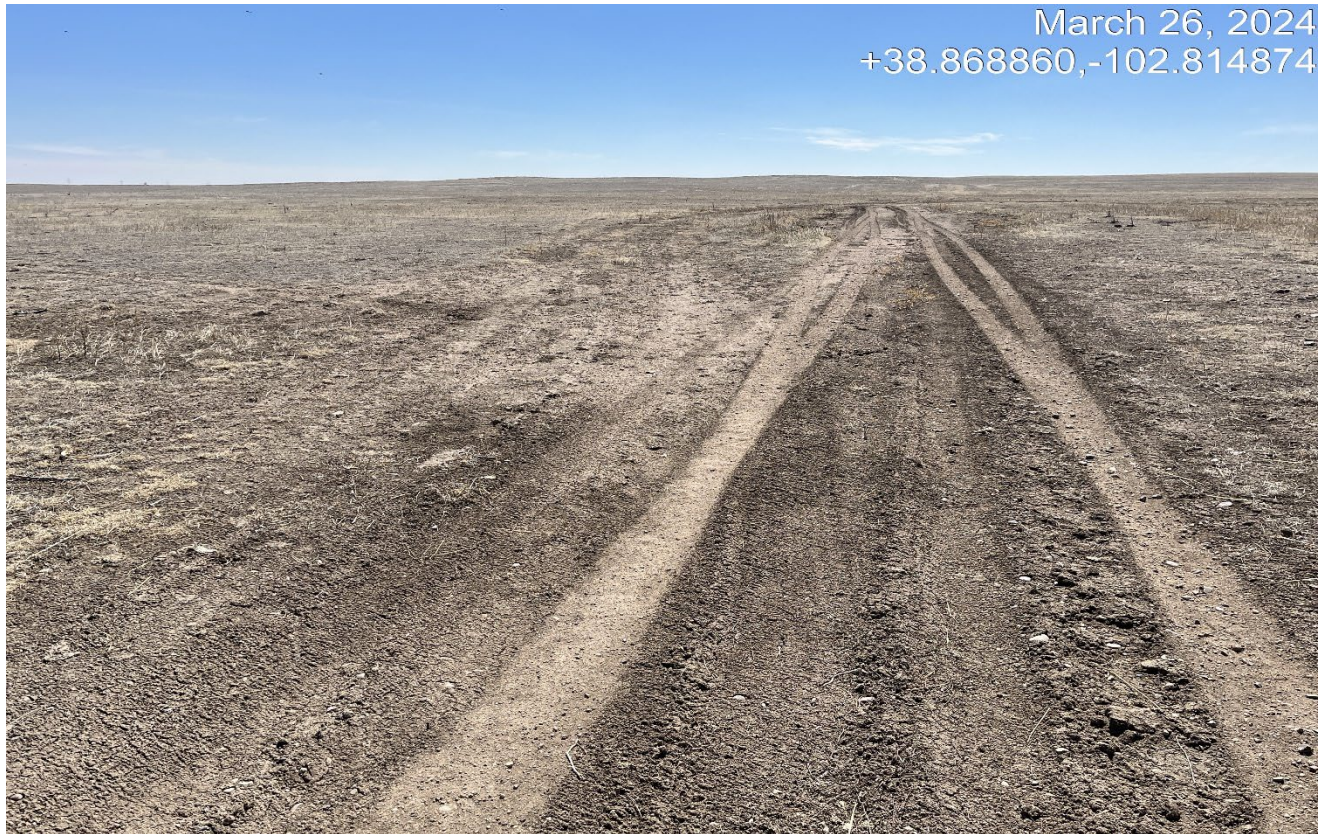
Photo 2. Facing east along the access road. Vehicles are causing unnecessary disturbance driving outside of the access road due to stormwater pooling on the road. The access road must be maintained and shall not drive outside of the access road boundary.

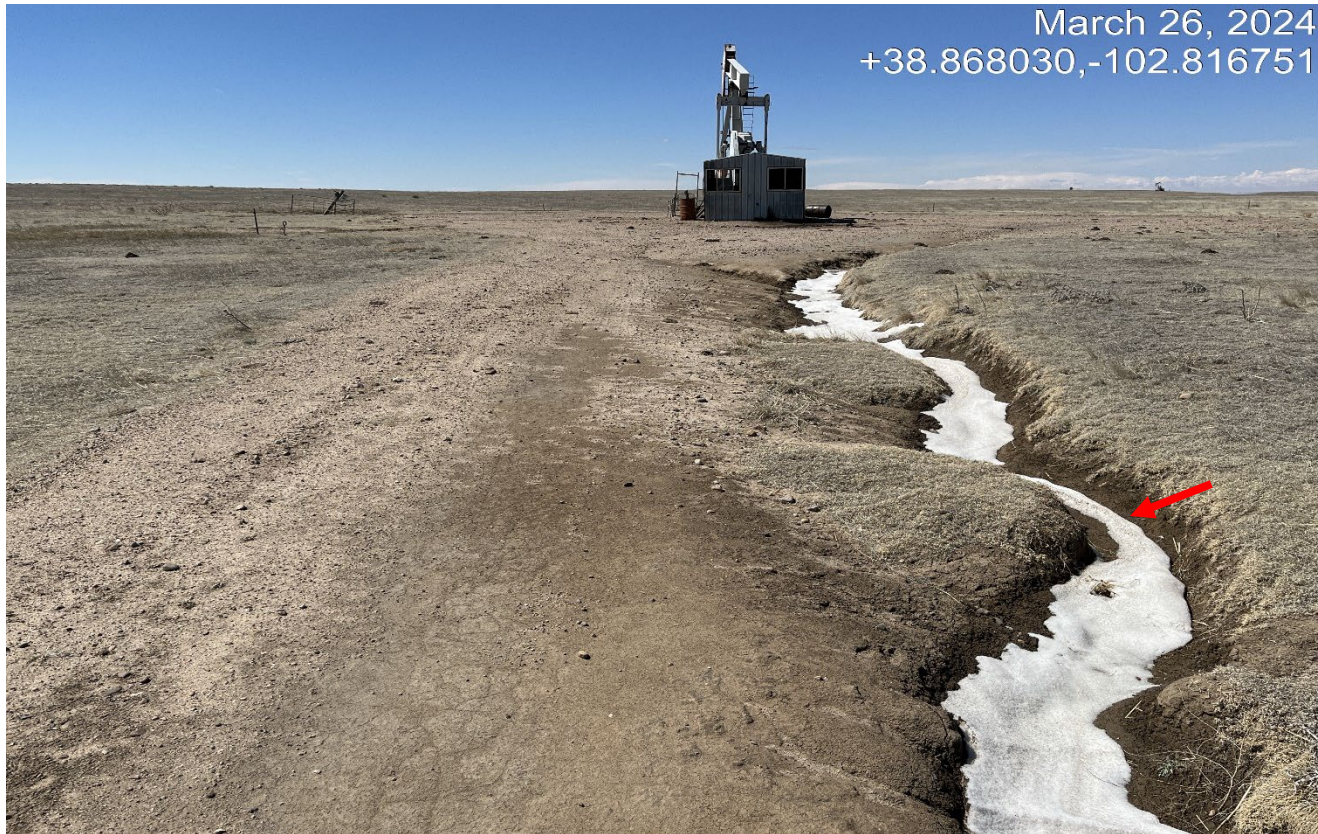
Photo 3. Facing west along the road toward the wellsite. There is an erosion channel coming from the wellsite along the road that will need to be repaired and stabilized.

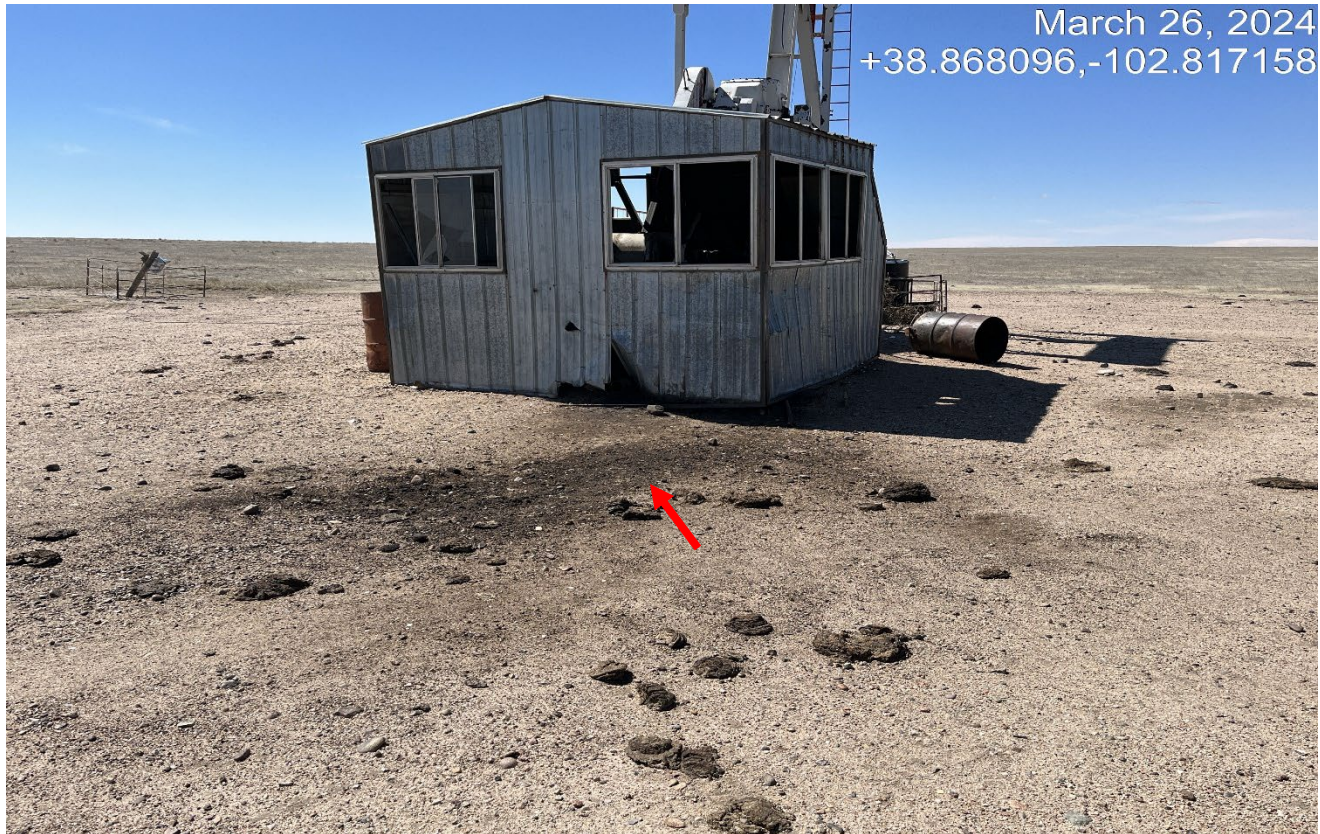
Photo 4. There is stained soils from a leak occurring from the pumpjack engine.

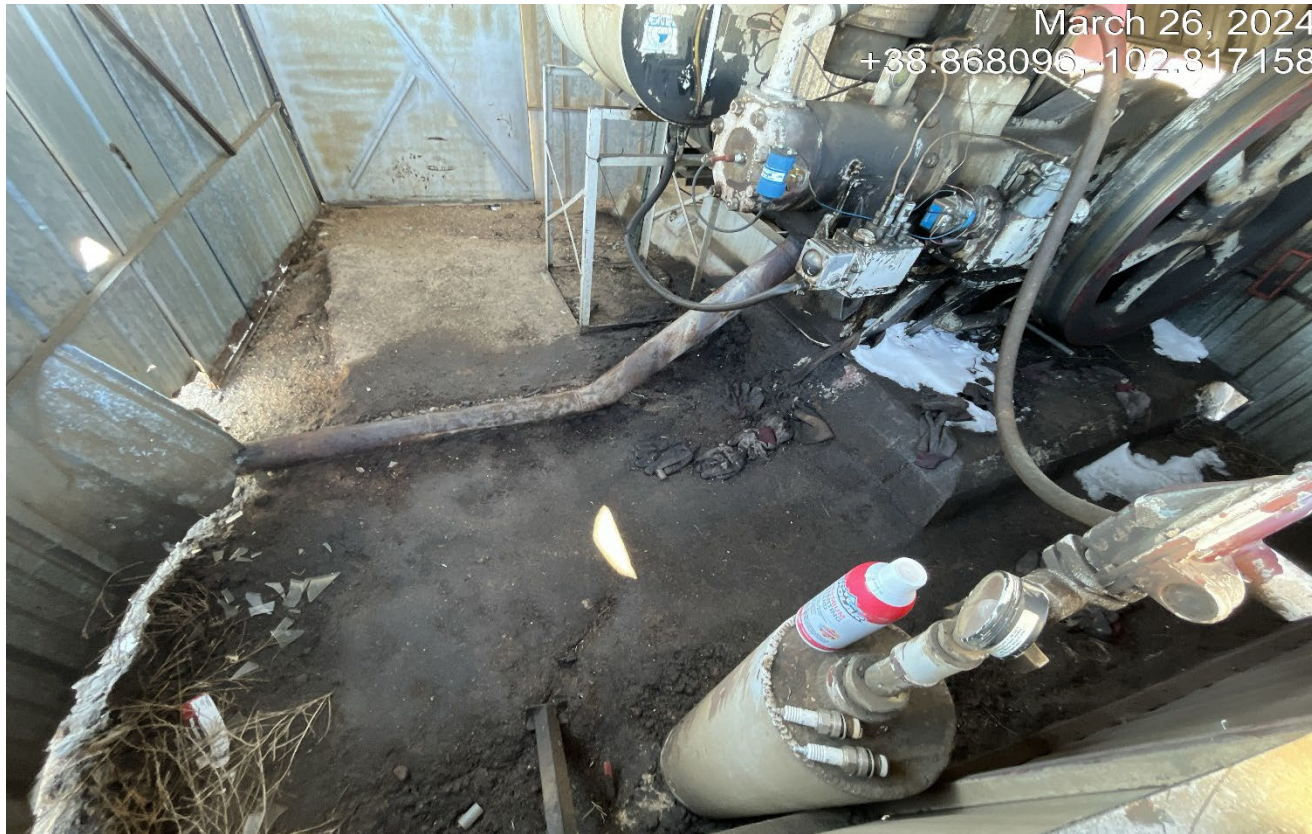
Photo 5. View of inside the shed shows oil saturated soils from the leaking engine.

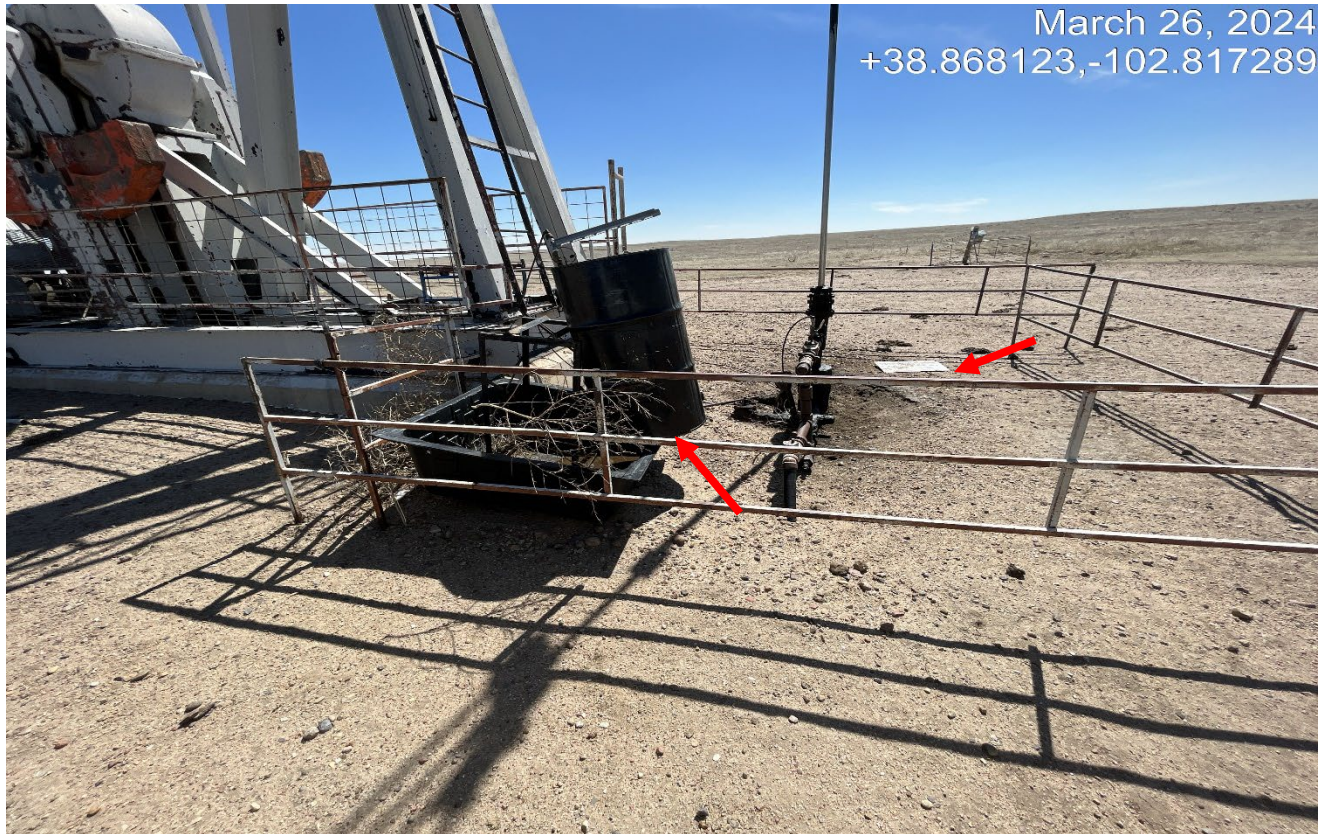
Photo 6. Facing toward the wellhead. The well sign is laying on the ground. The barrel is not properly set in the containment.

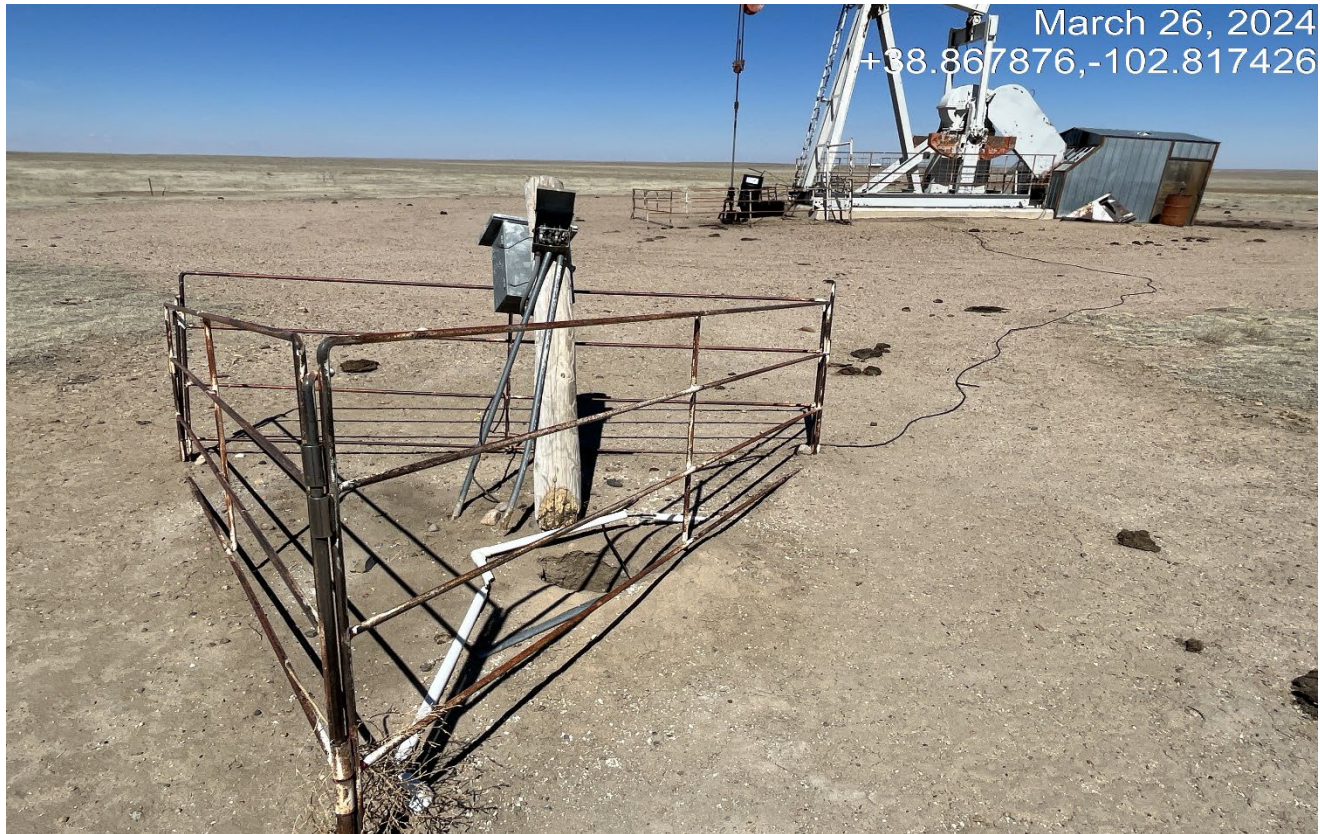
Photo 7. Facing toward the electric utility just south of the well. The electric wire is on the surface and not protected which is a safety concern. The electric breaker is disconnected from the electric line.

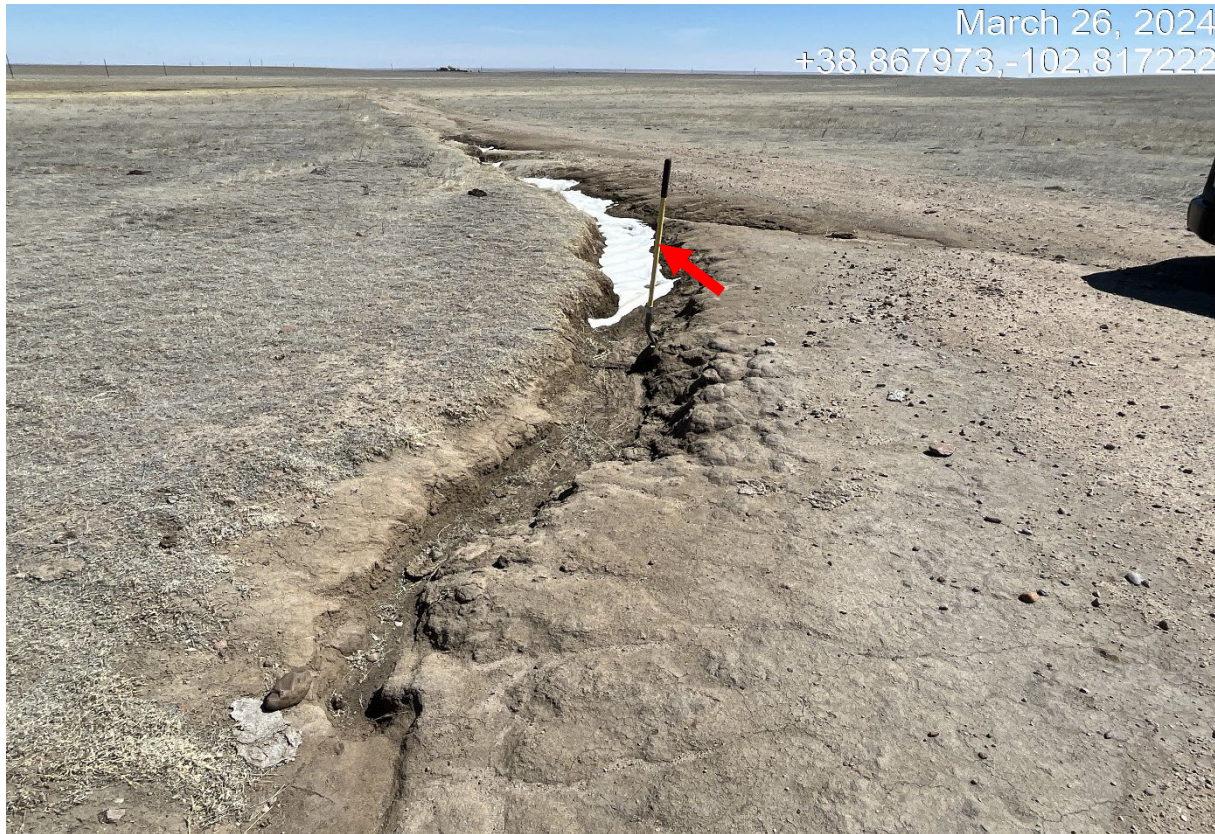
Photo 8. Facing east at the erosion channel occurring along the access road. The red arrow points to a 4.5 ft. shovel for scale.
