Operator: *Crestone Peak Resources*
Location Name: *RAY NELSON-62N68W32NESW*
Loc ID: *336364*
Inspection: *714300048*

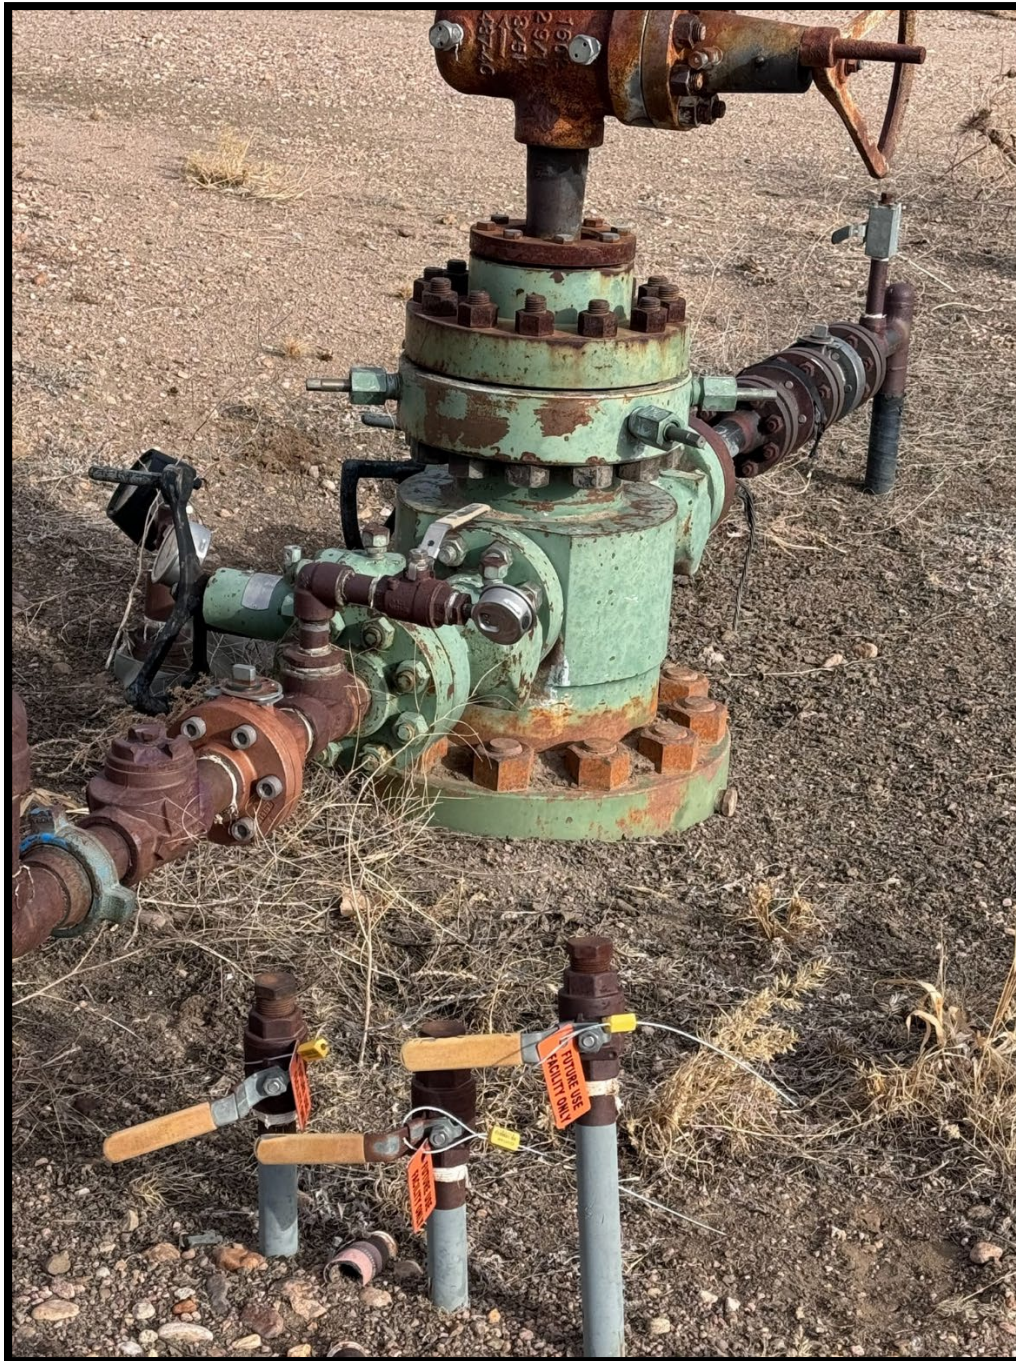
Exhibit A

CA: Unmarked OOSLAT Risers at Tanks, Separator, ECD and Wellhead. See photos. Complete flowline and crude oil transfer line abandonments to comply with Rule 1105.

CA Resolution: Operator has added tags to all identified Risers to comply with Rule 1105.
