KP Kauffman - ECMC Inspection Photos
Location: Facility #8 at Sebald Flowline Release
Spill ID #486343 Date 03/26/2024

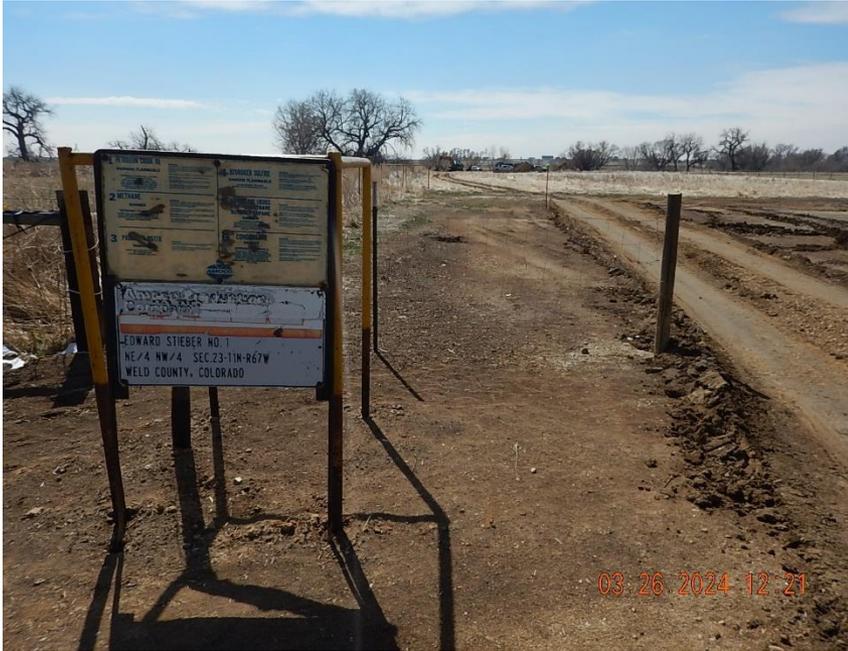
Signage at access road leading south to spill/ release site.

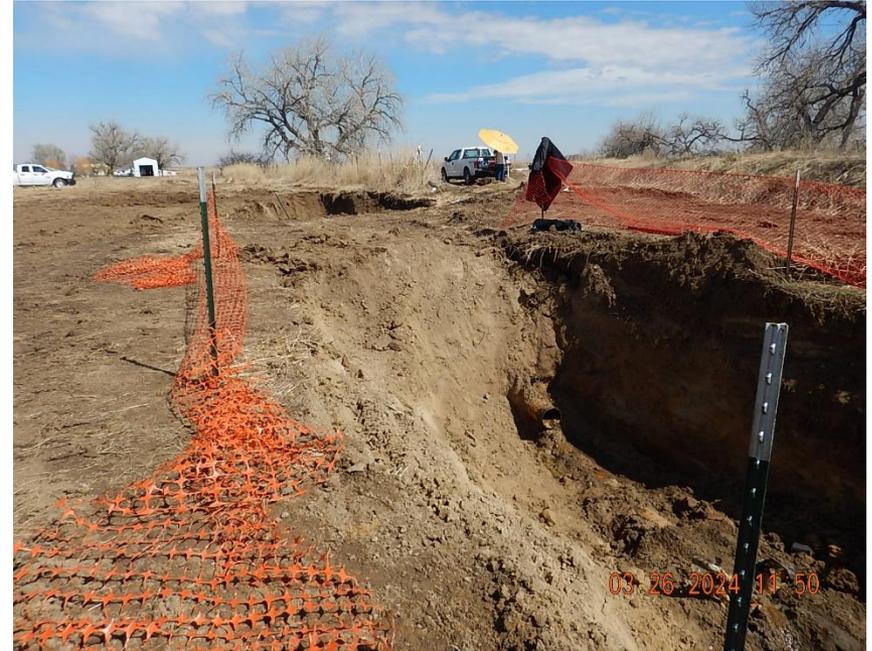
(2) Excavations uncovered off location flowlines. Photo looking north from the south end of the south excavation.

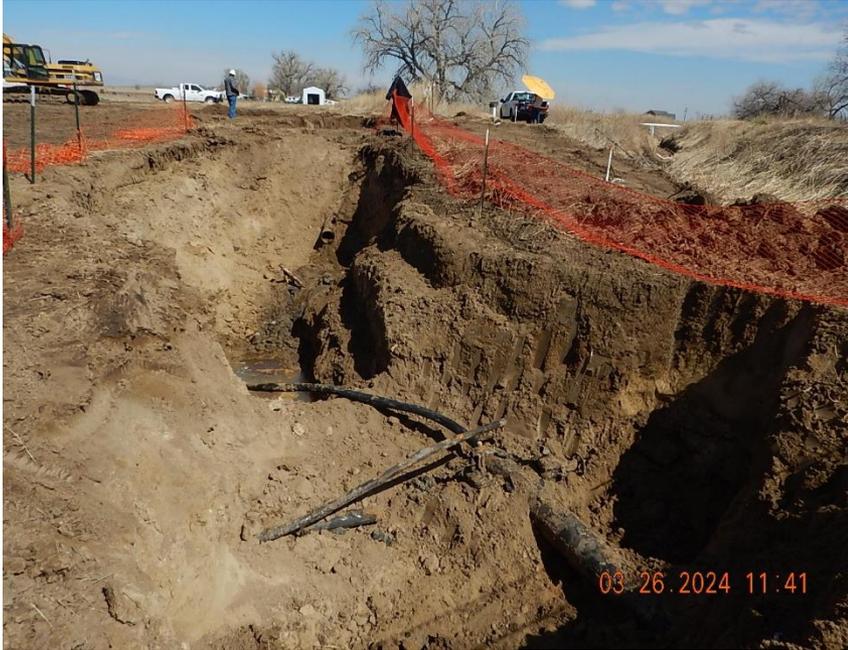
**Flowline pipe observed in the south excavation;
photo looking north.**

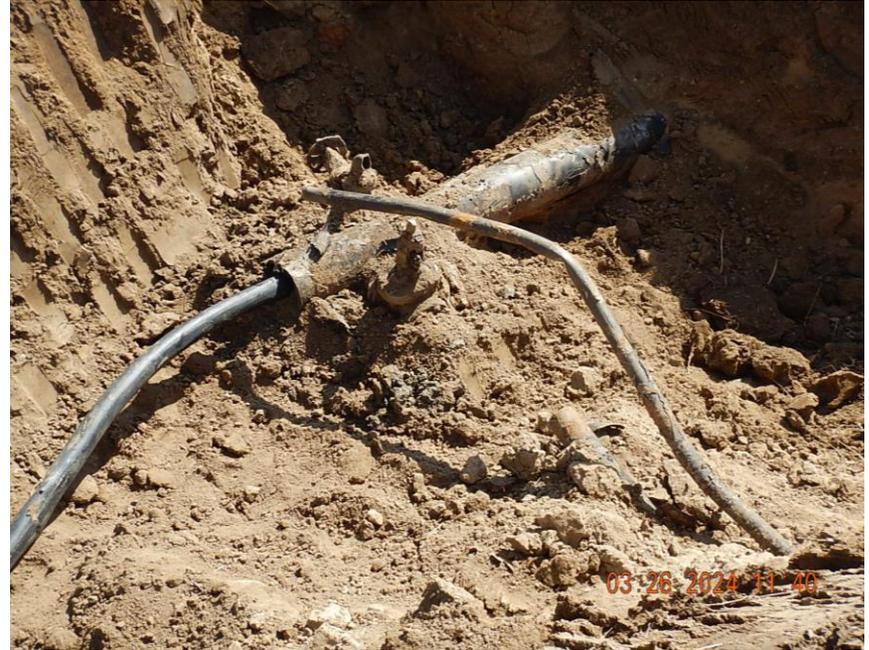
**Close up view of flowline pipe exposed in the south
excavation; 3" HDPE flowline can be seen entering the cut
end of the 8" carbon steel facility 8 flowline (slip line repair).
Also, 2" and 4" historically AIP flowlines (and associated tie
in valves) observed in the excavation.**

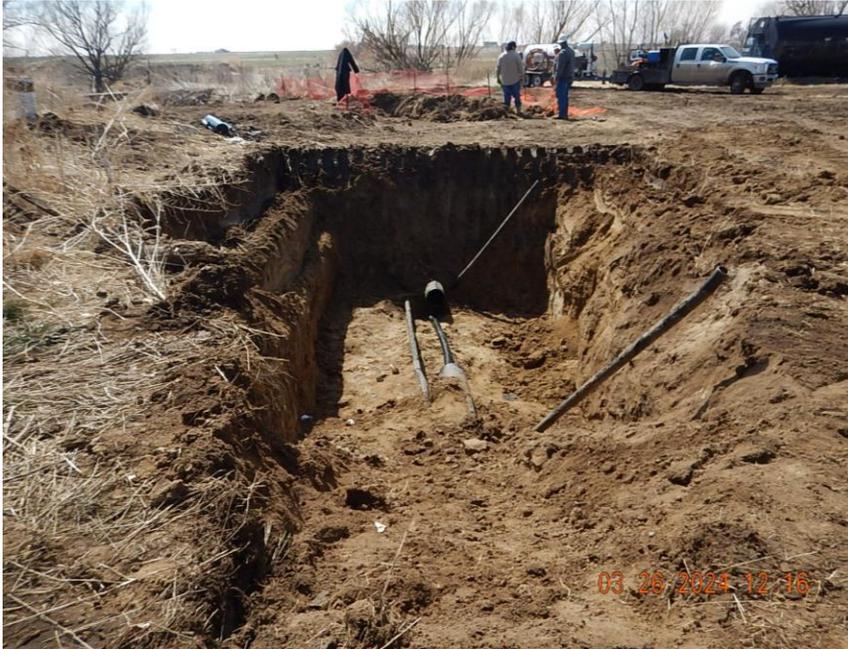
North excavation and flowline pipe exposed. View looking south to excavation where release point identified.

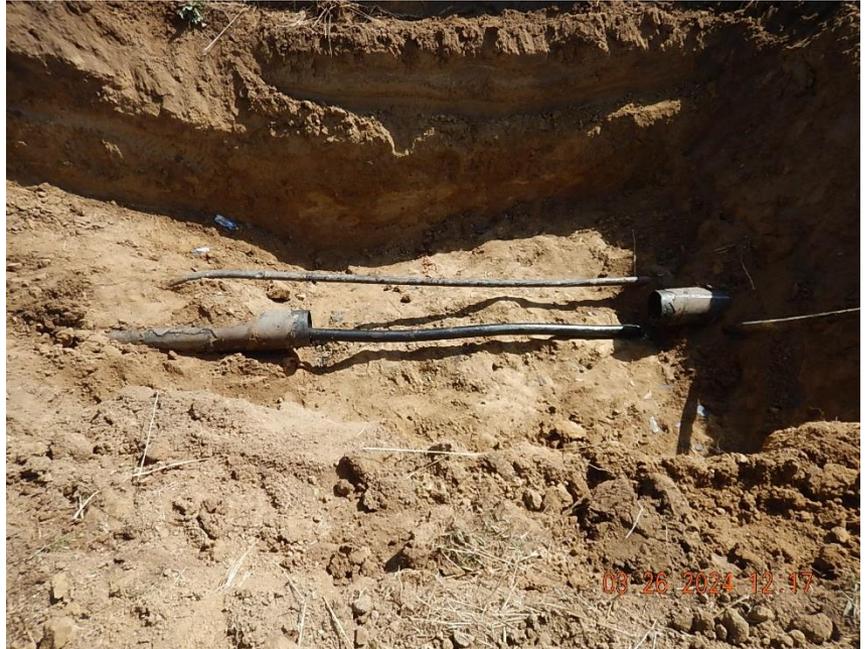
Closer view of flowline pipe observed in north excavation. 3" HDPE poly flowline can be seen entering the cuts end of the 8" carbon steel facility 8 flowline (OOS). In addition, historically AIP 2" CS flowlines were found in excavation.

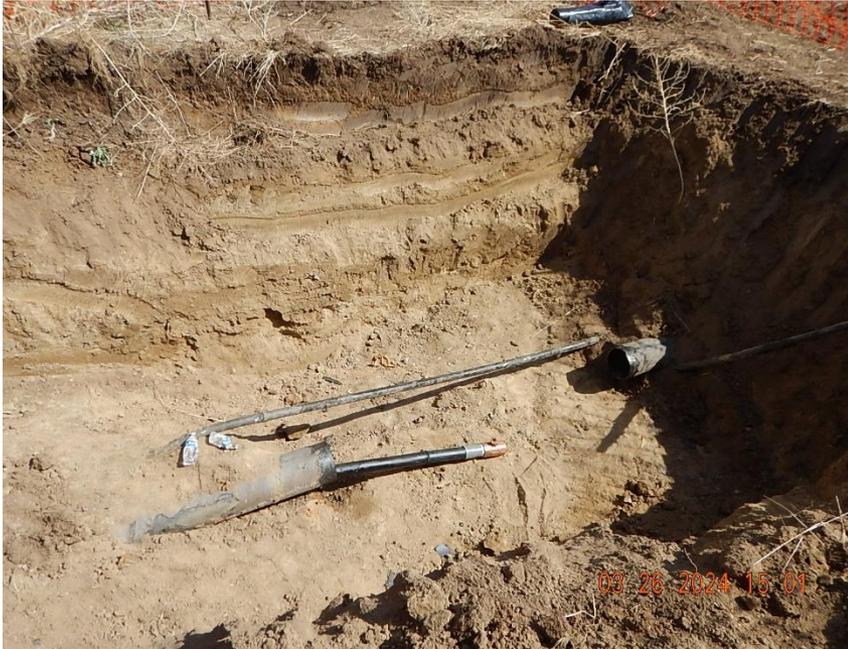
The failure point found inside the 8" CS pipe unearthed at the north excavation. The 8" pipe section has been cut out to access to the failed 3" HDPE flowline pipe inside; a separated poly fusion weld was found. A valve has been installed on the cut end of the 3" HDPE pipe by the operator.

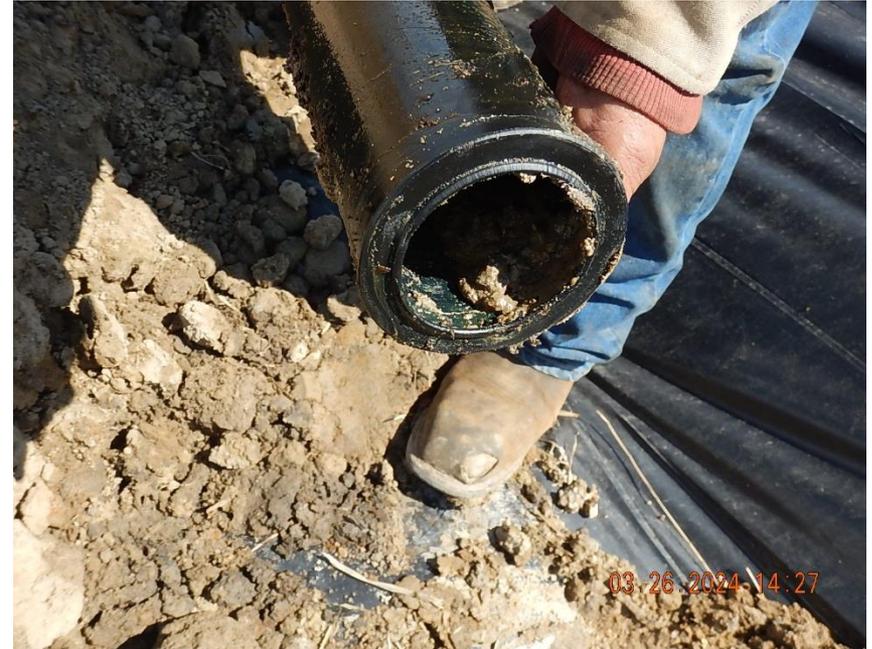
Photo of one end of the failed butt-end poly fusion weld. Root cause leading to poly weld failure to be determined.
