# Inspection Photos

Loc: 321574

Operator: MULL DRILLING COMPANY INC

Inspection Date: 3/26/2024

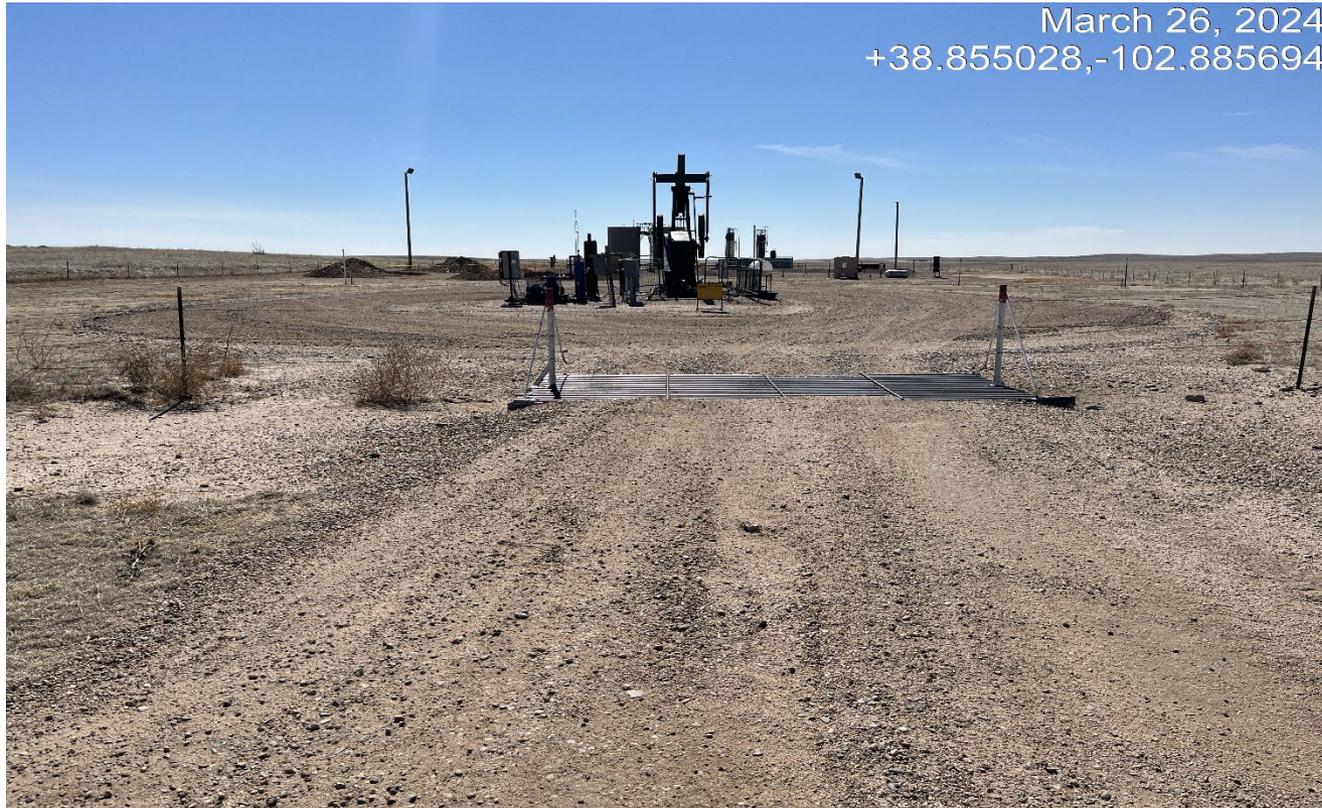
**Photo 1.** Facing south toward wellsite location.

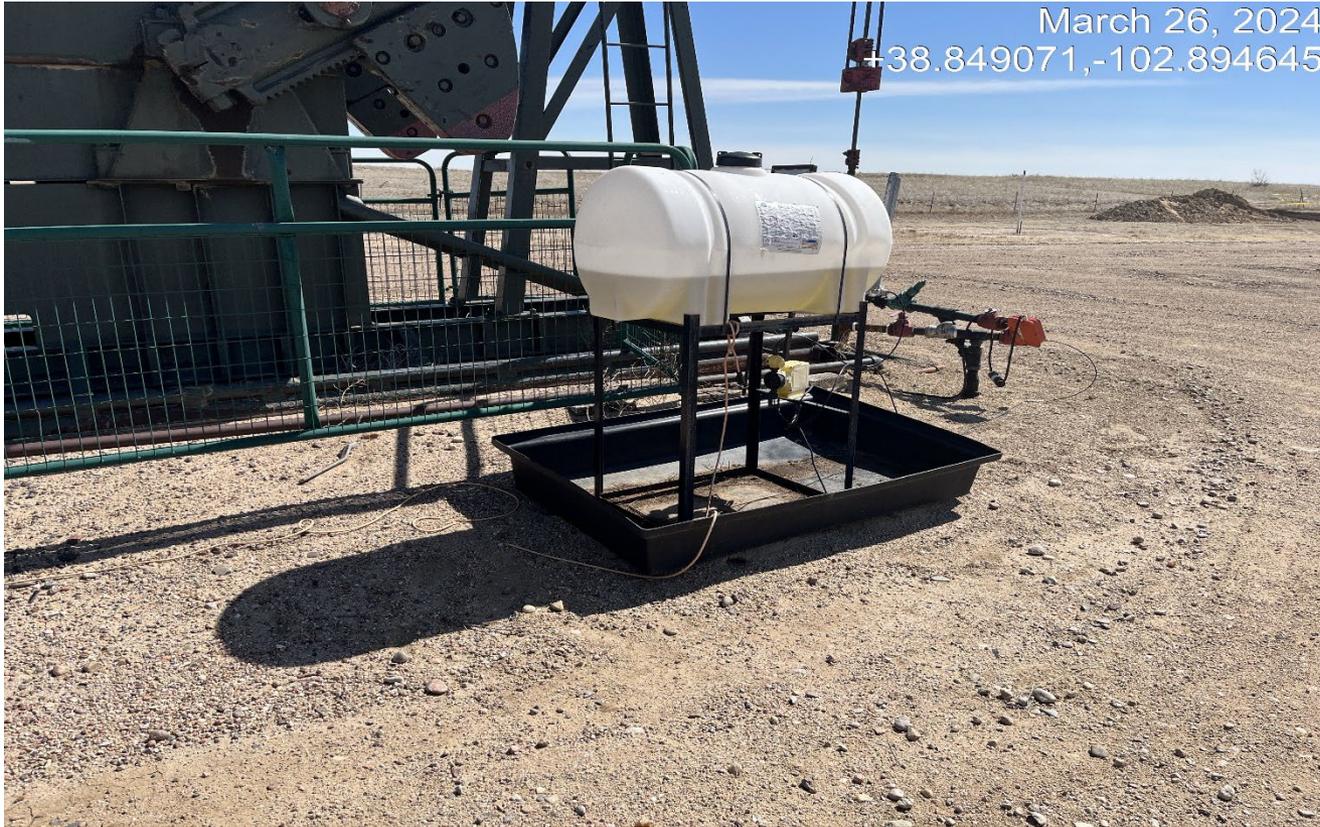
**Photo 2.** Facing toward the wellhead.

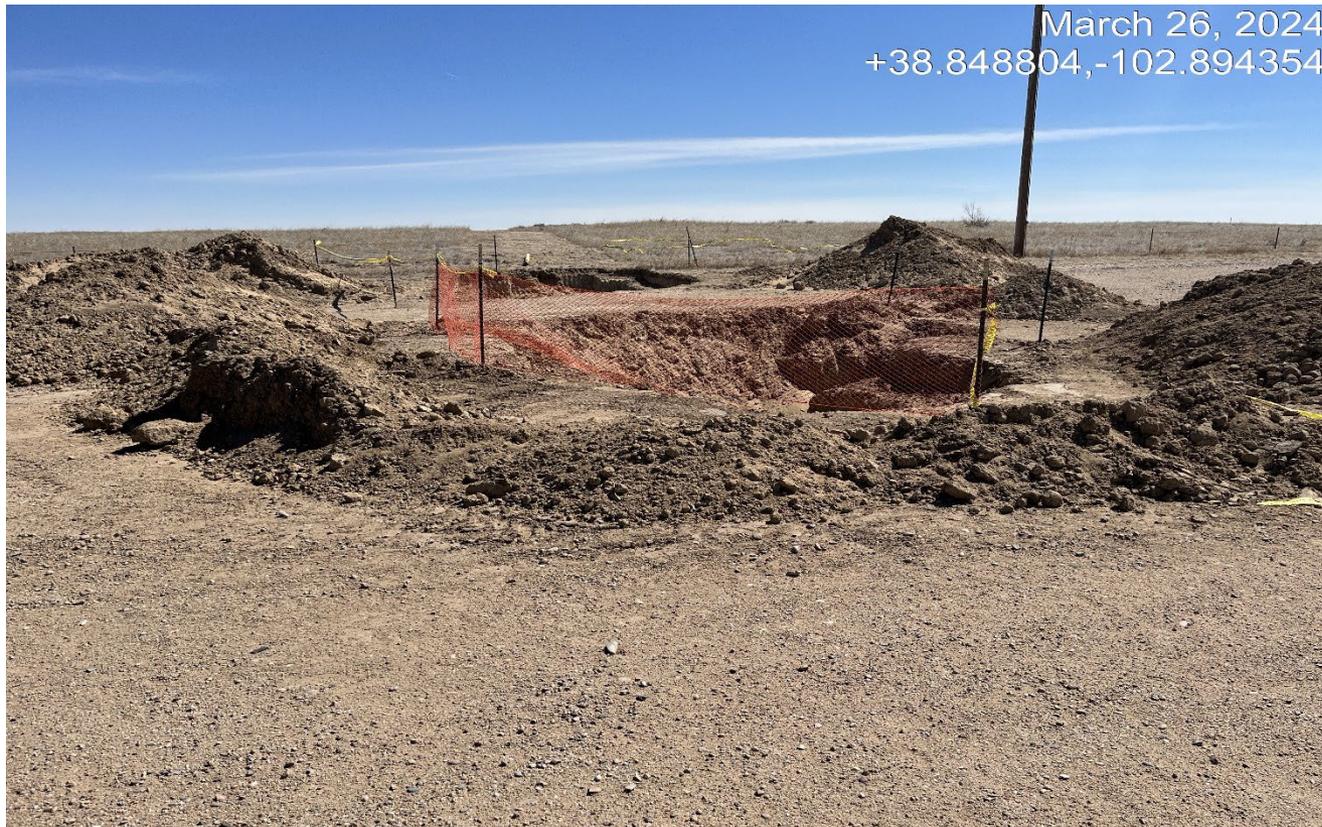
**Photo 3.** Facing northwest. There is an open excavation along the pipeline. There is an orange safety fence installed around the excavation.

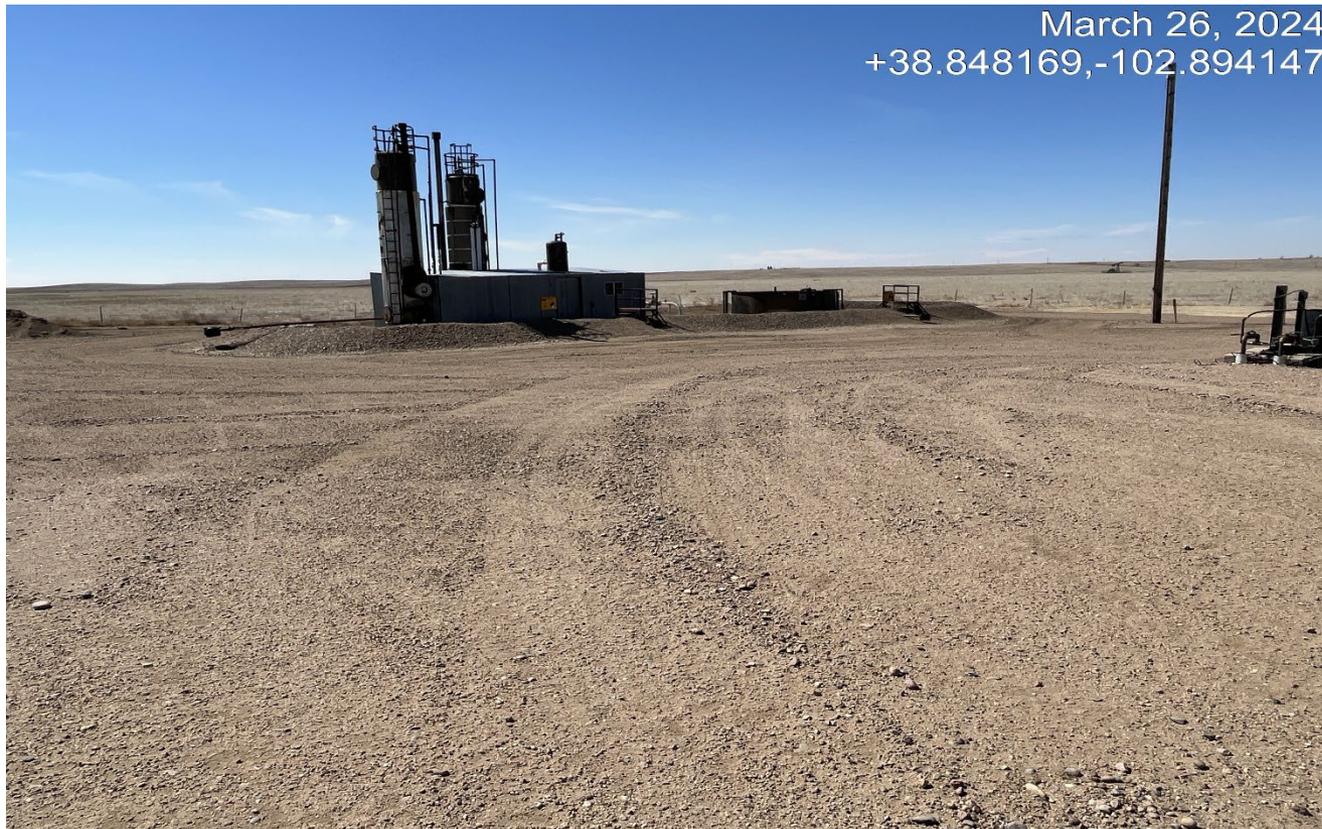
**Photo 4.** Facing toward the equipment at the south side of the location..

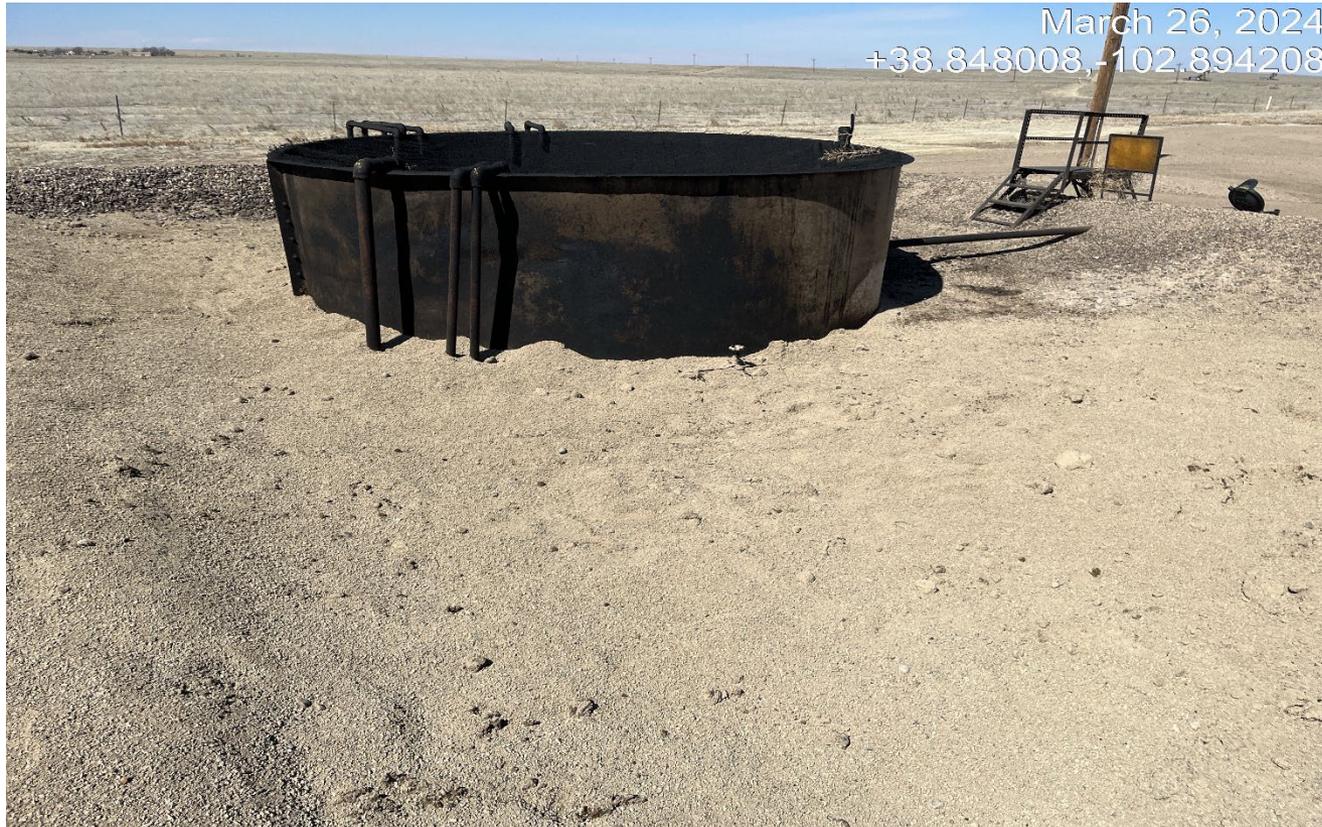
**Photo 5.** Facing toward the open top tank where the spill was observed during previous inspection. There is fresh sandy material that was spread over this area.

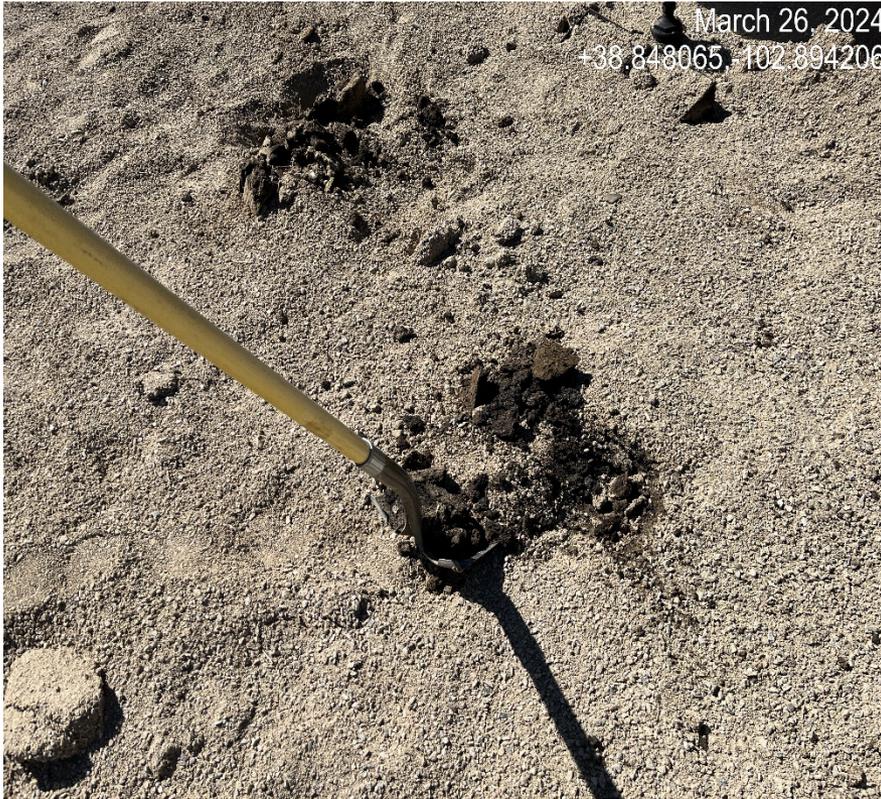
**Photo 6.** There is still oily soils and it appears material was spread over the spill to cover it up.

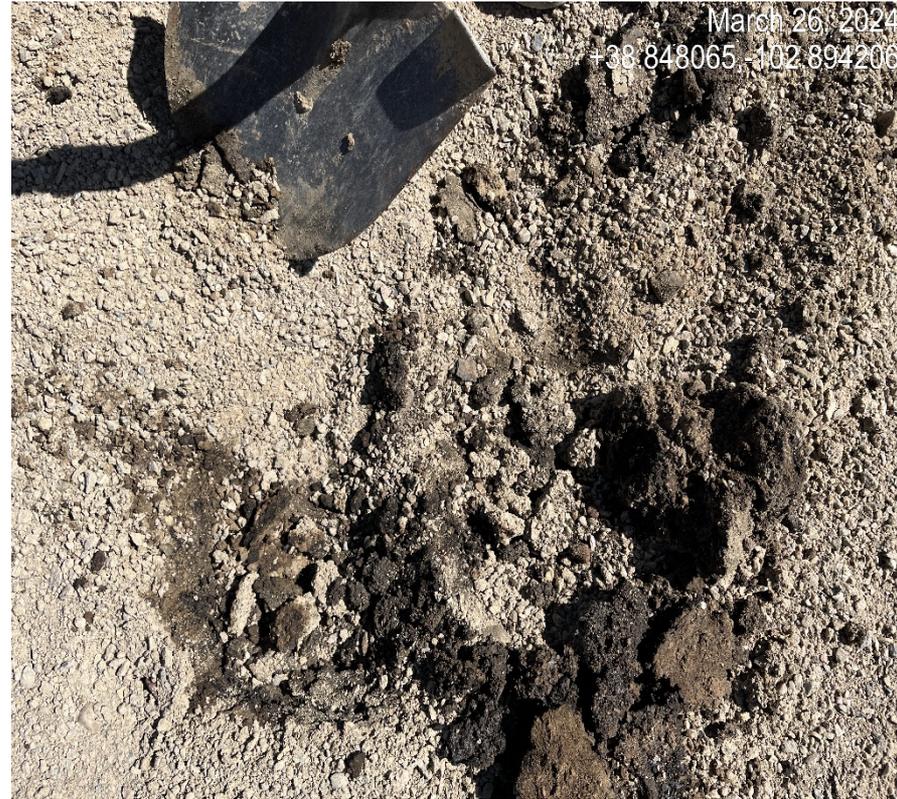
**Photo 7.** View of oily soils still found by the open top tank.

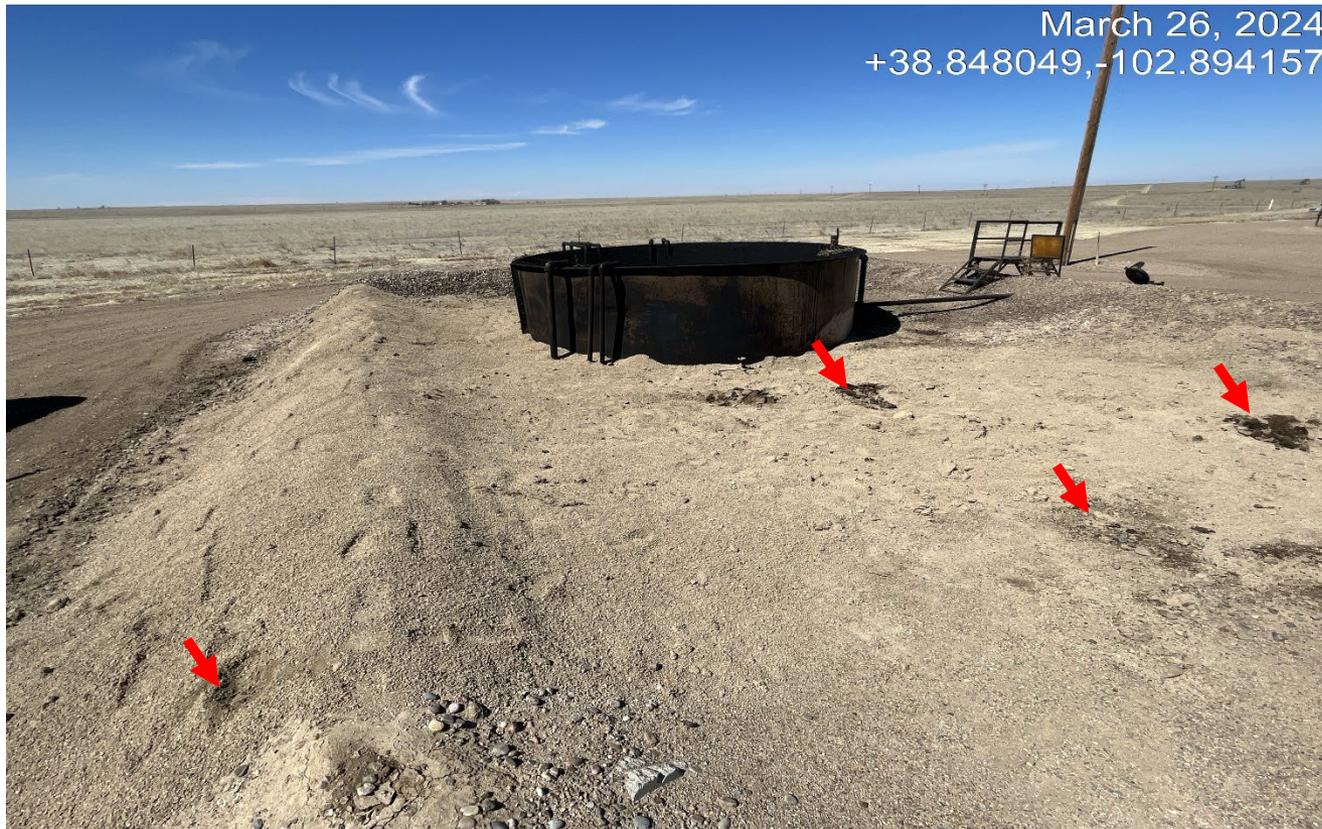
**Photo 8.** The red arrows point to areas where oily soils have not been cleaned up.
