Inspection Photos

Loc: 381172

Operator: CITATION OIL & GAS CORP

Inspection Date: 3/26/2024

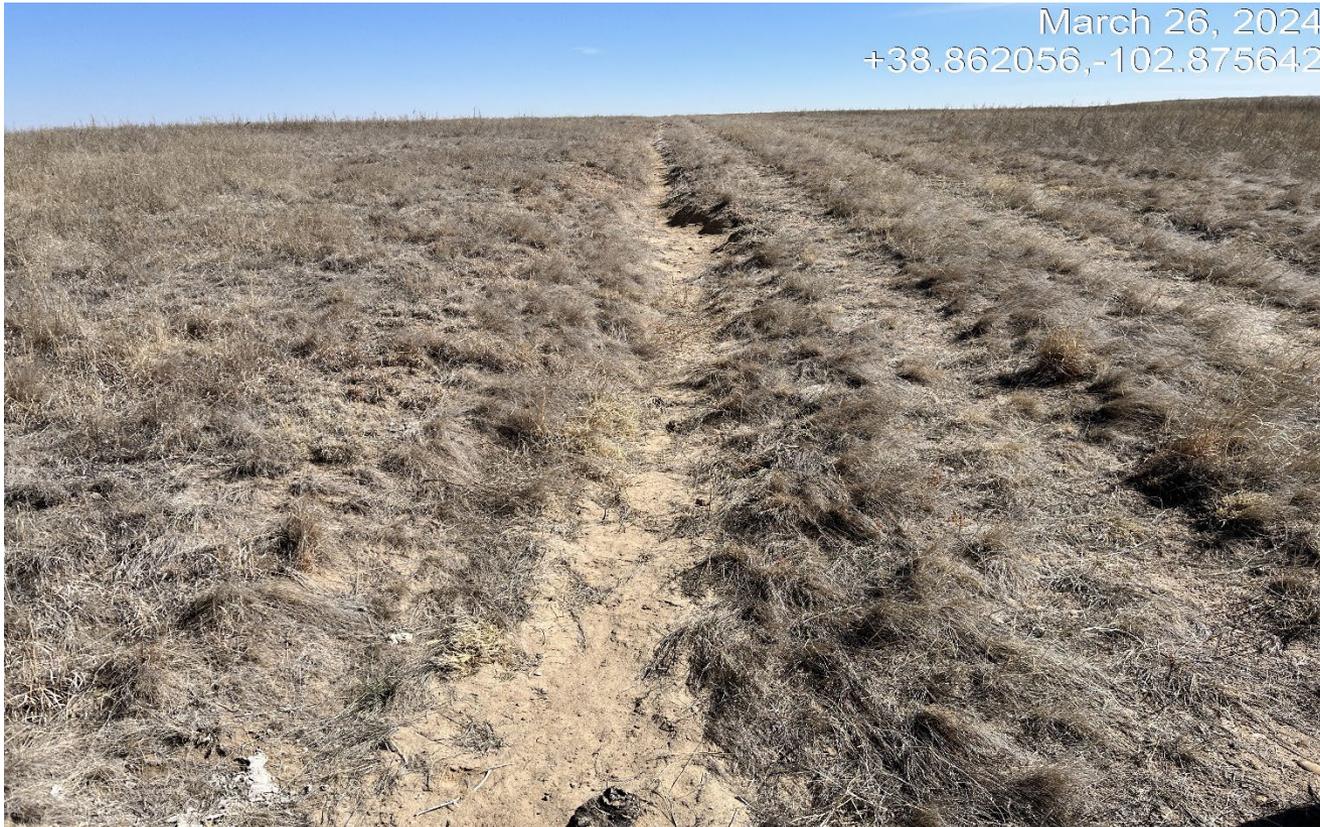
Photo 21. Facing northeast along the two track access road. There is an erosion channel along the road closer to the location that needs to be repaired.

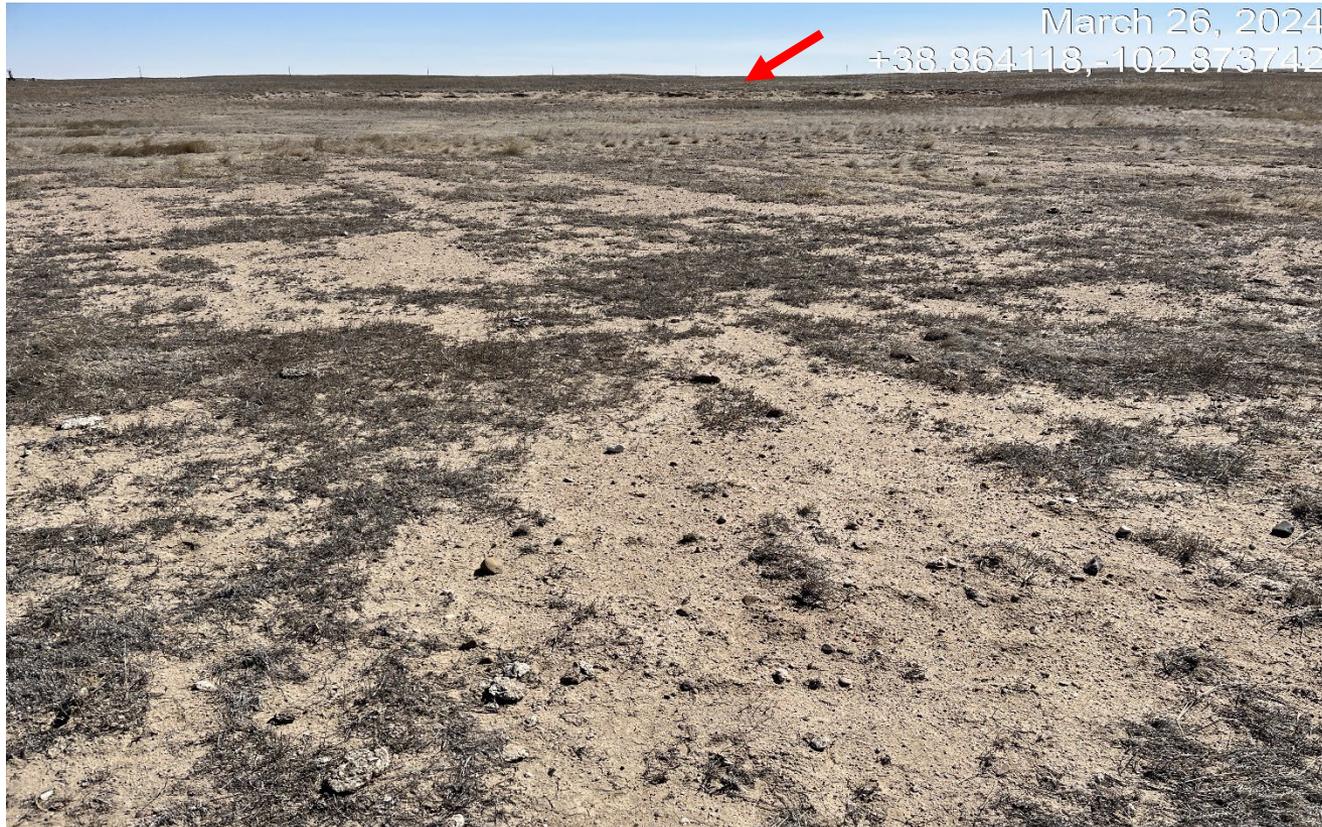
Photo 2. Facing northeast at the location. This area has not been reclaimed and perennial vegetation has not established. The cut slope can be seen at the red arrow.

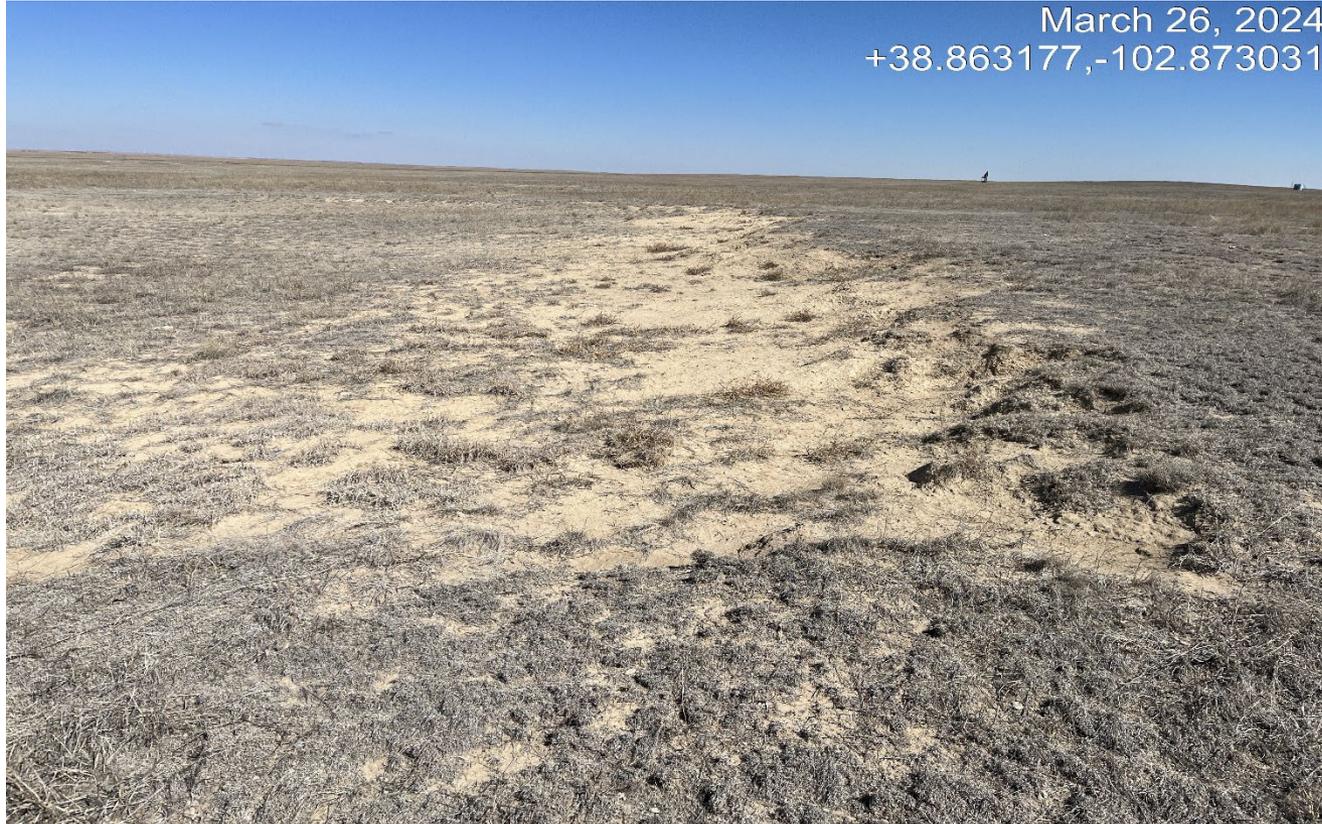
Photo 3. Facing north along the cut slope which is eroded and has not been regraded back to approximate grade..

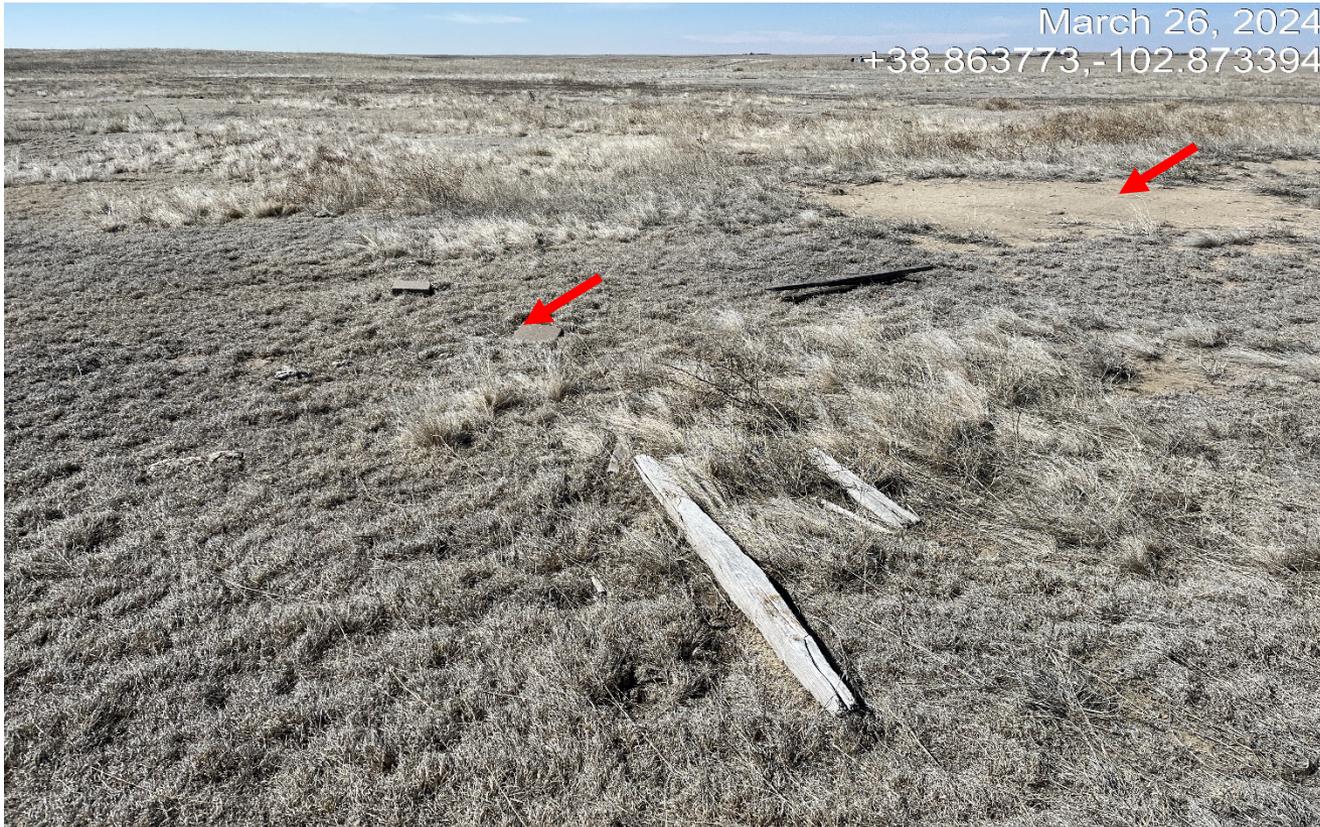
Photo 4. North side of the location facing southwest. There is some cement block debris and a bare area shown at red arrows.

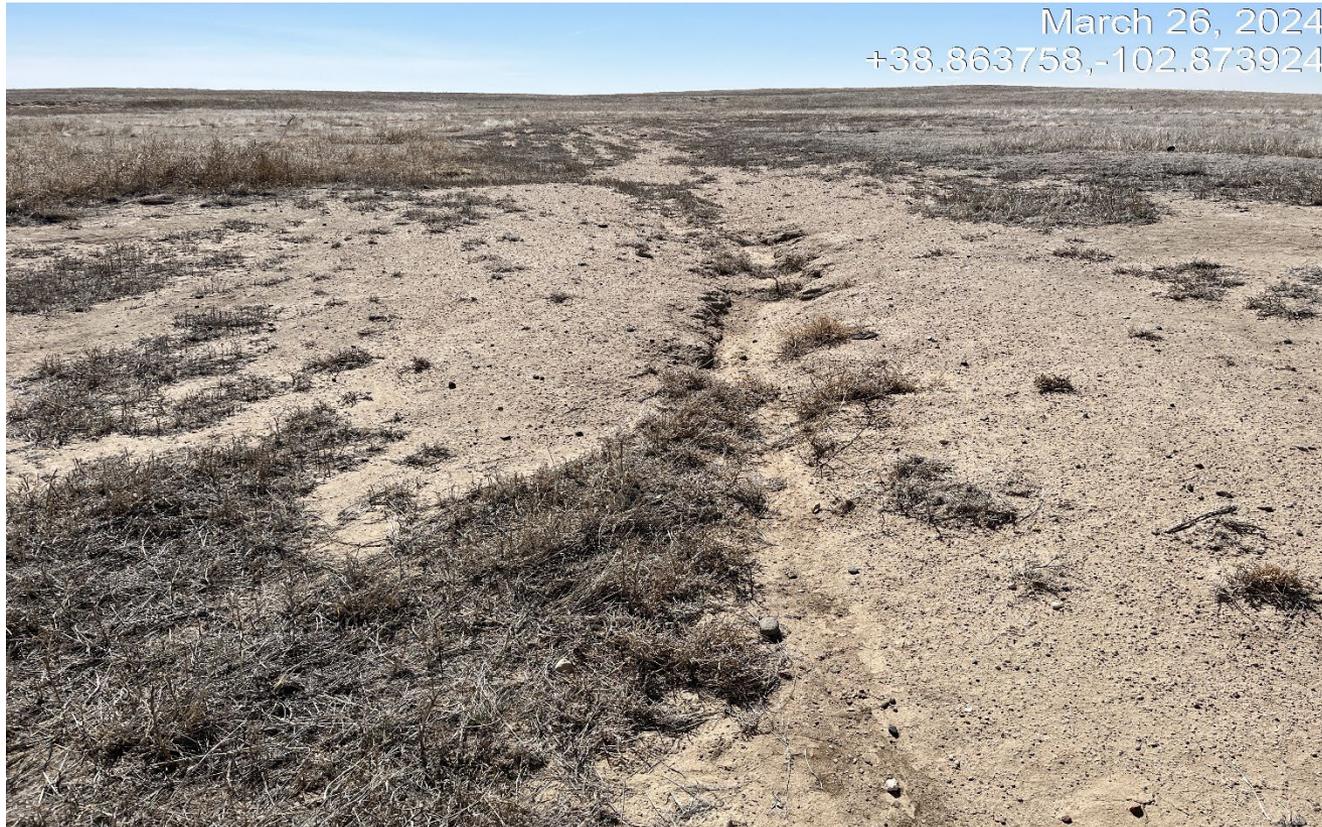
Photo 5. Northwest side of the location facing southeast. There is an erosion channel along this area and soils are bare of vegetation.

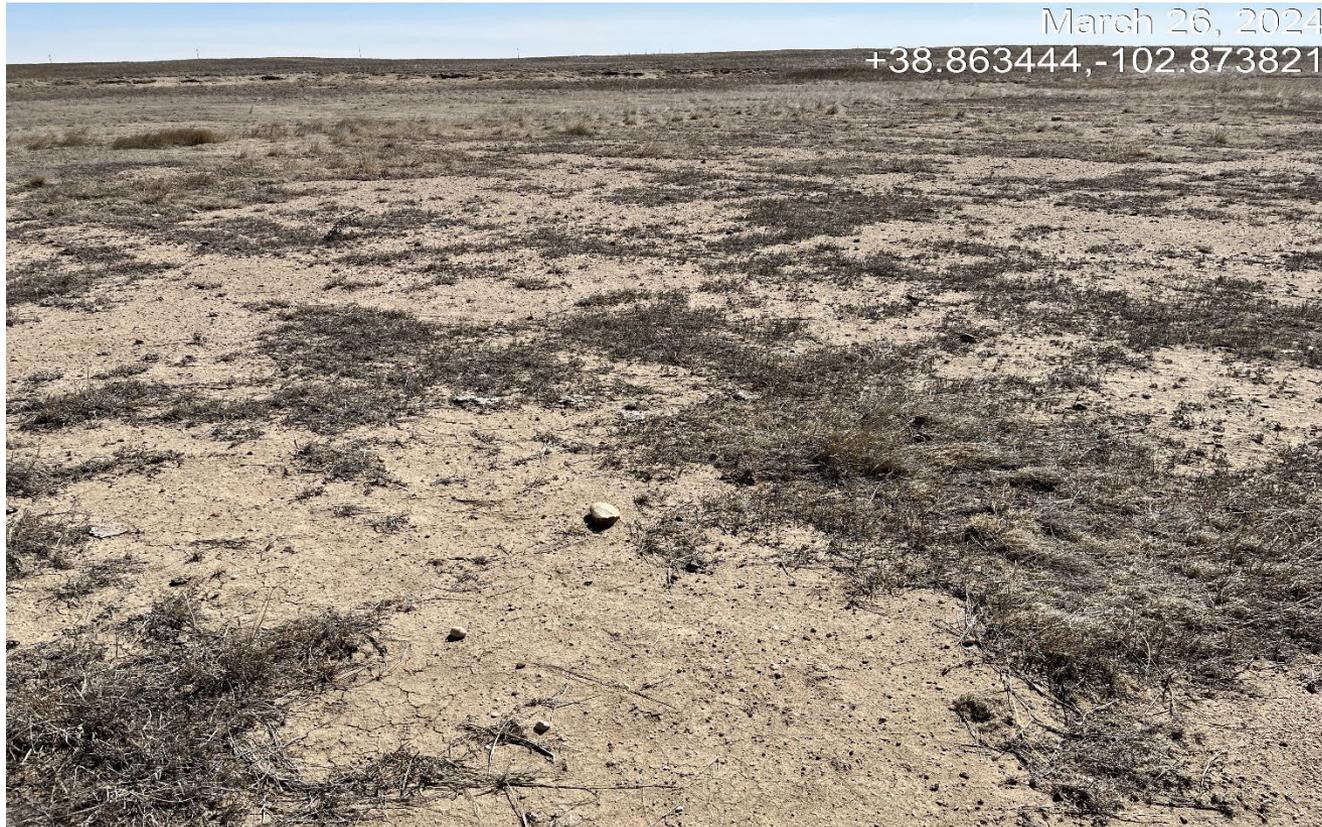
Photo 6. Facing east at the location. The location has not been reclaimed and perennial vegetation has not established.

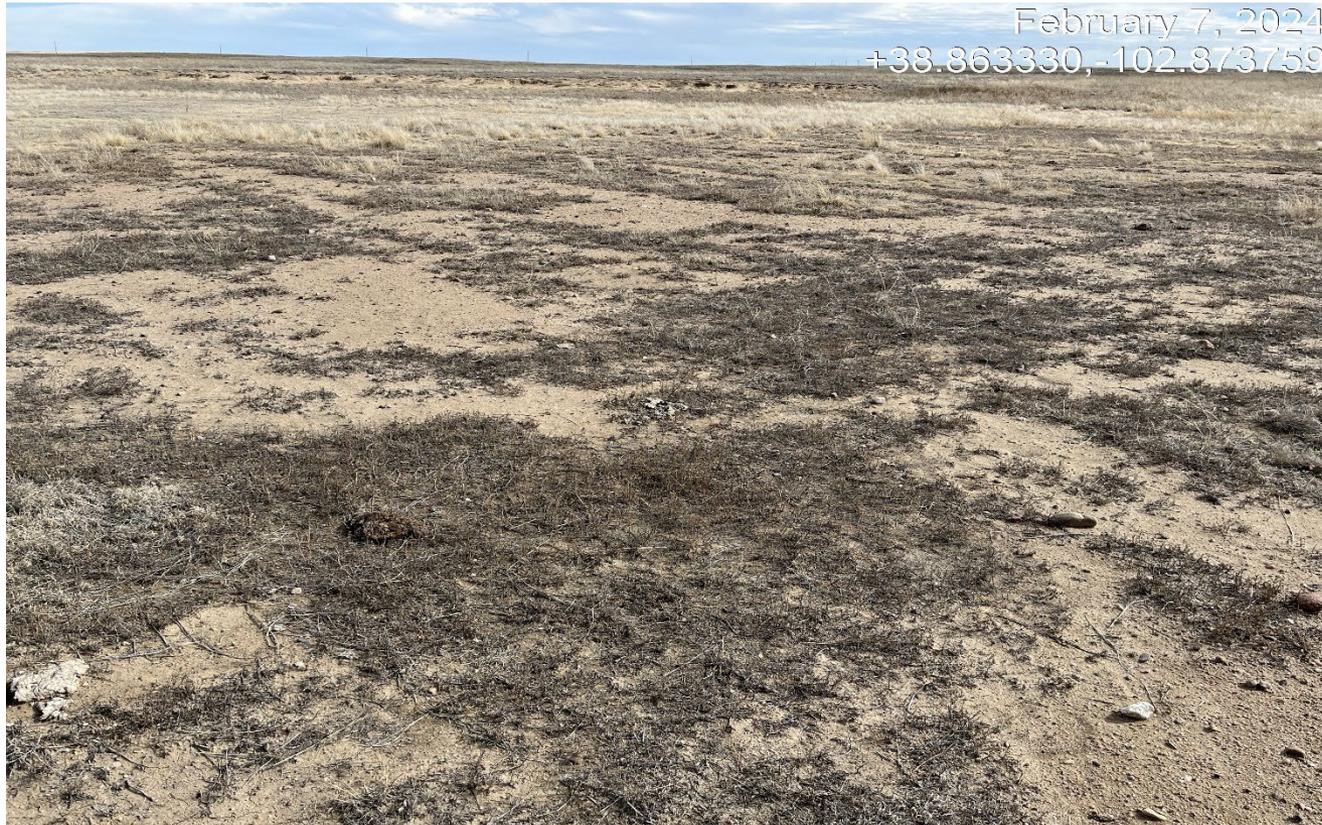
Photo 8. Facing east at the location. The location has not been reclaimed and perennial vegetation has not established.
