Inspection Photos

Loc: 321575

Operator: MULL DRILLING COMPANY INC

Inspection Date: 3/26/2024

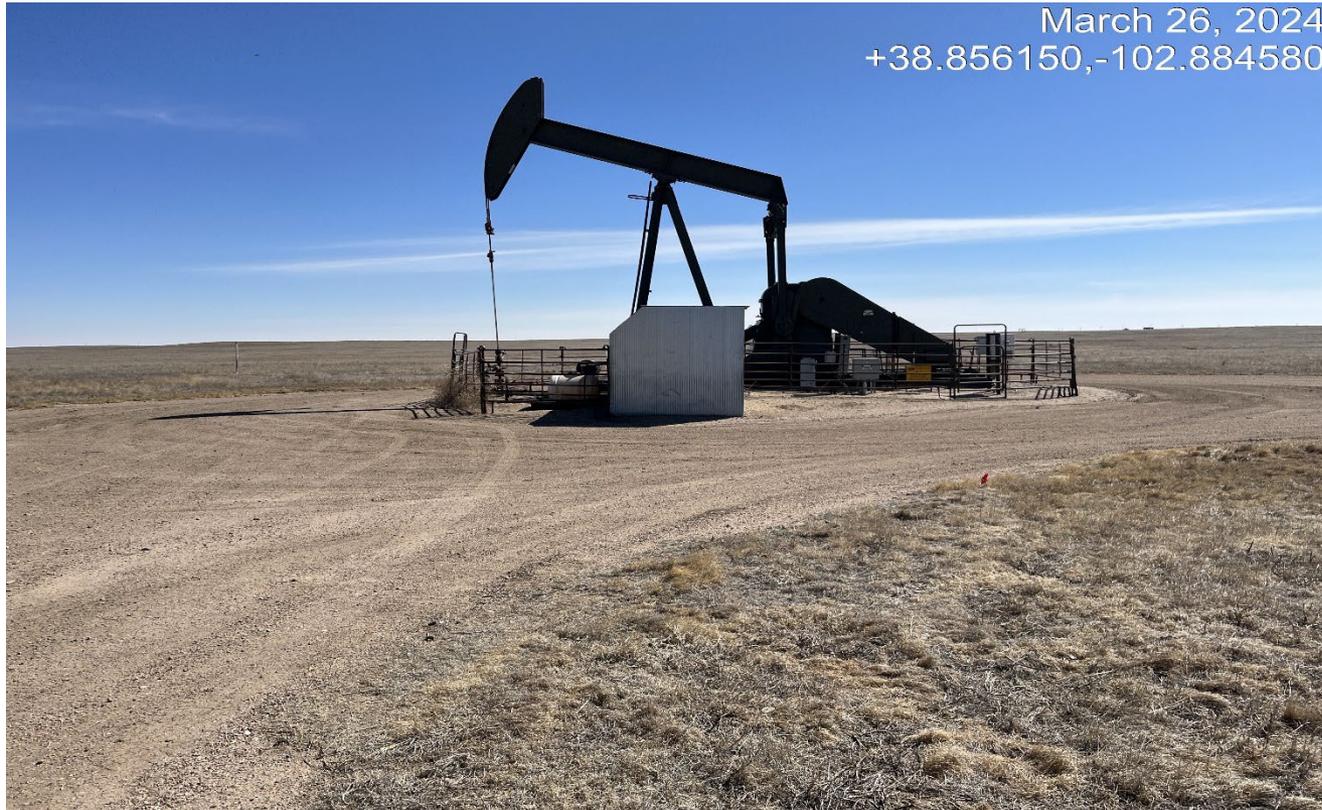
Photo 1. Facing west toward wellsite location.

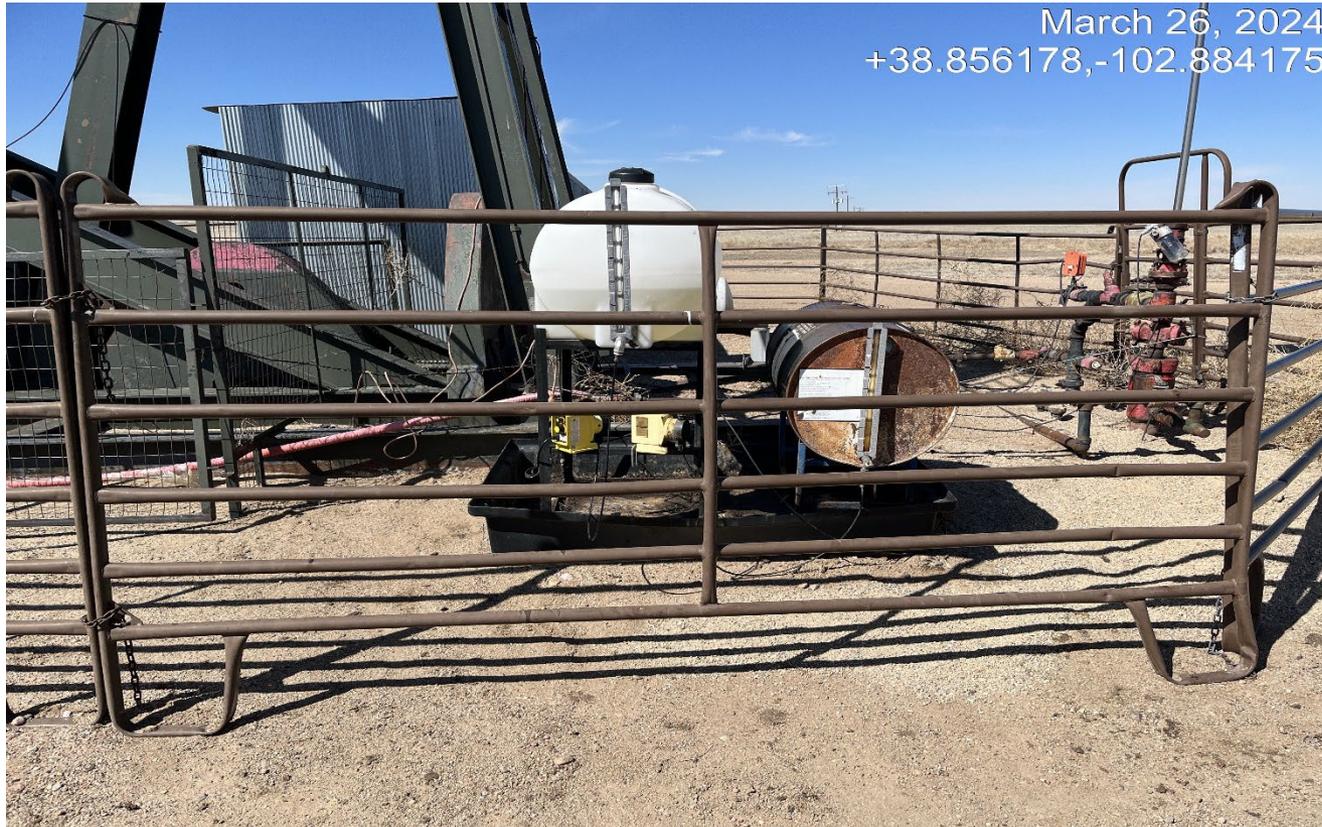
Photo 3. The secondary containment has been cleaned out and weeds removed..

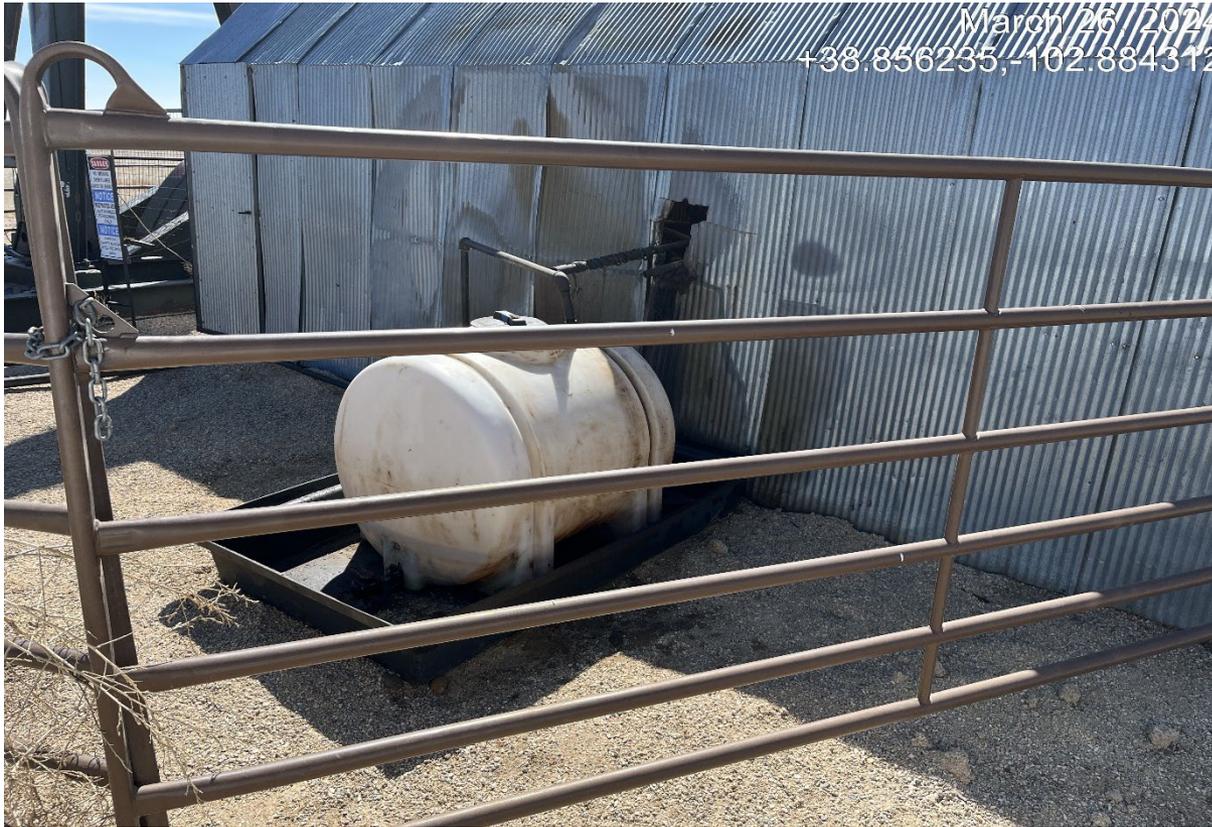
Photo 4. The secondary containment has been cleaned out..

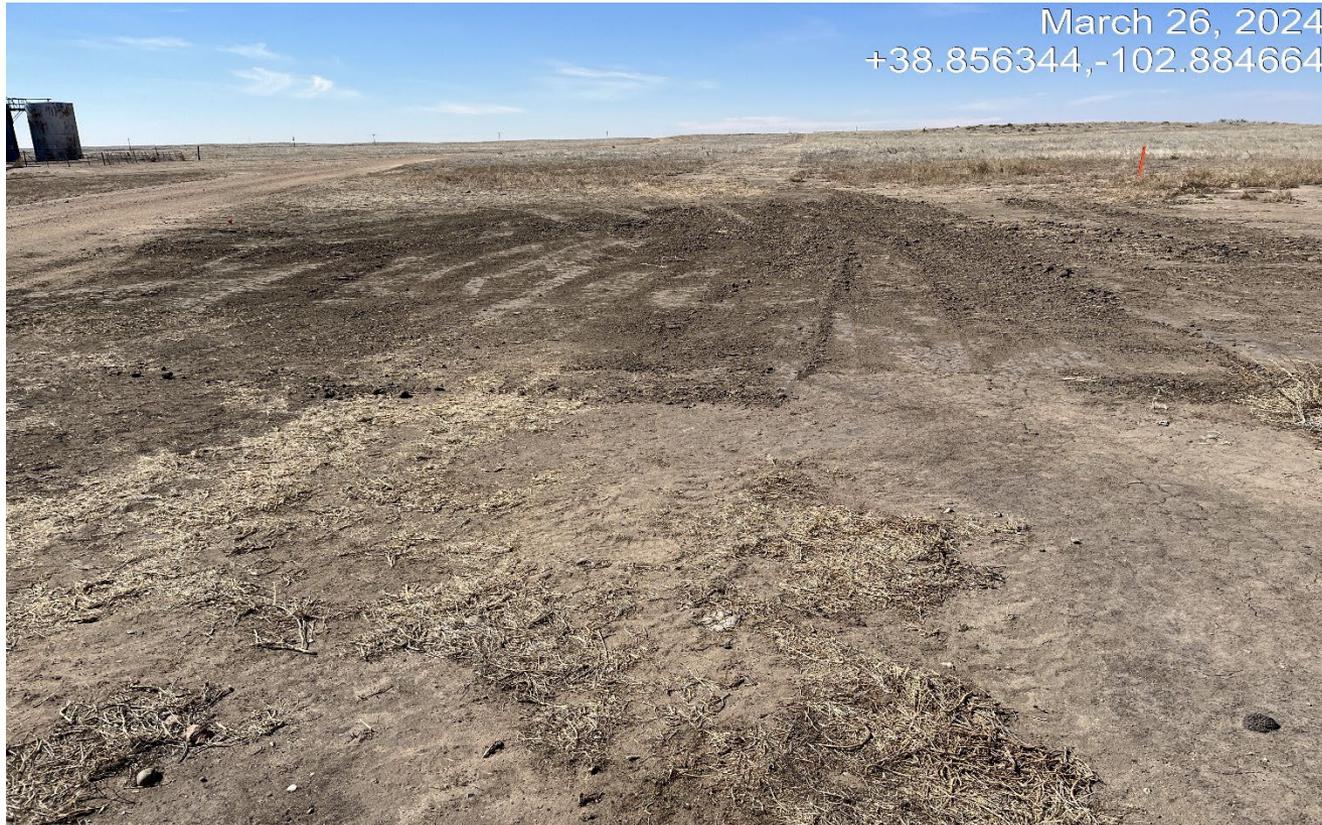
Photo 4. There is an area of disturbance along the flowline that will need to be reclaimed.
