# Inspection Photos

API: 017-06652

Operator: **CITATION OIL & GAS CORP**

Inspection Date: 3/26/2024

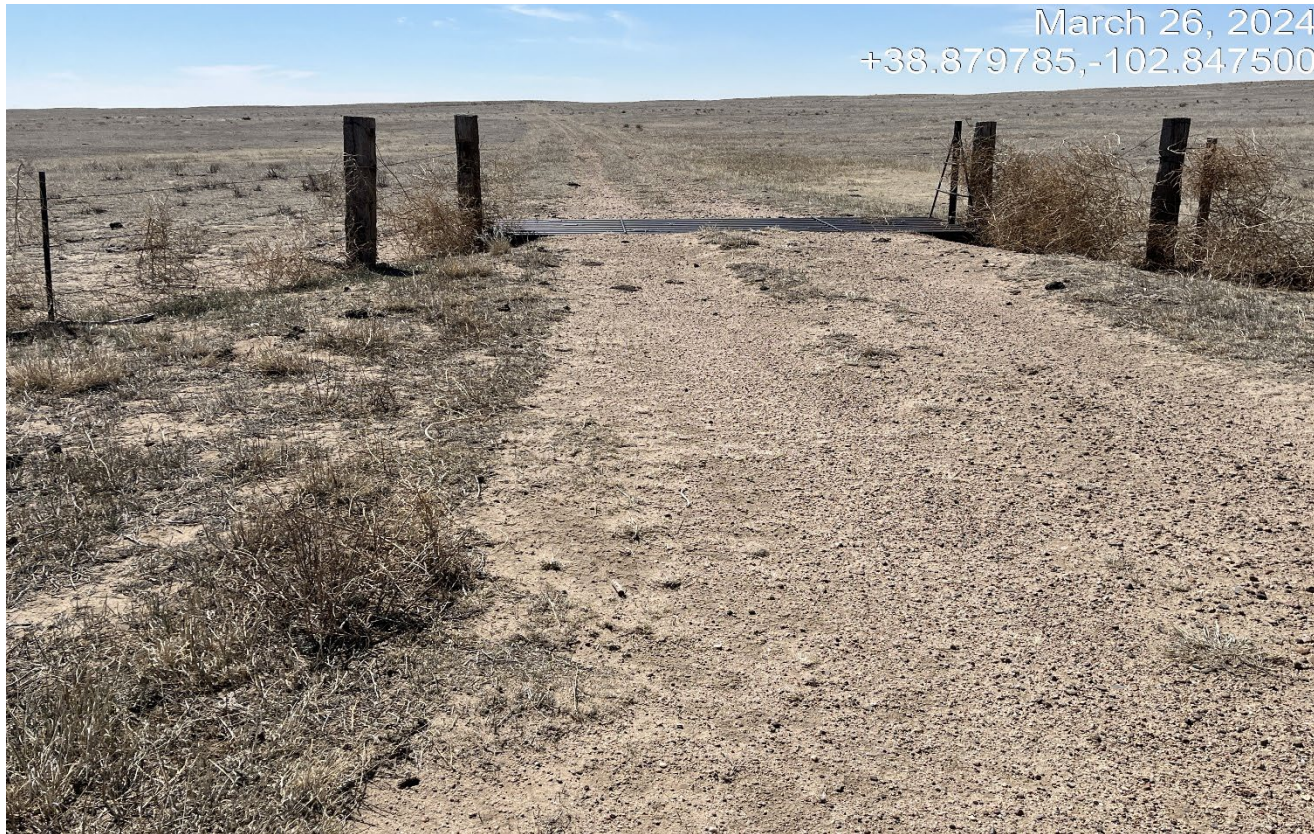
**Photo 1.** Facing south at the beginning of the access road. The cattleguard will need to be removed and fence installed back to original position. The road needs to be reclaimed.

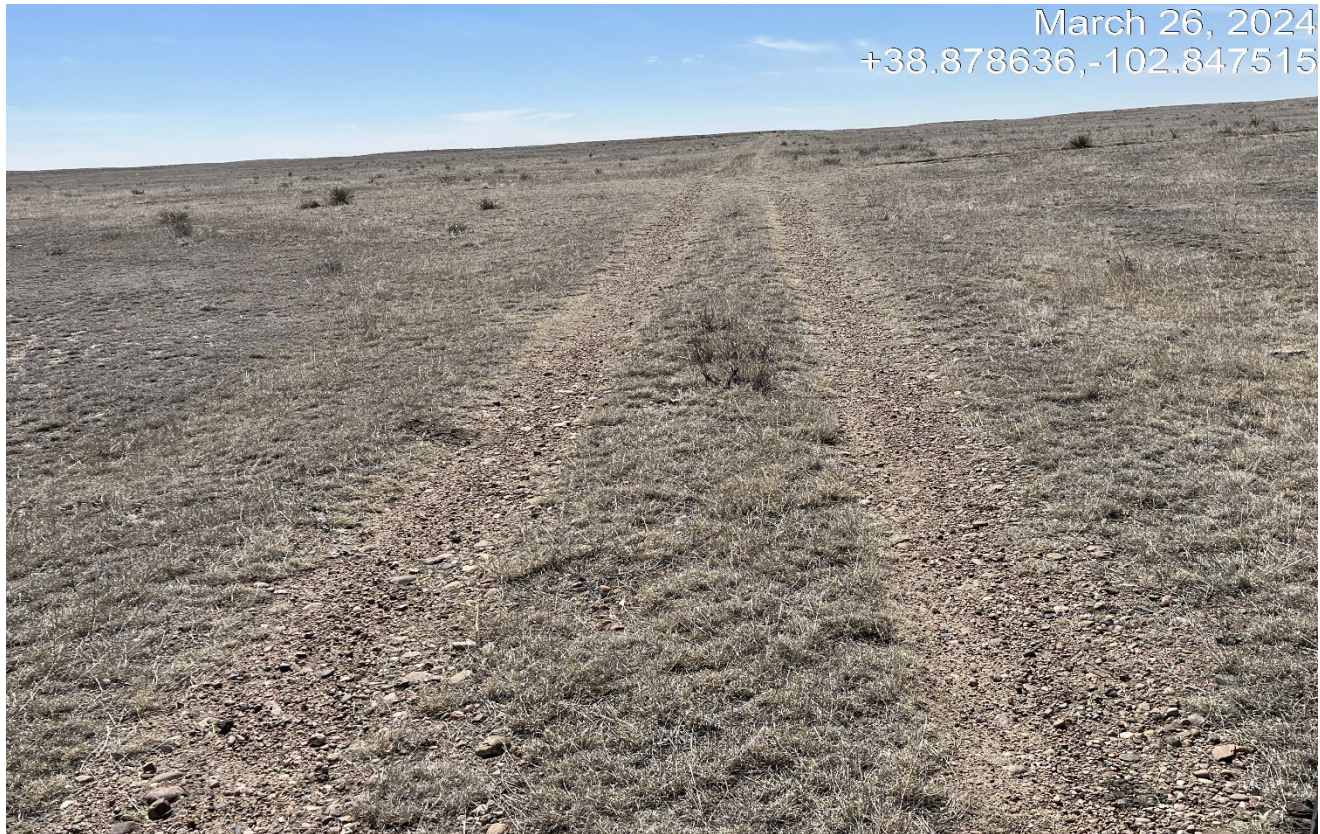
**Photo 2.** Facing south along the access road. The two track access road remains and will need to be decompacted. Consider decompacted only to two track portion to save vegetated areas.

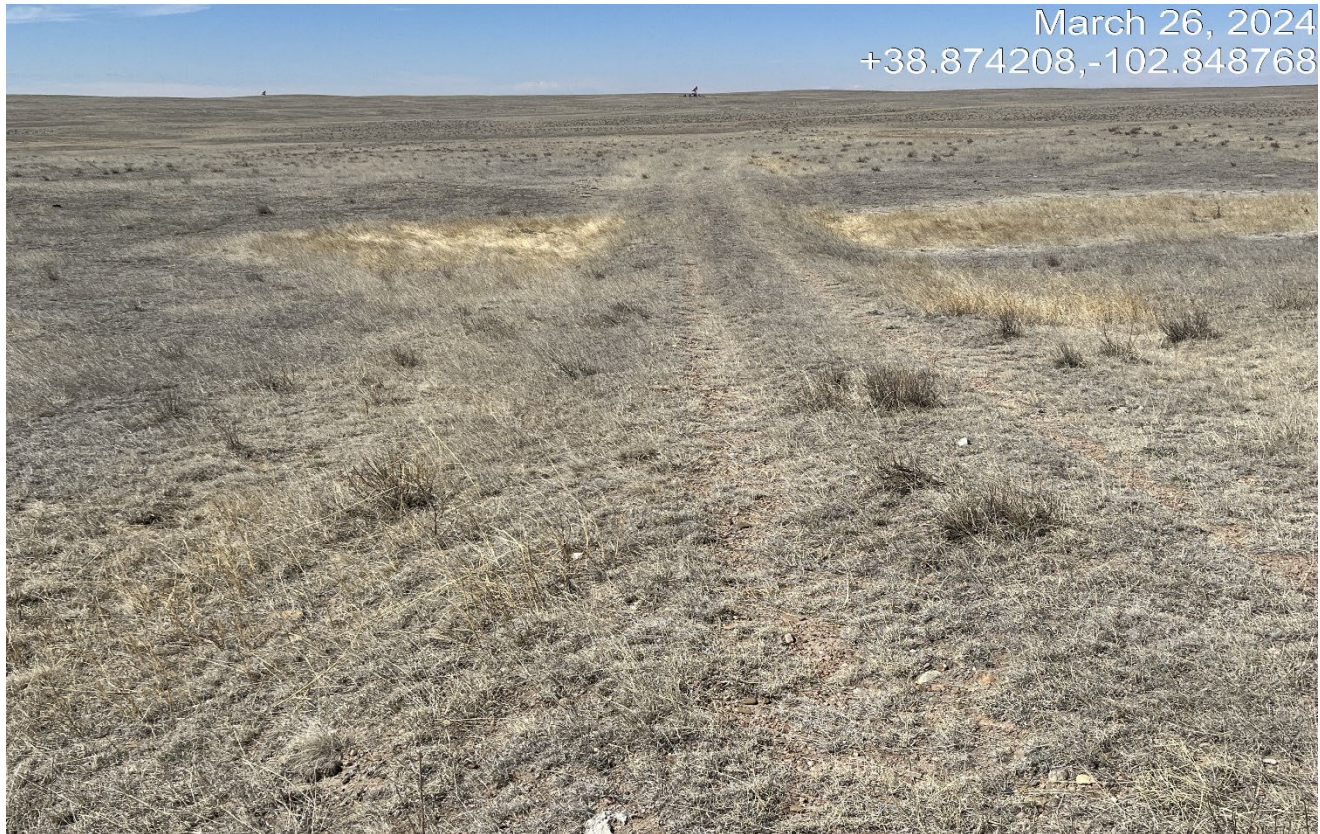
**Photo 3.** Facing west along the access road. This portion of the road has revegetated.

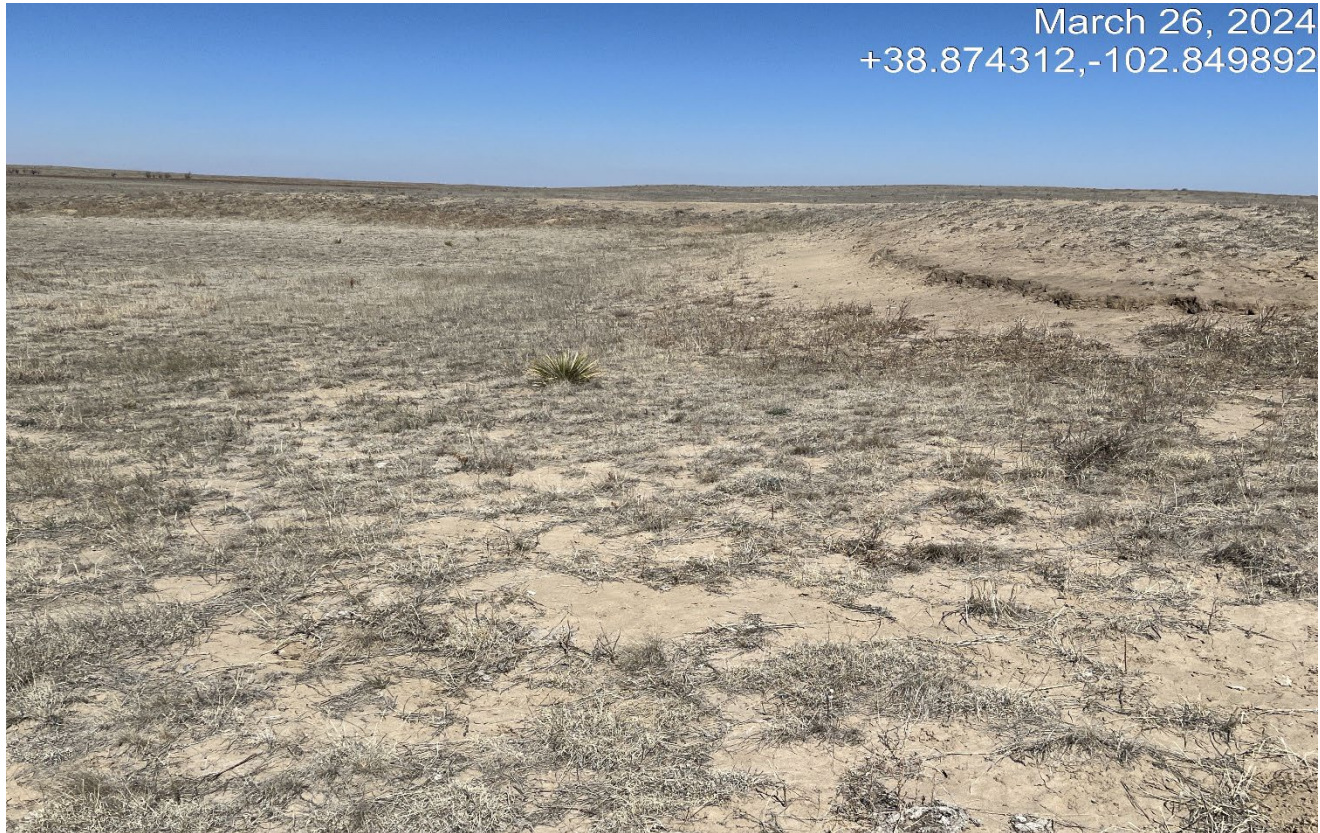
**Photo 4.** Facing north at the location. The cut slope has not been recontoured back to the original terrain contours.

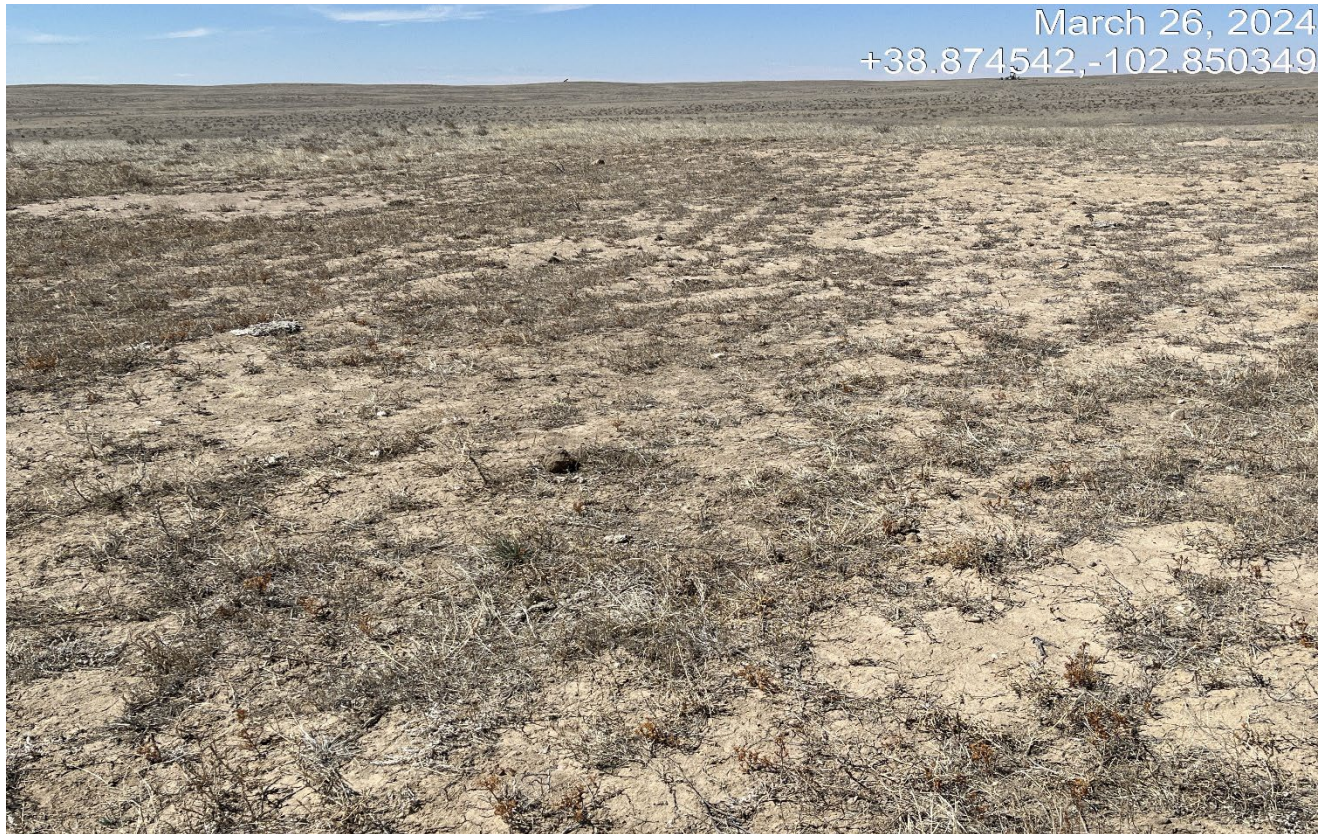
**Photo 5.** Facing west at center of the location. This area does not have sufficient vegetation establishment and needs to be reclaimed.

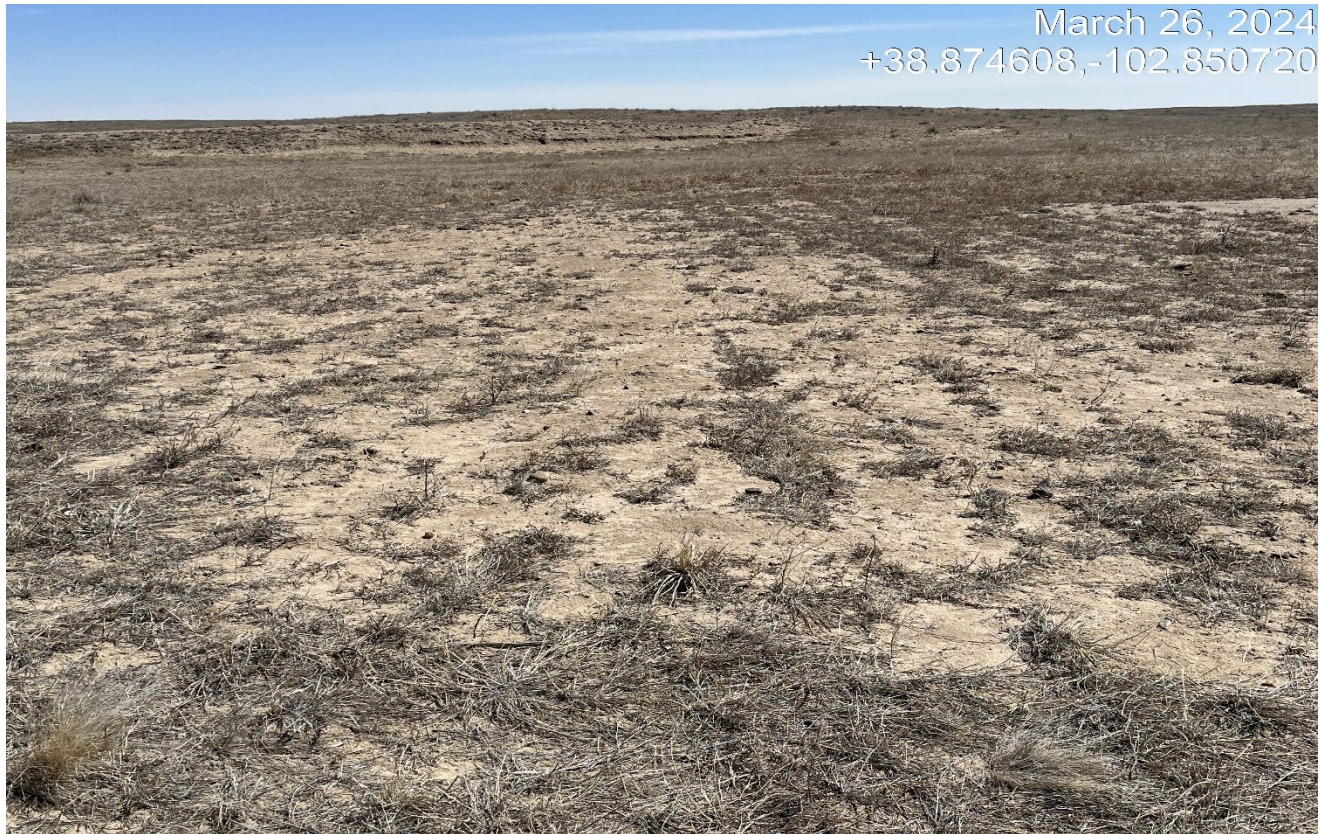
**Photo 6.** Facing east at center of the location. This area does not have sufficient vegetation establishment and needs to be reclaimed.

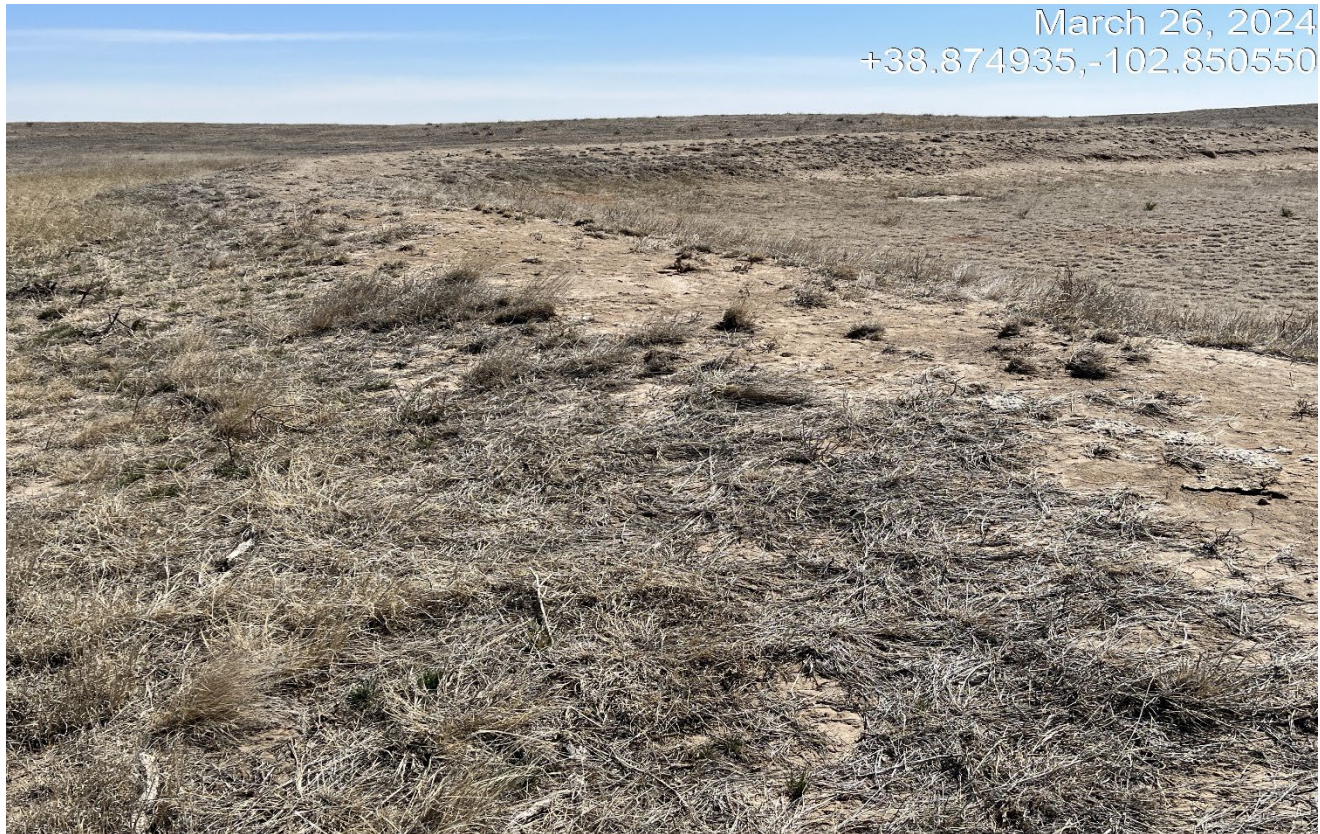
**Photo 7.** Facing southeast at the top of the cut slope. There is a berm along the top which needs to be recontoured along the cut slope.

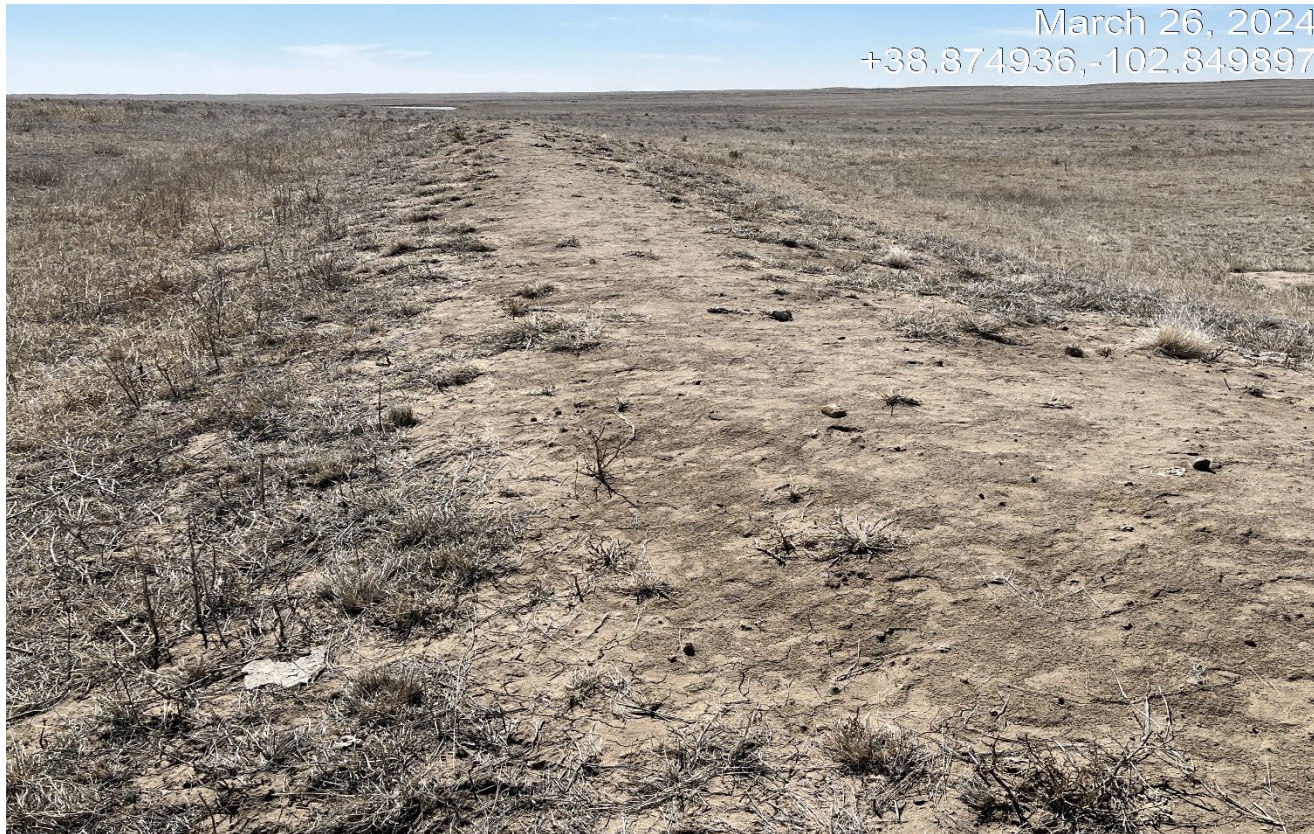
**Photo 8.** Facing south at the top of the cut slope. There is a berm along the top of the which needs to be recontoured along the cut slope.

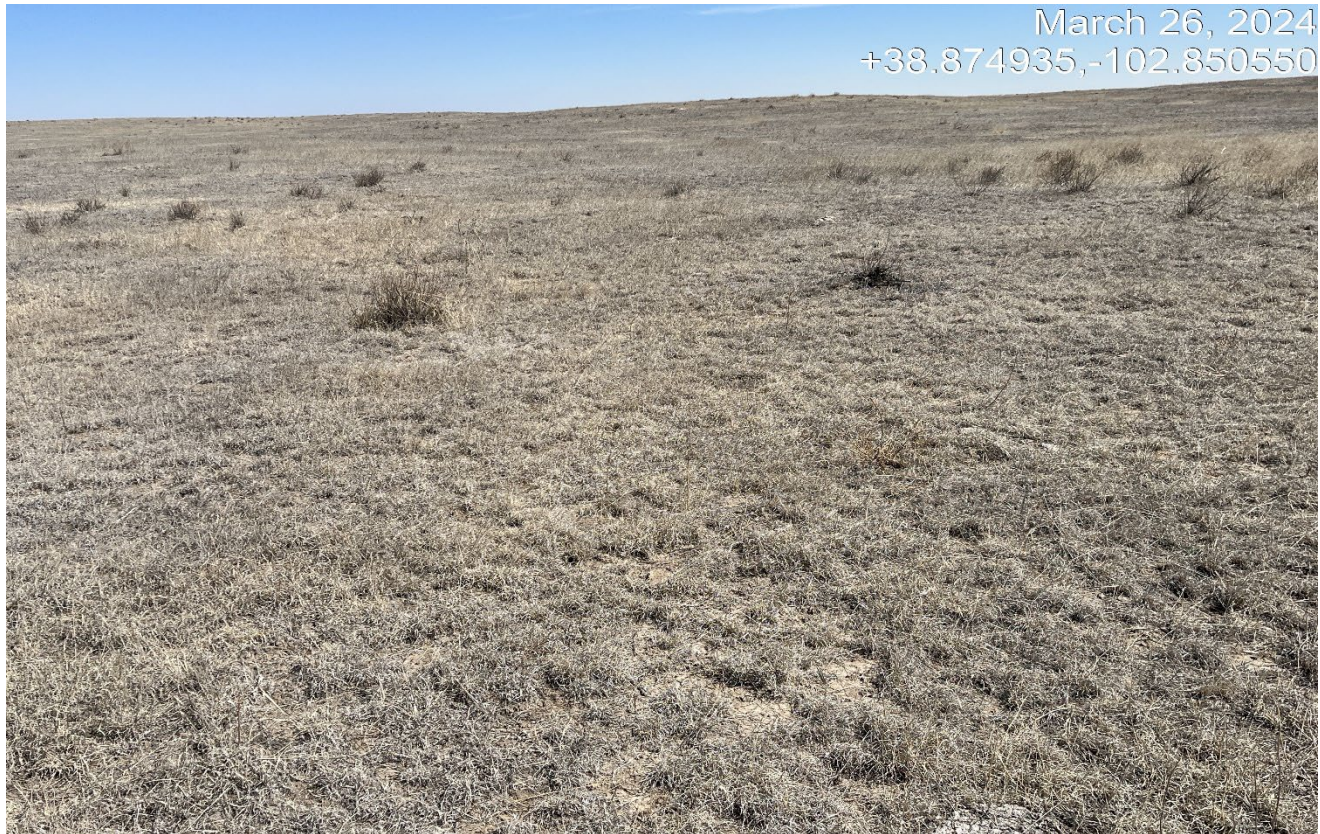
**Photo 9.** Facing north toward the surrounding undisturbed reference area.
