Inspection Photos

Location Name: CAERUS PICEANCE LLC, PUCKETT-66S96W/31SWNE

Location ID: 335390

Date: 3/26/2024

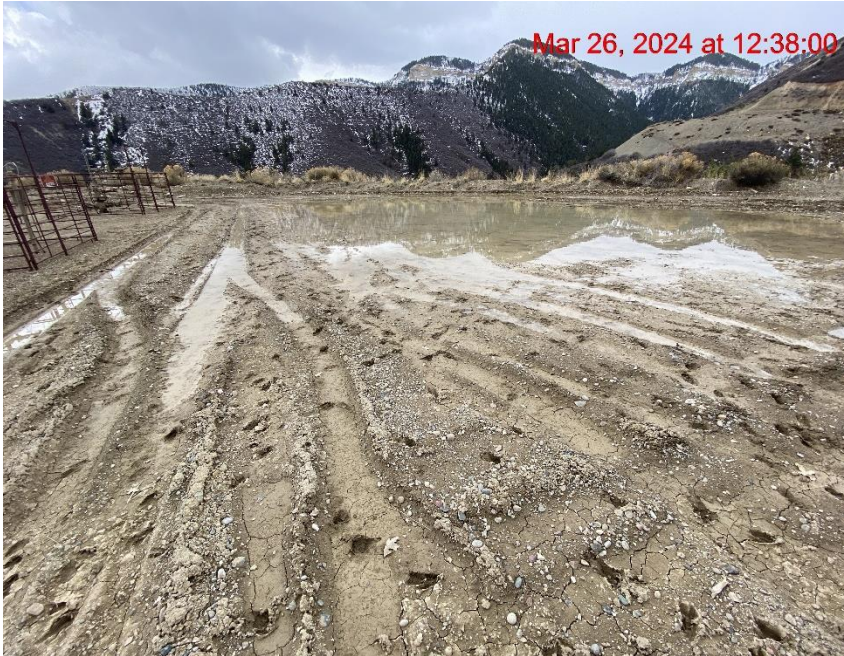
Lack of Stabilization/Degradation – Photo #00114

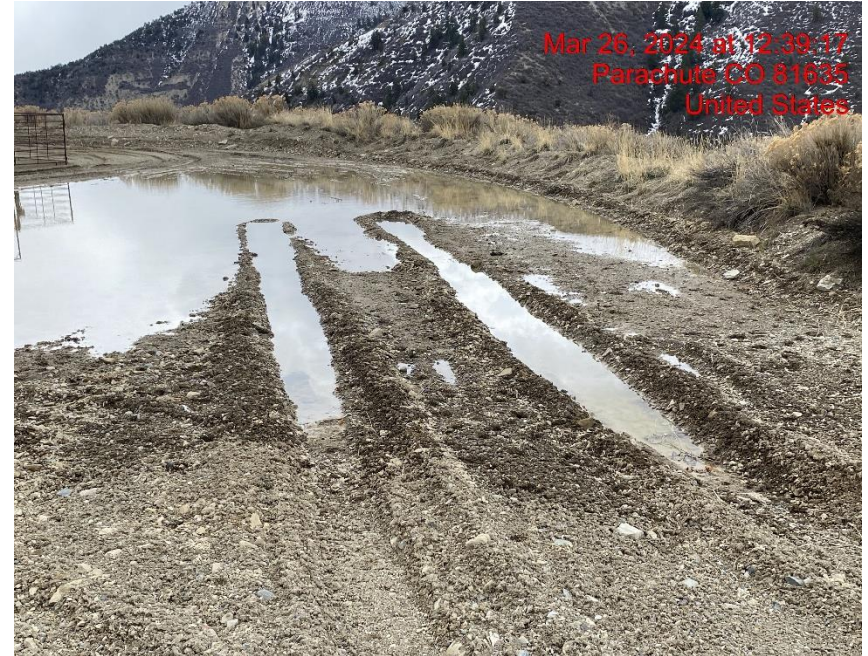
Lack of Stabilization/Degradation – Photo #00117

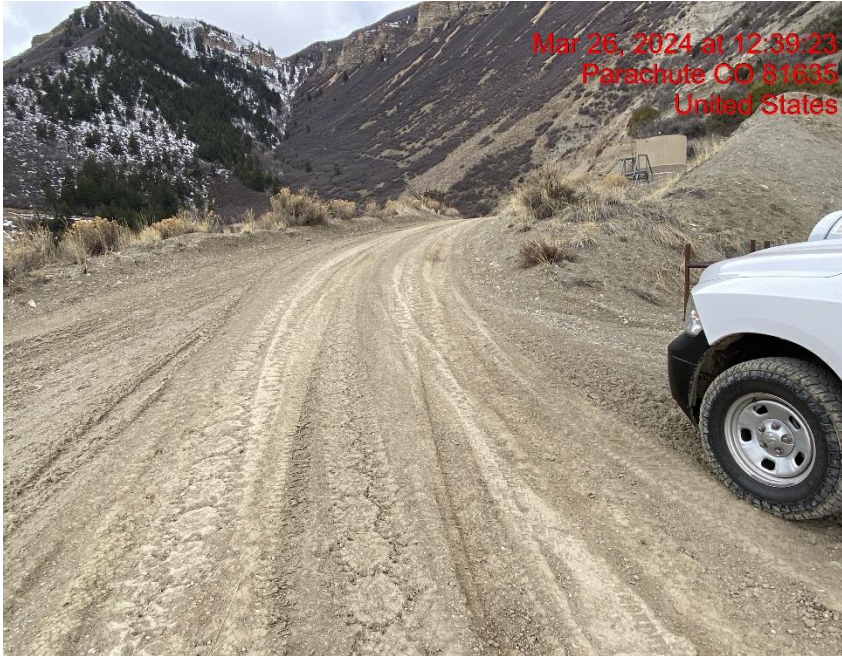
Insufficient Vehicle Tracking BMPs at Location Entrance/Exit
– Photo #00118
