## Inspection Photos

Location Name: TEP ROCKY MOUNTAIN LLC, Puckett/GM 333-31

Location ID: 416998

Date: 3/26/2024

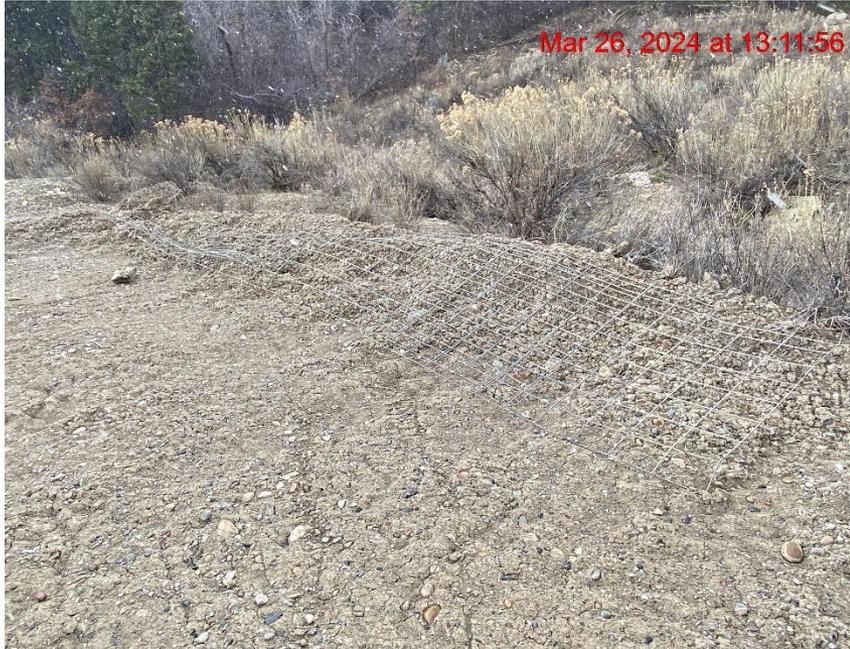
**Hog Panel Debris – Photo #00146**

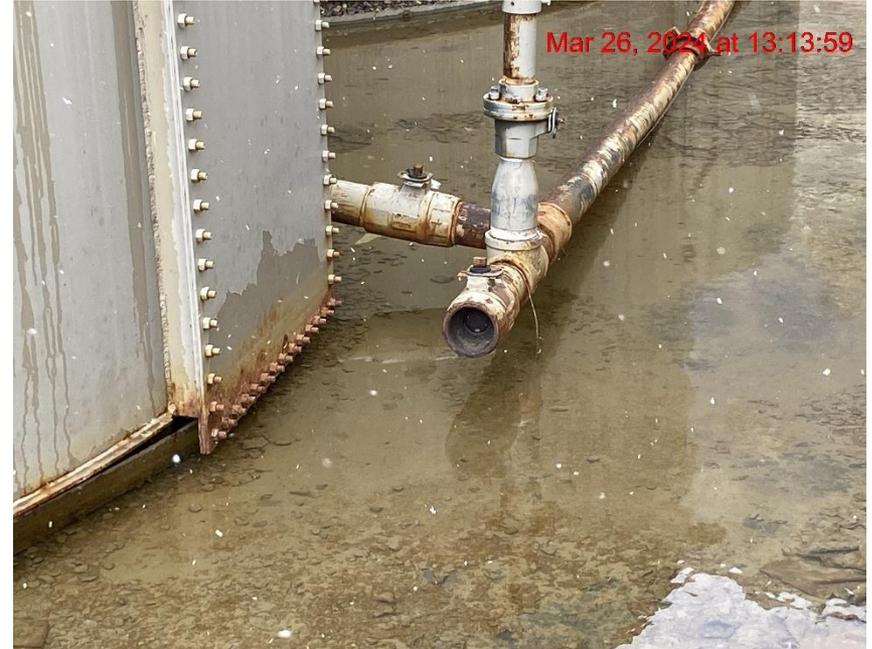
**Open-Ended Line in Tank Battery – Photo #00153**

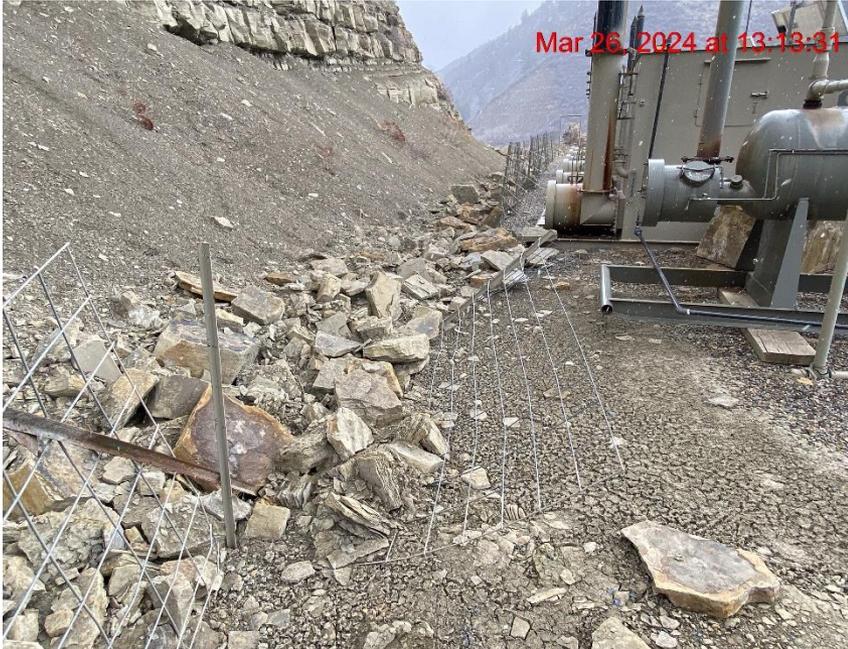
**Insufficient Erosion Control/Degradation – Photo #00150**

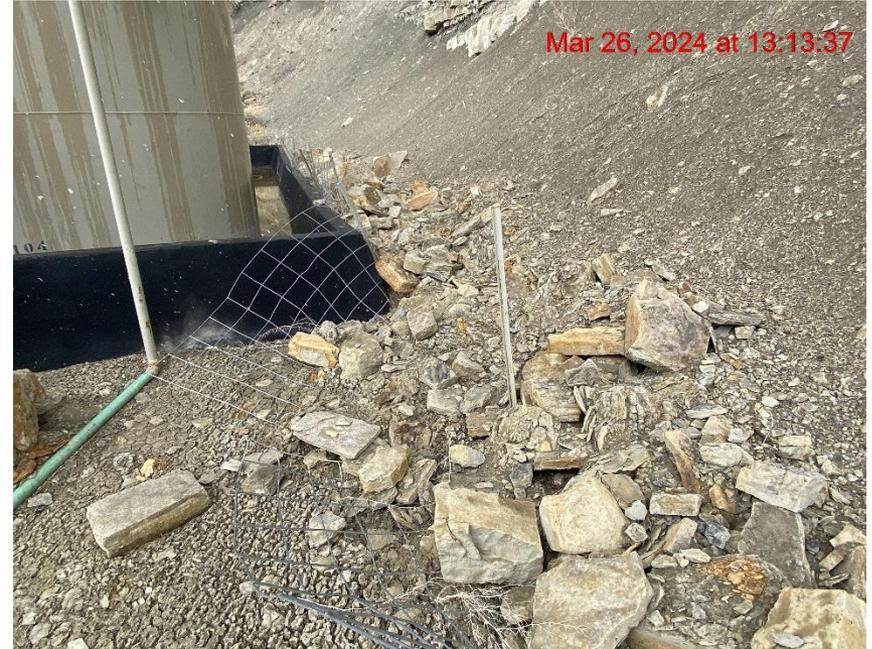
**Insufficient Erosion Control/Degradation – Photo #00151**

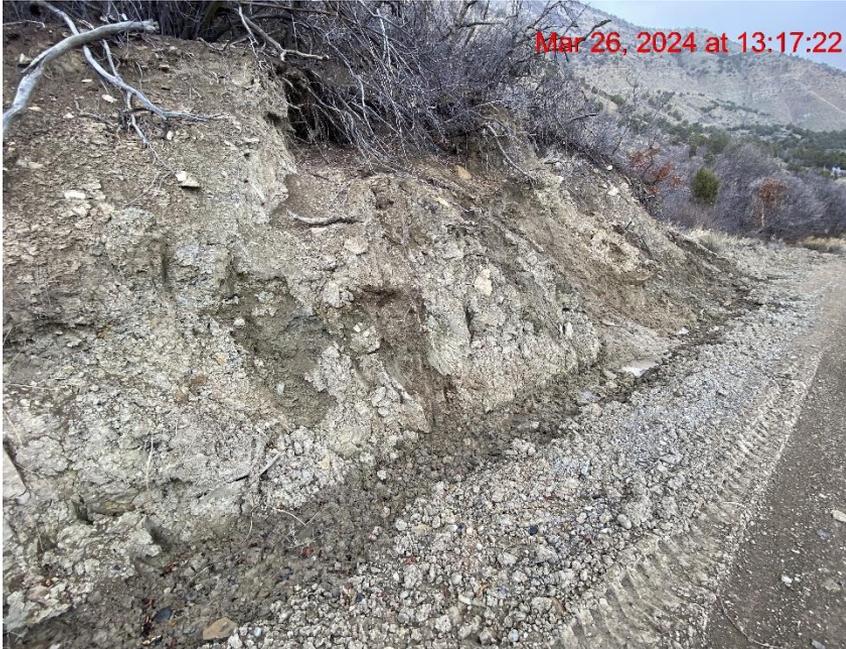
**Insufficient Erosion Control on Lease Road Cut Slopes –  
Photo #00155**

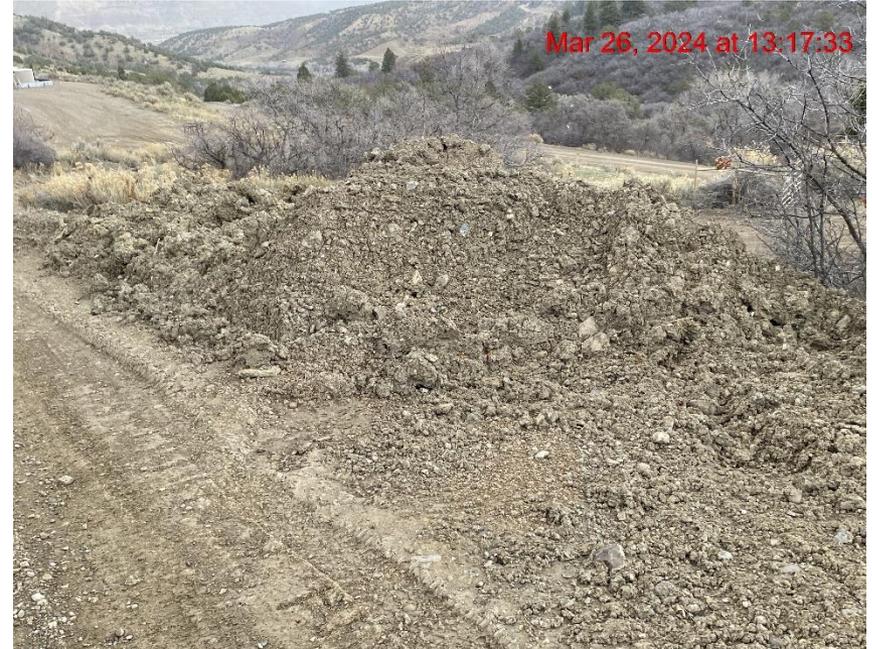
**Soil Stockpiled on Lease Road – Photo #00156**

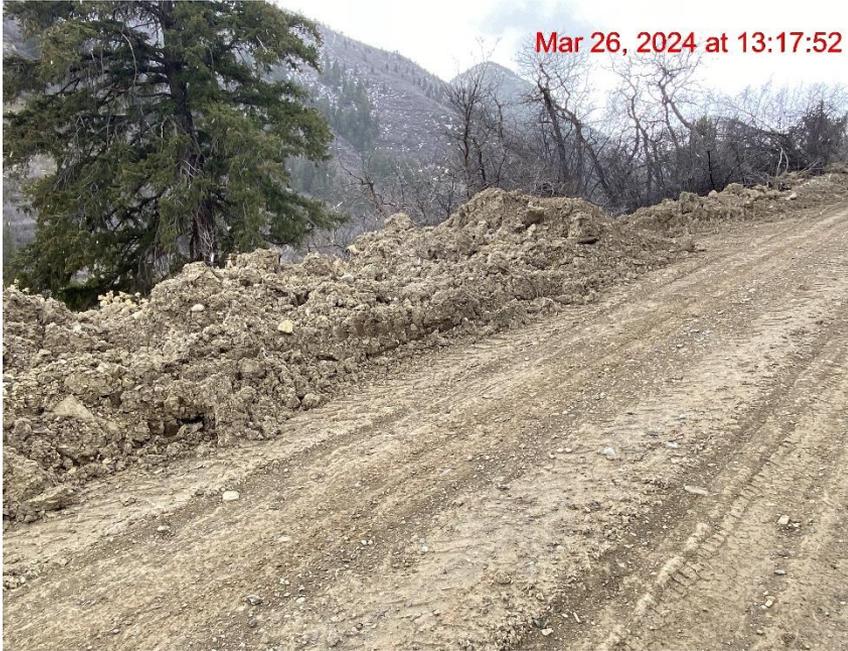
**Soil Stockpiled on Lease Road – Photo #00157**
