Final Reclamation Inspection

Operator: Hilcorp Energy Company - 10133

Location ID: 326162

Inspection Photos
Location Name: Ute 32-11 101
Location ID: 326162

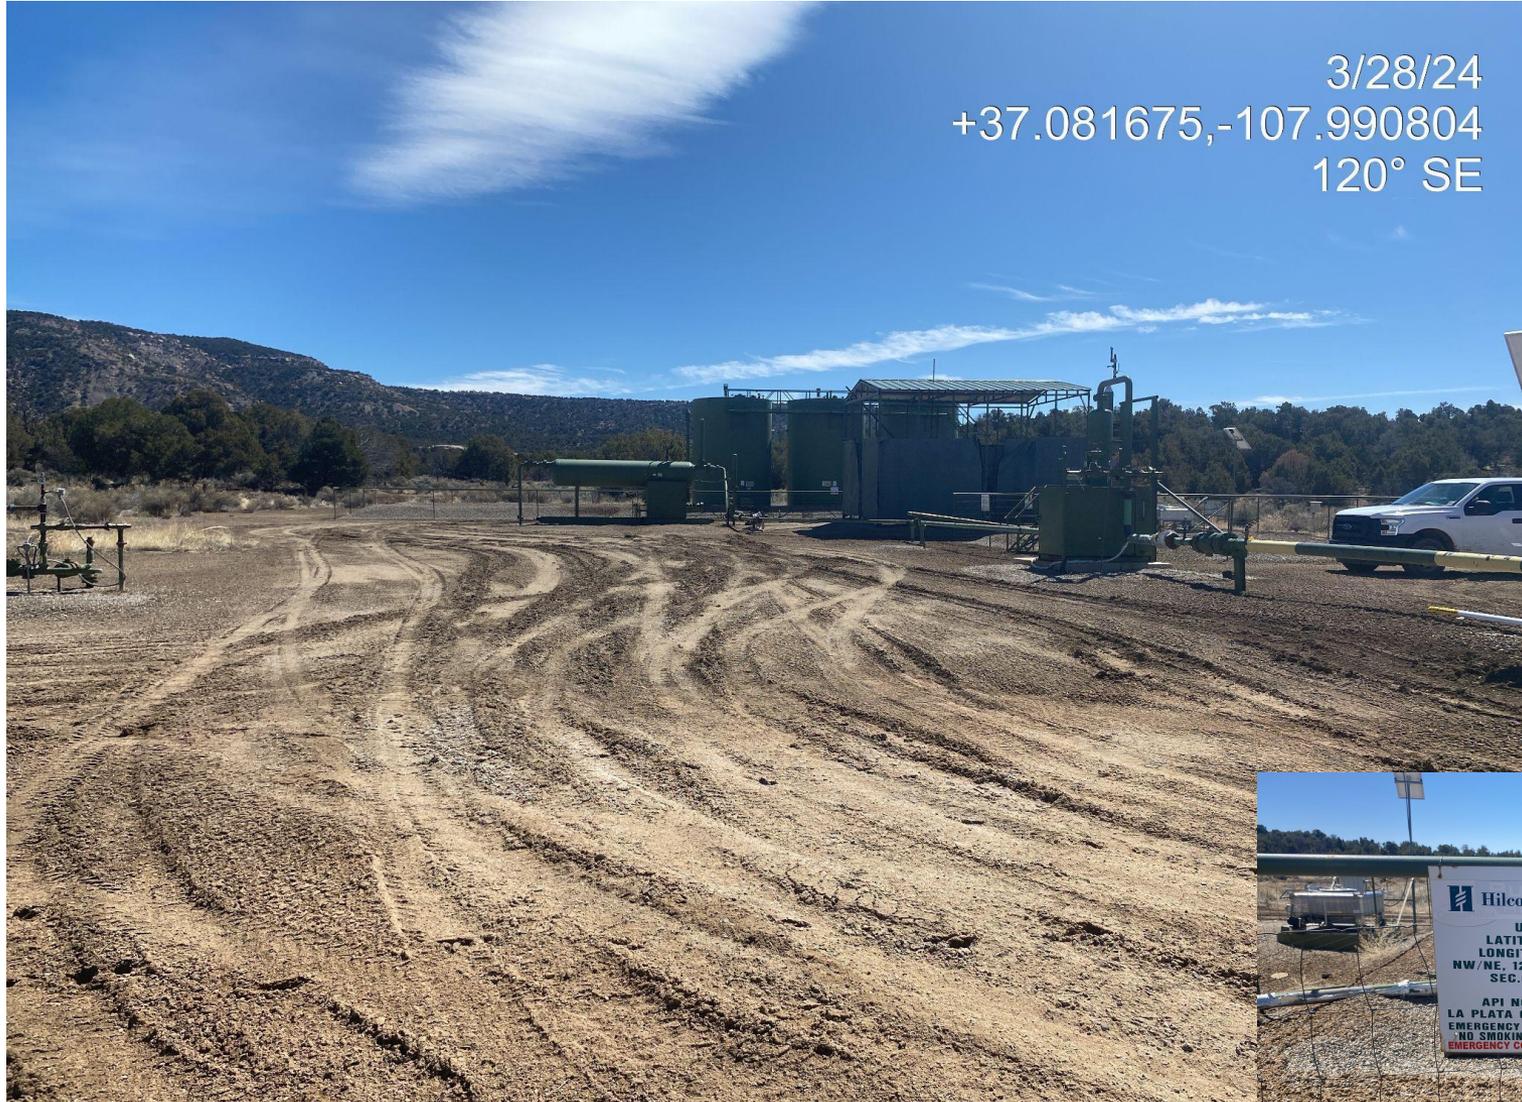
Photo 1. Overview of the disturbance taken from the access point facing center.

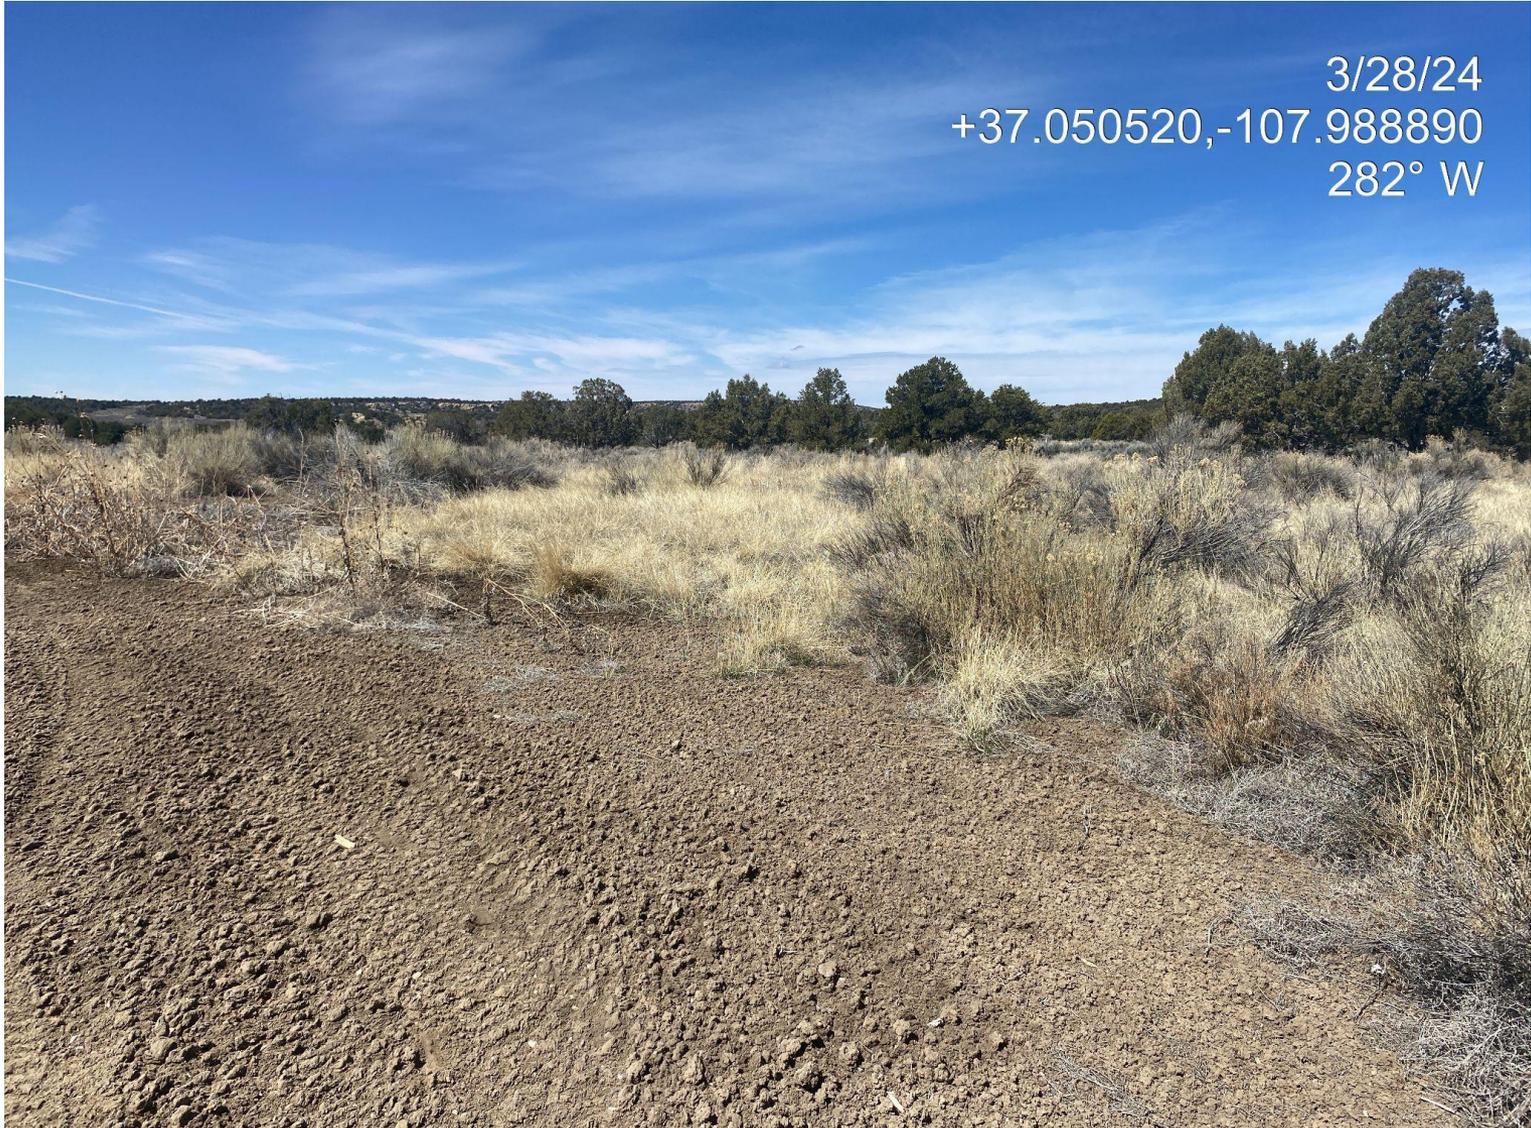
Photo 2. View of the western interim reclamation area facing west. Vegetation comprised of western wheatgrass, rabbitbrush and greasewood.

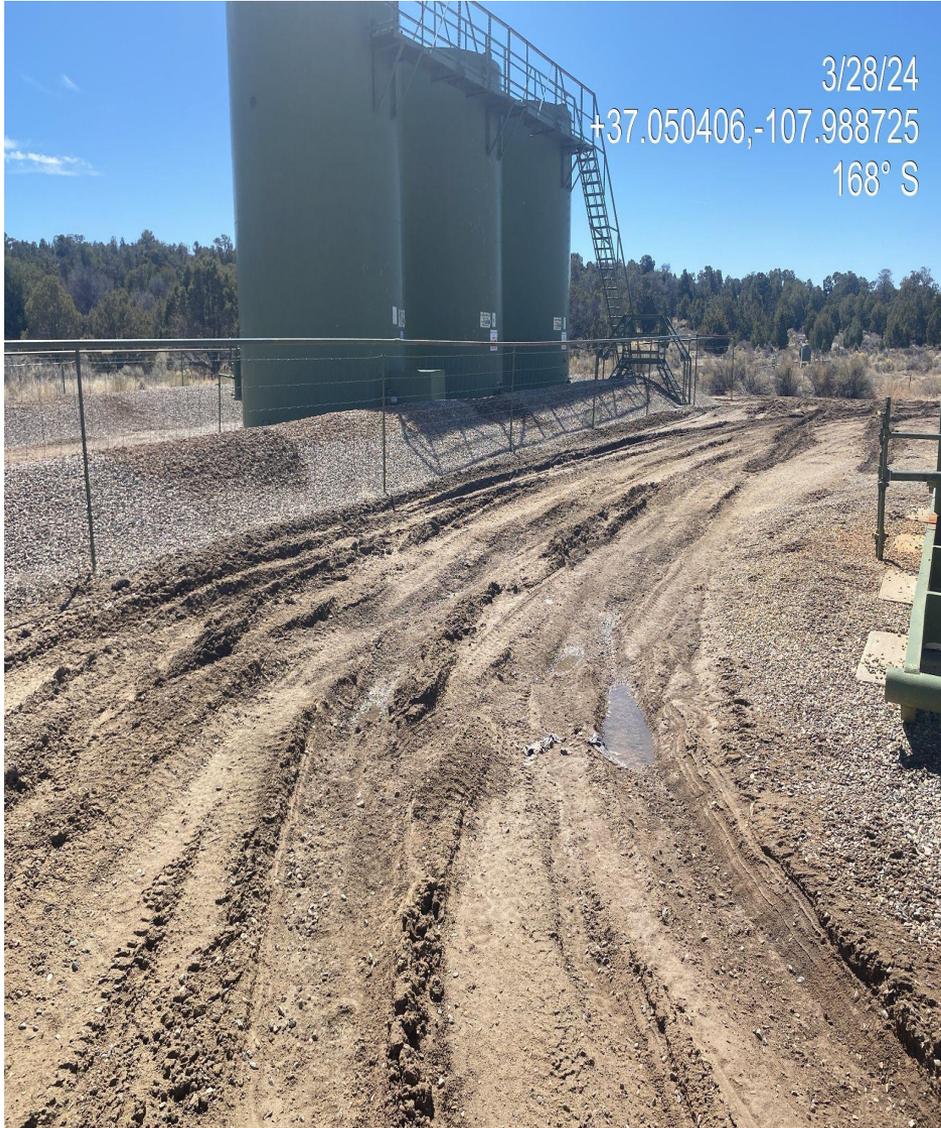
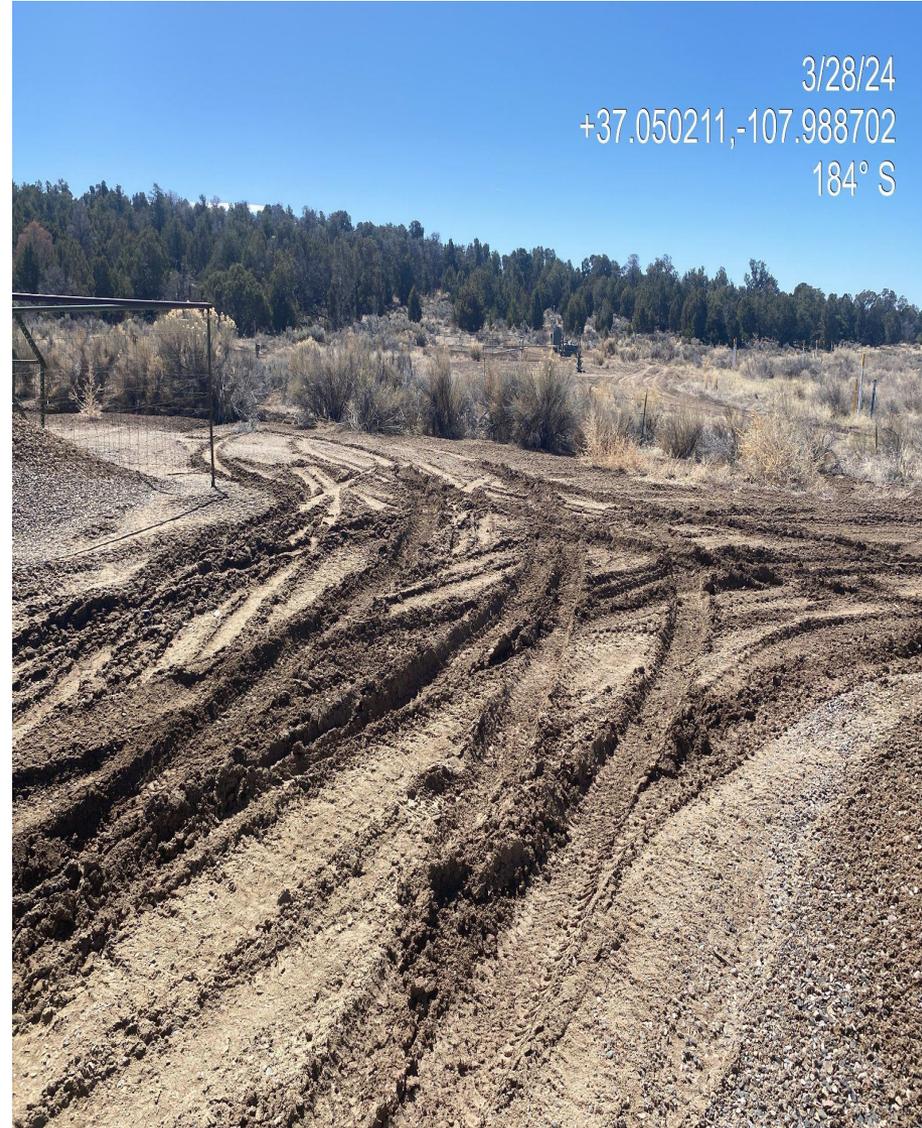
Photo 3. Rutting observed in the southern portion of the disturbance. Additional stabilization is needed to minimize stormwater and site degradation.

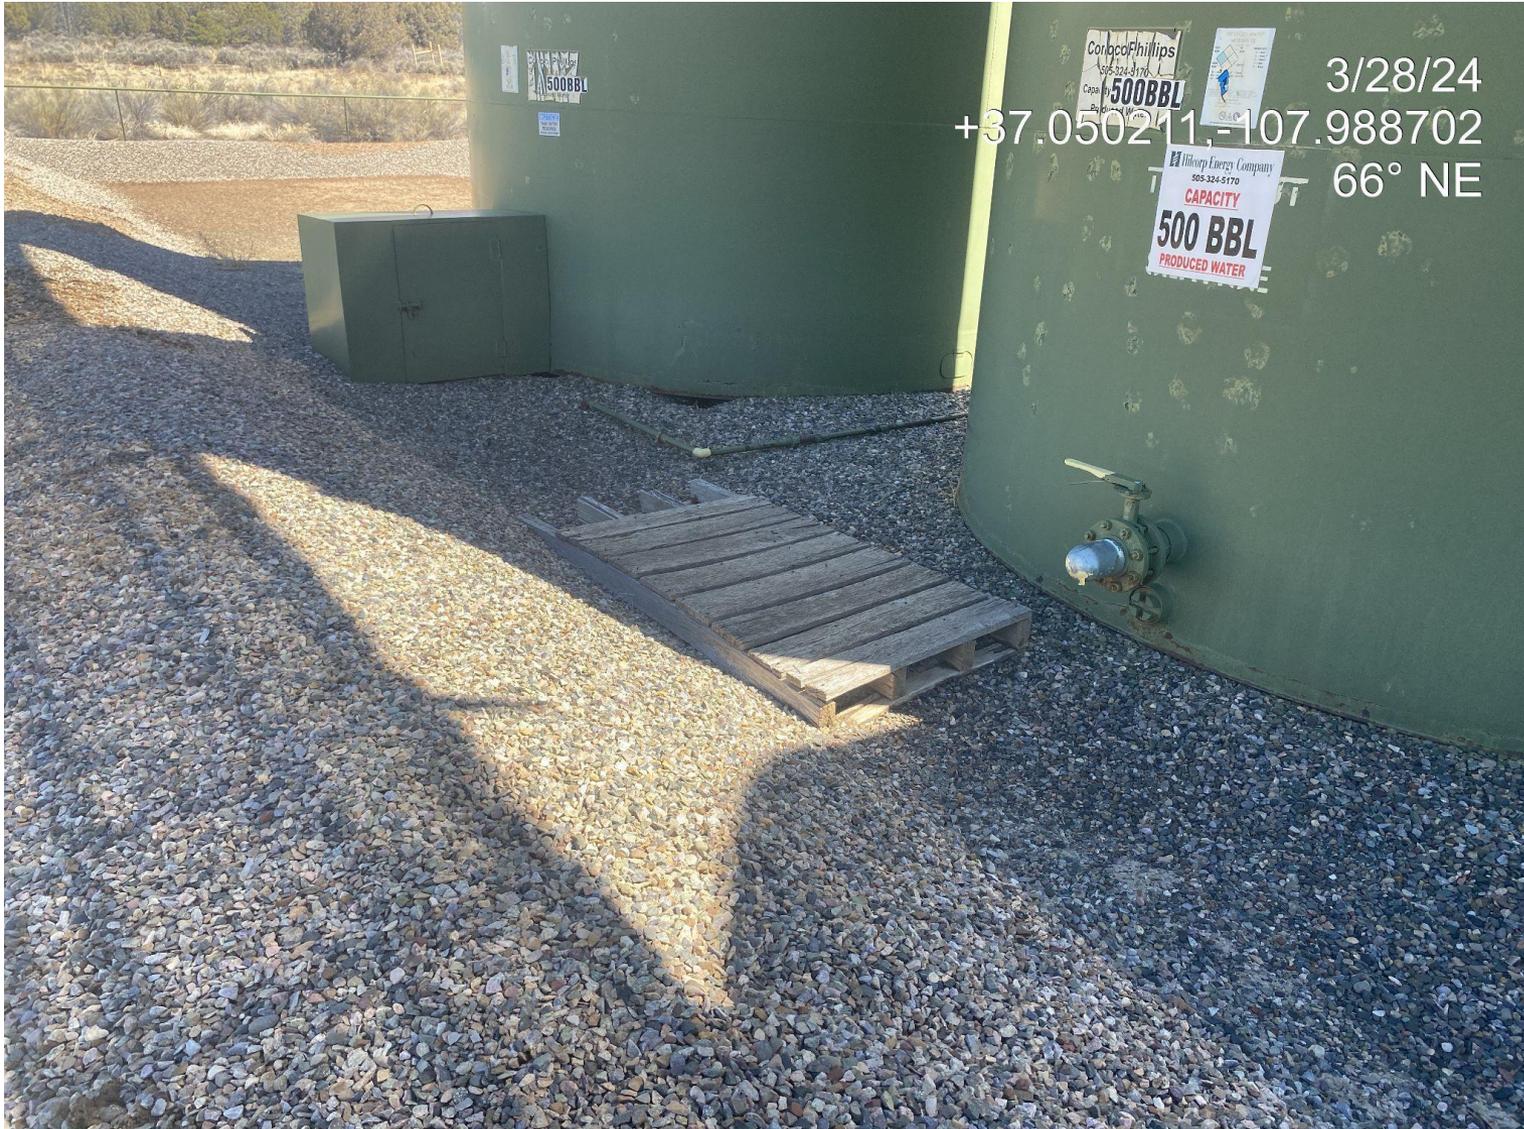
Photo 4. Wood pallet trash/debris observed on location within the produced water tank berm.

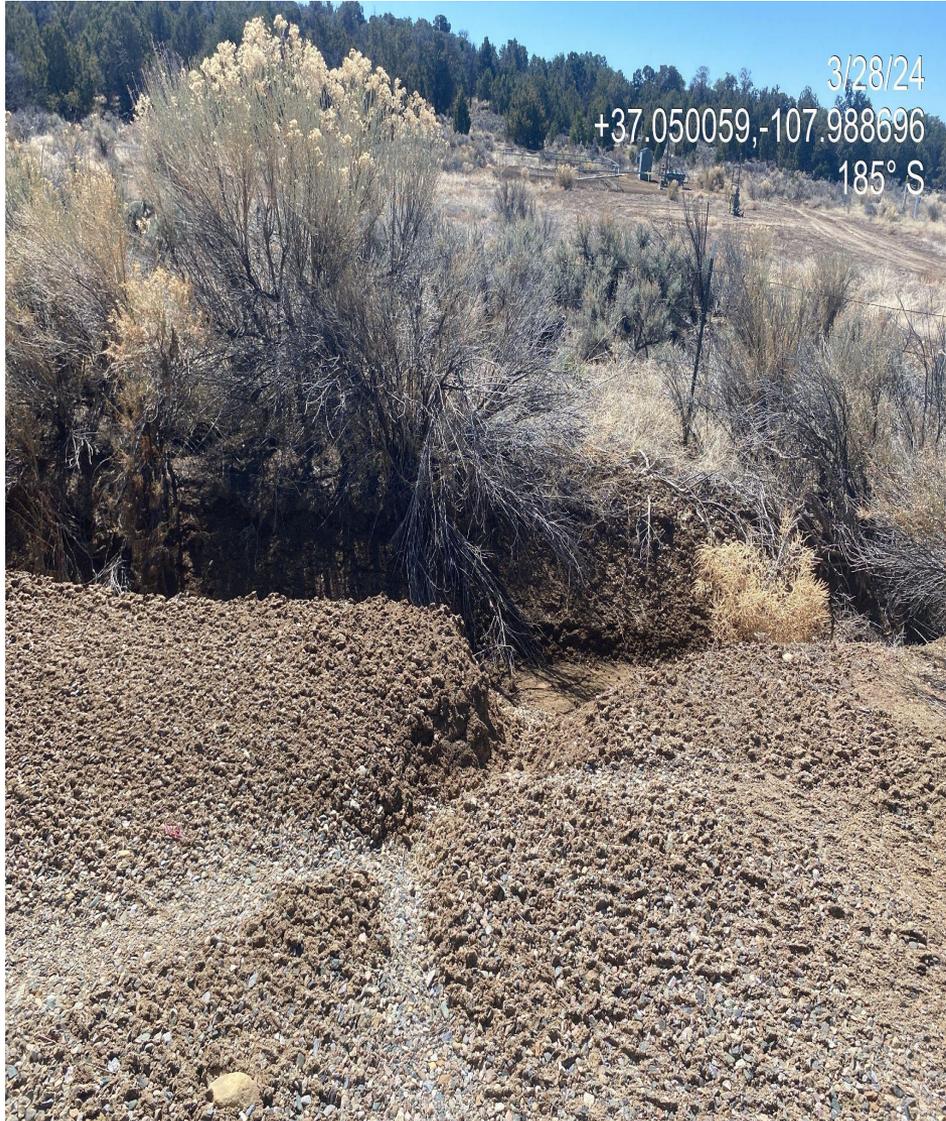
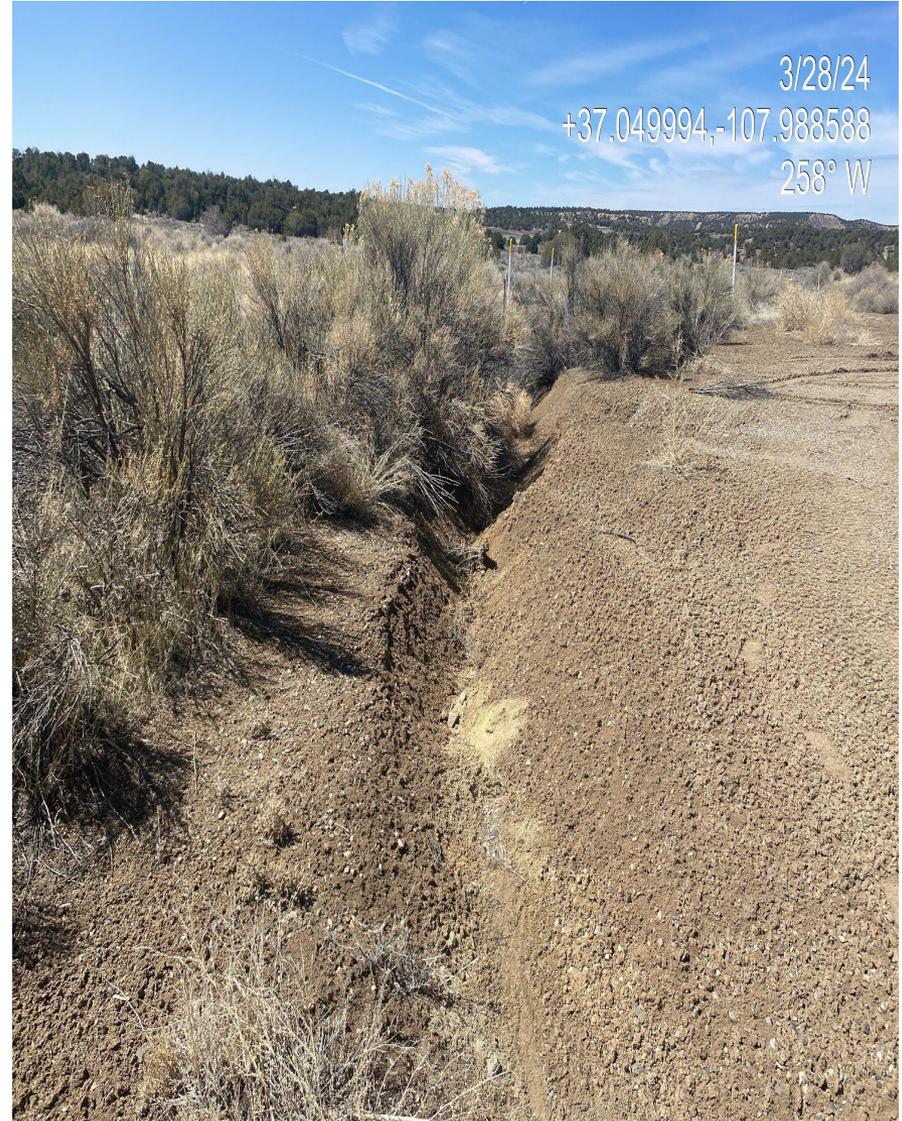
Photo 5. Gully erosion observed forming in the southwest corner of the disturbance.

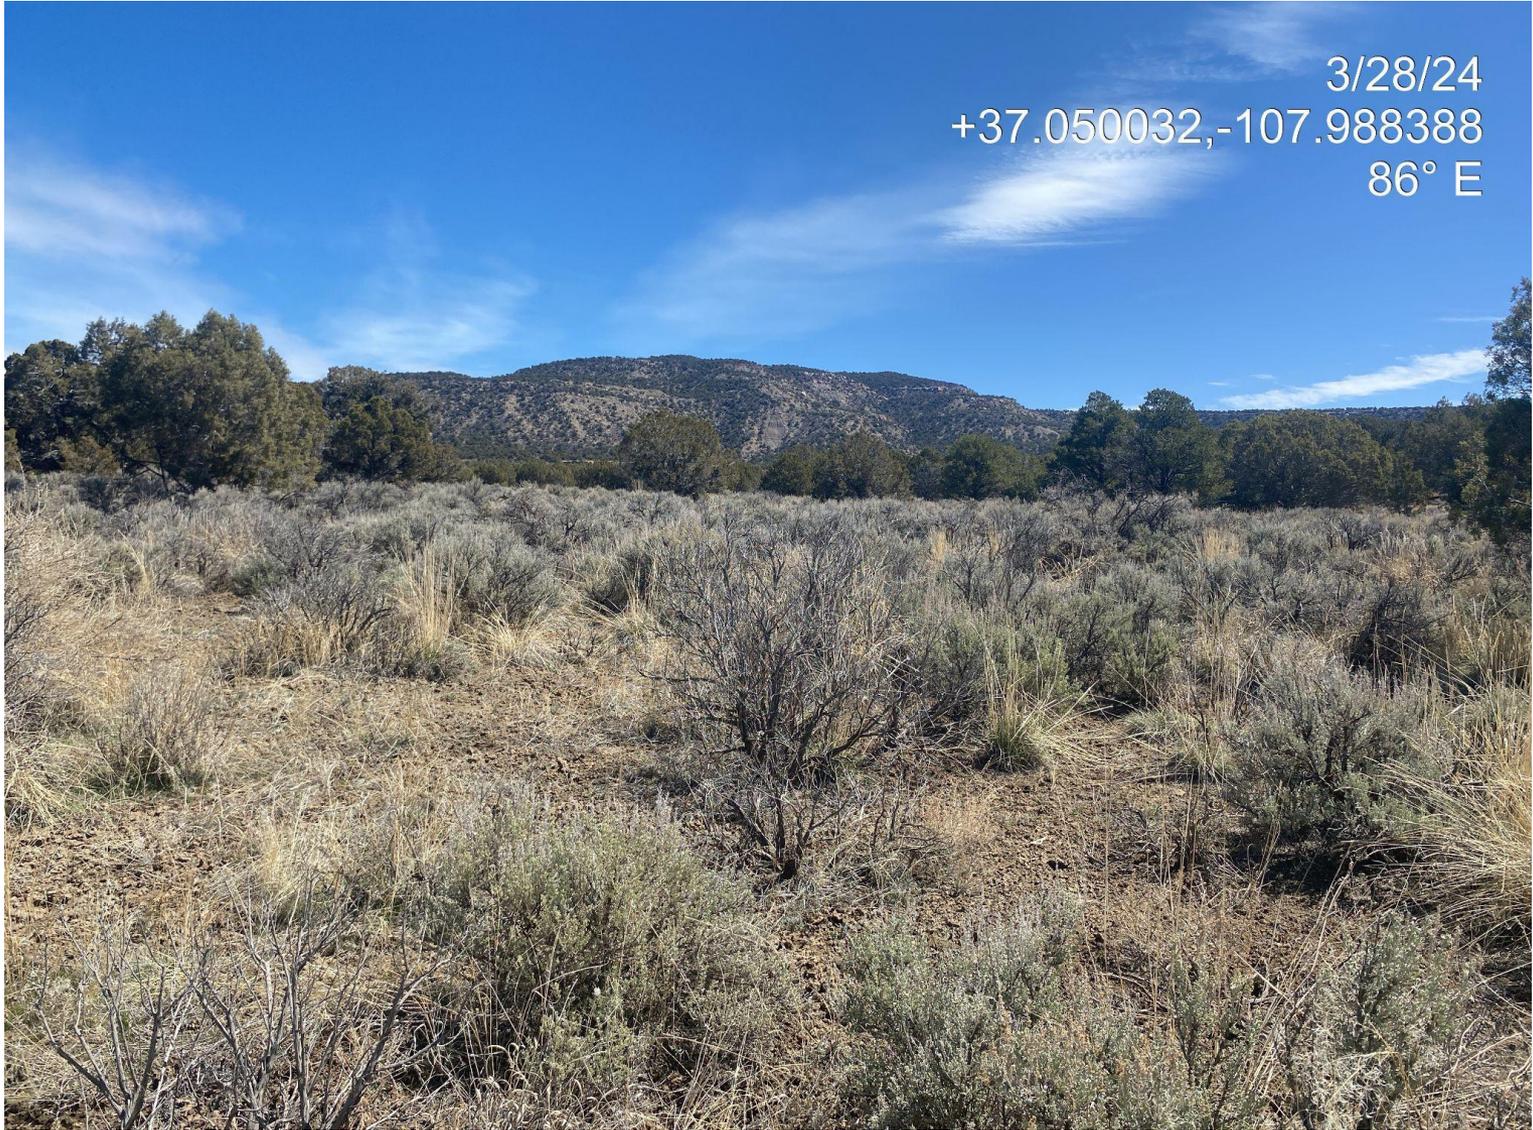
Photo 6. Reference are comprised of sagebrush, juniper and crested wheatgrass.
