Final Reclamation Inspection

Operator: Simcoe LLC - 10749

Location ID: 326198

Inspection Photos
Location Name: Eldridge 36-02 1
Location ID: 326198

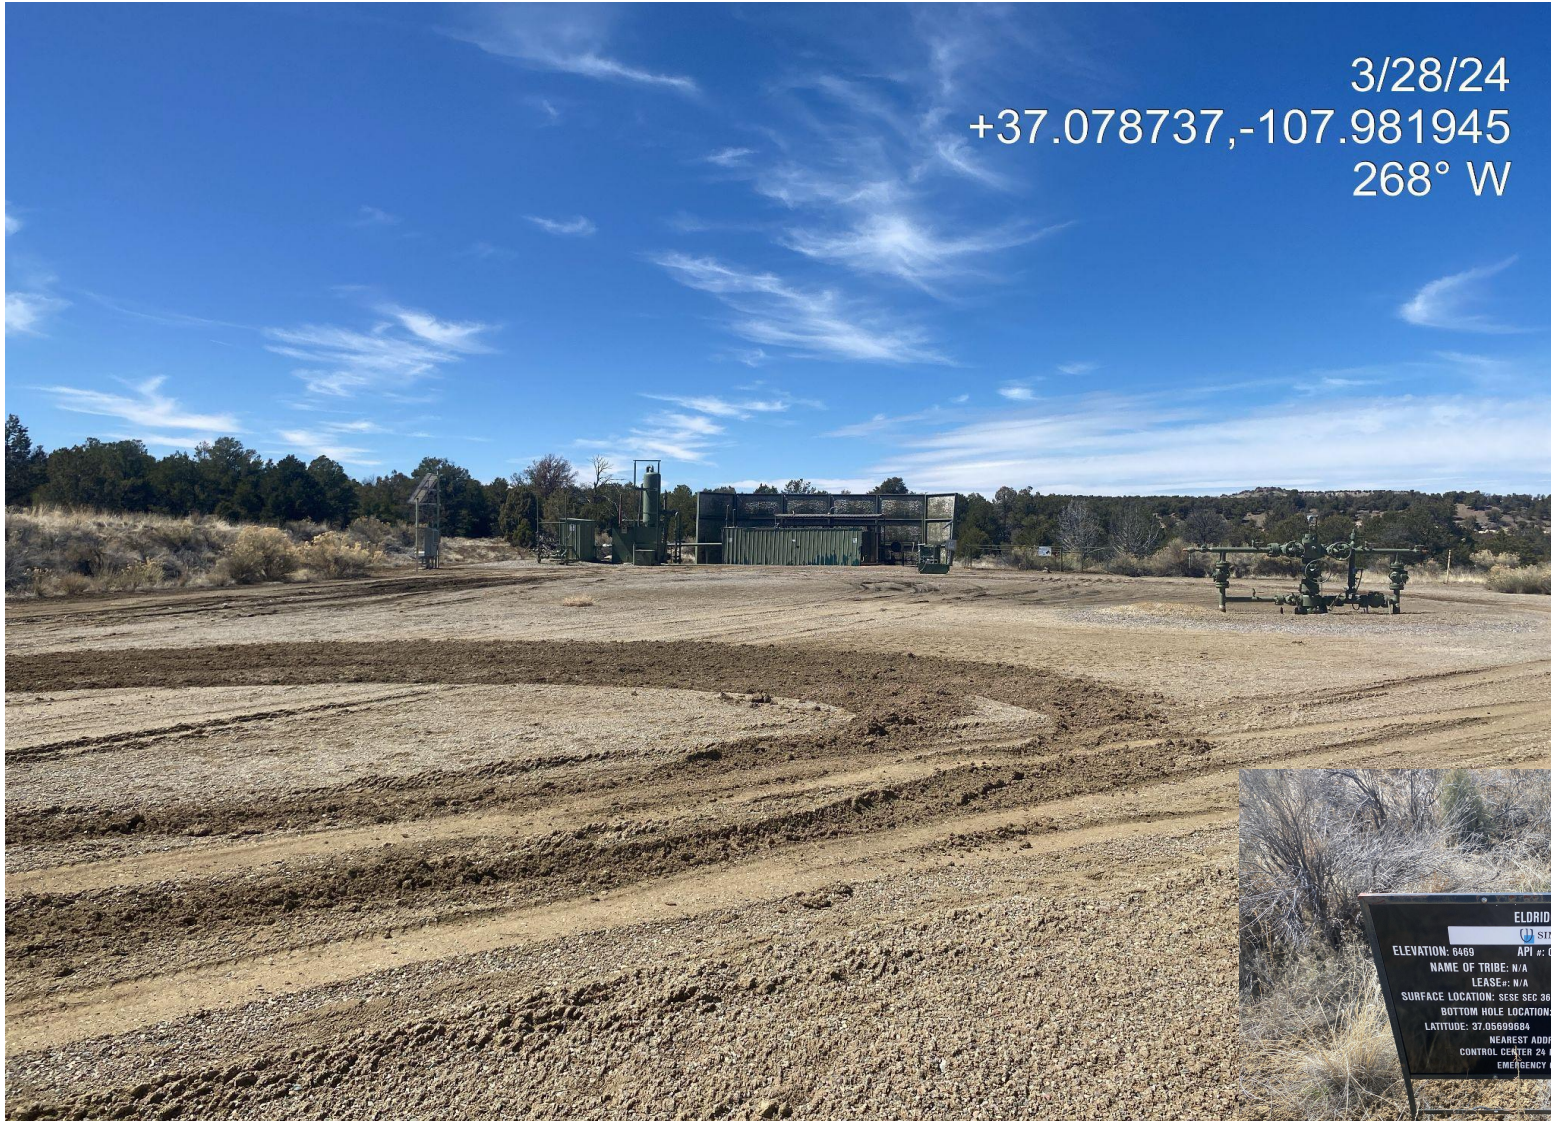
Photo 1. Overview of the disturbance taken from the access point facing center.

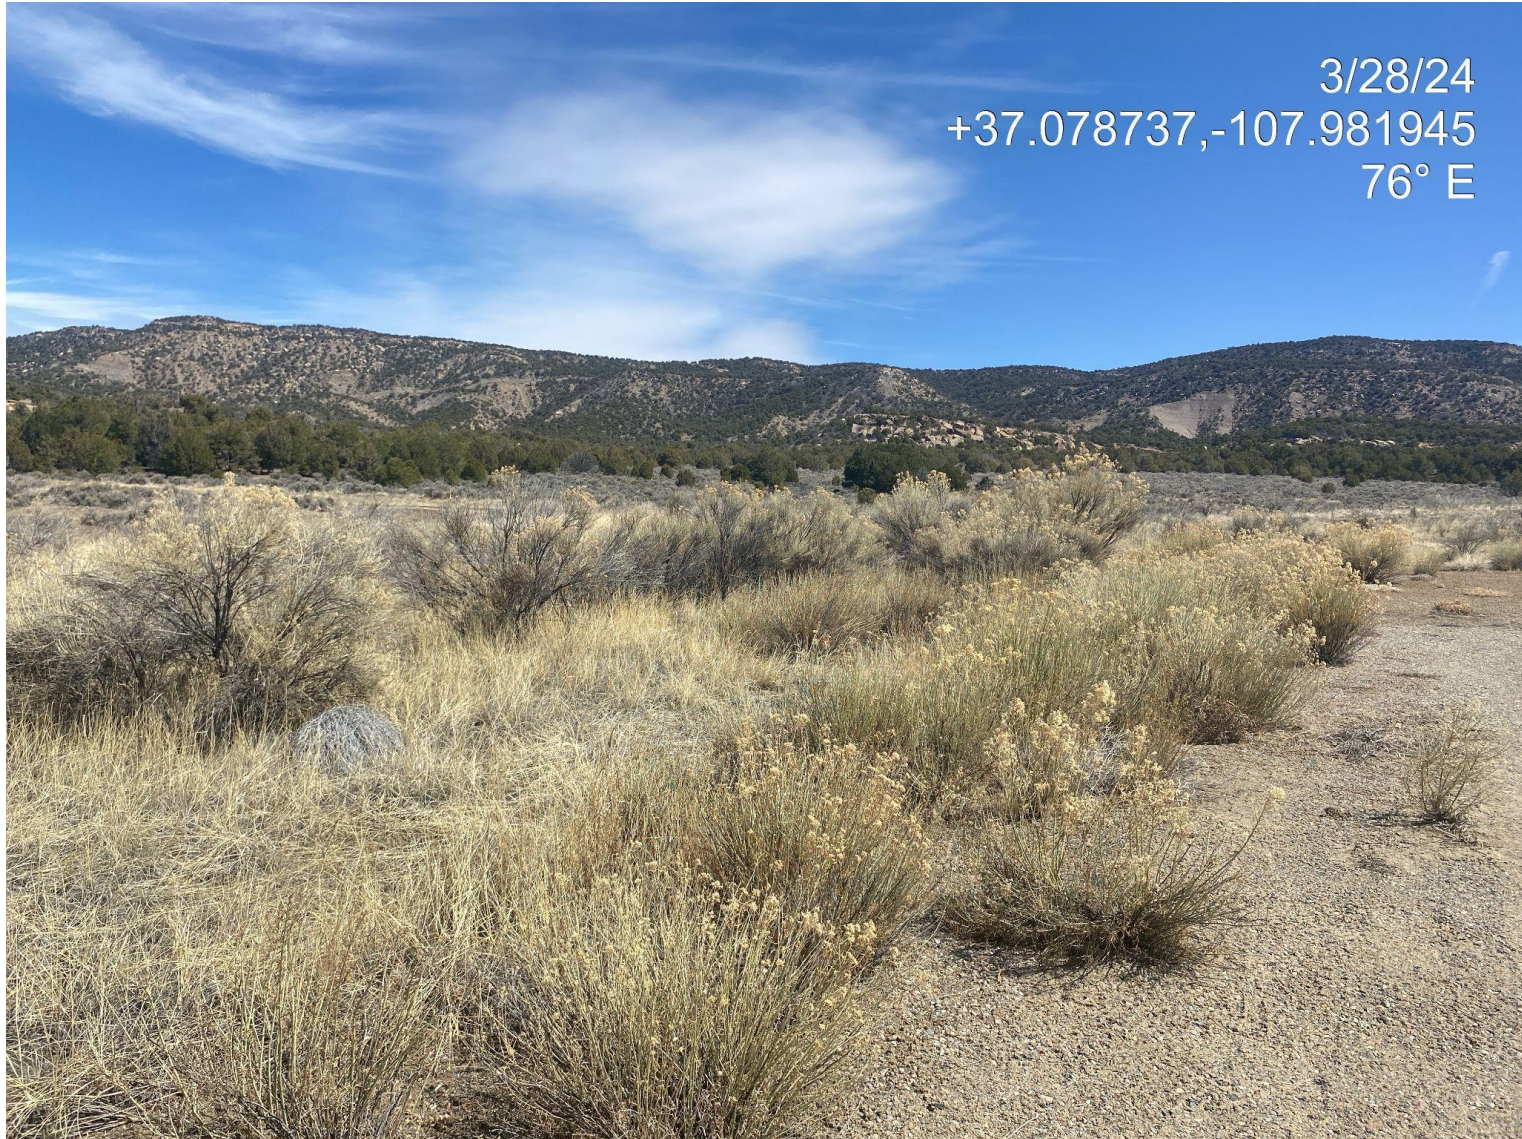
Photo 2. View of the northern interim reclamation area facing east.
Vegetation comprised of crested wheatgrass, indian rice grass, rabbit brush
and sage brush.

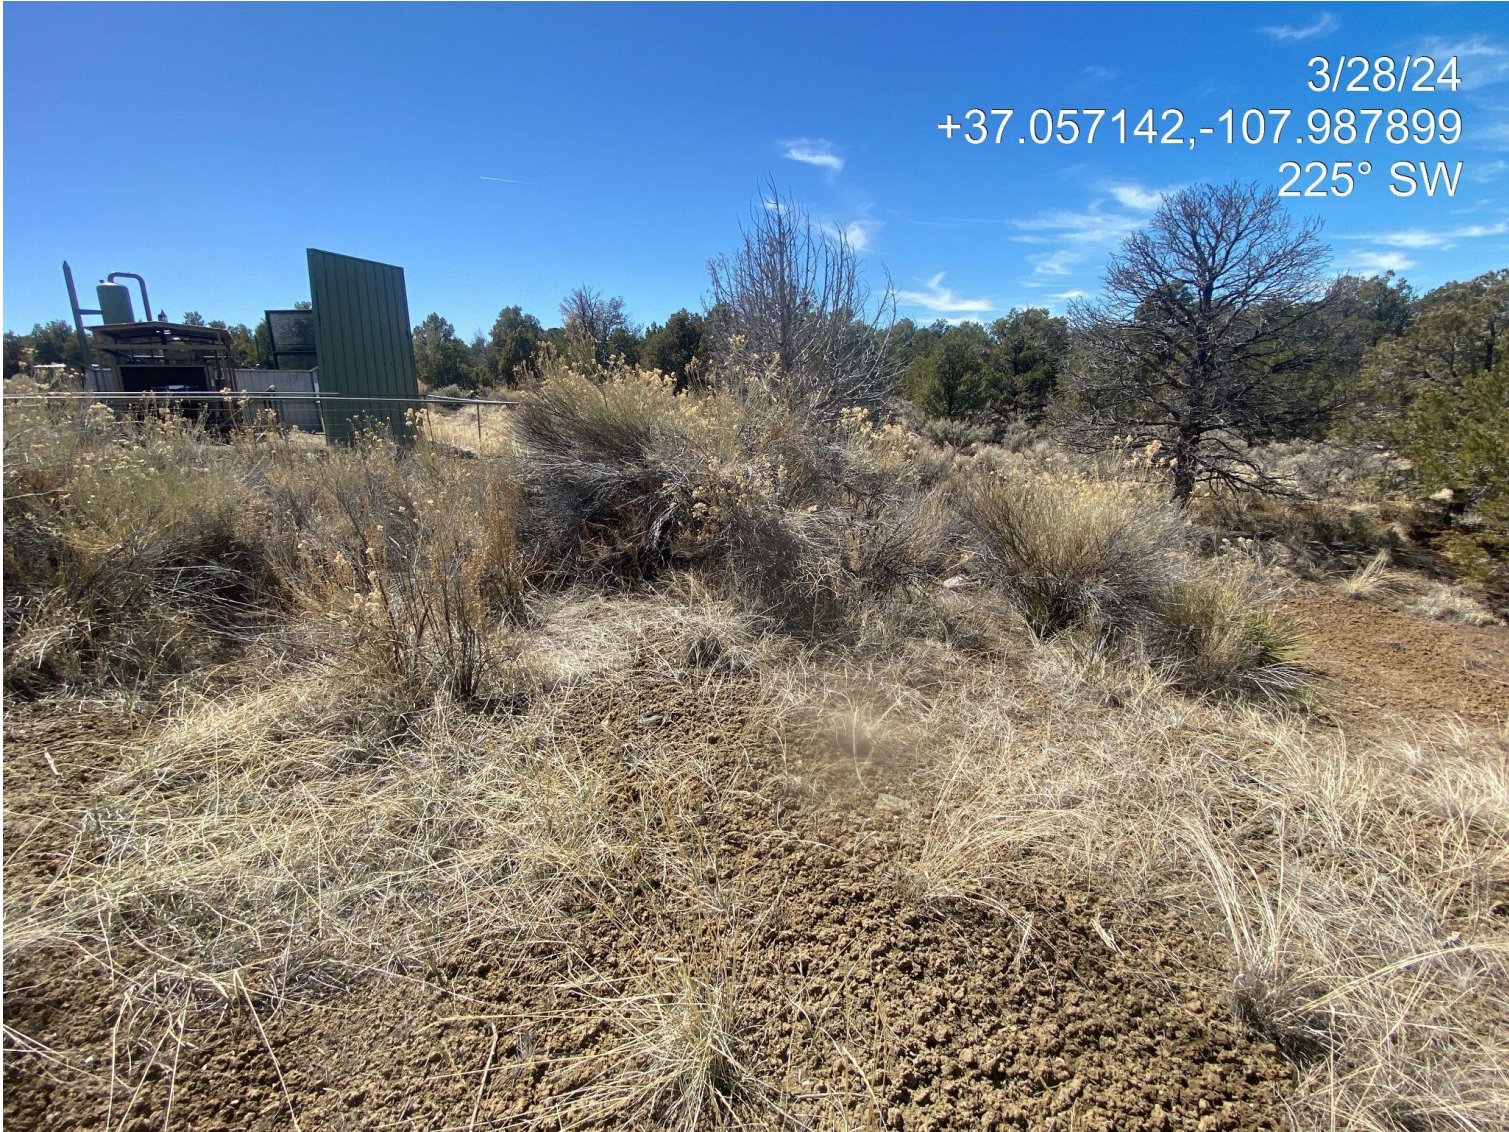
Photo 3. Waste/debris corrective action identified in the previous inspection doc #693903403 has been addressed/resolved.

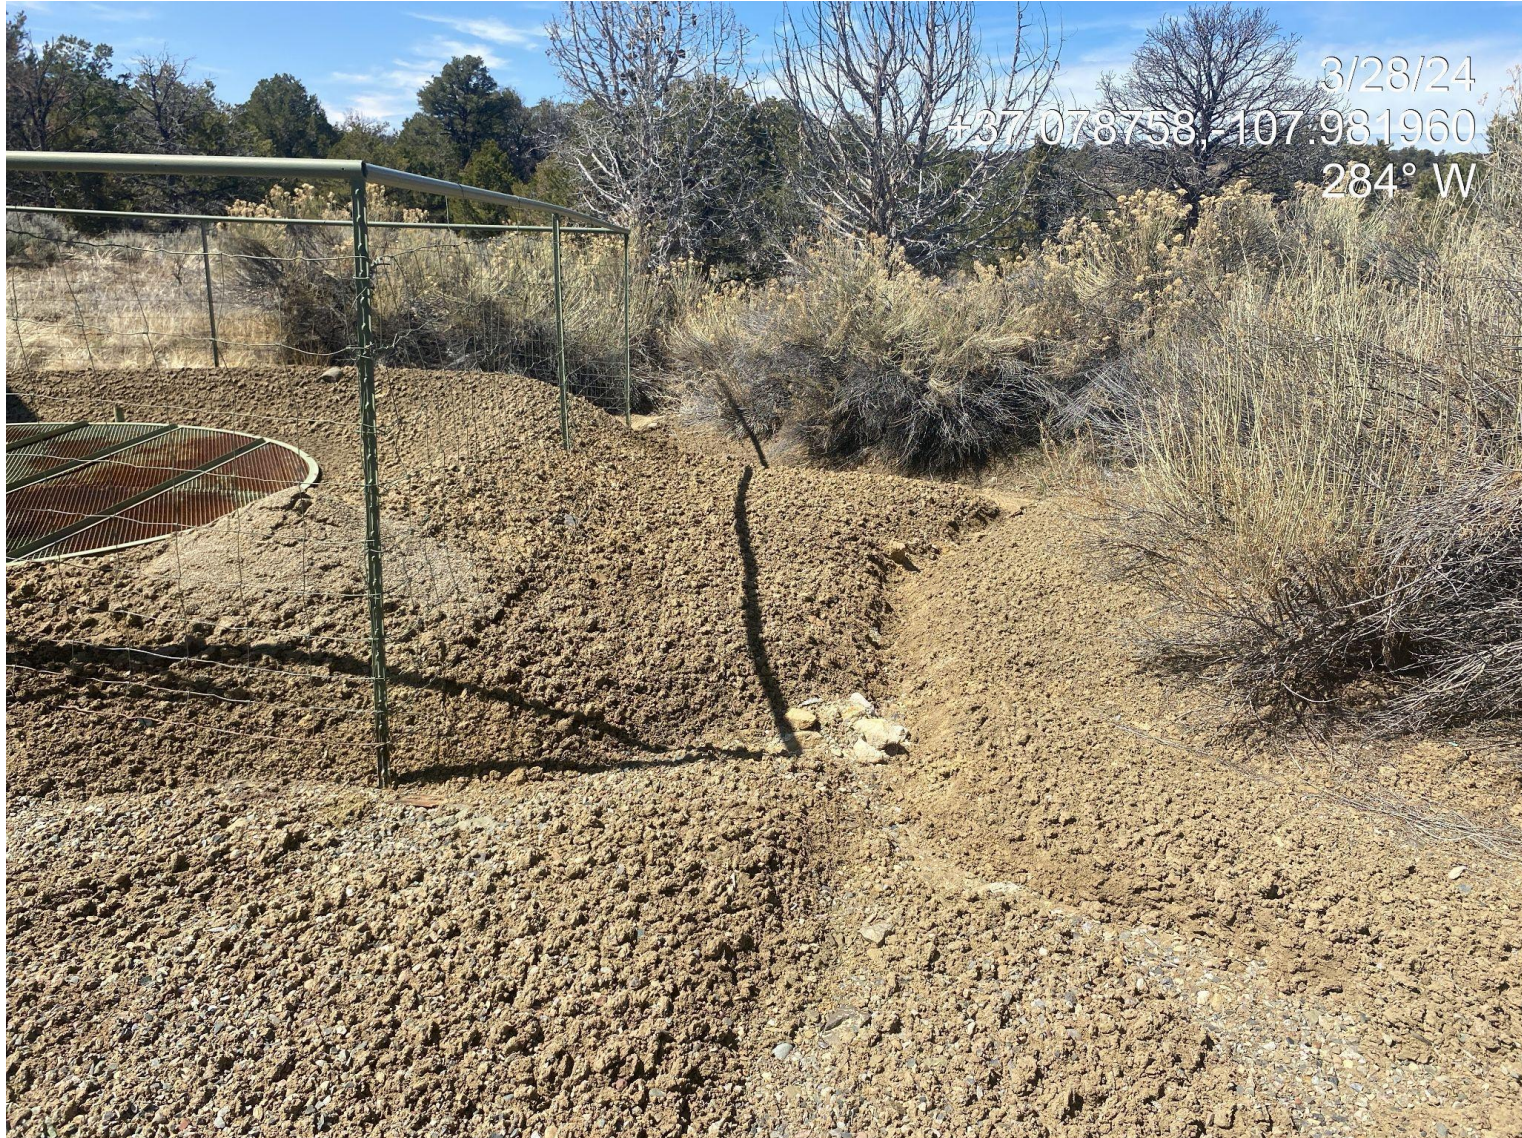
Photo 4. Rill erosion observed forming along the fence line of the produced water tank.

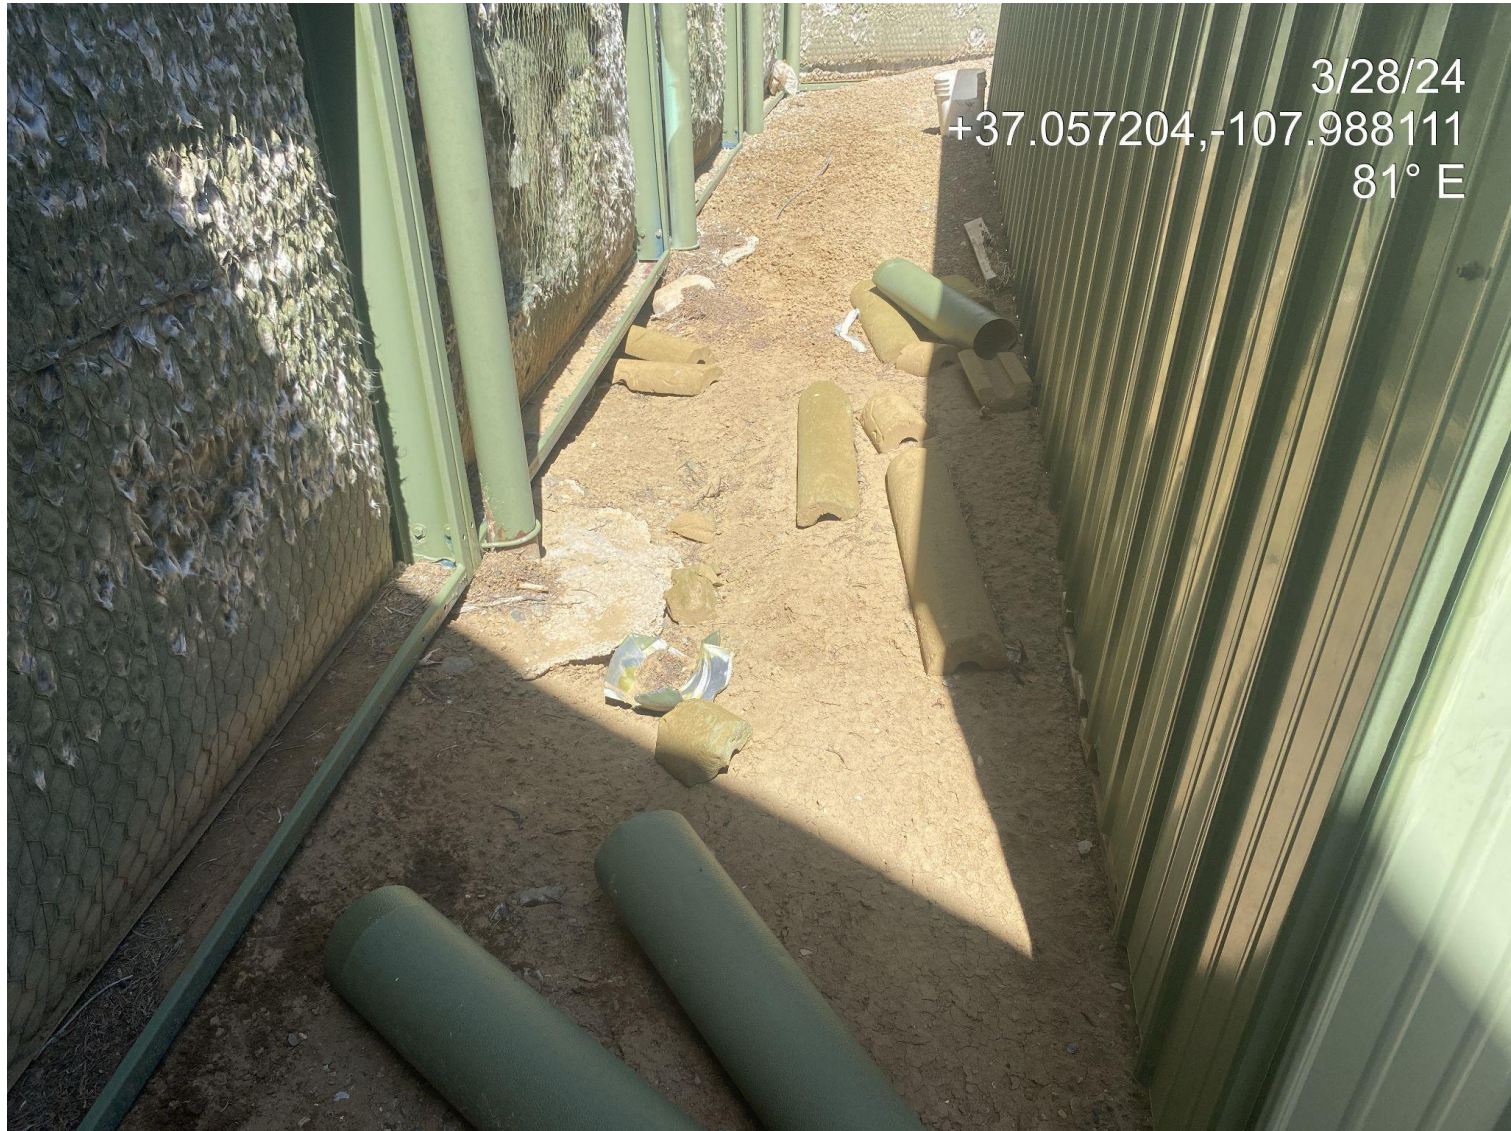
Photo 5. Plastic and foam waste/debris observed along the sound wall.

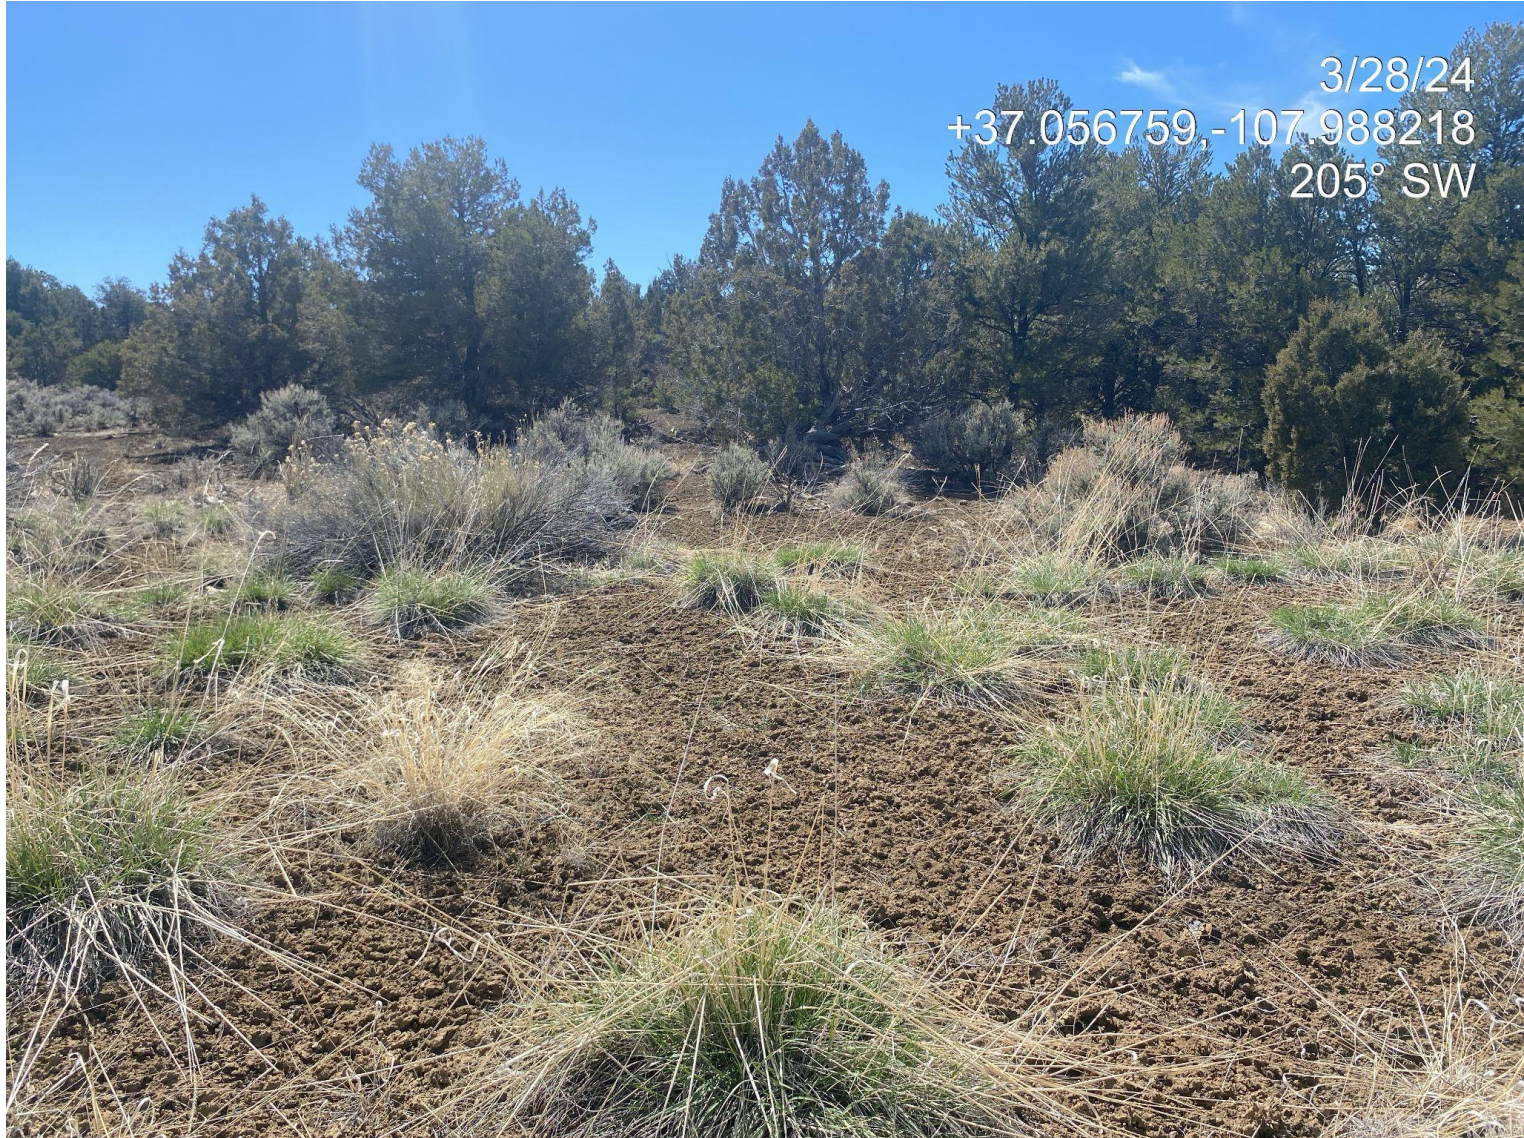
Photo 6. Reference area comprised of rabbitbrush, sage brush, crested wheatgrass and indian ricegrass.
