Interim Reclamation and Stormwater Inspection

Operator: KERR MCGEE OIL & GAS ONSHORE LP
-47120

Location ID: 333269

Inspection Document #: 708201011

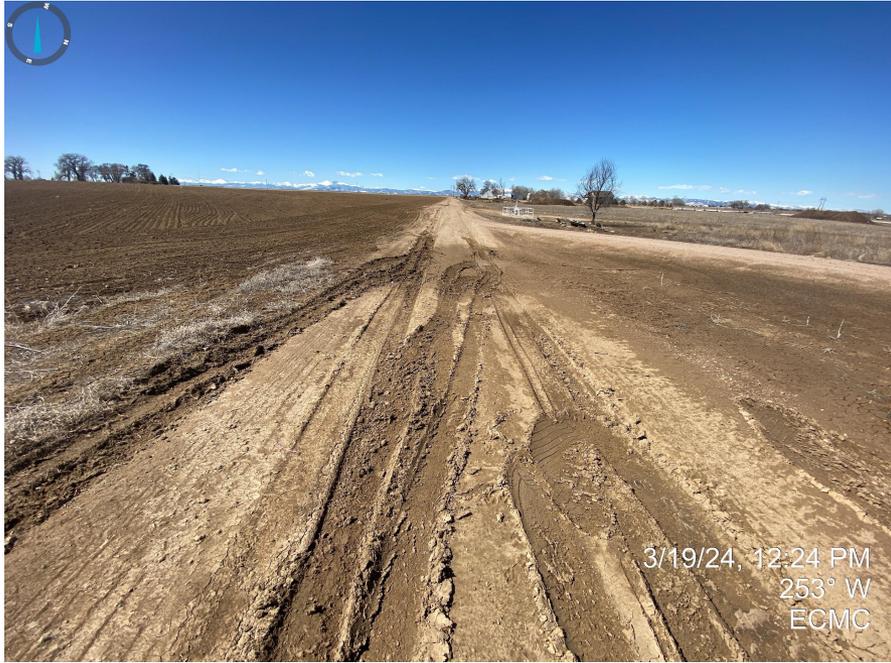
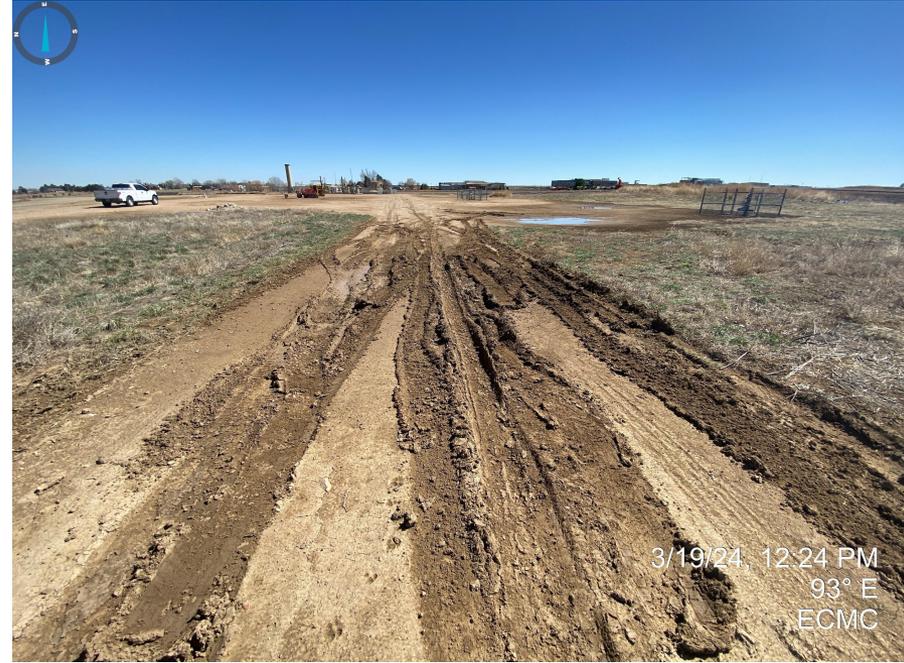
Photos 1 & 2. Taken near the location entrance and access road intersection. Access road requires maintenance as it is beginning to rut which can contribute to vehicle track out.

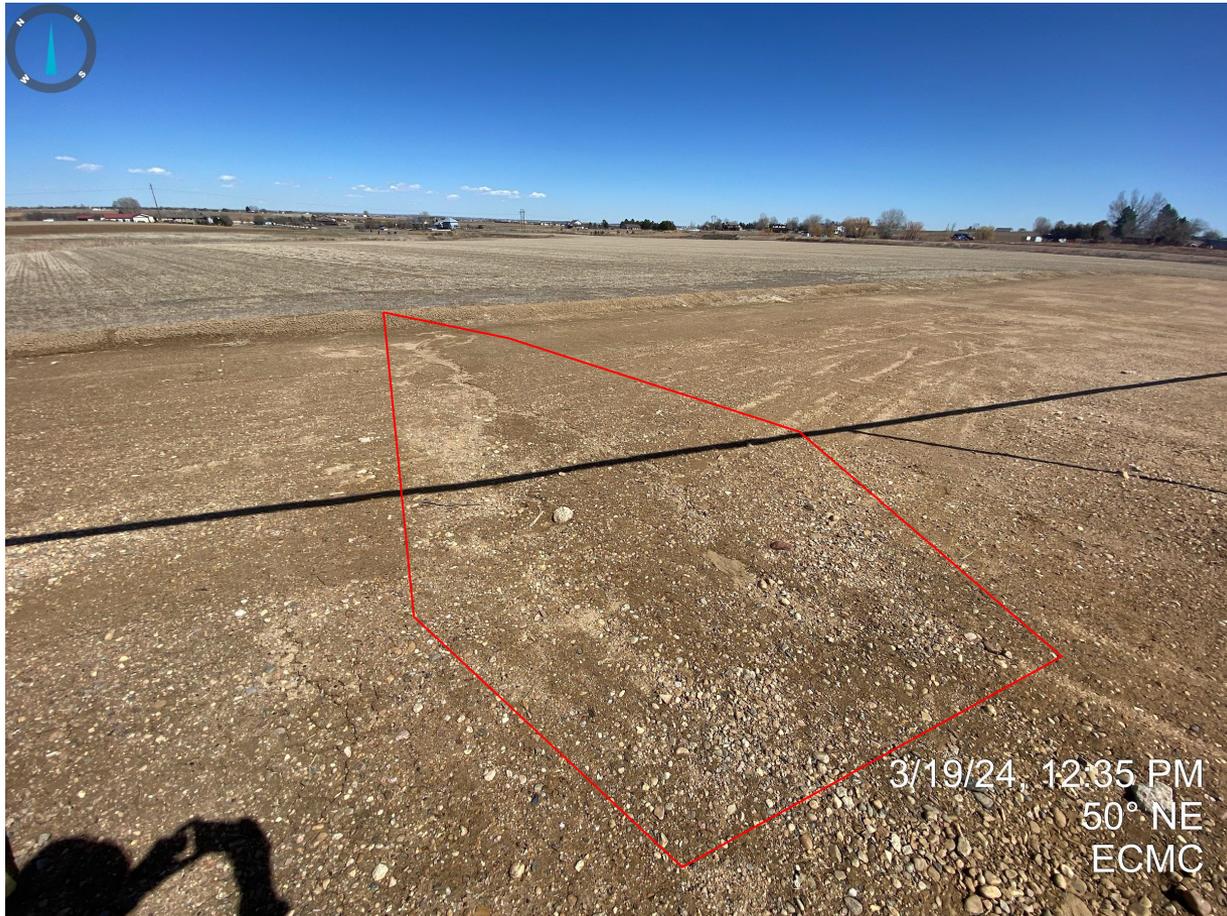
Photo 3. Erosion degradation (e.g. riling) occurring on the north side of the tank battery.

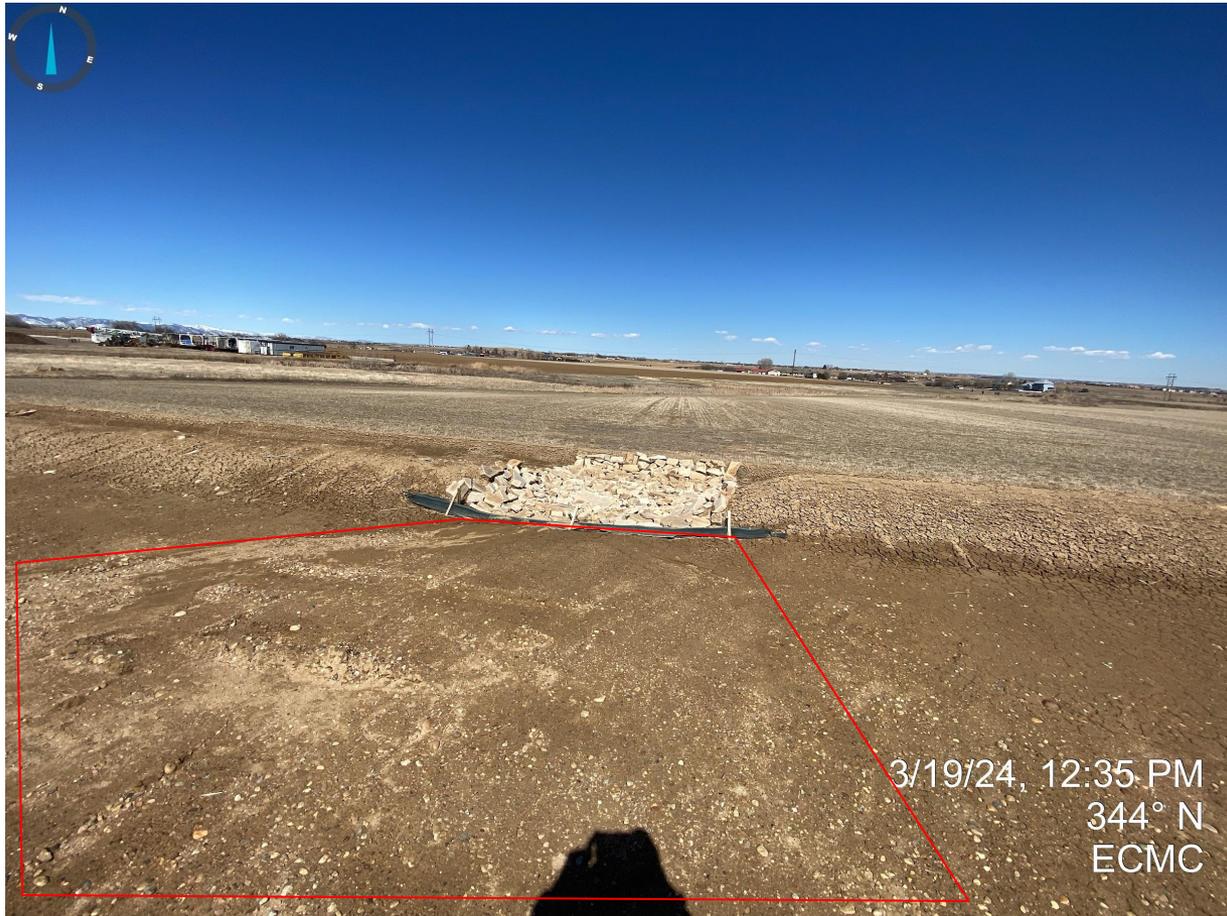
Photo 4. Erosion degradation (e.g. riling) occurring near one of the northern sediment traps. Sediment trap appears to have been recently replaced or had repairs.

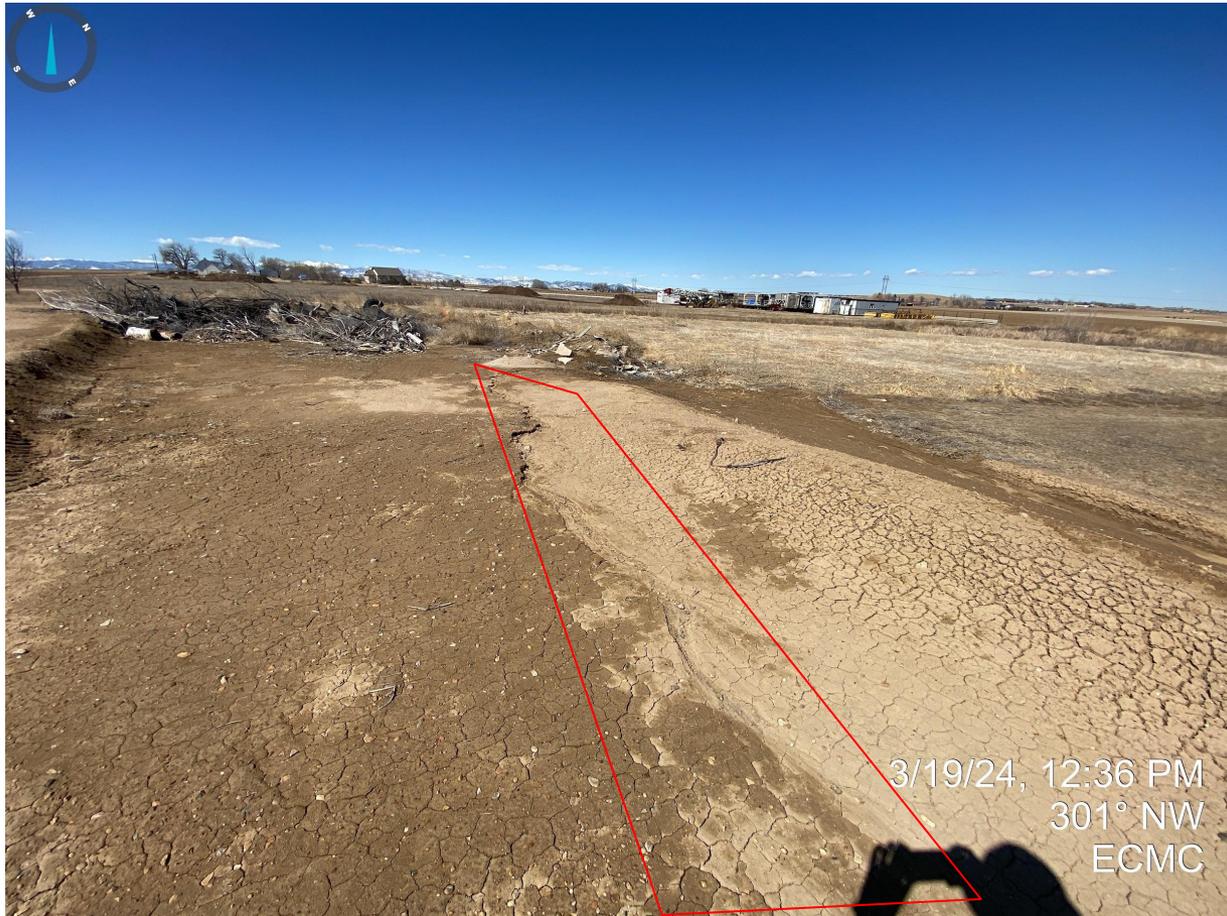
Photo 5. Erosion degradation occurring on the northwest portion of the location.

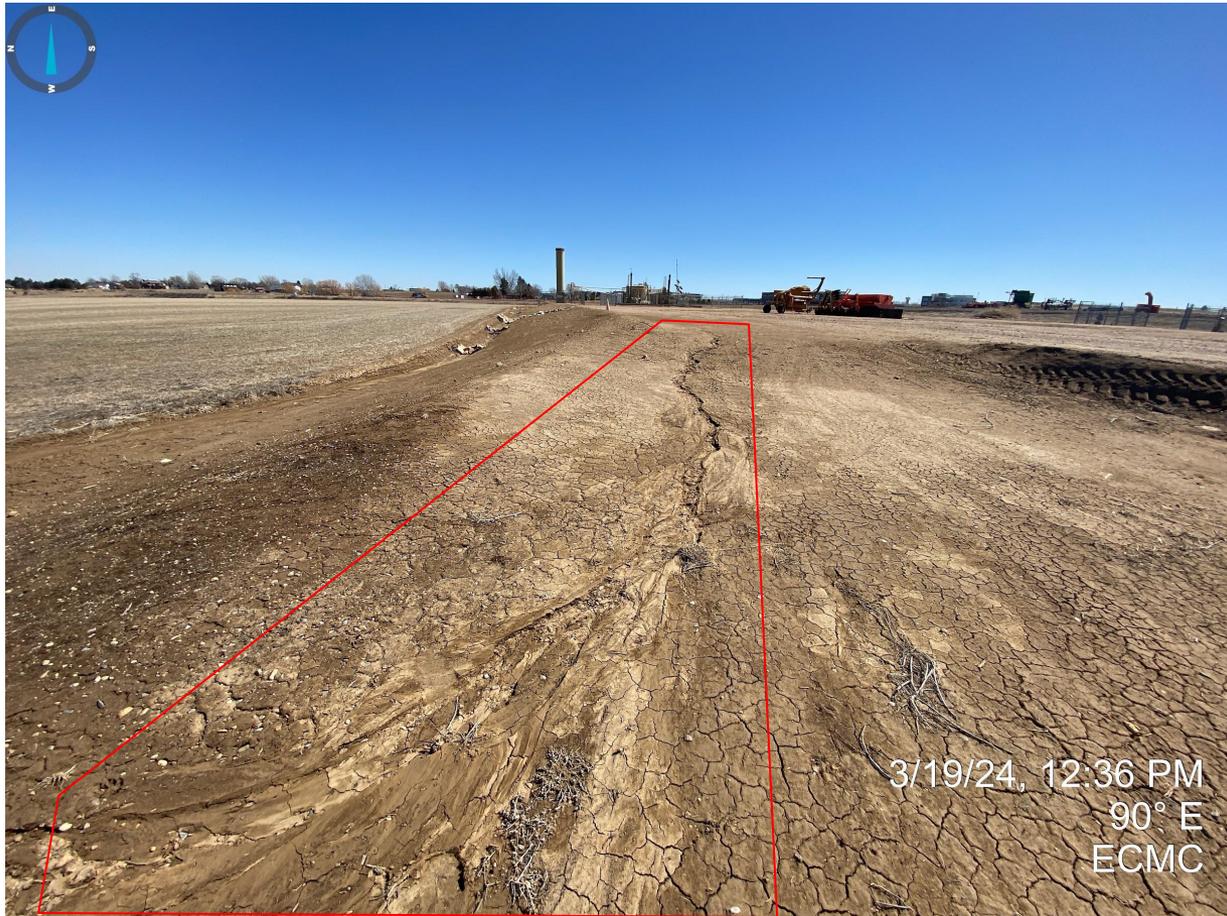
Photo 6. Continued from Photo 5, facing east.

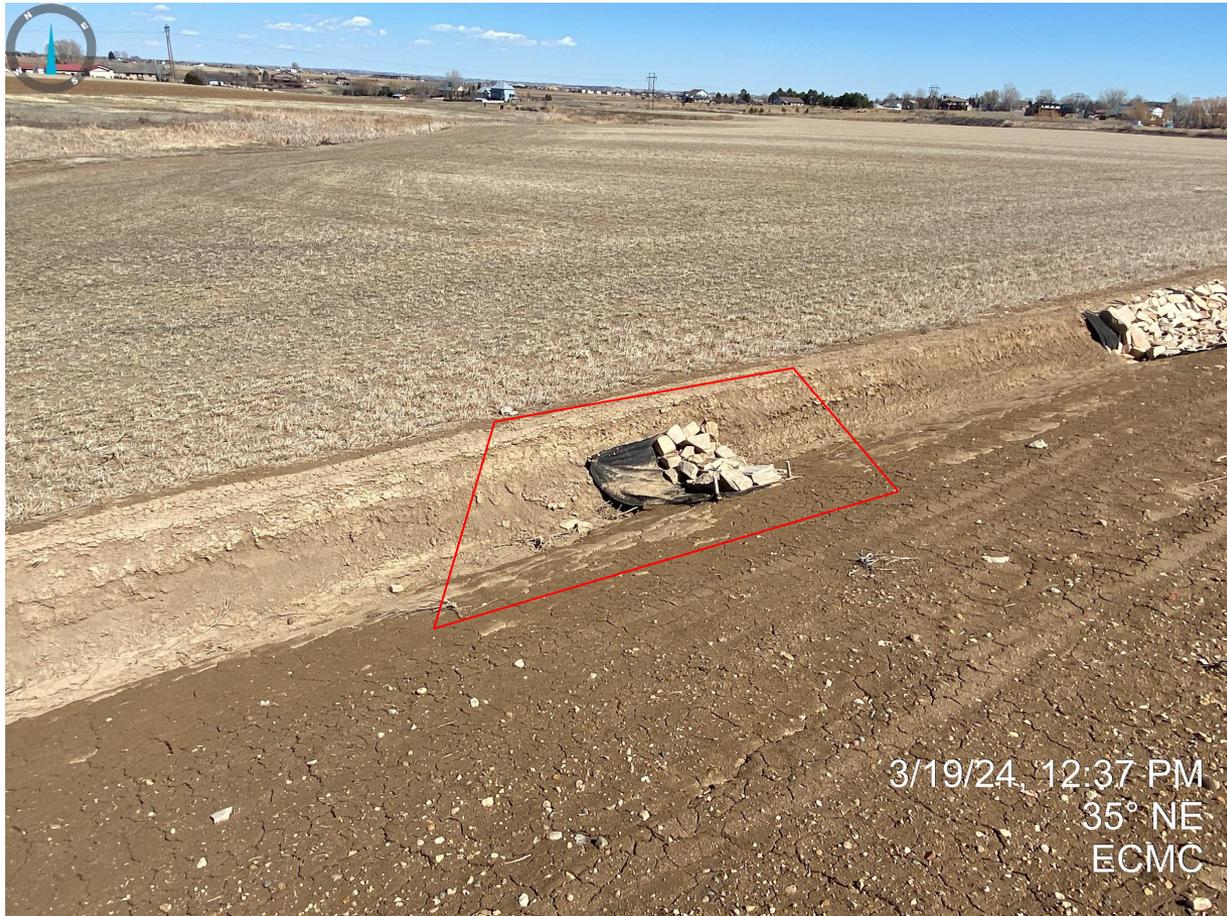
Photo 7. Stormwater control measure/BMPs requires maintenance as stormwater is beginning to undercut the velocity check/structure.
