Interim Reclamation and Stormwater Inspection

Date: 03/20/2024

Operator: WESTERN OPERATING COMPANY - 95620

Inspection Photos
Location Name: Propst 2
Location ID: 312292

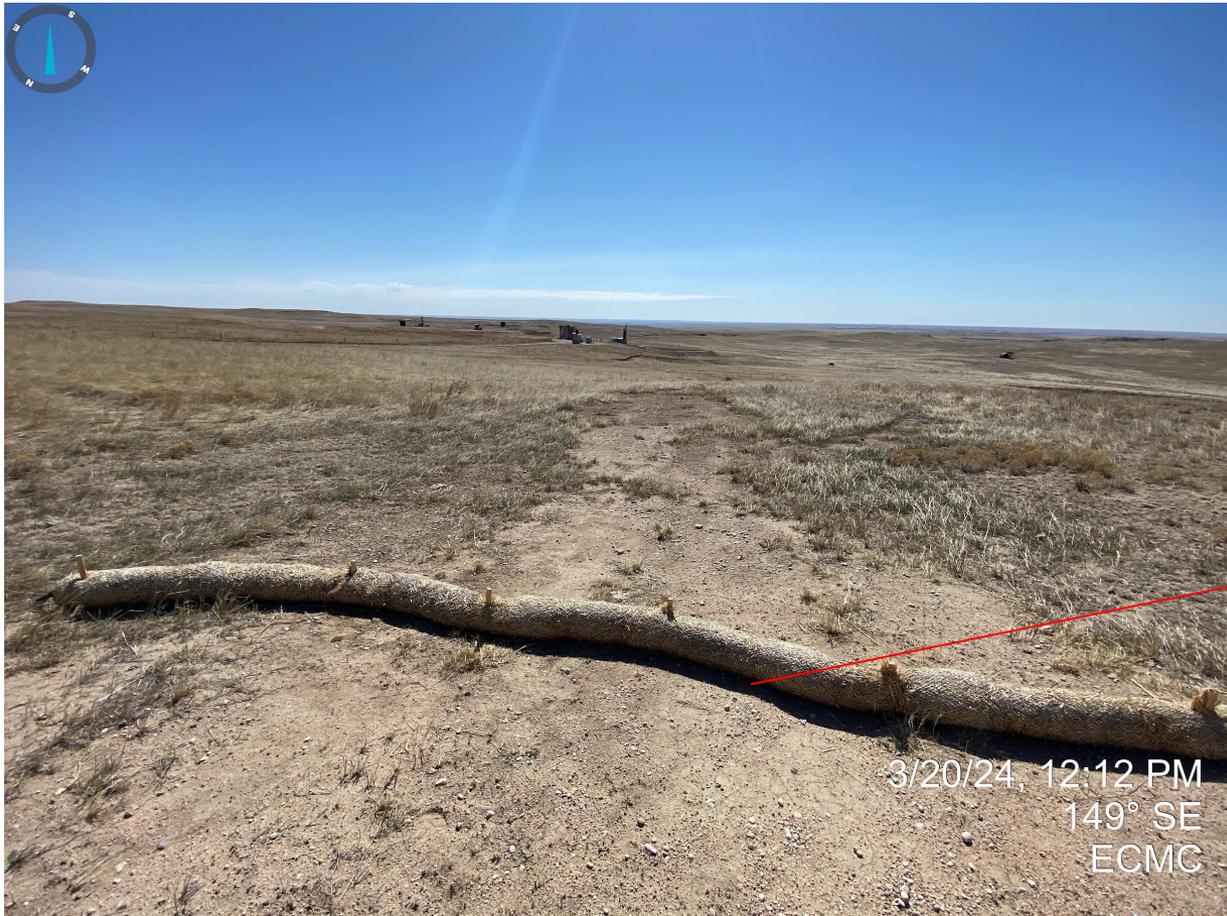
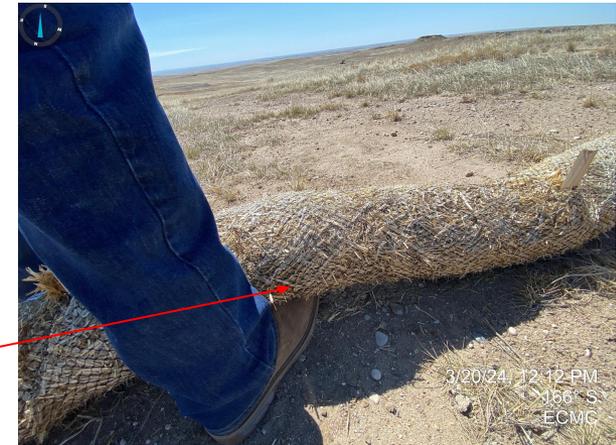
Photo 1. Taken south of the vertical heater treater. Straw wattles have been staked in place but do not appear to be installed per good engineering practices (e.g. trenched and backfilled). Soils remain bare/exposed and are susceptible to wind and water erosion degradation.

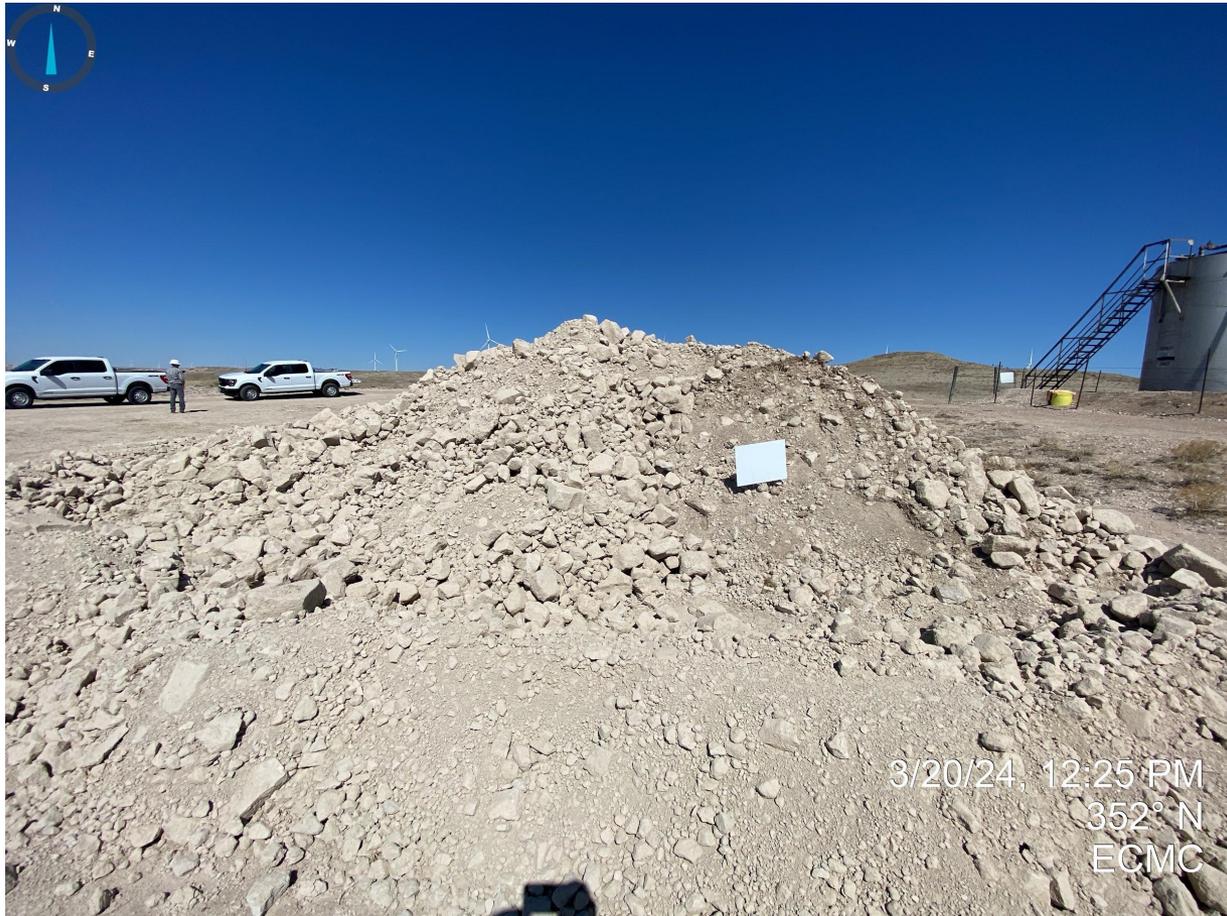
Photo 2. Stockpiled materials on the working pad surface are not properly identified as the writing on the white sign was illegible.

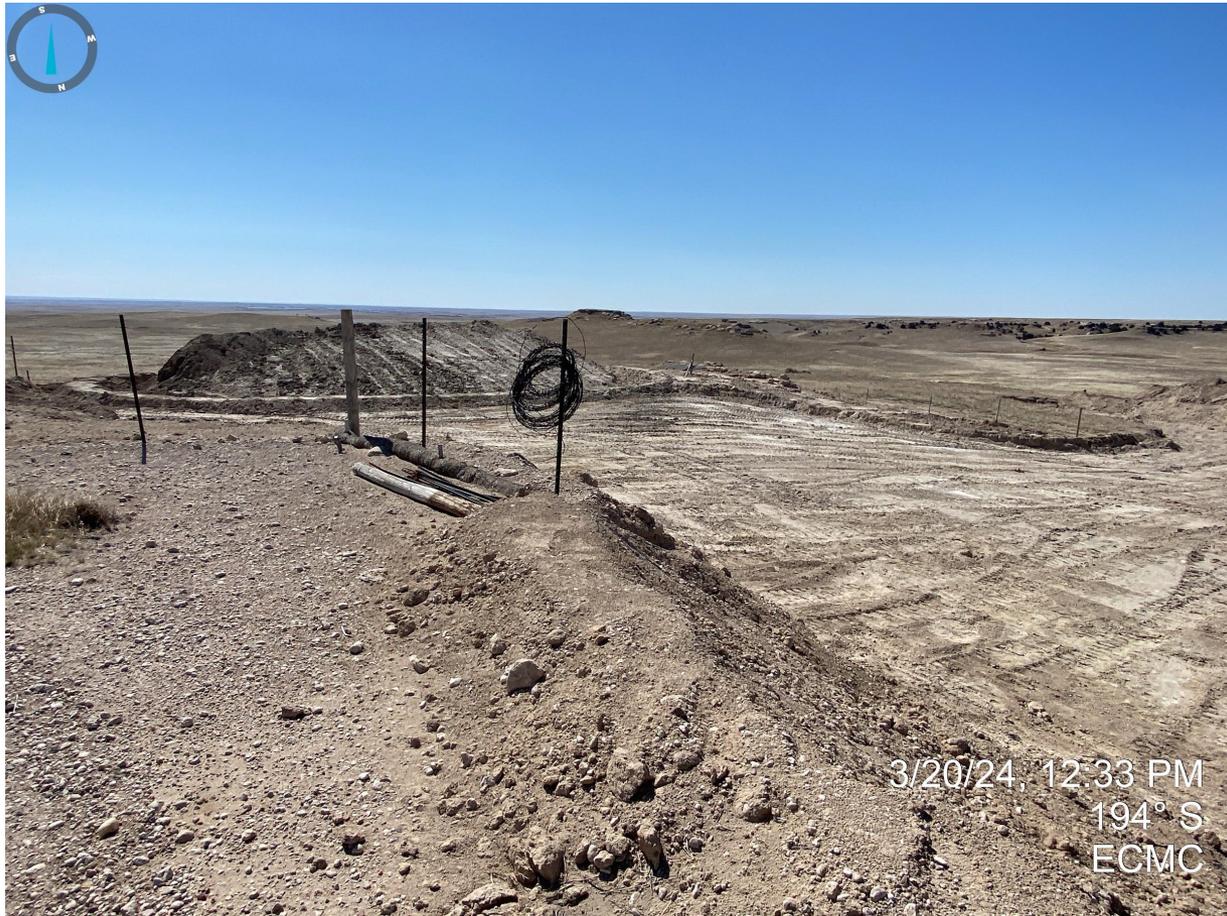
Photo 3. Unused equipment (e.g. fencing) observed on location. All fencing materials need to be removed or returned to service.

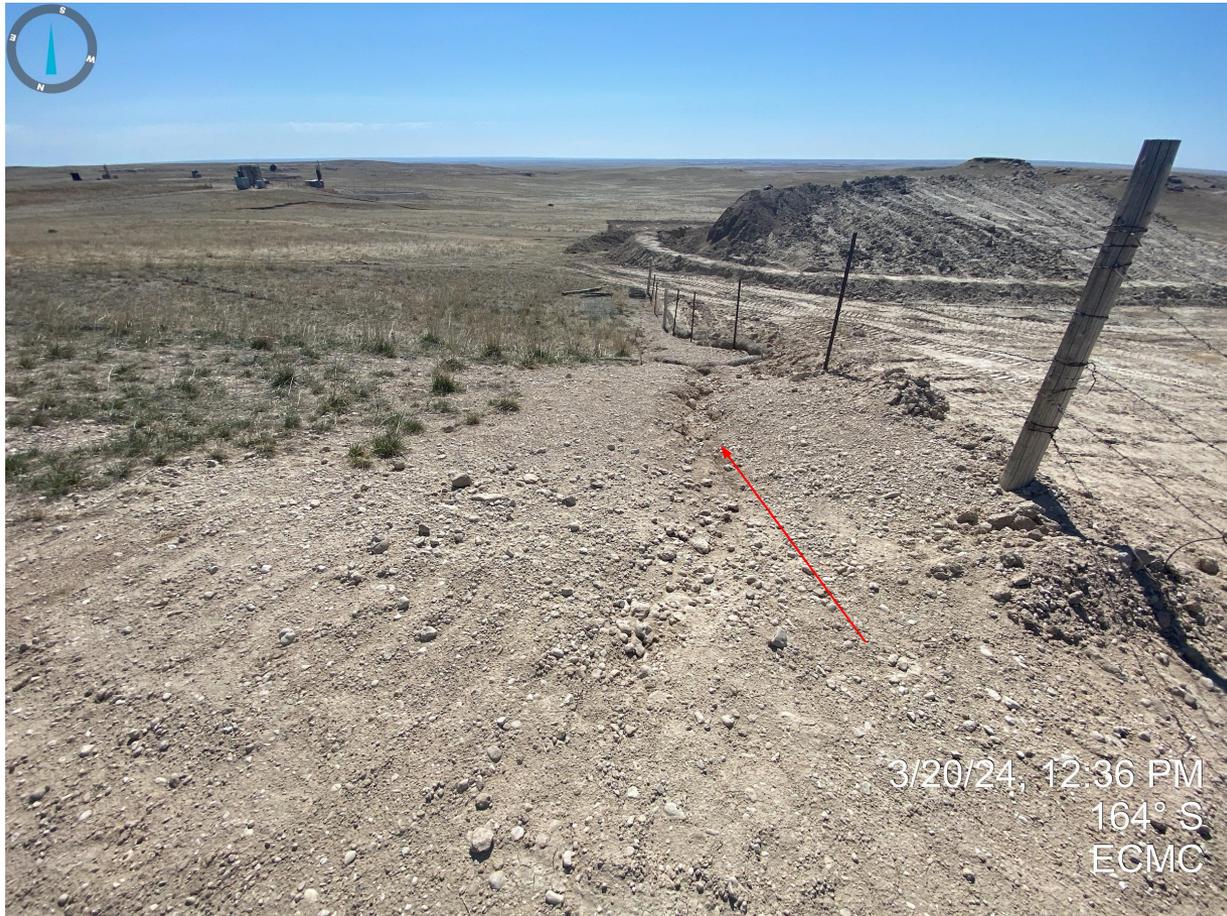
Photo 4. Erosion degradation on the east side of the pit. No stormwater control measures/BMPs observed.

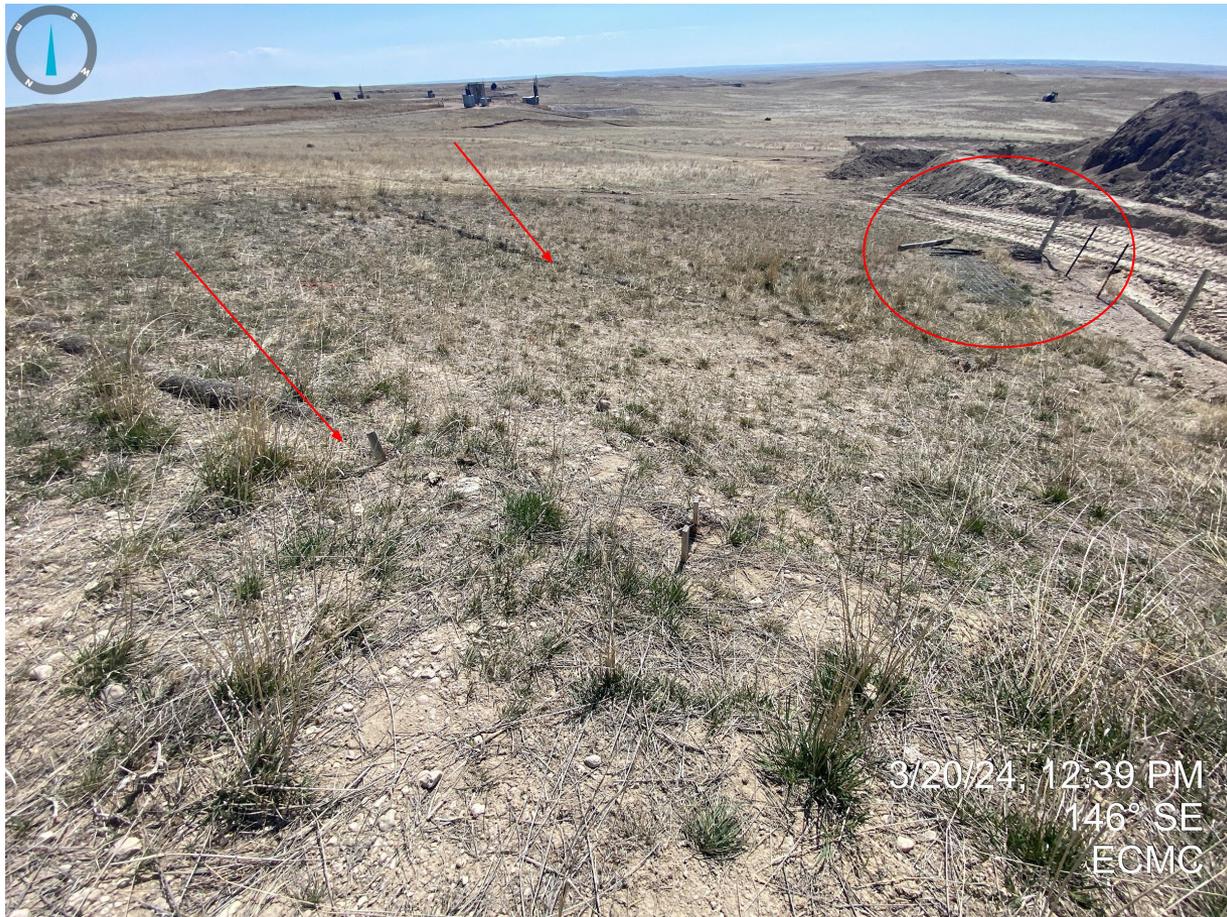
Photo 5. Degraded straw wattles are considered debris as they're beginning to fill with sediment and are no longer adequate or in proper working condition. Also pictured in background (red circle), fencing materials are considered unused equipment and need to be removed or returned to service.

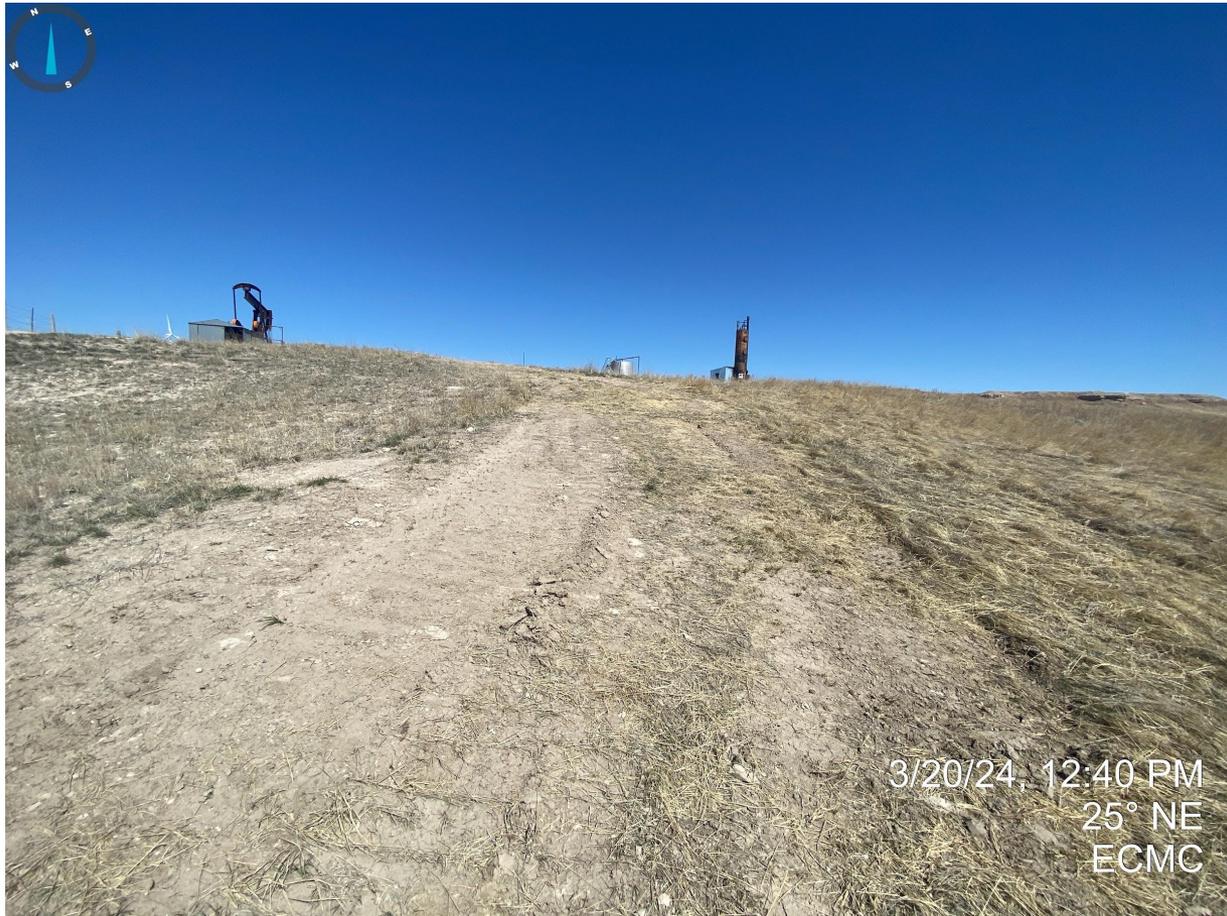
Photo 6. Evidence of vehicle traffic observed east of the pit has left the soil unstabilized; the implementation of stormwater control measures/BMPs and/or reclamation activities are required to prevent erosion degradation.

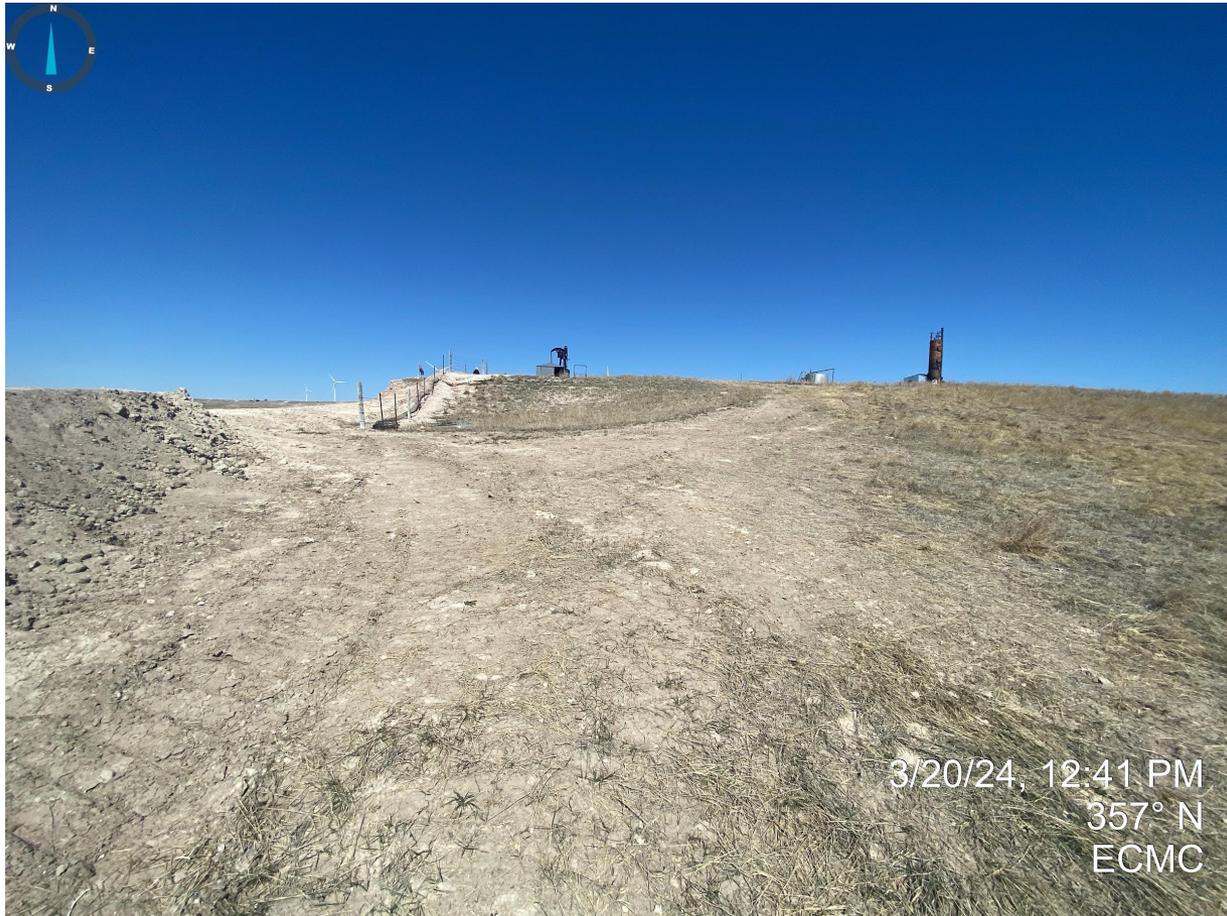
Photo 7. Continued from Photo 6.

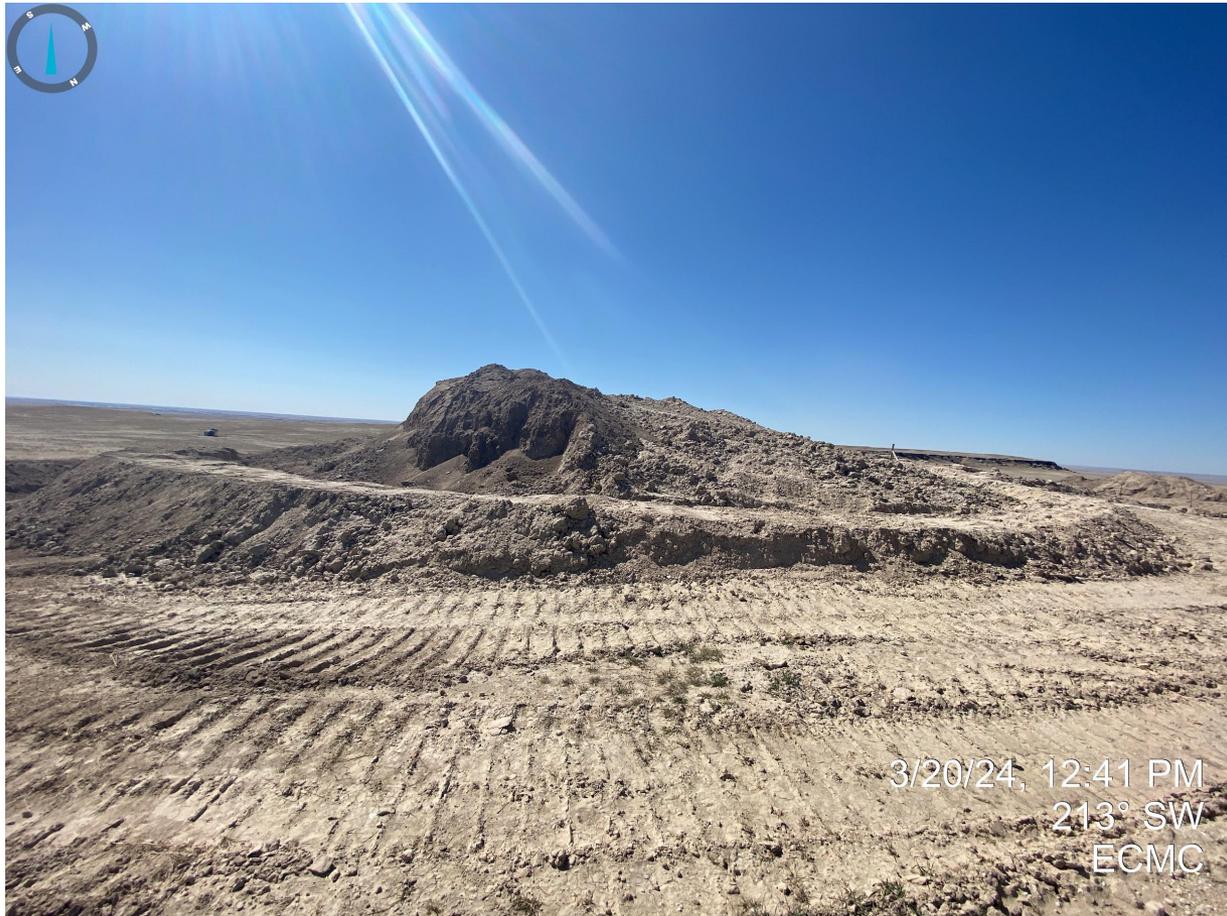
Photo 8. East side of stockpiled pit soils. Photo illustrates that both the stockpile and berms have been left unconsolidated. Unconsolidated materials can become a potential pollution source as it is not properly stabilized.

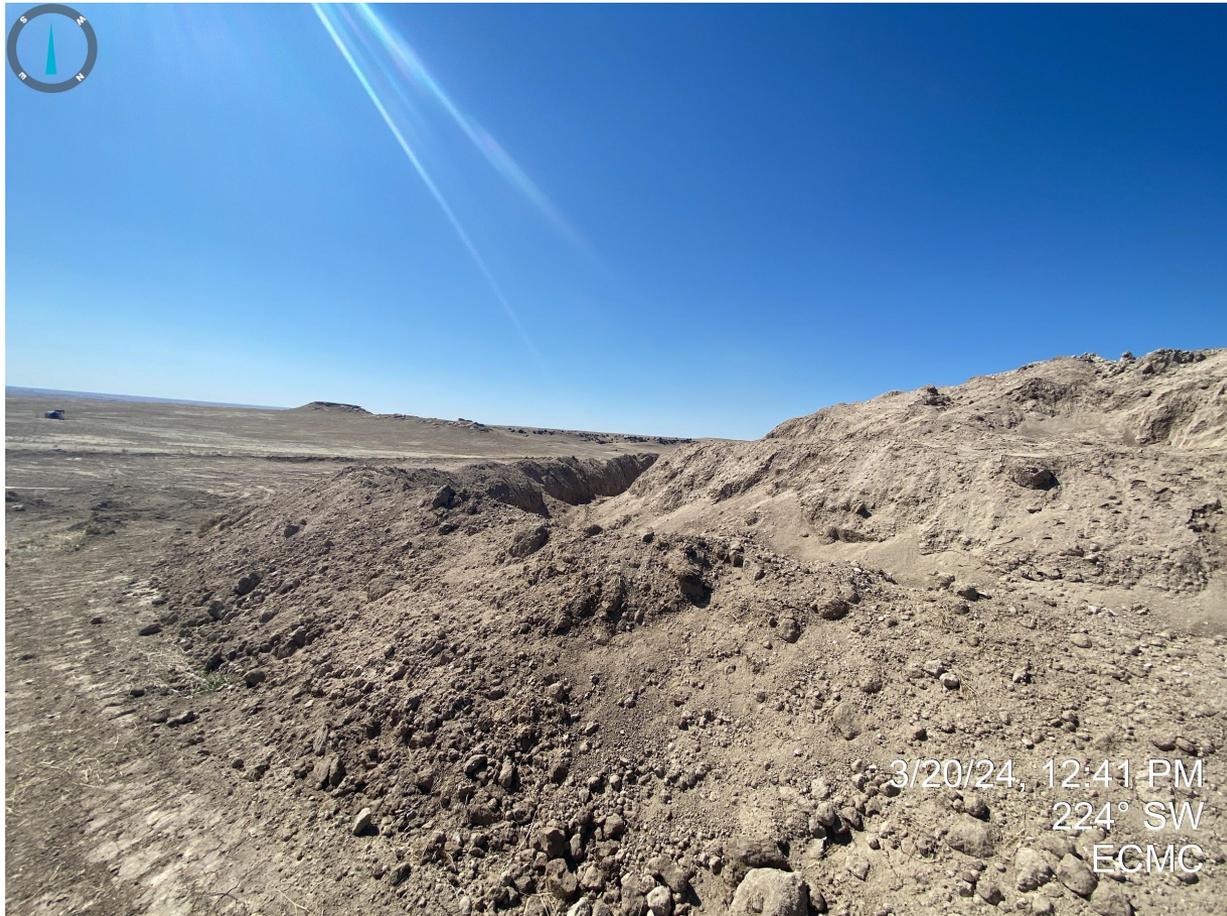
Photo 9. Close up of unconsolidated soils.

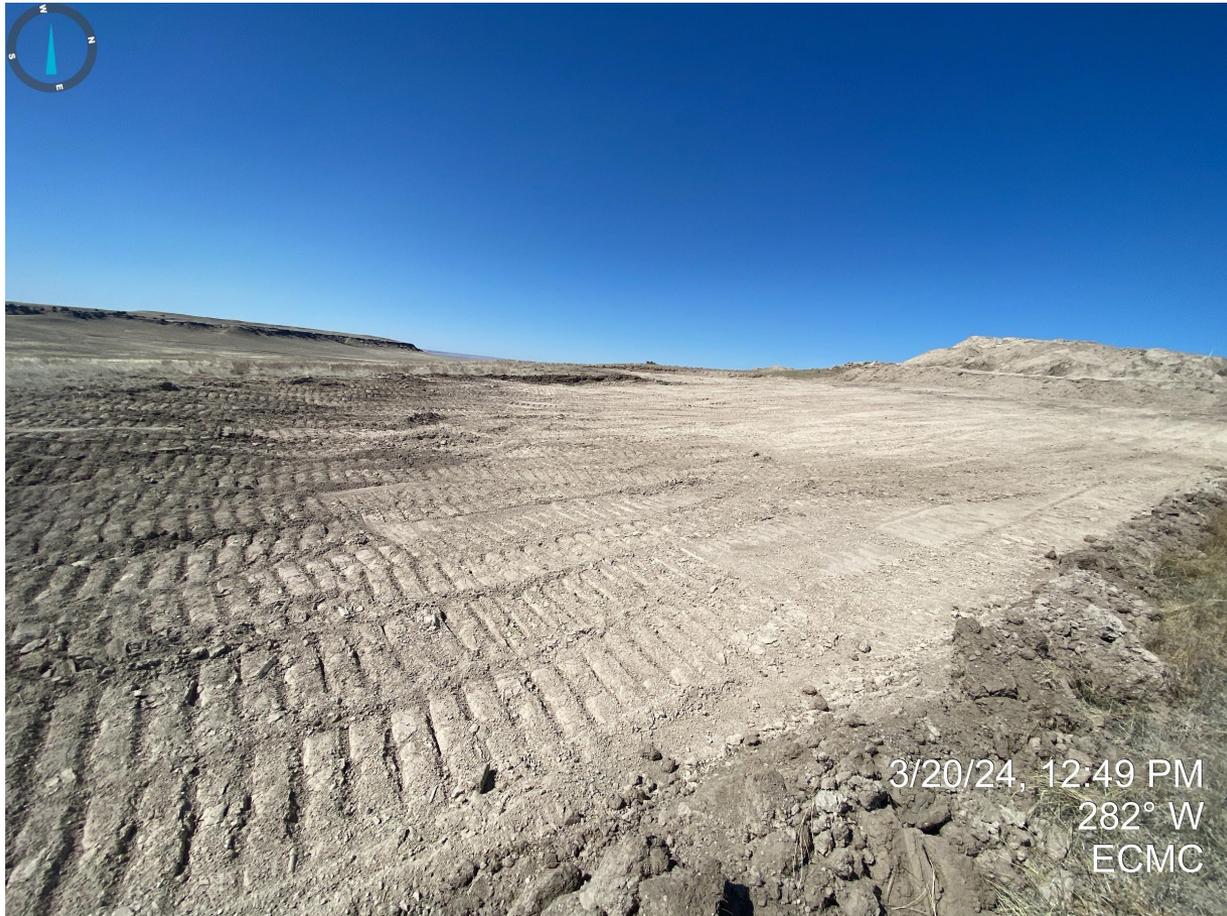
Photo 10. An area approximately 0.50 acres in size has been excavated south of the pit and stockpile. No evidence of stormwater controls measures were observed around the perimeter of the excavated salt kill impacted area.

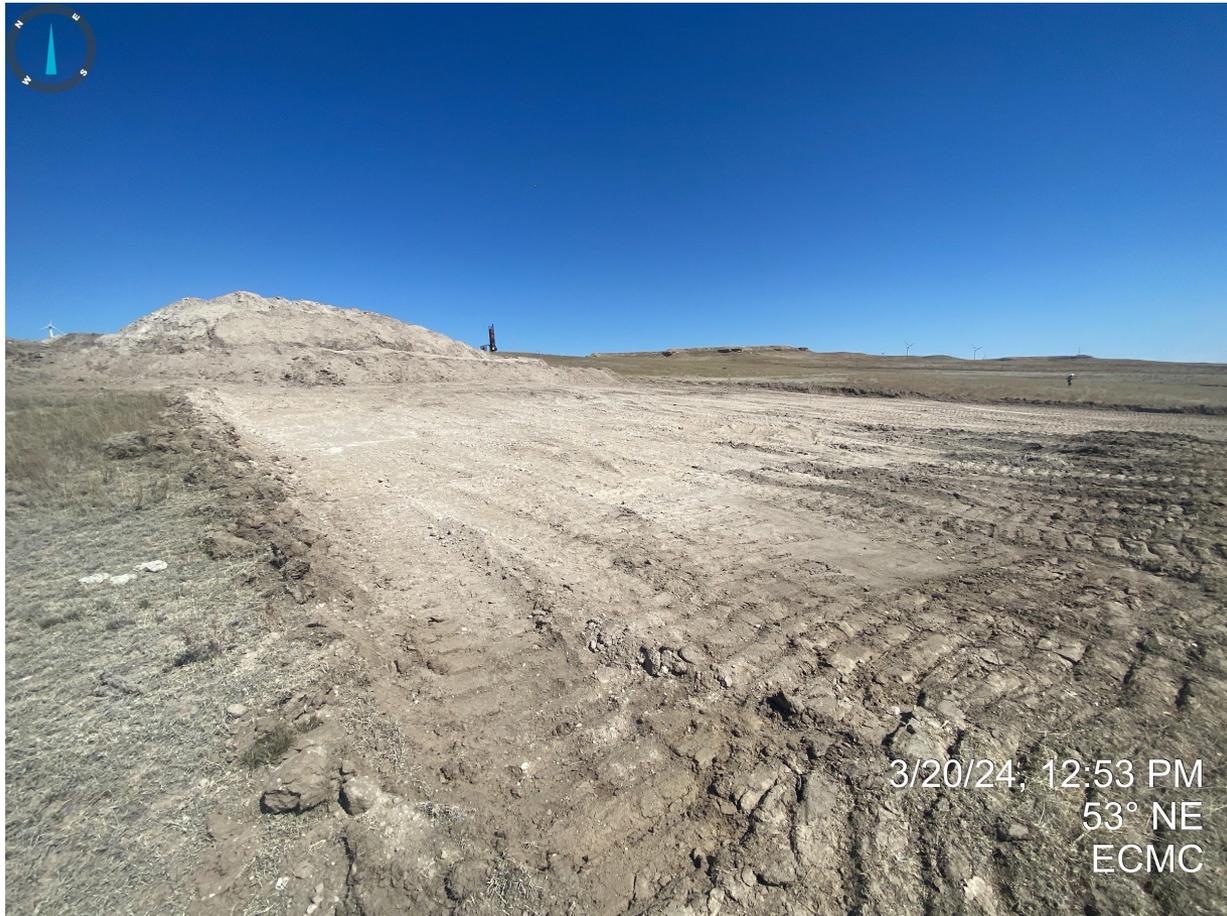
Photo 11. Facing northeast; see comments in Photo 10.

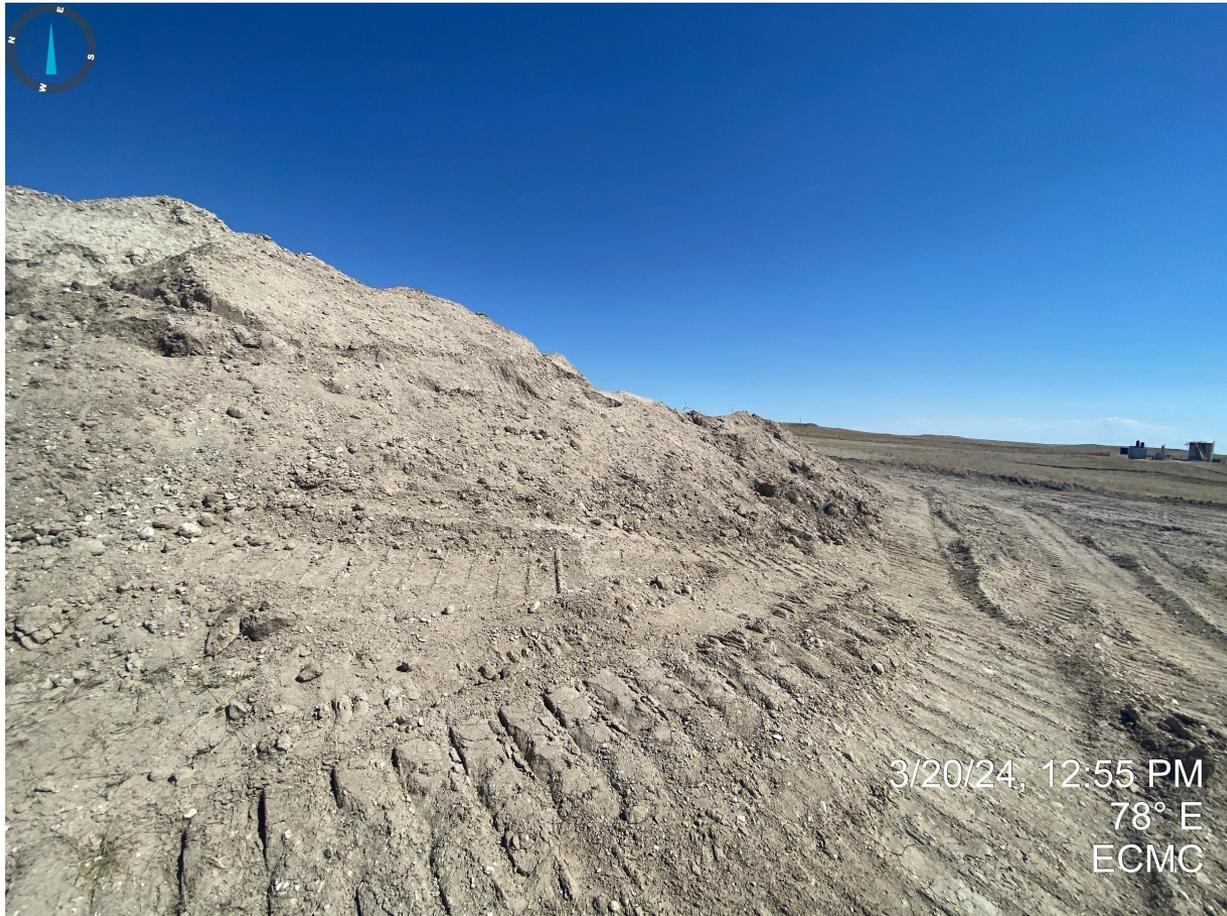
Photo 12. West side of the southern topsoil stockpile; see comments in Photo 8.

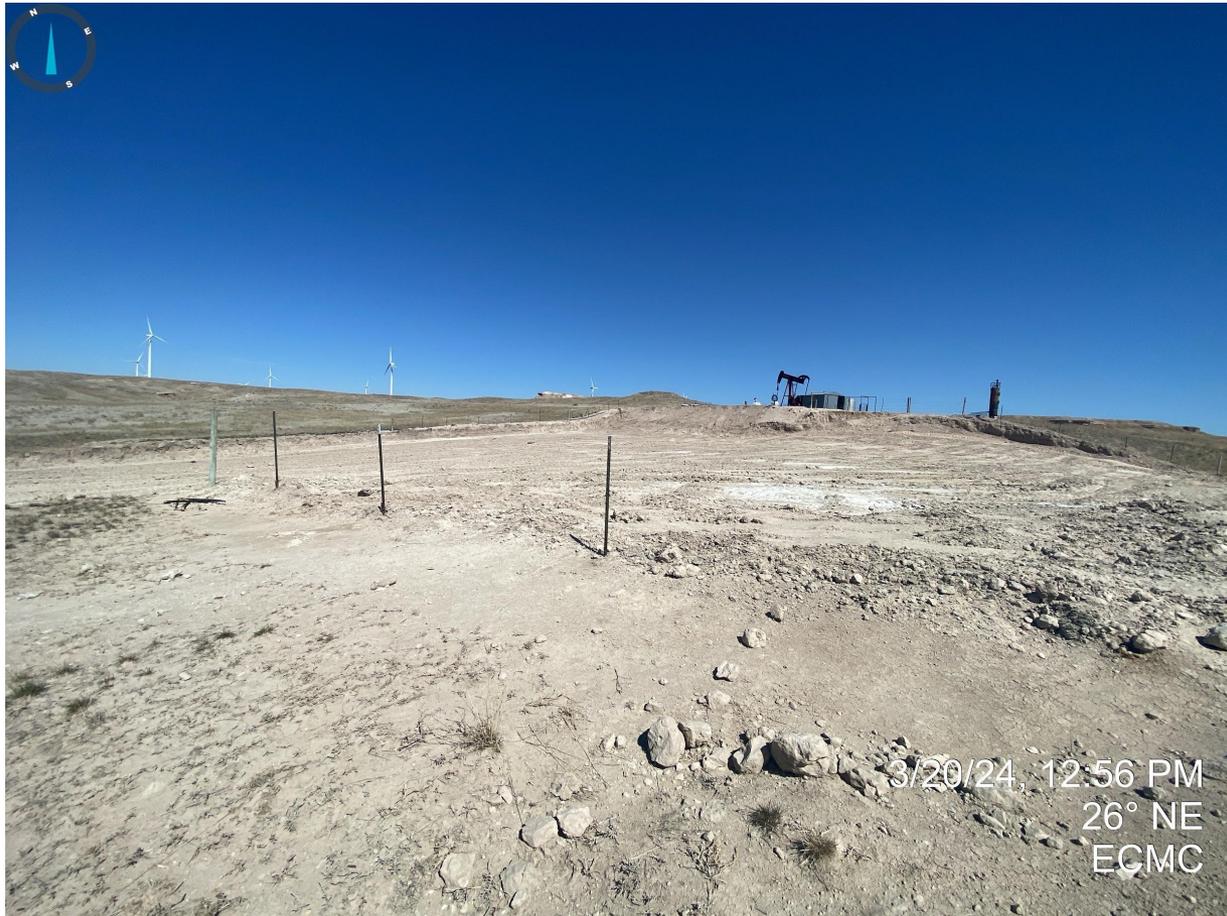
Photo 13. Overview of excavated pit and salt kill area. Soils do not appear to be properly stabilized from wind and water erosion degradation.

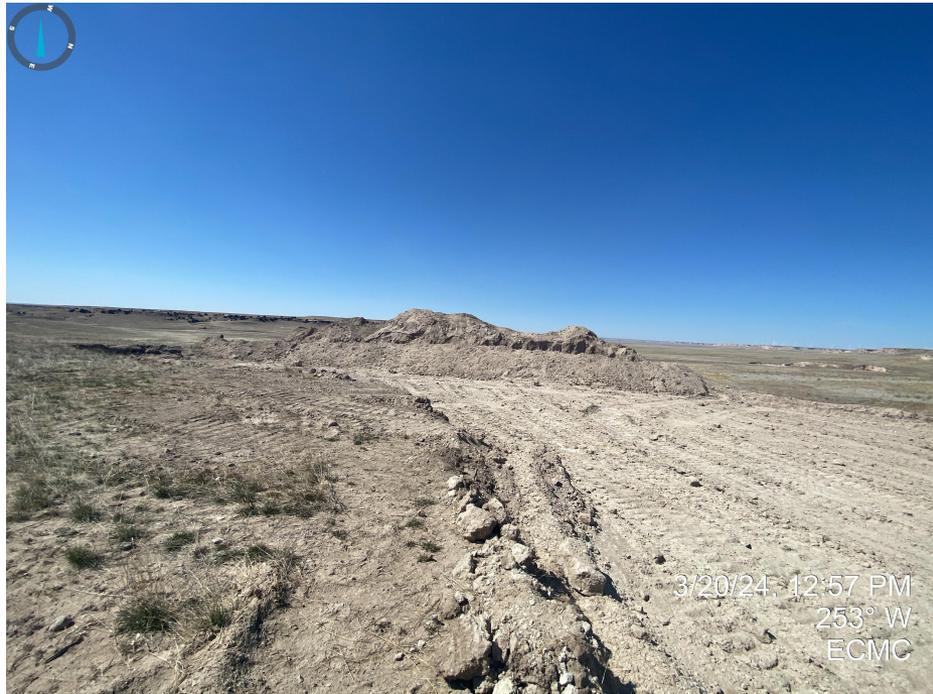
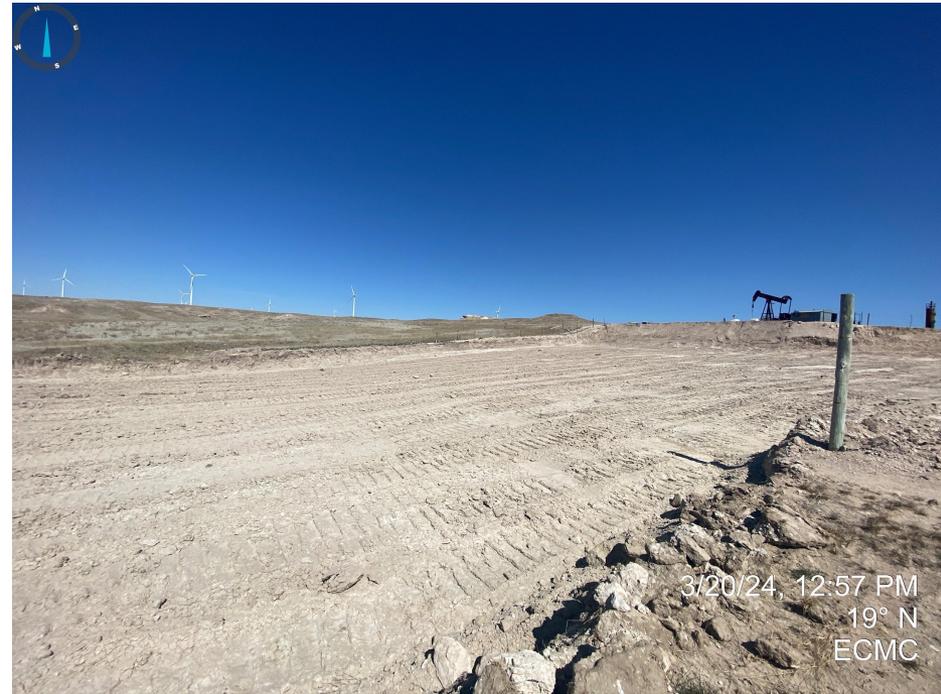
Photos 14 & 15. Overview of excavated pit and salt kill areas; see comments in Photo 13.

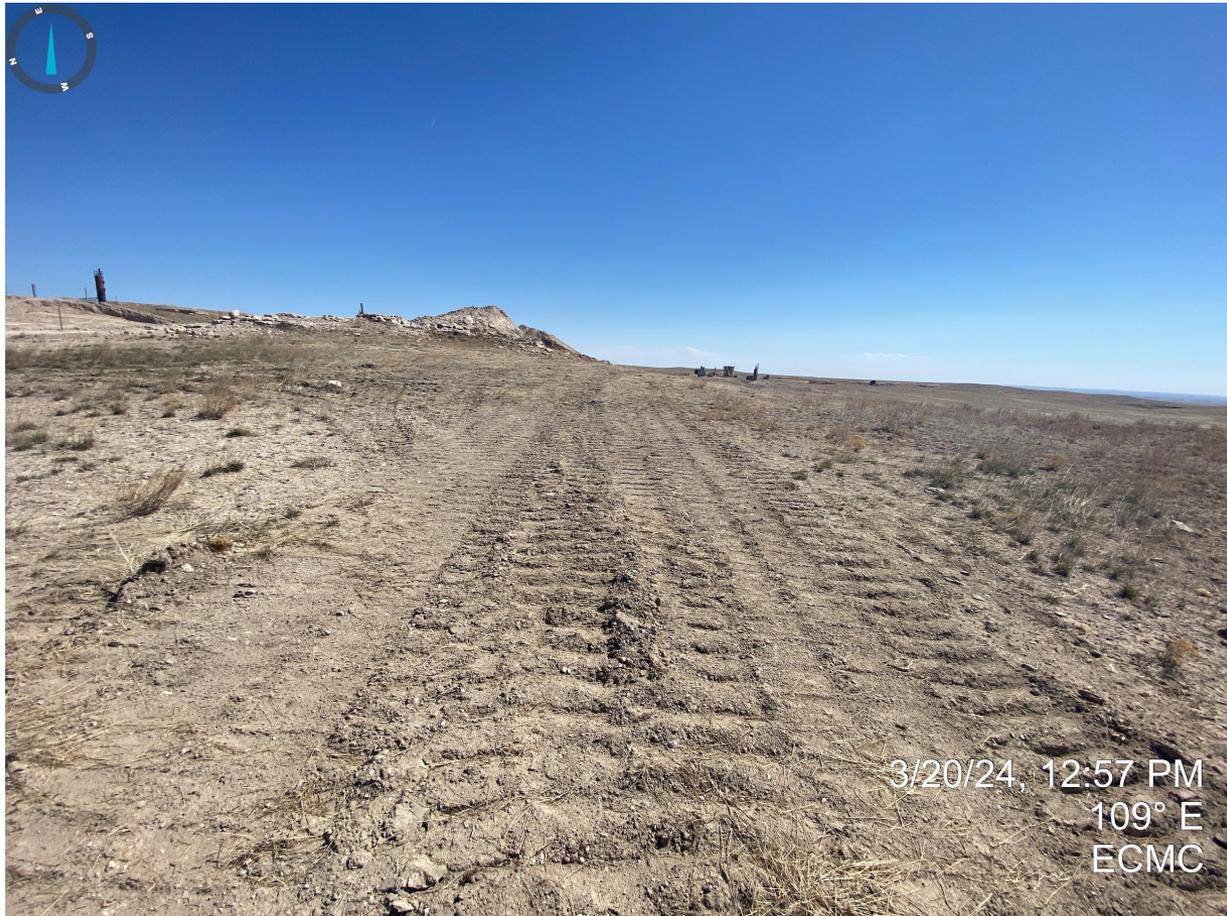
Photo 16. Additional disturbance observed south of the salt kill impacted areas. Any disturbance will need to be reclaimed per the reclamation rules as the area is now susceptible to wind and water erosion degradation.

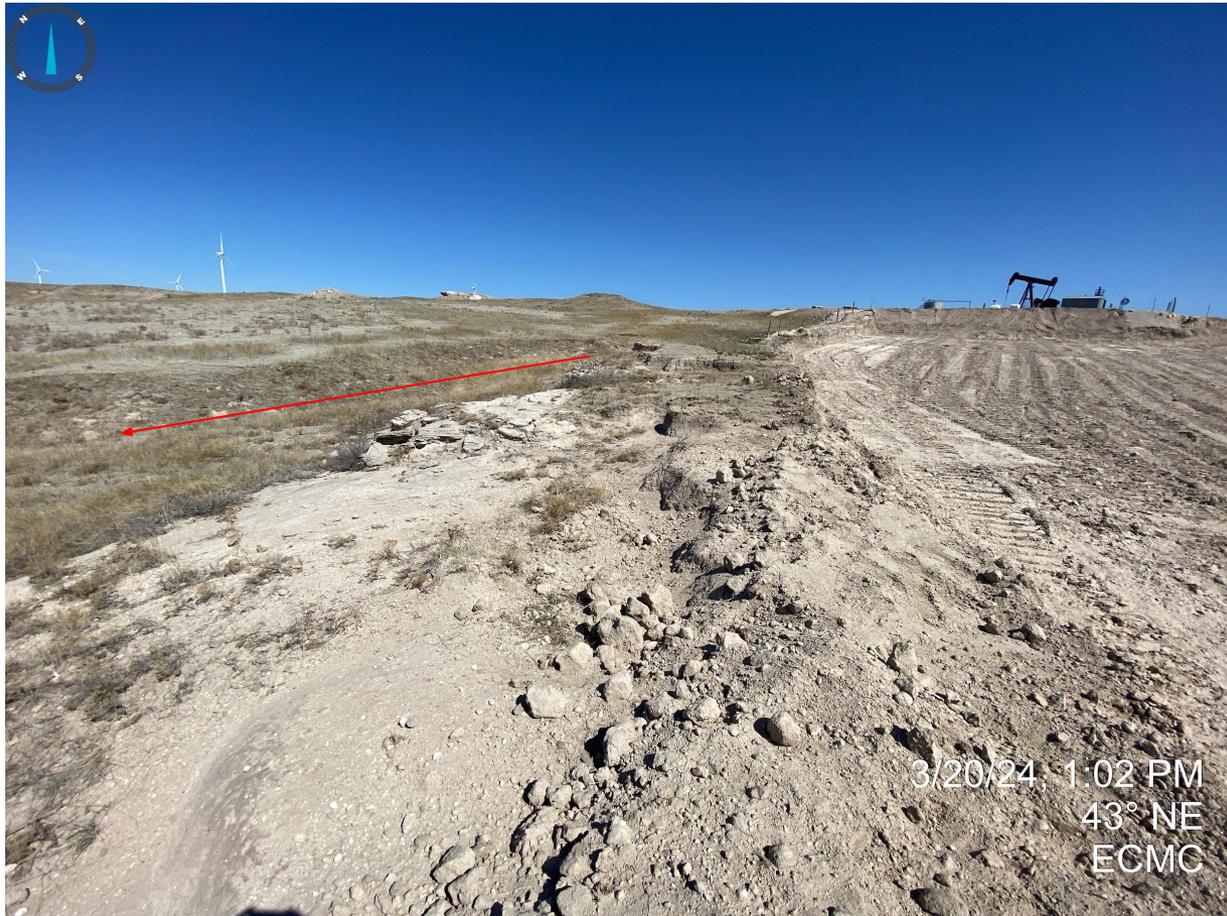
Photo 17. North side of excavation. No stormwater control measures were observed around the perimeter of the excavated area that would prevent off location stormwater discharge from entering nearby drainage (indicated by red arrow).

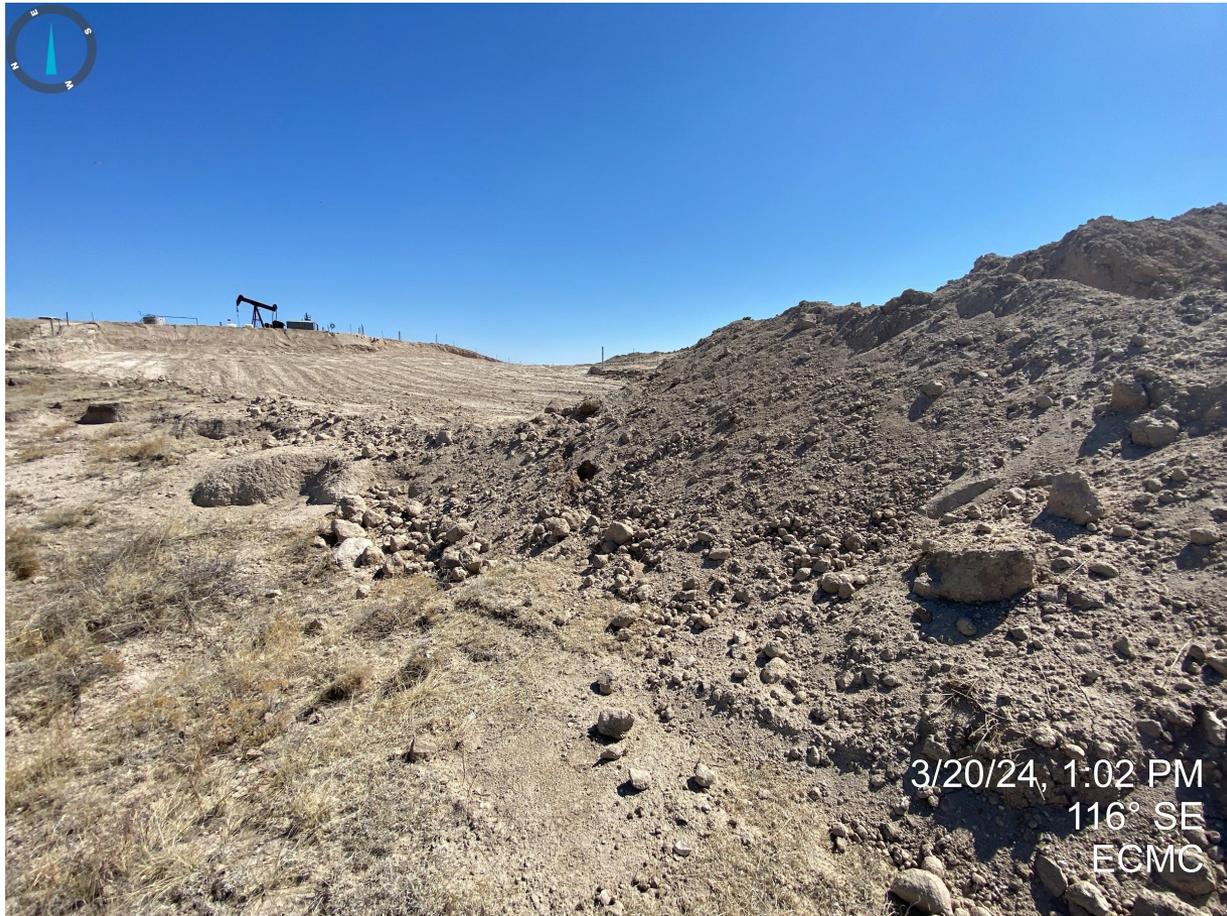
Photo 18. Continued from Photo 17. Photo illustrates unconsolidated materials with no apparent stormwater control measures.

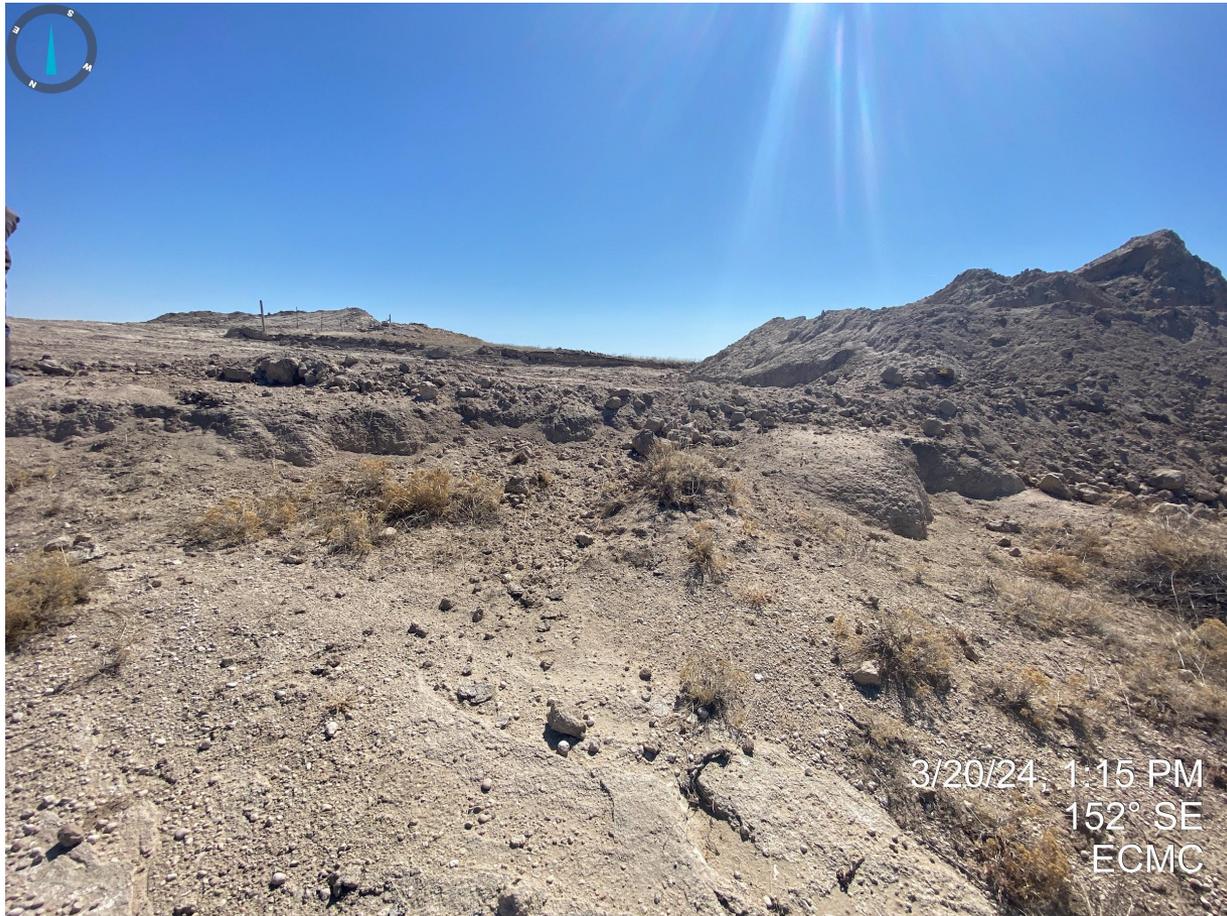
Photo 19. Continued from Photo 17 & 18; taken from nearby drainage. No perimeter stormwater control measures observed around the excavated areas or stockpiled material.

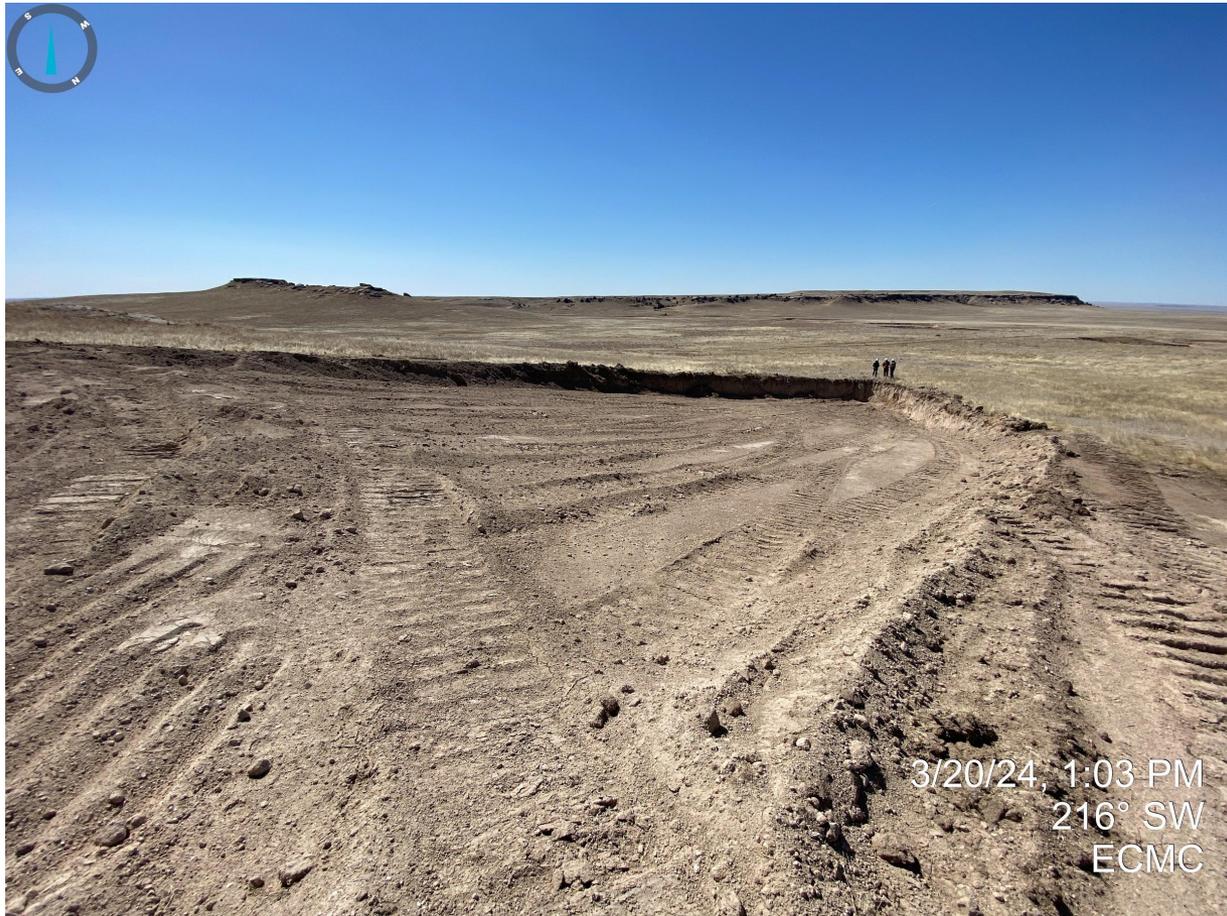
Photo 20. At the time of this inspection, Staff observed a new excavation extending to the western portions of the salt kill impacted area. No apparent stormwater control measures were observed around the perimeter of the excavation and soils have been left unconsolidated.
