Interim Reclamation and Stormwater Inspection

Date: 03/20/2024

Operator: WESTERN OPERATING COMPANY - 95620

Inspection Photos
Location Name: Propst 2
Location ID: 312292

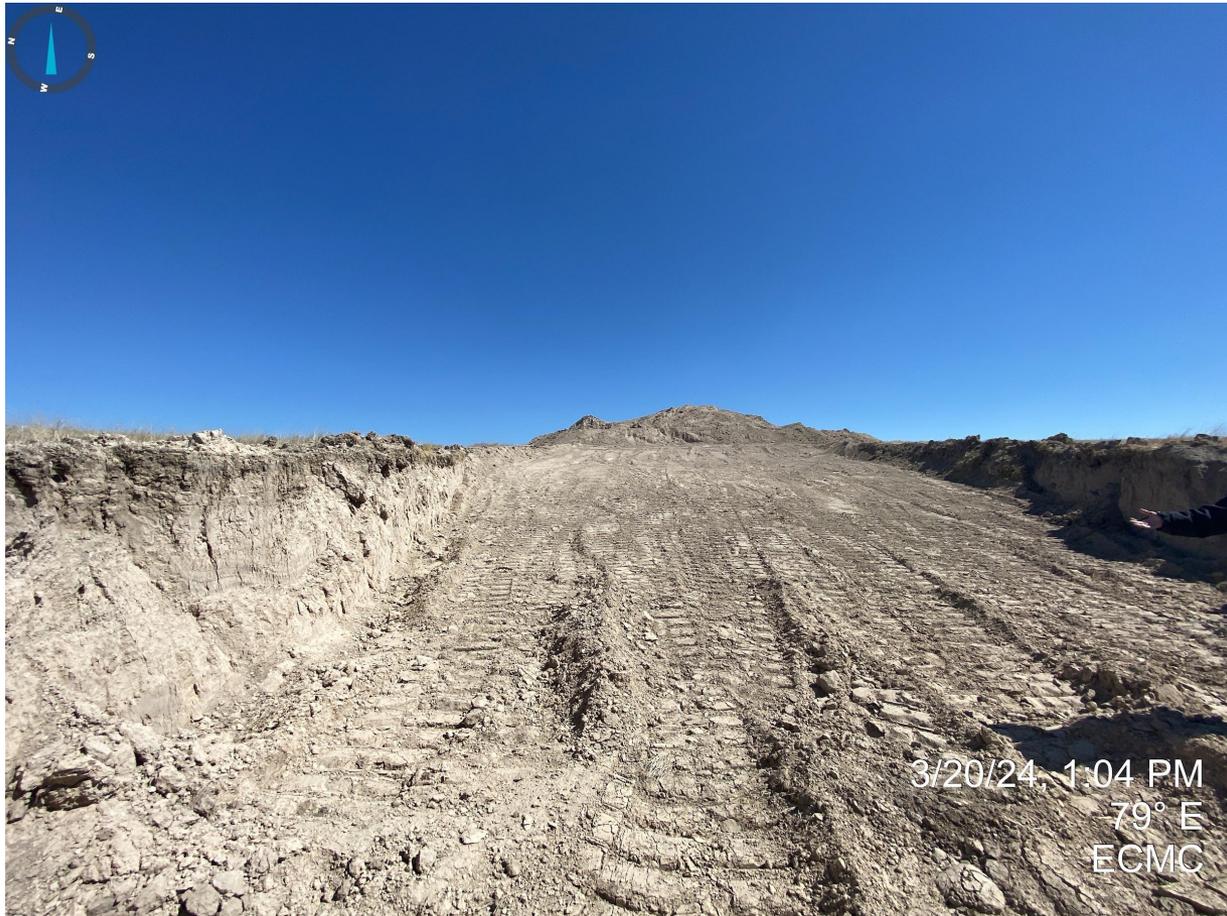
Photo 21. Taken within the western most portion of the excavation identified in Photo 20. Stockpiled material pictured in background.

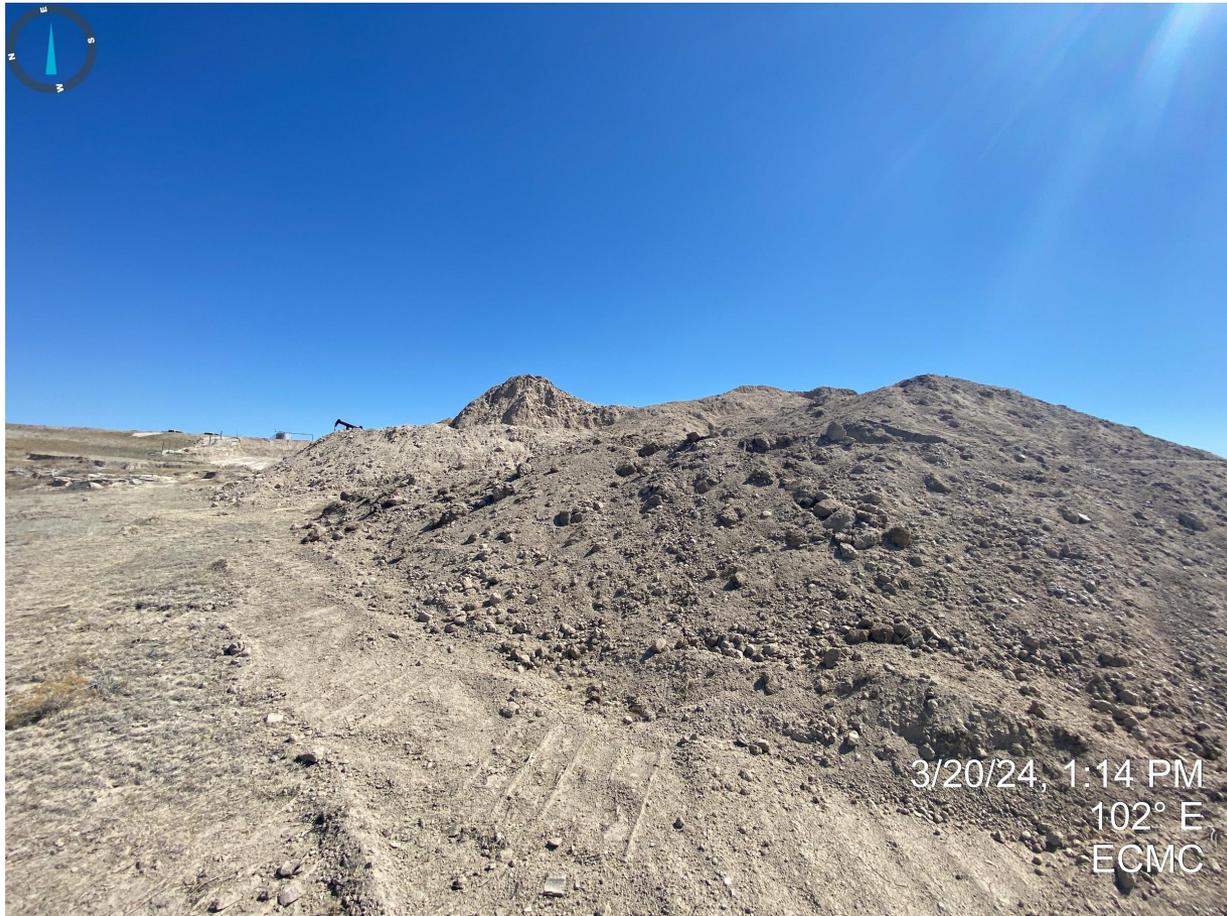
Photo 22. Continued from Photo 21. Western stockpiled material is not properly stabilized with evidence of unconsolidated materials.

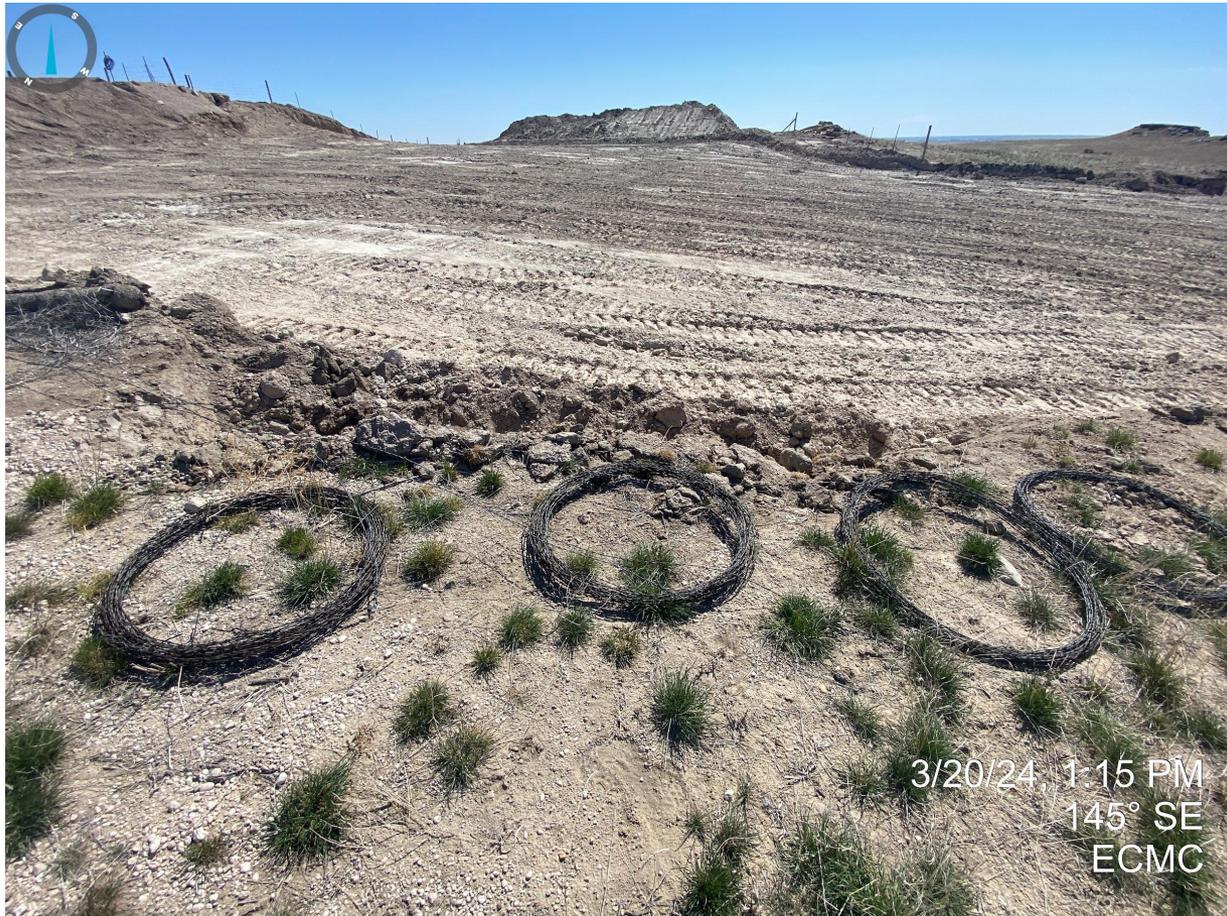
Photo 23. Unused fencing material needs to be removed from the location or returned to service as it poses a potential hazard to personnel, livestock and wildlife resources.

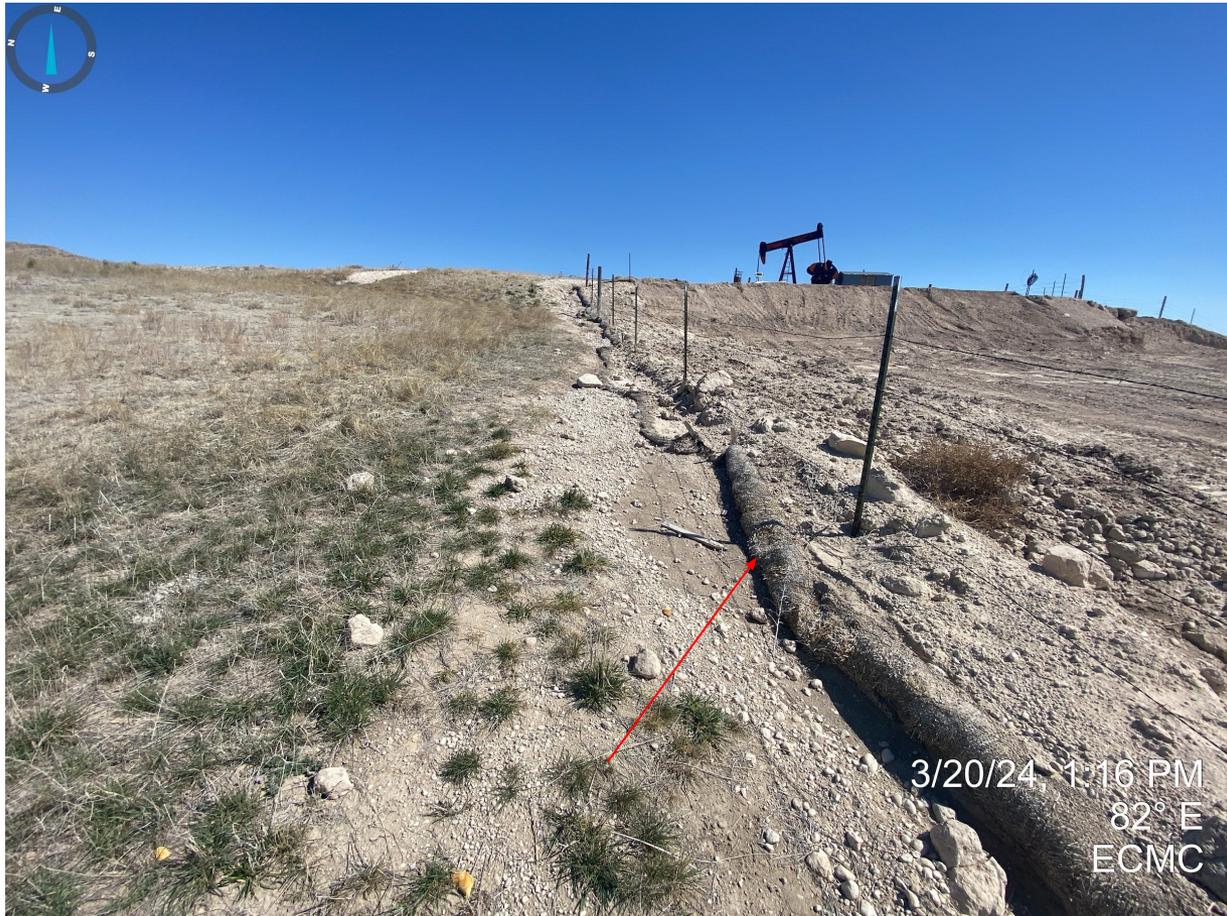
Photo 24. Taken from the north side of the pit. It does not appear that any erosion degradation has been properly stabilized or repaired, and stormwater control measure remain inadequate as the straw wattles are either degraded or not installed properly.

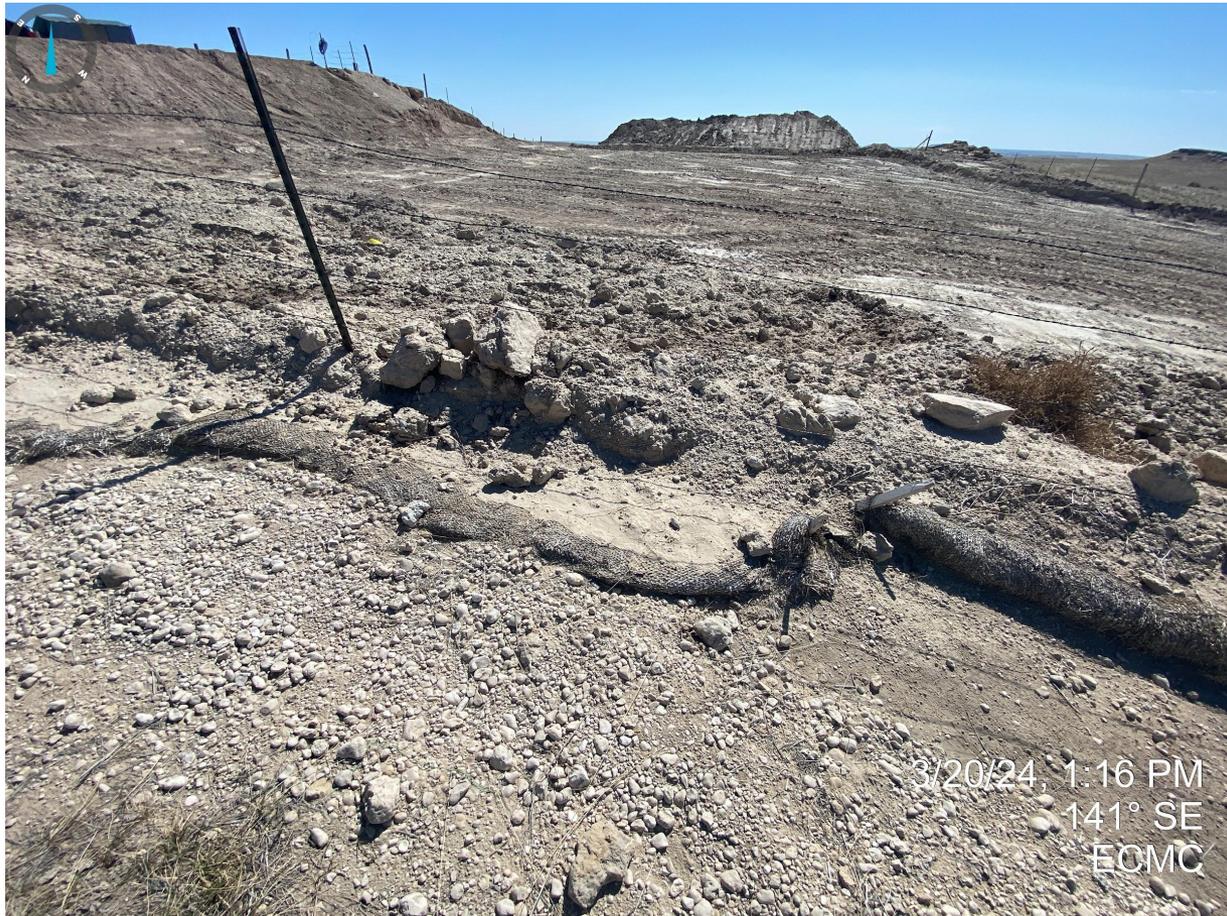
Photo 25. Continued from Photo 24; close up of degraded stormwater BMPs.

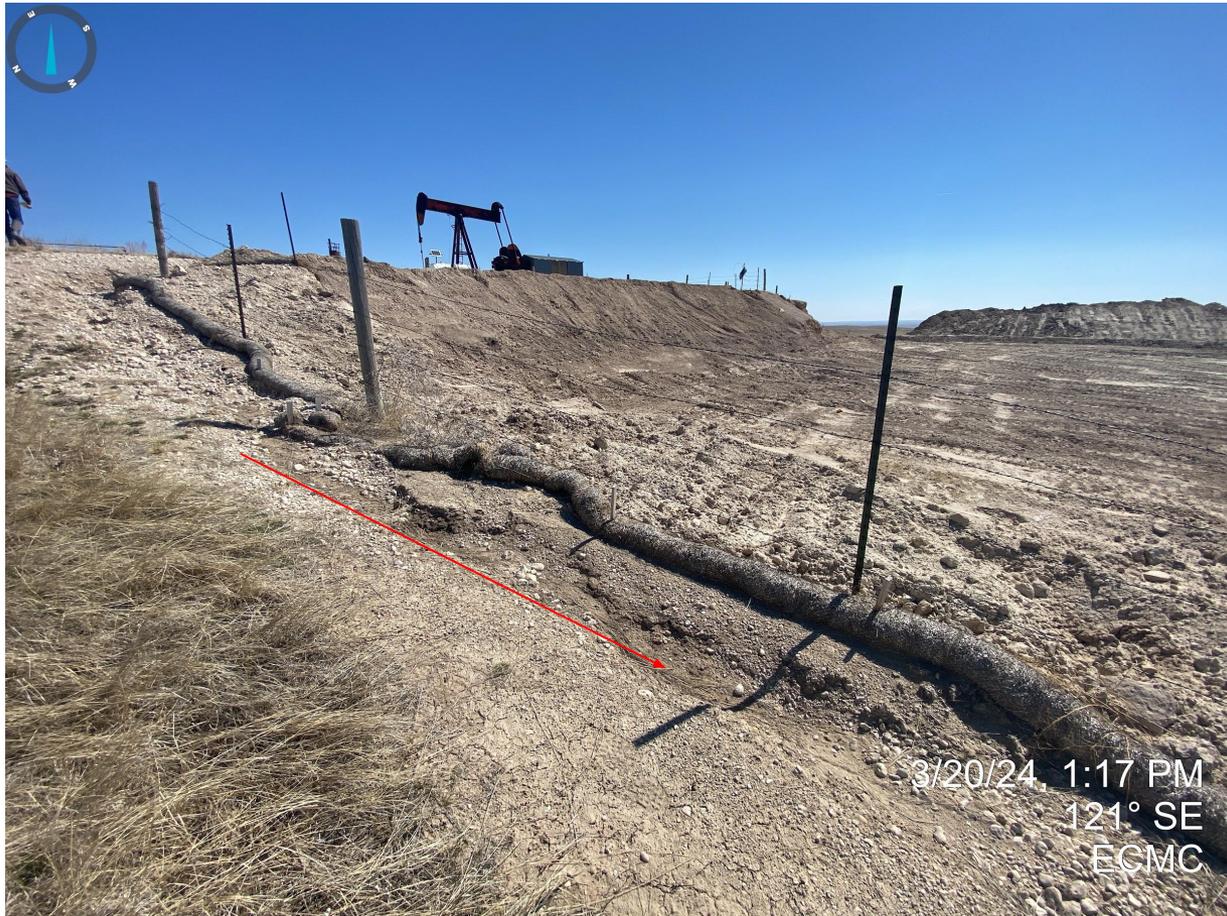
Photo 26. Continued from Photo 24; erosion degradation has not been repaired or stabilized.

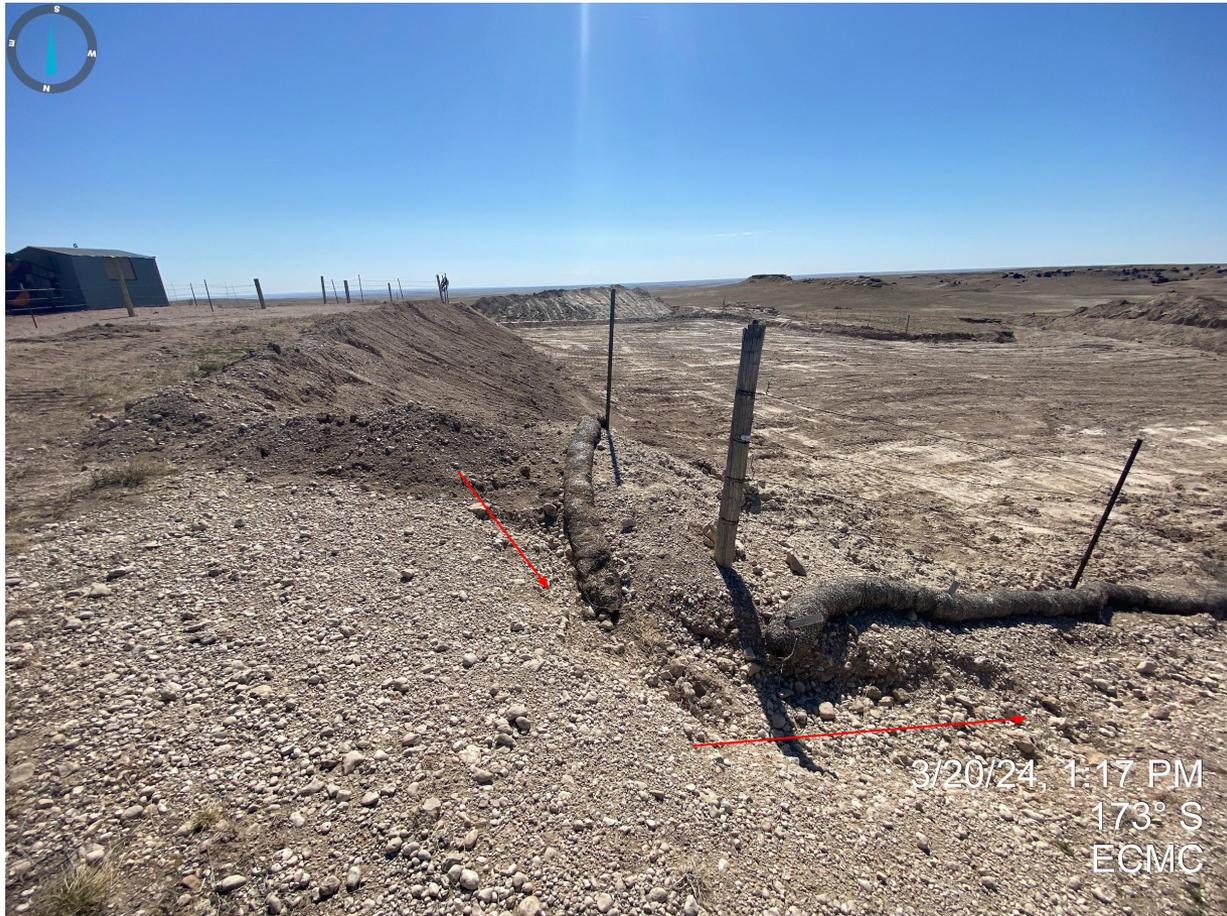
Photo 27. Continued from Photo 24; erosion degradation has not been repaired or stabilized.

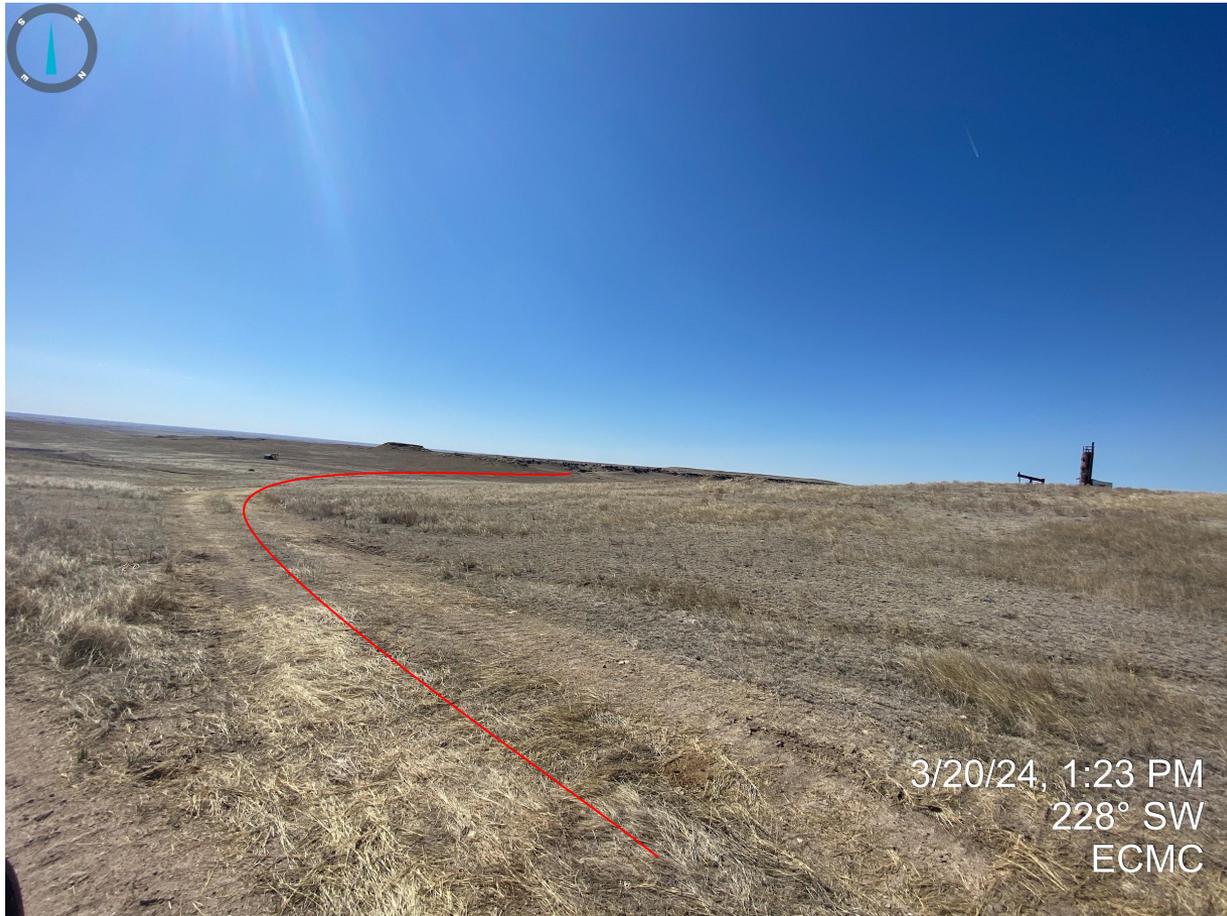
Photo 28. Taken east of the location along adjacent access road, illustrating traffic disturbance occurring outside of the permitted access roads. Red line illustrates vehicle traffic and associated disturbance that will need to be reclaimed per the reclamation rules.

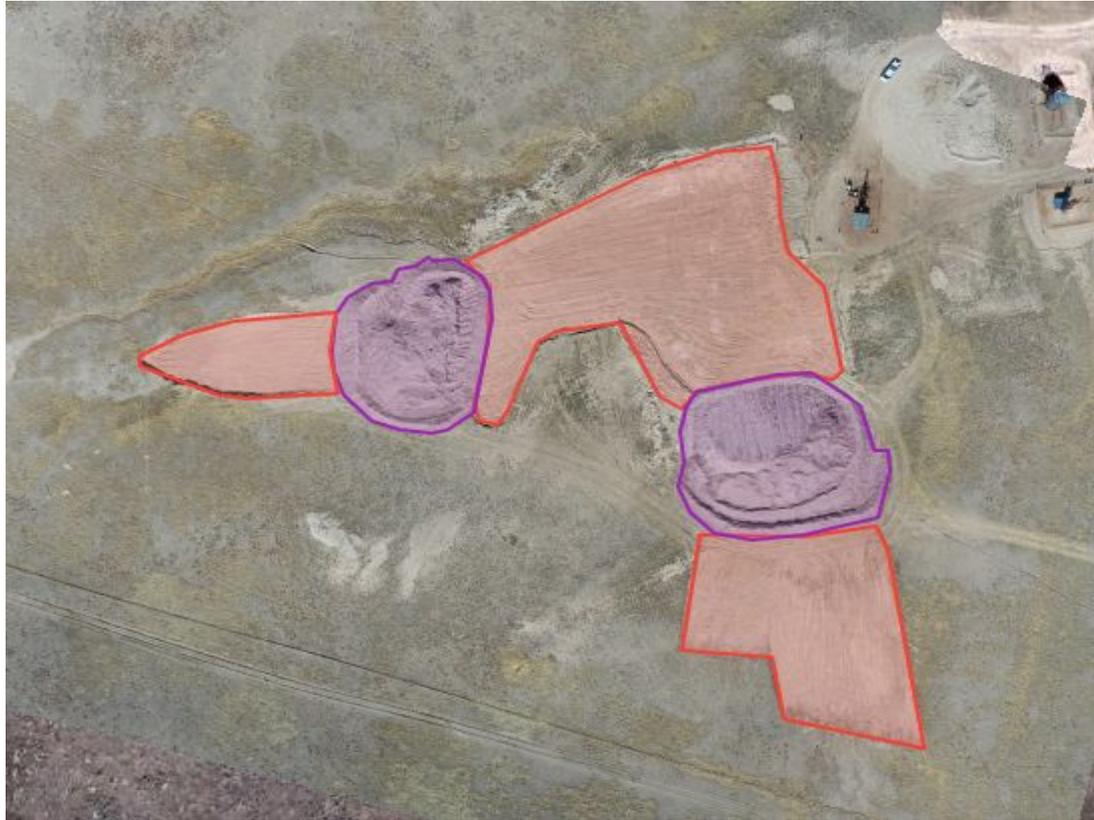
Photo 29. Drone aerial imagery captured 03/20/2024. Red shaded outlines illustrate (approx. 1.5 acres) of excavation within the former pit and salt kill areas. Purple shaded outlines (approx 0.75 acres, combined) indicate the soil stockpiles which are approximately 6300 CY in total (2700 CY for west stockpile and 3600 CY for east/south stockpile).

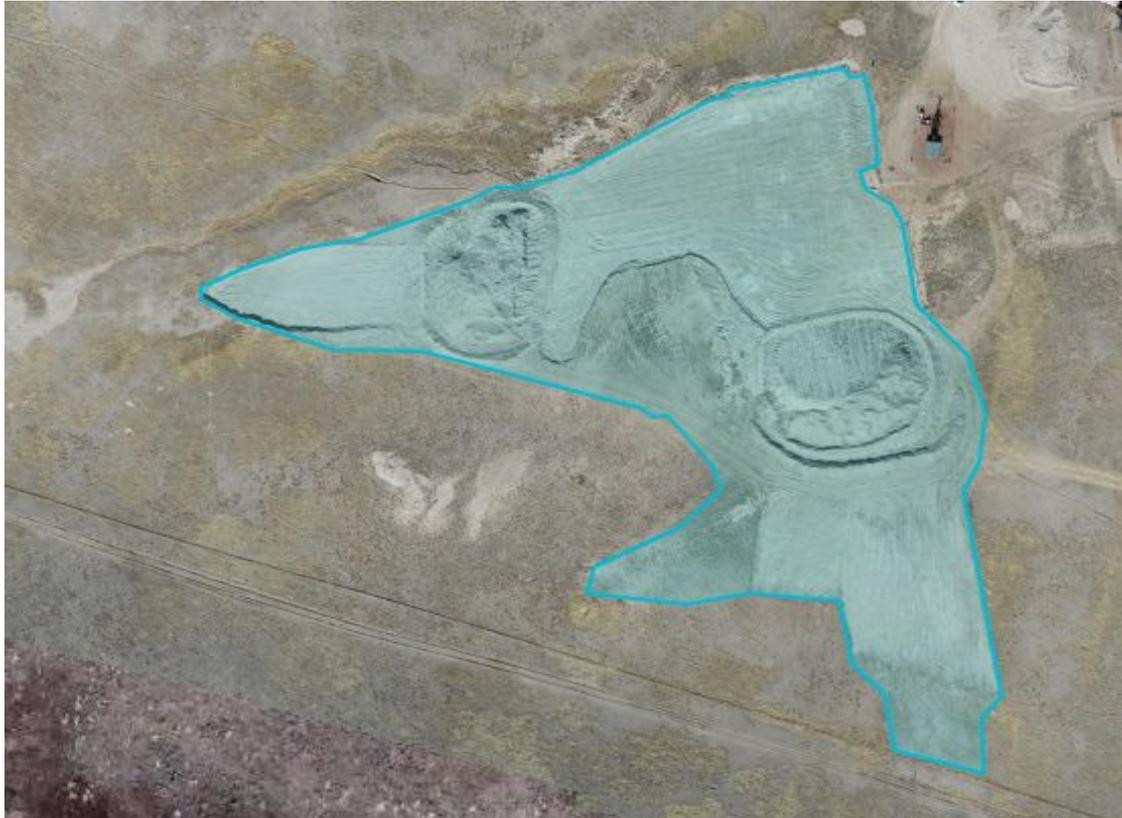
Photo 30. Drone aerial imagery captured 03/20/2024. Blue shaded outline illustrates a disturbance area of approximately 3.10 acres (excavation, stockpiles and salt kill impacted areas).
