# Photos, Annotation and Issue Report

**Operator:** PETROLEUM RESOURCE  
MANAGEMENT CORP #10421

**Location ID:** 485573

# PRM Duncan Pad Unpermitted Pad Annotation Report

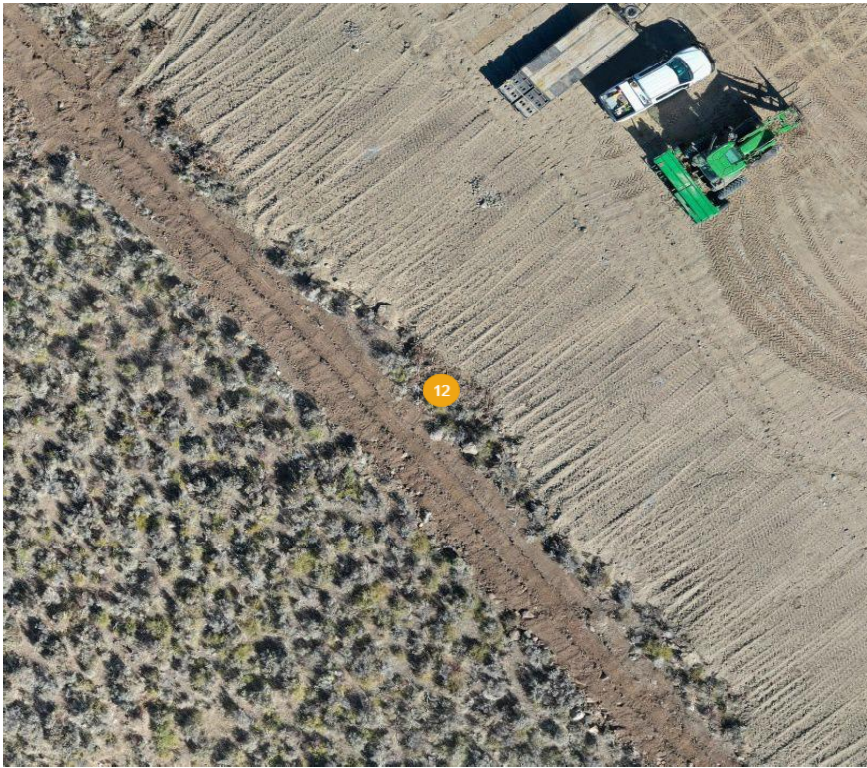
**Details**    Intact vegetation evident at the toe of the slopes, partially covered with fill material, indicates that not all of the topsoil had been salvaged and segregated.

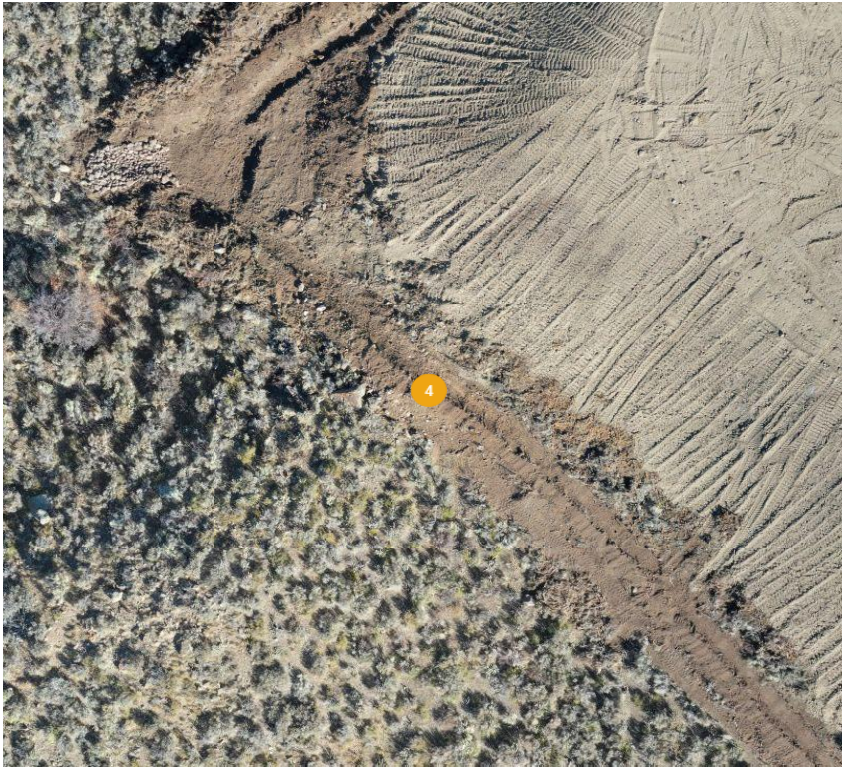
**Details**    Operator has utilized topsoil material at the base of the fill slopes/subsoils of the Location as a ditch/berm.

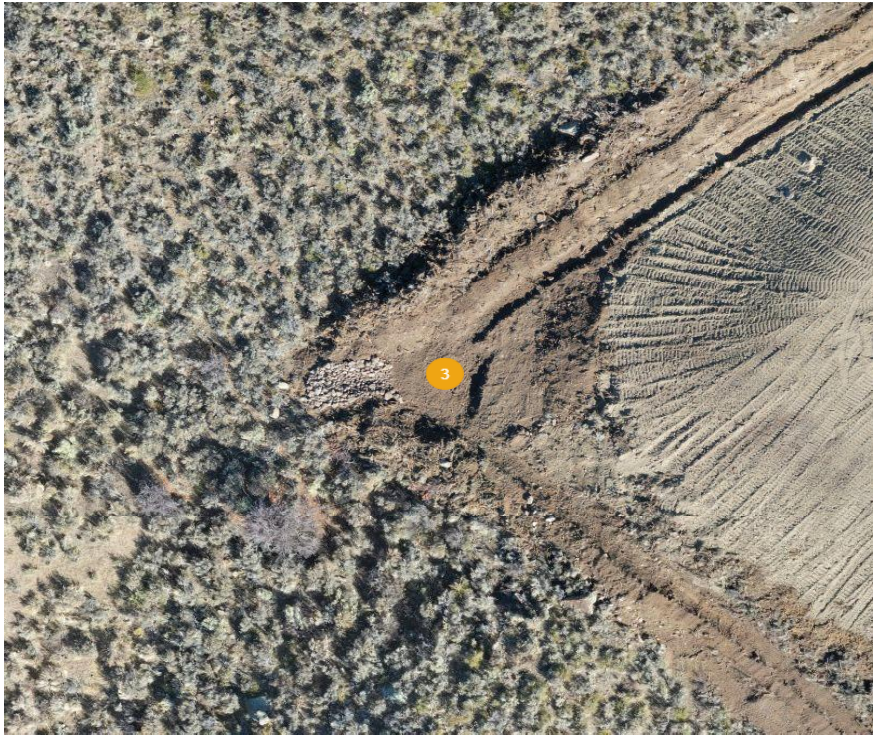
**Details**    Operator has utilized topsoil material in the construction of the sediment trap BMP. This does not comport with Rule 1002.b. and 1002.c.

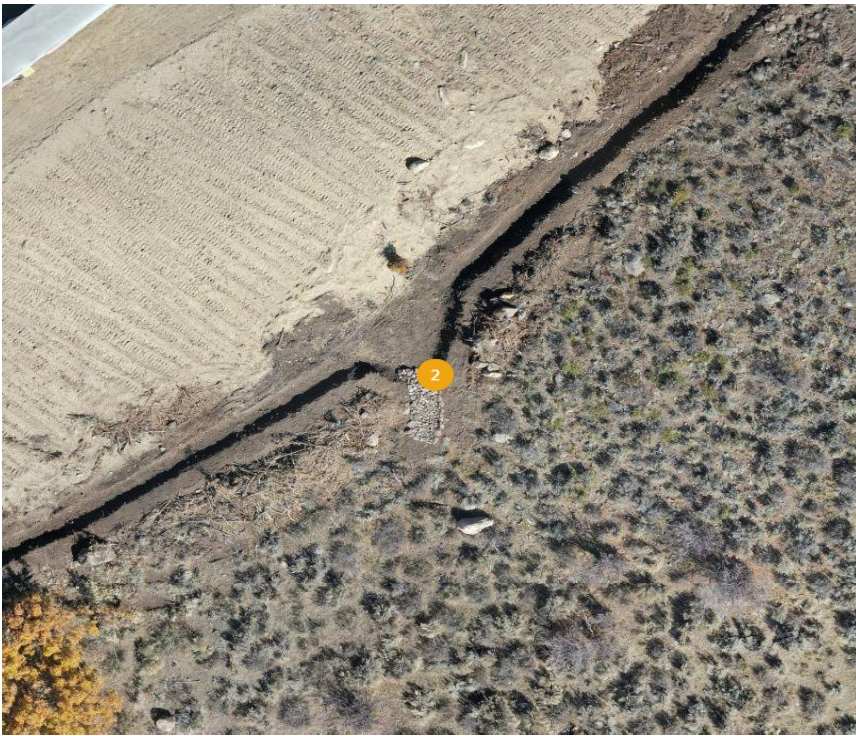
**Details**    Operator has utilized topsoil material in the construction of the sediment trap BMP. This does not comport with Rule 1002.b. and 1002.c.

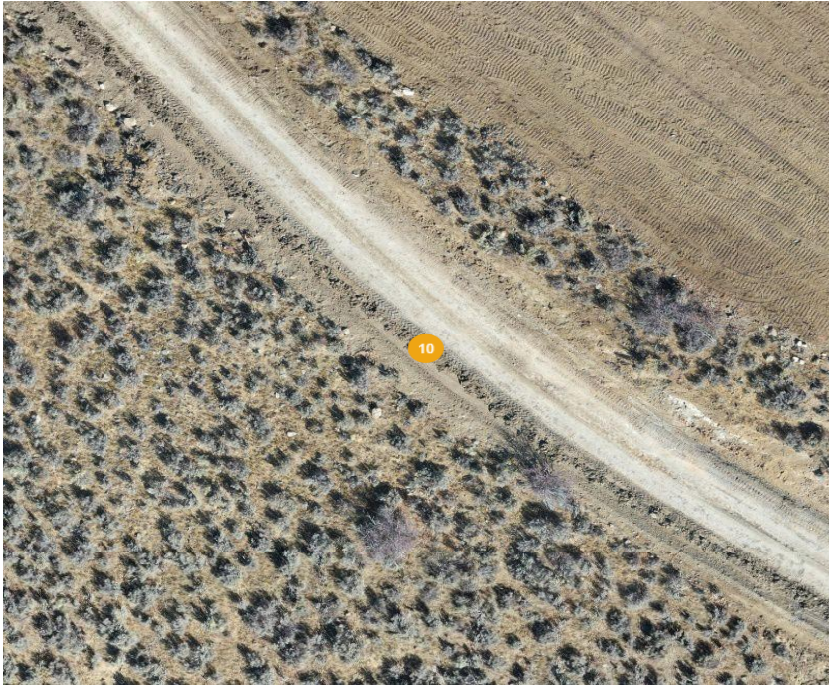
**Details** Perimeter stormwater and erosion control BMPs missing or insufficient along the access road, including the fill slopes; slopes lack stabilization and BMPs to minimize sediment transport.

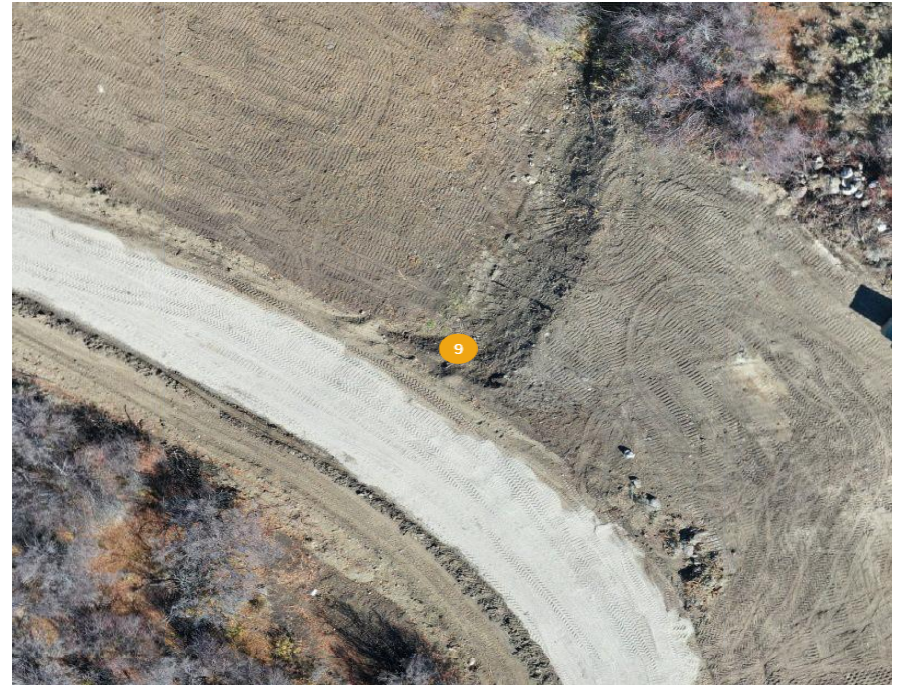
**Details** Inlet/Outlet protections and armoring not observed.

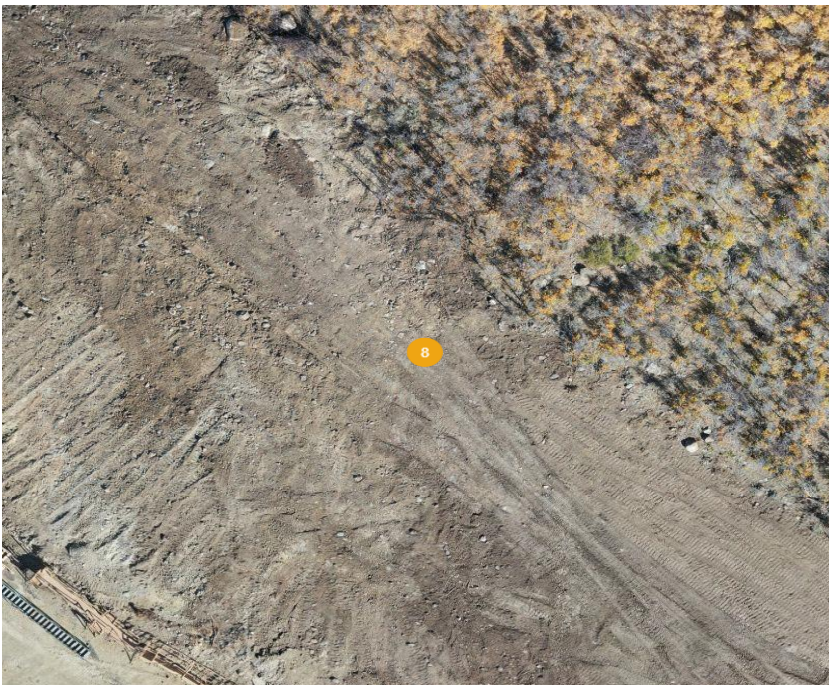
**Details** Stormwater erosion control measures to manage runoff in a manner that minimizes erosion, degradation and sediment transport were missing or insufficient throughout the Flowline System disturbance

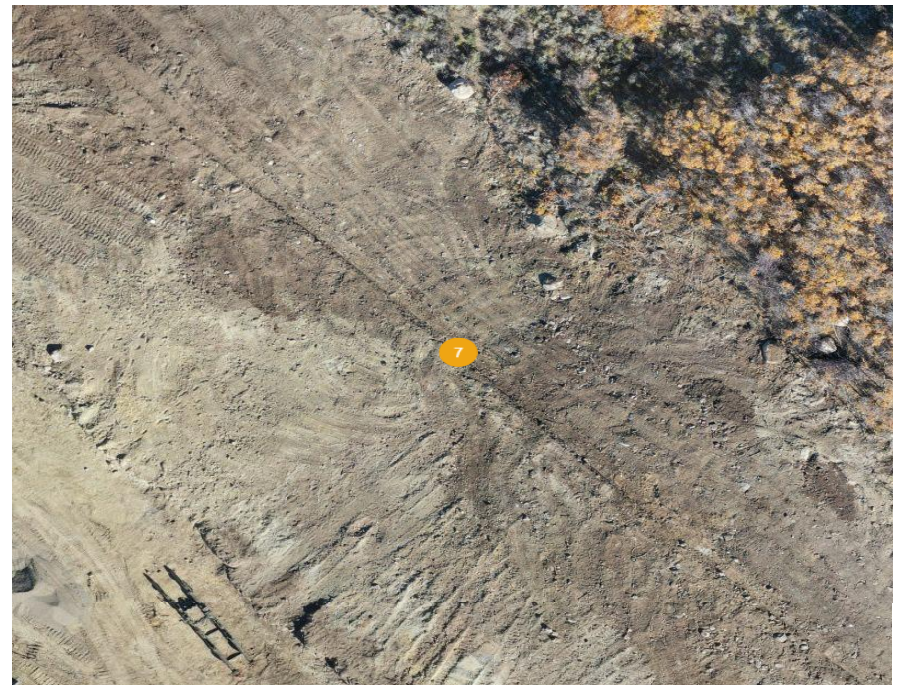
**Details** Stormwater and erosion control measures to stabilize, as well as to manage runoff in a manner that minimizes erosion and degradation at the (cut) slopes on the northeast end of the Location are missing or insufficient; slopes bare and at risk to erosion degradation. Perimeter stormwater and erosion controls not installed along the northeastern perimeter of the Location. These areas also include disturbances related to the Flowline System construction.

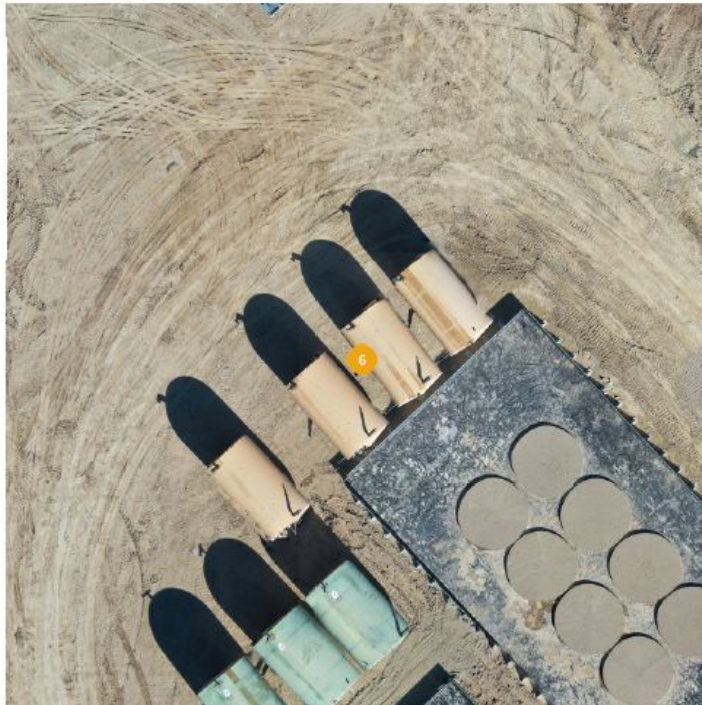
## 6 - Observation

**Summary:** Wildlife Protections- Tanks open at manhole, or other areas of the tanks. Tanks have not been properly closed, covered, or lack other BMPs to prevent unauthorized access by people or wildlife.

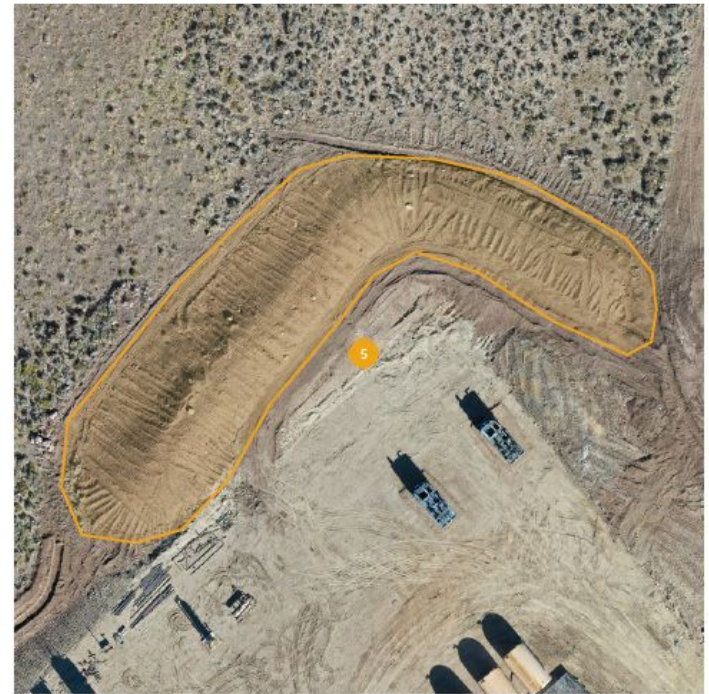
## 5 - Observation

**Summary:** Stormwater and erosion control measures to stabilize, as well as to minimize erosion, degradation and sediment transport missing or insufficient at the topsoil stockpile.

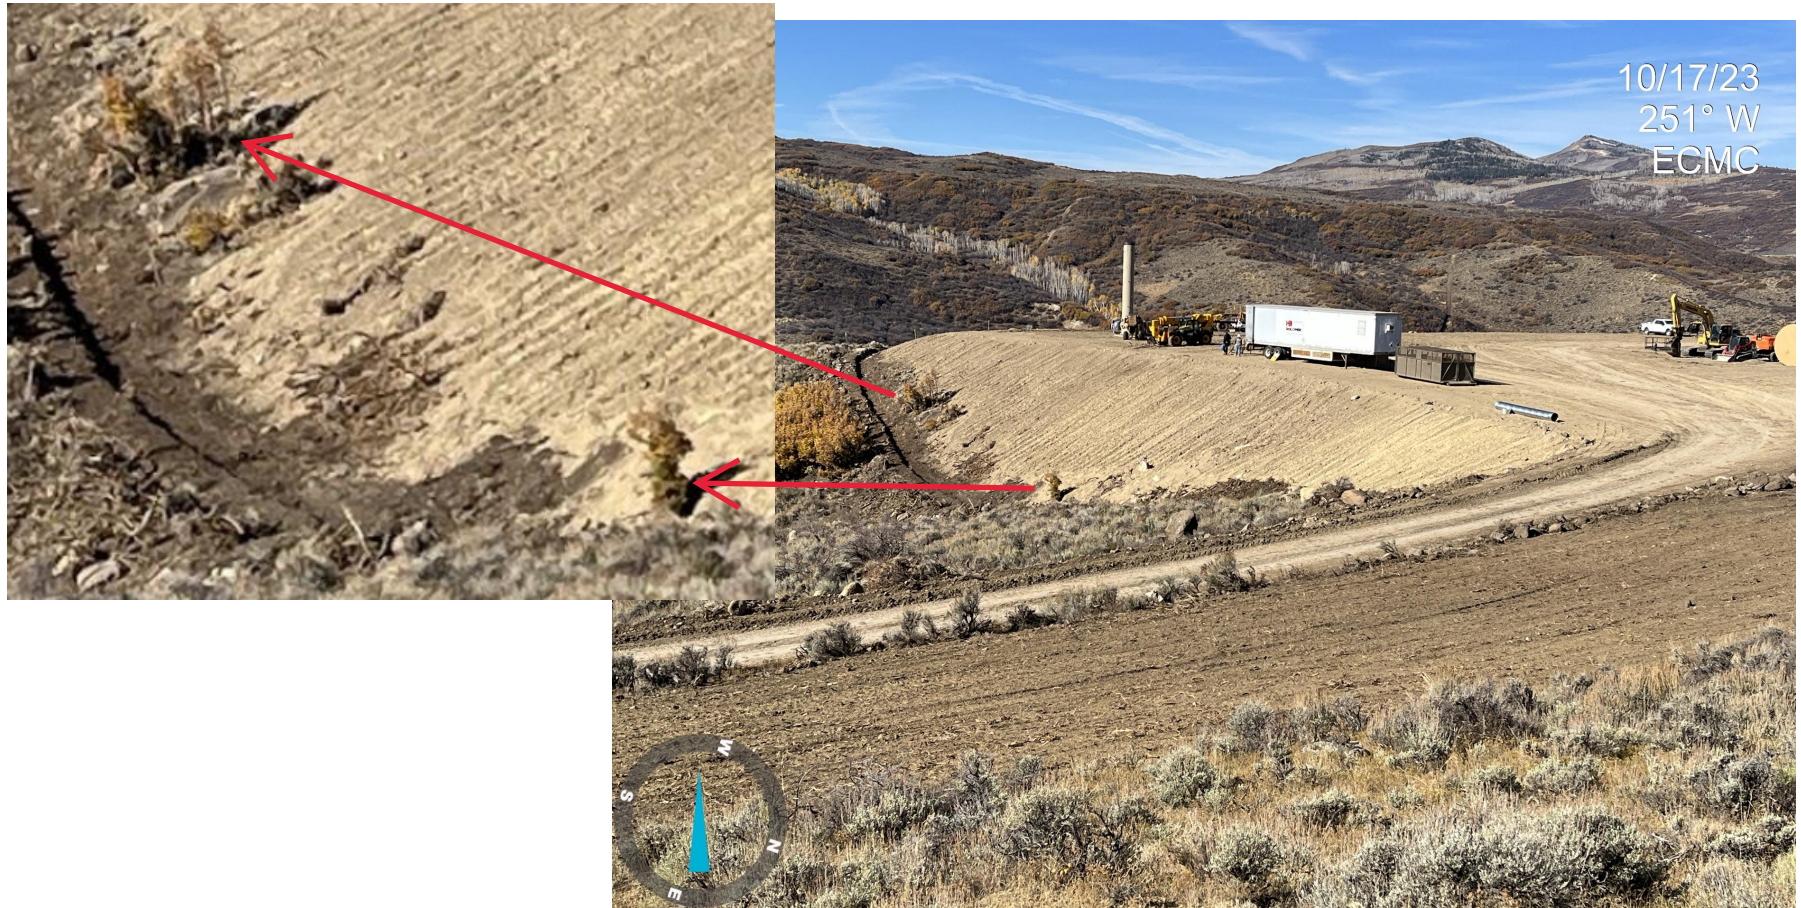
**Photo 4:** Photo taken from the east of the Location, facing west. Photo provides an overview of the Location. Photo also shows intact vegetation (arrow, trees and shrubs) along the perimeter of the Location, partially covered with fill material, indicating that not all topsoil had been salvaged and segregated during construction.

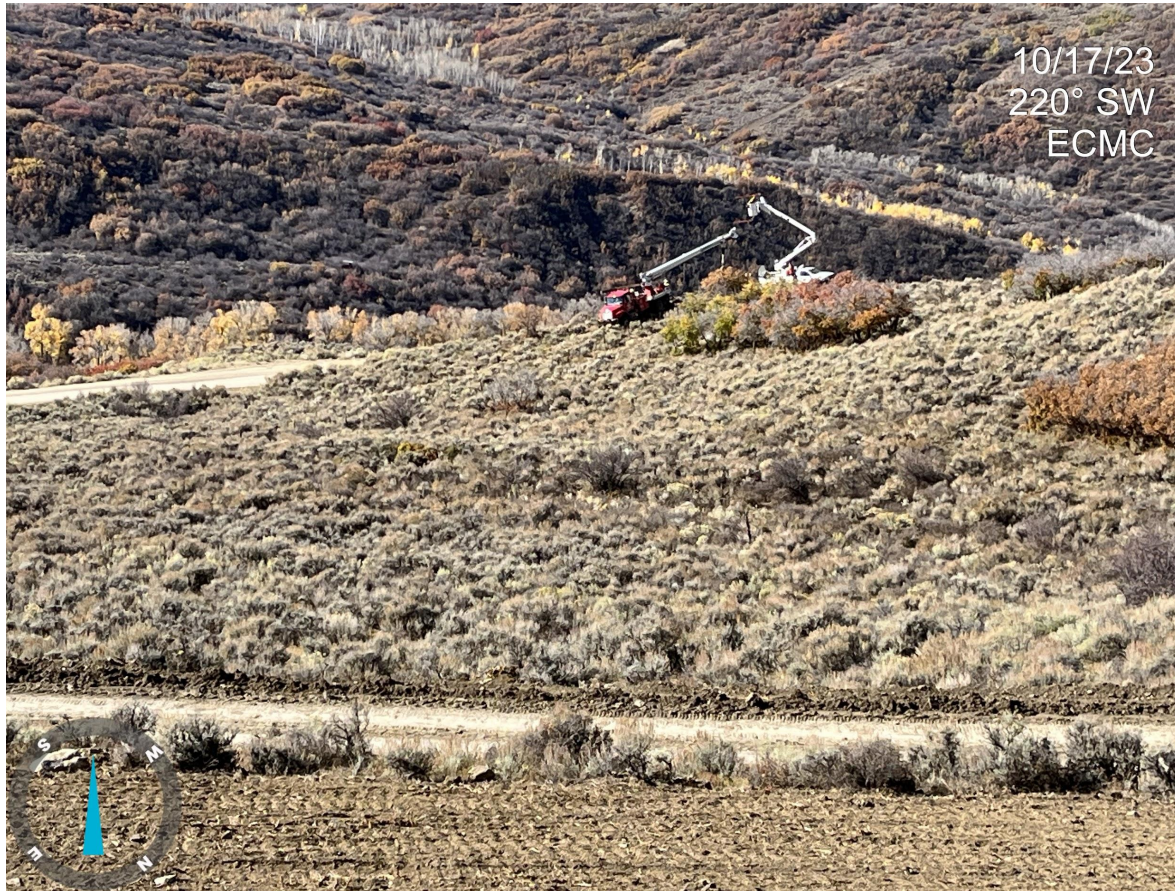
**Photo 5:** Photo taken from the east of the Location, facing southwest. ECMC had directed Operator to stop construction related activities; photo example showing utility installation activities ongoing at time of the inspection, but after Operator was directed to stop work.

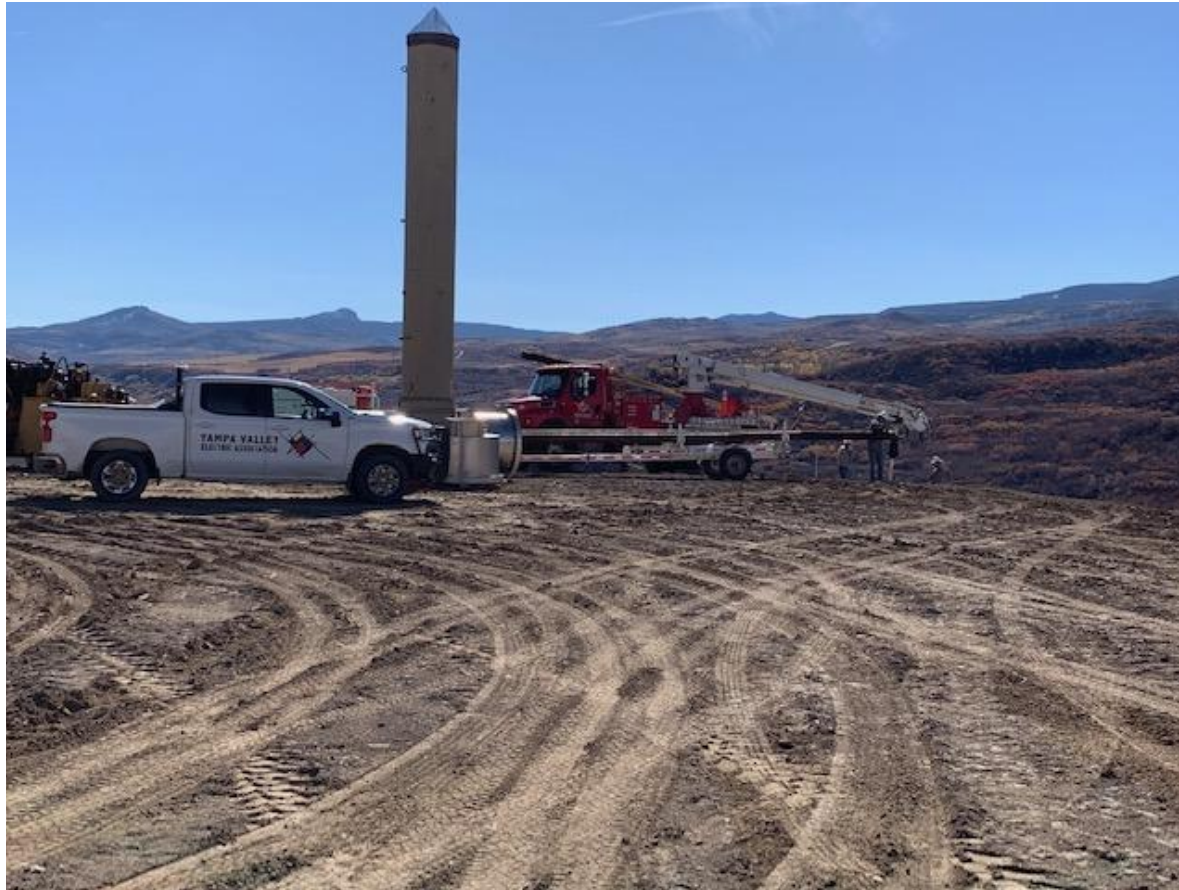
**Photo 6:** Photo taken from the south of the Location, facing south. ECMC had directed Operator to stop construction related activities; photo example showing utility installation activities ongoing at time of the inspection, but after Operator was directed to stop work.

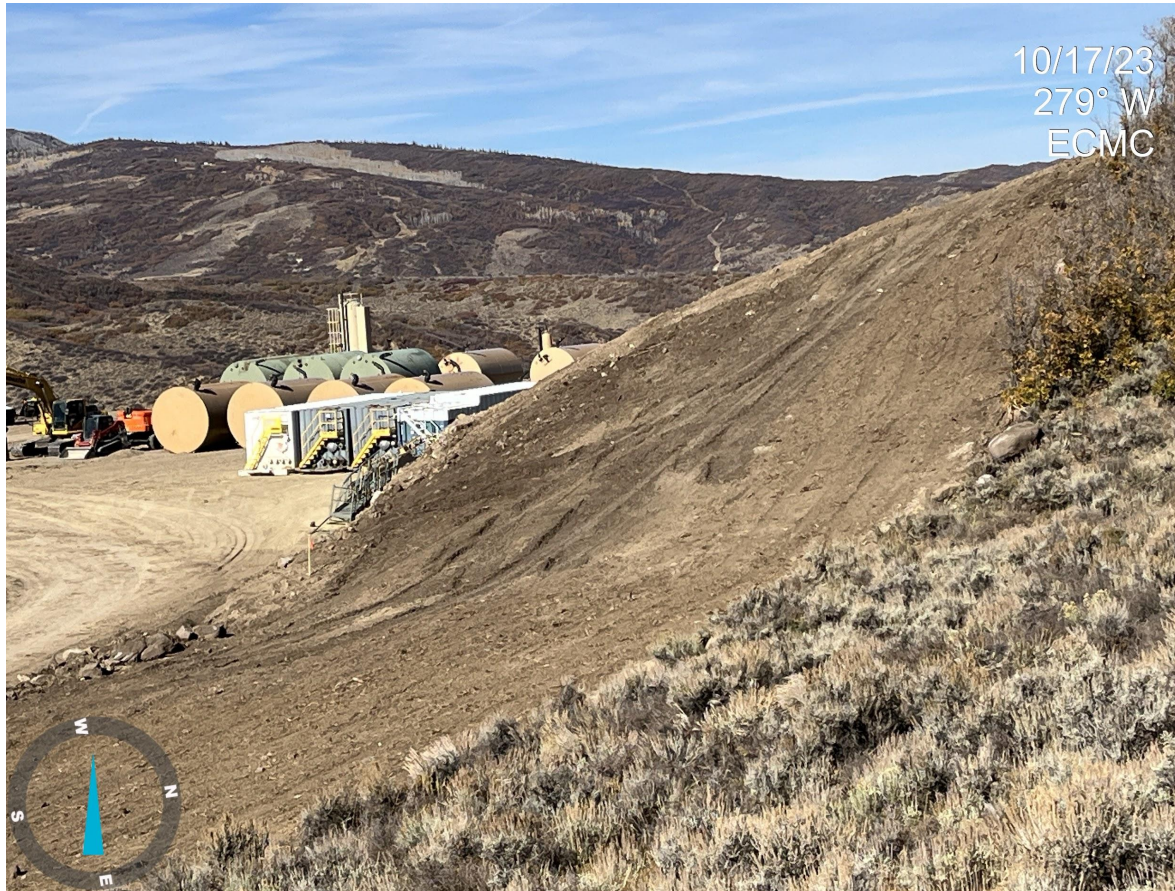
**Photo 7:** Photo taken from the east end of the Location, facing west. Photo shows areas of the eastern perimeter of the Location's disturbance, including the Flowline System disturbance. Photo example showing perimeter stormwater and erosion control BMPs are missing or insufficient along the perimeter of the Location and slopes of the disturbance.

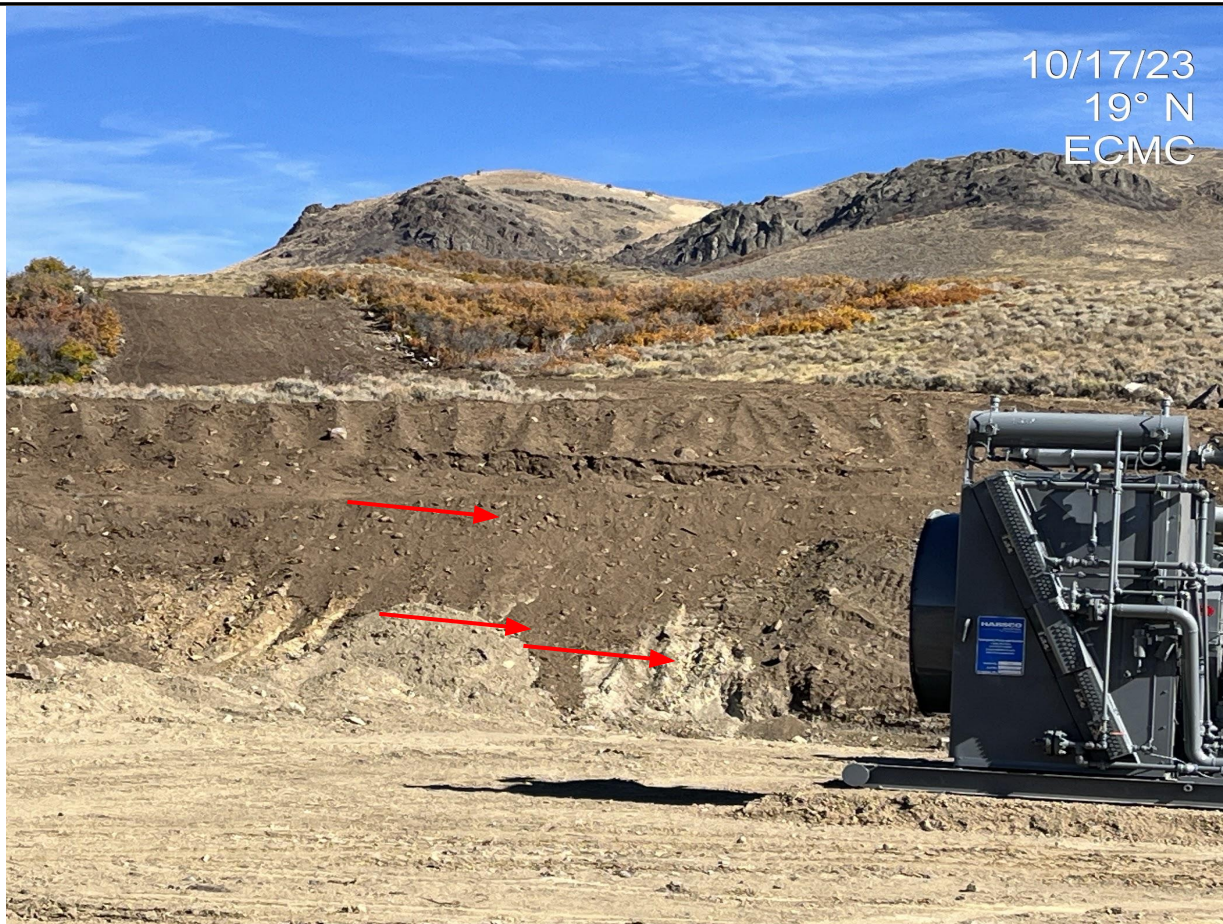
**Photo 8:** Photo taken from the north end of the Location, facing northeast. Photo shows cut slopes of the Location lack stabilization. BMPs to minimize erosion, degradation and sediment transport are missing or insufficient; BMPs to manage runoff/runoff along eastern perimeter missing or insufficient. Photo also shows the mixing of soil horizons, such as the topsoil; Operator failed to salvage all topsoil on the Location; Operator failed to separate and store soil horizons separately based on changes in physical characteristics (such as organic content, color, texture, density or consistency).

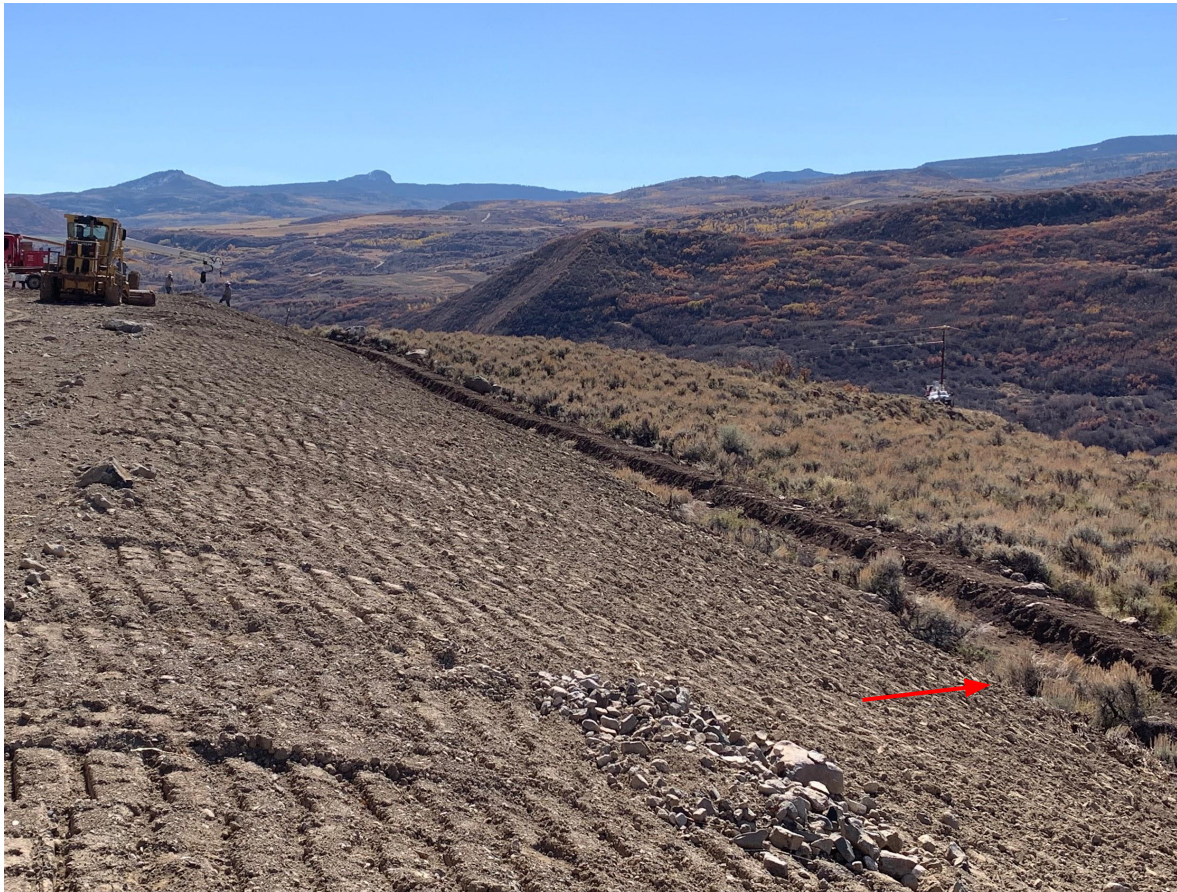
**Photo 9:** Photo taken from the southwest end of the Location, facing southeast. Photo example showing surface roughening (tracking) implemented on fill slopes. Photo also example showing ditch/berm constructed along the perimeter of the Location; BMPs had been constructed with use of topsoil material. Photo also shows intact vegetation (arrow, shrubs) along the perimeter of the Location, partially covered with fill material, indicating that not all topsoil had been salvaged and segregated during construction.

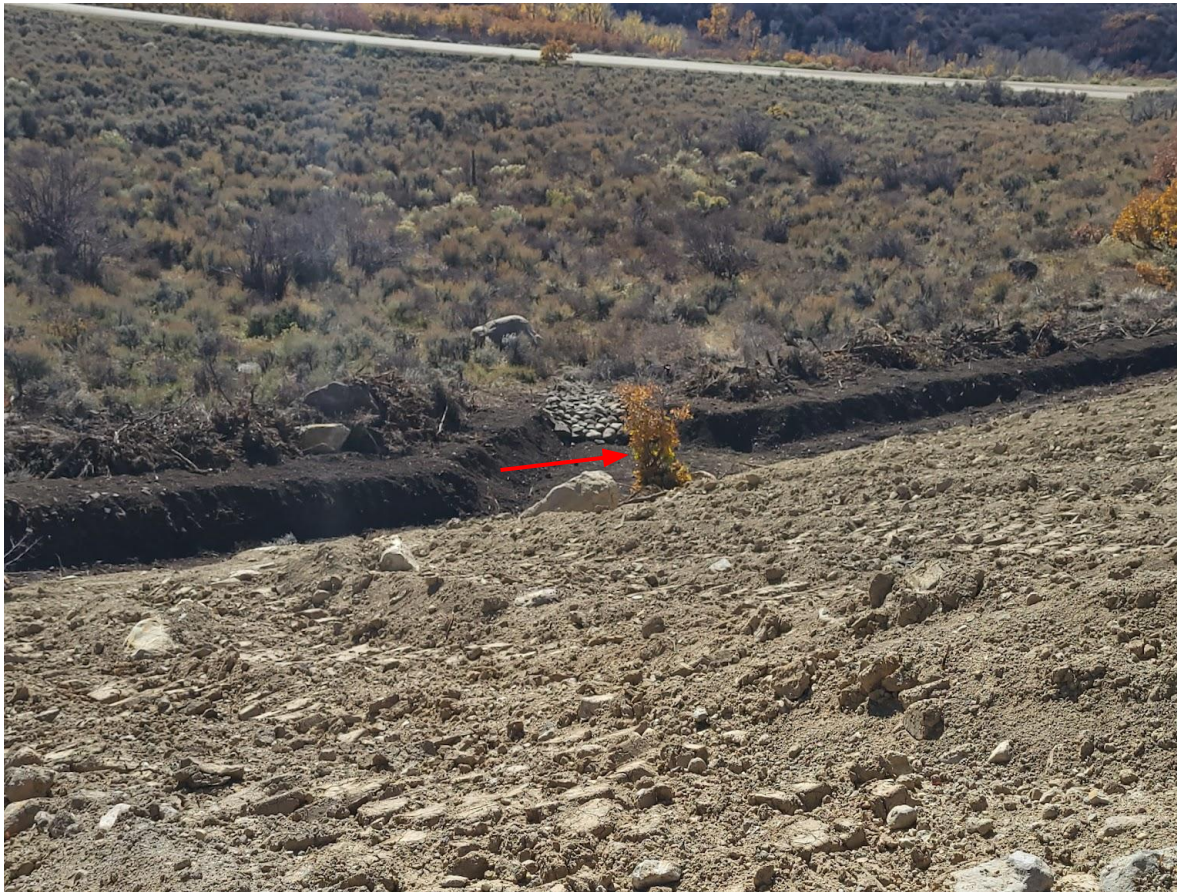
**Photo 10:** Photo taken from the southeast end of the Location, facing southeast. Photo shows 1 of the 2 sediment traps on the Location, as well as the ditch/berm along the perimeter; BMPs had been constructed with use of topsoil material. Photo also shows intact vegetation (arrow, tree) along the perimeter of the Location, partially covered with fill material, indicating that not all topsoil had been salvaged and segregated during construction.

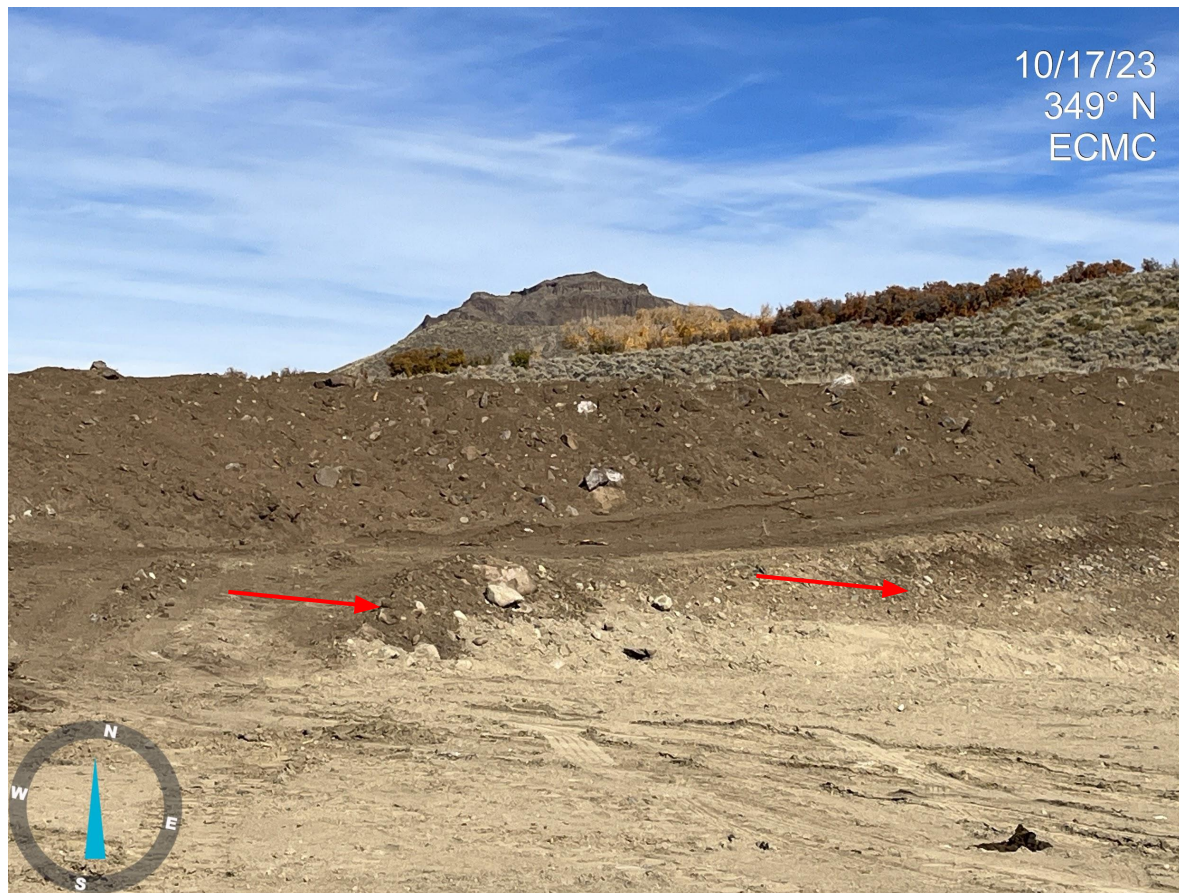
**Photo 11:** Photo taken from the north end of the Location, facing northwest. Photo shows the topsoil stockpile. Stockpile bare, unstabilized and at risk from wind and water erosion; BMPs to minimize erosion and degradation missing from the stockpile; control measures to manage stormwater runoff and minimize sediment transport are also missing along the perimeter of the stockpile. Photo also shows the mixing of different soil horizons, such as the topsoil; Operator failed to salvage all topsoil on the Location; Operator failed to separate and store soil horizons separately based on changes in physical characteristics (such as organic content, color, texture, density or consistency).

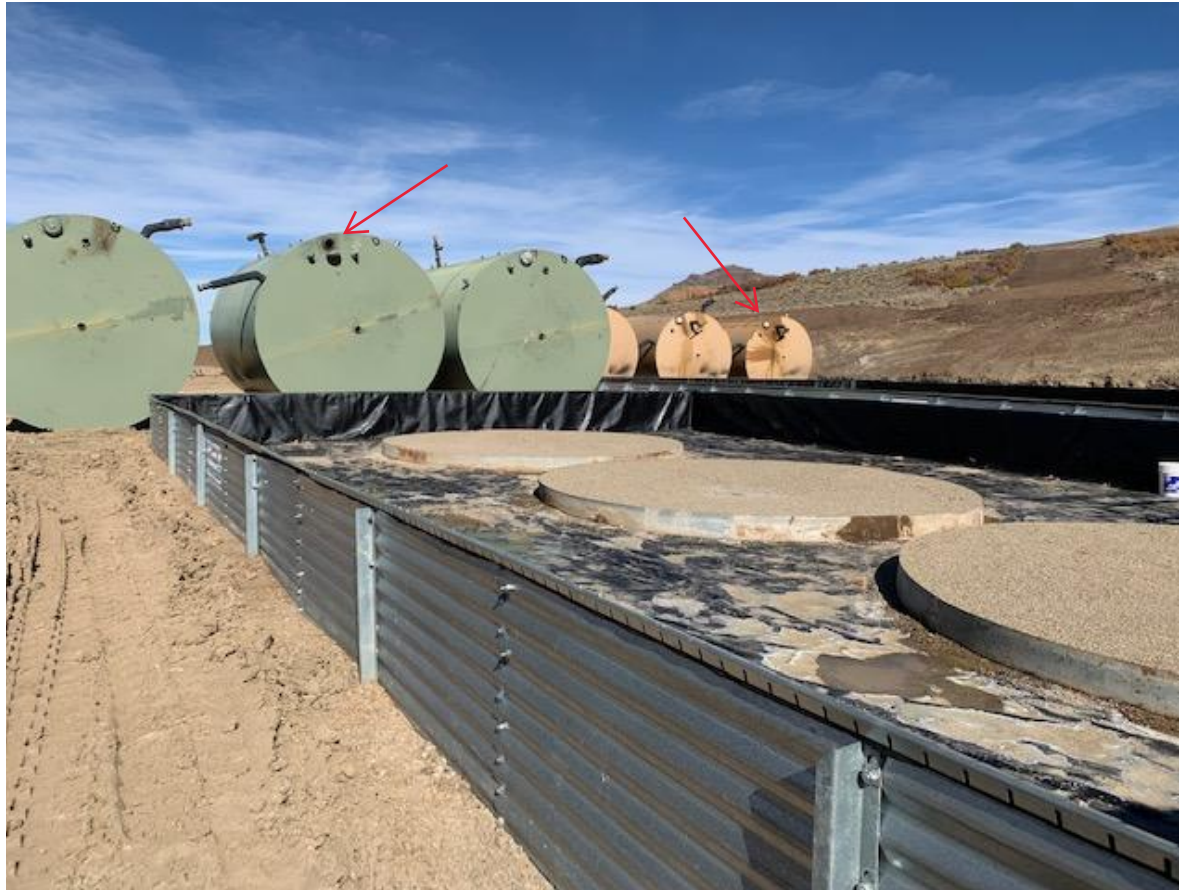
**Photo 13:** Photo taken from the center of the Location, facing north northwest. Photo shows tank battery/production equipment placed and/or installed on the Location. Photo also example showing hatches open at tanks.

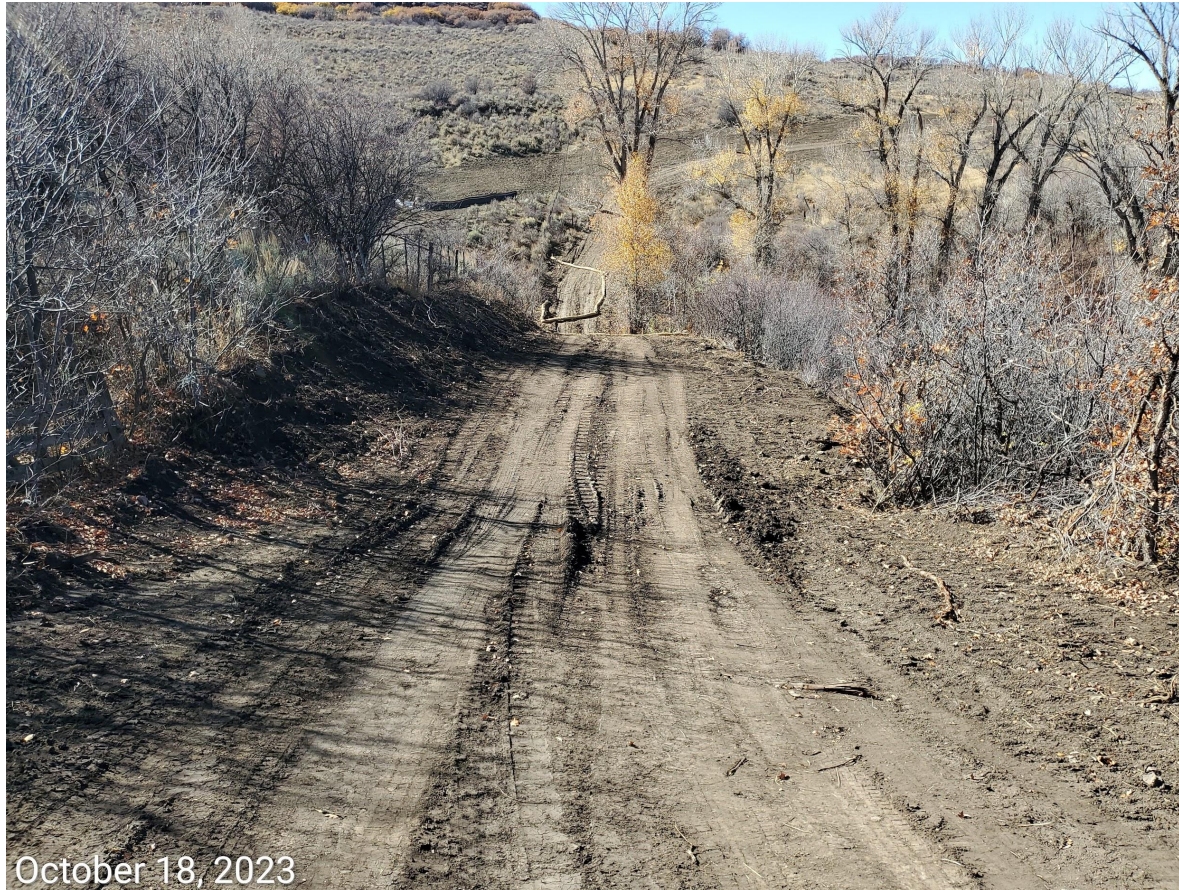
**Photo 17:** Photo taken from ~40.889363, -107.333643. Photo shows a newly constructed access road and stream crossing associated with the Flowline System construction. This stream crossing may require an Army Corps of Engineers permit.

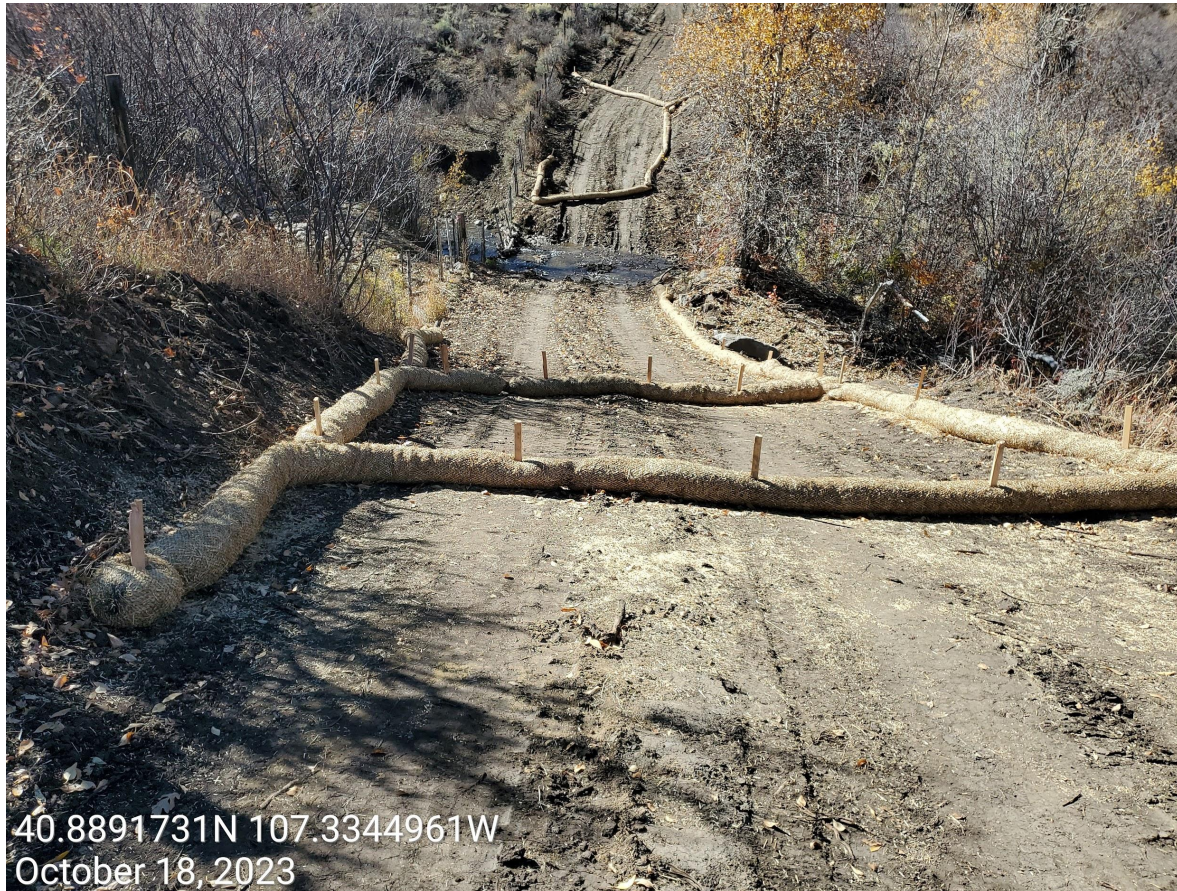
**Photo 18:** Continued from photo 17. Operator has placed erosion logs (straw wattles) along sections of the access road. BMP has not been installed in accordance with good engineering practices, and alone is inadequate to manage runoff in a manner that minimizes erosion, degradation and sediment transport at the access road.

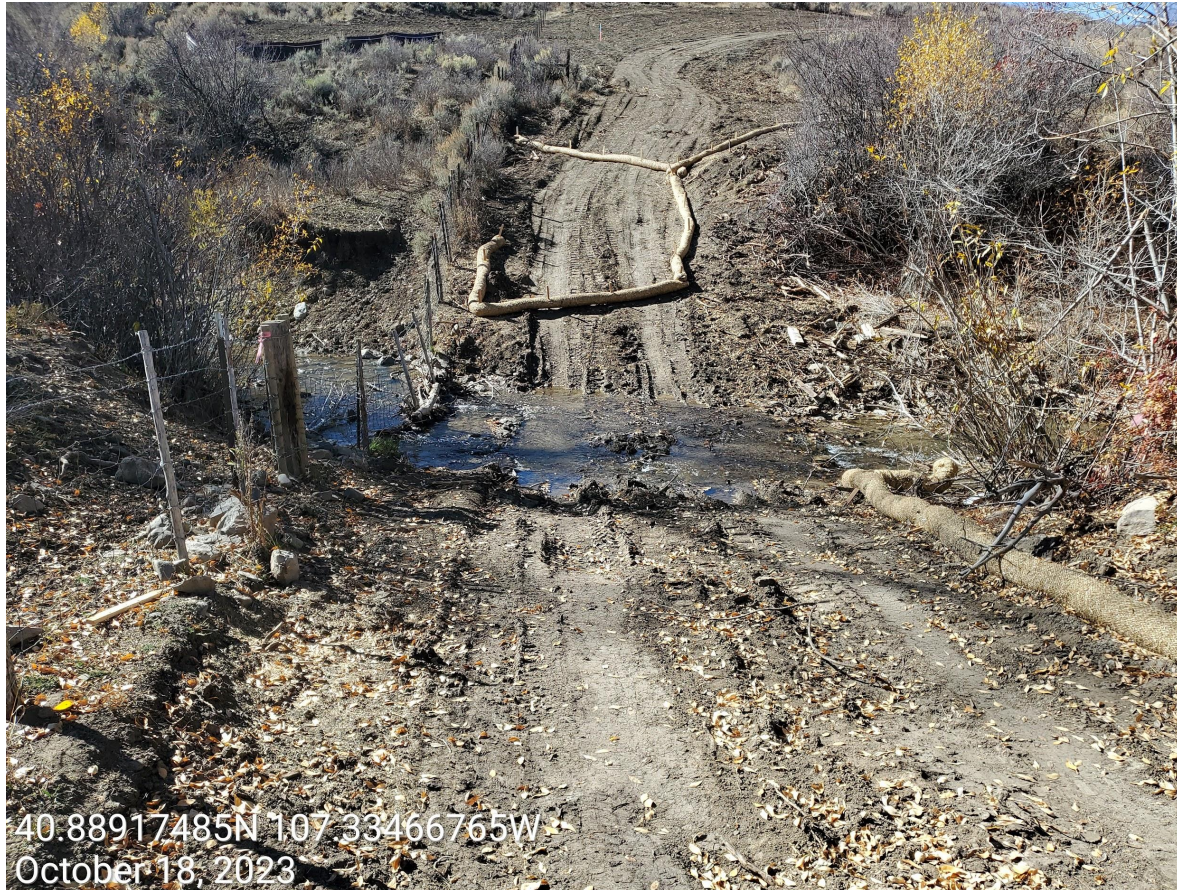
**Photo 19:** Continued from Photo 17. Photo shows the intersection of the new access road, and Slater Creek; access road has not been constructed with an engineered stream crossing; degradation and tracking evident; crossing lacks stabilization and has resulted in impacts to Waters of the State.

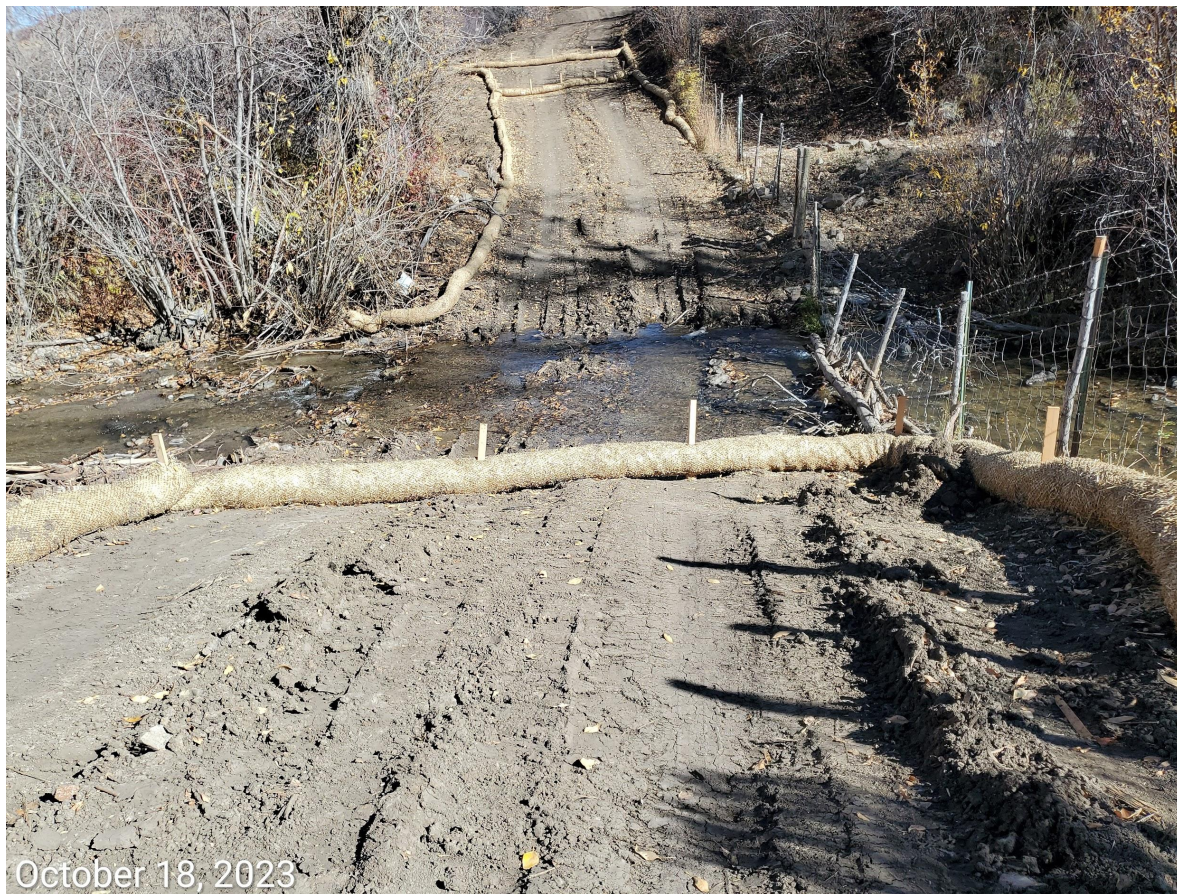
**Photo 20:** Continued from Photo 17. Photo shows the intersection of the new access road, and Slater Creek; access road has not been constructed with an engineered stream crossing; degradation and tracking evident; crossing lacks stabilization and has resulted in impacts to Waters of the State. Operator has placed erosion logs (straw wattles) along sections of the access road. BMP has not been installed in accordance with good engineering practices, and alone is inadequate to manage runoff in a manner that minimizes erosion, degradation and sediment transport at the access road.
