# Photos, Annotation and Issue Report

**Operator:** PETROLEUM RESOURCE  
MANAGEMENT CORP #10421

**Location ID:** 485573

# PRM Duncan Pad Unpermitted Pad Annotation Report

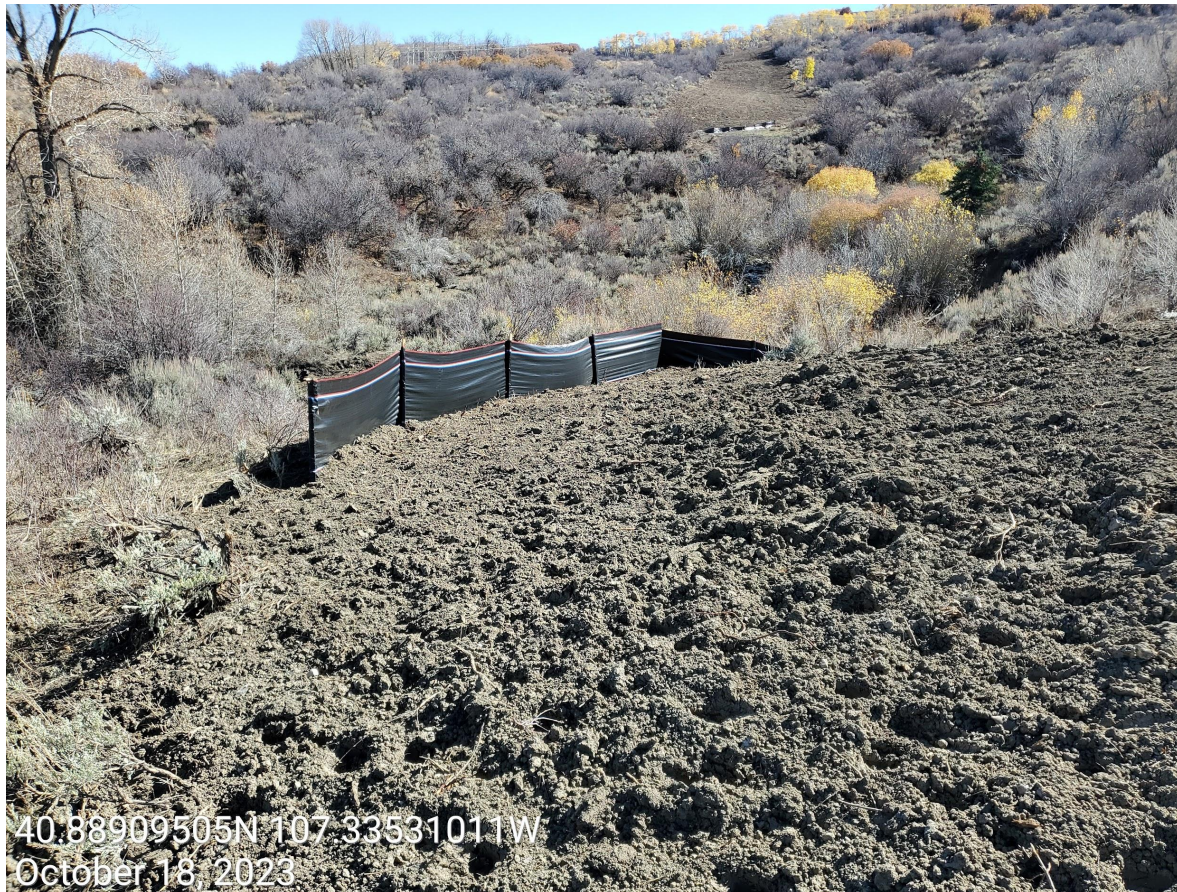
**Photo 21:** Photos taken from the Flowline System disturbance. Stormwater and erosion control BMPs along ~4 mile disturbance leading south of the Unpermitted Duncan Facility are inadequate. Photo example showing silt fence; Operator had installed silt fence along the toe of the slopes adjacent to the pipeline stream crossings; ~30-40 foot sections of silt fence were the only control measure observed installed on the disturbance area; BMPs to stabilize the soils, as well as to manage runoff missing or insufficient.

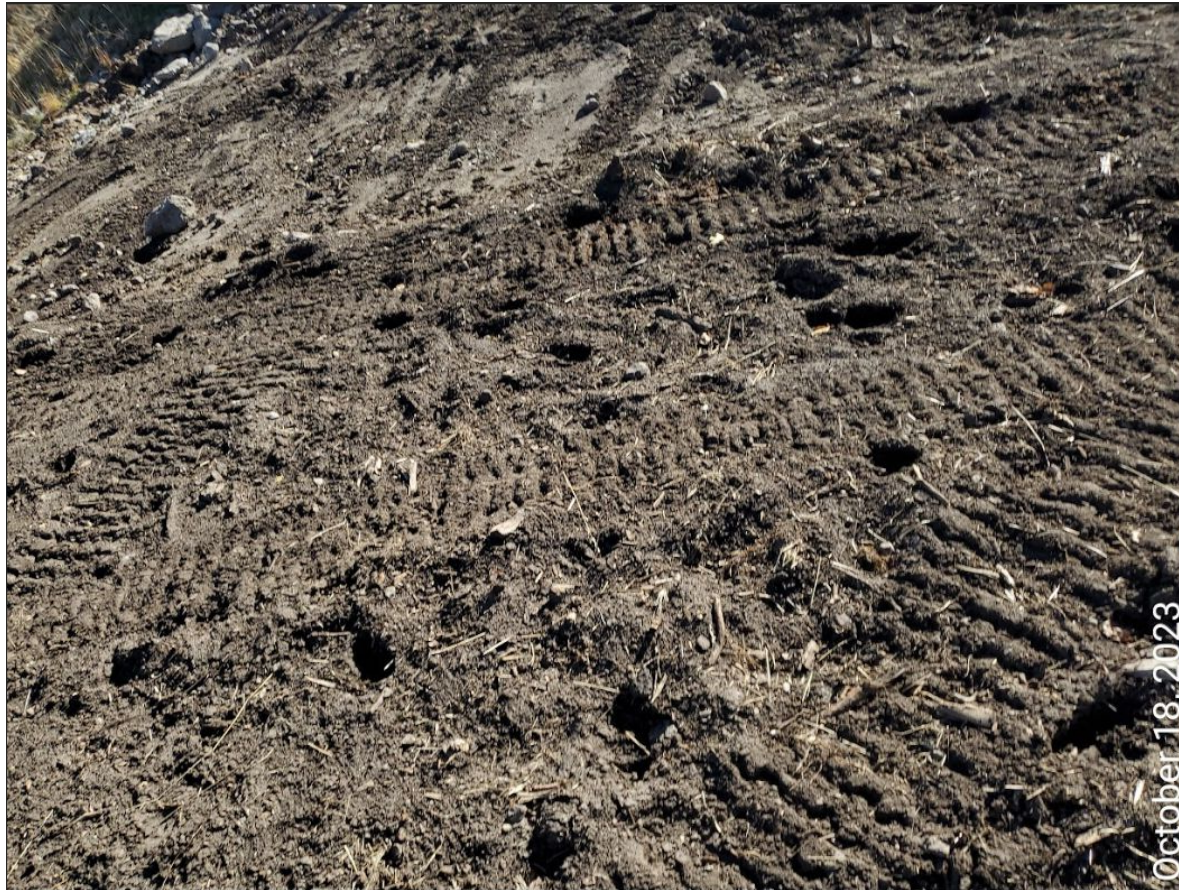
**Photo 22:** Photo taken from the Flowline System disturbance. Photo example showing soils along the ~4 miles disturbance leading south of the Unpermitted Duncan Facility are bare, unstabilized and at risk to wind and water erosion. BMPs to stabilize the soils, as well as to manage runoff/runoff are missing or insufficient along the Flowline System disturbance.

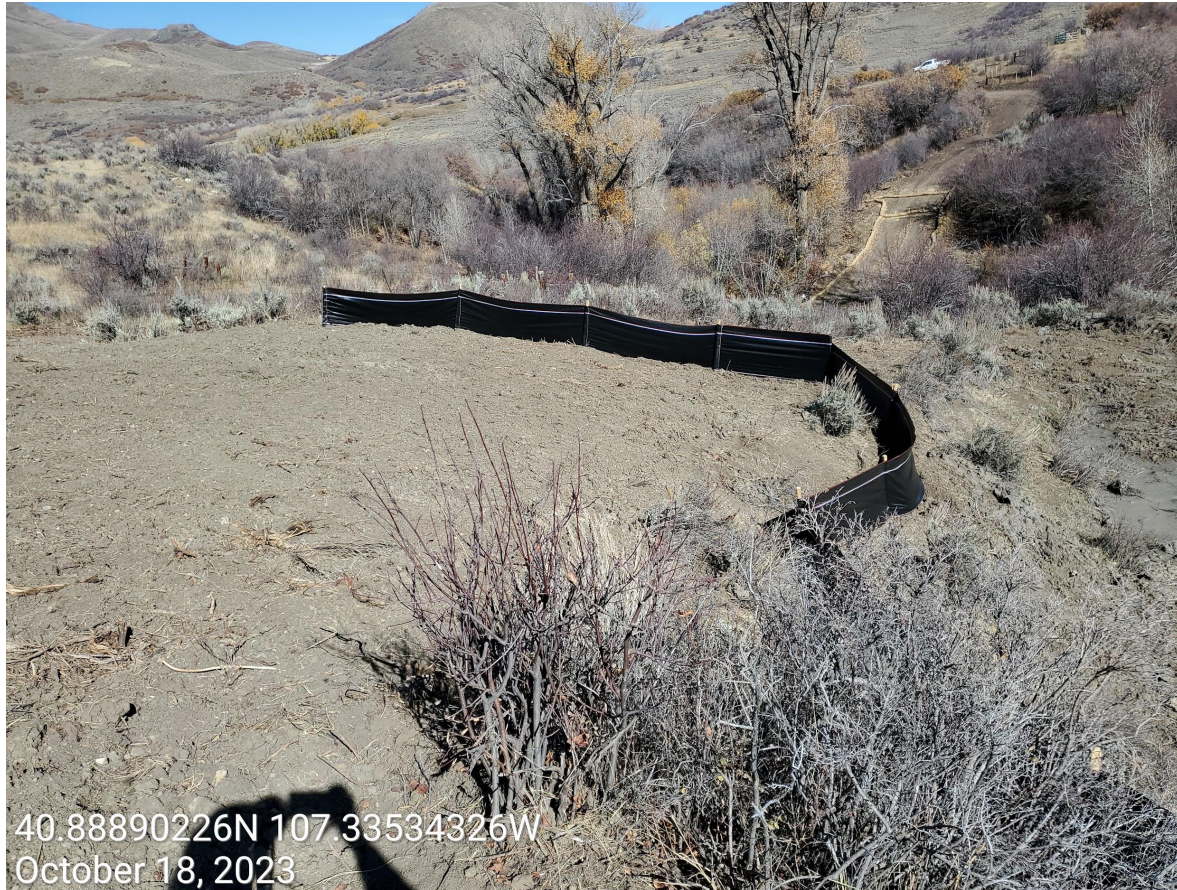
**Photo 23:** See comments under photo 21. Silt fence installed along areas of the Flowline System disturbance have not been installed per good engineering practice; BMP has been installed backwards, and not properly trenched.

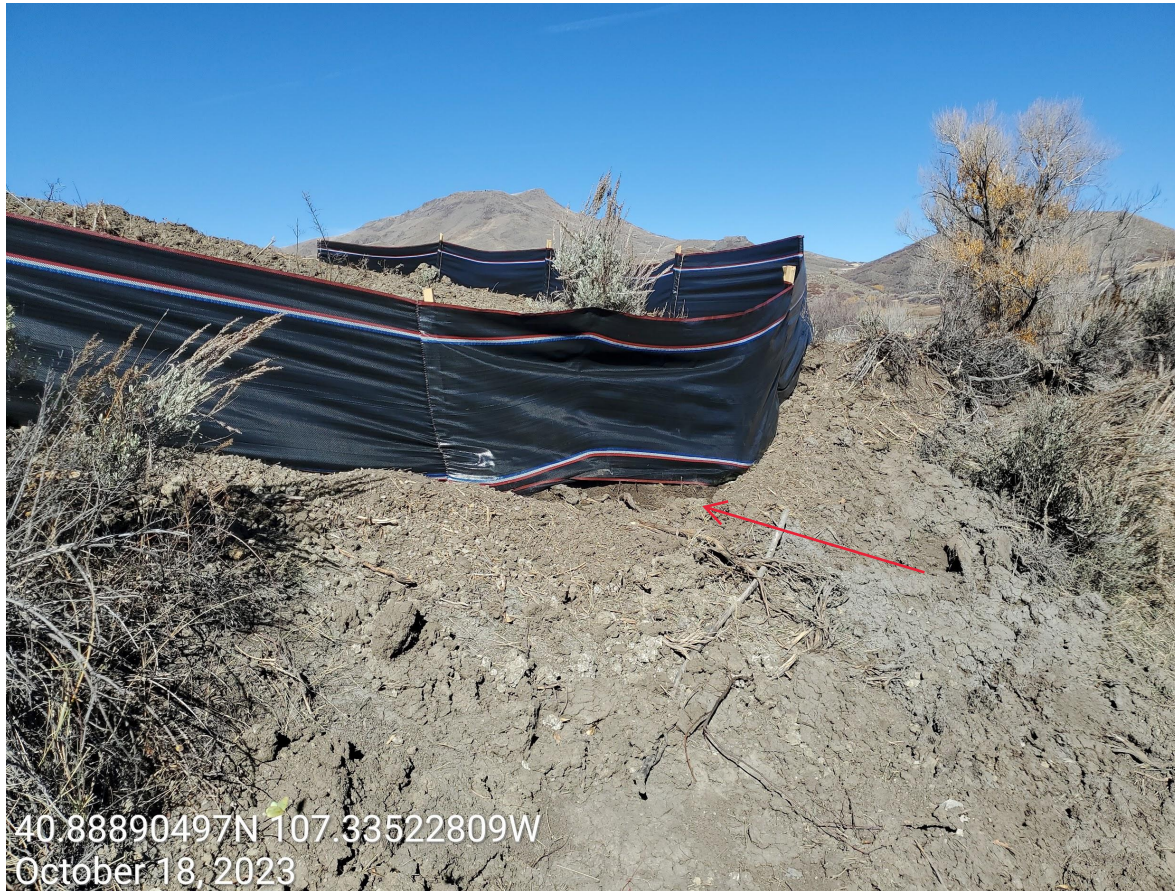
**Photo 24:** Continue from photo 21. BMP has been installed backwards, and not properly trenched. This is resulted in sediment transport and deposition.

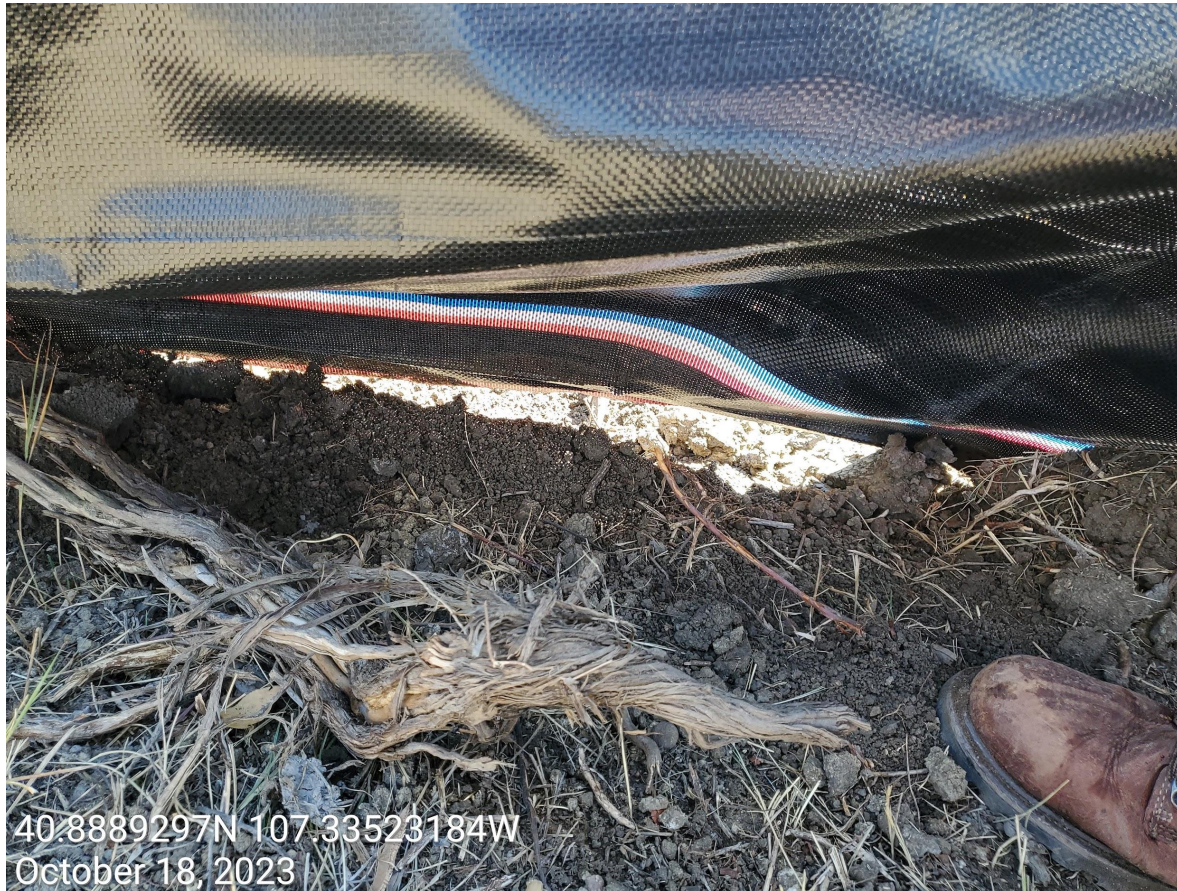
**Photo 25:** Continue from photo 21. BMP has been installed backwards, and not properly trenched. This is resulted in sediment transport and deposition.

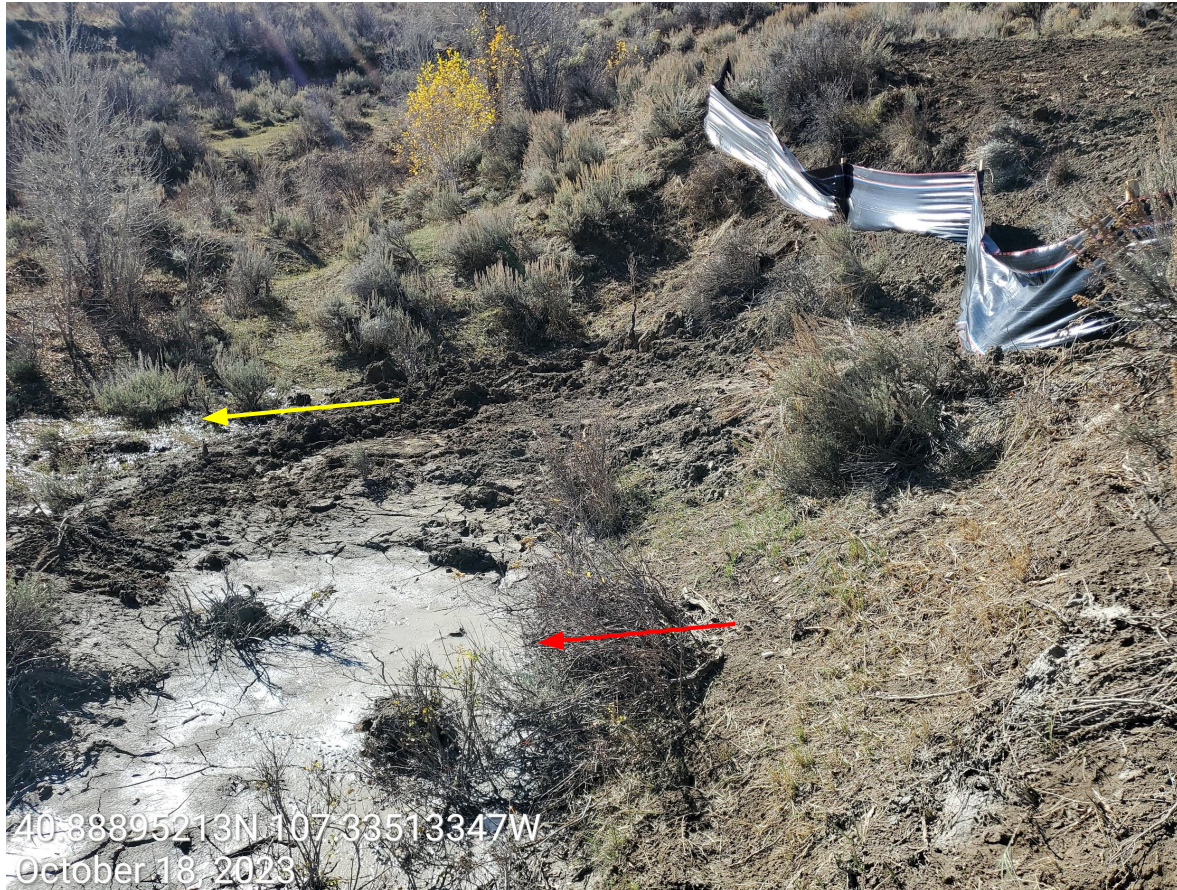
**Photo 26:** Continue from photo 21. Photo shows a spring (red arrow) that feeds into Slater Creek (yellow arrow). Spring has been impacted during the Flowline System construction; combination of construction activities, runoff from the Flowline System disturbance, and inadequate Stormwater BMPs has resulted in sediment deposition and degradation of the spring.

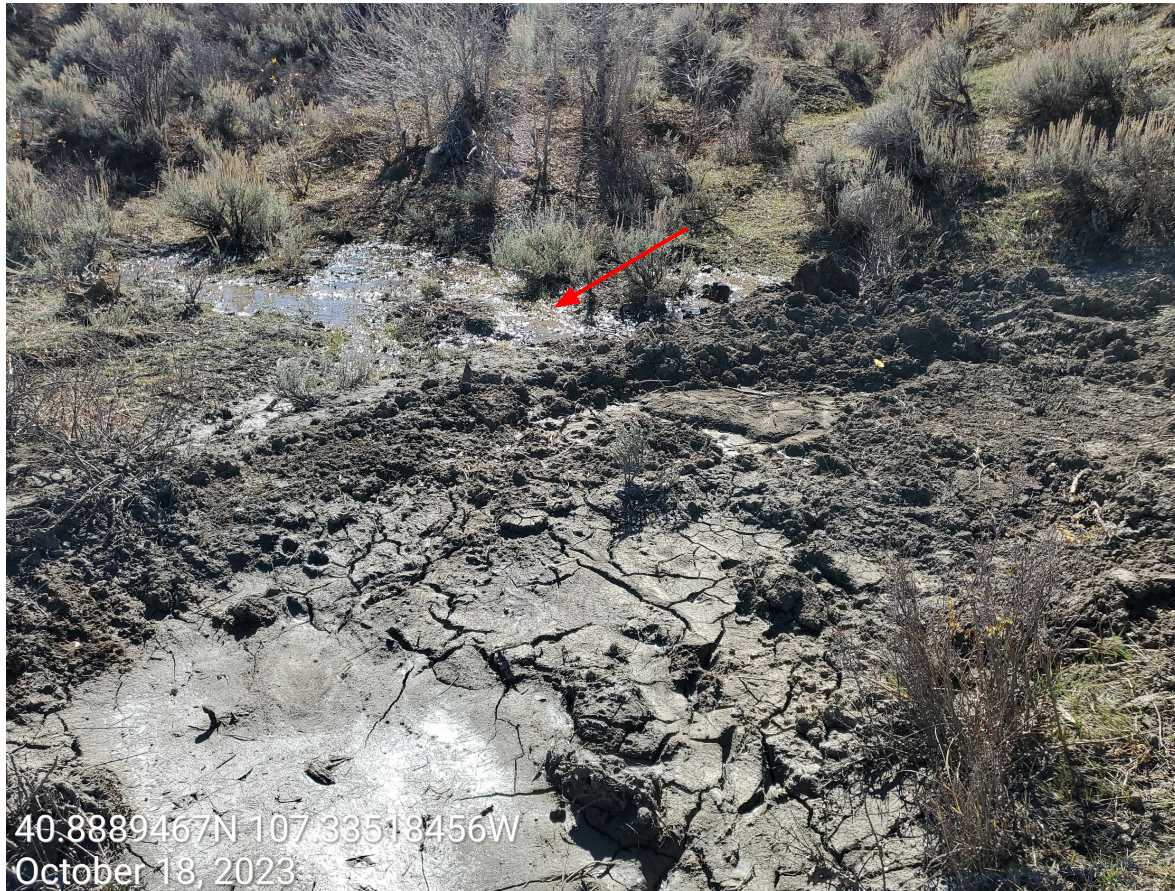
**Photo 27:** Continue from photo 21. Photo shows a spring that feeds into Slater Creek (arrow). Spring has been impacted during the Flowline System construction; combination of construction activities, runoff from the Flowline System disturbance, and inadequate Stormwater BMPs has resulted in sediment deposition and degradation of the spring.
