Caerus Piceance LLC
Piceance Creek Unit-62S97W 3ESE
Location ID: 335796

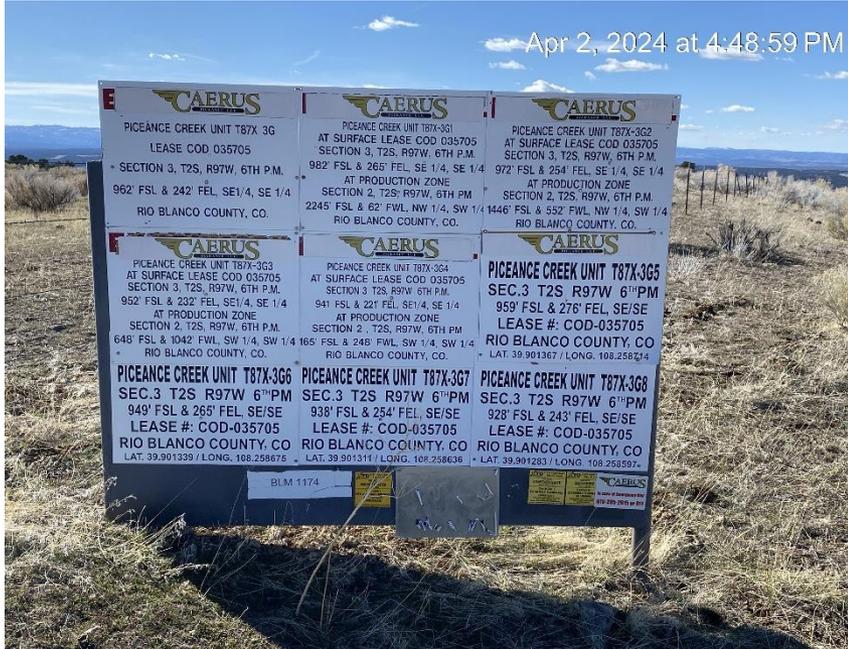
When replaced additional information is required

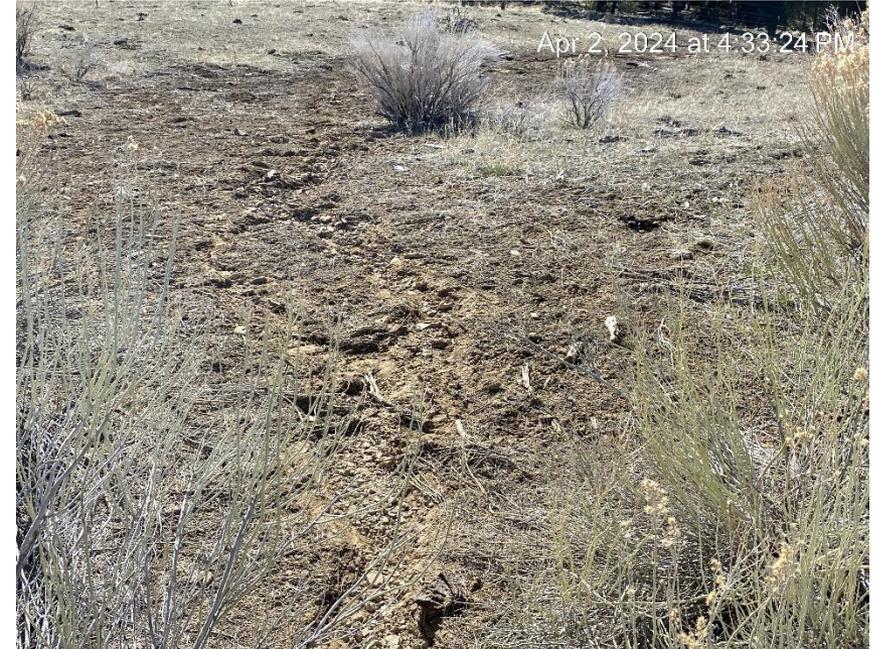
Erosion and sediment migration

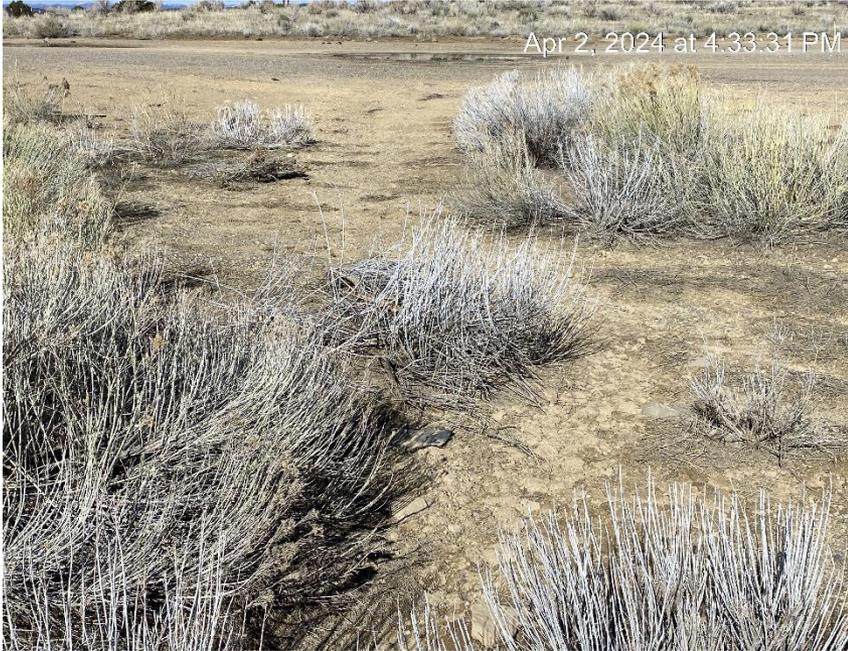
Sediment migration

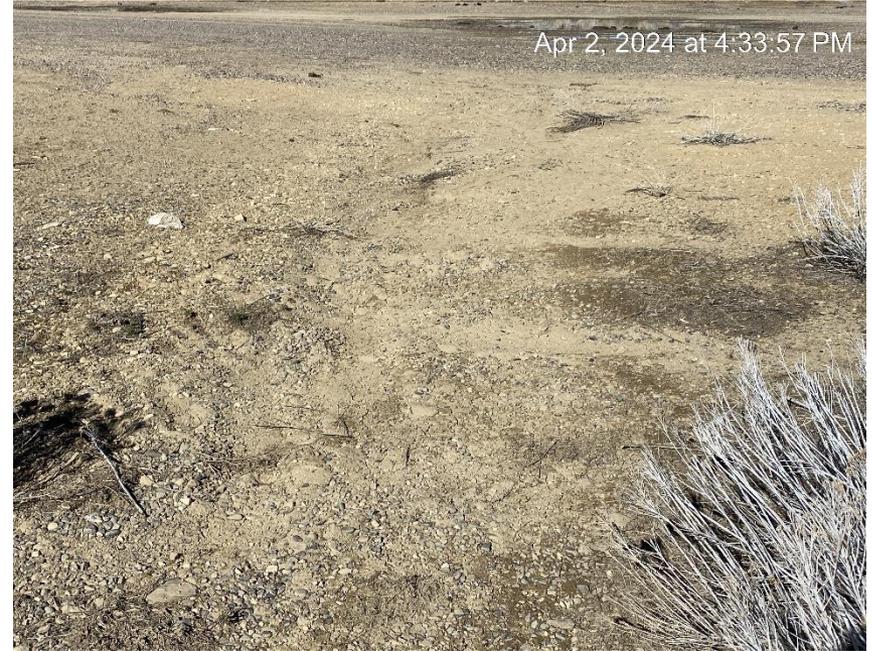
Sediment migration

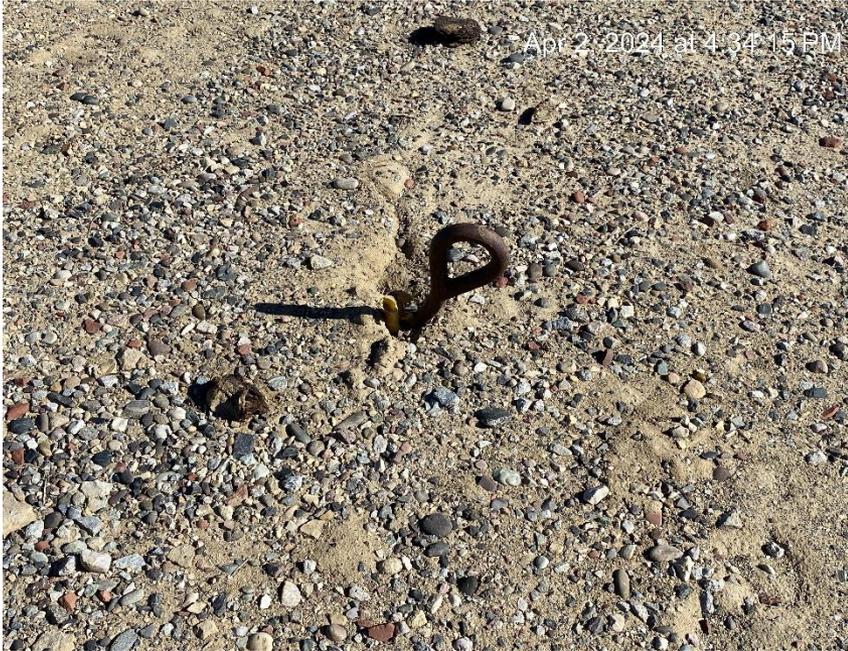
Unmarked anchor

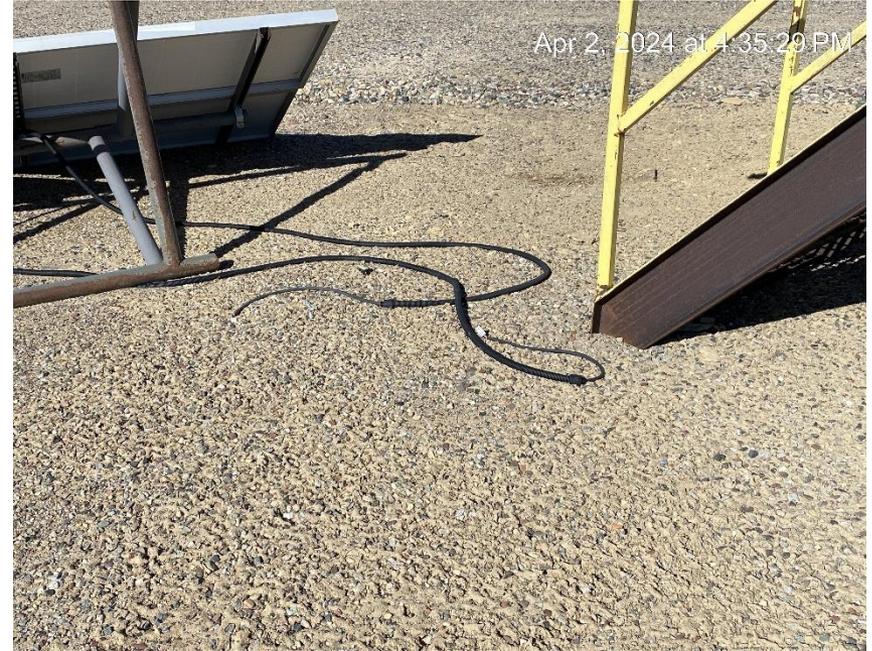
Unused equipment

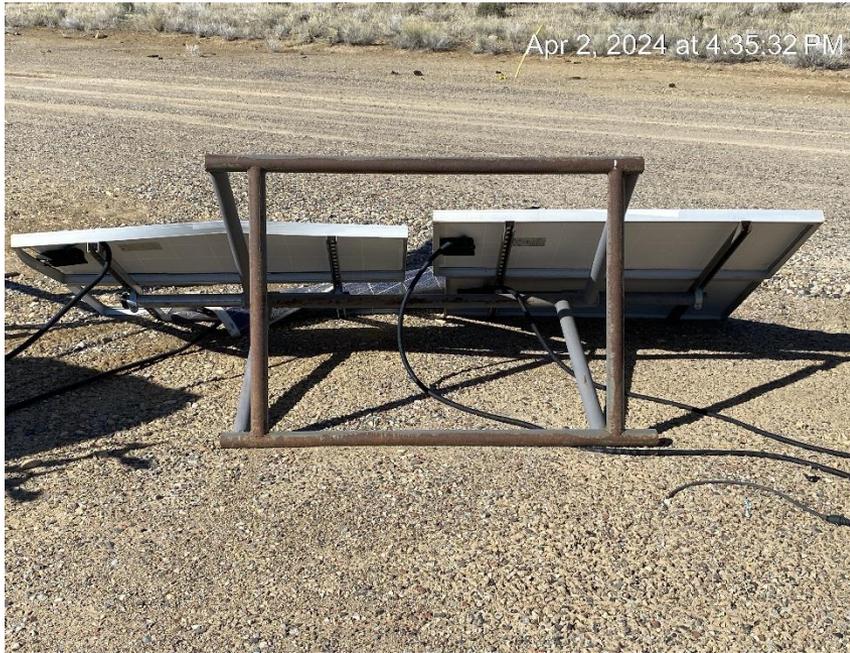
Unused equipment

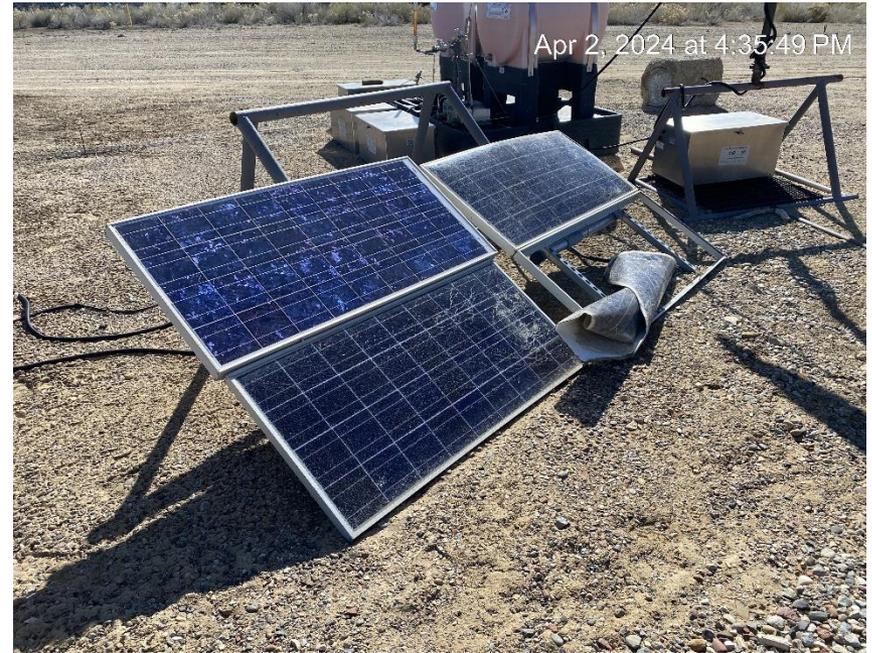
Unused equipment

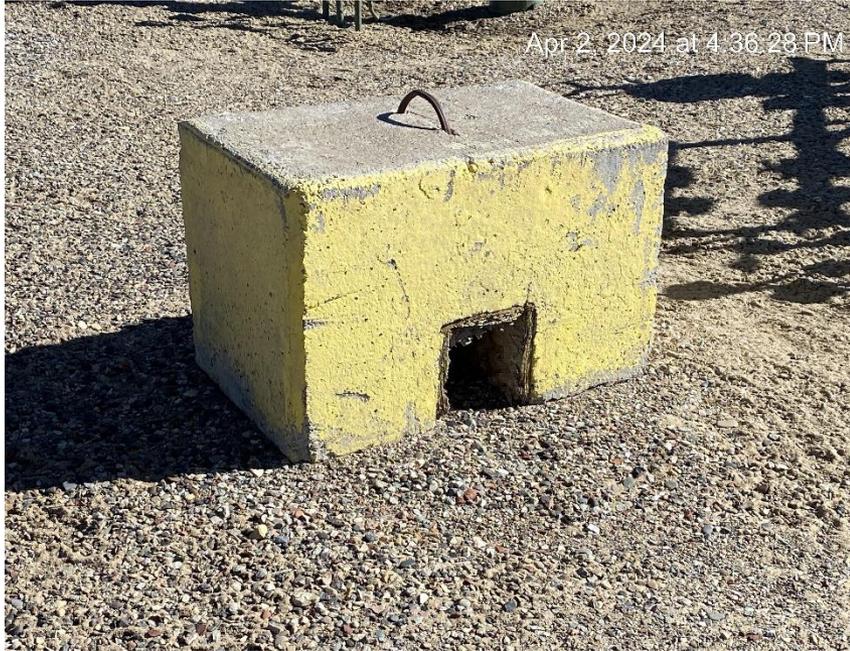
Debris

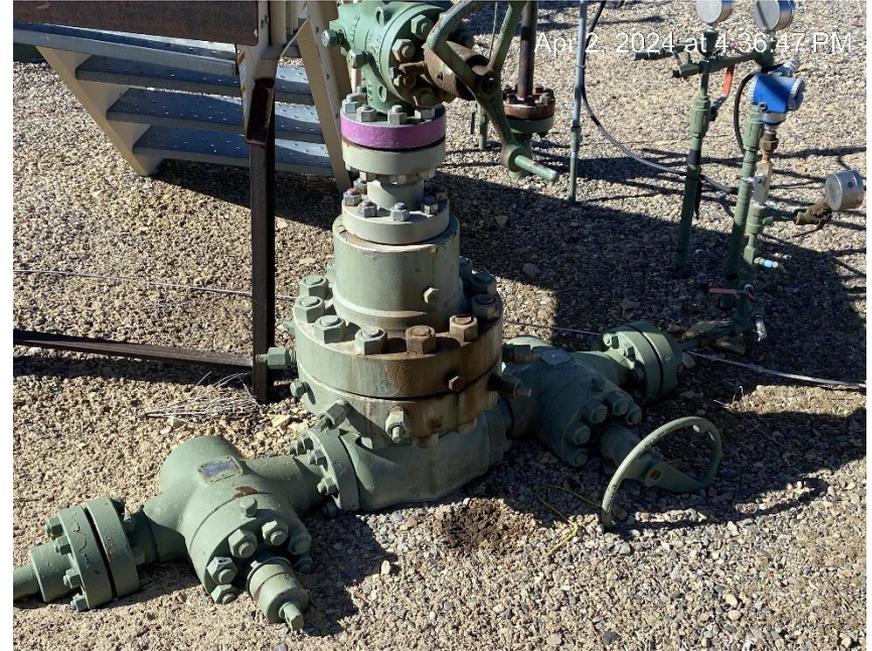
Soil staining

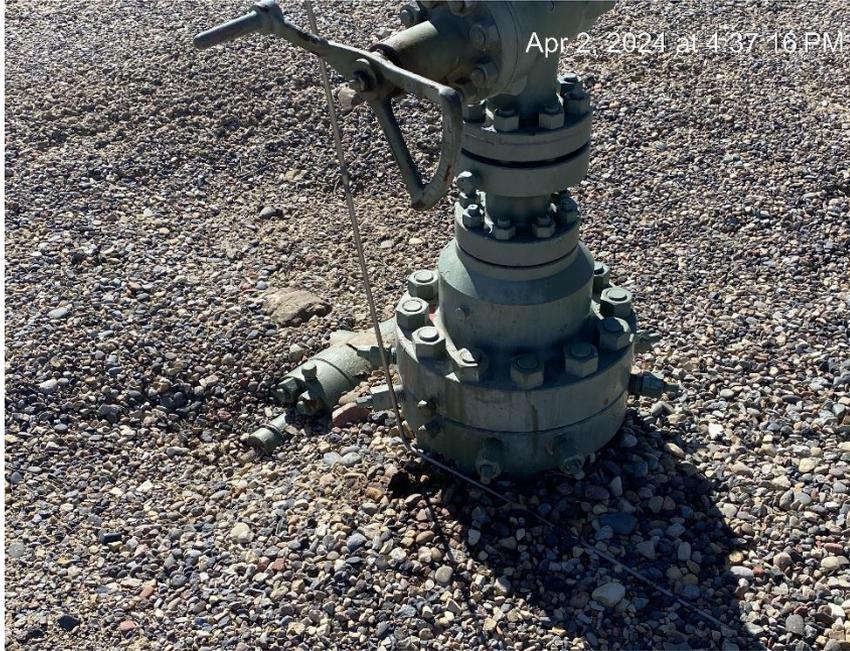
Soil staining

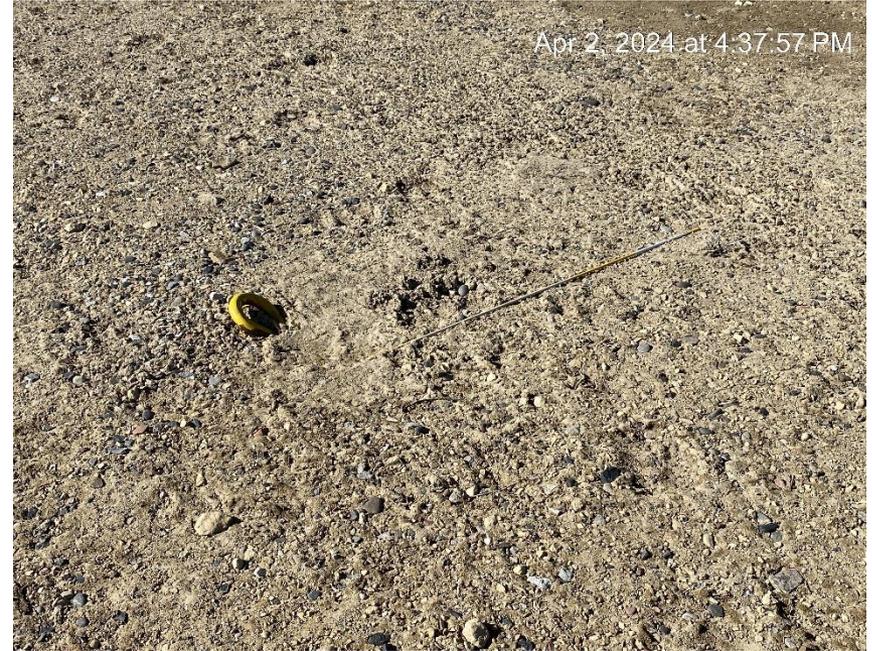
Unmarked anchor

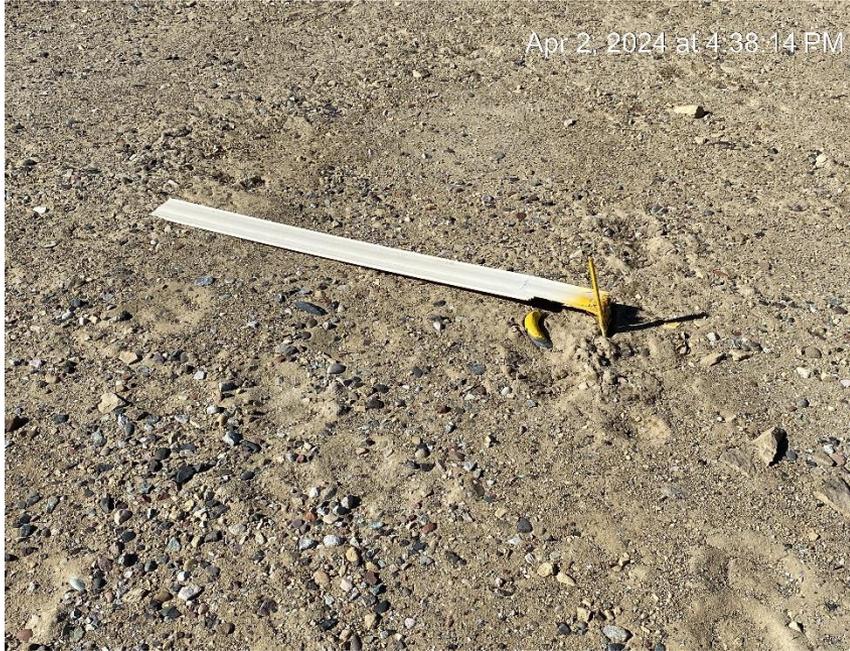
Unmarked anchor

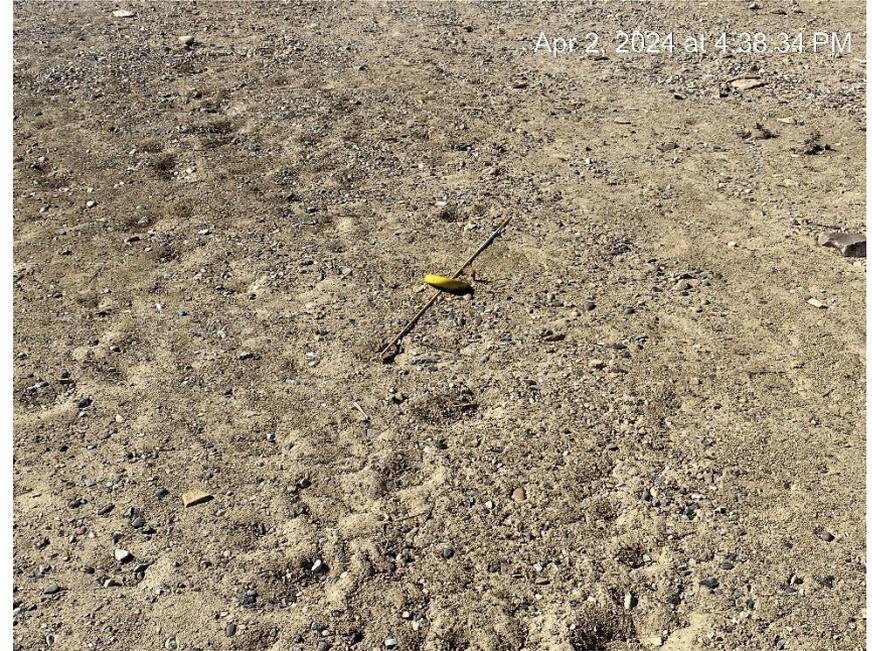
Unmarked anchor

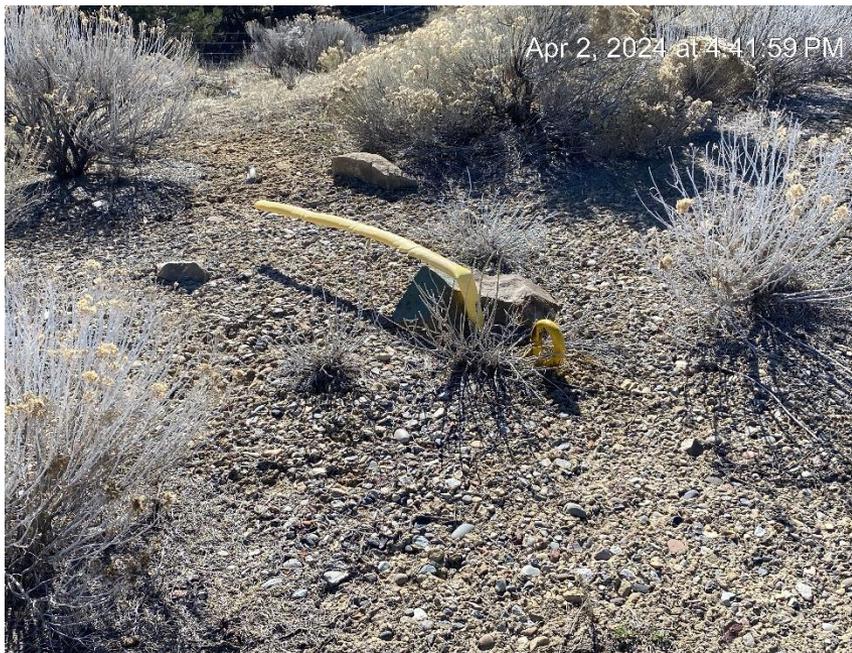
Unmarked anchor

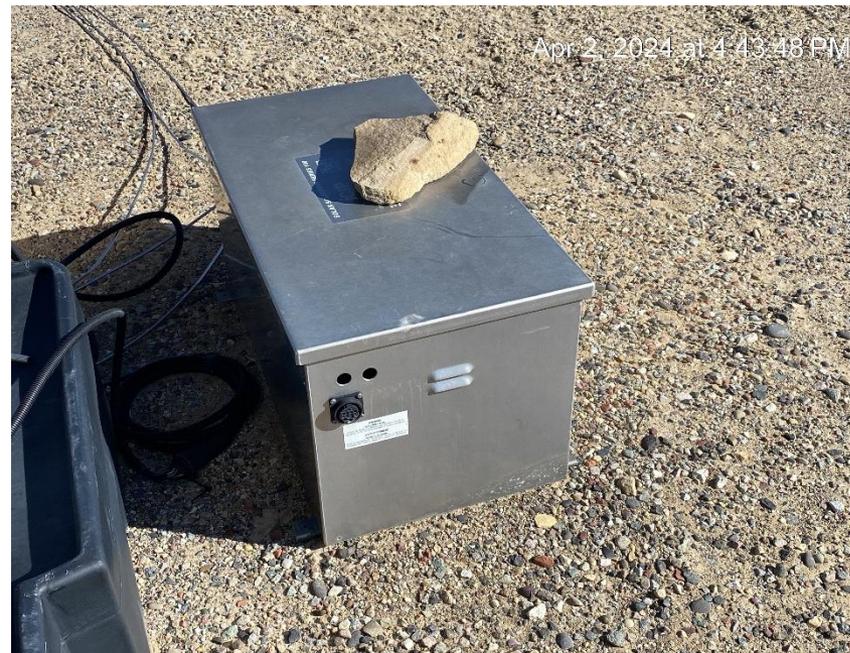
Unused equipment

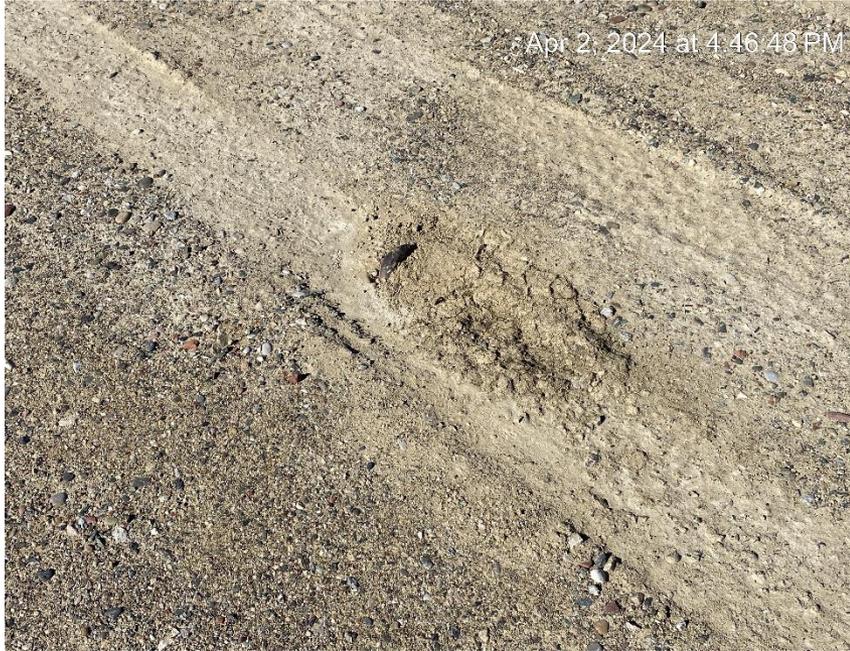
Unmarked anchor

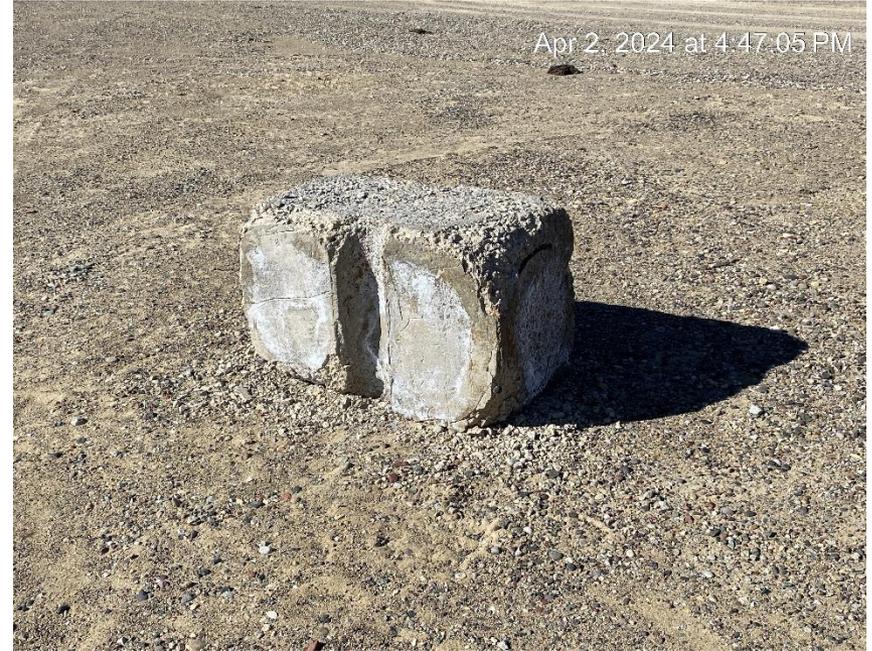
Debris

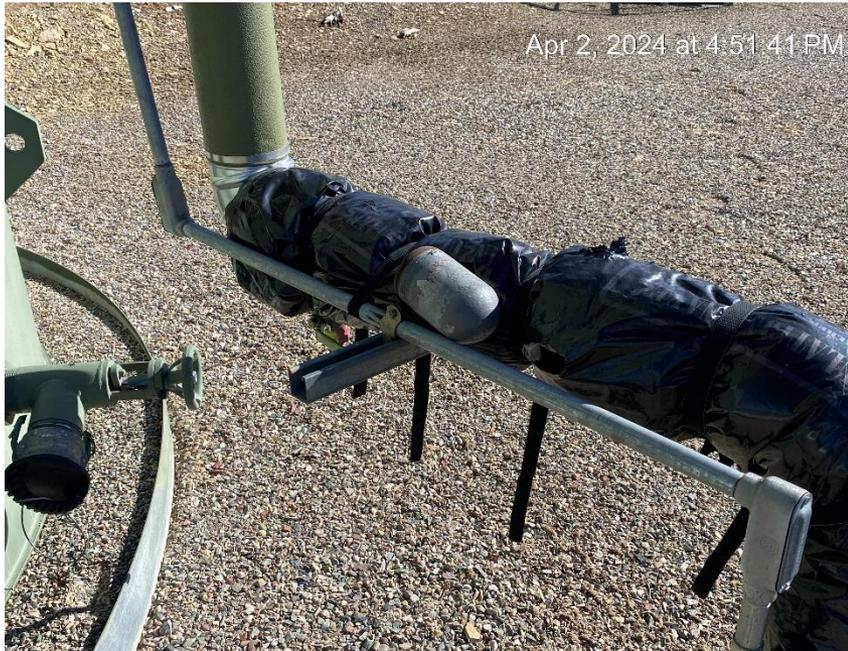
Debris

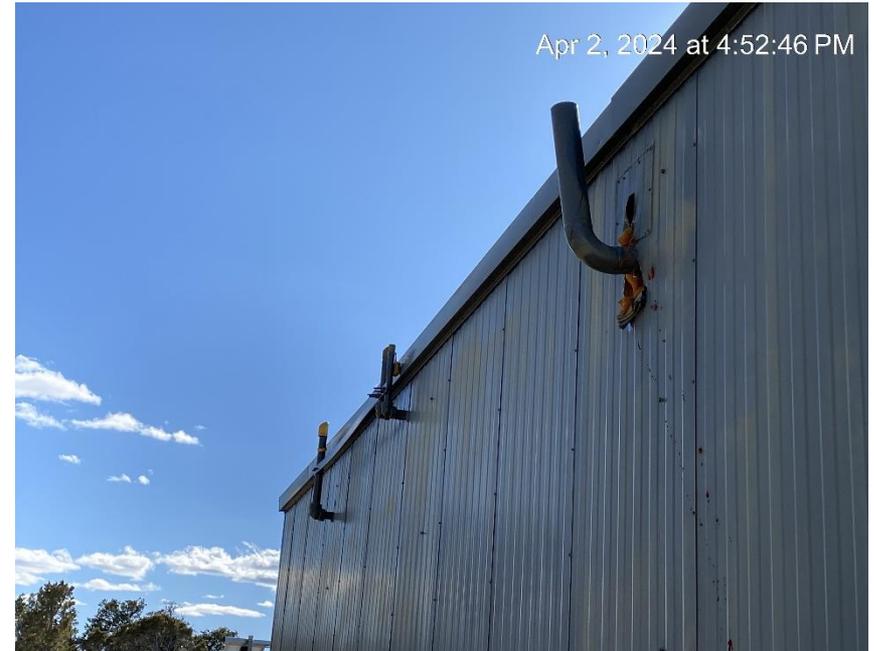
Relief risers missing rain protection

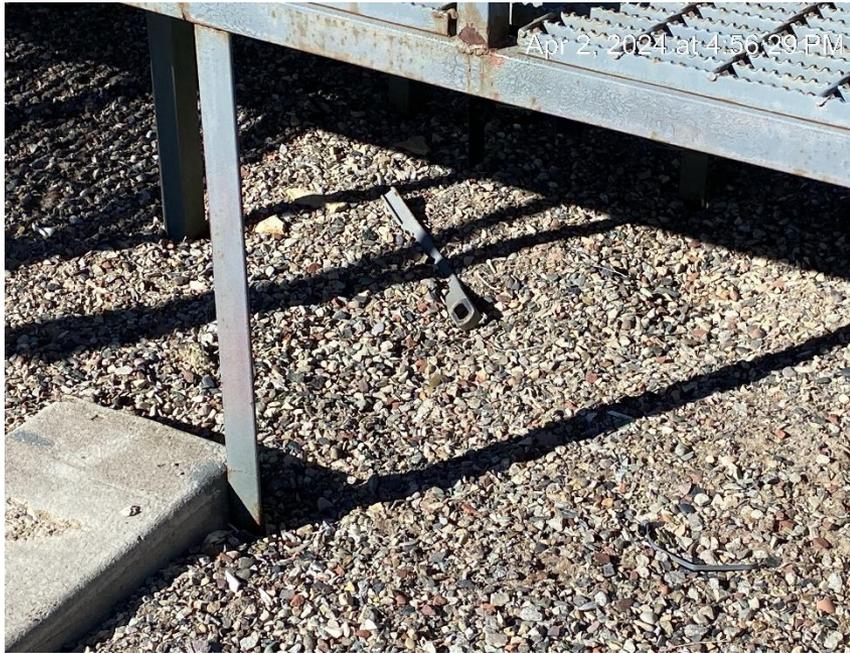
Debris

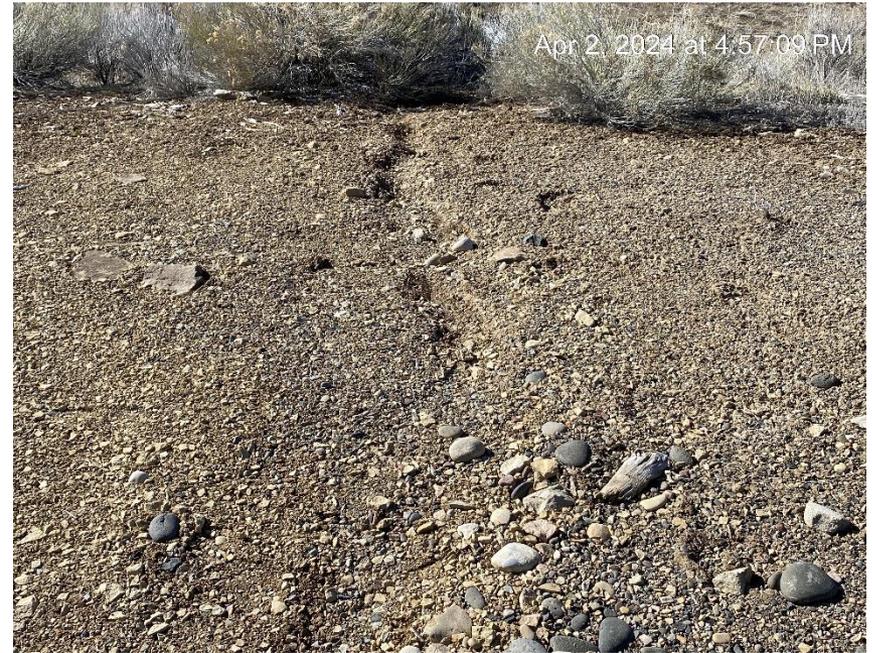
Erosion and sediment migration

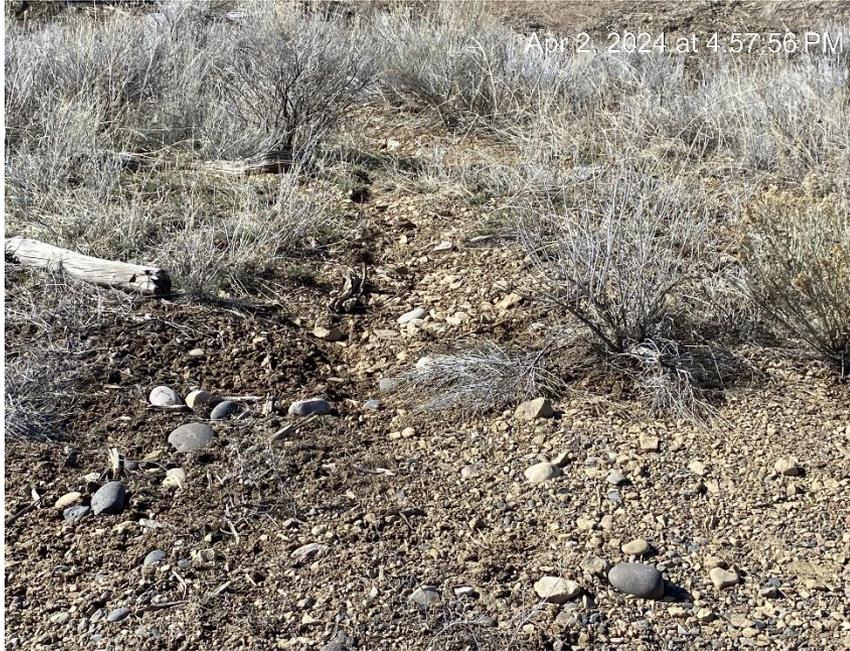
Erosion and sediment migration

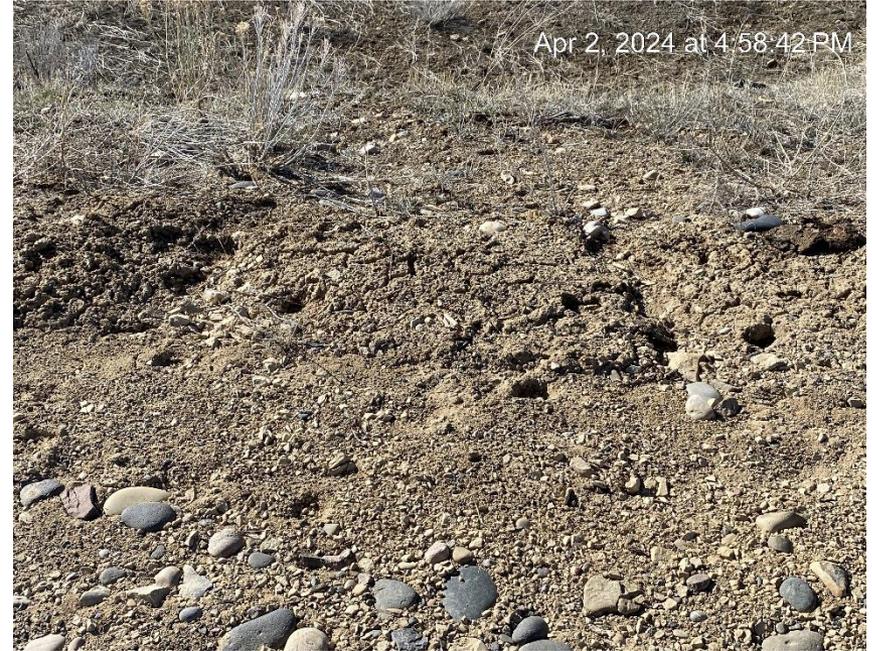
Erosion and sediment migration
