Inspection Photos
Location Name: CAERUS PICEANCE LLC RJ2 Pad
Location #: 334698

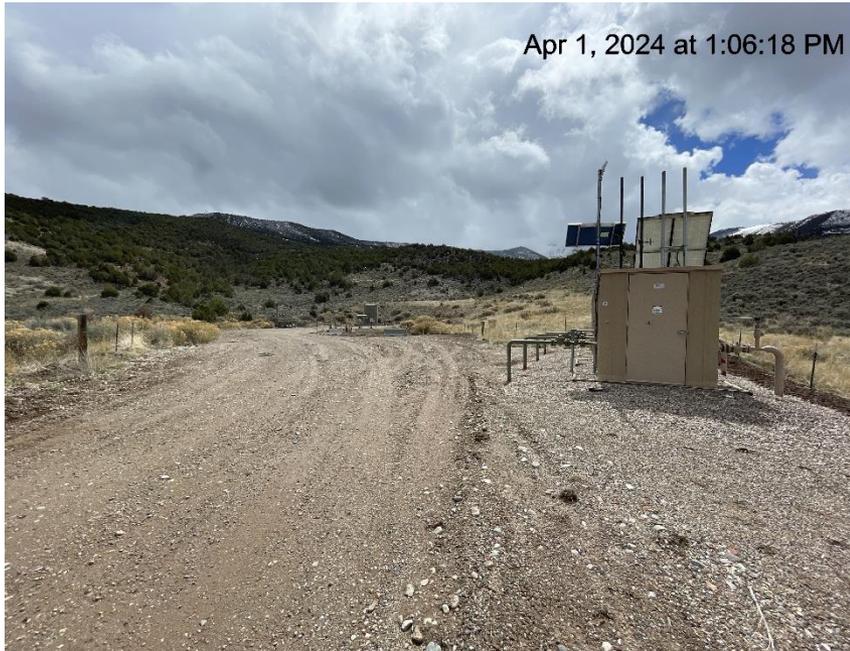
Photo # 2233 From entrance to location

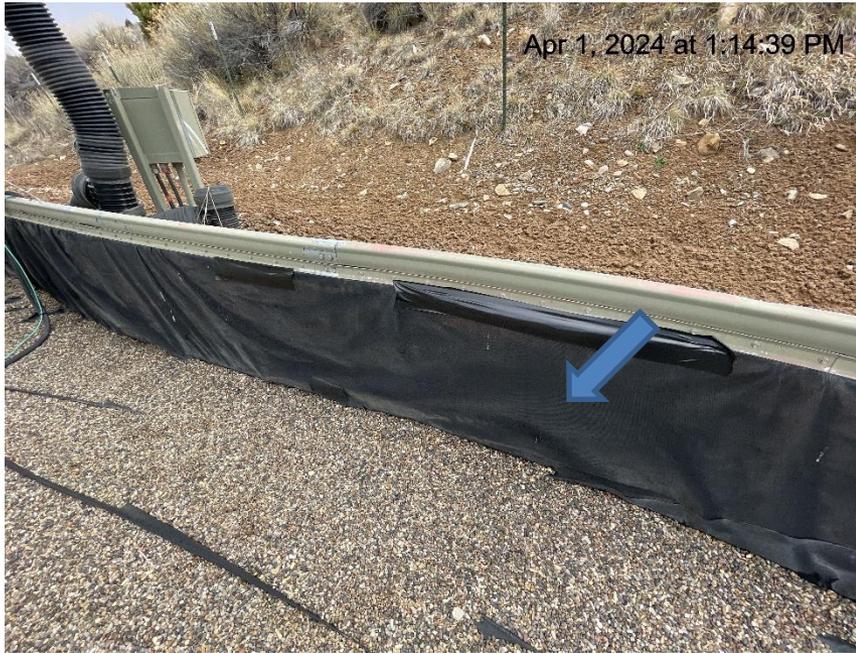
Photo # 2239 Hole in liner/liner needs maintenance

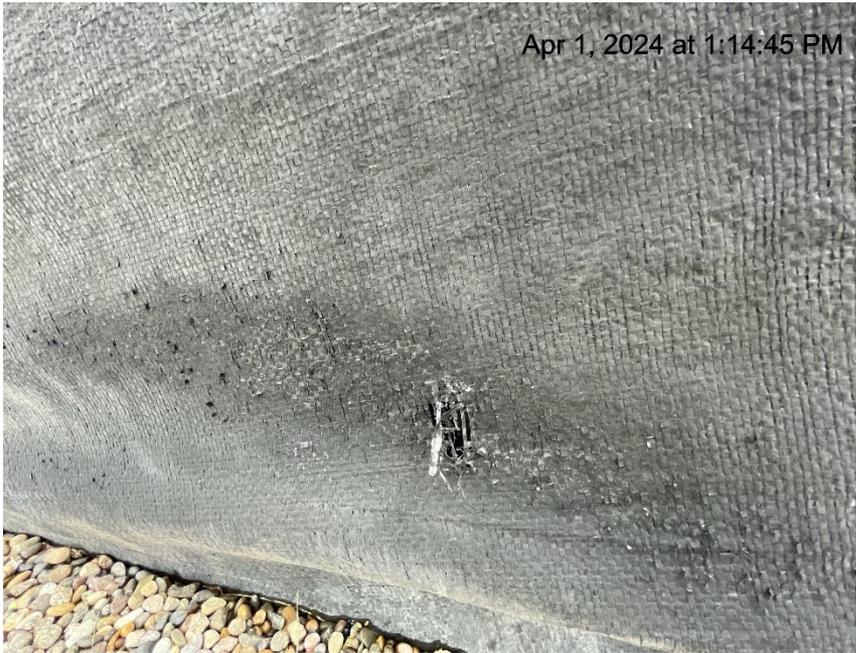
Photo # 2240 Hole in liner/liner needs maintenance & liner showing signs of deterioration

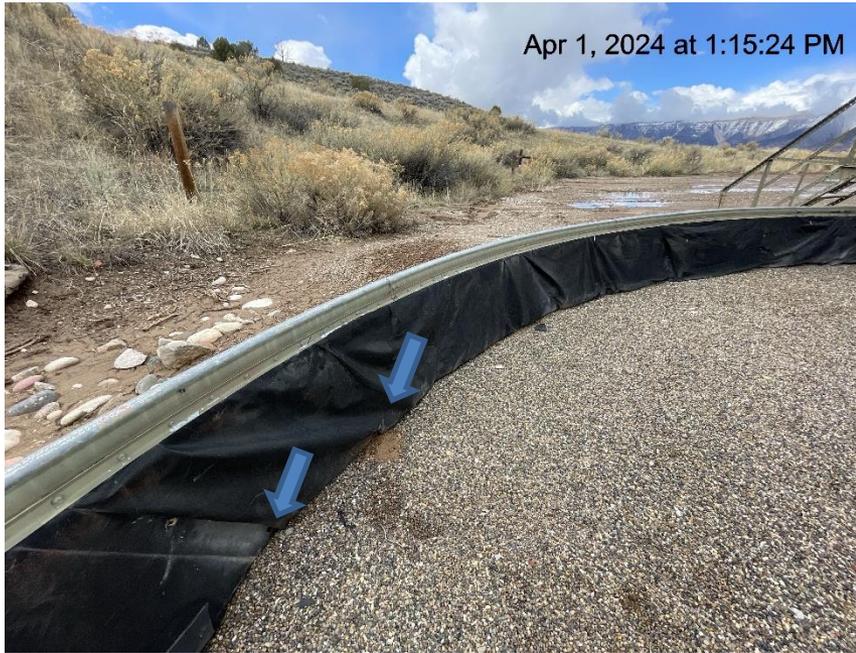
Photo # 2241 Holes in liner/liner needs maintenance

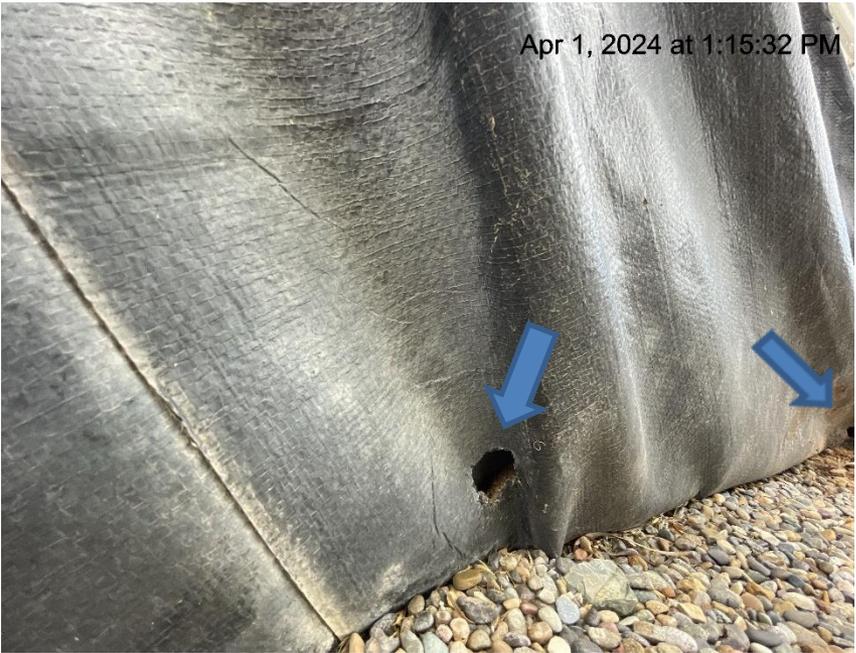
Photo # 2242 Holes in liner/liner needs maintenance

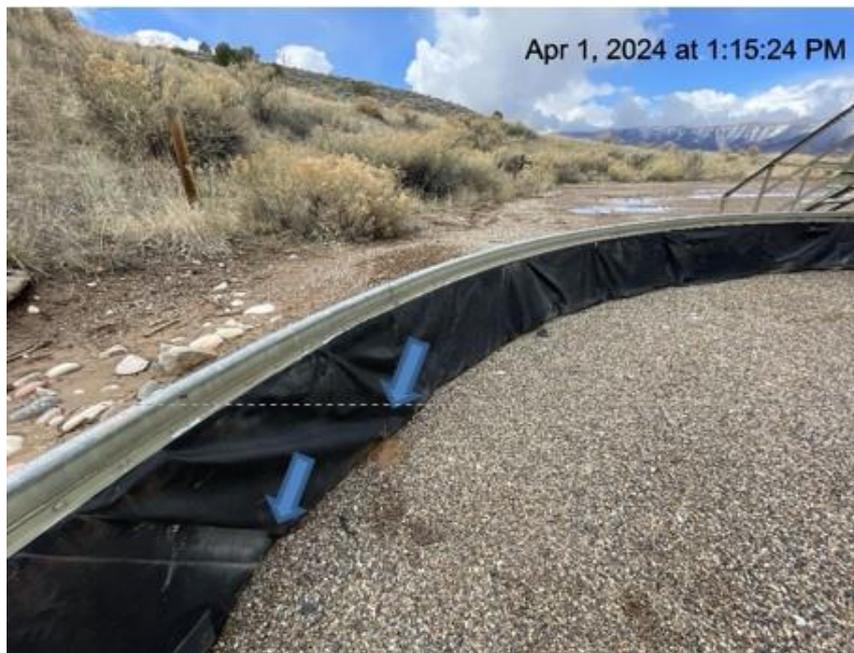
Photo # 2243 Holes in liner/liner needs maintenance

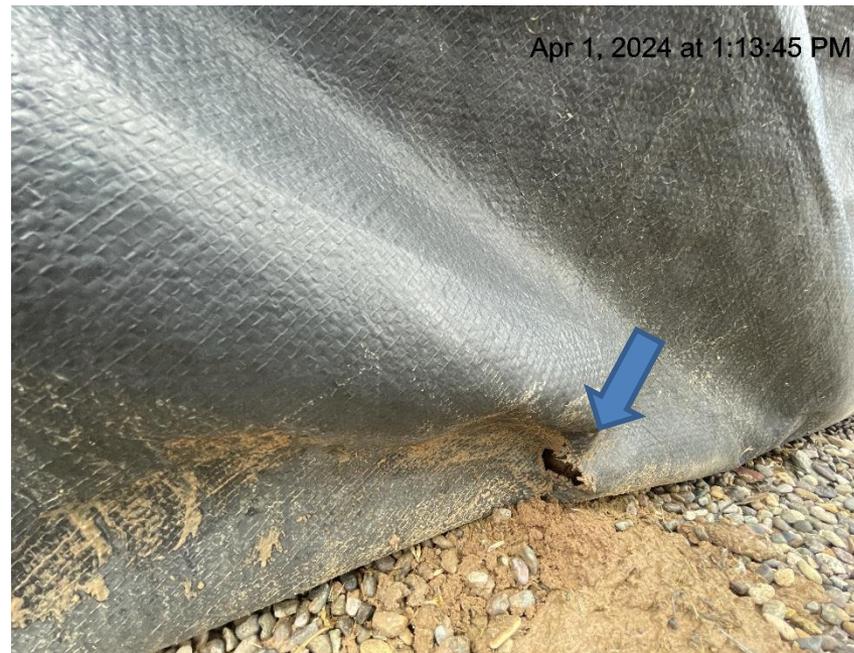
Photo # 2244 Hole in liner/liner needs maintenance

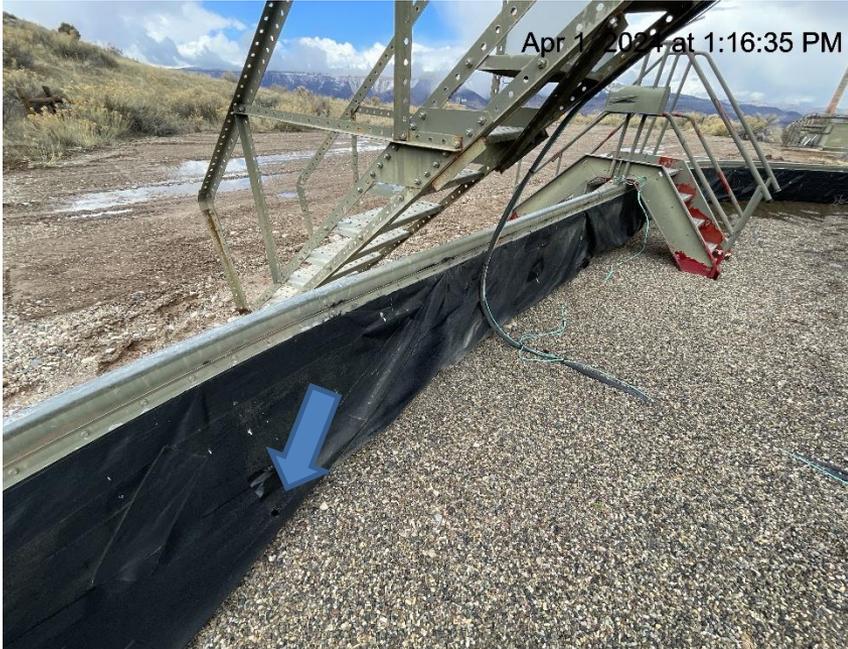
Photo # 2245 Hole in liner/liner needs maintenance

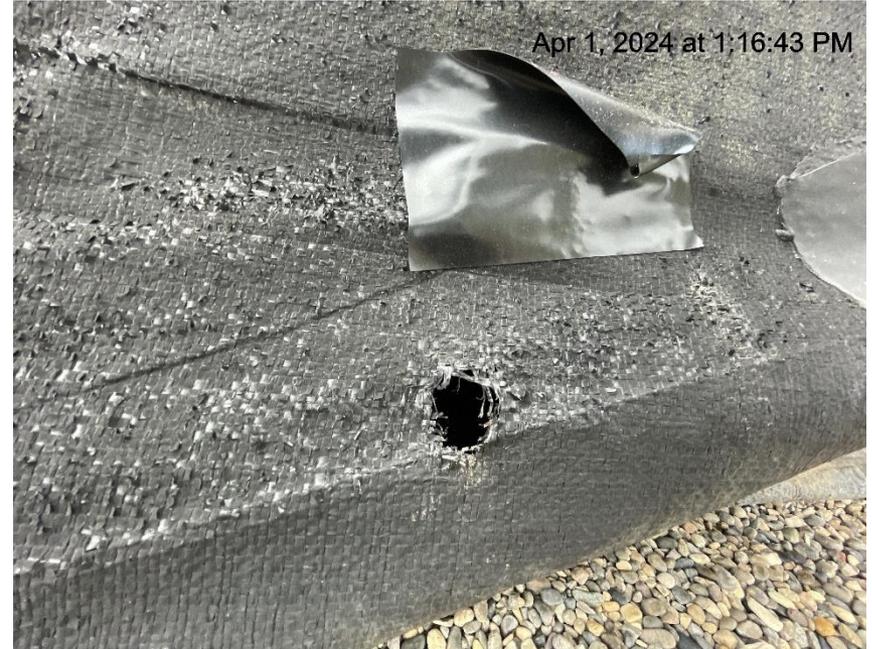
Photo # 2246 Hole in liner/liner needs maintenance & liner showing signs of deterioration
