Inspection Photos

Loc: 485654

Operator: BNL (ENTERPRISE) INC

Inspection Date: 4/2/2024

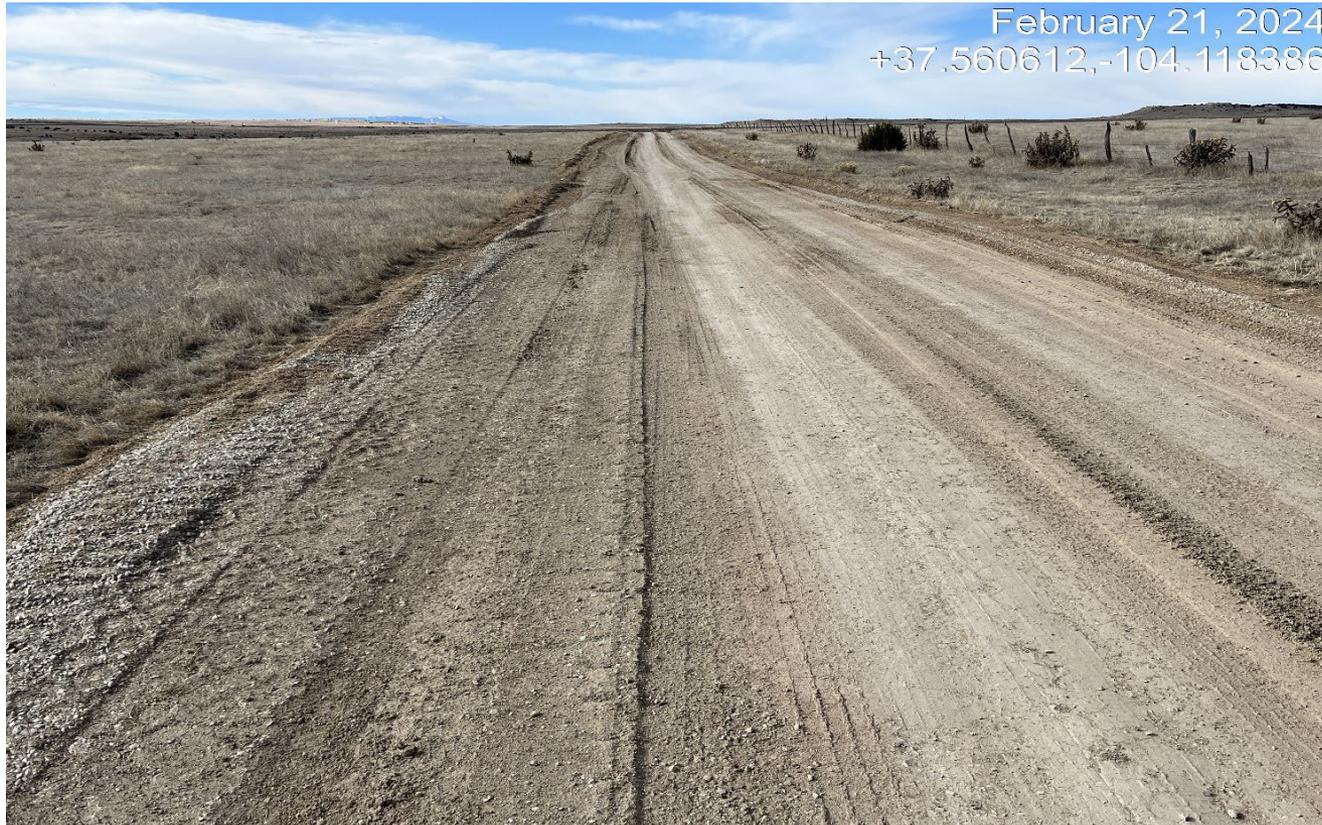
Photo 1. Facing south toward the access road. The sides of the road will need to be reclaimed. The road is not crowned and there are no ditches for stormwater which may become a problem. Previous corrective action was not completed.

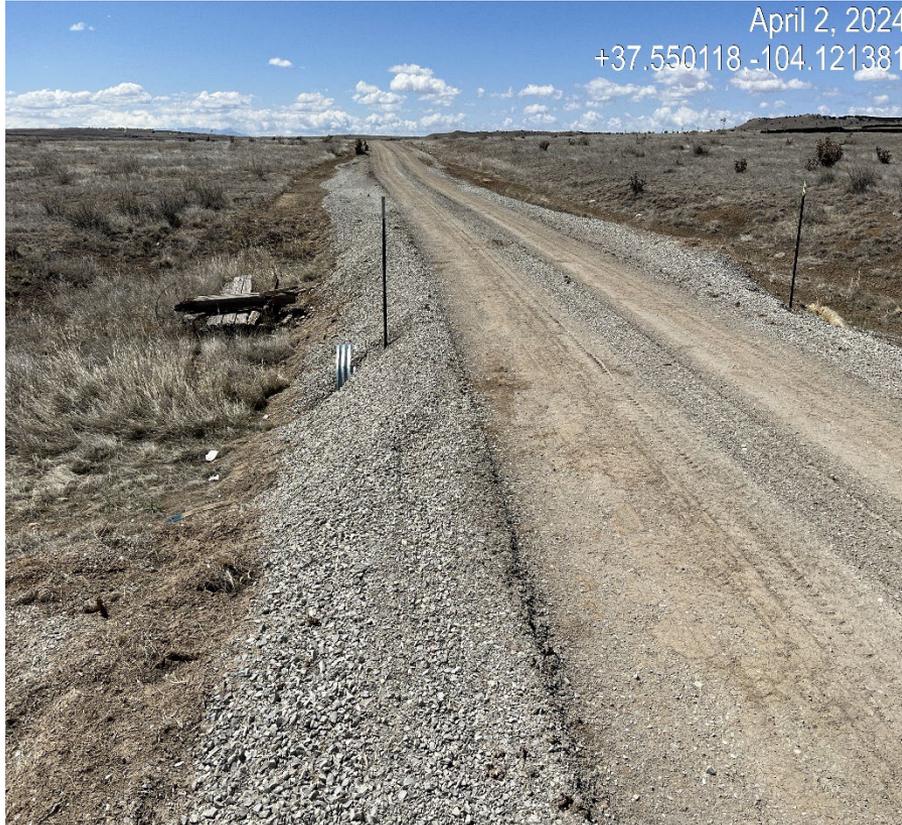
Photo 2. The drainage crossing has a large culvert but there is no outlet protection and loose gravel is falling into the culvert. Previous corrective action was not completed.

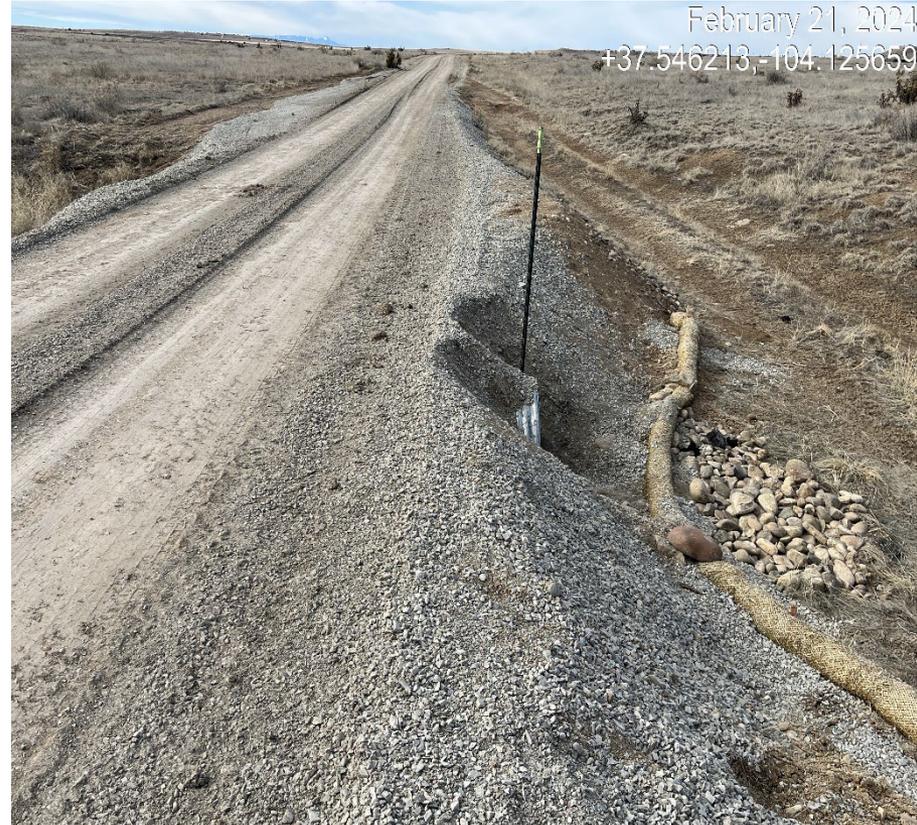
Photo 3. The embankment along the road side at the culvert is not stabilized and loose gravel is falling into the culvert.

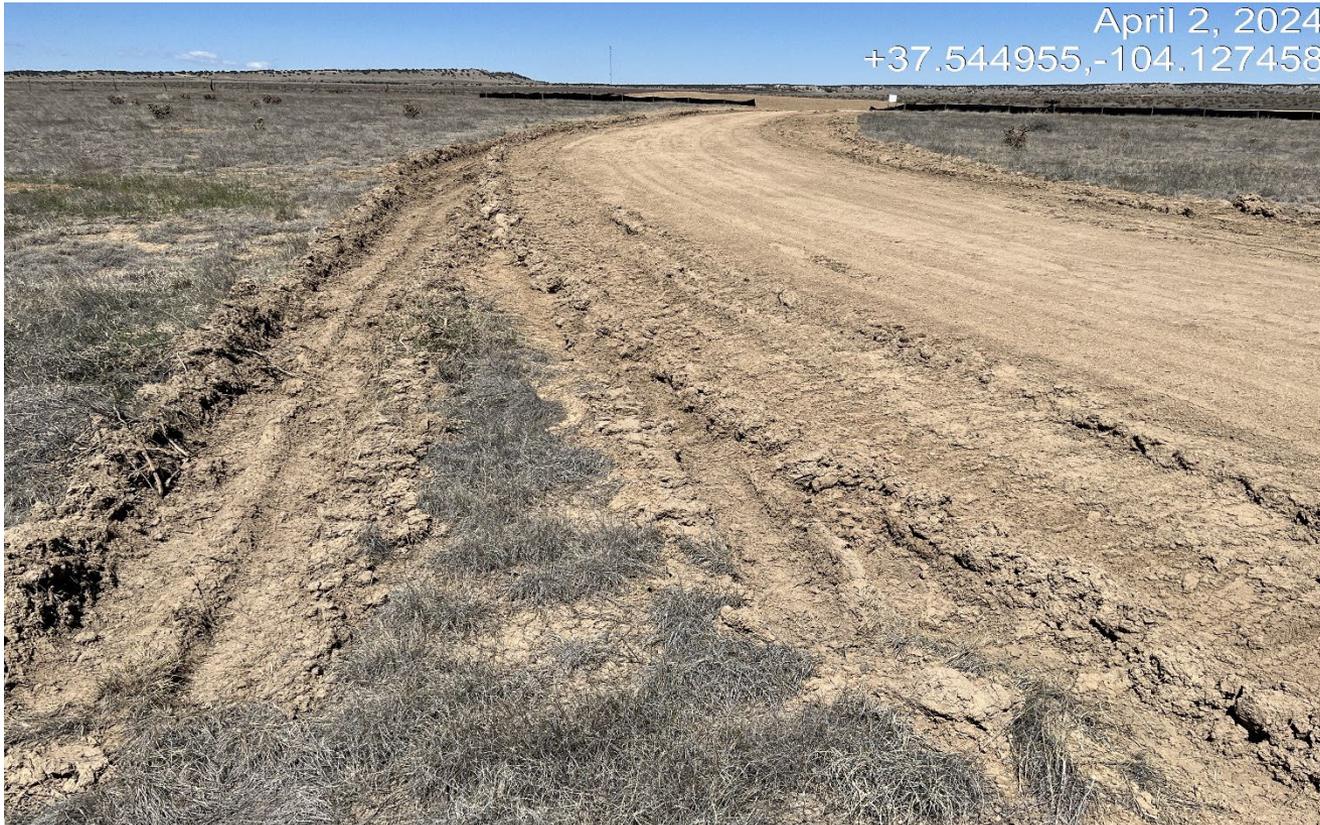
Photo 3. Facing northwest toward the access road. The side of the road needs to be seeded and stabilized and the road needs to be crowned and graveled. Previous corrective action was not completed.

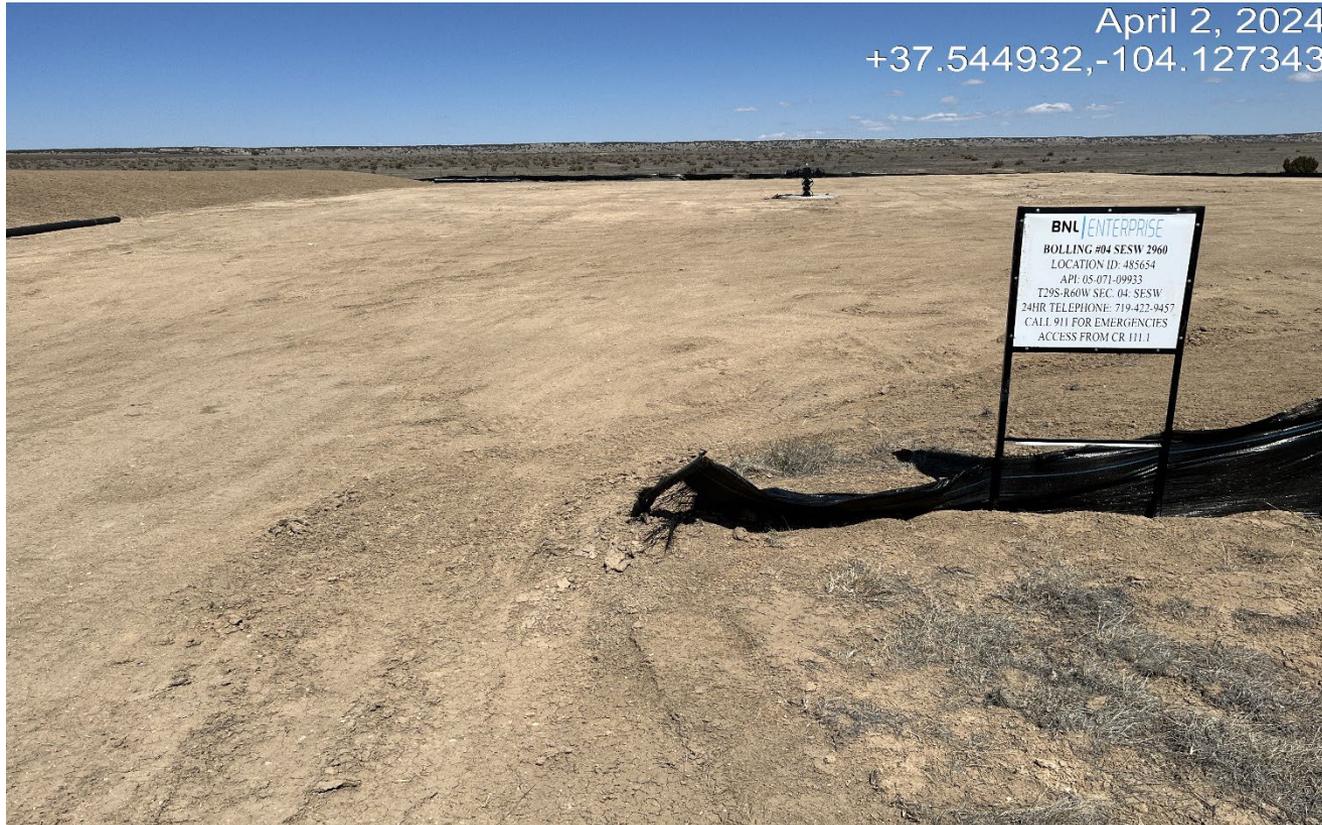
Photo 4. Facing northwest toward the location. Sign posted at entrance.

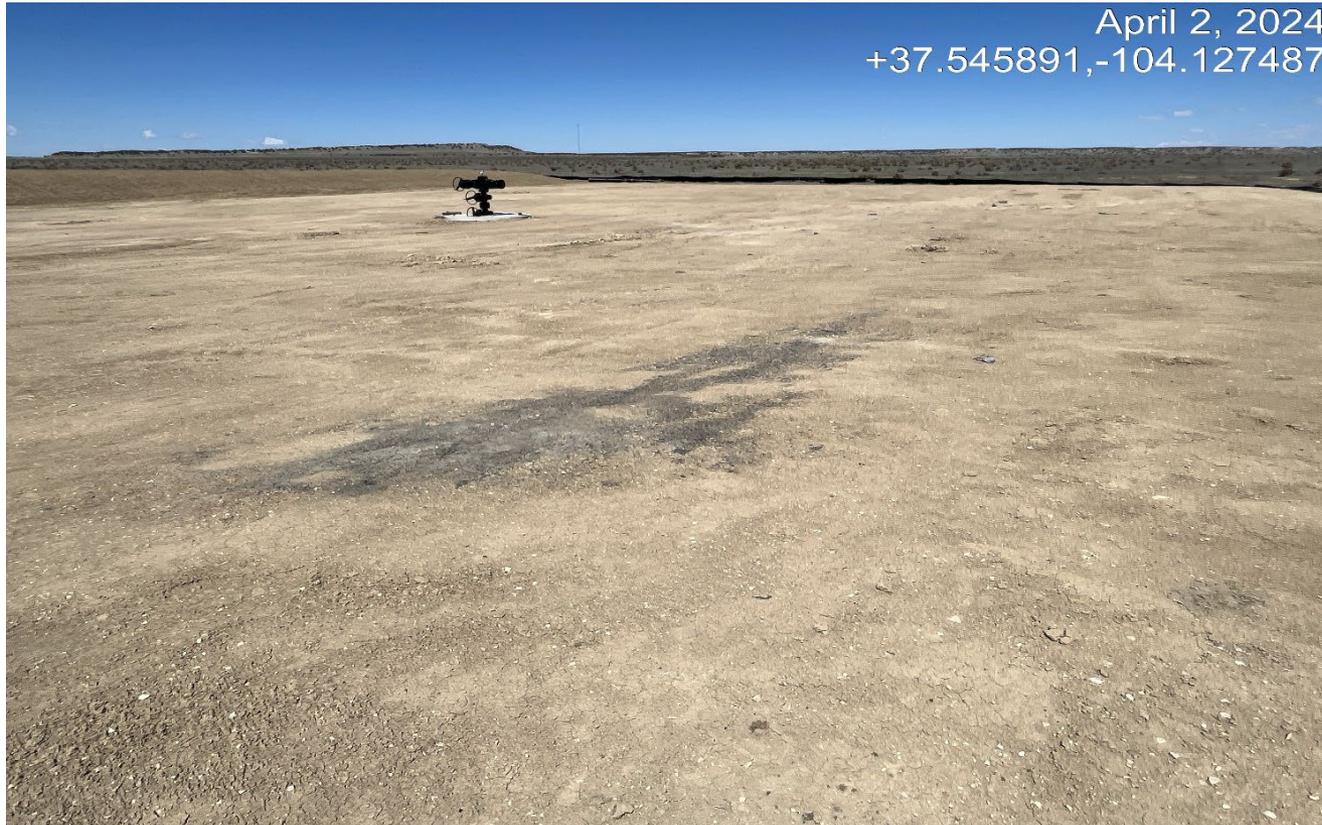
Photo 5. Facing toward the drilled well. The drill cuttings have been removed.

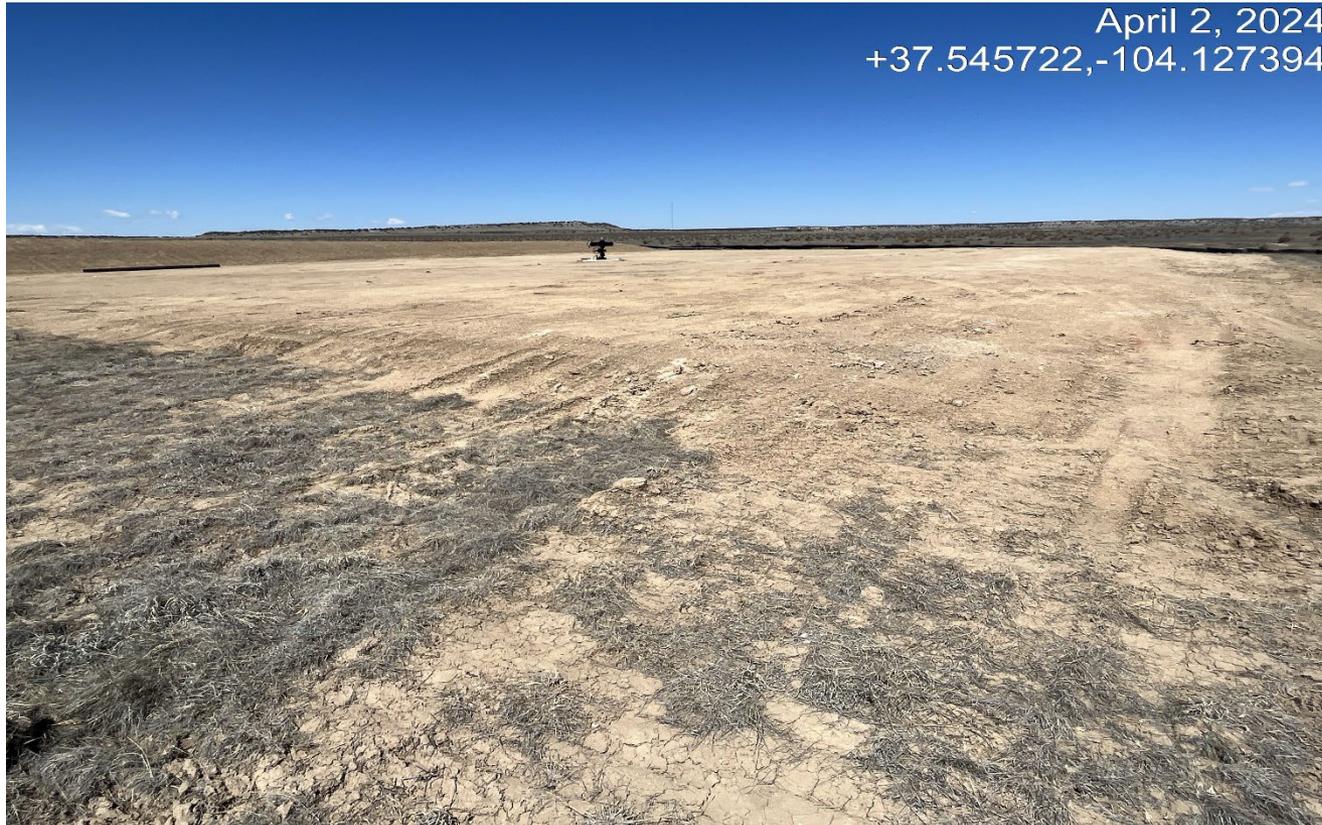
Photo 6. Facing west at the corner of the location. Unused areas of the location will need to be recontoured and reclaimed with 6 moths of drilling.

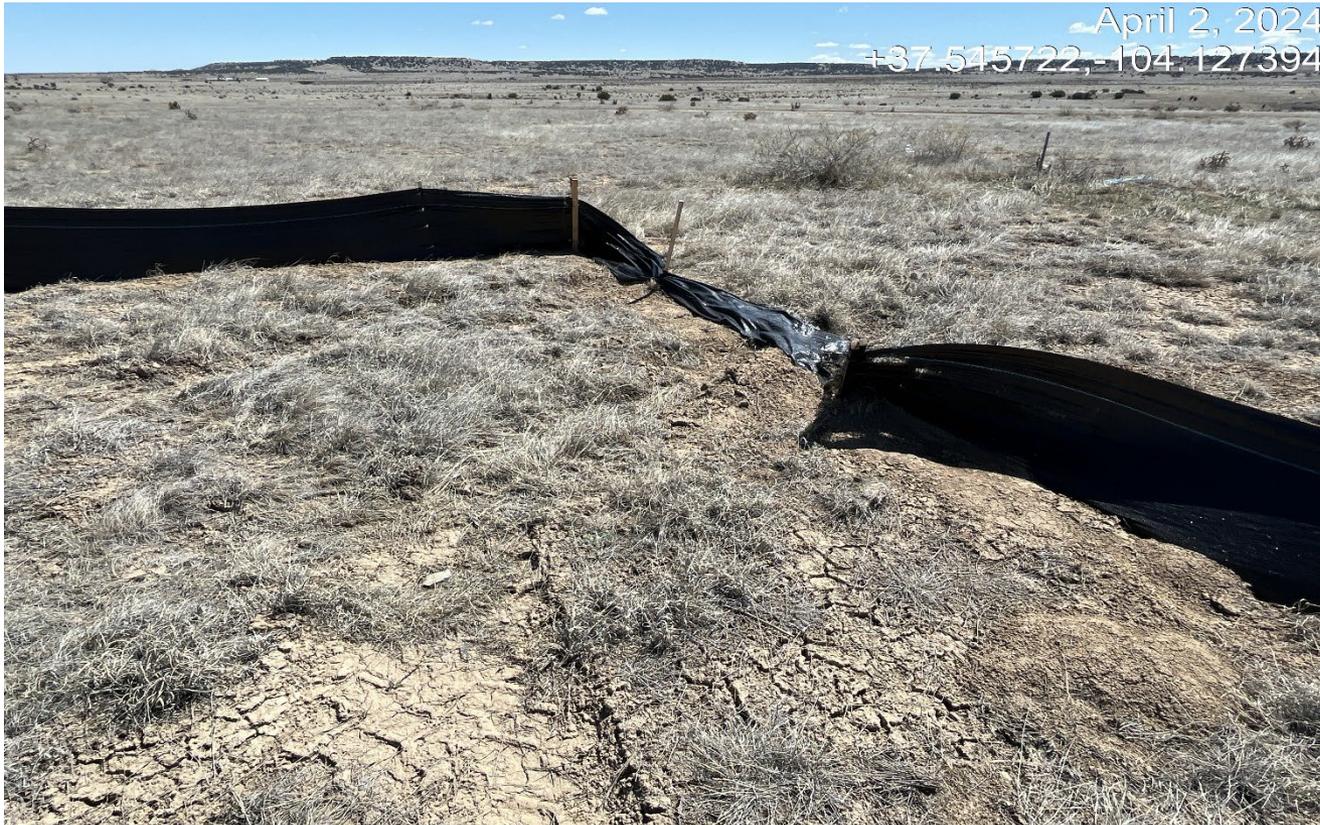
Photo 7. There are several areas where the silt fence is not maintained. Previous corrective was not completed.

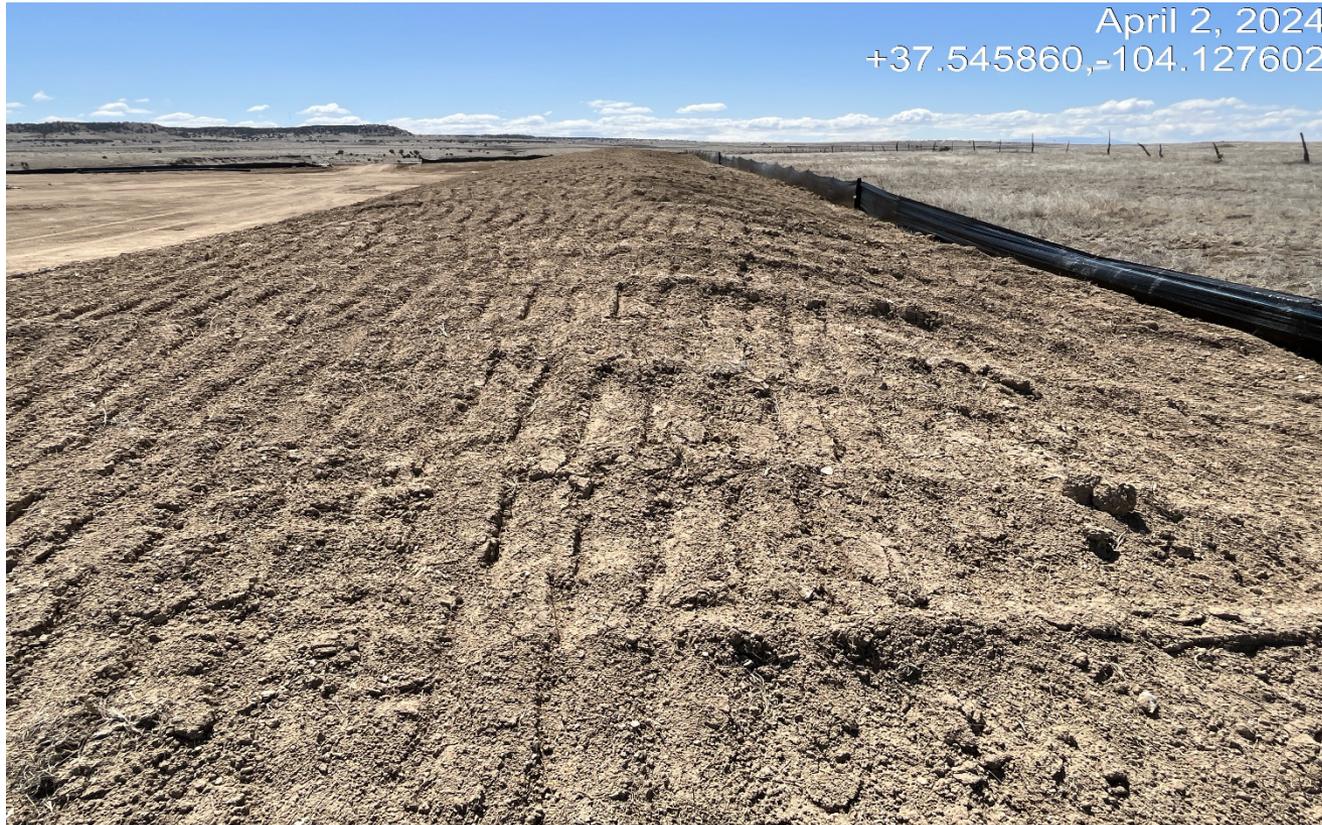
Photo 8. Facing toward the soil stock pile. The stock pile will need to be seeded before the growing season unless it will be re-spread for reclamation before that time.

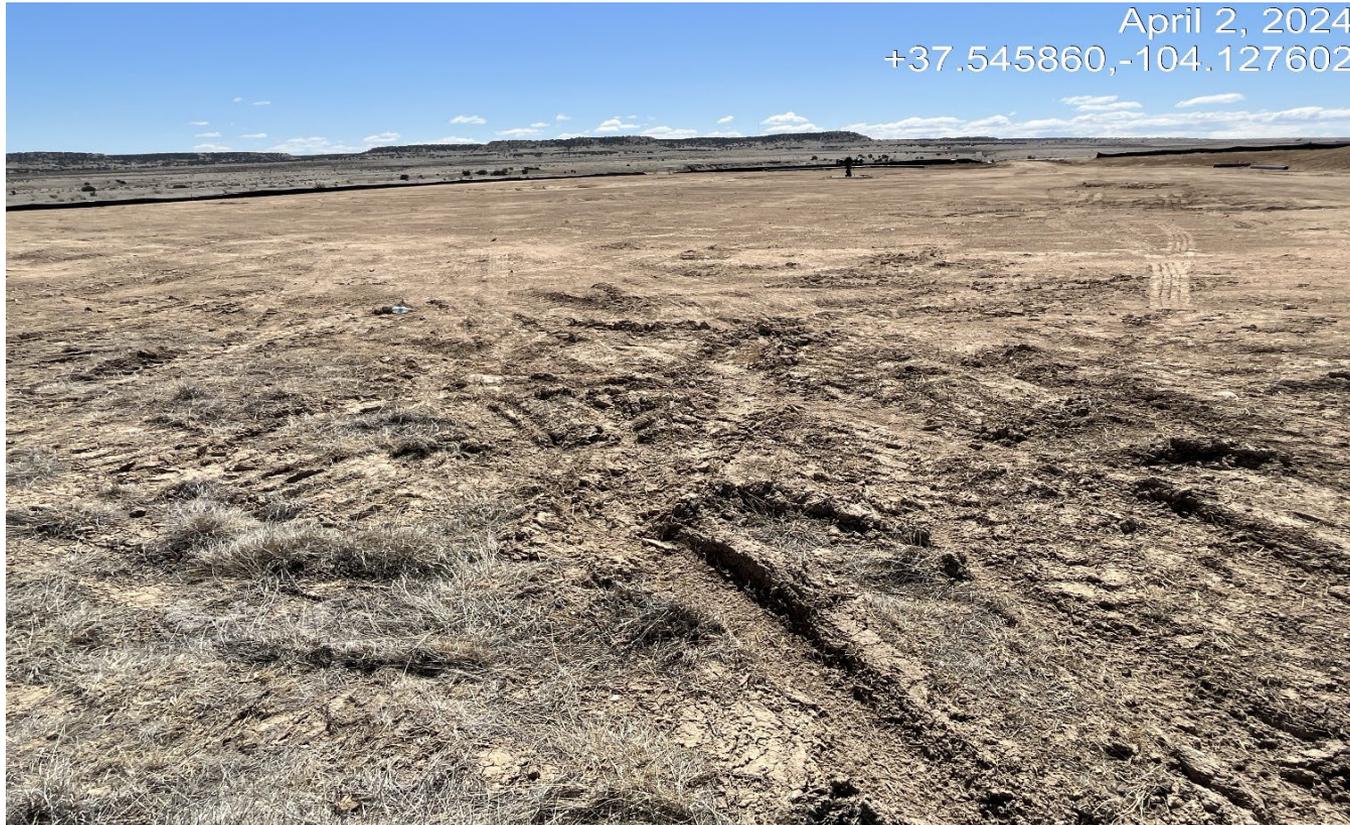
Photo 9. Facing east at the corner of the location. Unused areas of the location will need to be recontoured and reclaimed with 6 months of drilling.

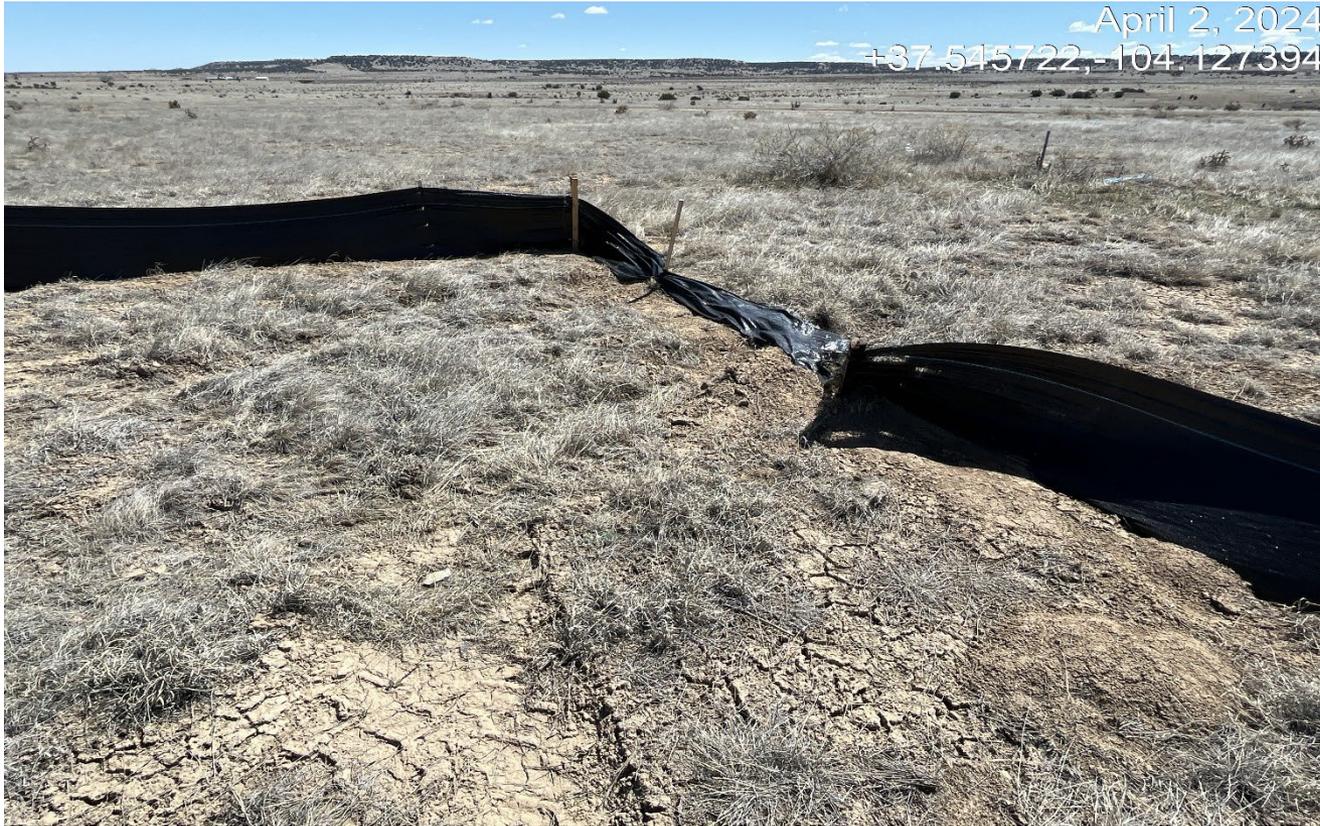
Photo 10 There are several area where the silt fence is not maintained. Previous corrective action was not completed.
