# Construction and Stormwater Inspection

Date: 03/29/2024

Operator: KERR MCGEE OIL & GAS ONSHORE LP -  
47120

Location ID: 485056

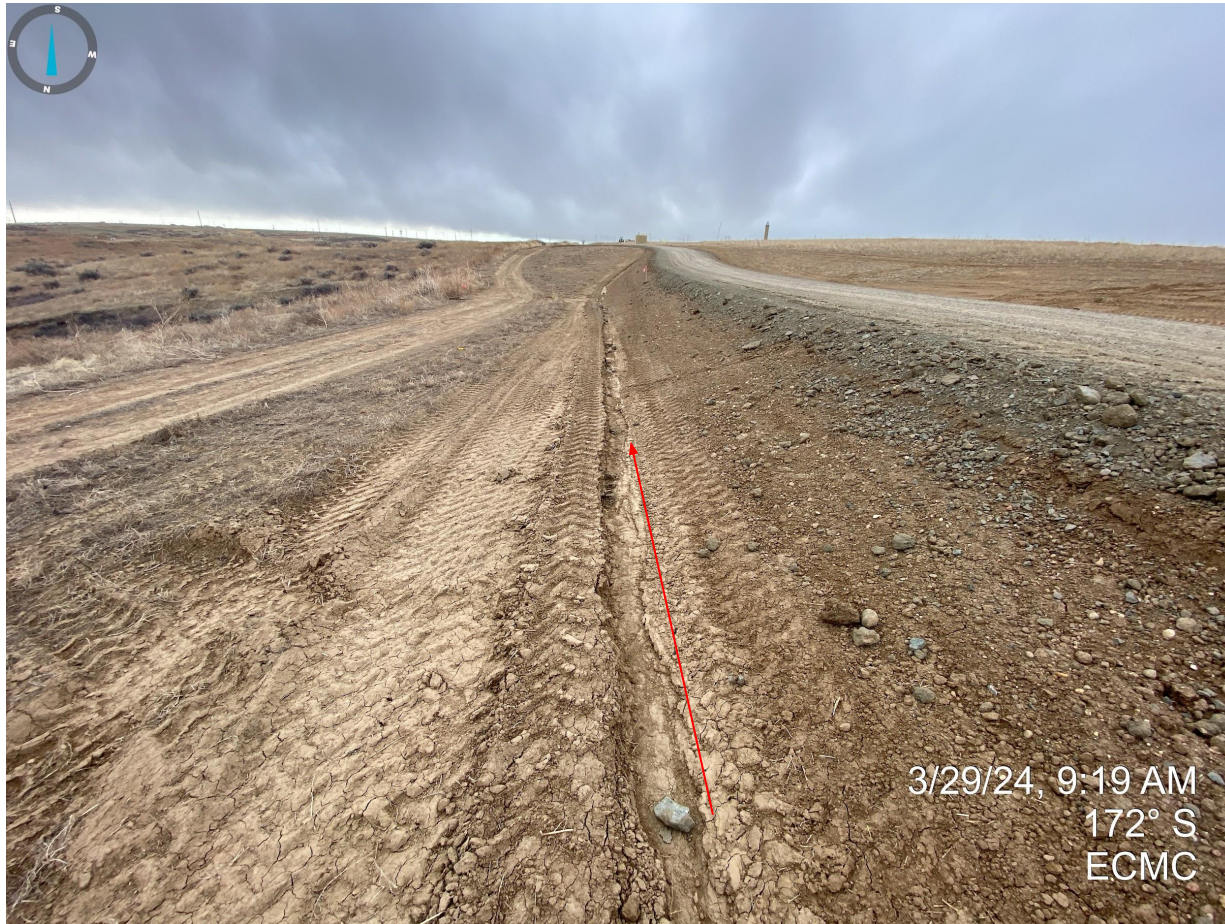
**Photo 1.** Erosion degradation (riling) occurring along the new access road.

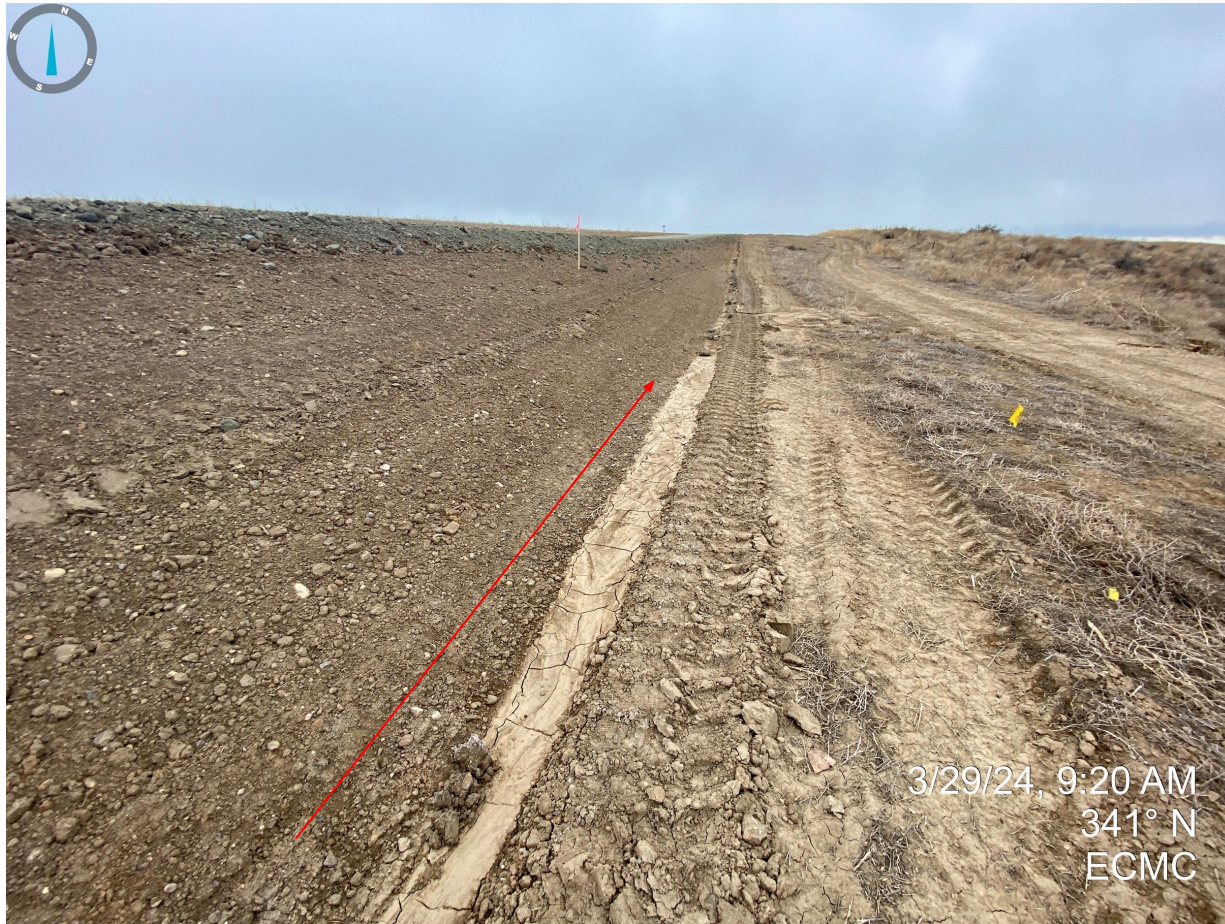
**Photo 2.** Erosion degradation (riling) and sediment deposition occurring along the new access road.

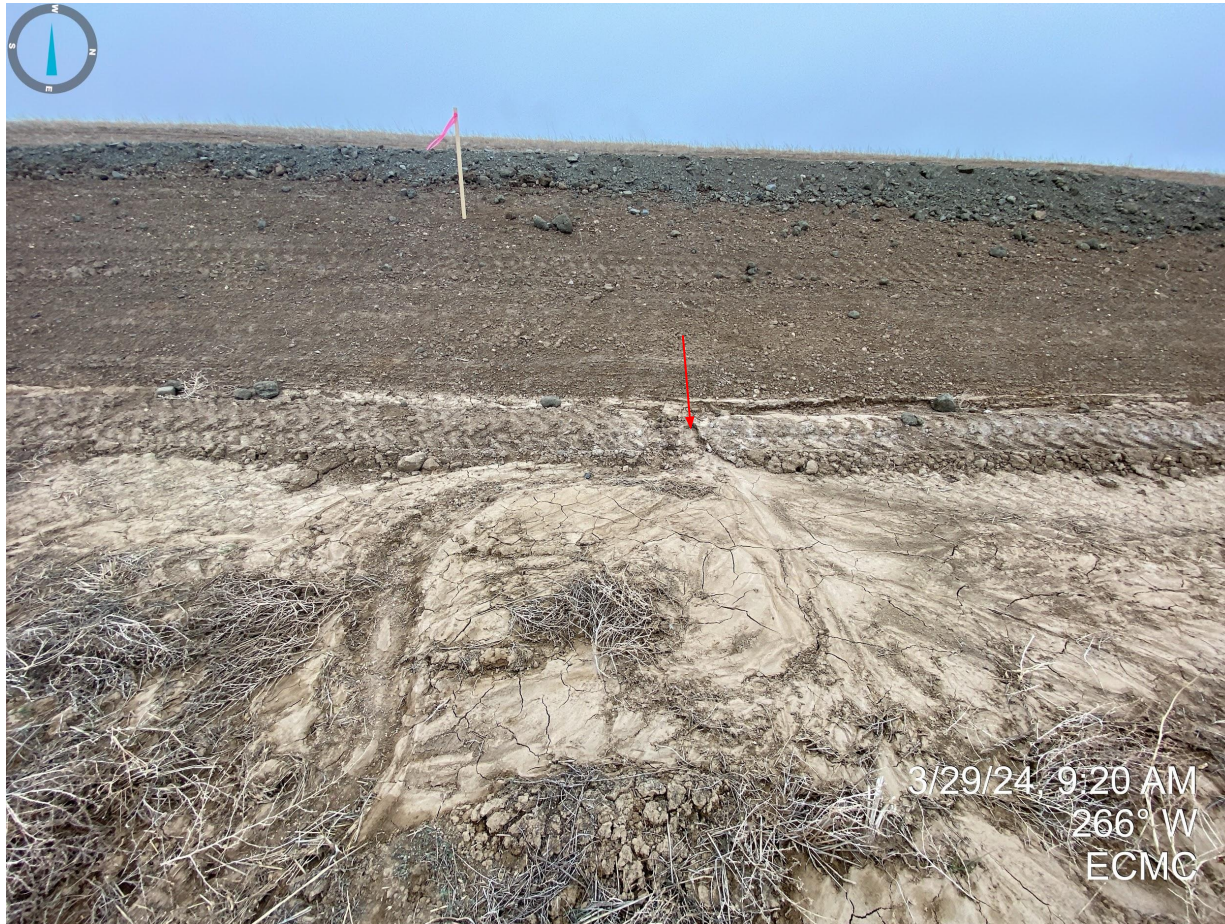
**Photo 3.** Sediment deposition observed on the east side of the new access road.

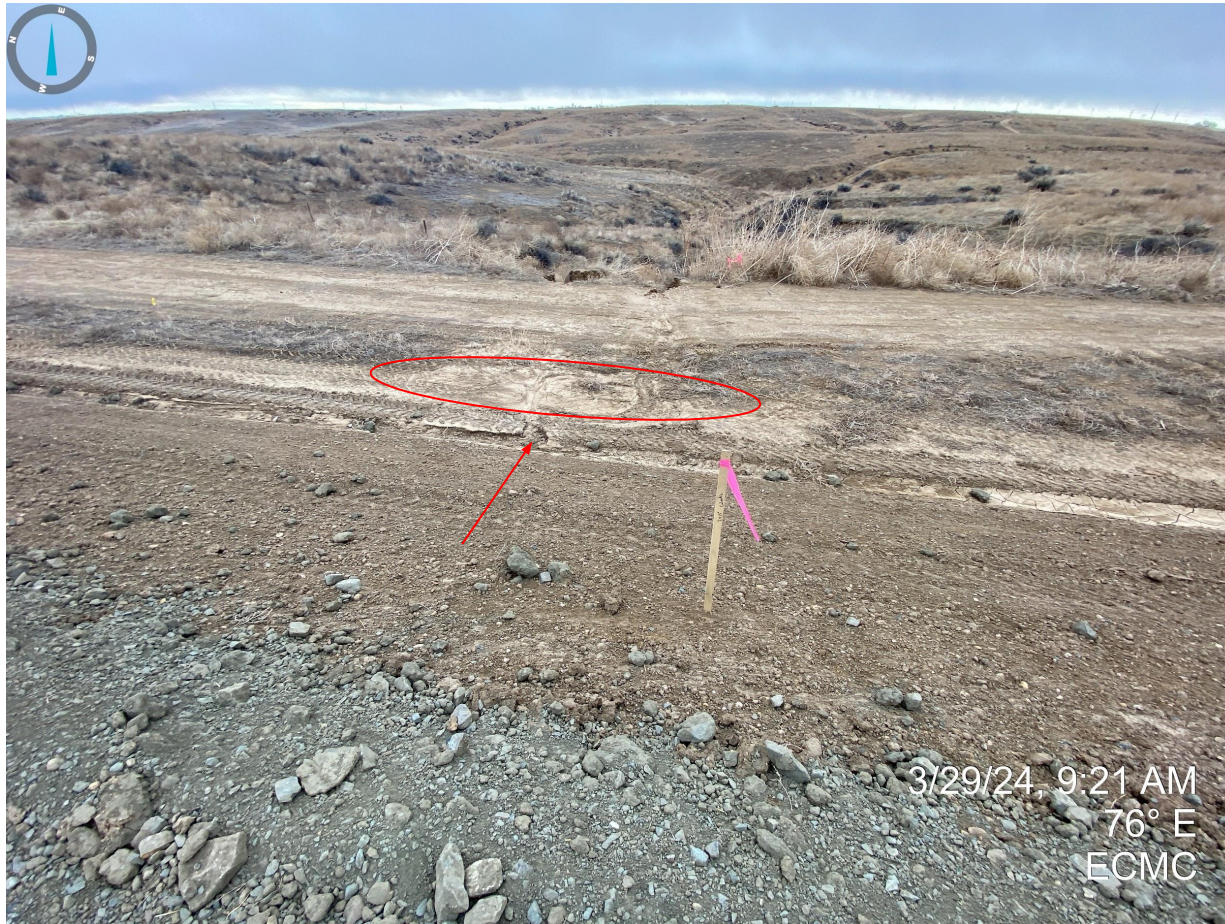
**Photo 4.** Sediment deposition observed on the east side of the new access road.

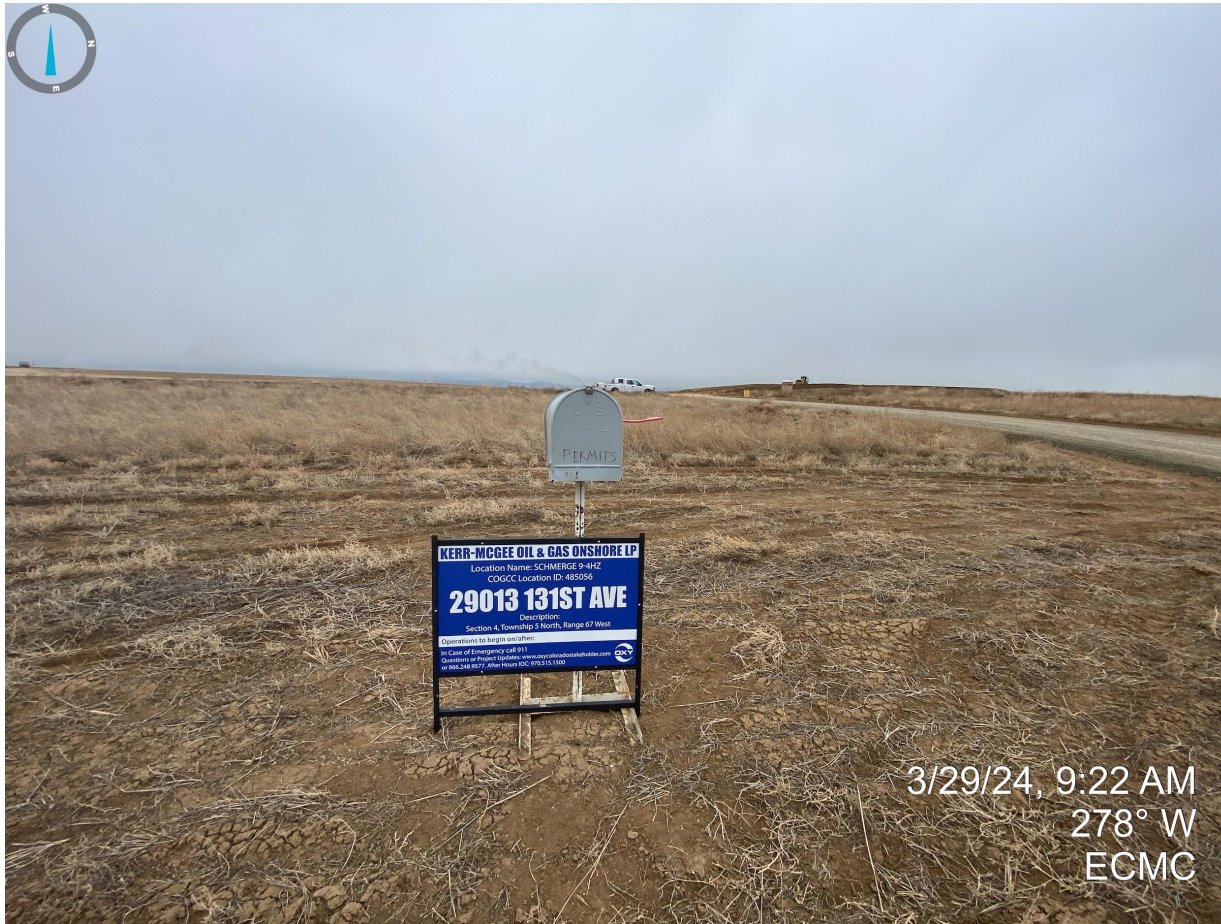
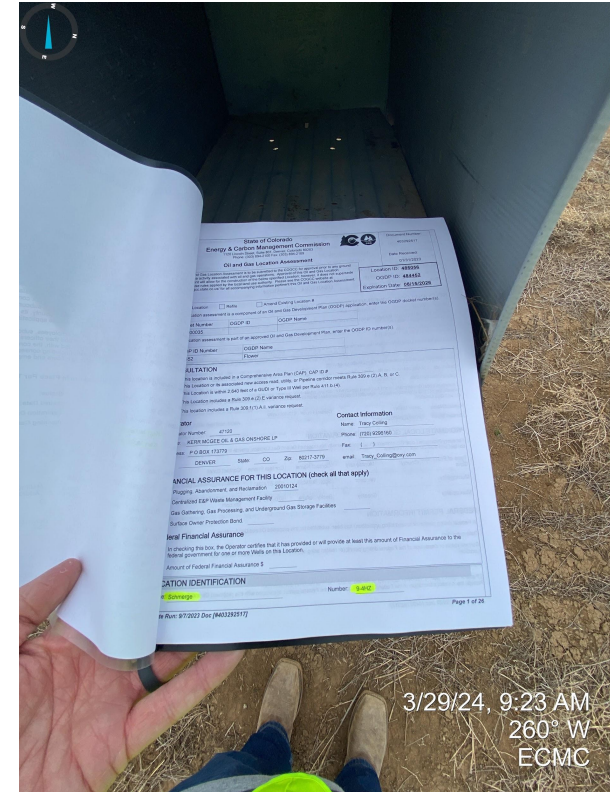
Photo 5. Form 2A was posted on location near the entrance.

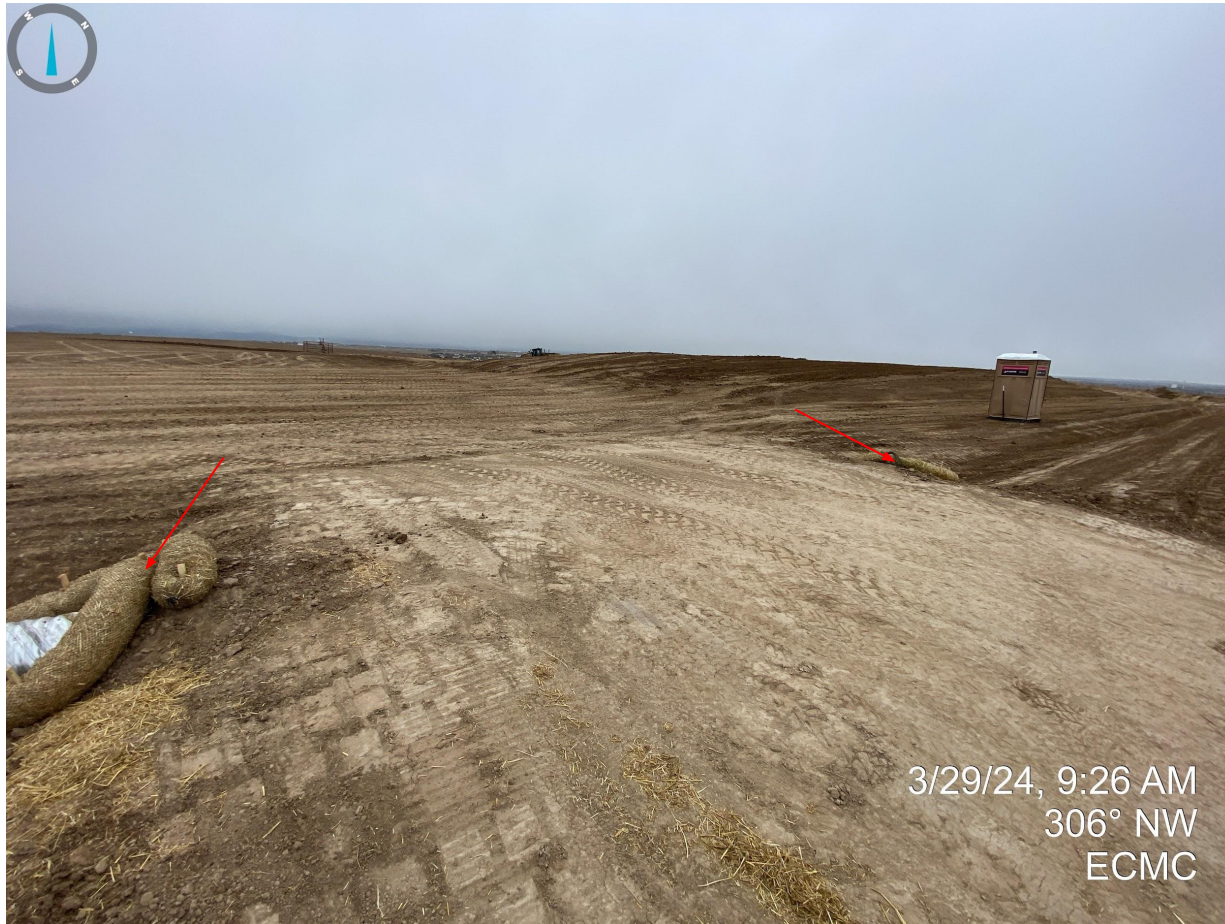
**Photo 6.** Temporarily stabilized inlets/outlets at culvert crossings observed at the location entrance.

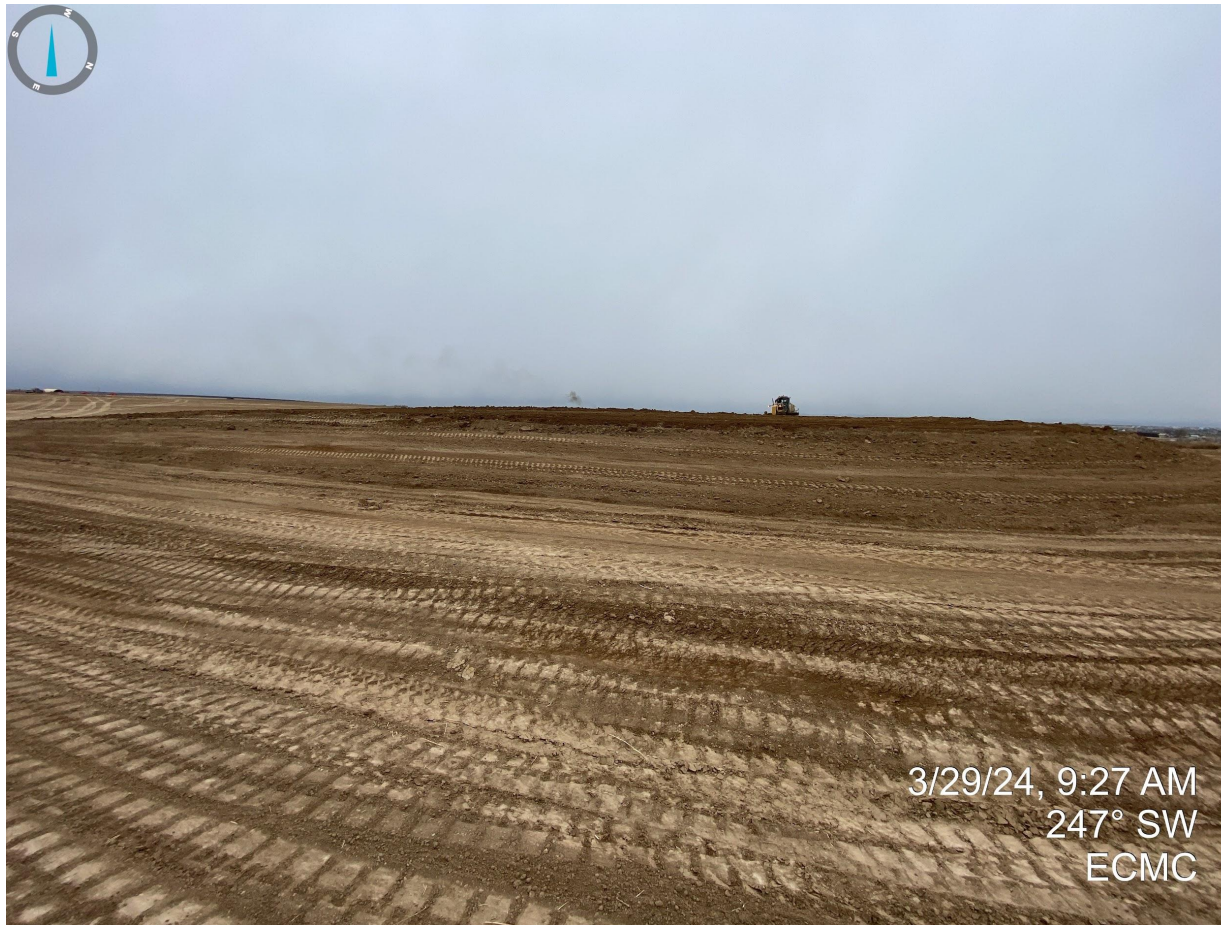
**Photo 7.** Taken near the northeast corner of the disturbance area. Photo illustrates the topsoil stockpile on the northern end of the location; crews were actively salvaging topsoil at the time of this inspection.

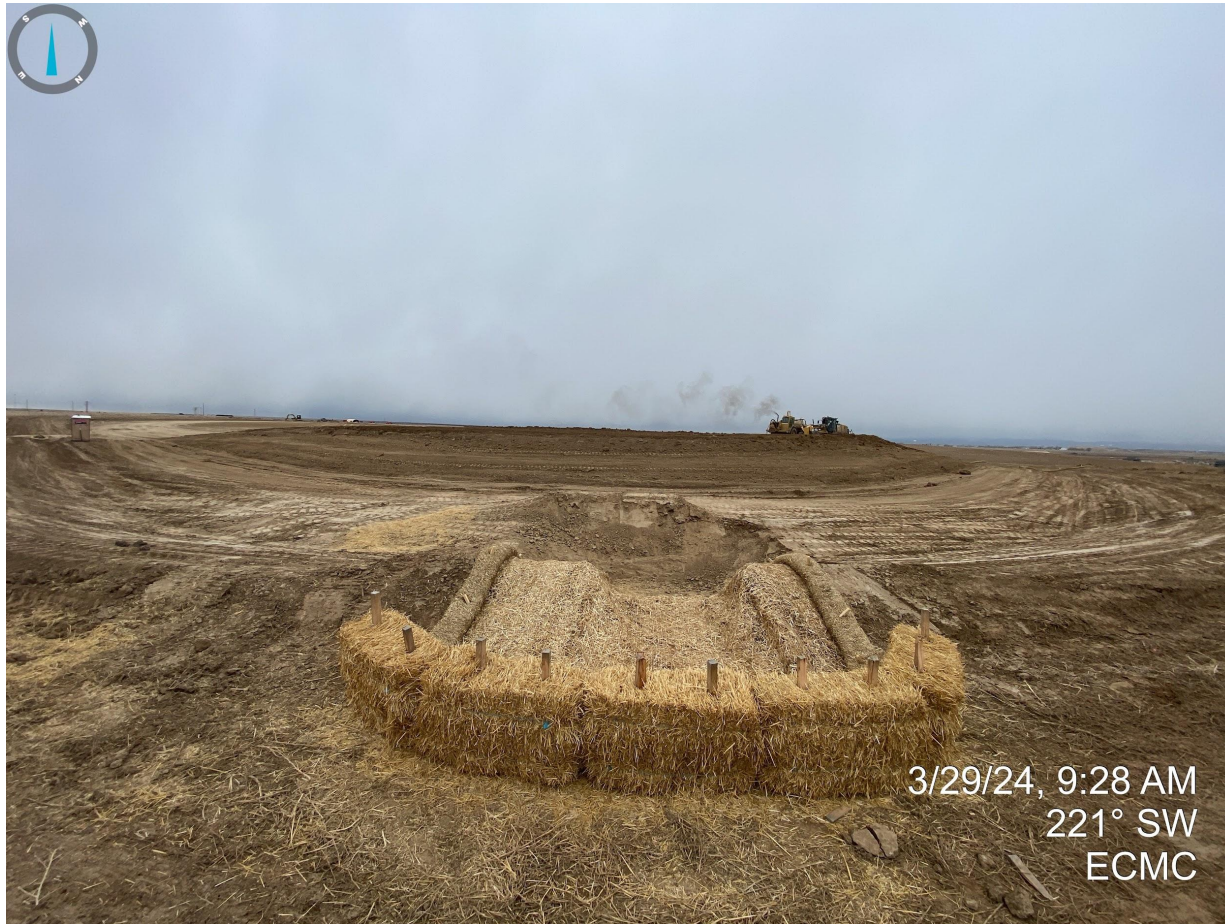
**Photo 8.** Taken near the northeast corner of the disturbance area. Photo illustrates a sediment trap with temporarily stabilized outlet protections.

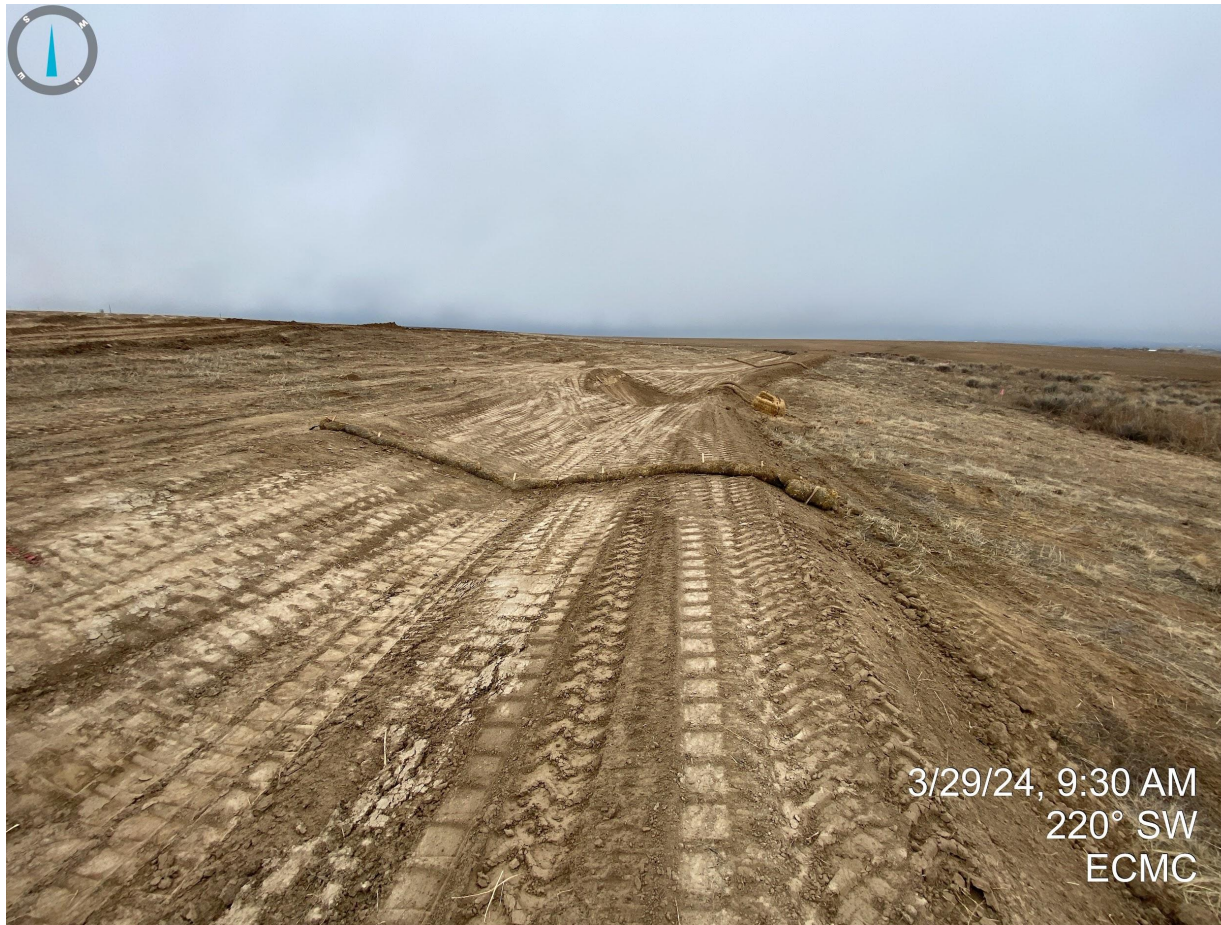
**Photo 9.** Taken along the northern perimeter of the construction area. A perimeter ditch and berm has been installed along the entire perimeter of the location with velocity checks (straw wattles) installed along gradients.

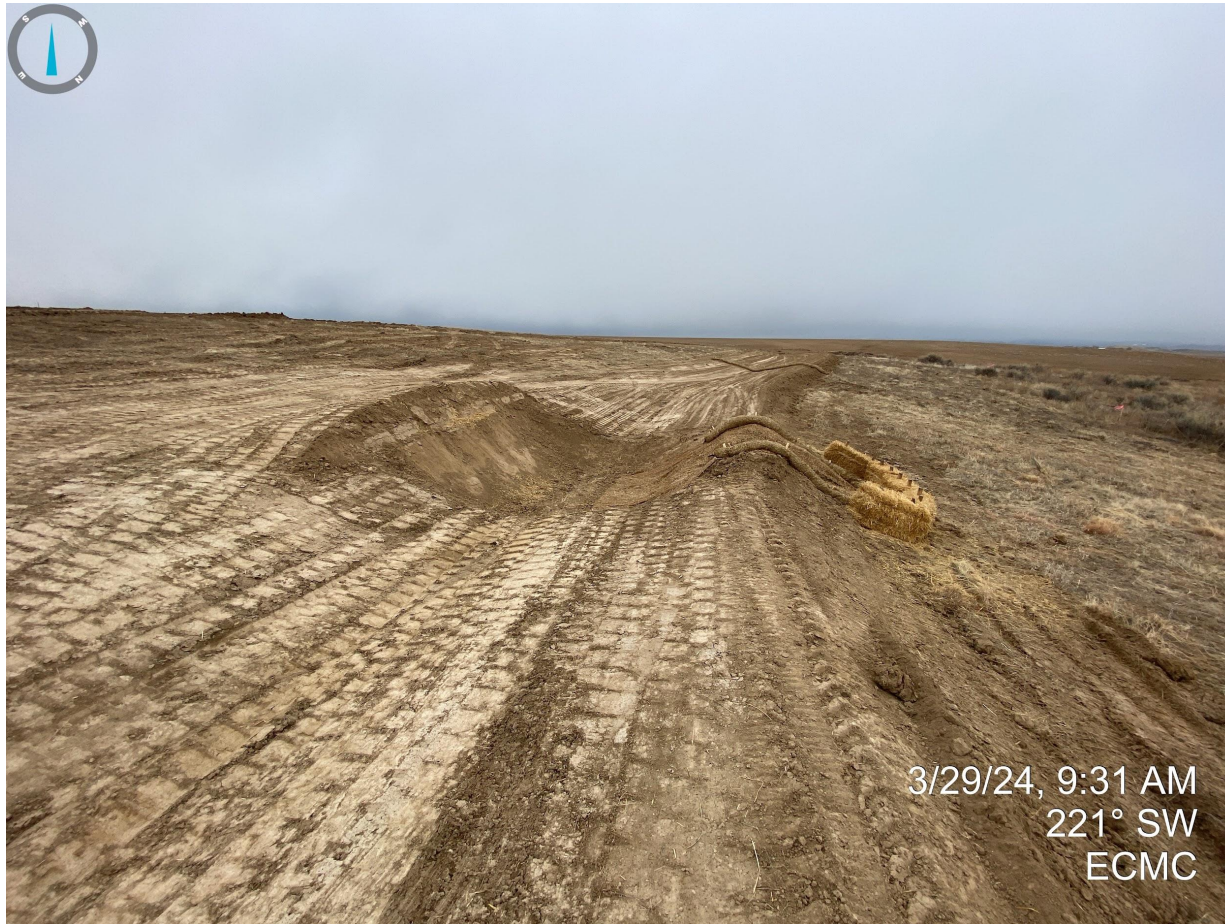
**Photo 10.** Taken near the northern portion of the disturbance area. Photo illustrates a sediment trap with temporarily stabilized outlet protections.

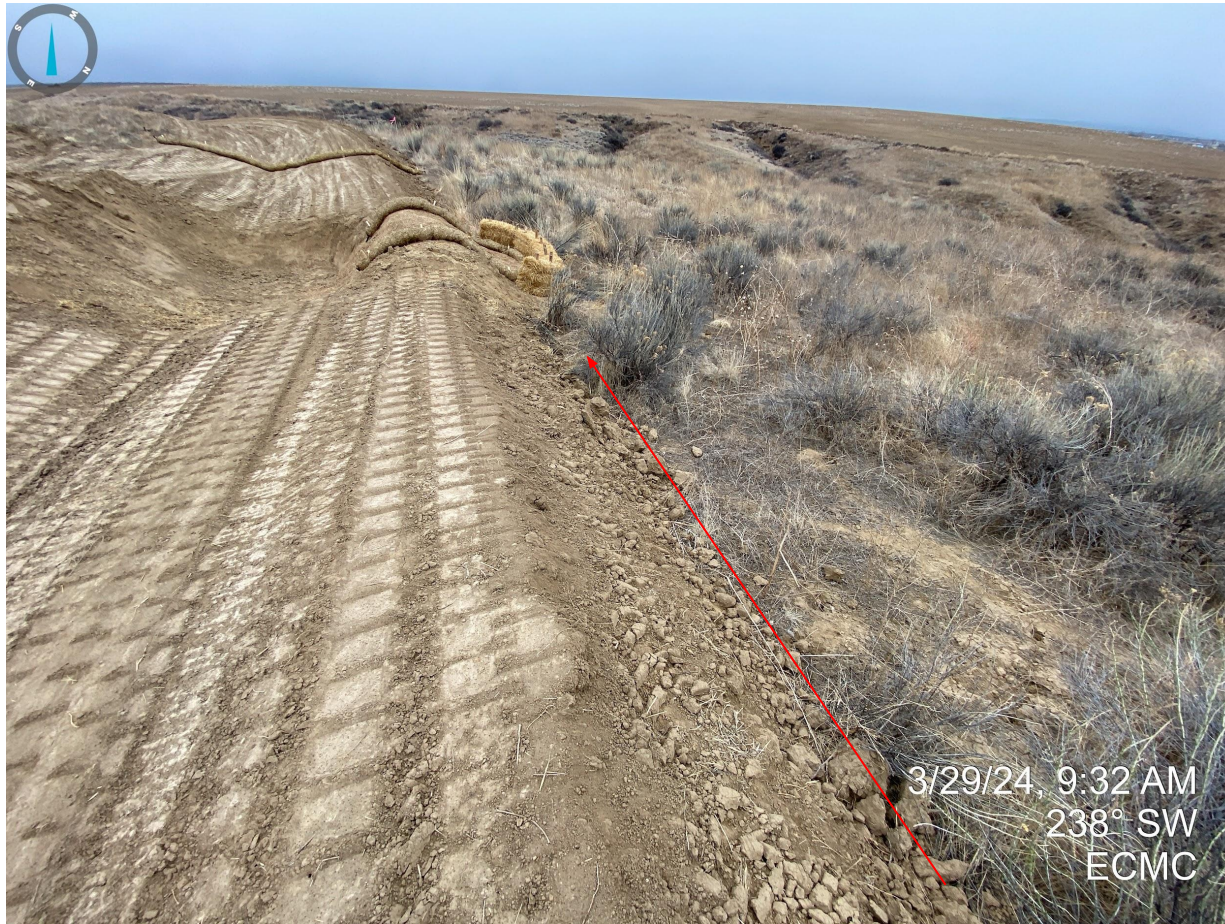
**Photo 11.** Taken near the northern portion of the disturbance area. Portions of the perimeter berm appear to be unconsolidated and require additional stabilization.

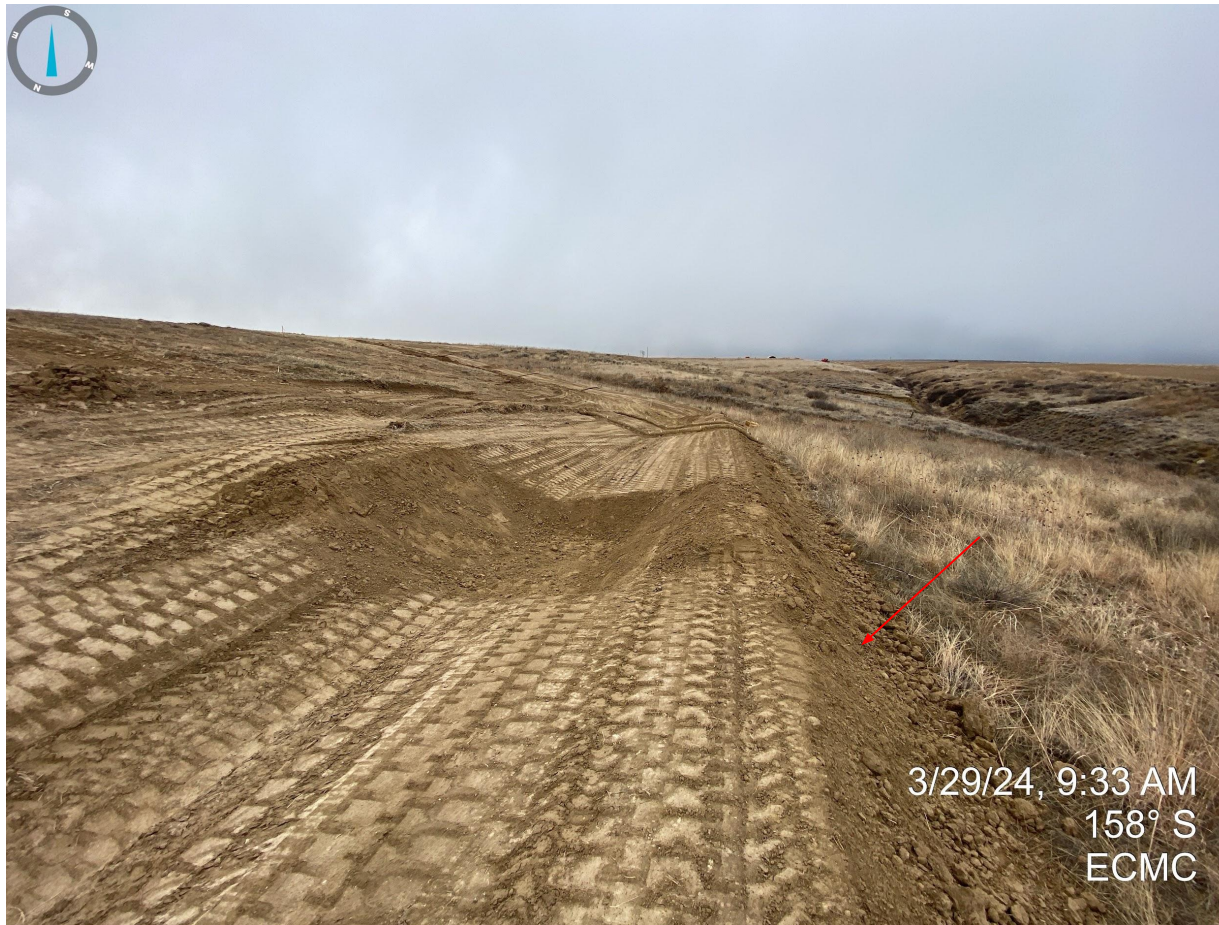
**Photo 12.** Taken near the western portion of the disturbance area. Some BMPs (sediment trap) remain in process. Portions of the perimeter berm do not appear to be properly stabilized as they have been left unconsolidated.

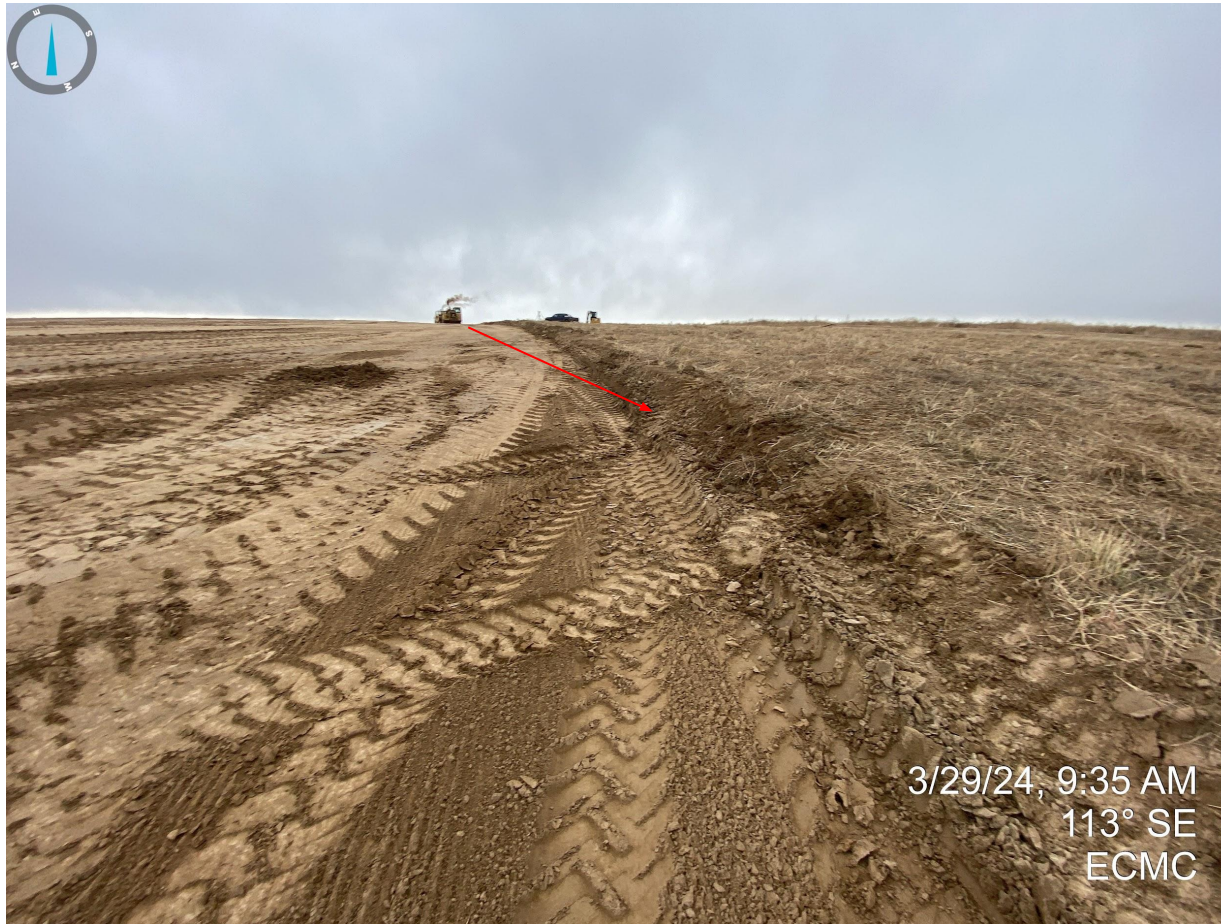
**Photo 13.** Taken near the southwest portion of the drilling pad construction. Photo illustrates topsoil salvage operations. Operator shall ensure that all topsoil on location is salvaged in accordance with Rule 1002.b.

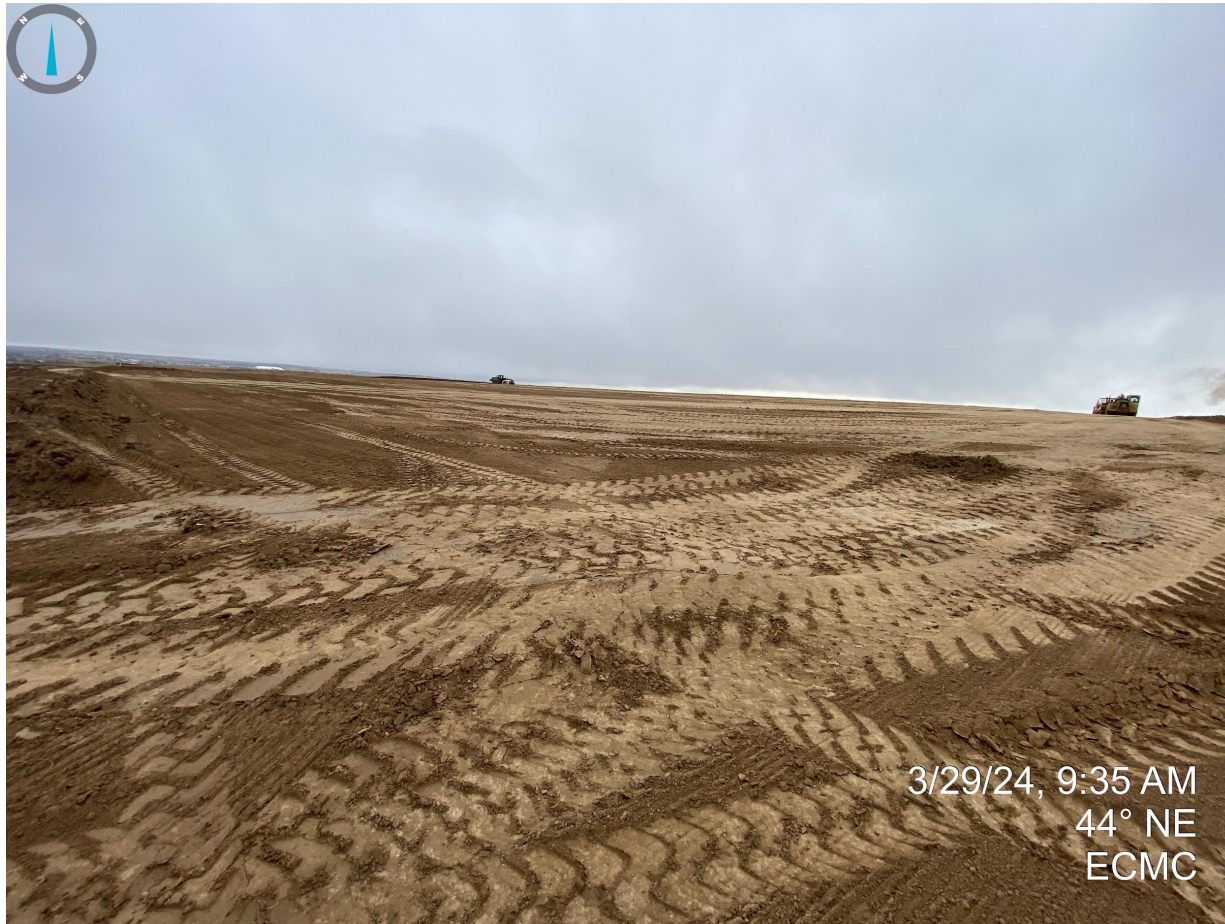
**Photo 14.** Taken near the southwest corner of the drilling pad construction; see comments in Photo 13.

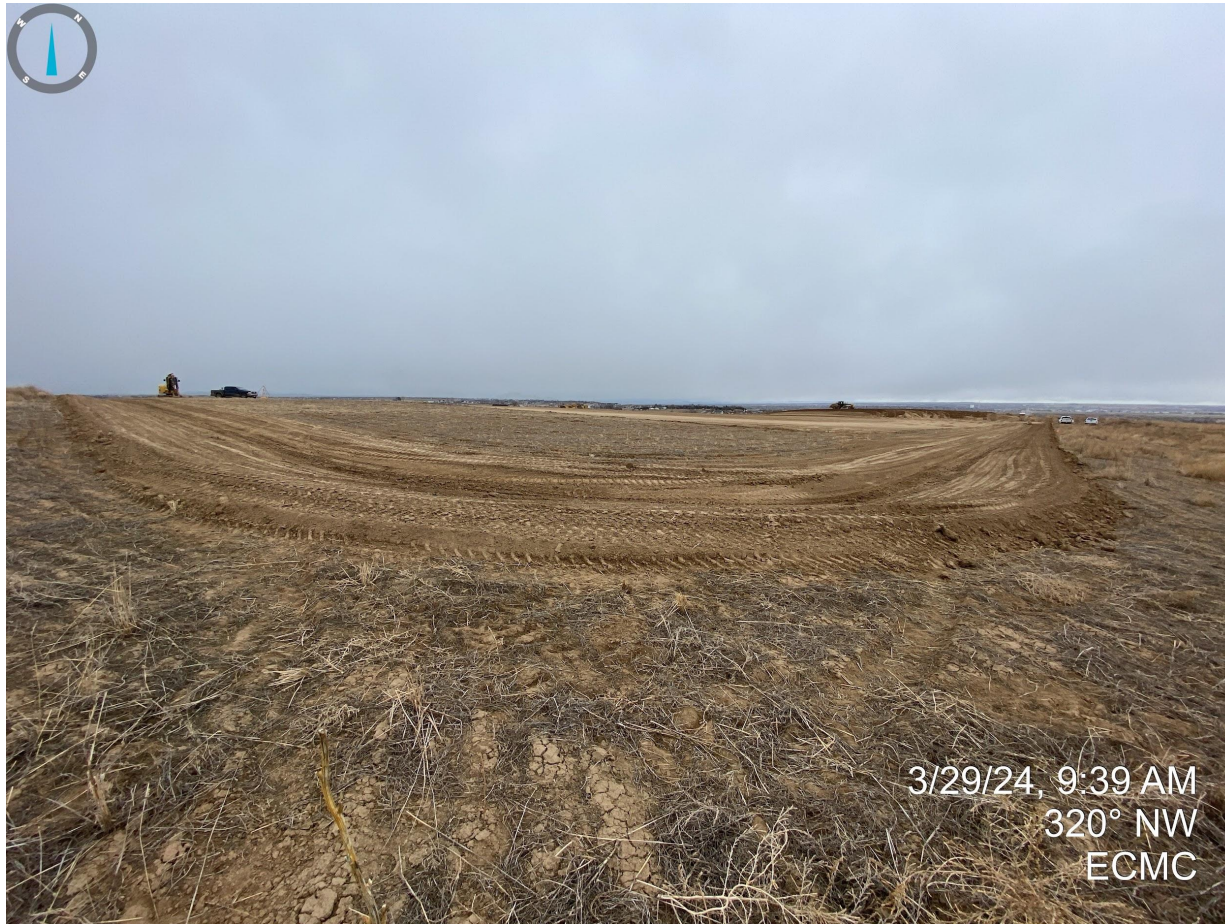
**Photo 15.** Taken near the southeast corner of the drilling pad construction; see comments in Photo 13.

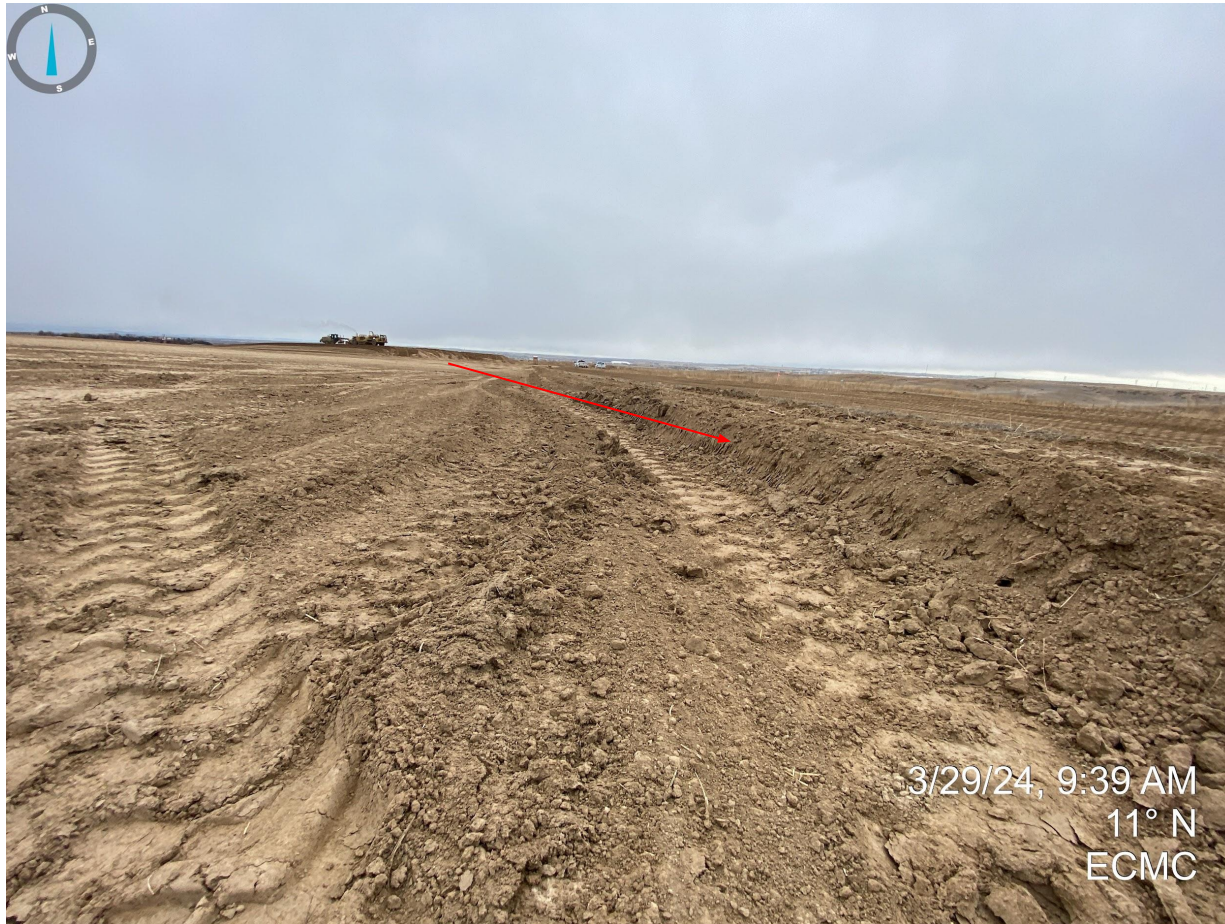
**Photo 16.** Taken near the southwest corner of the drilling pad construction; see comments in Photo 13.

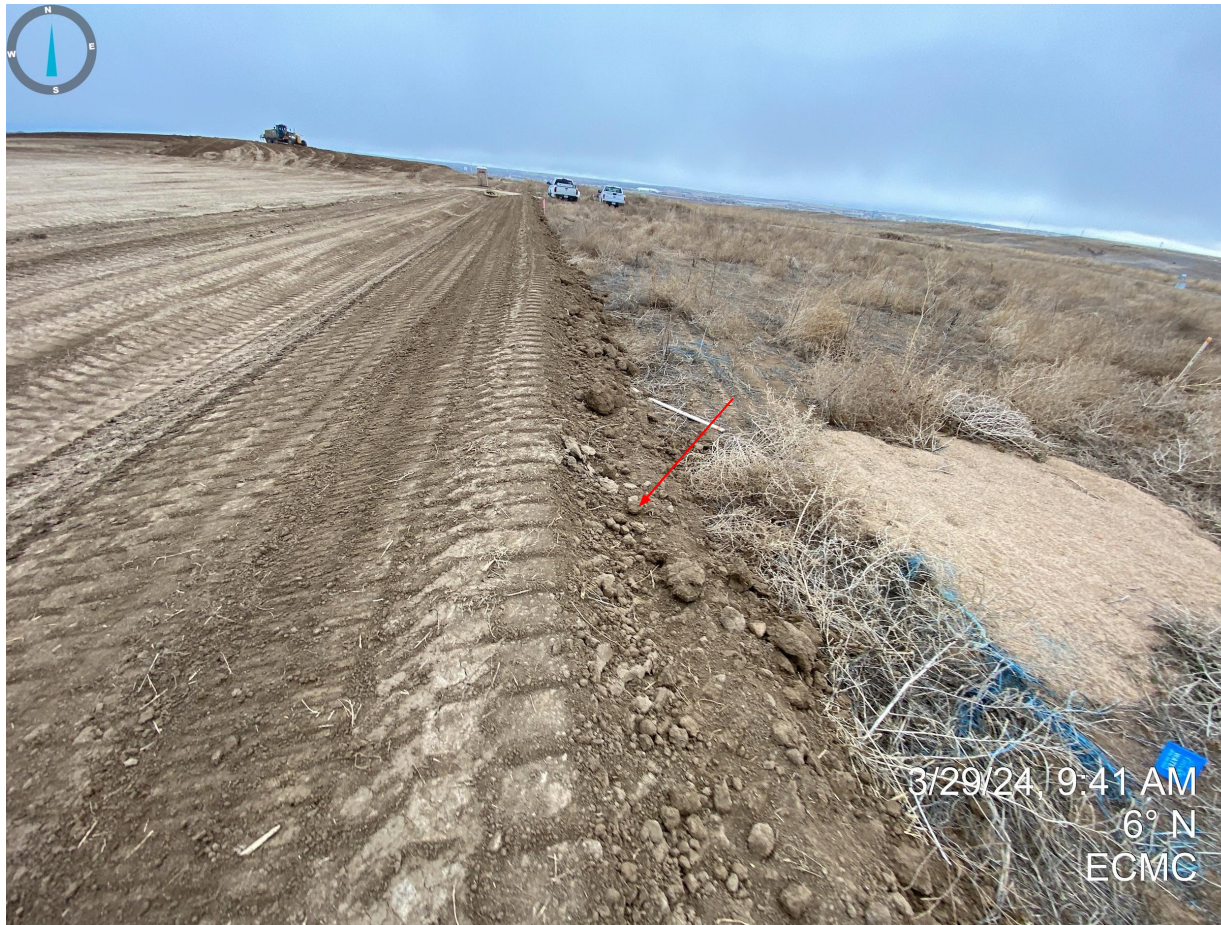
**Photo 17.** Taken from the eastern portion of the disturbance area. Photo illustrates that portions of the perimeter berm BMP do not appear to be properly stabilized as the soil has been left unconsolidated.

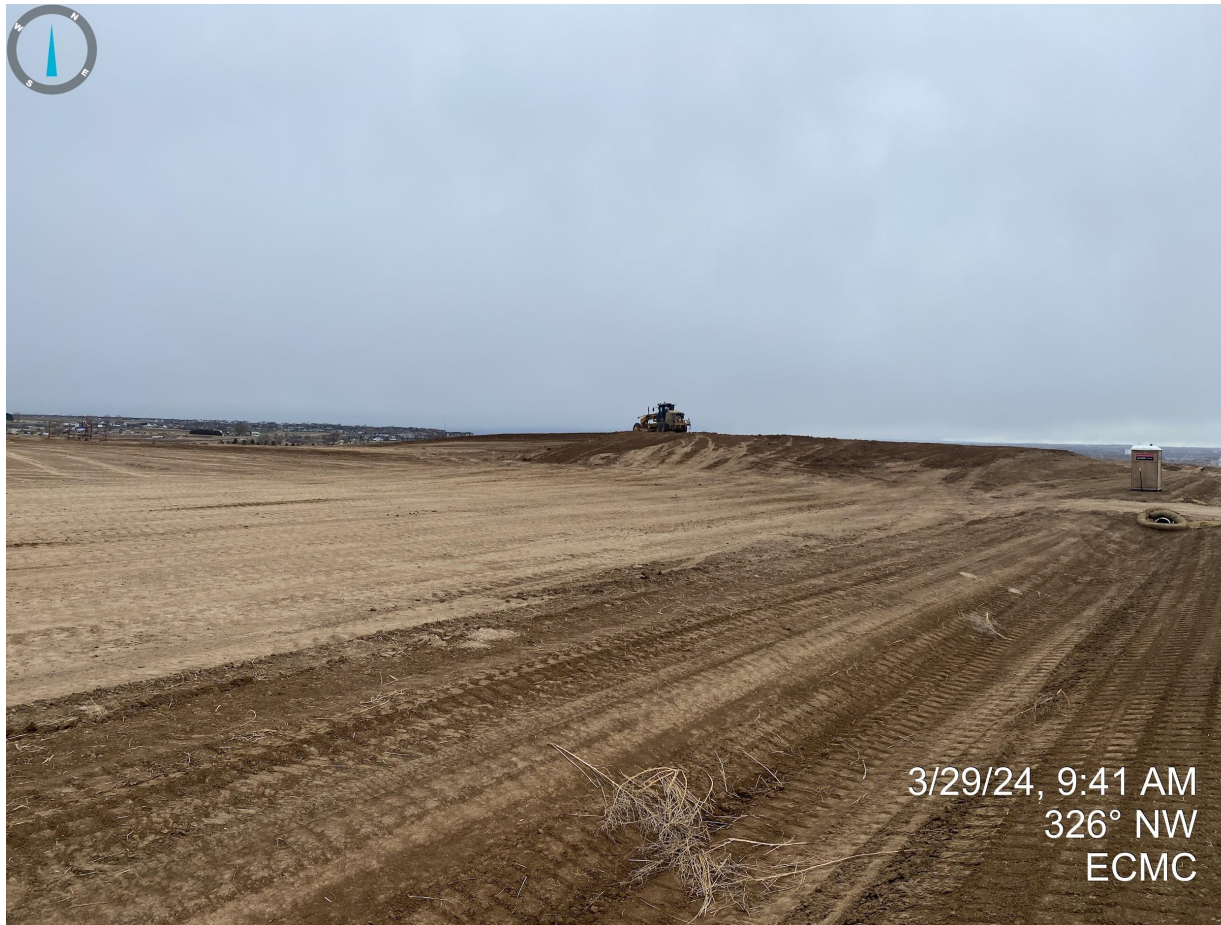
**Photo 18.** Taken near the location entrance. Photo illustrates overview of topsoil salvage operations and topsoil stockpile in the background. Operator shall ensure that all topsoil on location is salvaged in accordance with Rule 1002.b and that stockpiled soils are properly stabilized against wind and water erosion degradation.
