Inspection Photos

Operator: ENDURING RESOURCES LLC -10663

Location Name: STATE #36-6 API #:05-067-09452

Inspection Date:4/3/2024 Inspection Doc#: 693807028

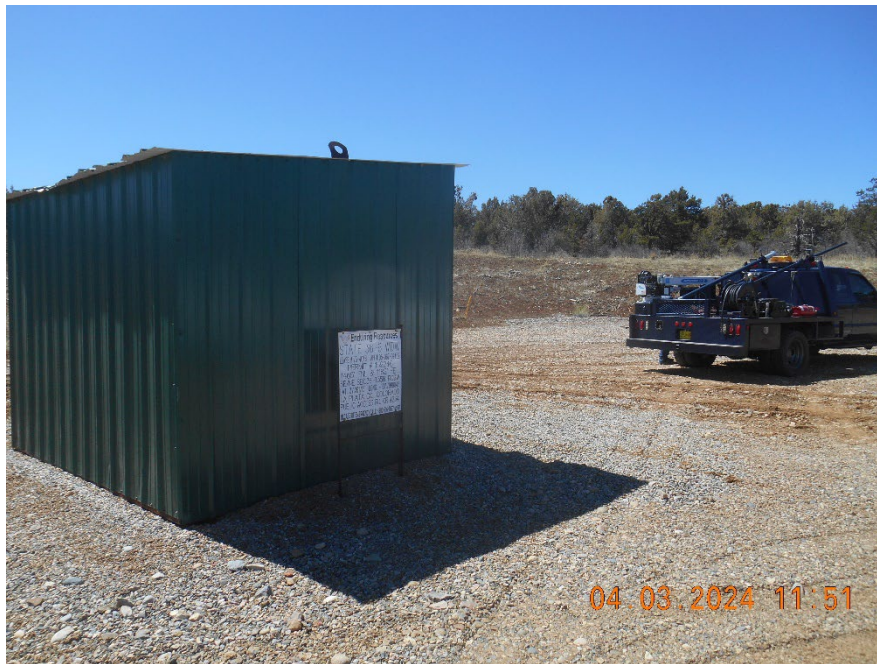
Injection wellhead during MIT
STATE #36-6 API #:05-067-09452

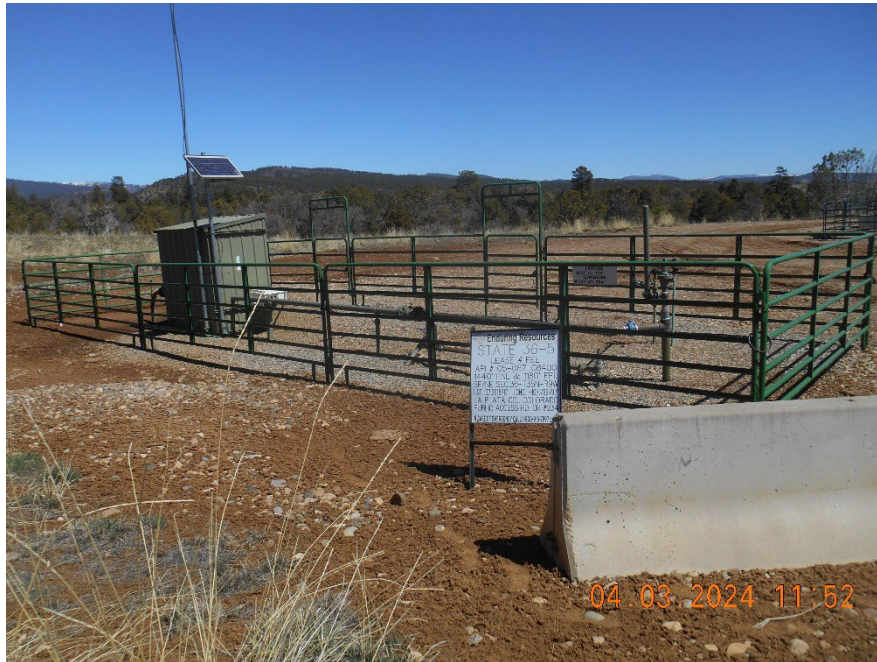
**Location entrance with sign
Gas meter and flowline fencing.
Separator and tank battery removed**

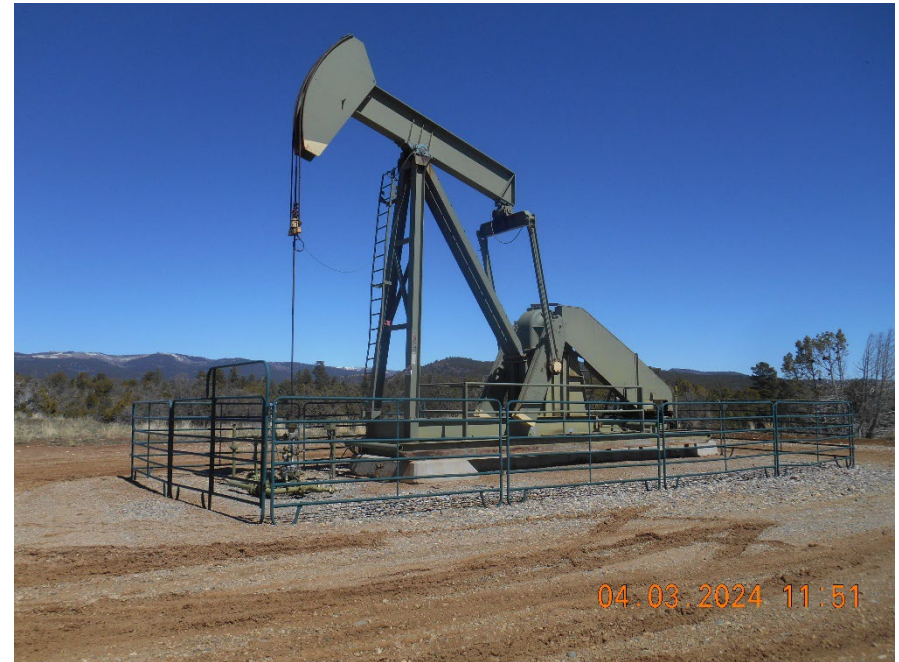
**Wellhead with pump jack
STATE #36-5 API #:05-067-08400**
