Inspection Photos on 4/2/24
Operator: Phoenix Resources
Location Name: Mosher 1-1H
API: 05-073-06393

Inspection #715200028

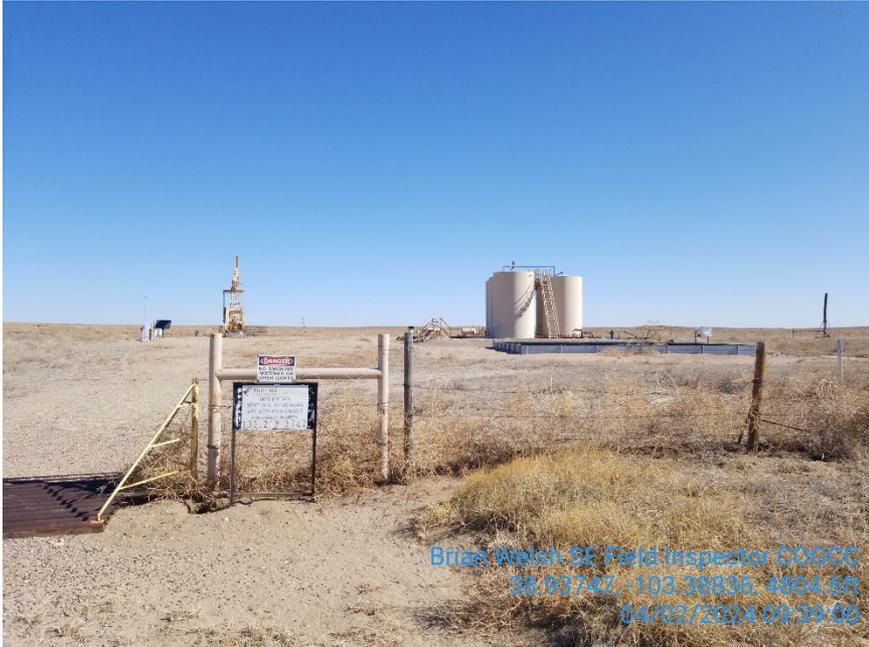
Looking north from entrance at cattle guard

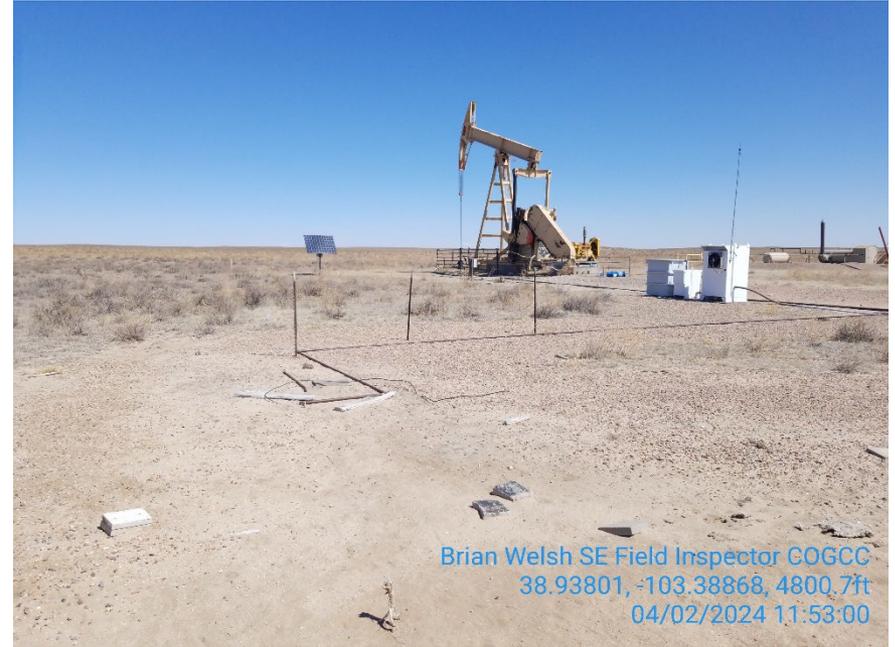
Concrete blocks and debris laying around

On April 2nd 2024, the Compliance Specialist observed that the corrective actions from the previous inspection on 9/21/23 (Doc #701007374) were not completed

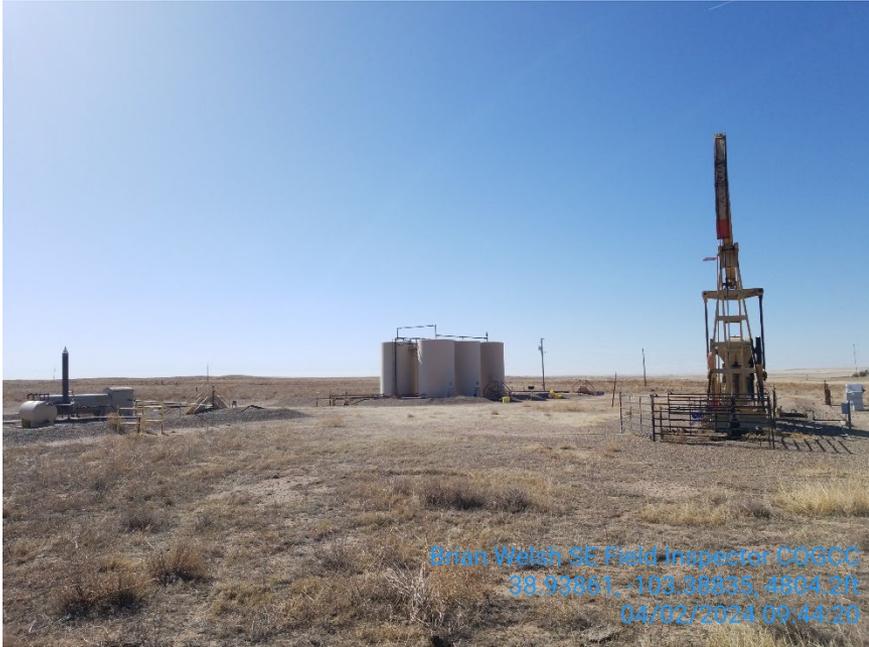
NW corner of location looking south

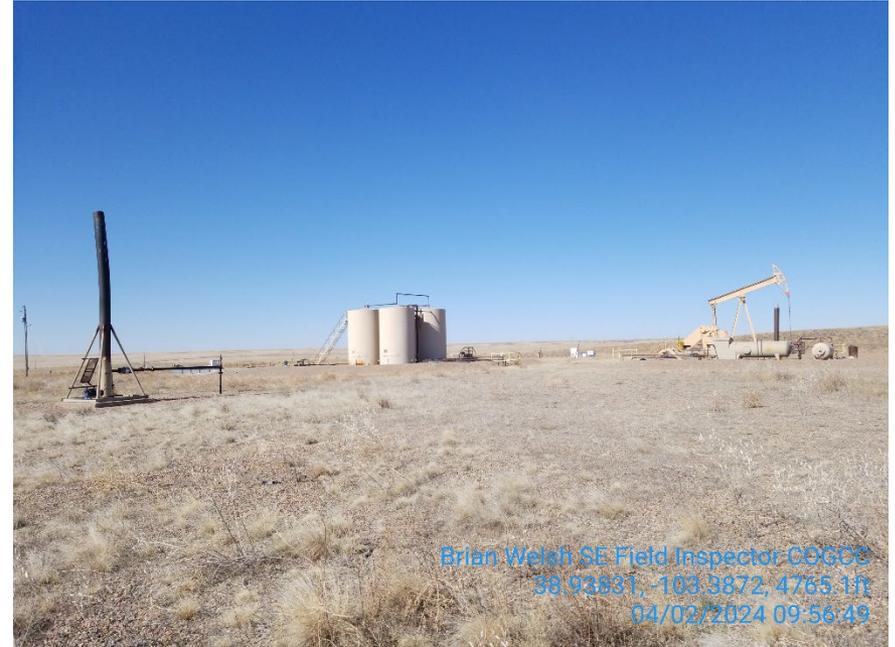
NE corner of location looking SW

On April 2nd 2024, the Compliance Specialist observed that the corrective actions from the previous inspection on 9/21/23 (Doc #701007374) were not completed

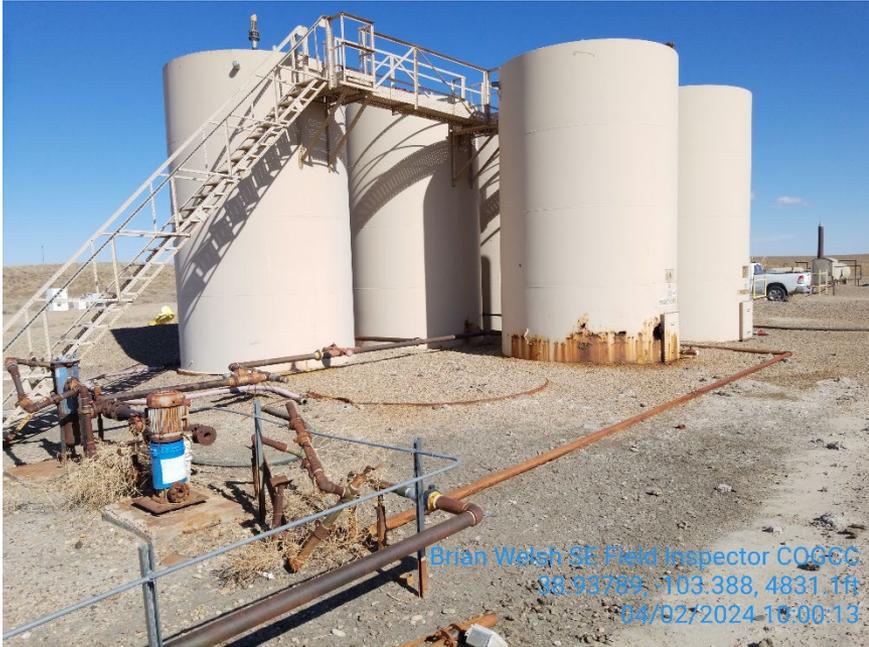
SE corner of tank berms

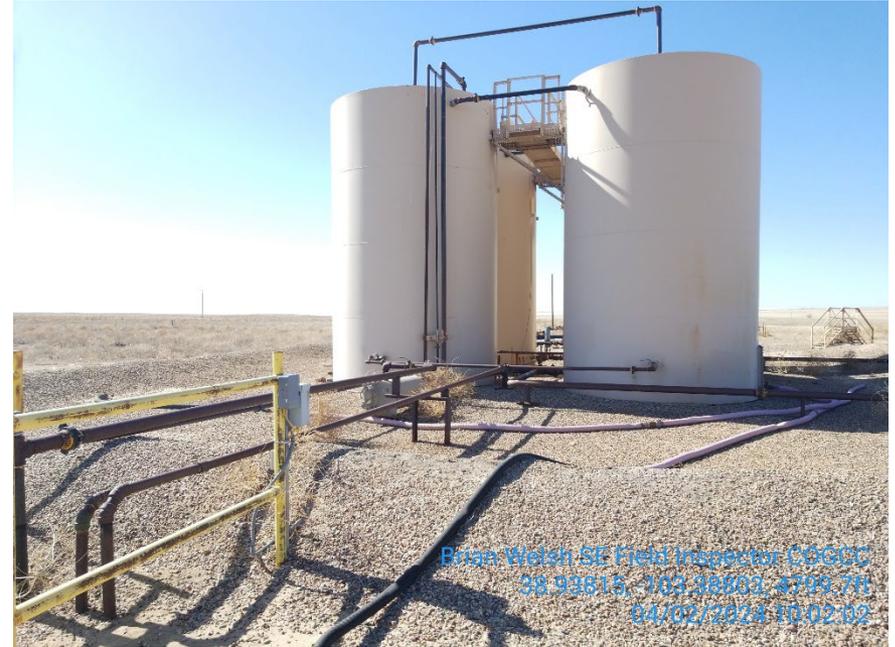
North side of tank battery

On April 2nd 2024, the Compliance Specialist observed that the corrective actions from the previous inspection on 9/21/23 (Doc #701007374) were not completed

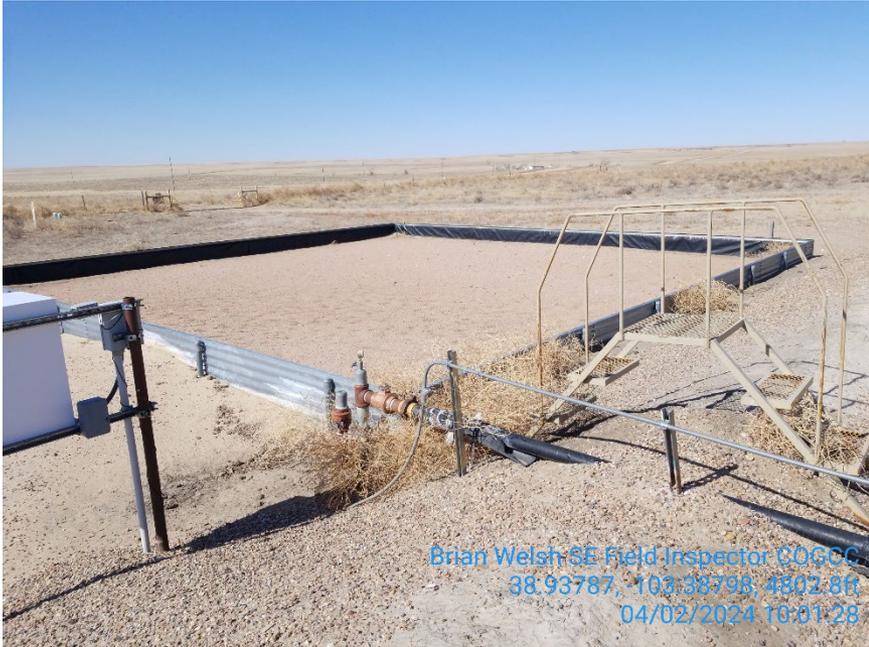
Old metal berms on south side of existing battery

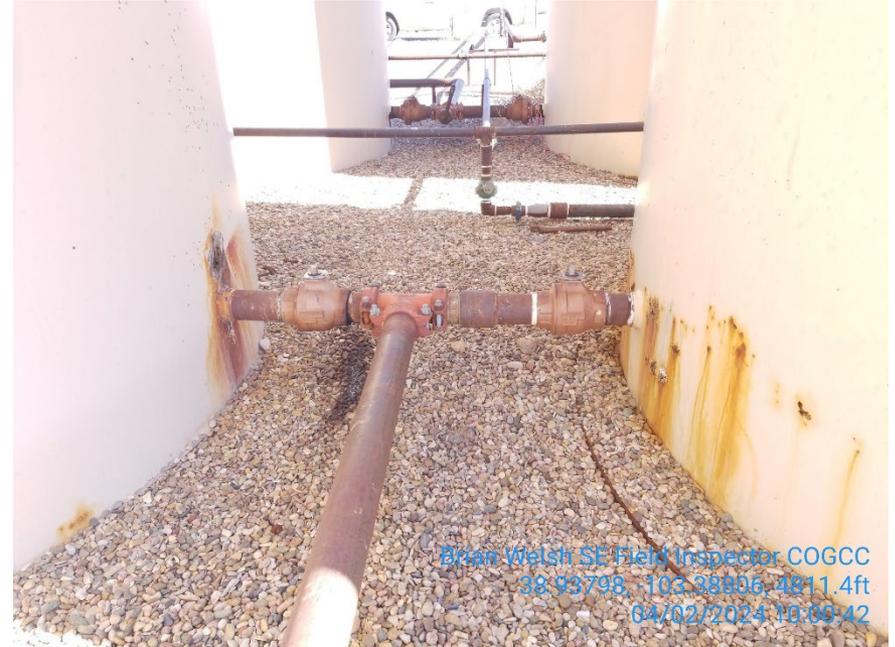
Picture showing how bad tanks are rotting

On April 2nd 2024, the Compliance Specialist observed that the corrective actions from the previous inspection on 9/21/23 (Doc #701007374) were not completed
