Inspection Photos

Location Name: TEP ROCKY MOUNTAIN LLC, MV/34-5

Location ID: 334816

Date: 4/4/2024

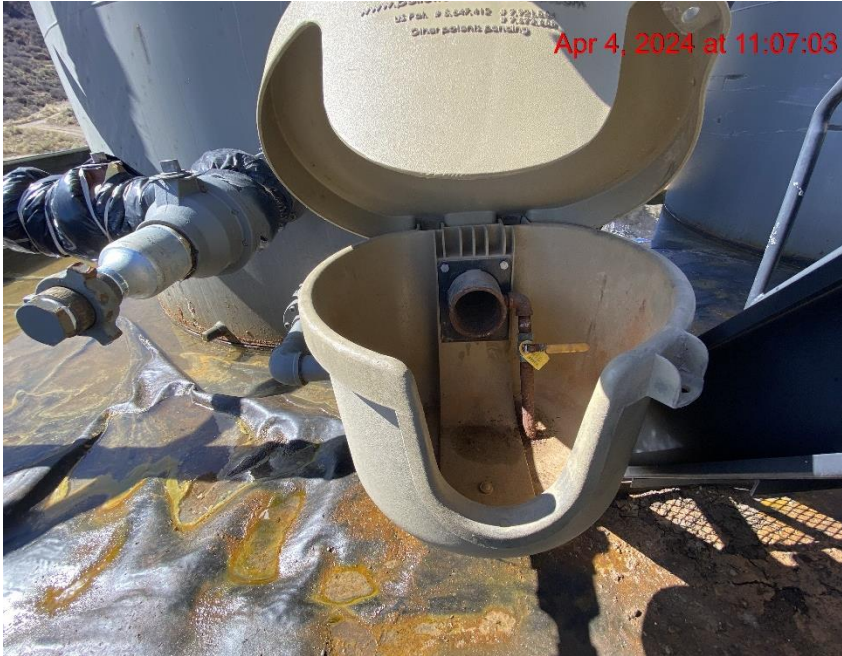
Open-Ended Load Line – Photo #00370

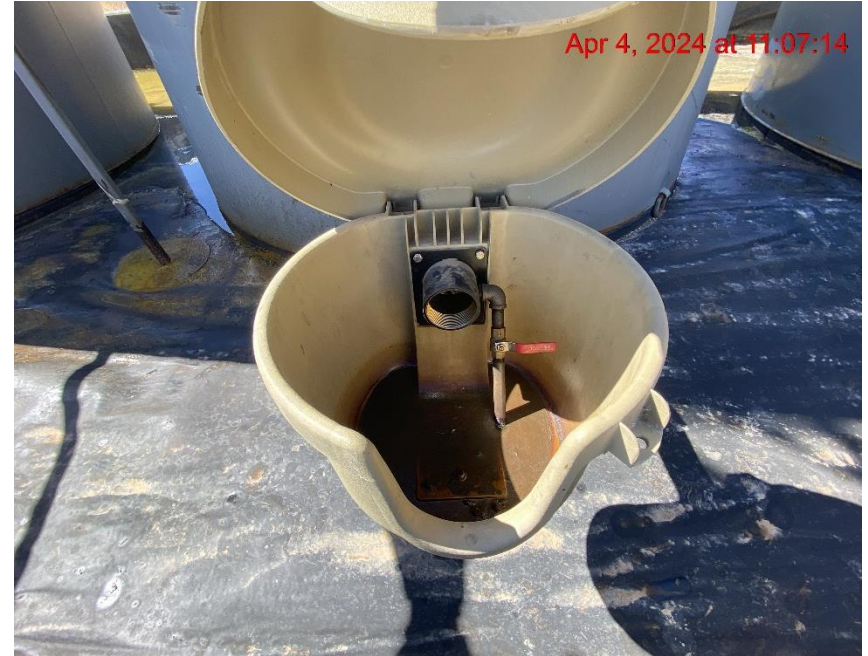
Open-Ended Load Line – Photo #00371

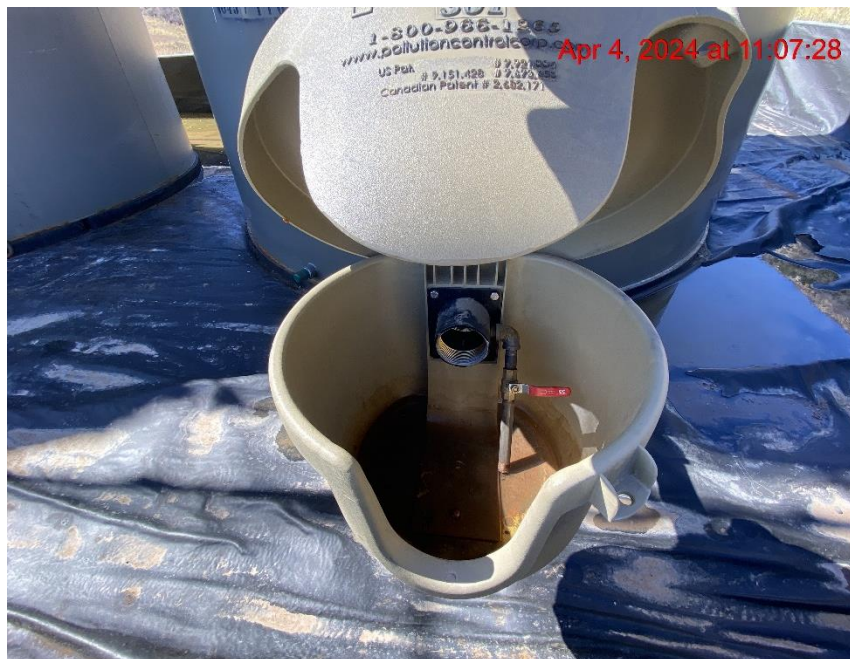
Open-Ended Load Line – Photo #00373

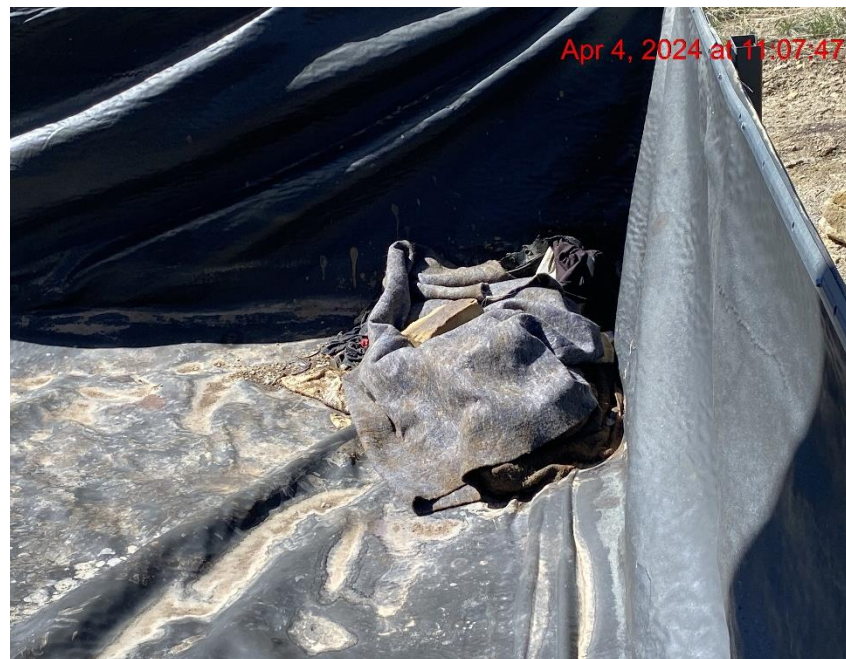
Debris in Containment – Photo #00374

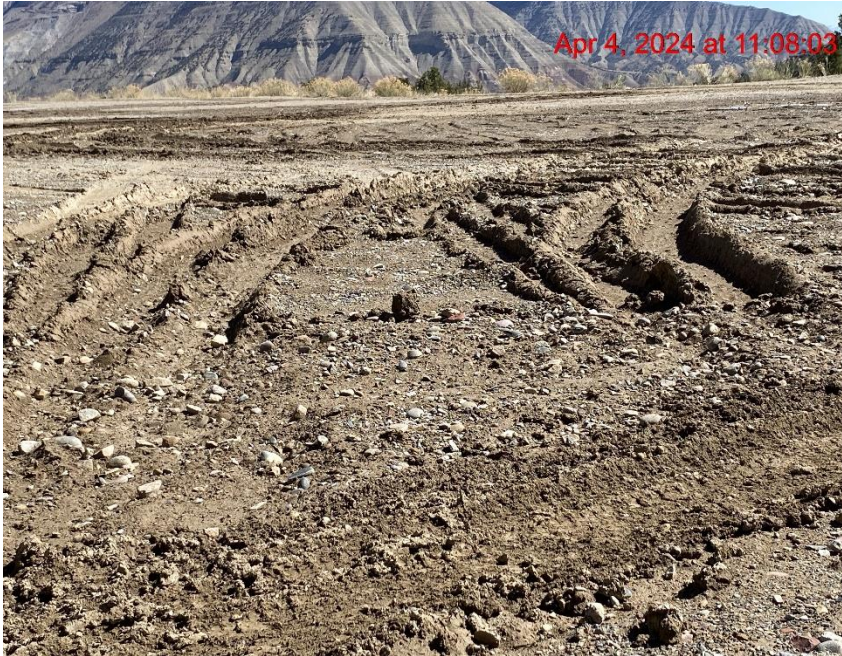
Lack of Stabilization – Photo #00375

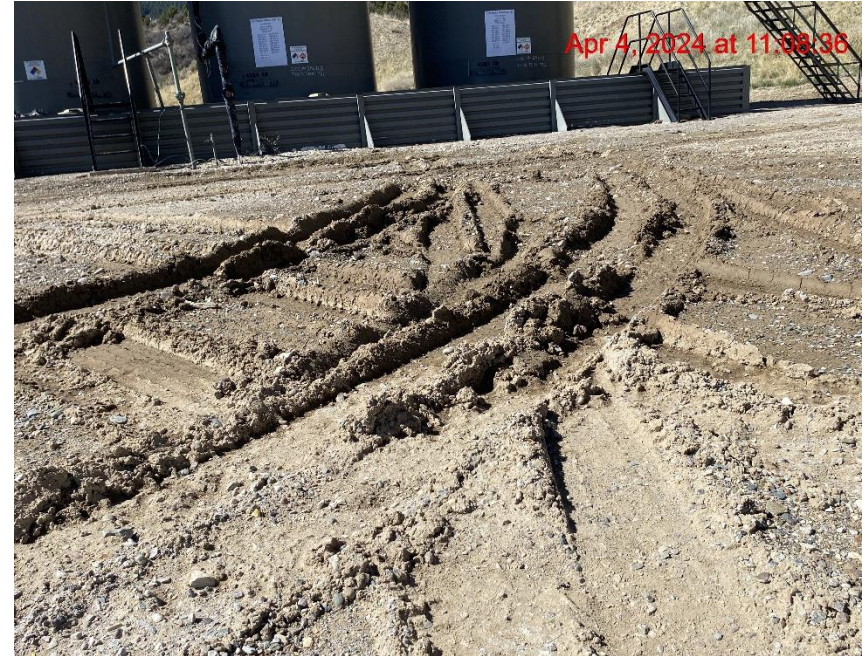
Lack of Stabilization – Photo #00376

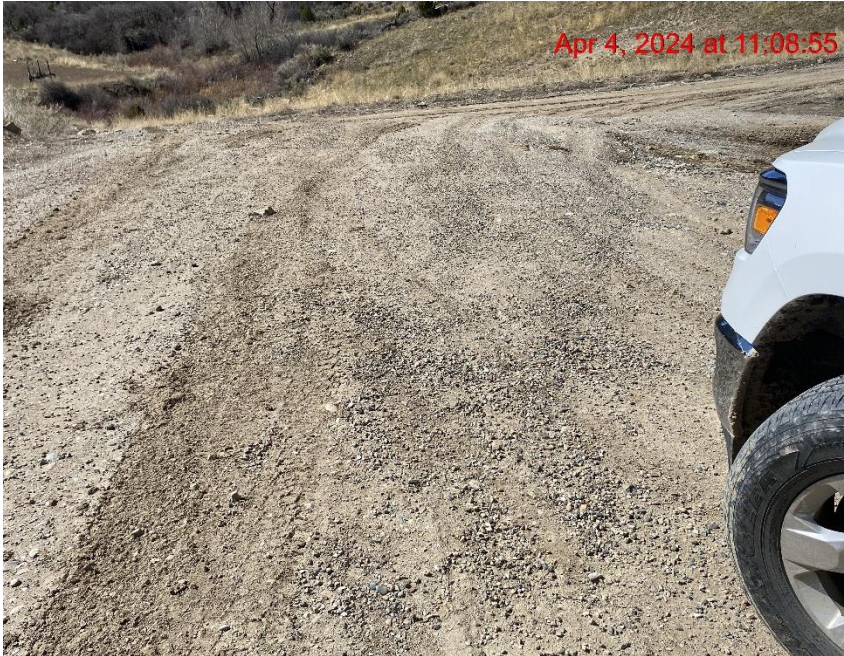
Insufficient Vehicle Tracking BMPs at Location Entrance/Exit
– Photo #00377
