Inspection Photos

Location Name: TEP ROCKY MOUNTAIN LLC, MV/16-9

Location ID: 334717

Date: 4/4/2024

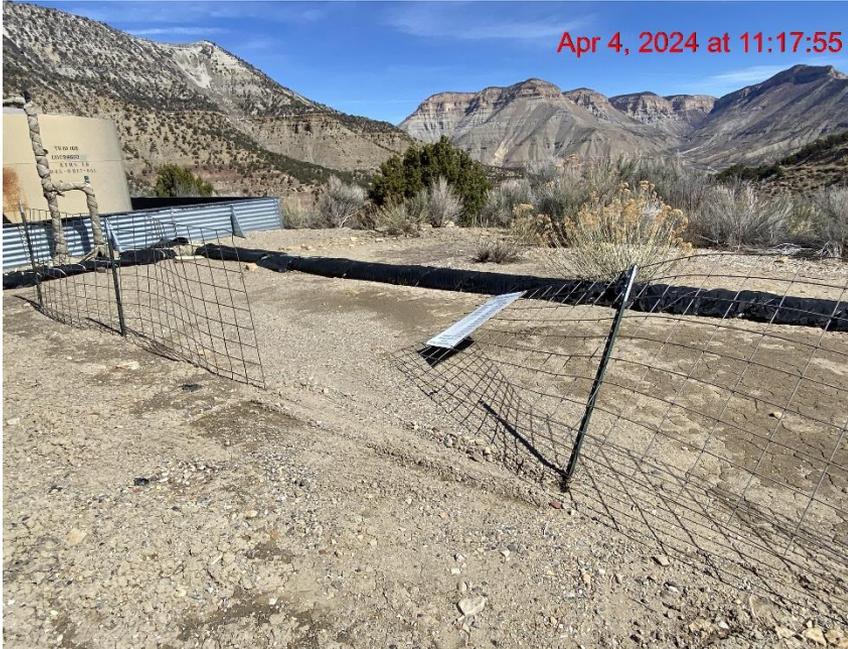
Damaged Fencing – Photo #00385

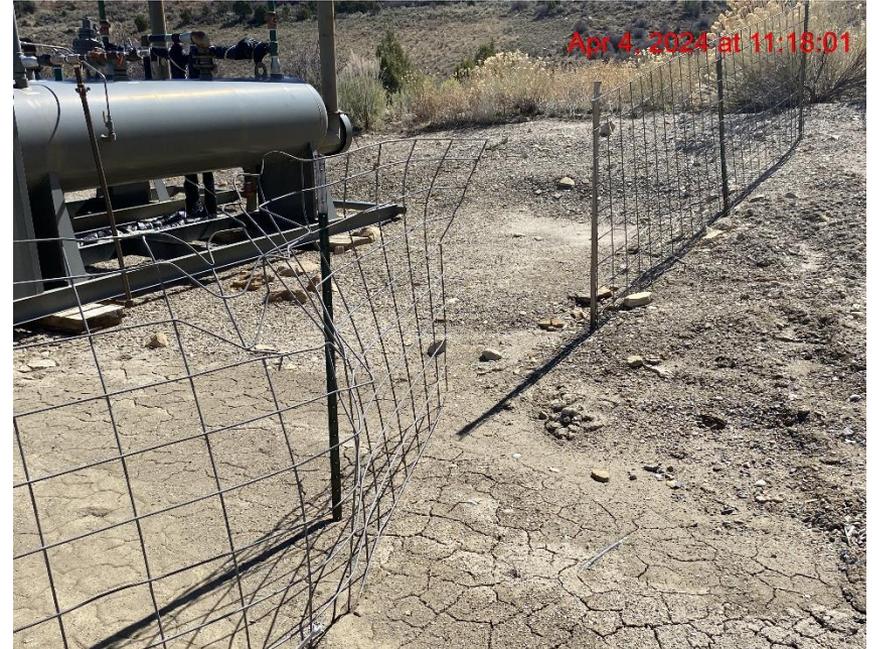
Damaged Fencing – Photo #00386

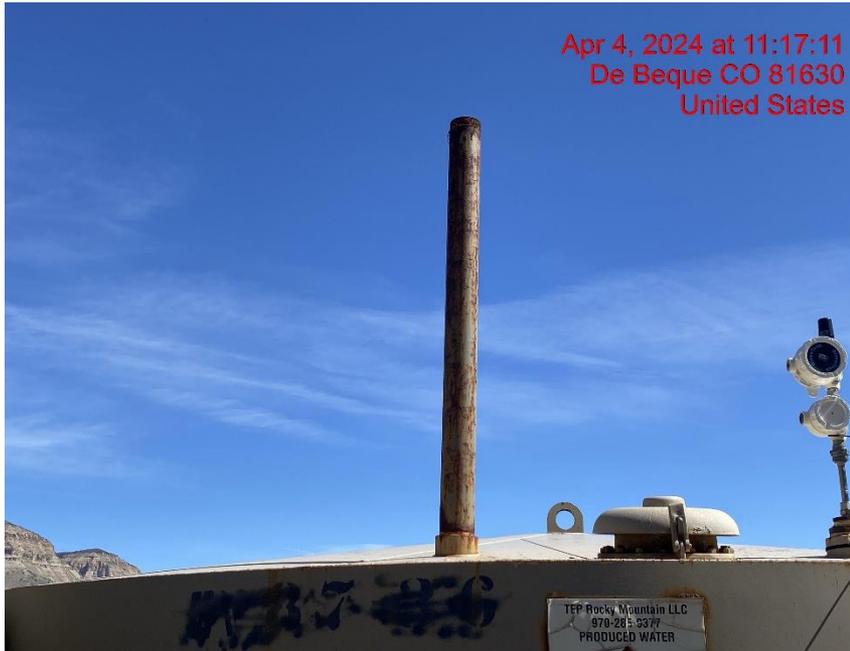
Open-Ended Vent/Wildlife Entry Hazard – Photo #00384

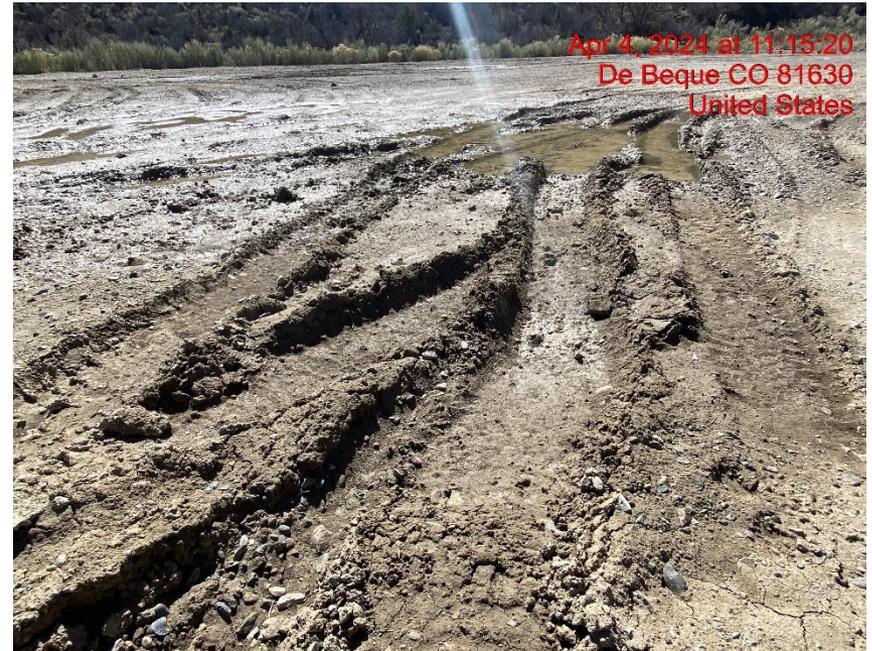
Lack of Stabilization – Photo #00380

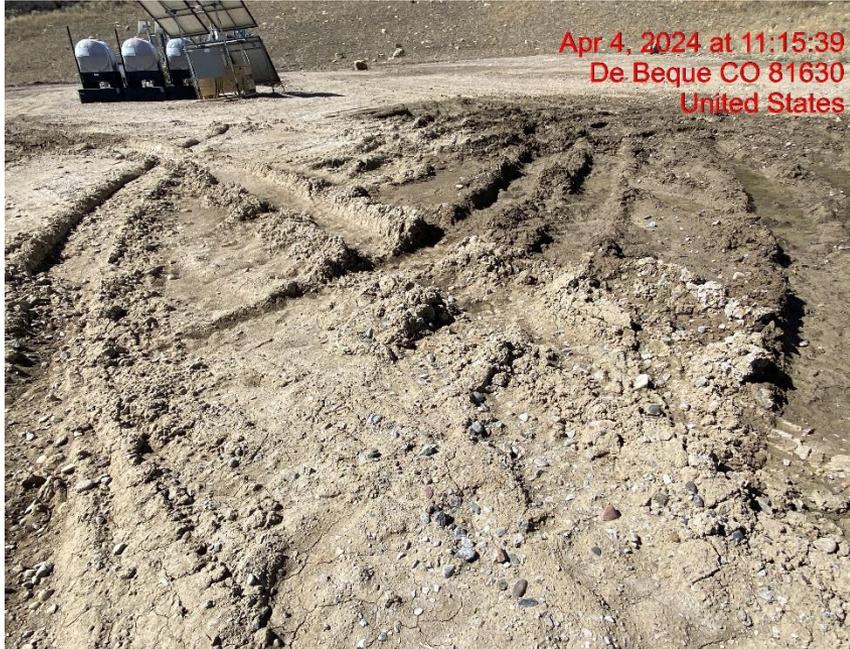
Lack of Stabilization – Photo #00381

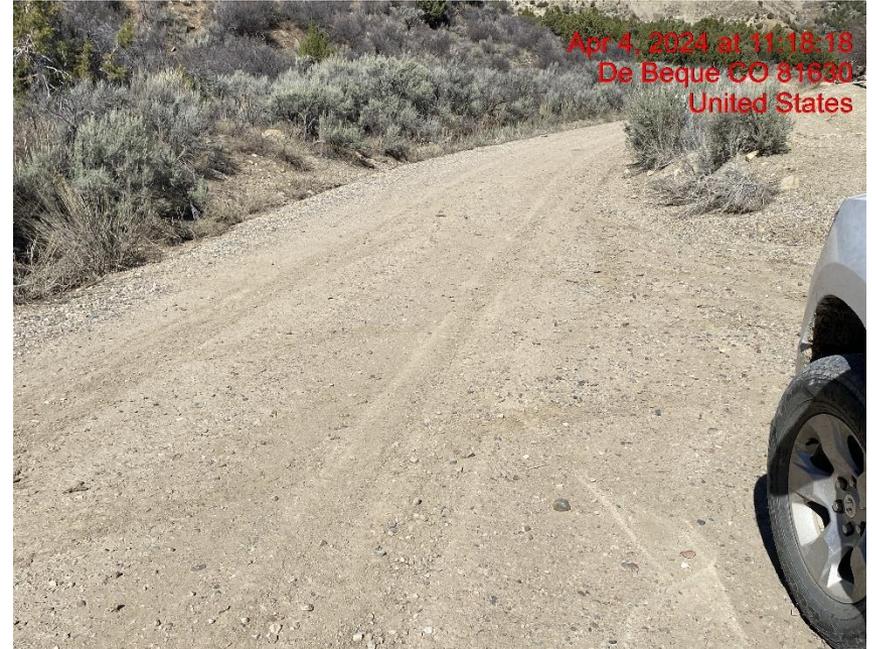
**Insufficient Vehicle Tracking BMPs at Location Entrance/Exit
– Photo #00388**
