Inspection Photos

Location Name: CAERUS PICEANCE LLC Rulison Compressor Station

Location # 466236

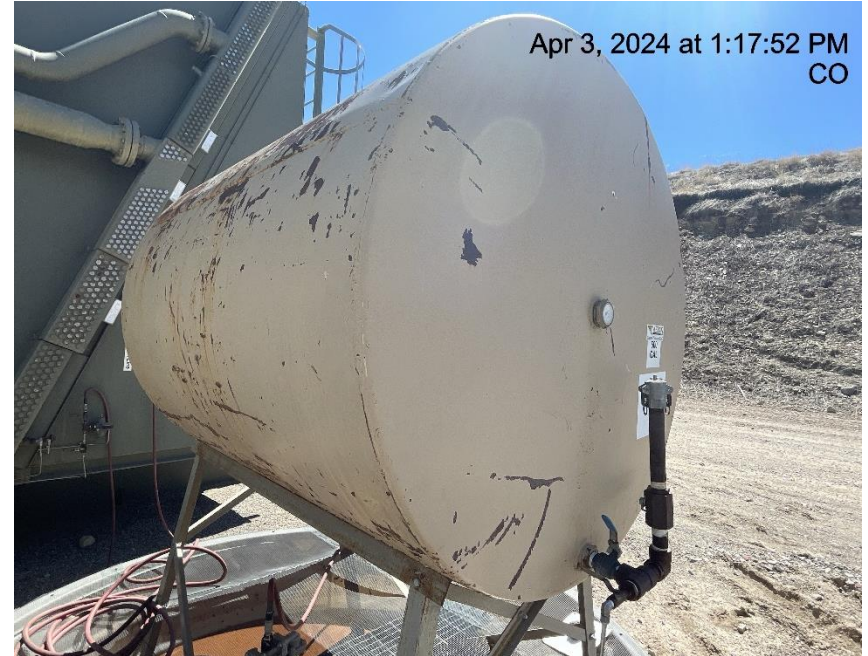
Photo # 2629 Tank missing required information & some information is illegible

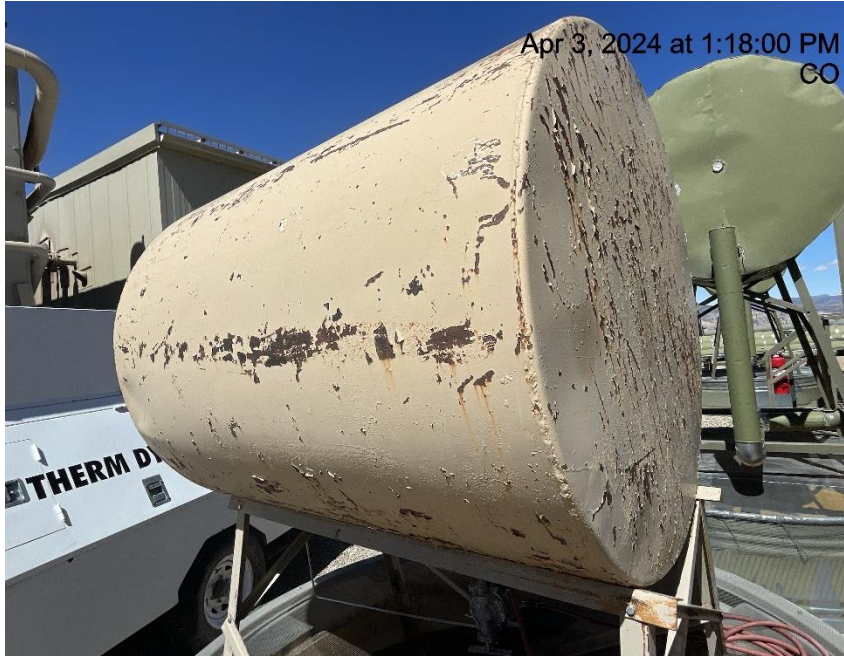
Photo # 2630 Tank missing required information

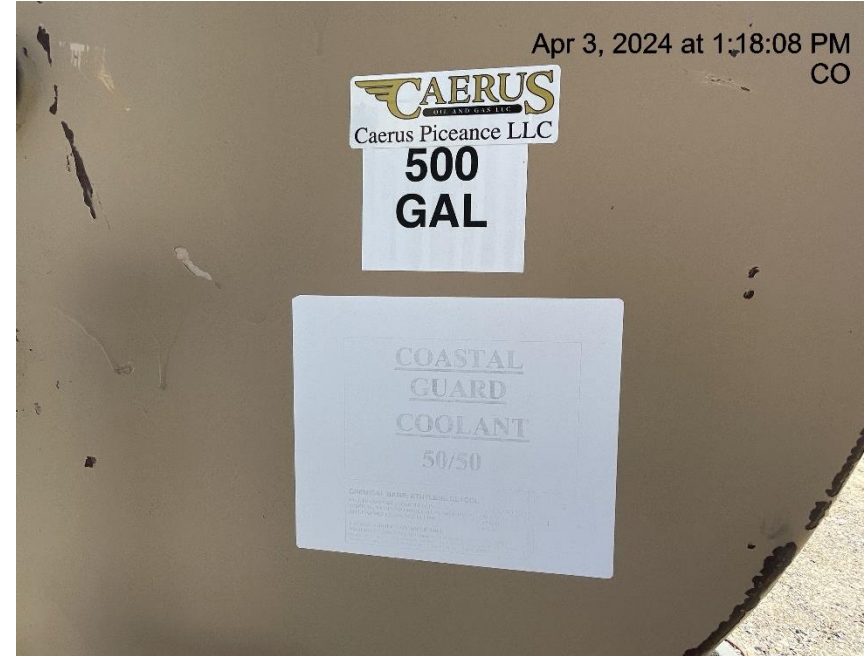
Photo # 2631 Tank missing required information & some information is illegible

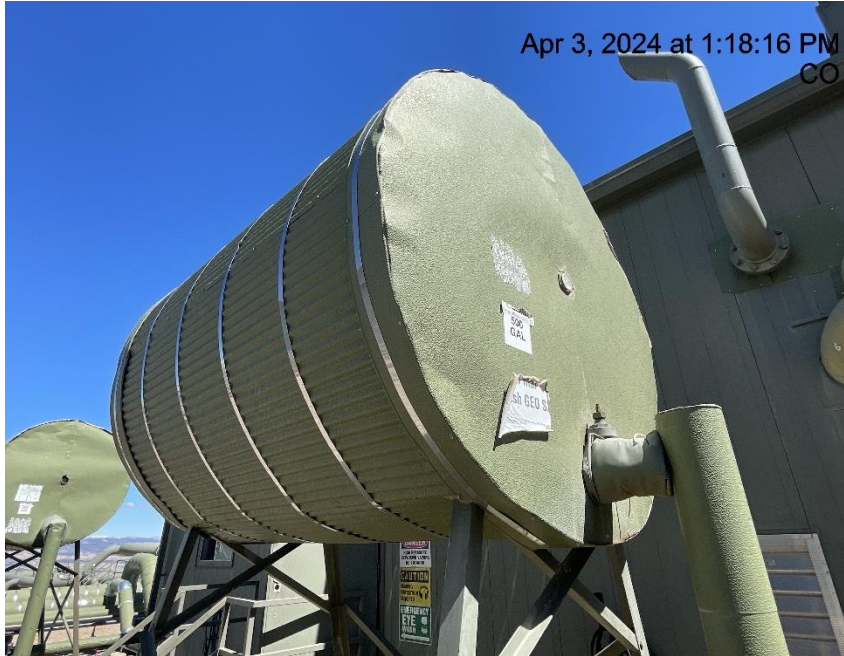
Photo # 2632 Tank missing required information & some information is illegible

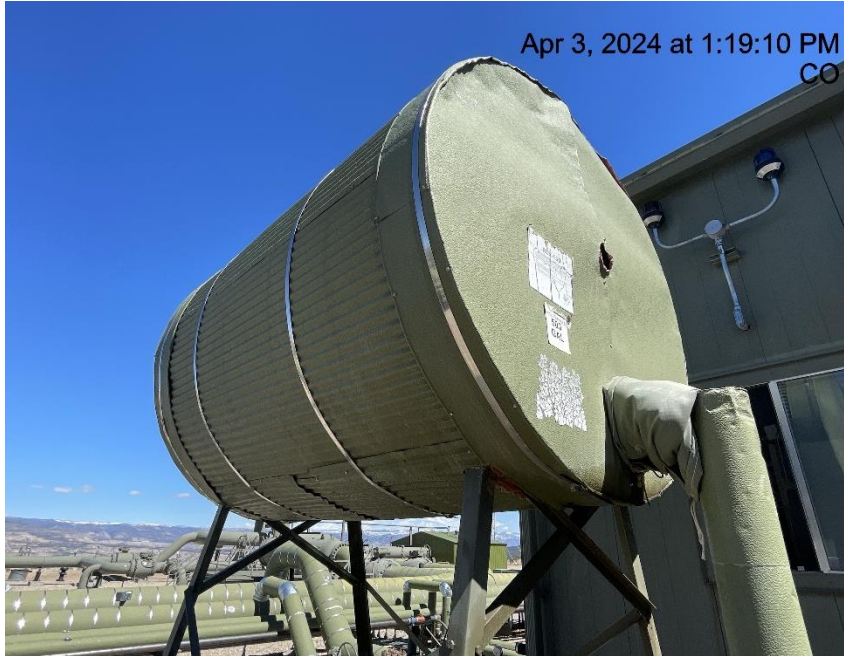
Photo # 2634 Tank missing required information & some information is illegible

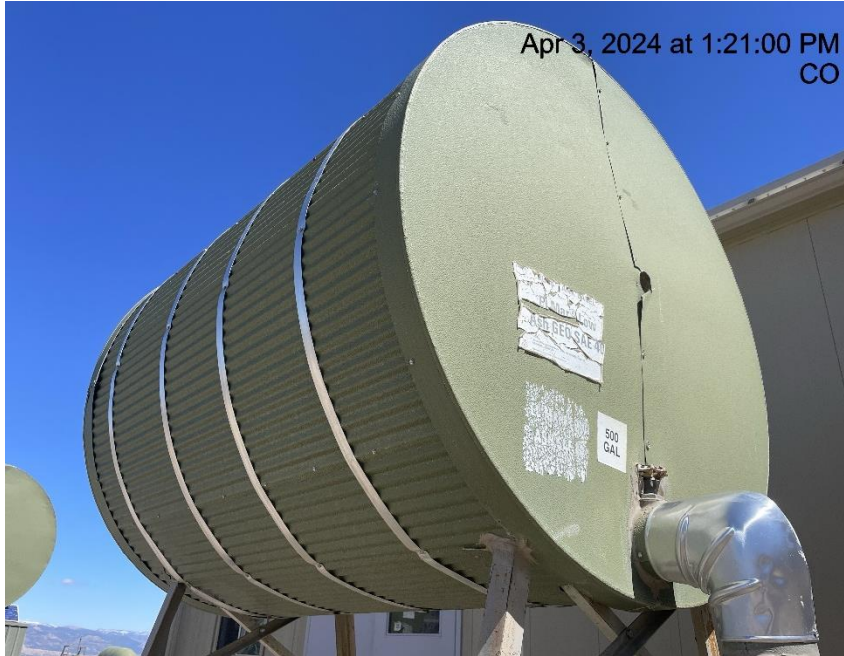
Photo # 2636 Tank missing required information & some information is illegible

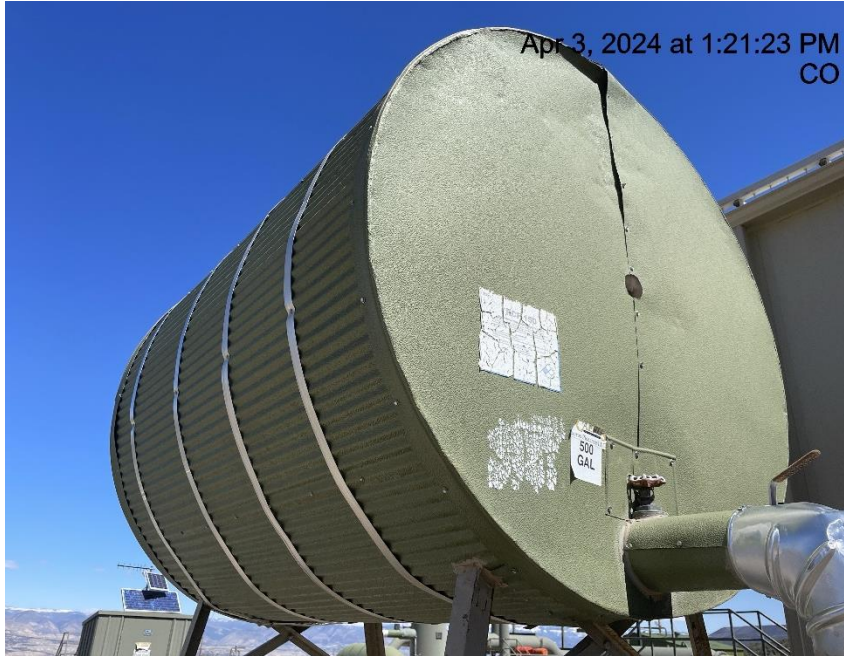
Photo # 2638 Tank missing required information & some information is illegible

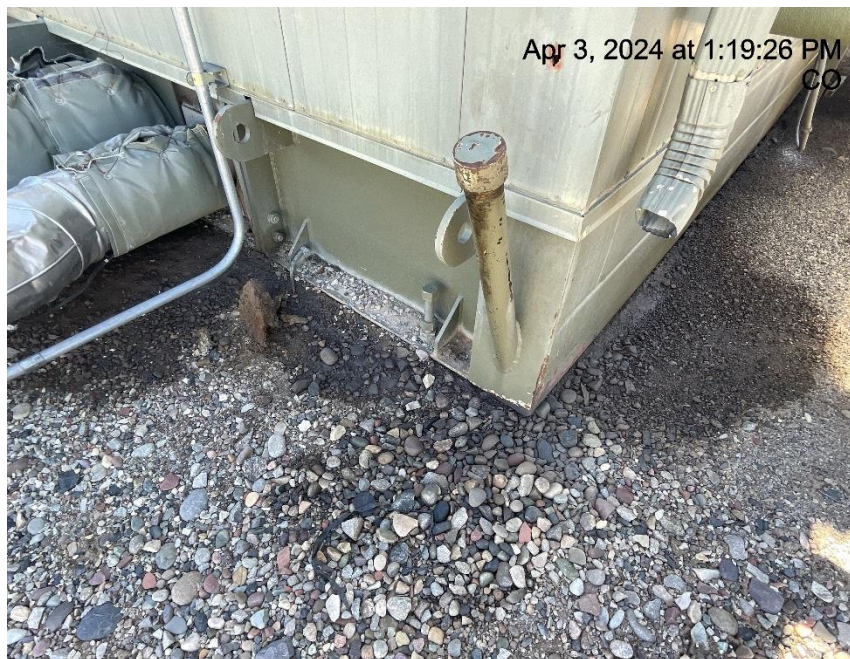
Photo # 2640 Storage tank on compressor skid lacks required labeling

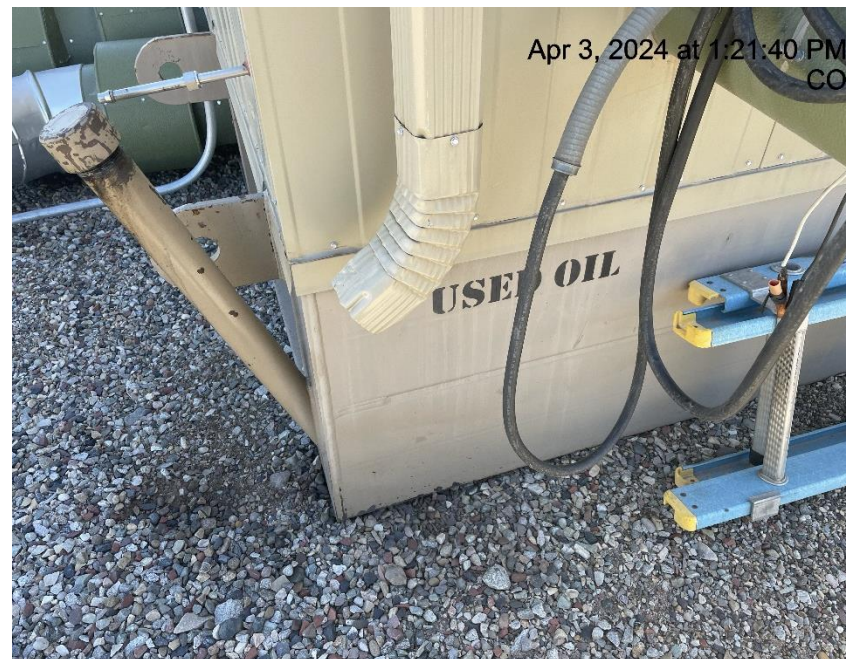
Photo # 2641 Storage tank on compressor skid lacks required labeling

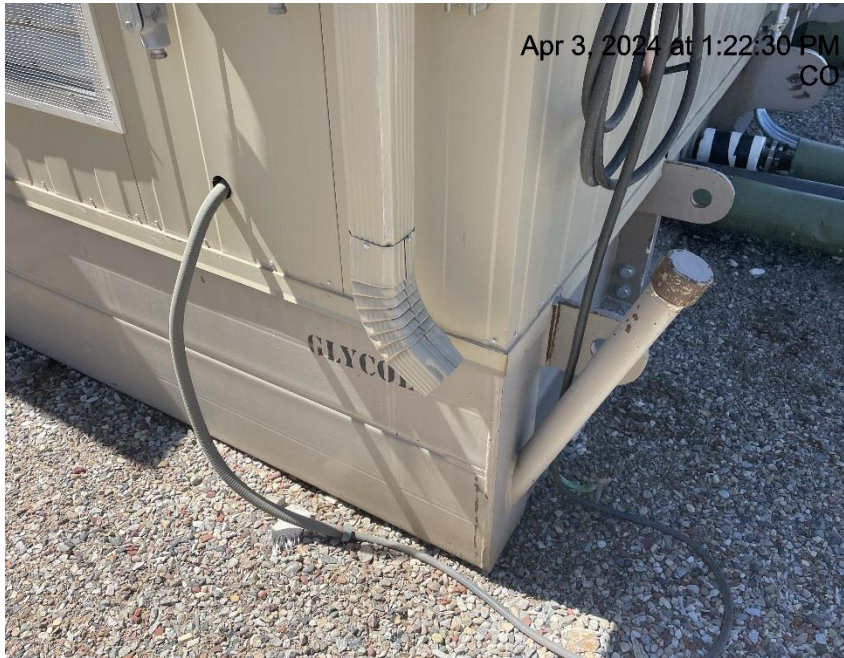
Photo # 2642 Storage tank on compressor skid lacks required labeling

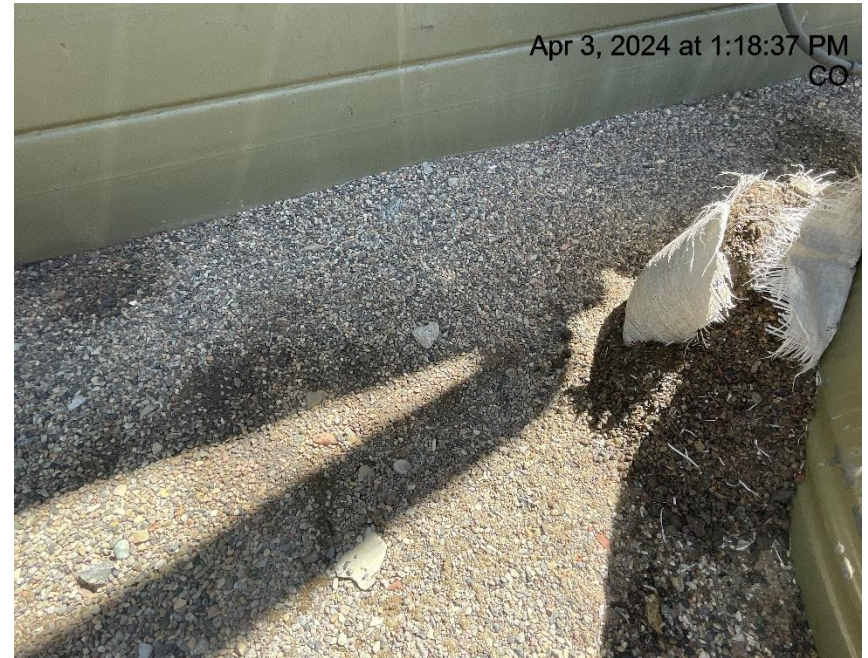
Photo # 2643 Stained soils & gravel

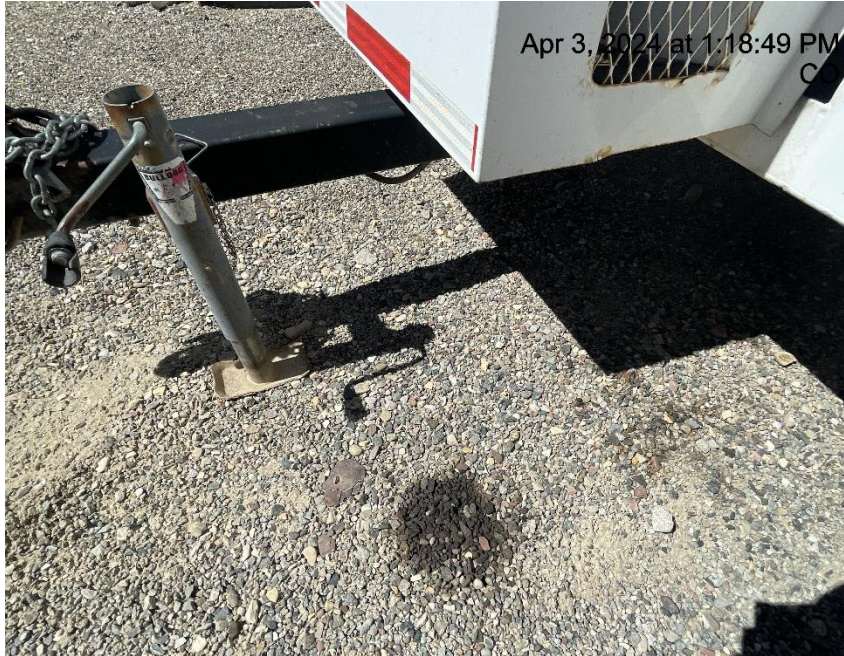
Photo # 2644 Stained soils & gravel

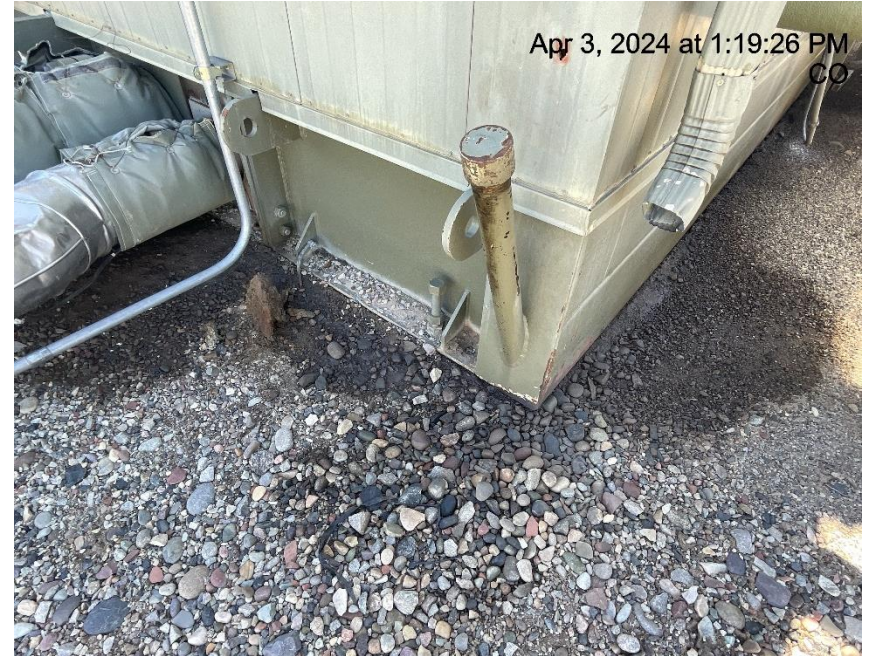
Photo # 2645 Stained soils & gravel

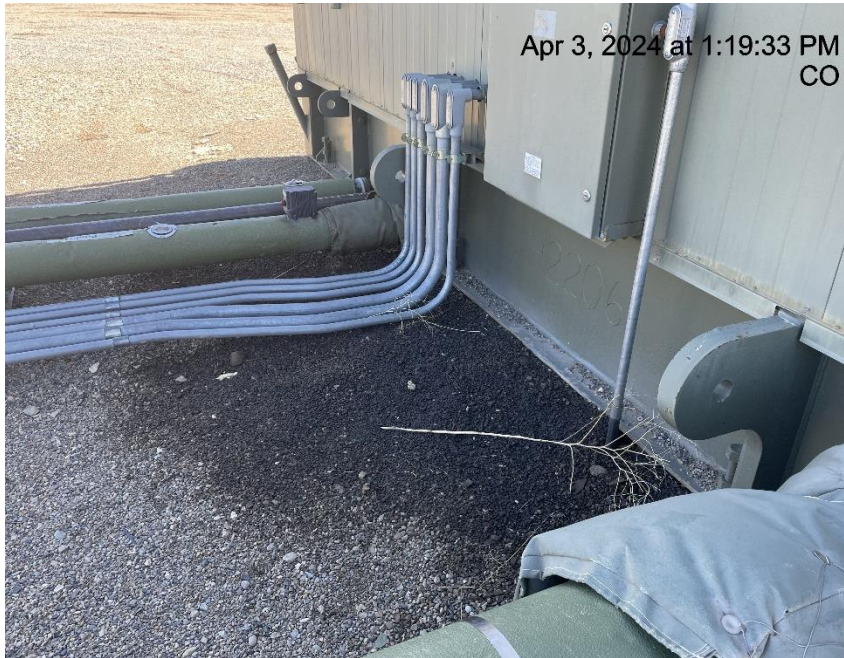
Photo # 2646 Stained soils & gravel

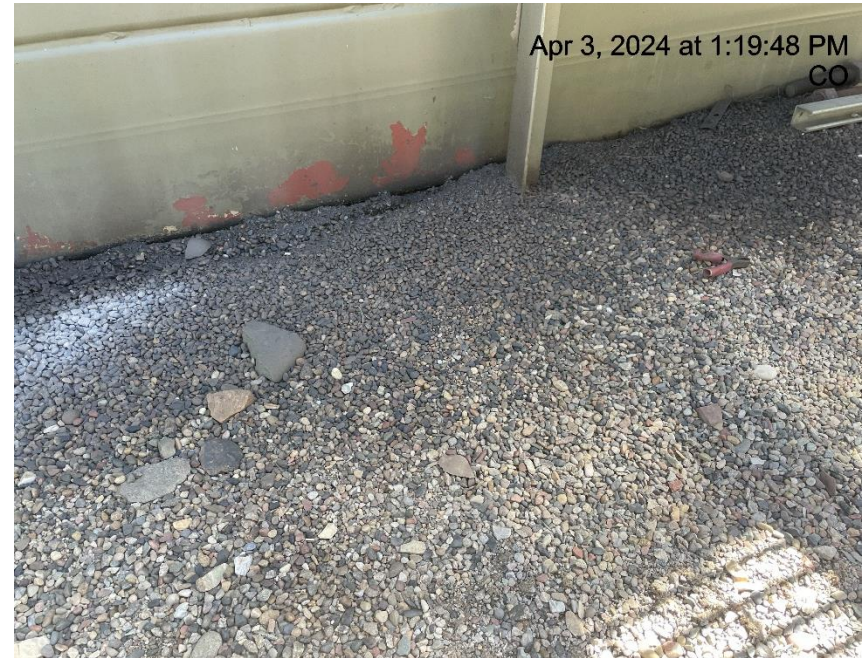
Photo # 2647 Stained soils & gravel

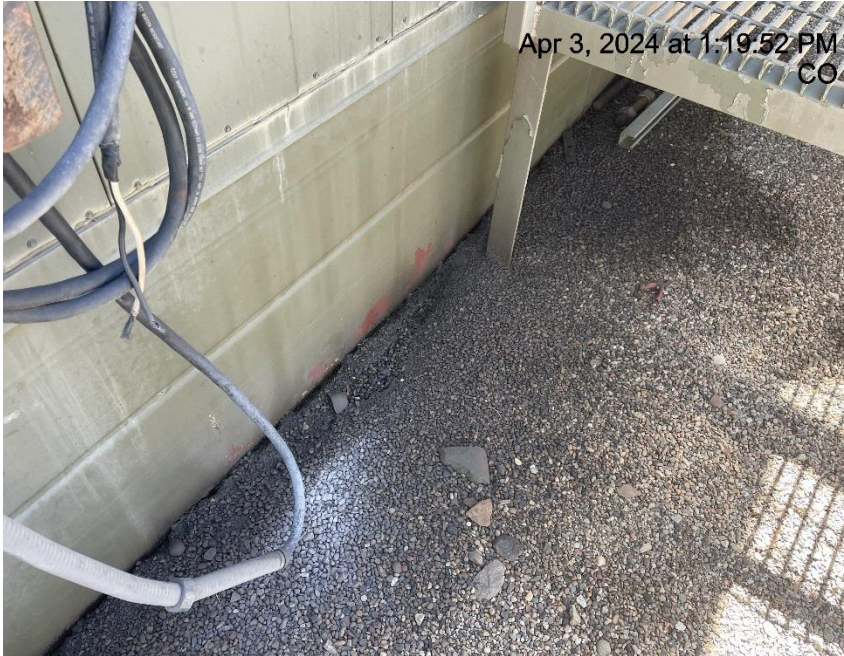
Photo # 2648 Stained soils & gravel

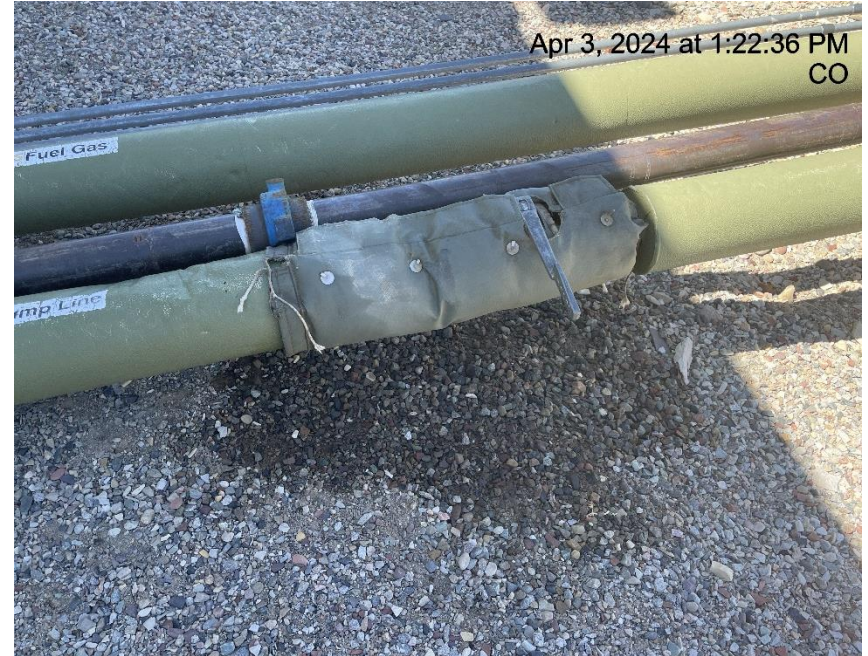
Photo # 2649 Stained soils & gravel

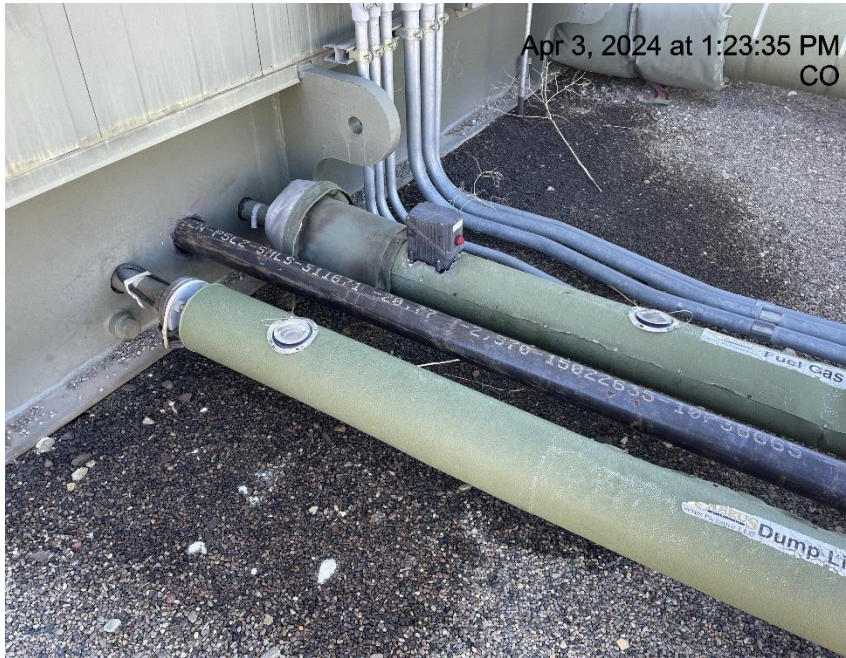
Photo # 2650 Stained soils & gravel

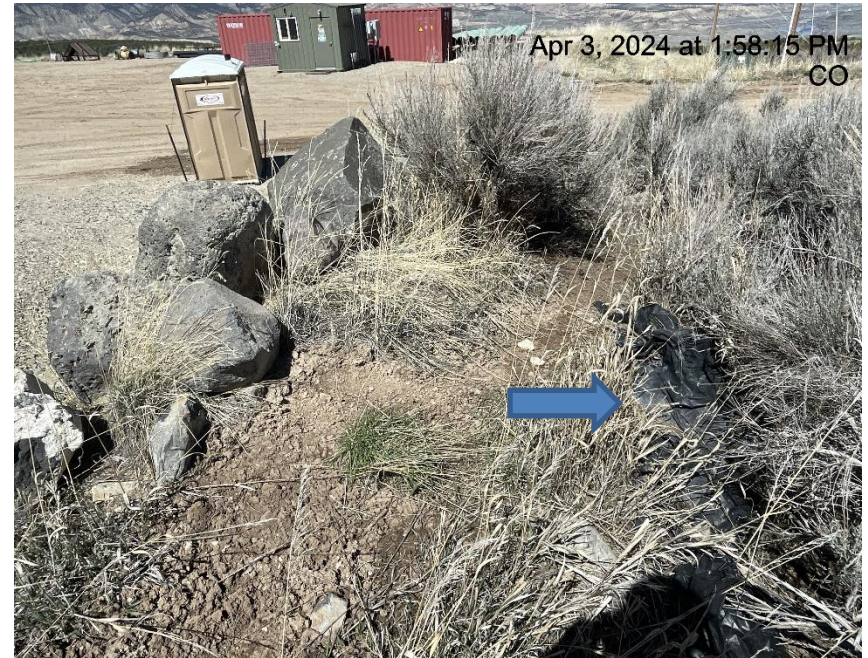
Photo # 2651 Debris

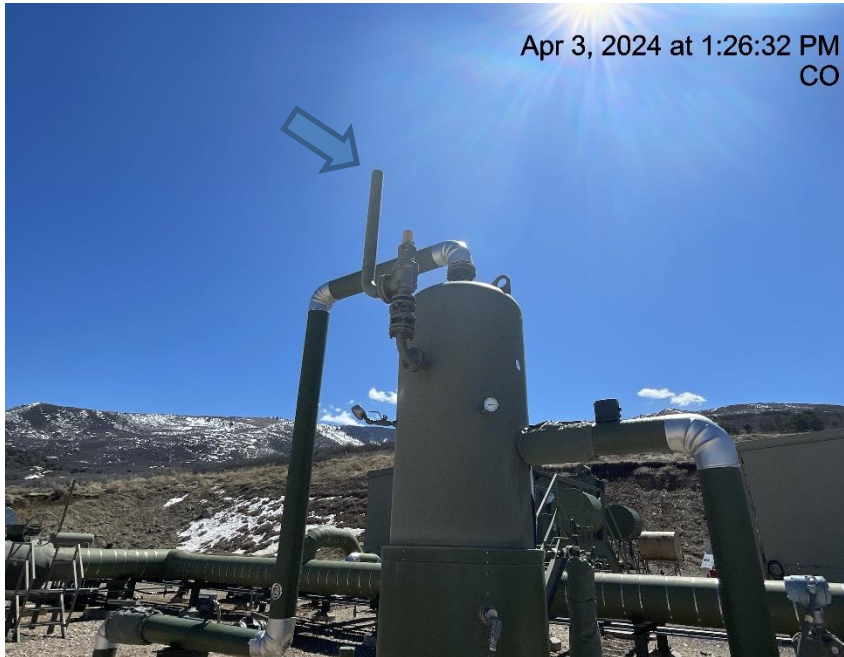
Photo # 2652 PRV vent line does not comply with CECMC pressure safety device rules

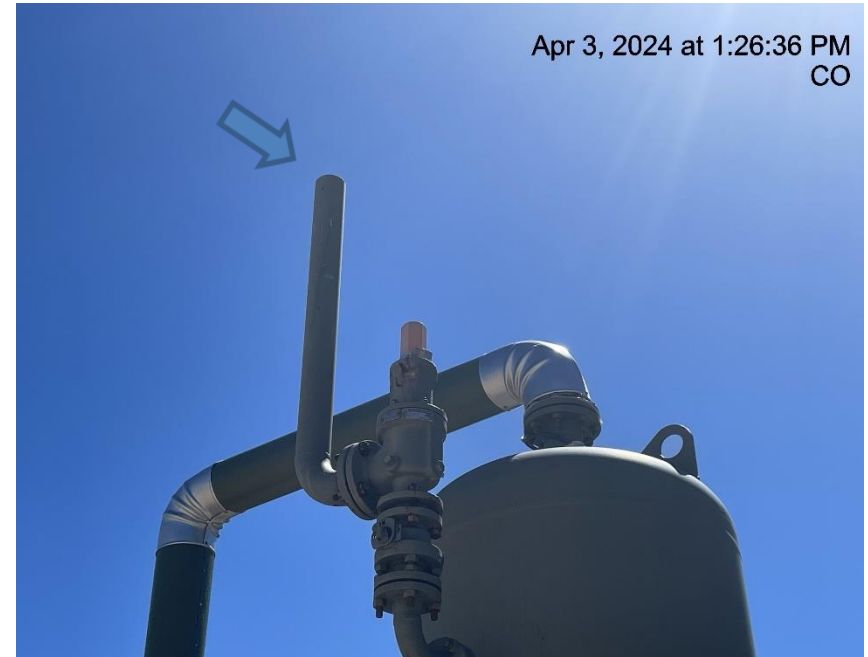
Photo # 2653 PRV vent line does not comply with CECMC pressure safety device rules

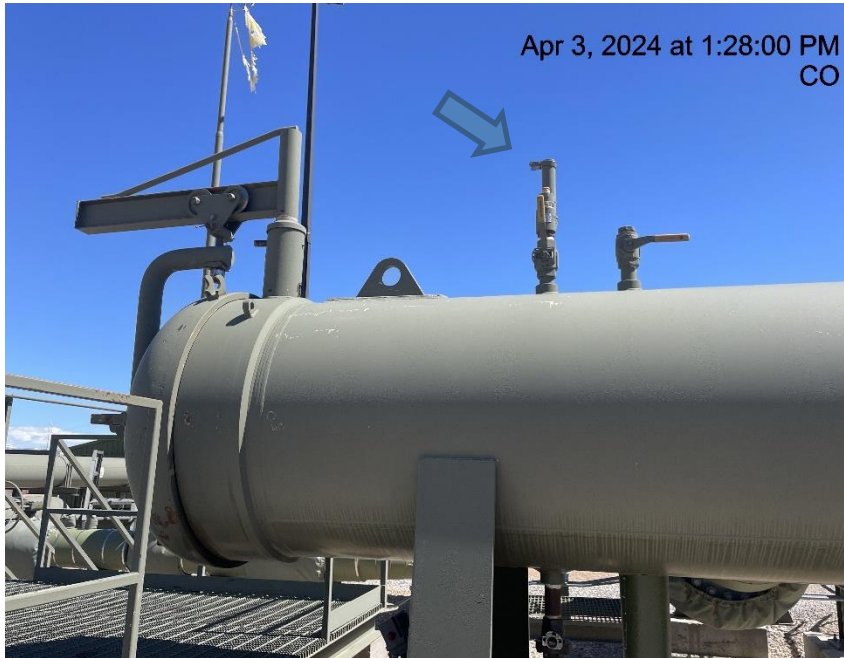
Photo # 2654 PRV vent line does not comply with CECMC pressure safety device rules

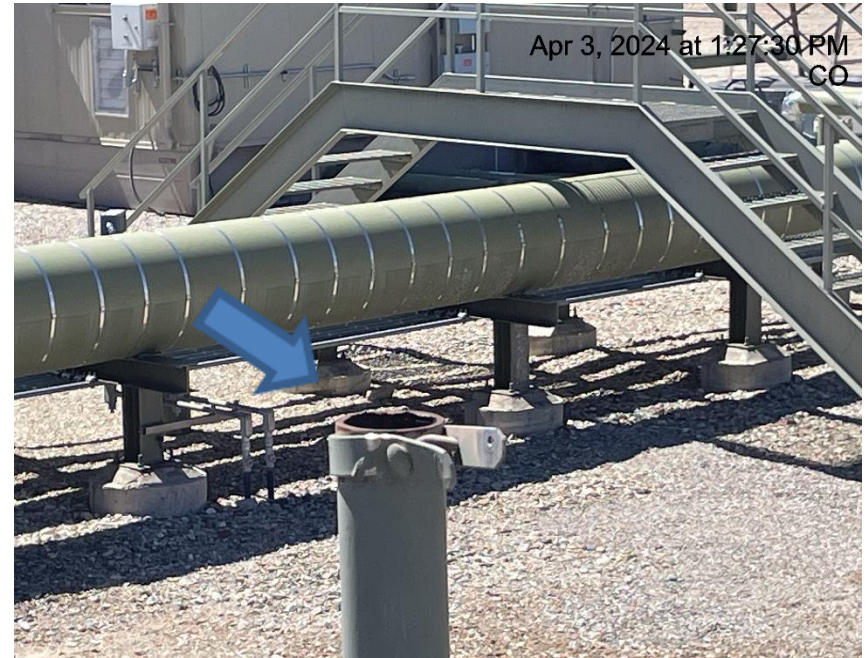
Photo # 2655 PRV vent line does not comply with CECMC pressure safety device rules

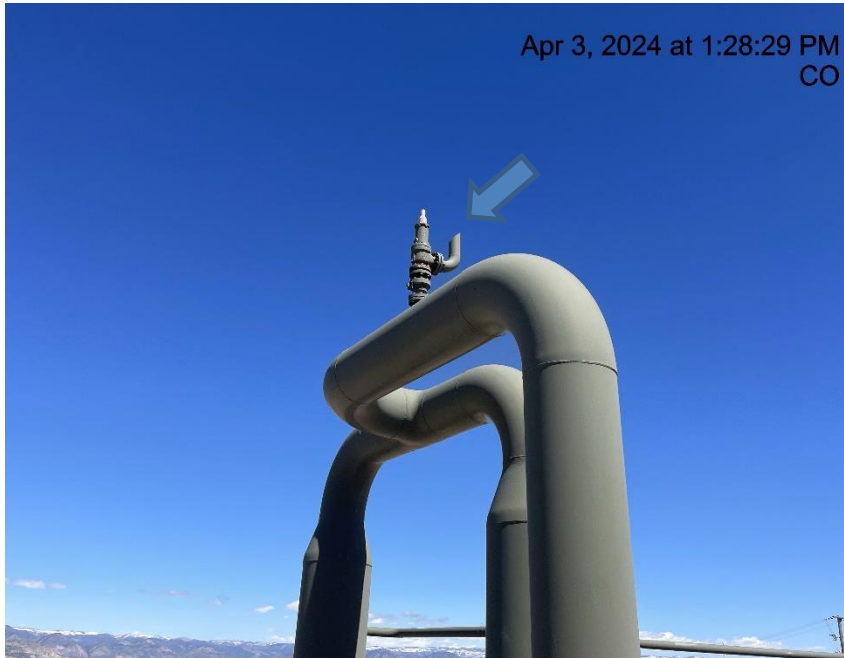
Photo # 2656 PRV vent line does not comply with CECMC pressure safety device rules

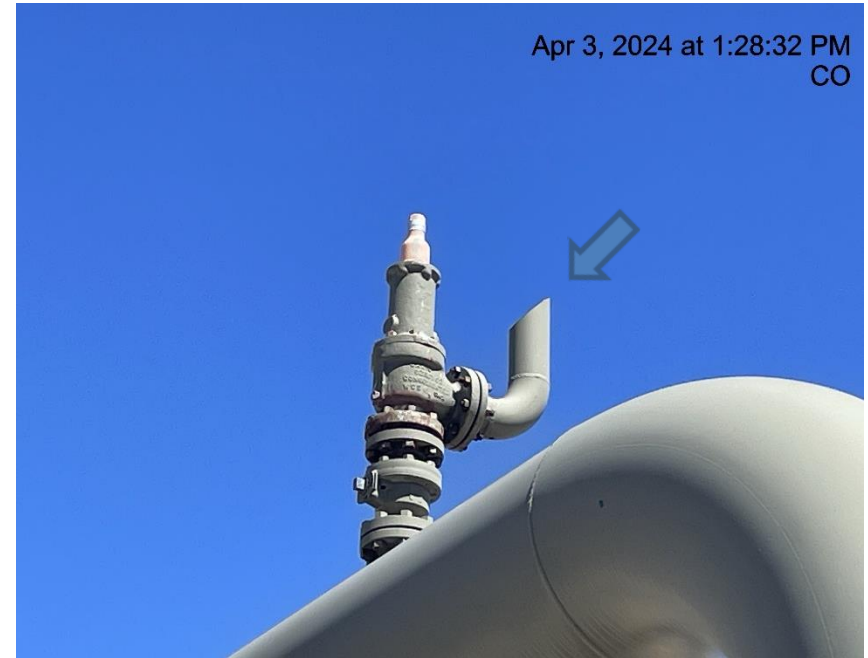
Photo # 2657 PRV vent line does not comply with CECMC pressure safety device rules

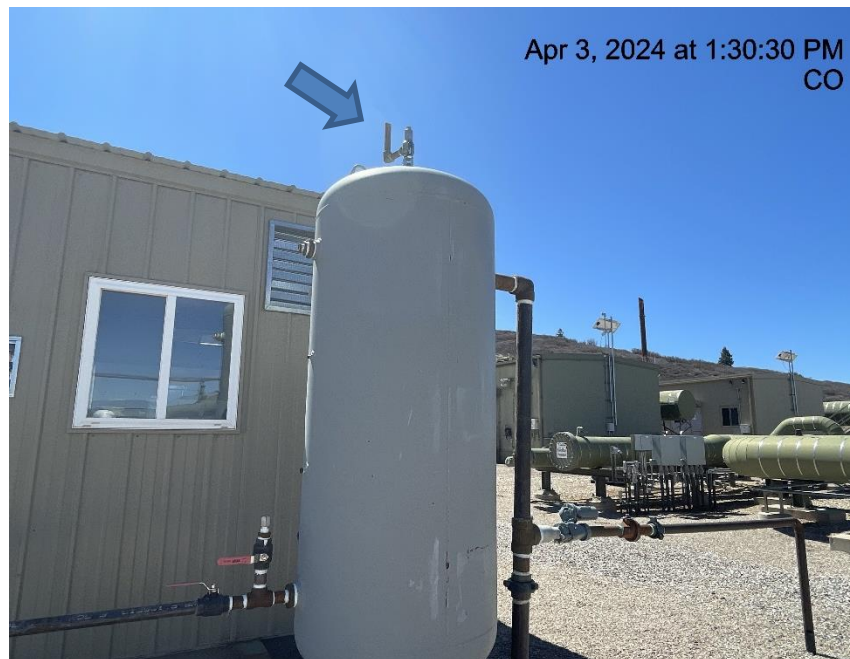
Photo # 2658 PRV vent line does not comply with CECMC pressure safety device rules

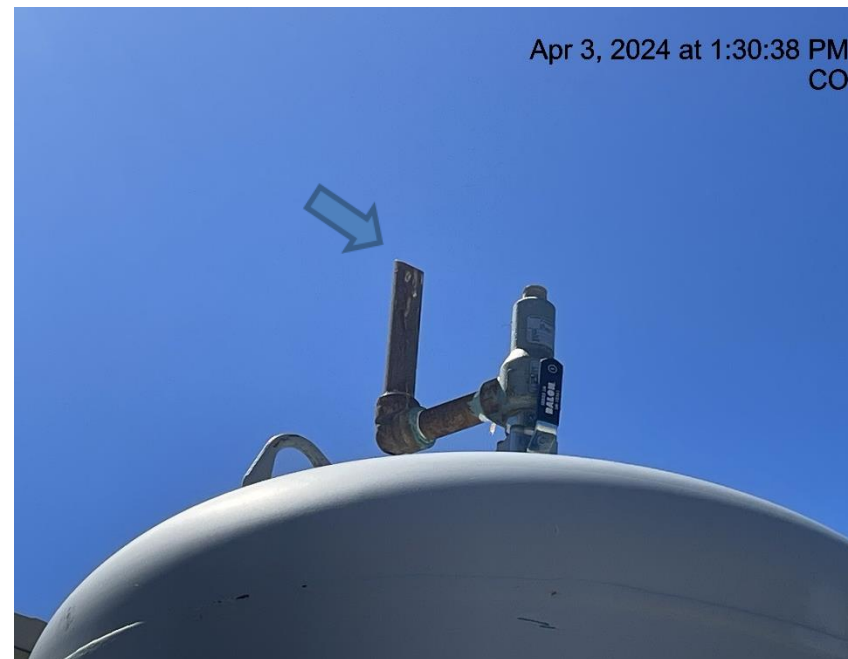
Photo # 2659 PRV vent line does not comply with CECMC pressure safety device rules

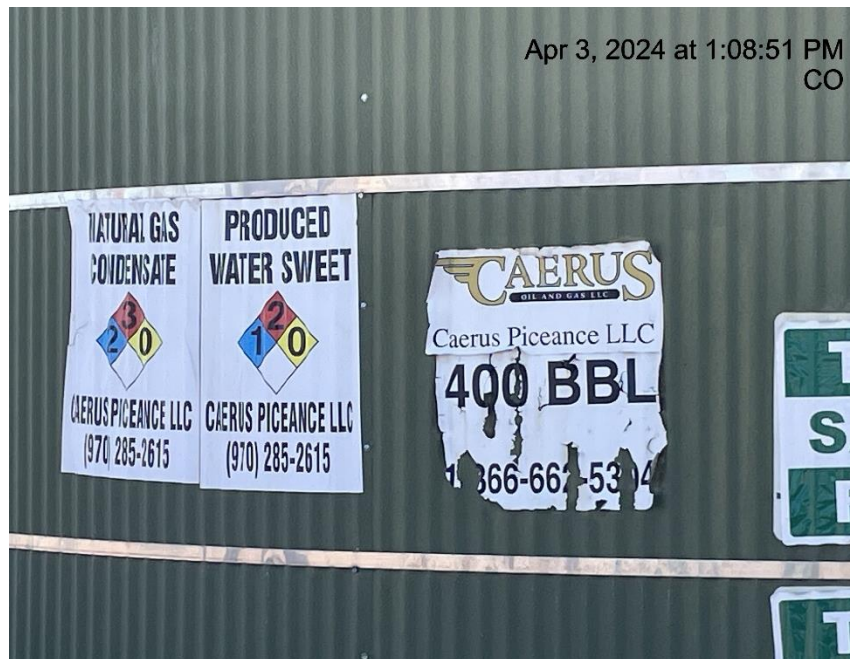
Photo # 2660 Tank label damaged & becoming illegible

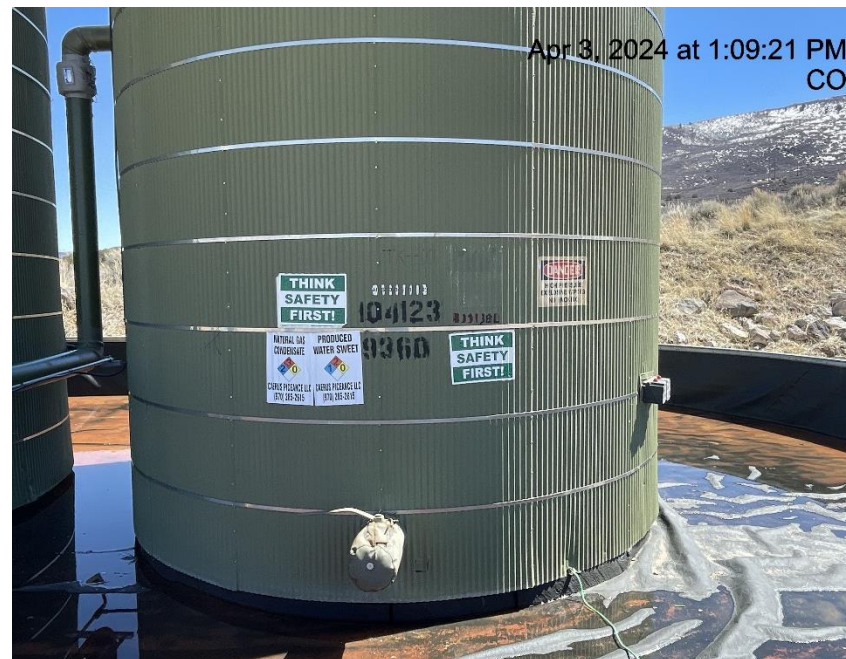
Photo # 2661 Production tank lacks some required info

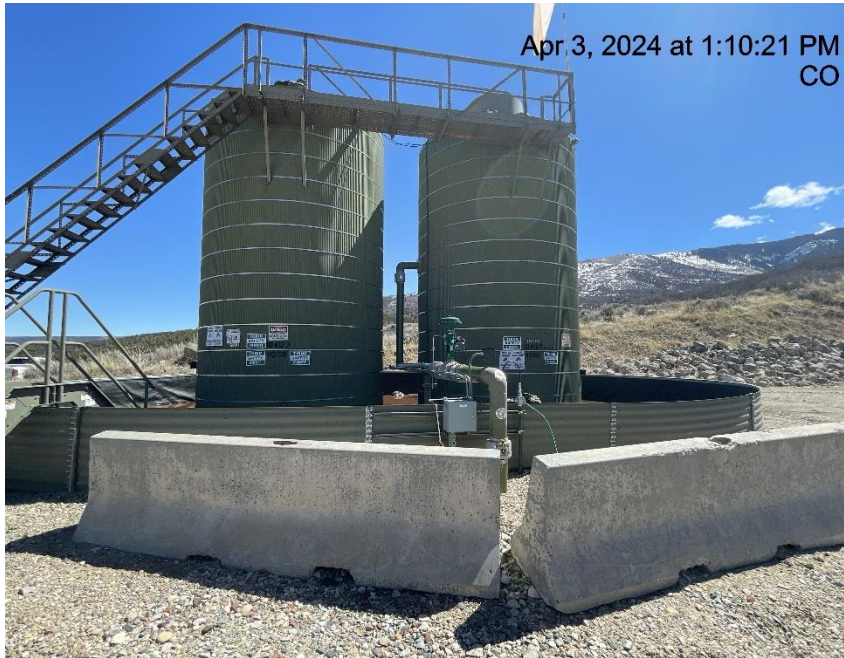
Photo # 2662 Tank battery lacks required signage
