Caerus
F17
Location ID: 335023

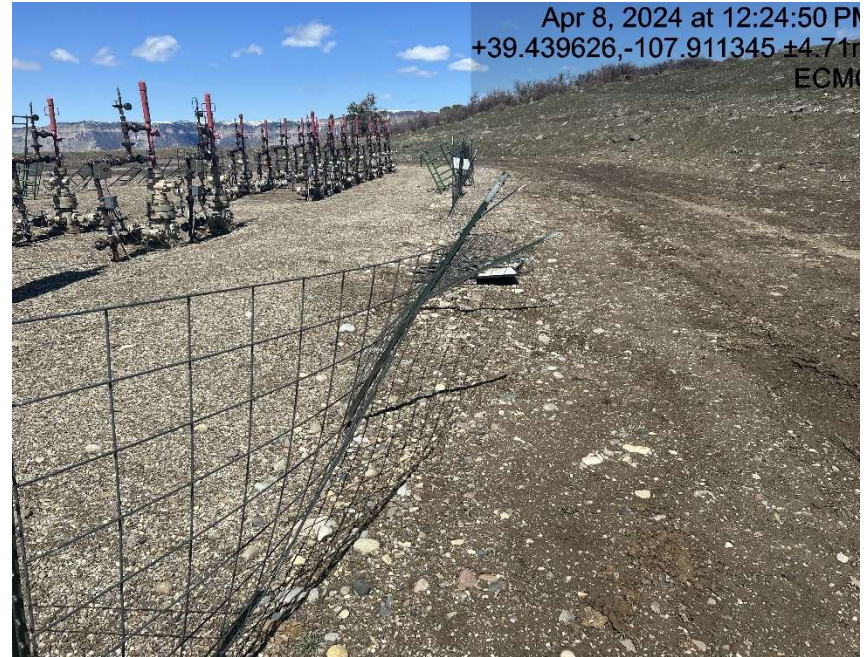
Fencing is falling down

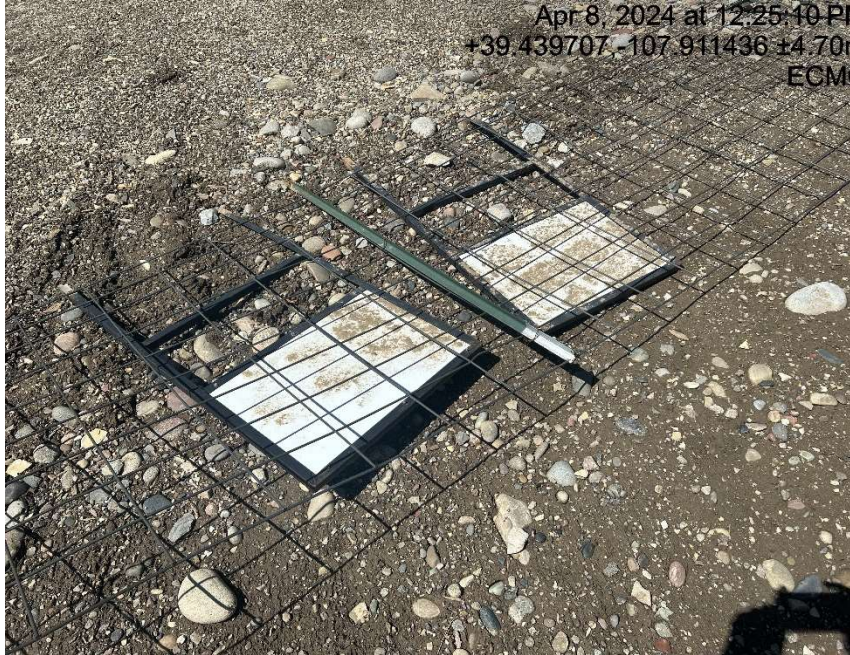
Fencing is falling down

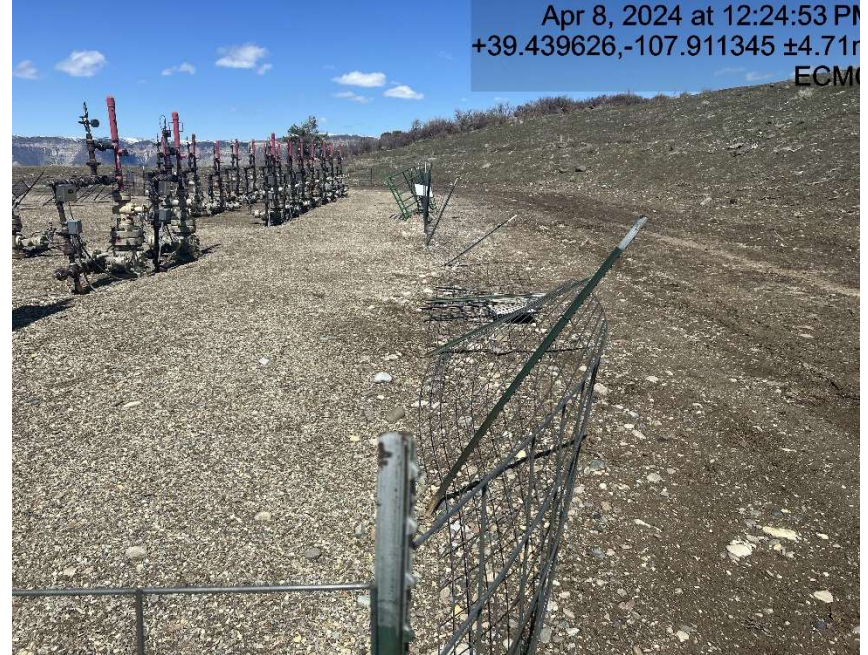
Fencing is falling down

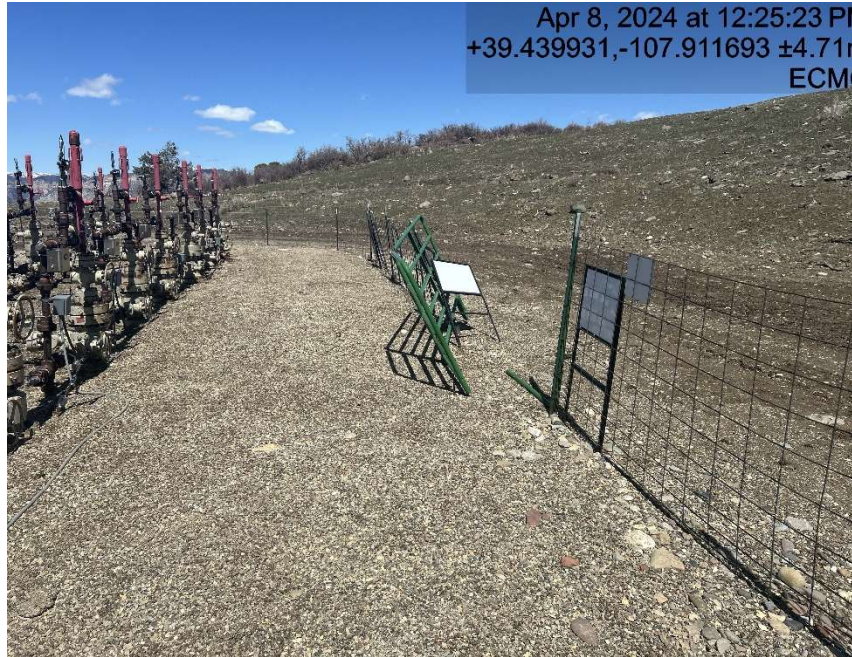
Fencing is falling down

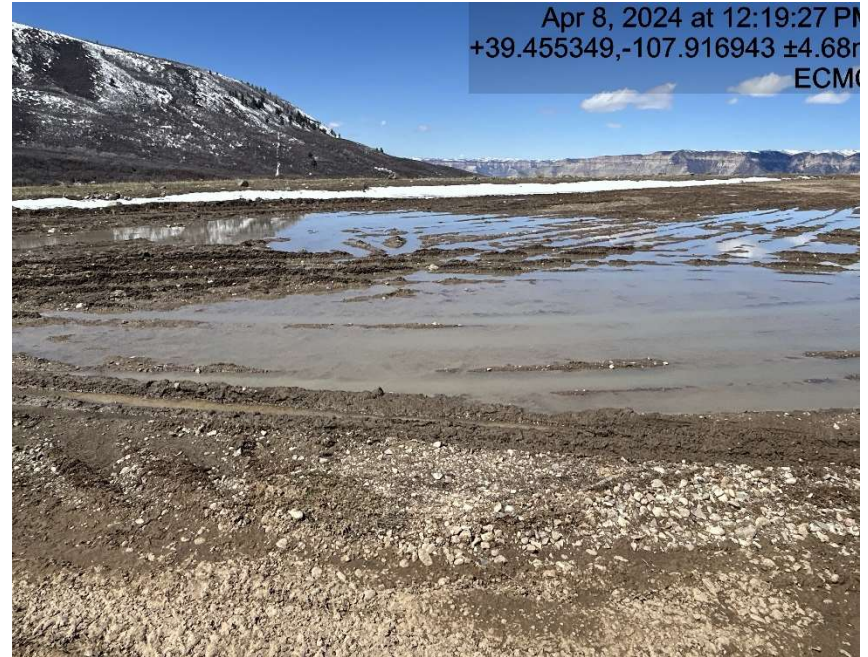
Lack of stabilization/compaction

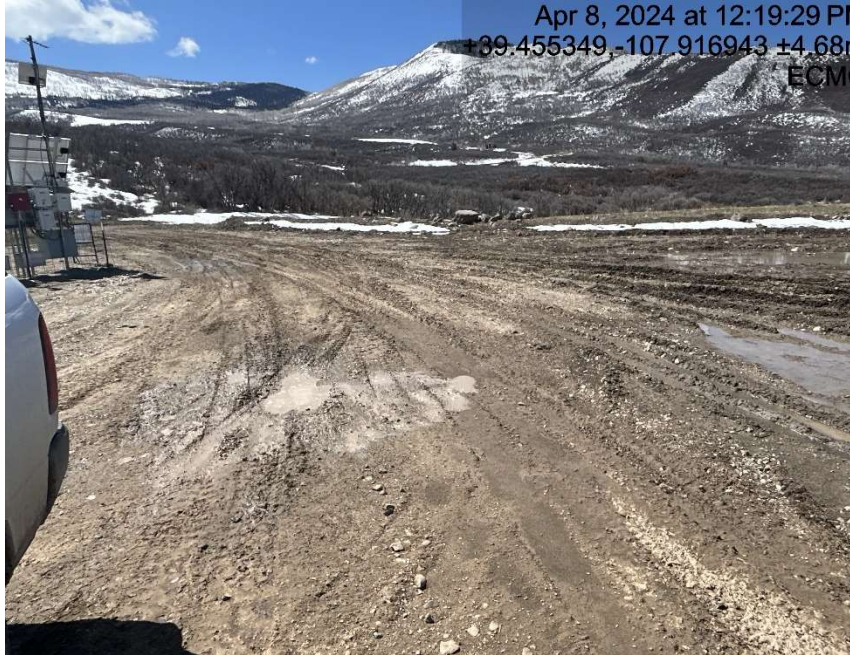
Lack of stabilization/compaction

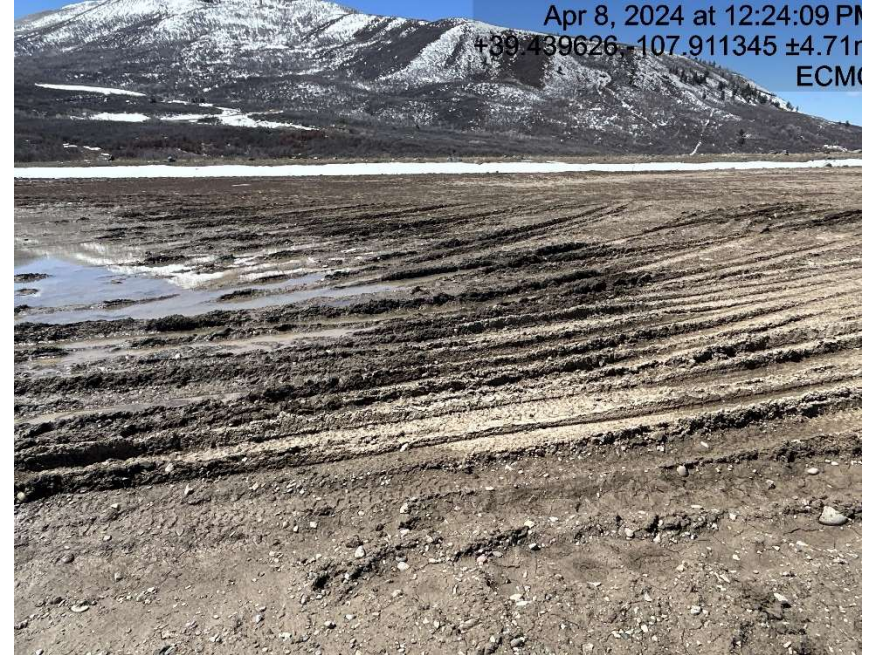
Lack of stabilization/compaction

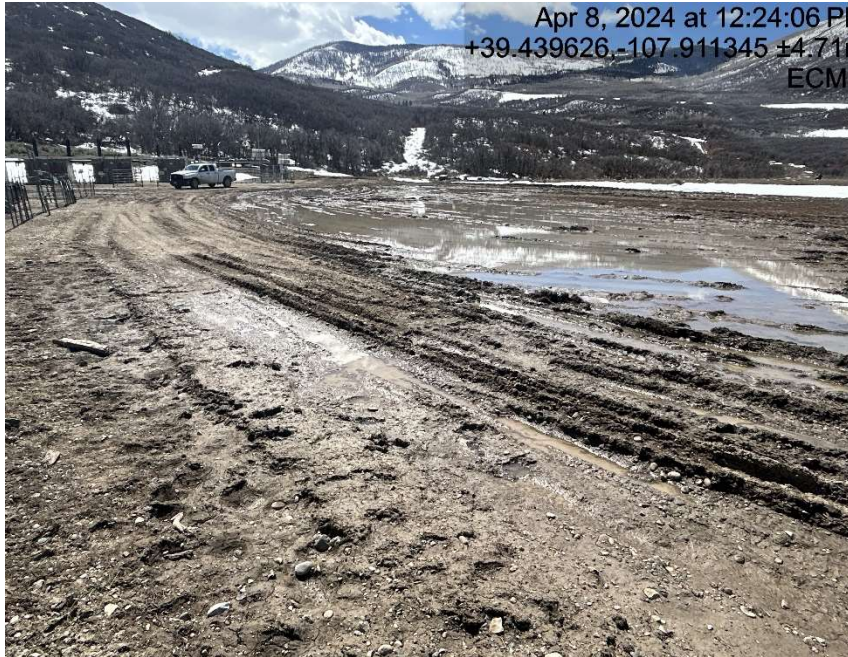
Lack of stabilization/compaction

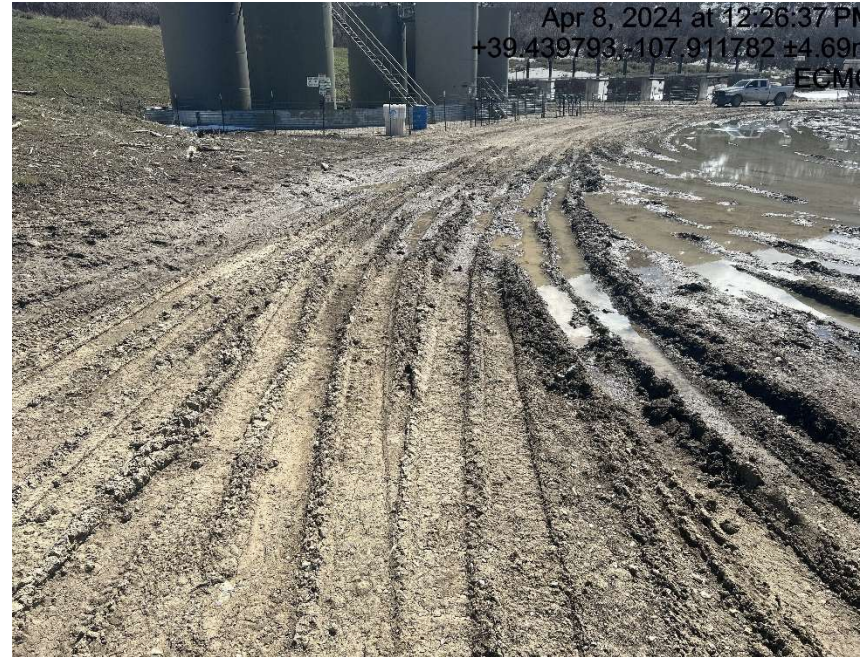
Lack of stabilization/compaction

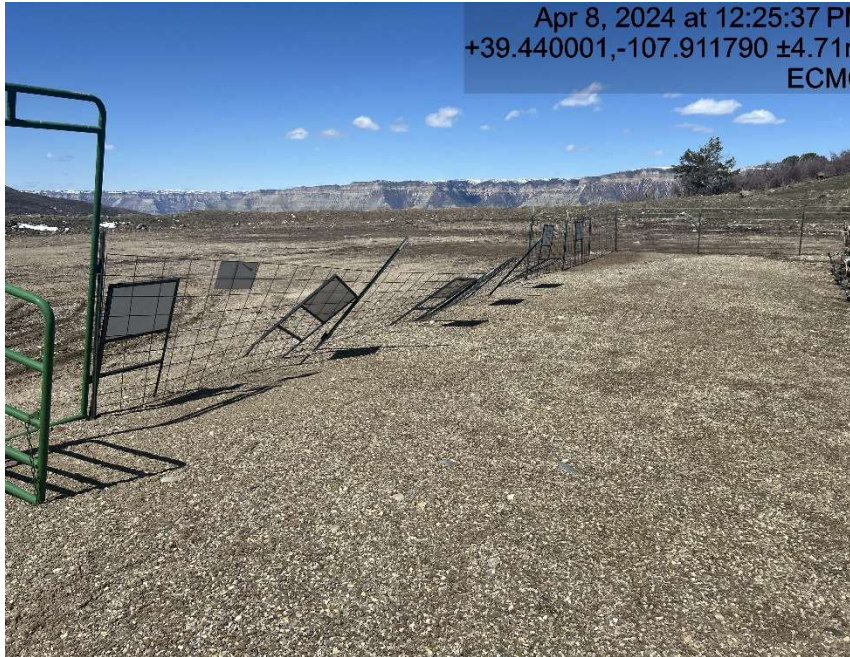
Fencing is falling down

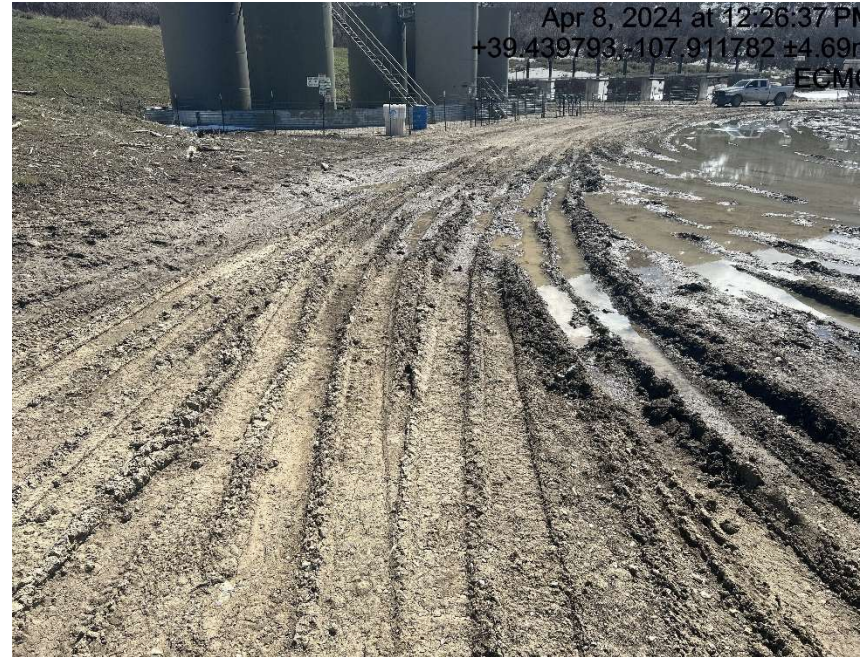
Lack of stabilization/compaction

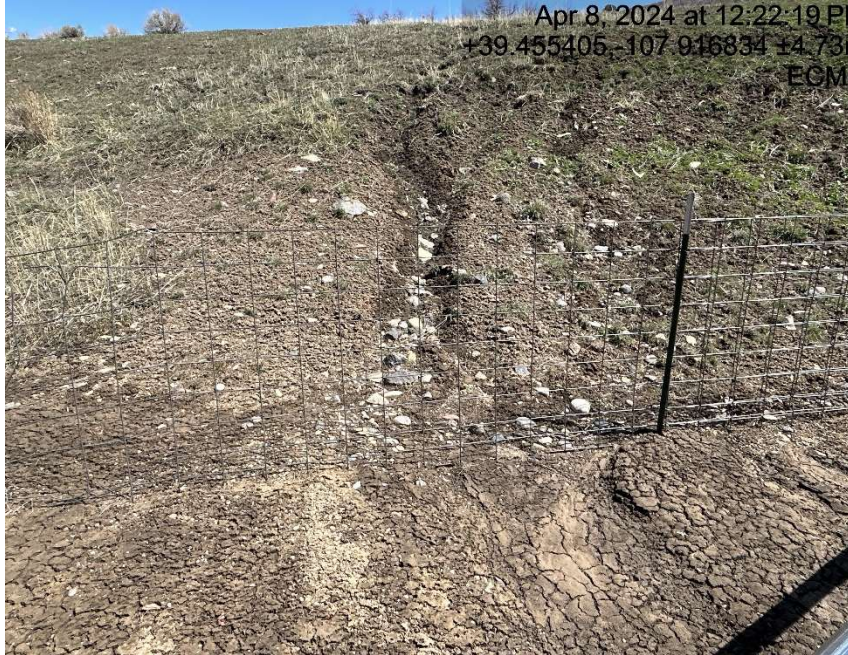
Some areas of cut slope show signs of erosion
