Interim Reclamation and Stormwater Inspection

Operator: Highpoint Operating Corporation - 10071

Weld County, CO

Location Name: Anschutz Equus Farms

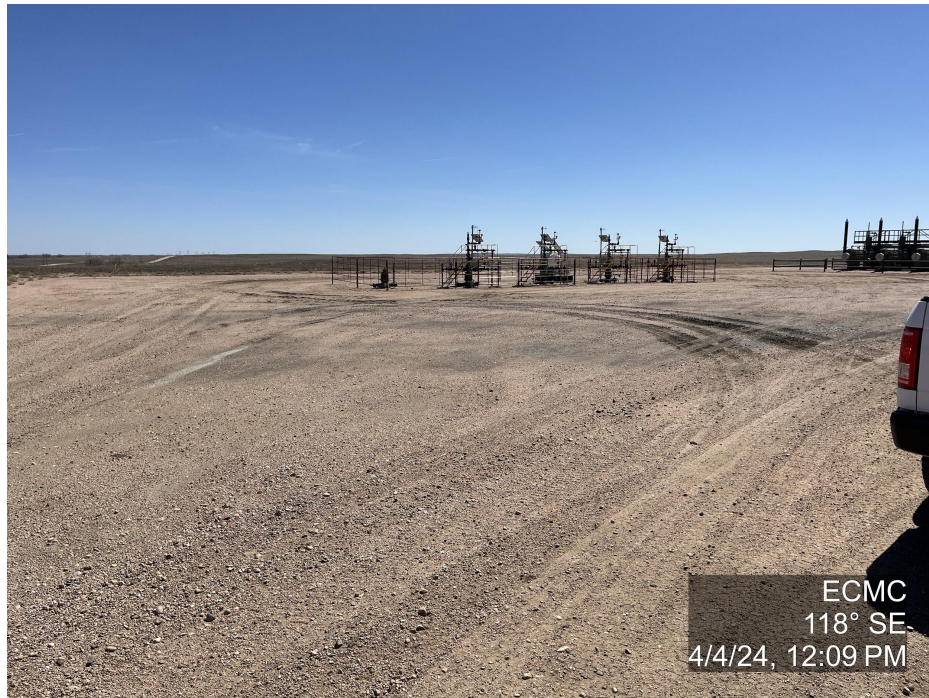
Photo 1. The photo was taken at the well location facing Southeast. The photo illustrates the production pad.

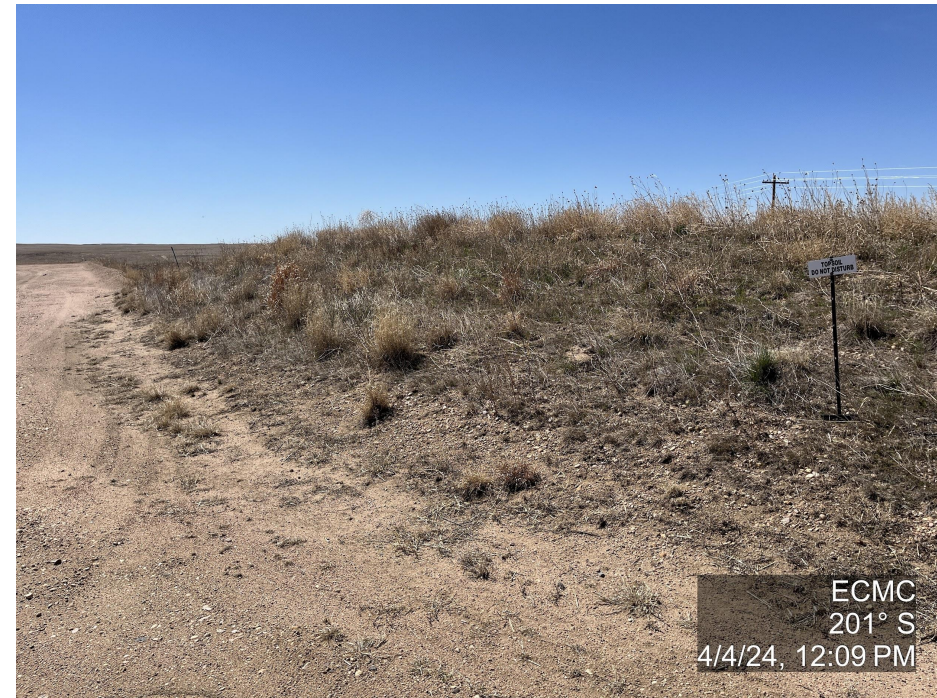
Photo 2. The photo was taken at the well location facing South. The photo illustrates the marked topsoil stockpile with good germination of perennial vegetation.

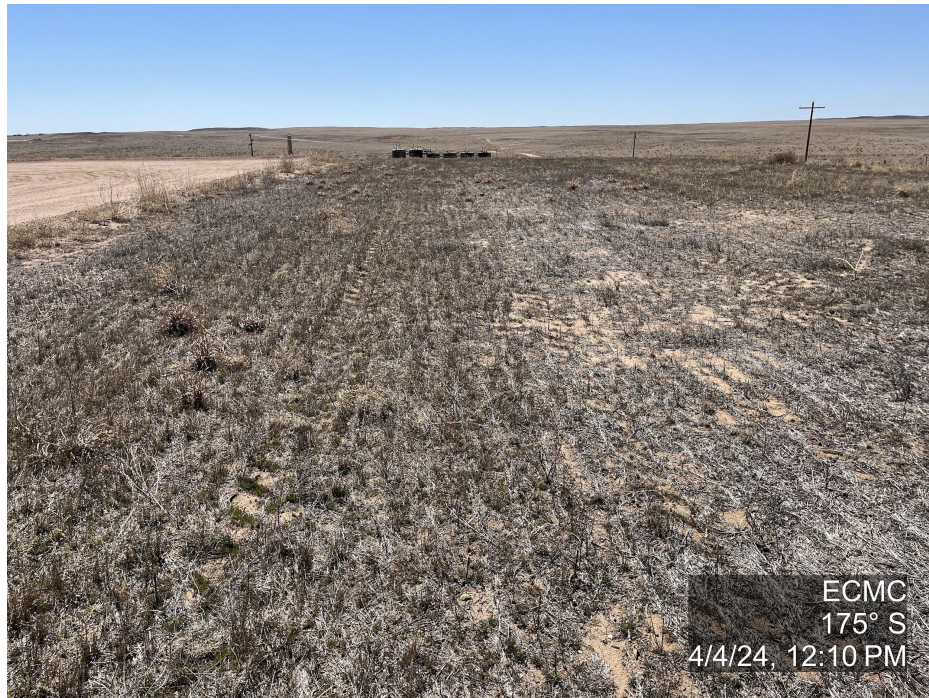
Photo 3. The photo was taken at the well location facing South. The photo illustrates the interim area on the West side of the location has been mowed.

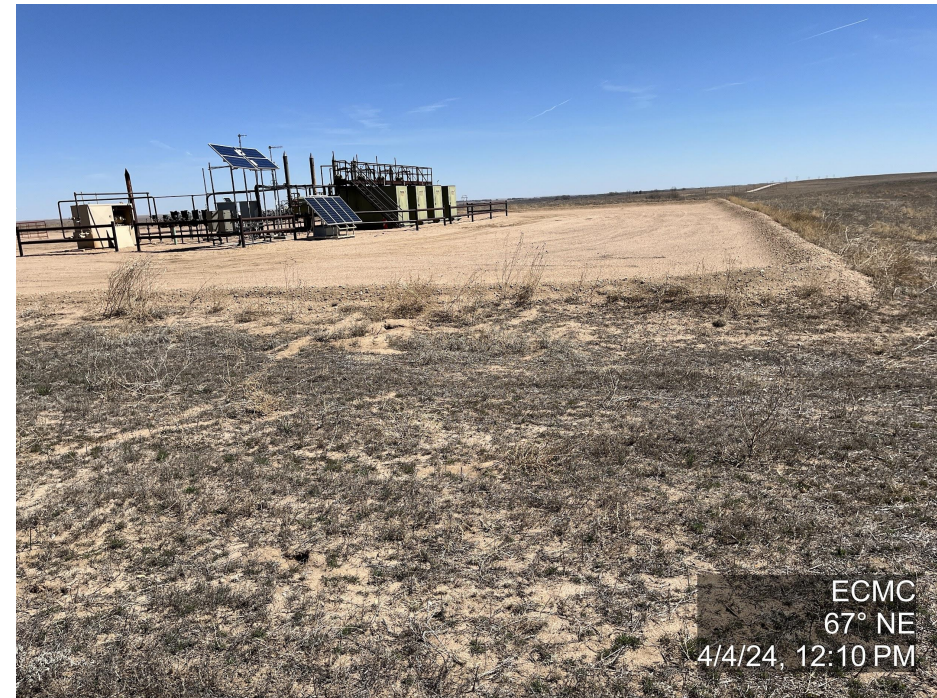
Photo 4. The photo was taken at the well location facing Northeast. The photo illustrates the berm around the edge of the production pad.

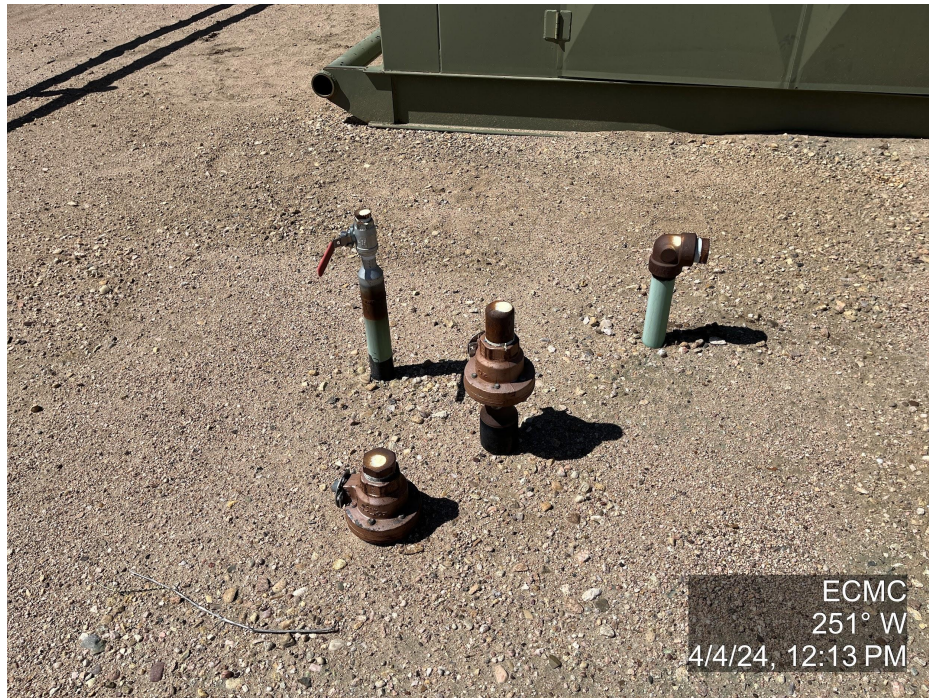
Photo 5. The photo was taken at the well location facing West. The photo illustrates unmarked risers at the location.

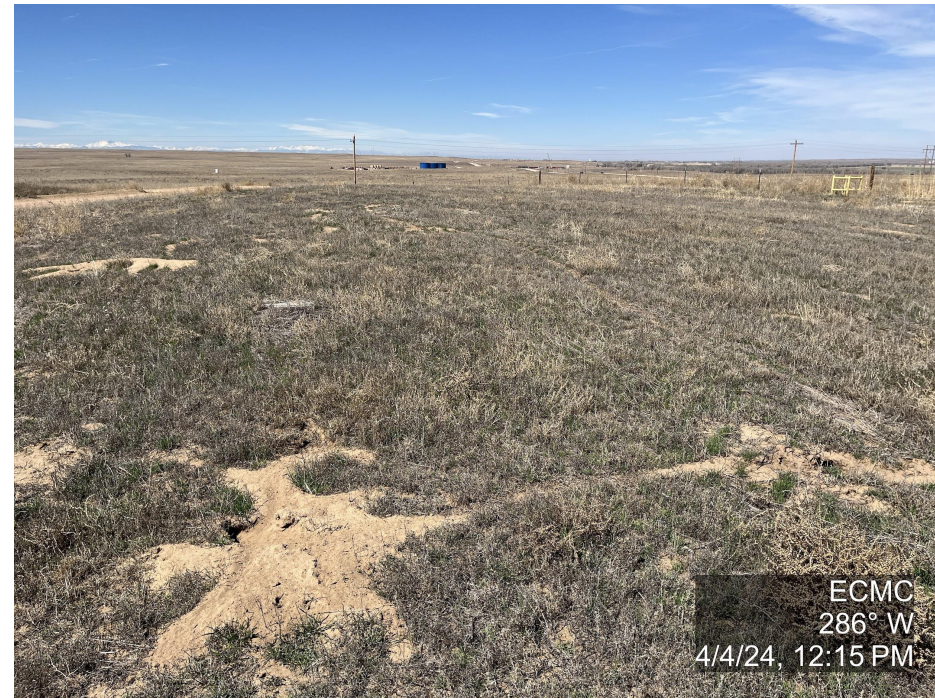
Photo 6. The photo was taken at the well location facing West. The photo illustrates the Northern interim area has been mowed.

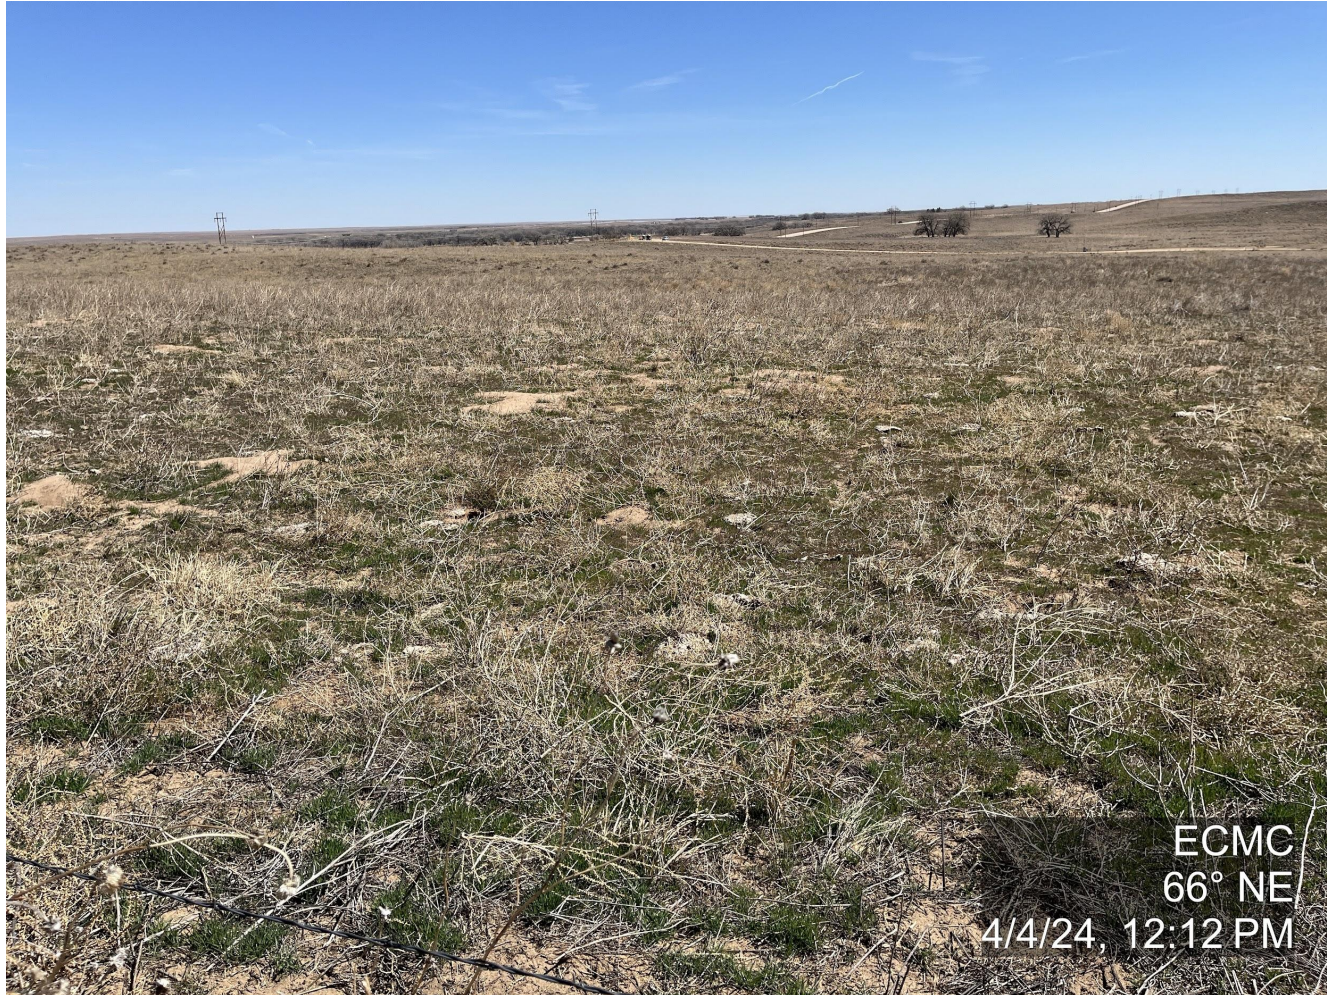
Photo 7. The reference photo was taken at the edge of the location facing Northeast.
