Inspection Photos

Location Name: CAERUS PICEANCE LLC CLEM JR. (PB-15) Pad

Location ID: 334653

COLORADO
Energy & Carbon Management
Commission
Department of Natural Resources

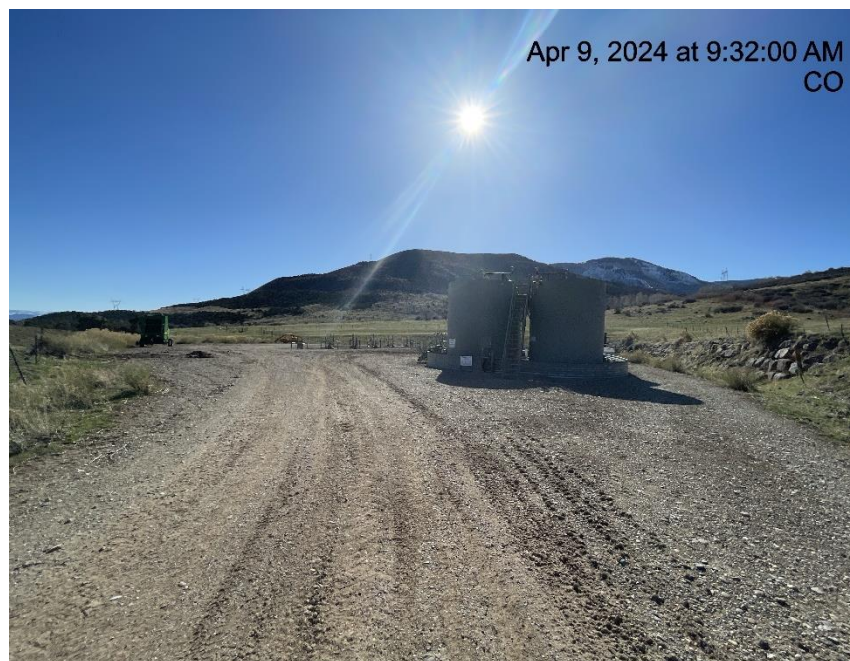
Photo # 3210 From entrance to location

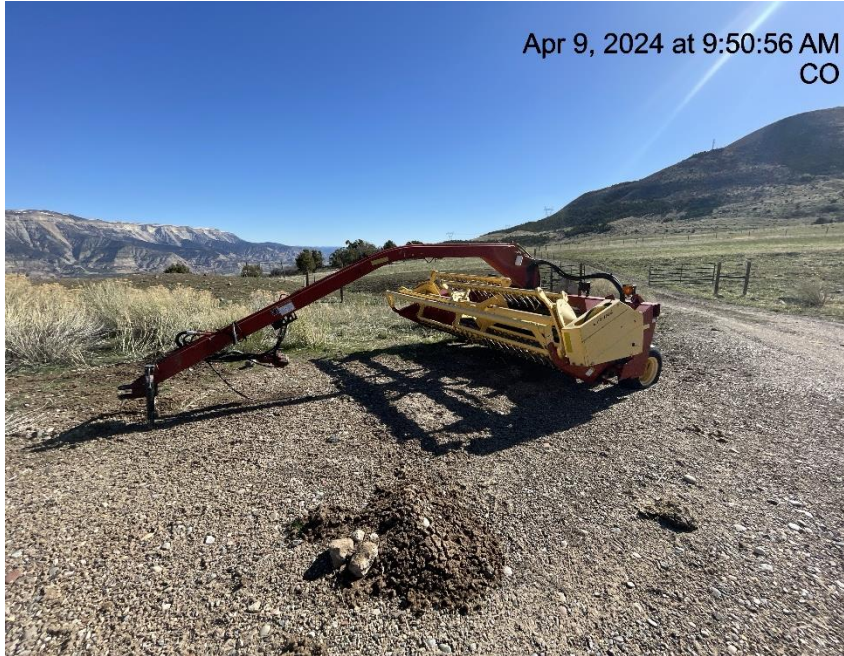
Photo # 3218 Stored farm equipment on location

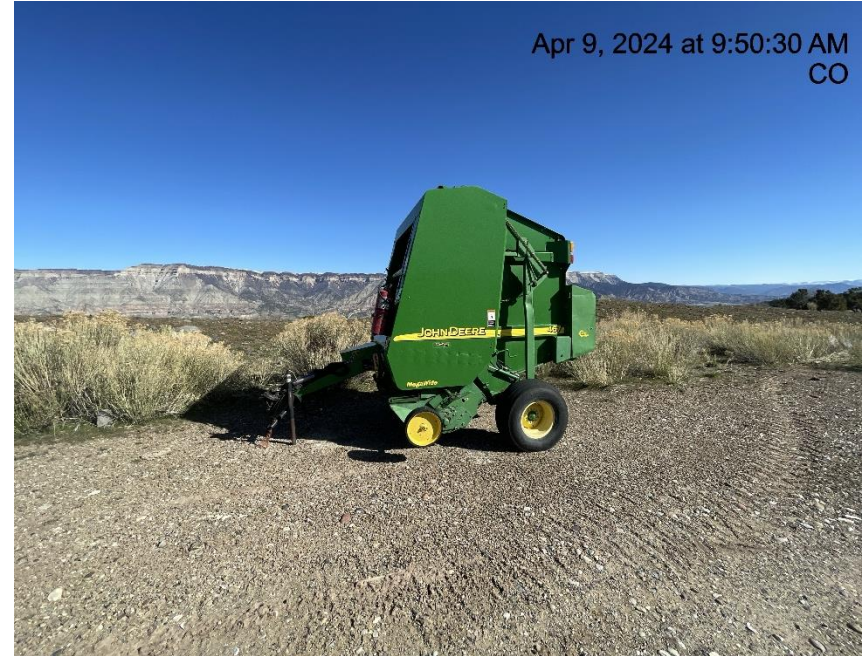
Photo # 3219 Stored farm equipment on location

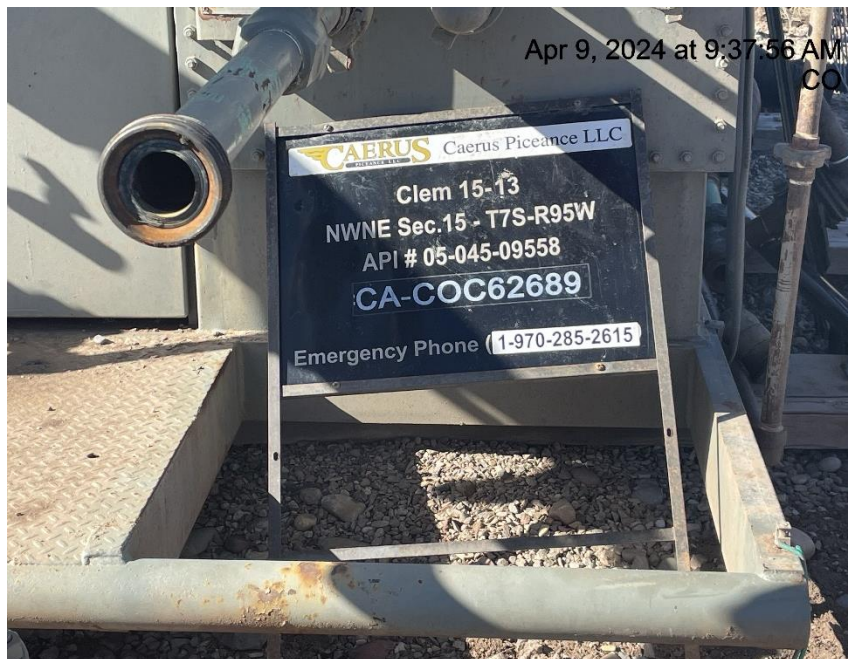
Photo # 3220 Open ended piping on separator/wildlife hazard/available for entry by wildlife

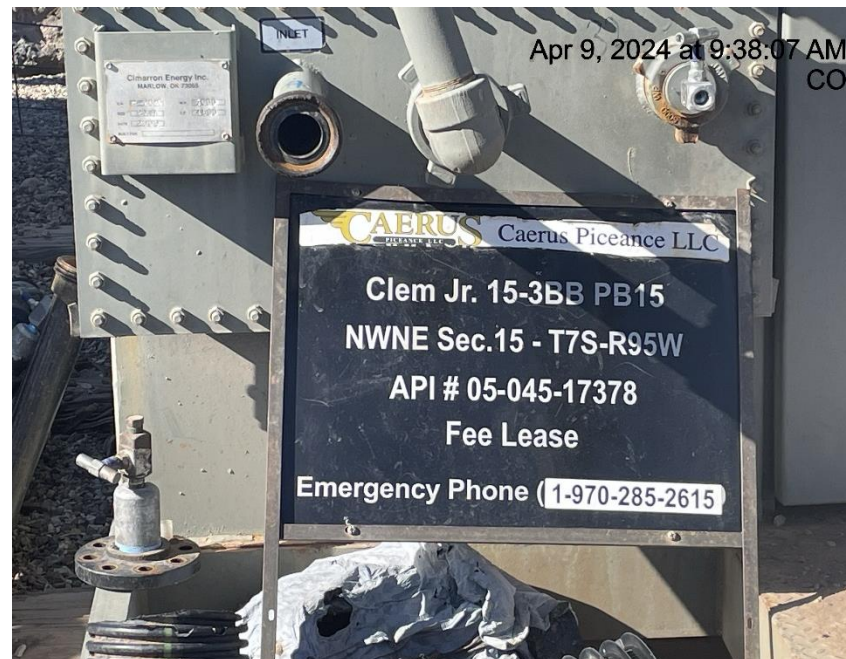
Photo # 3221 Open ended piping on separator/wildlife hazard/available for entry by wildlife

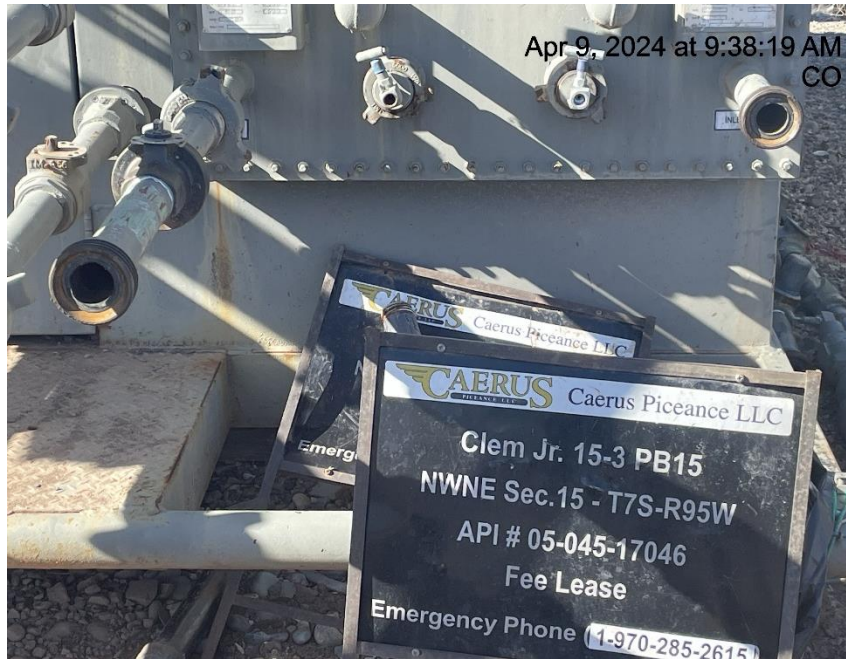
Photo # 3222 Open ended piping on separator/wildlife hazard/available for entry by wildlife

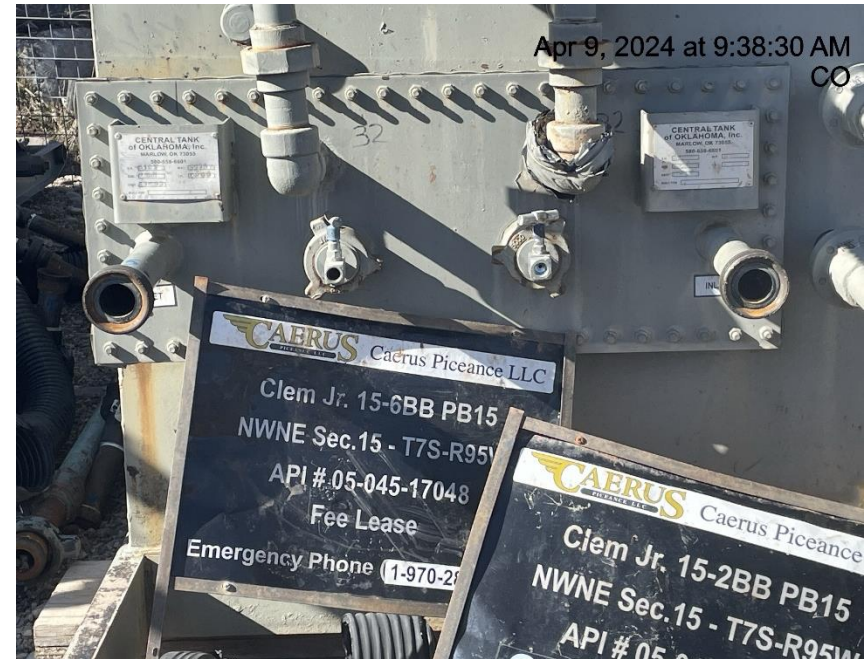
Photo # 3223 Open ended piping on separator/wildlife hazard/available for entry by wildlife

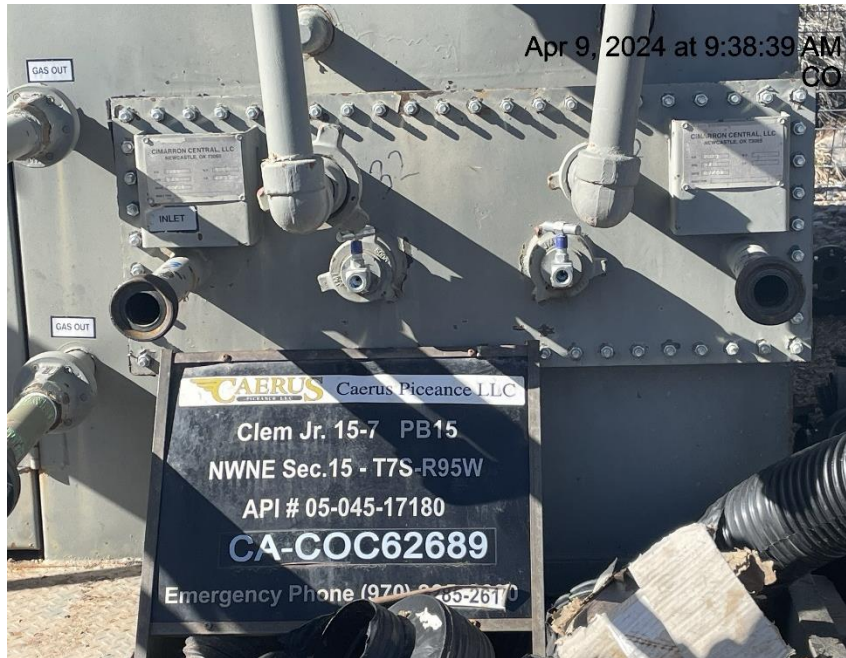
Photo # 3224 Open ended piping on separator/wildlife hazard/available for entry by wildlife

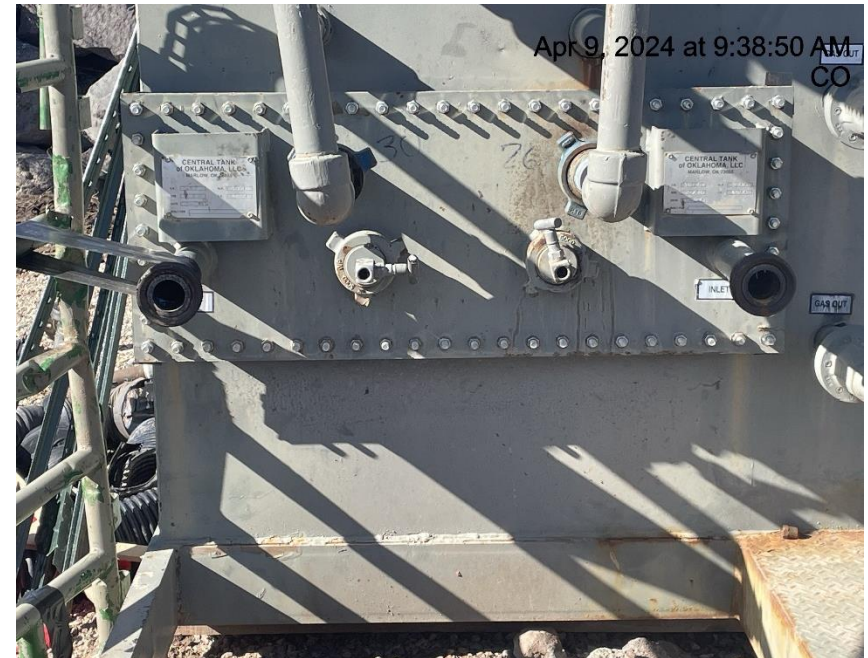
Photo # 3225 Open ended piping on separator/wildlife hazard/available for entry by wildlife

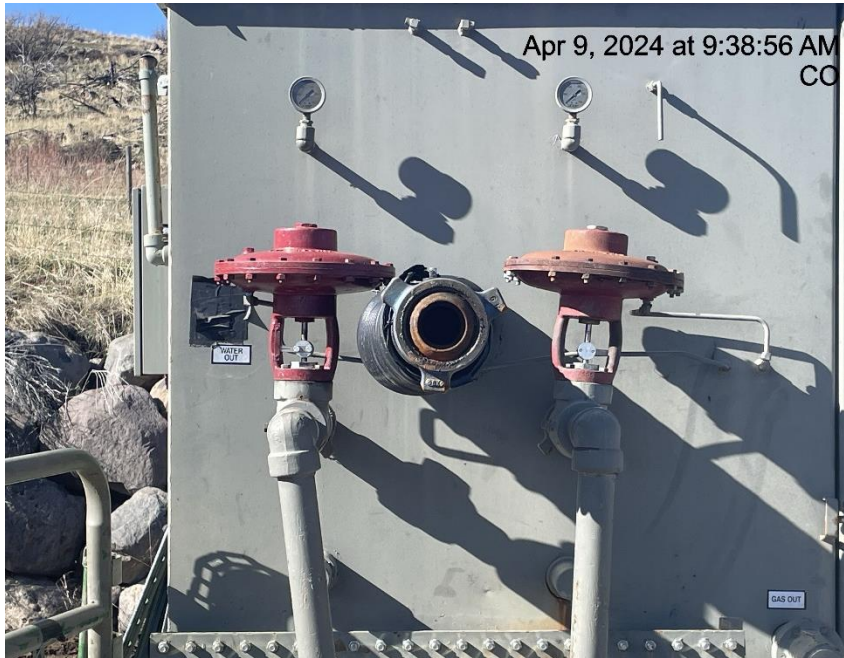
Photo # 3226 Open ended piping on separator/wildlife hazard/available for entry by wildlife

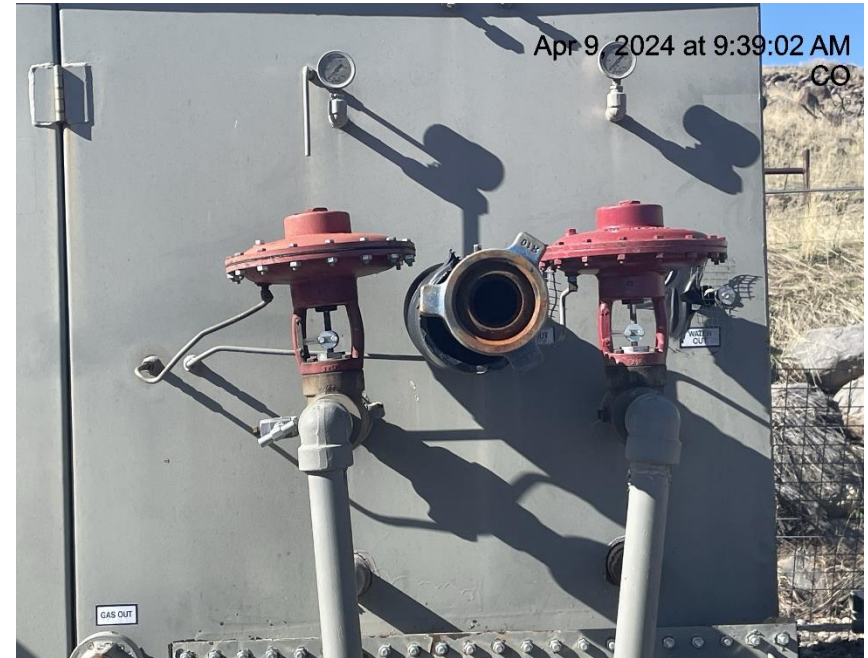
Photo # 3227 Open ended piping on separator/wildlife hazard/available for entry by wildlife

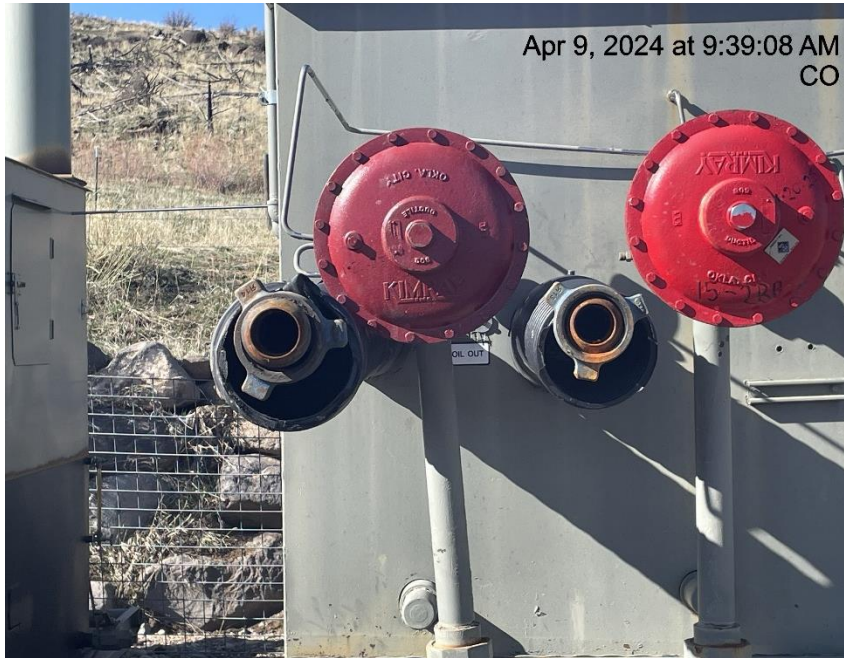
Photo # 3228 Open ended piping on separator/wildlife hazard/available for entry by wildlife

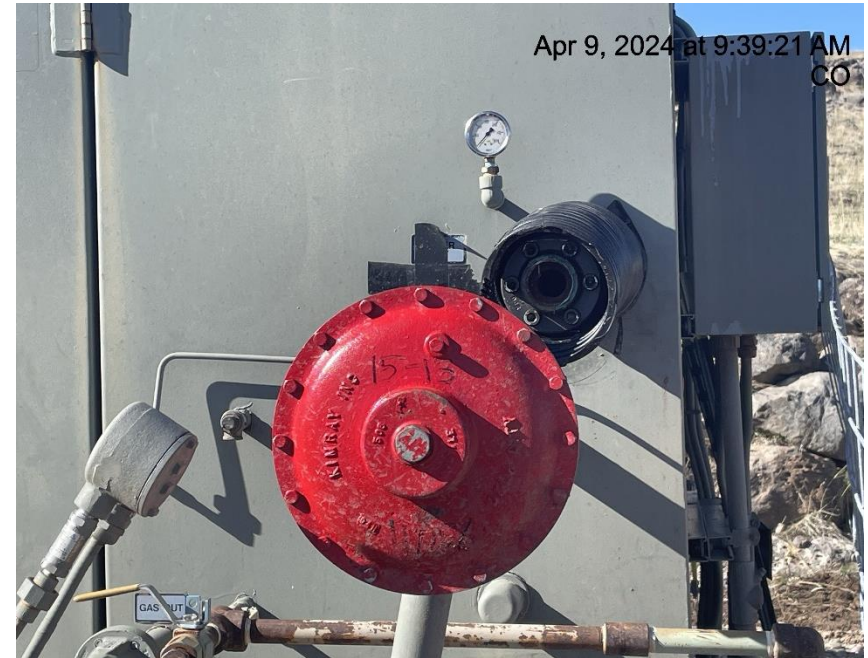
Photo # 3229 Open ended piping on separator/wildlife hazard/available for entry by wildlife

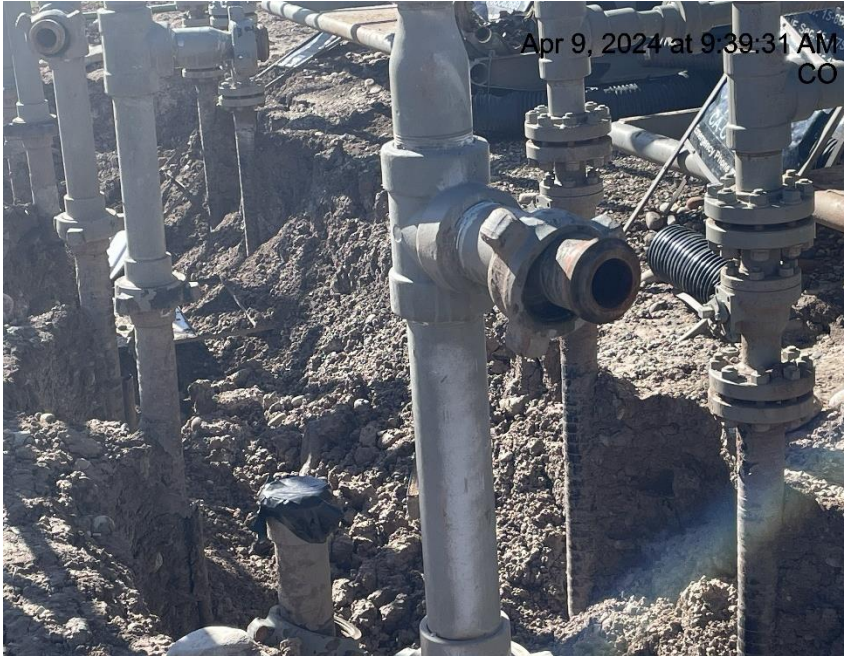
Photo # 3230 Open ended piping/wildlife hazard/available for entry by wildlife

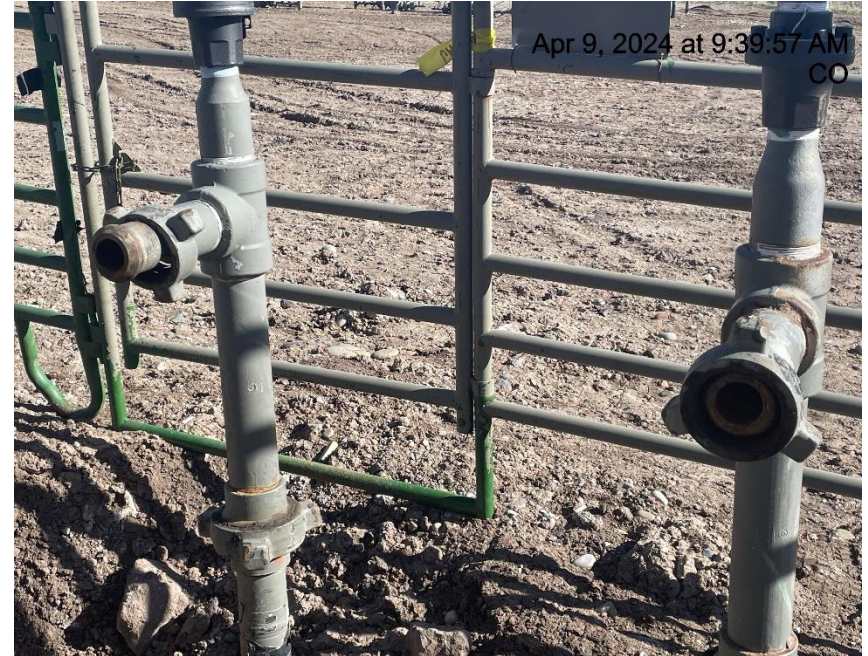
Photo # 3231 Open ended piping/wildlife hazard/available for entry by wildlife

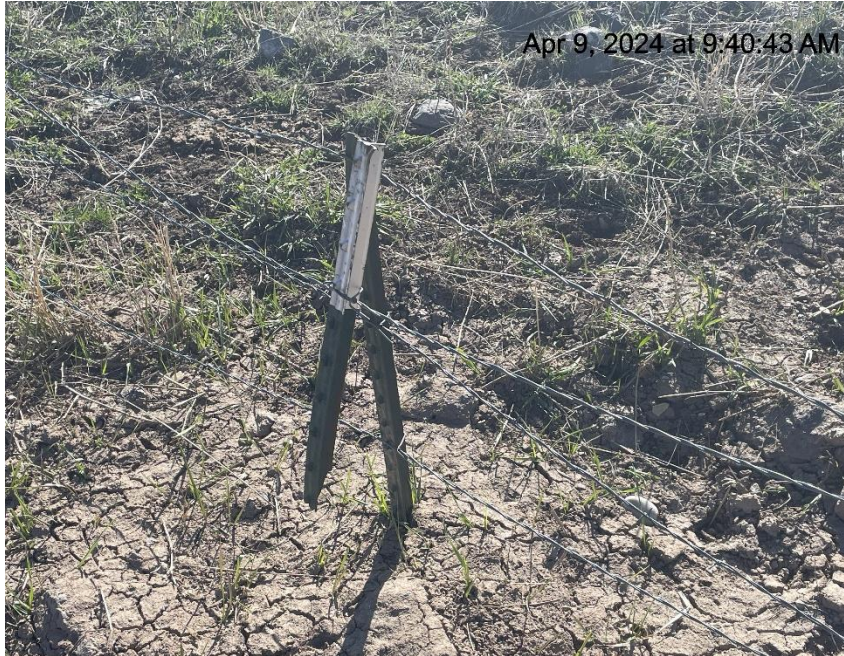
Photo # 3232 Barbed wire fence needs maintenance

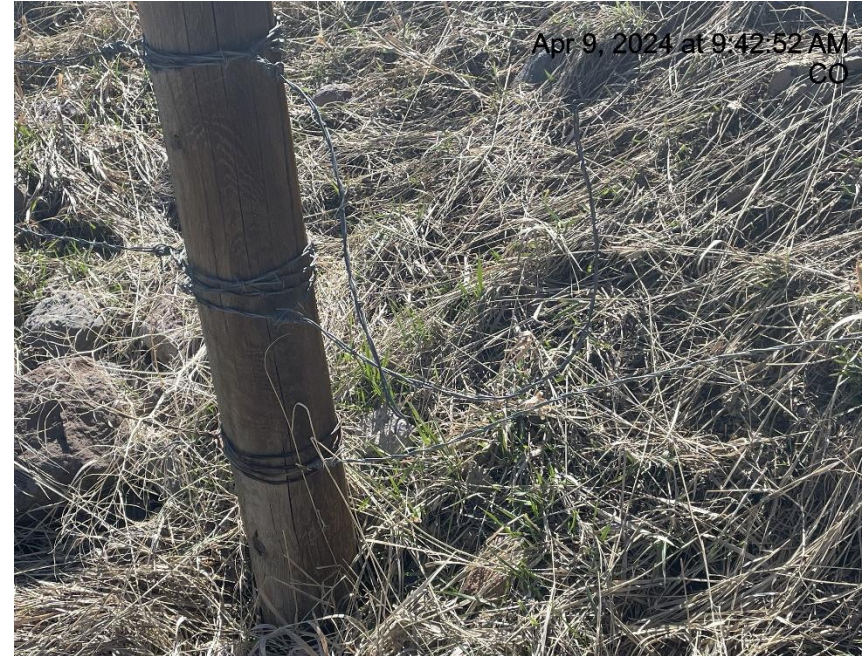
Photo # 3233 Barbed wire fence needs maintenance/wildlife hazard

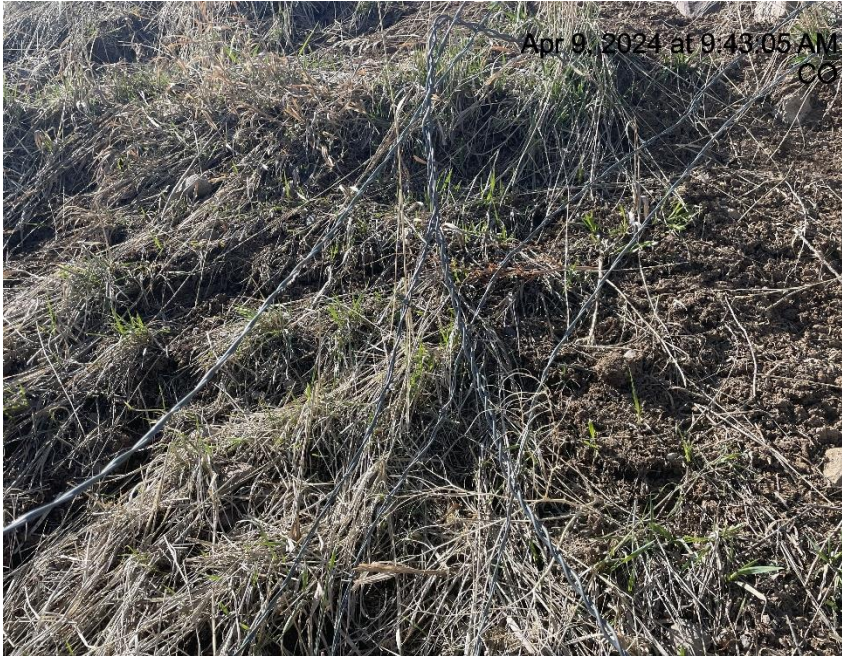
Photo # 3234 Barbed wire fence needs maintenance/wildlife hazard

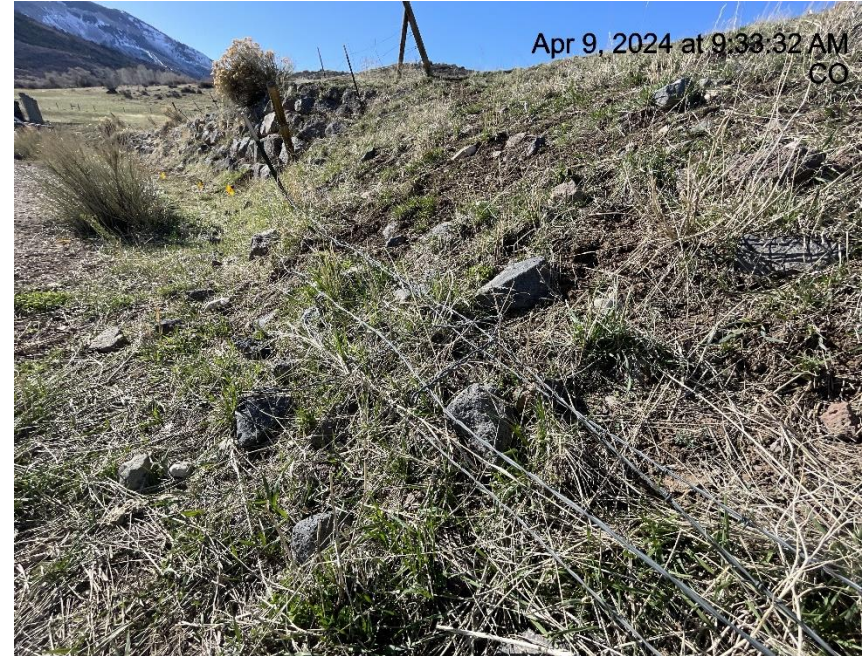
Photo # 3235 Barbed wire fence needs maintenance/wildlife hazard

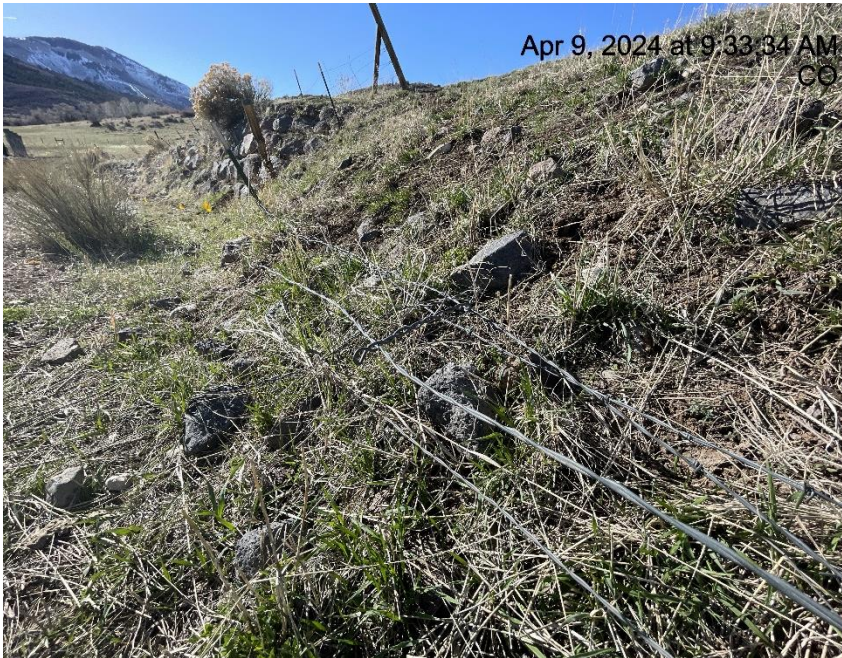
Photo # 3236 Barbed wire fence needs maintenance/wildlife hazard

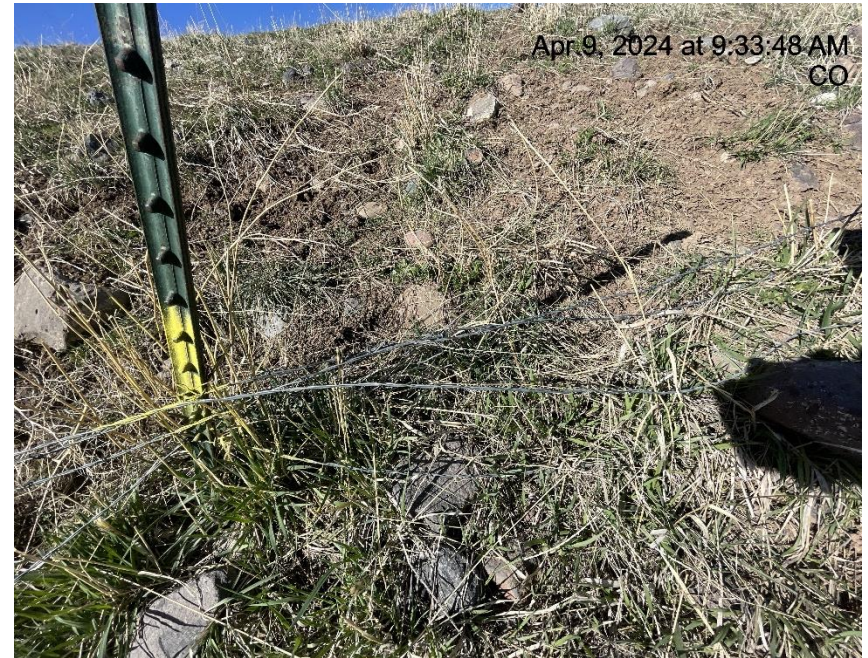
Photo # 3237 Barbed wire fence needs maintenance/wildlife hazard

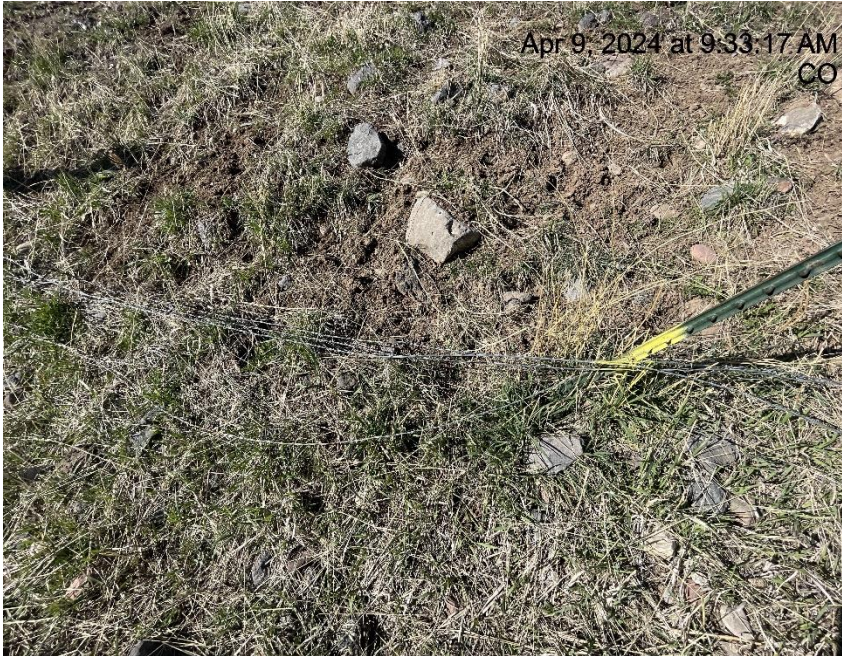
Photo # 3238 Barbed wire fence needs maintenance/wildlife hazard

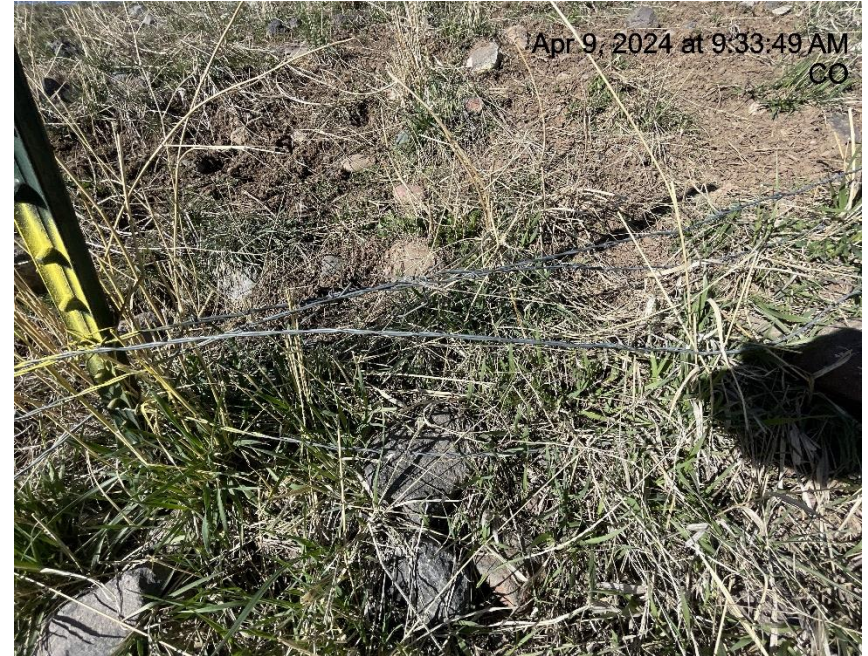
Photo # 3239 Barbed wire fence needs maintenance/wildlife hazard

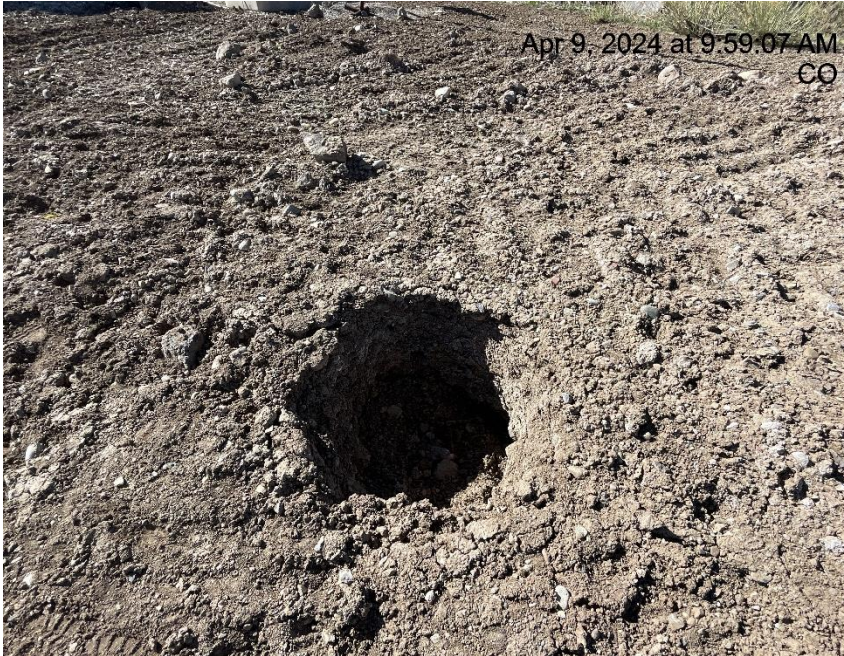
Photo # 3240 Hole/wildlife & personnel hazard
