Final Reclamation Inspection

Operator: Nuevida Resource - 10764

Location ID: 484496

Inspection Photos
Location Name: Ardourel 33081718 3HL
Location ID: 484496

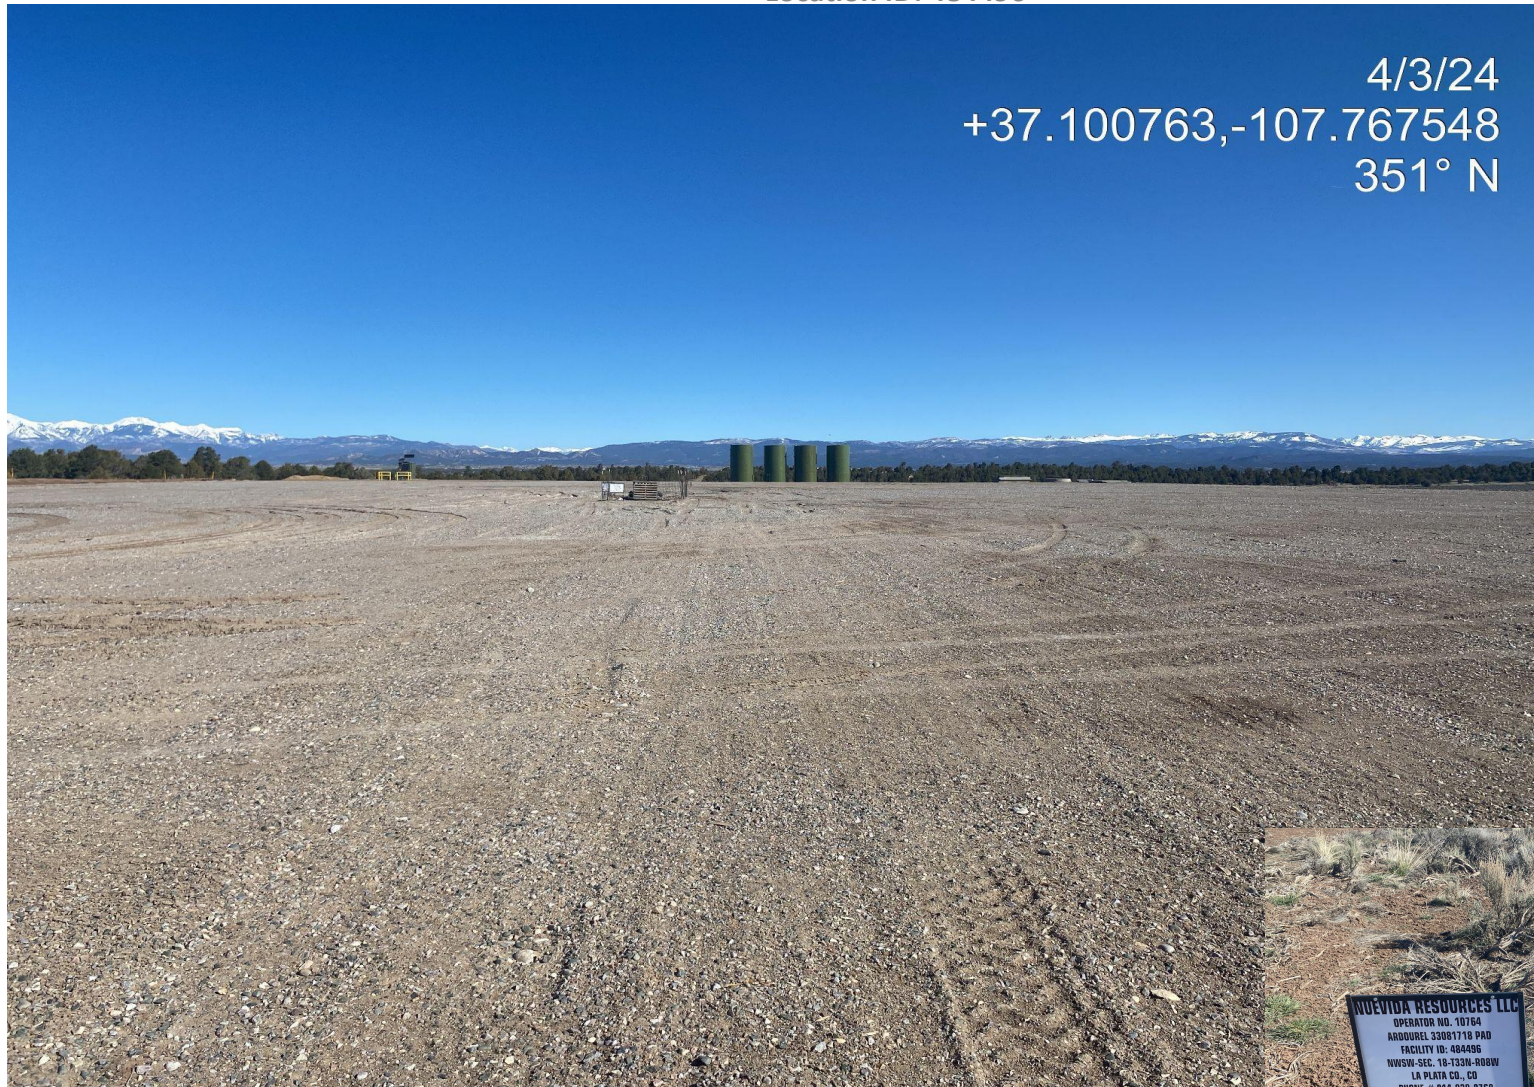
Photo 1. Overview of the northern well pad disturbance taken from the access point facing center.

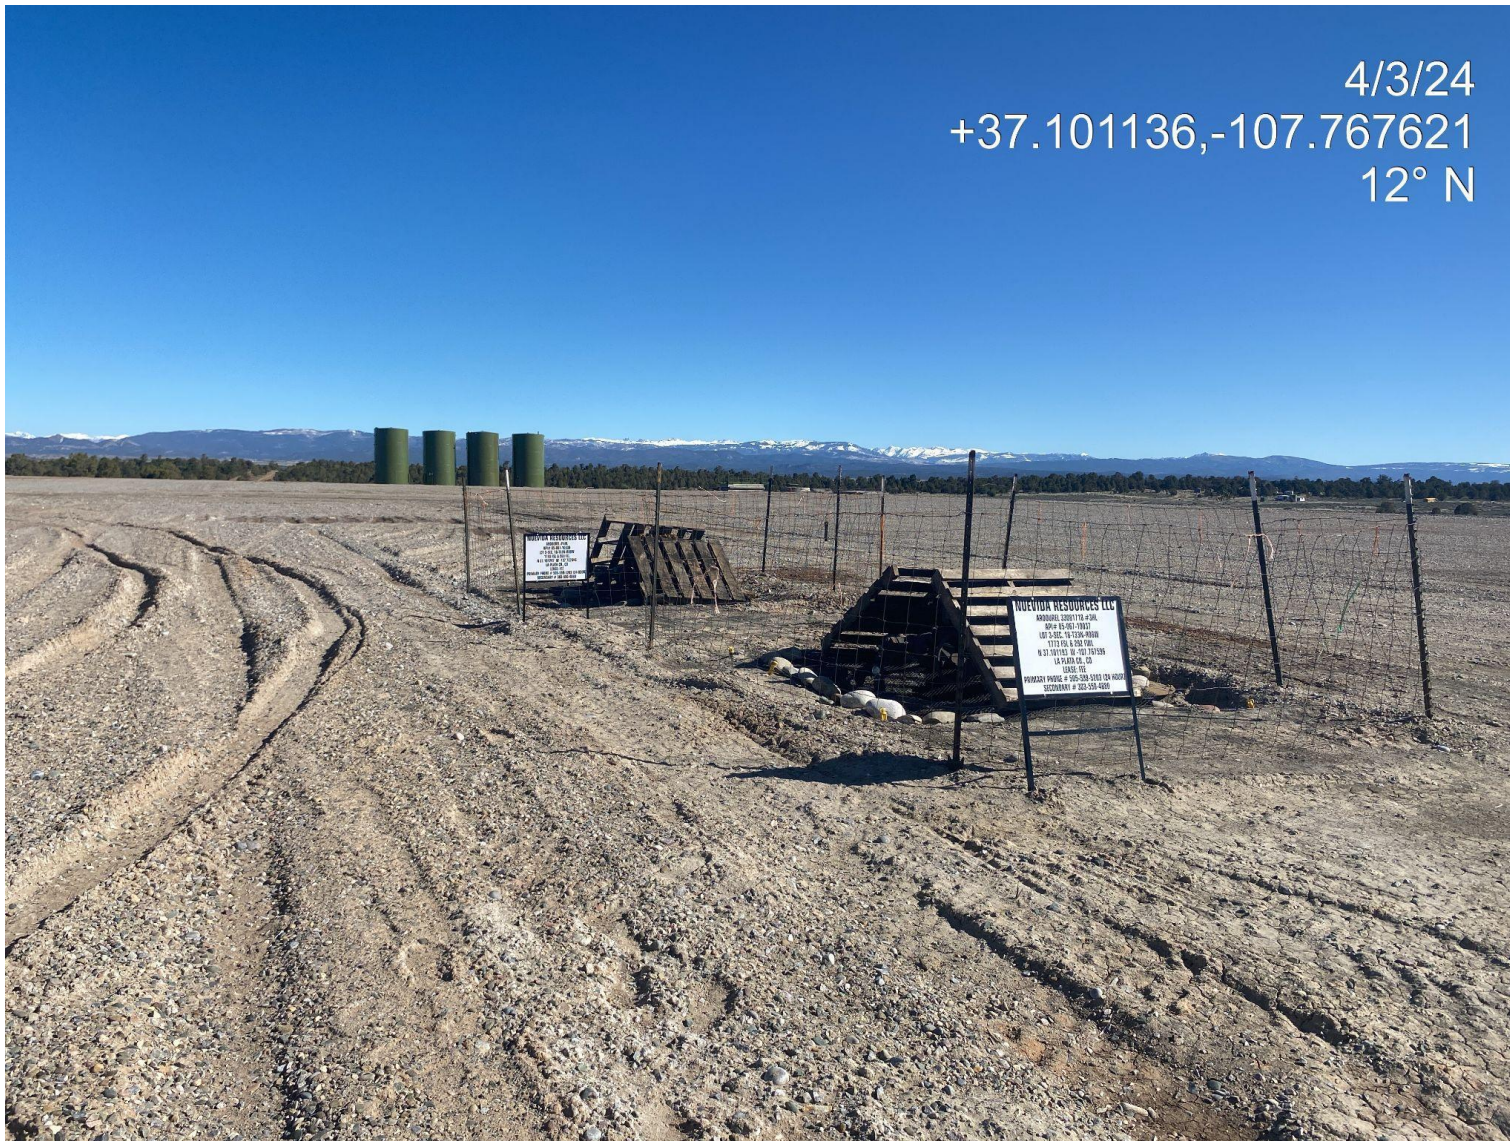
Photo 2. View of well heads with temporary wildlife BMPs installed.

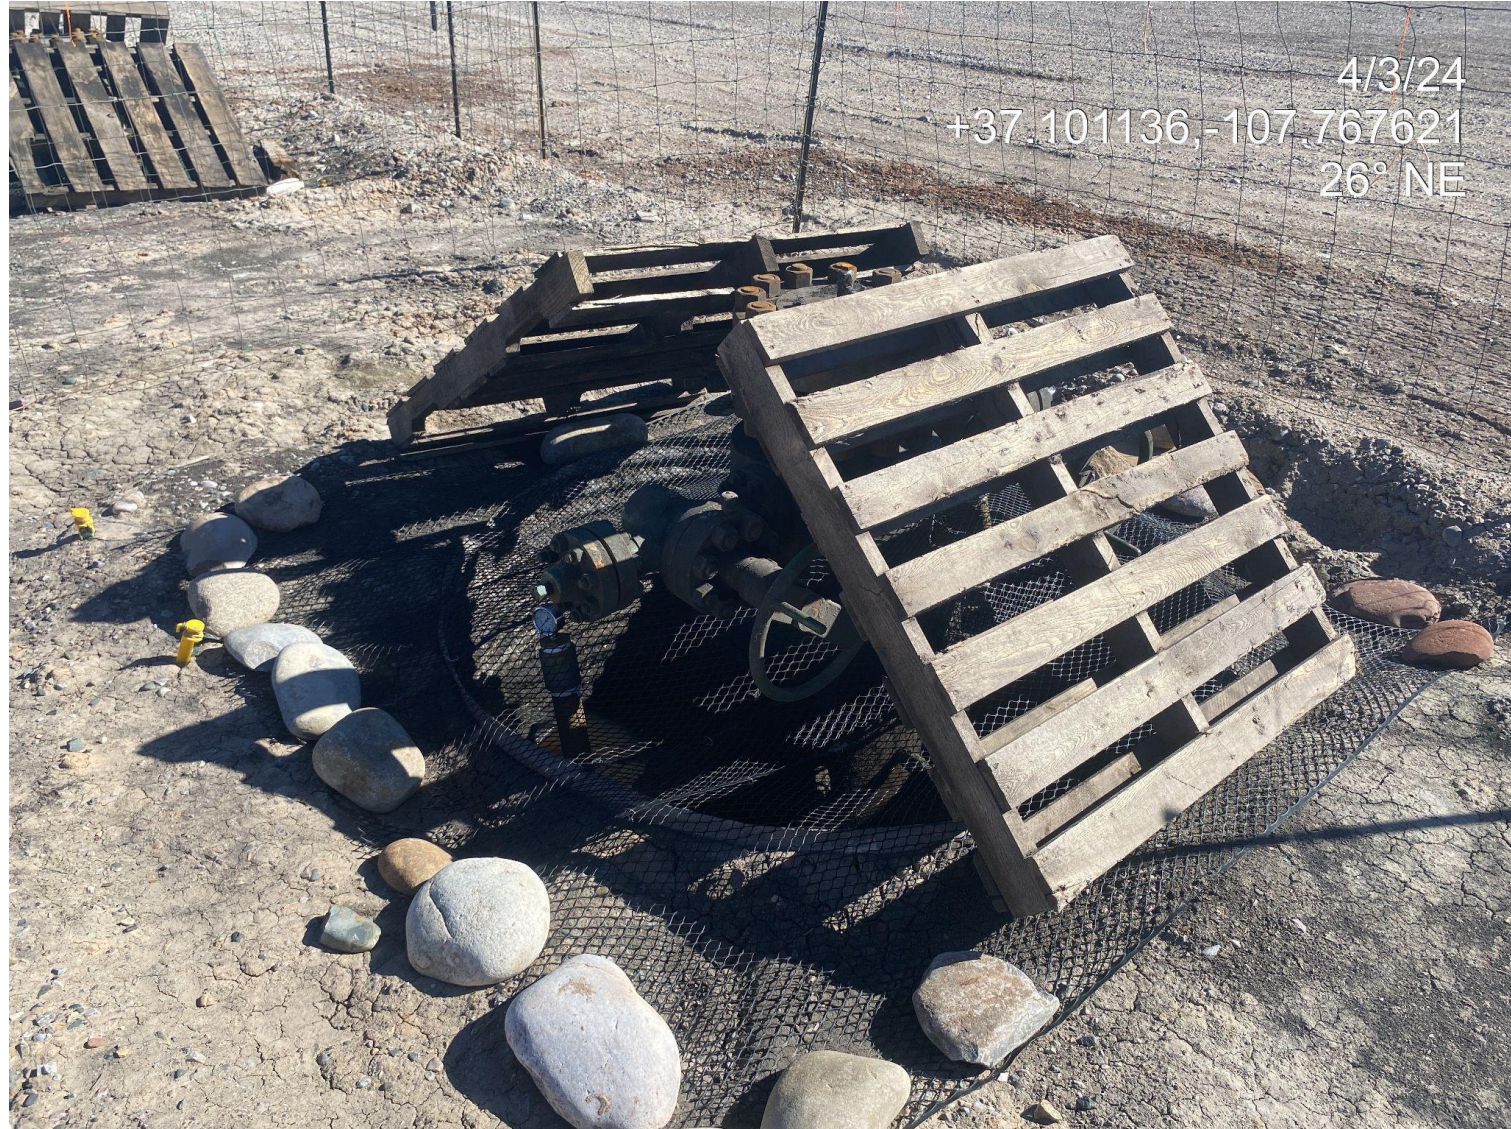
Photo 3. View of temporary wildlife BMPs/netting at the well heads.

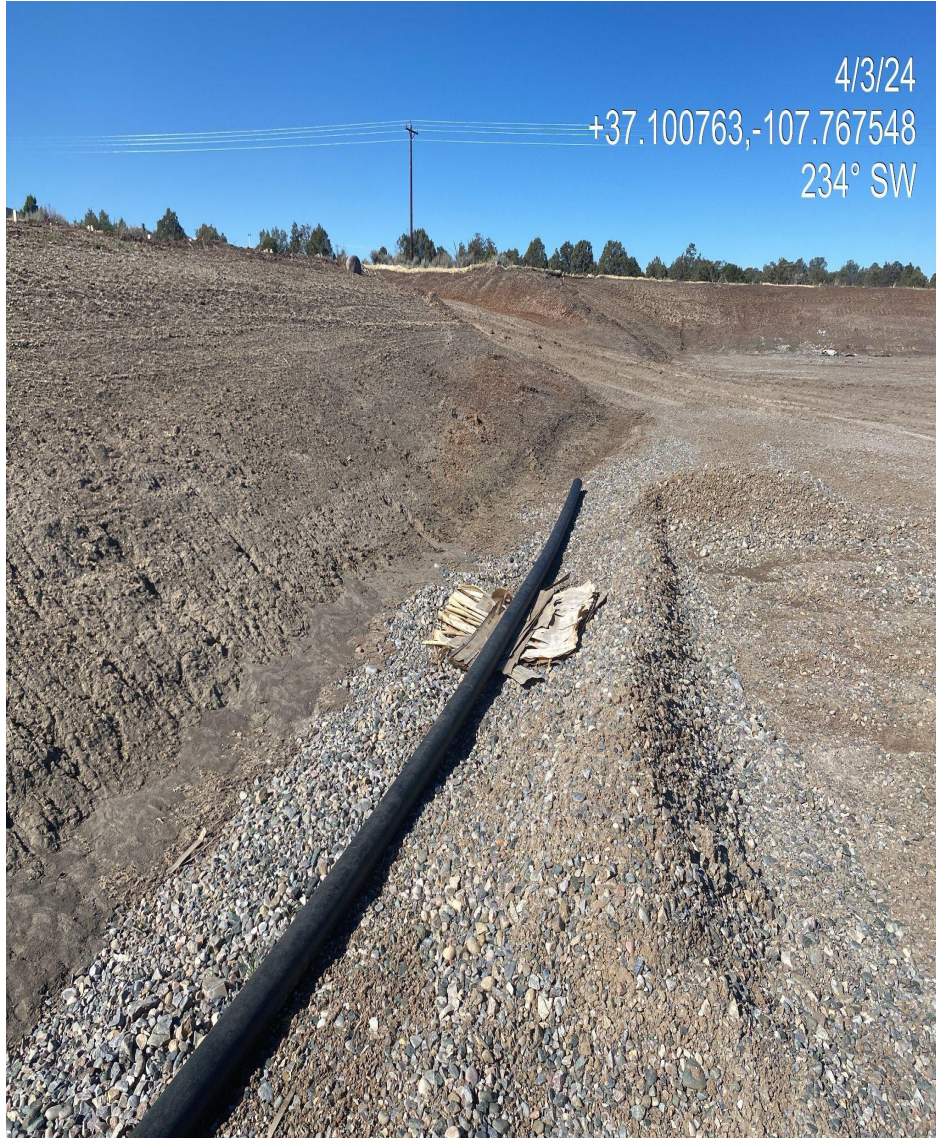
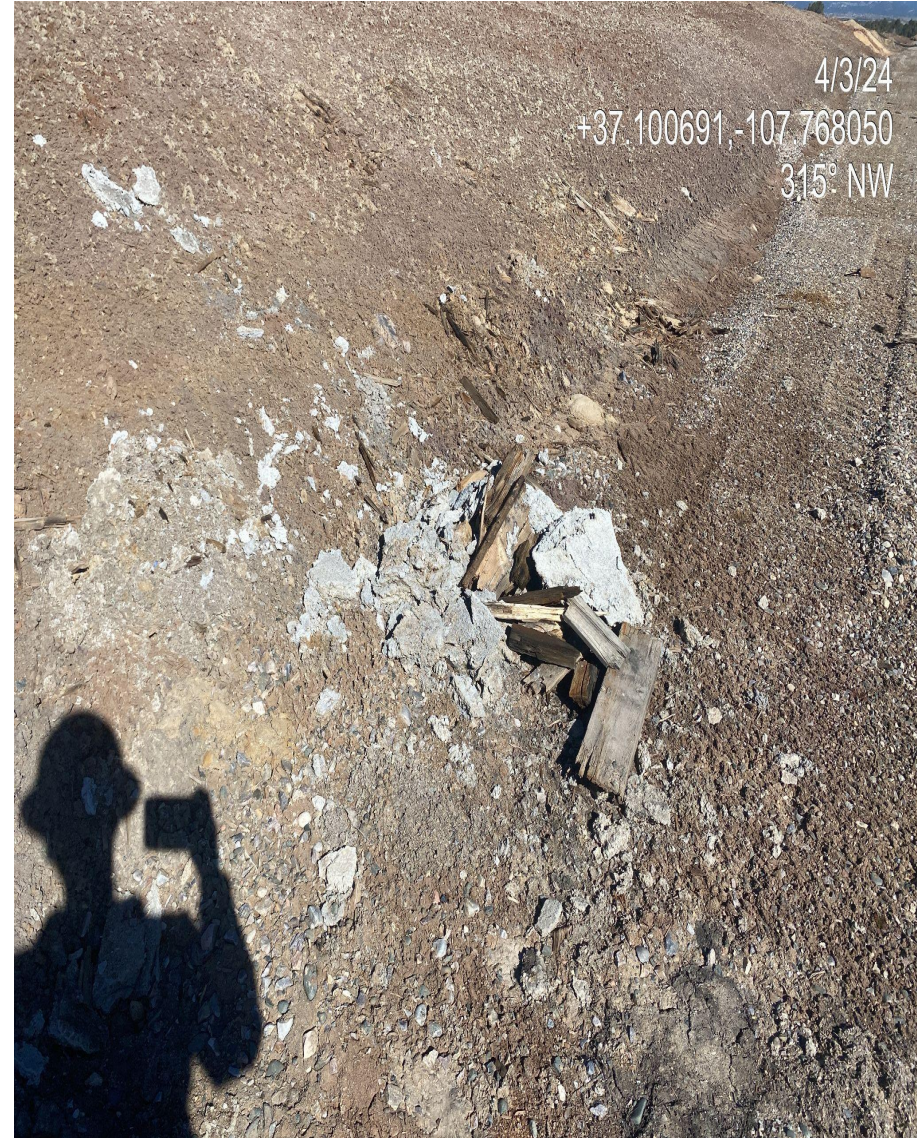
Photo 4. View of trash/debris observed in the southern and western edges of the well pad disturbance.

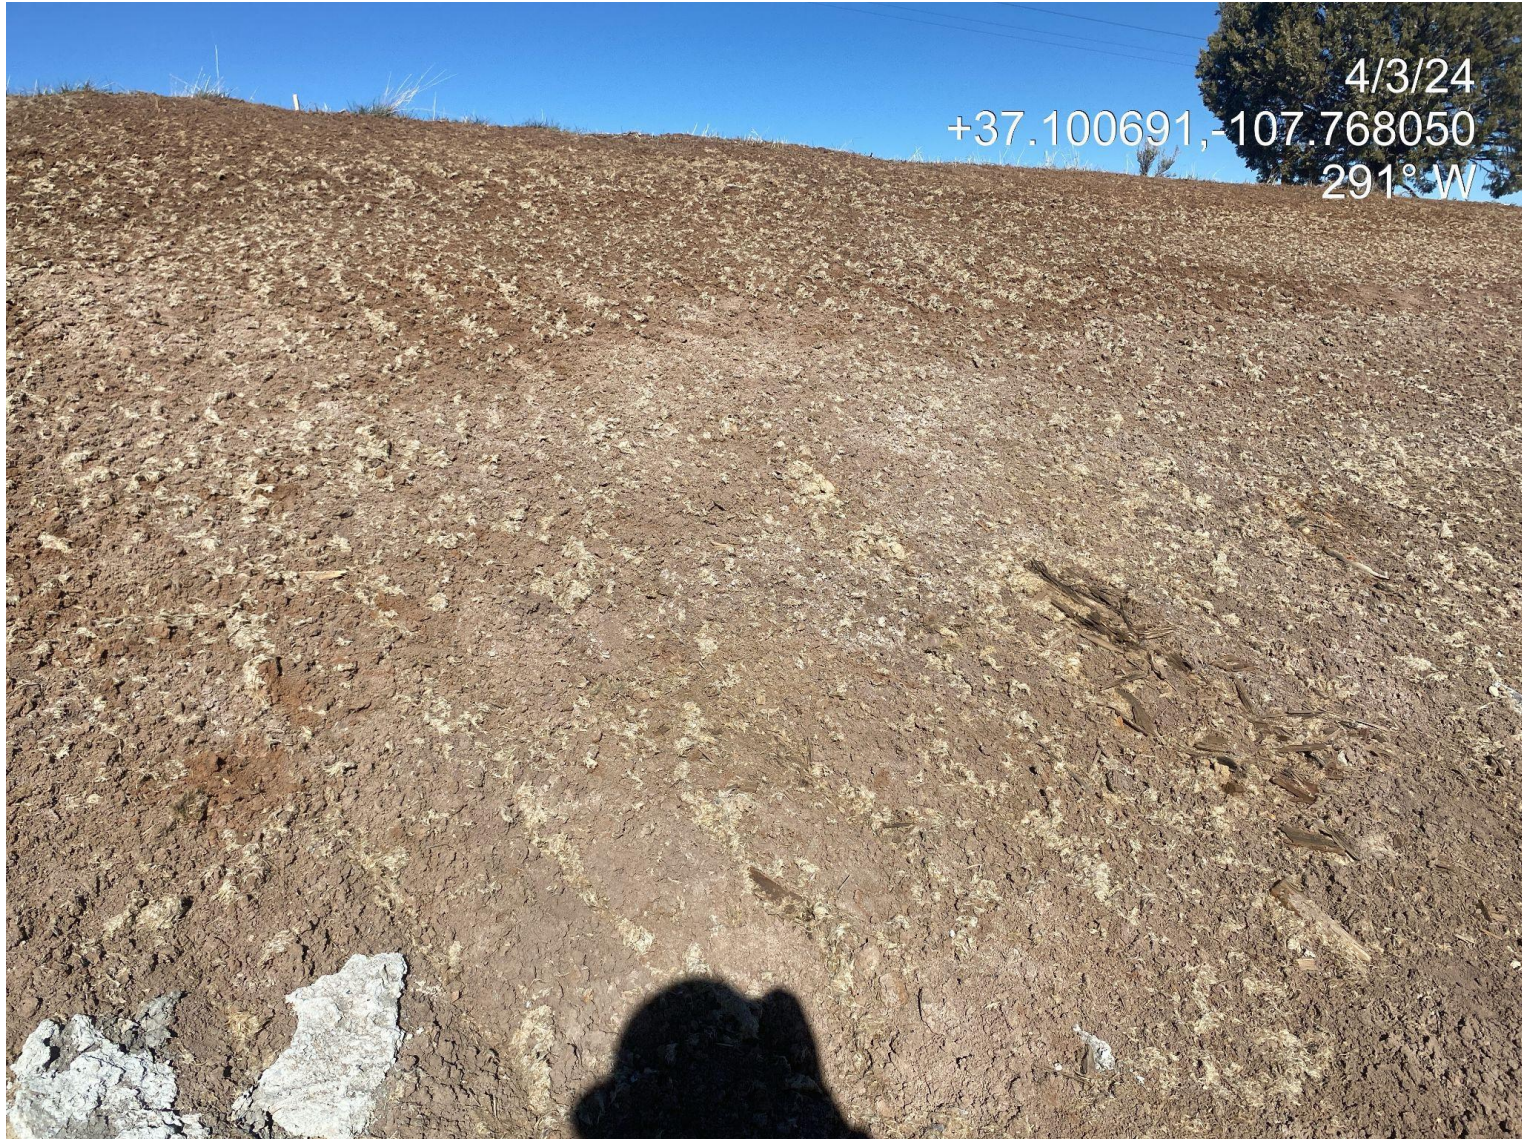
Photo 5. View of sparsely applied hydromulch/tacifier observed on the western cut slope of the well pad disturbance.

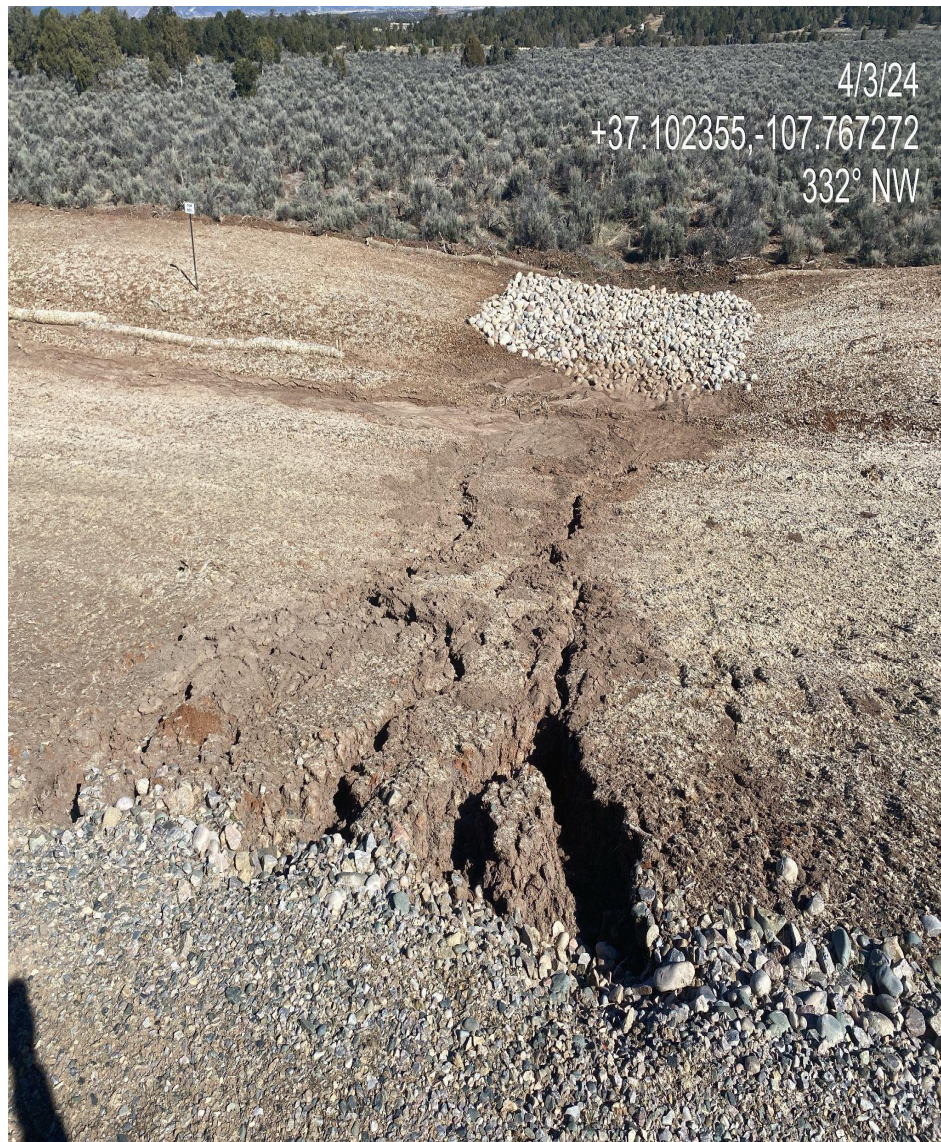
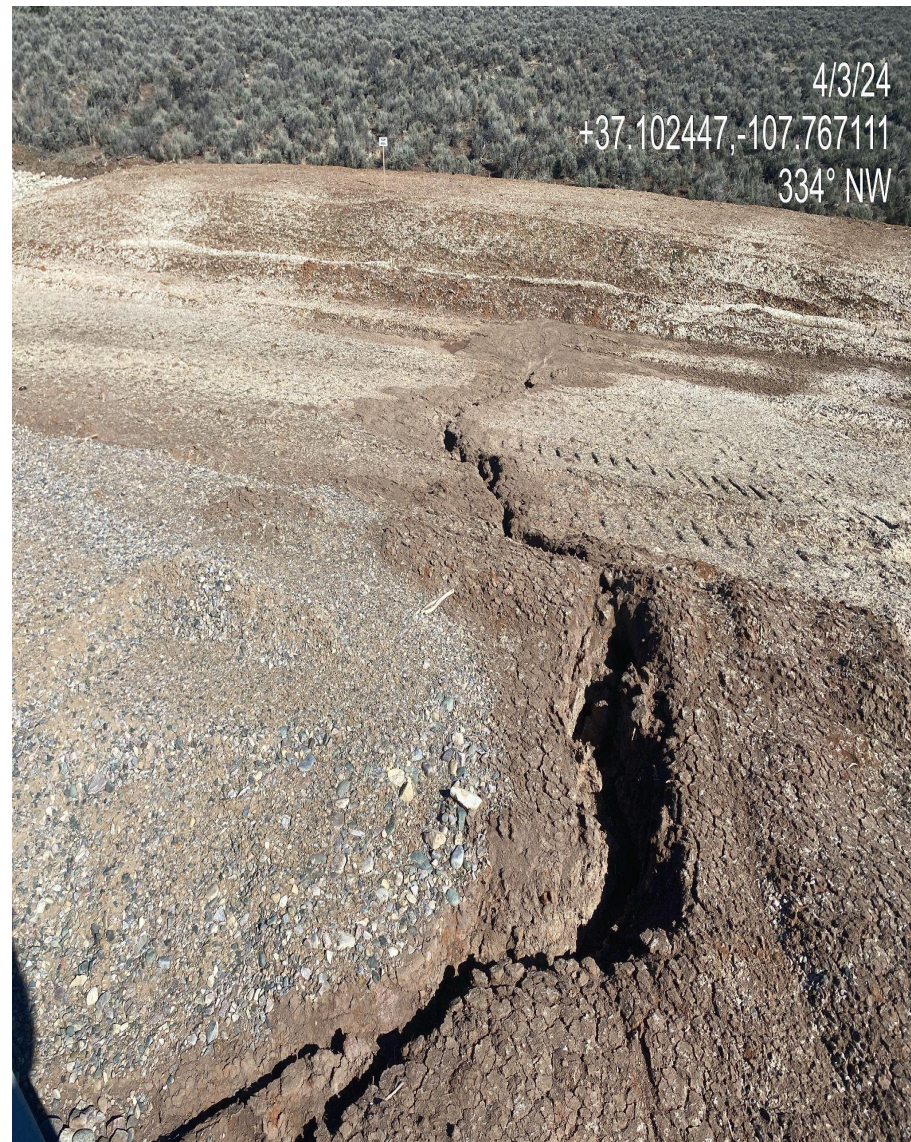
Photo 6. View of gully erosion forming along the northern fill slope of the well pad disturbance. Maintenance/storm water BMPs needed in this area.

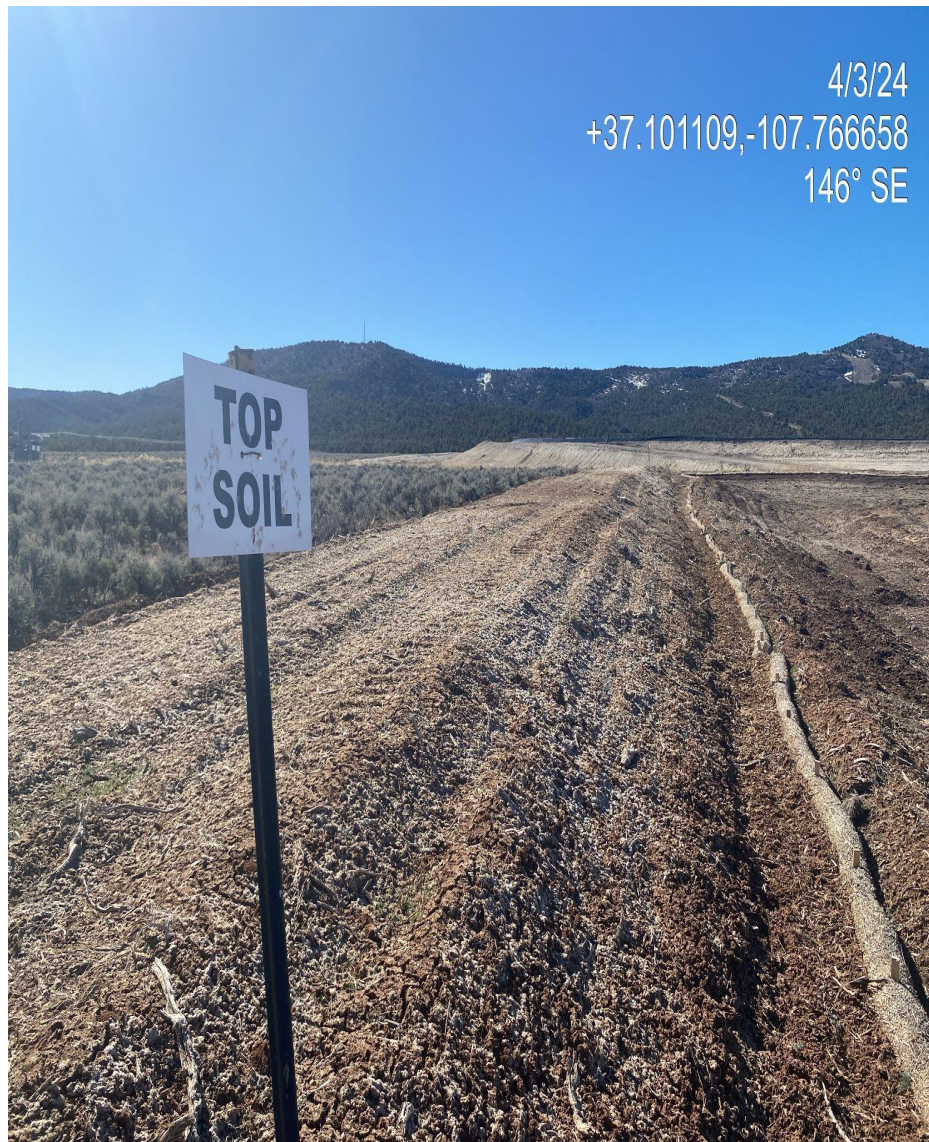
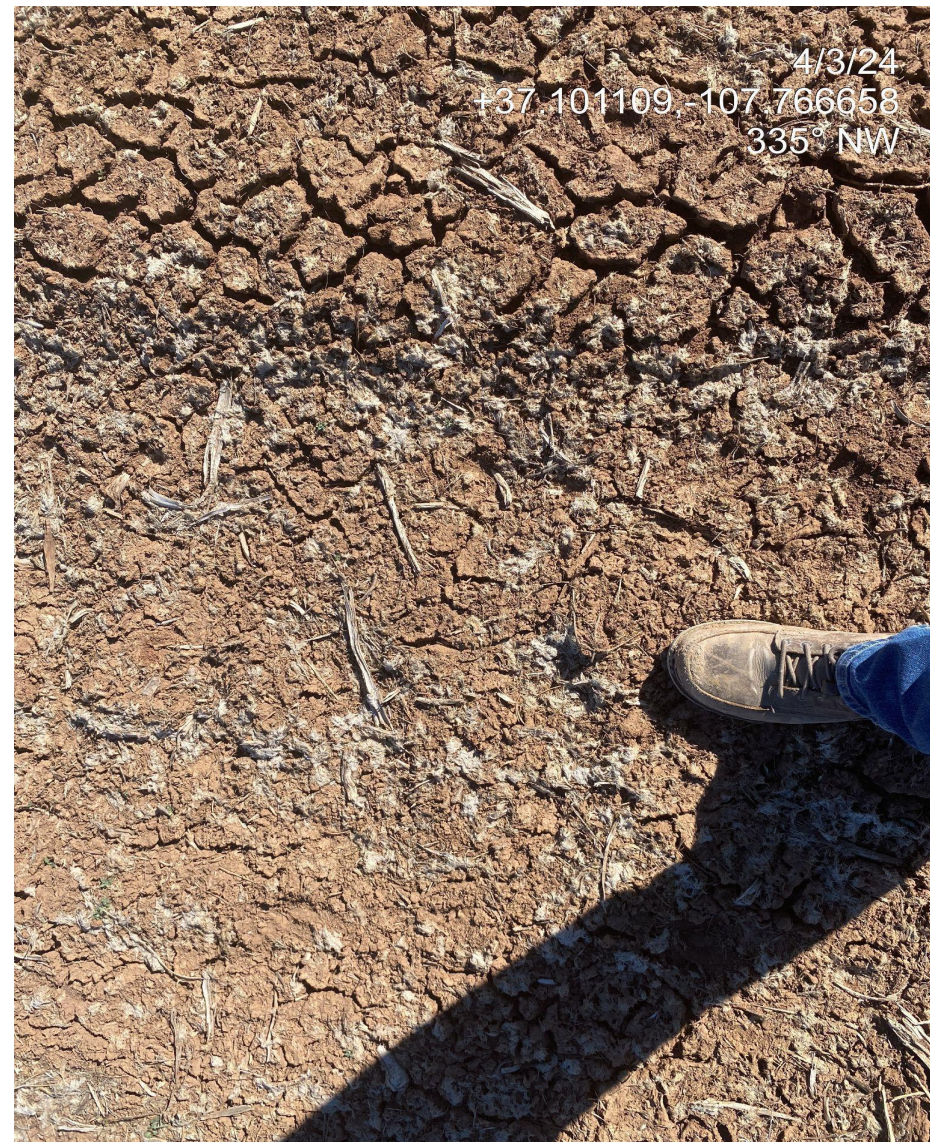
Photo 7. View of top soil stored on the eastern edge of the well pad disturbance. Sparsely applied hydro mulch/tacifier observed on the top soil salvage.

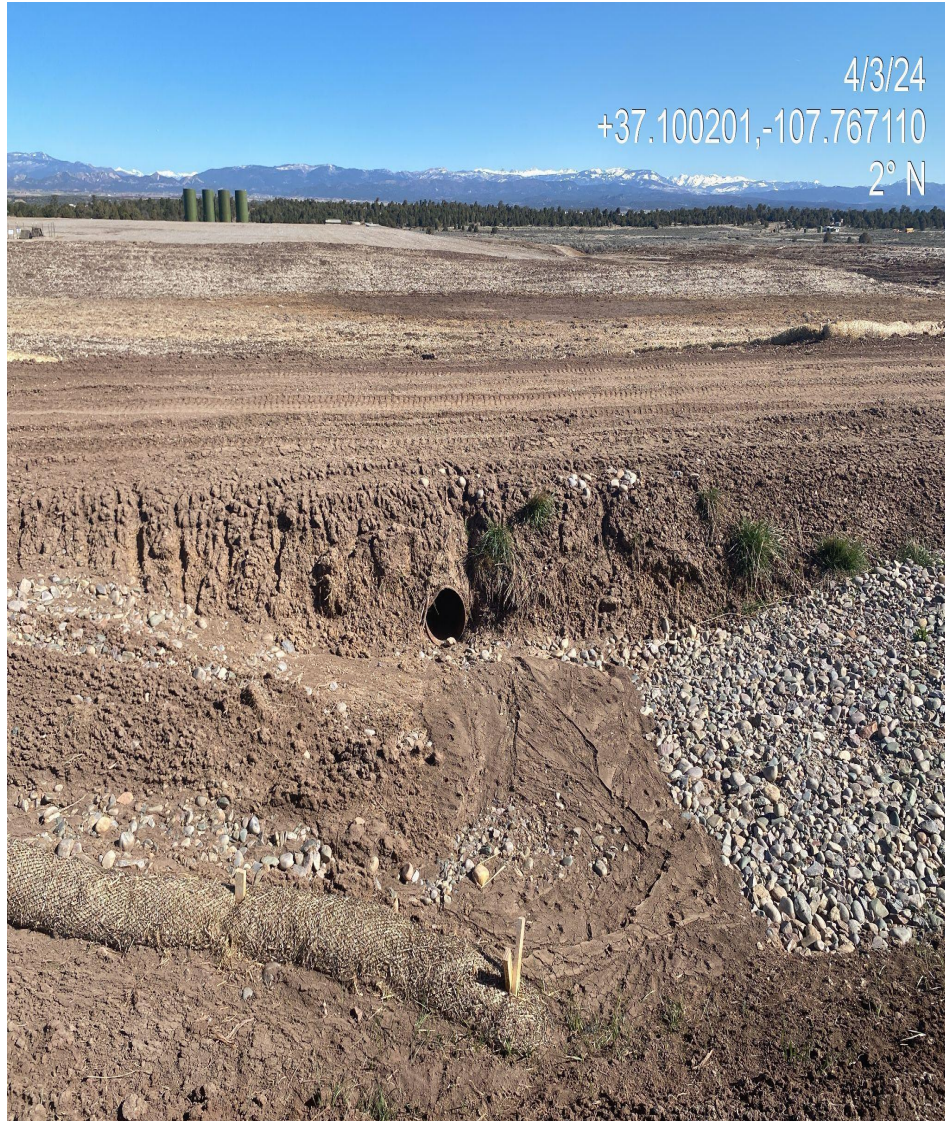
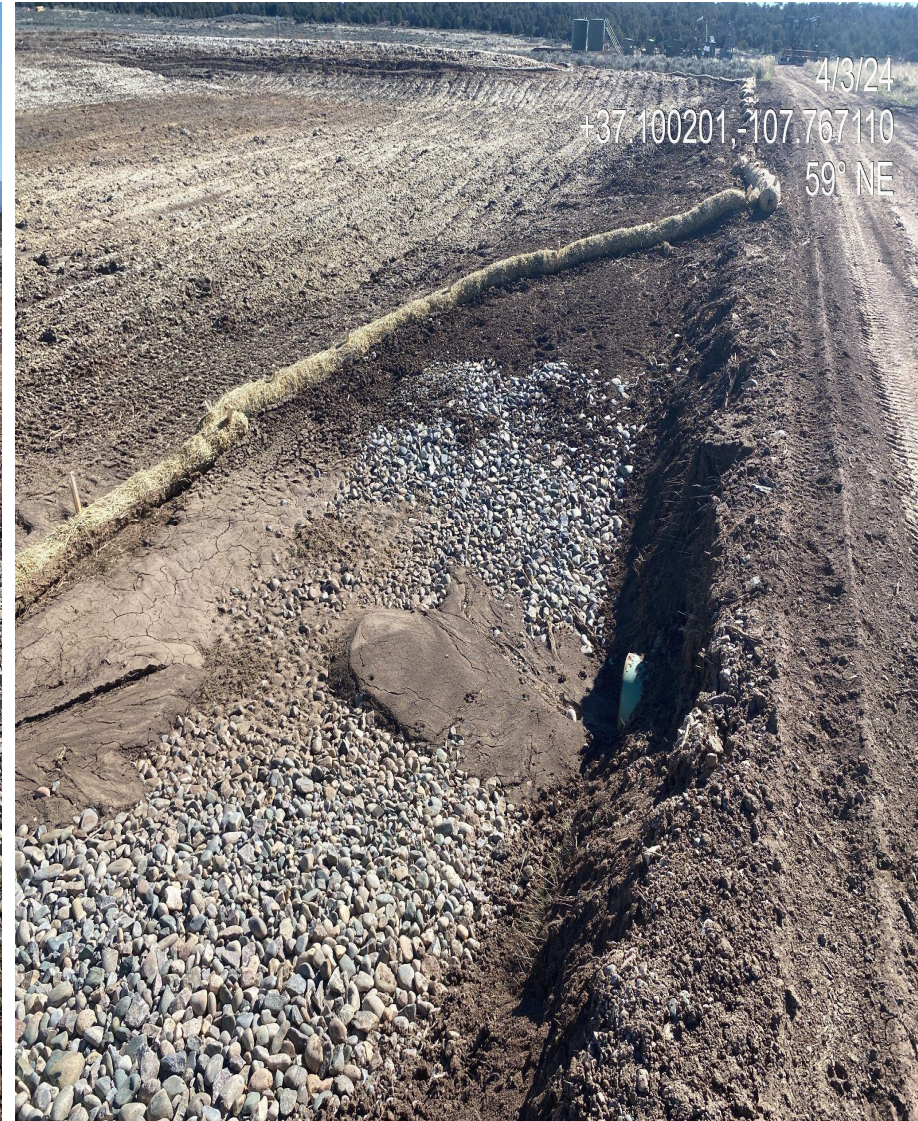
Photo 8. View of inflow and outflow of culvert built across access road that separates the southern and northern disturbances. Culvert has not been installed per good engineering practices and additional stabilization is needed.

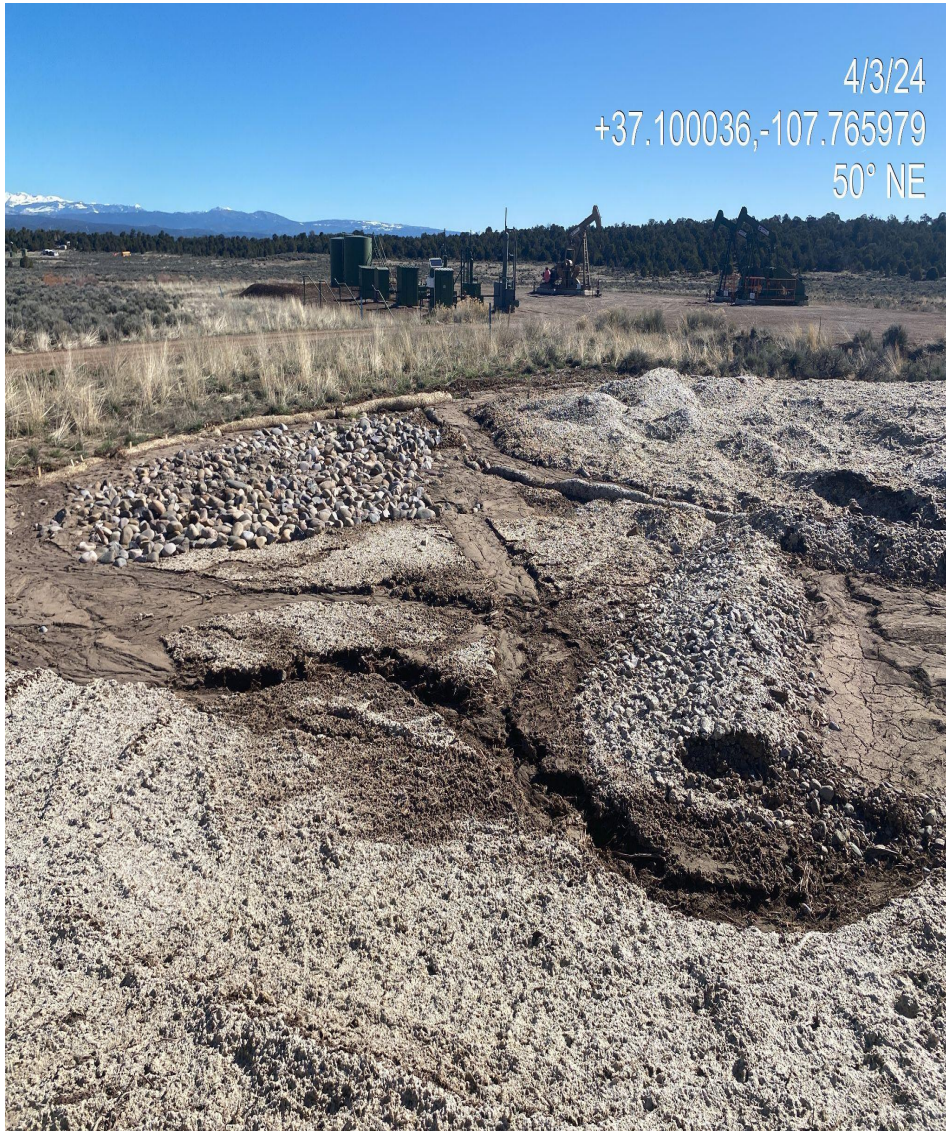
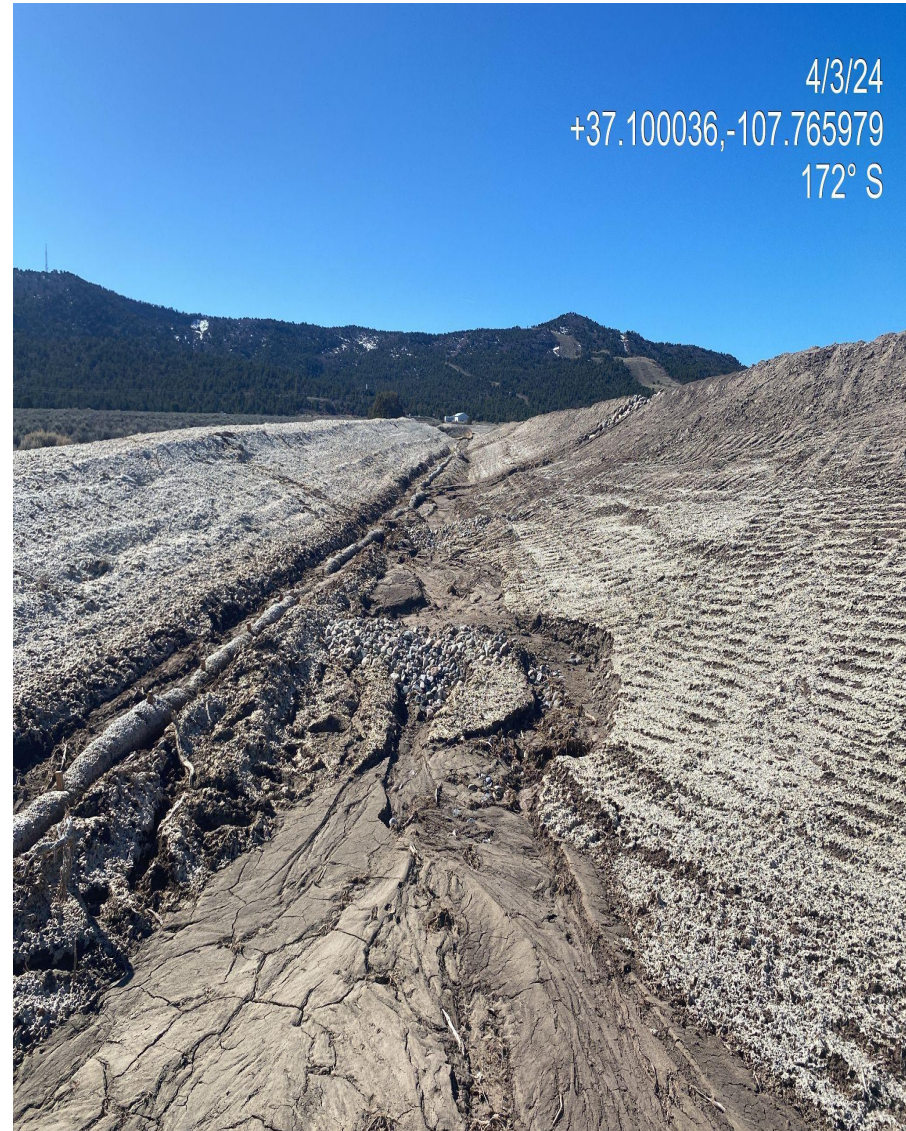
Photo 10. View of failing/inadequate stormwater BMPs in the northeast portion of the southern disturbance. Maintenance is needed in this area.

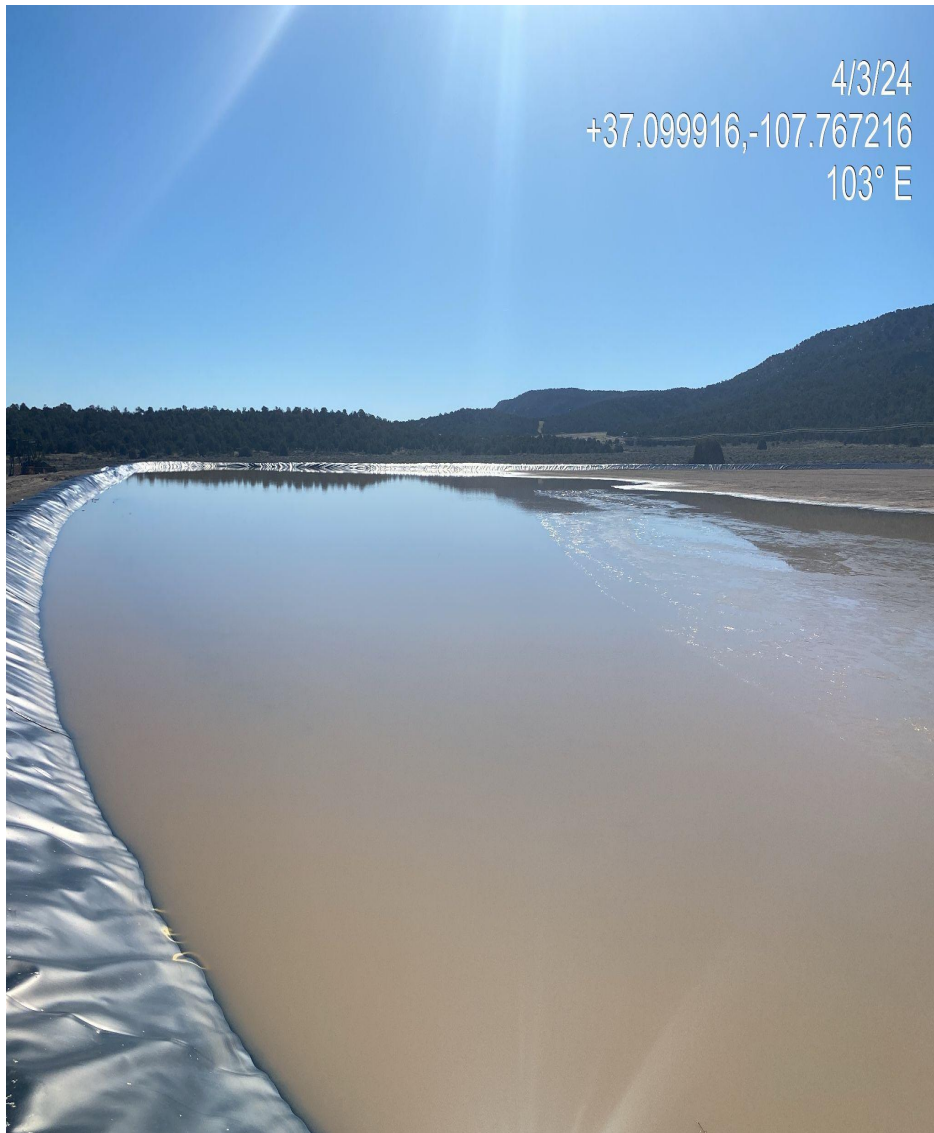
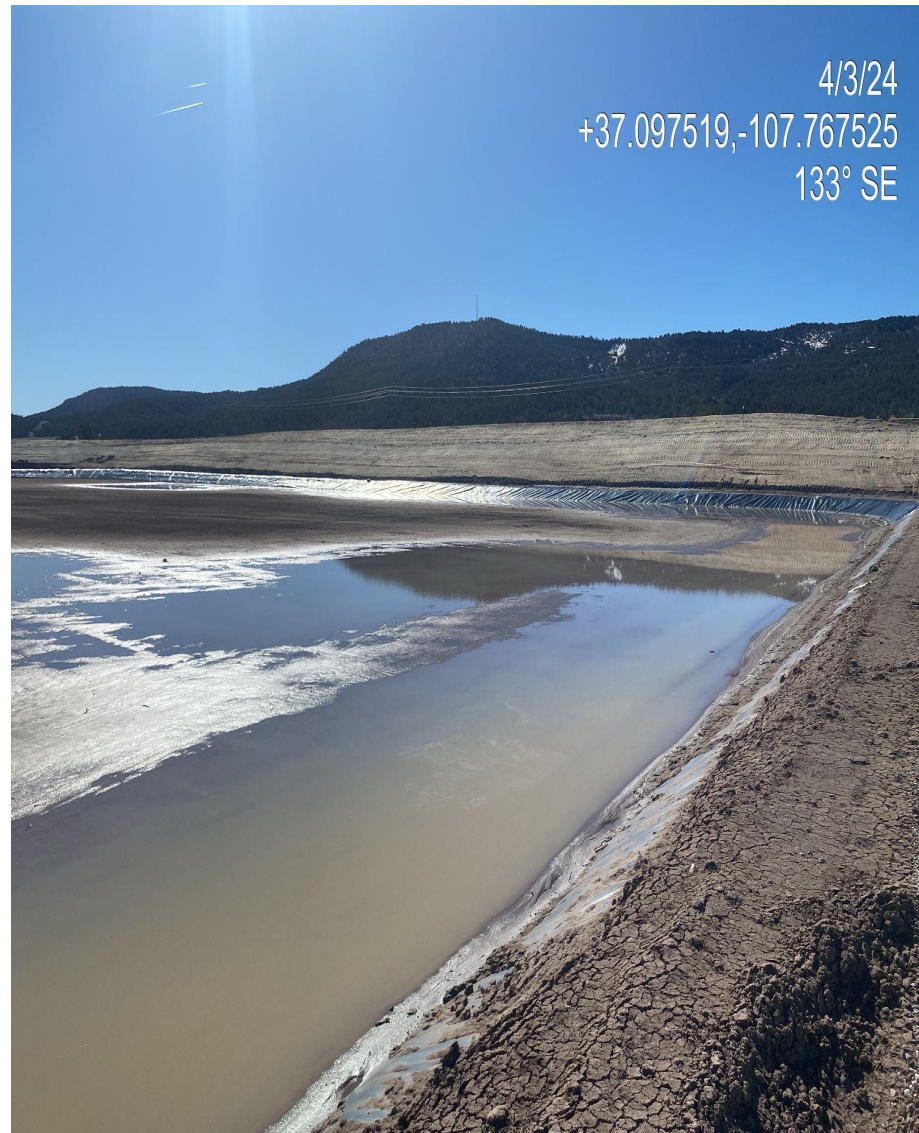
Photo 12. Storm water ponding appears evident on TUA pad. Pursuant to COA #10 a sump is planned for the northeast corner of the pad. Sump was not observed during inspection.

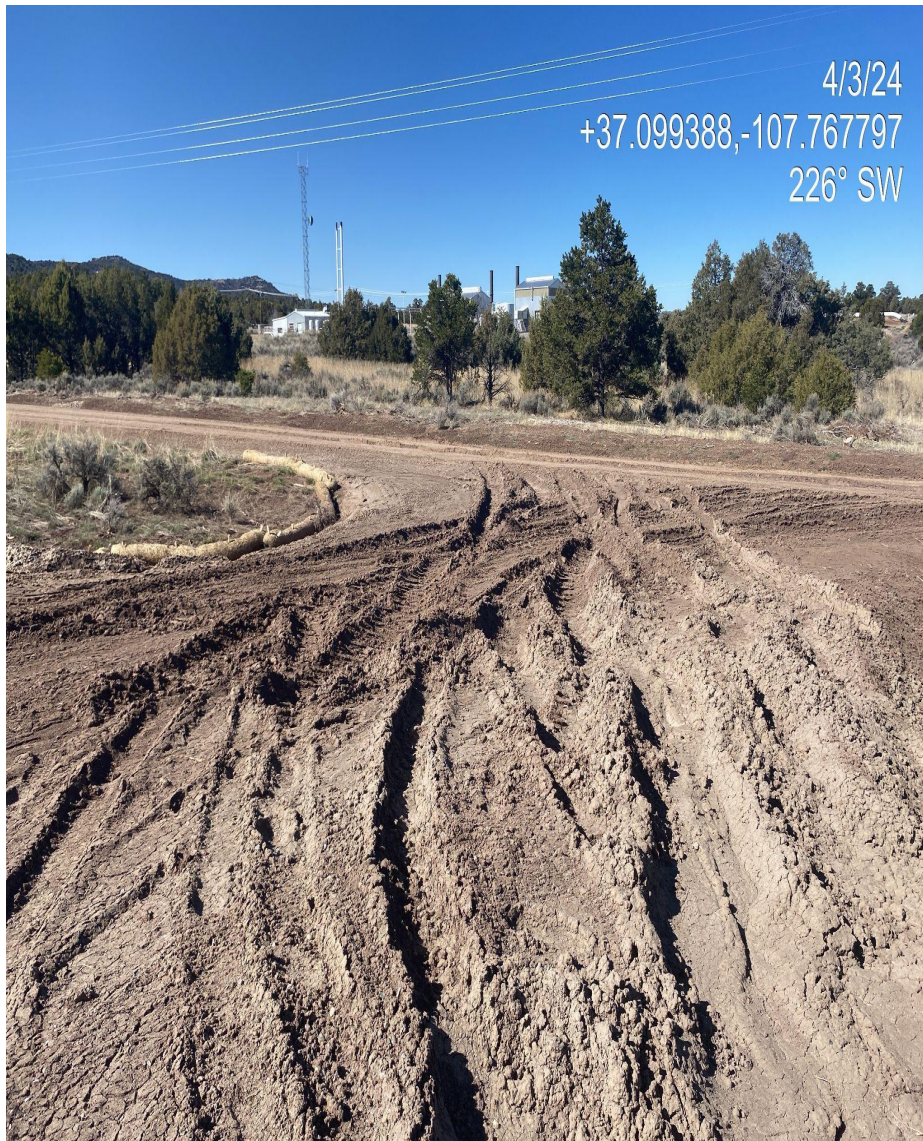
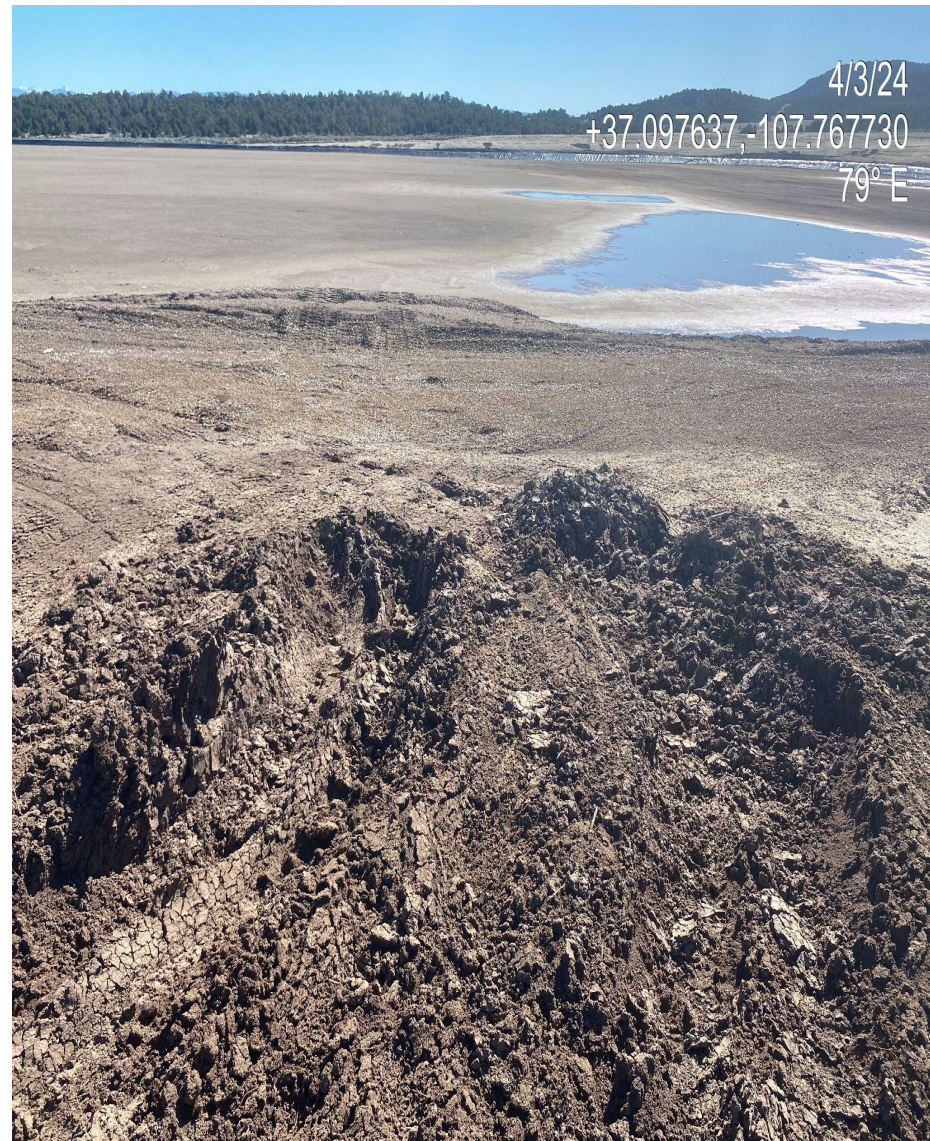
Photo 13. Severe rutting observed at both access points for the southern tank pad disturbance. Additional stabilization is needed to minimize site degradation.
