Final Reclamation Inspection

Operator: Nuevida Resource - 10764

Location ID: 484496

Inspection Photos
Location Name: Ardourel 33081718 3HL
Location ID: 484496

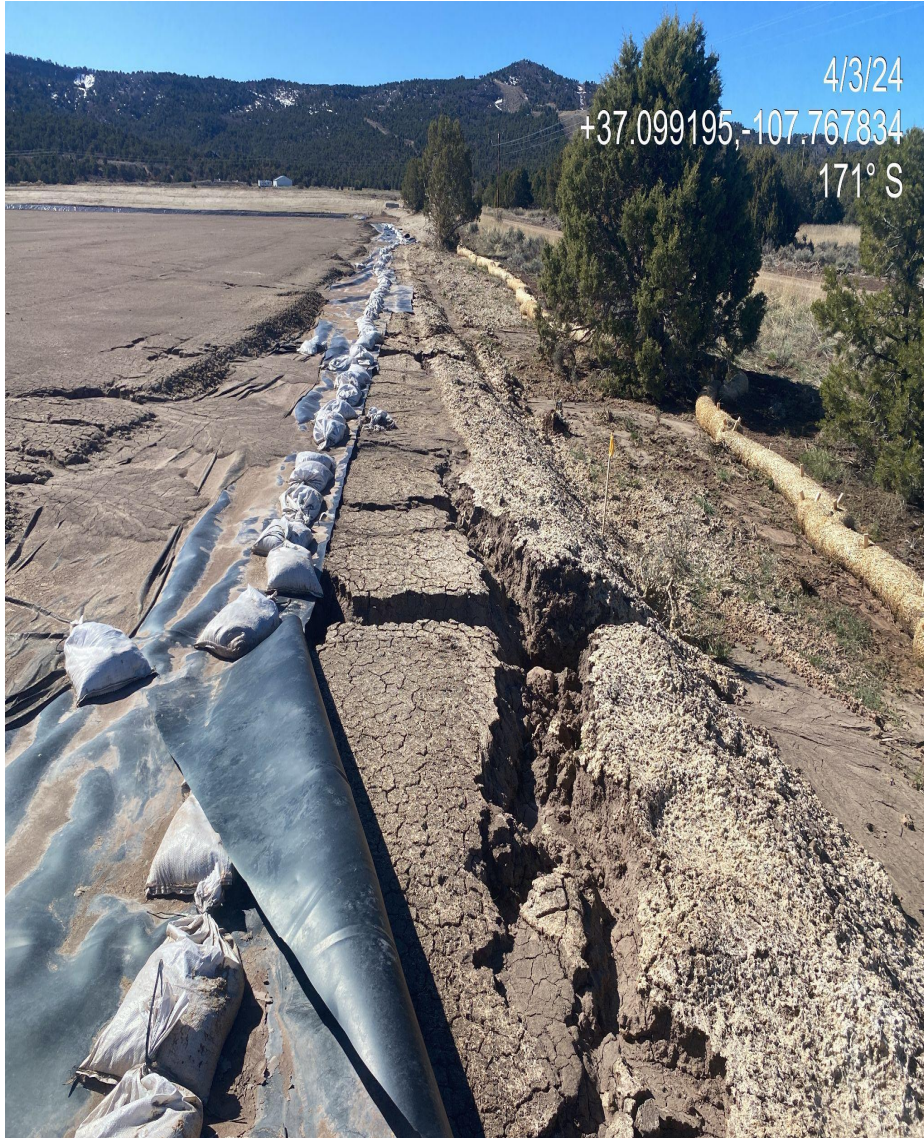
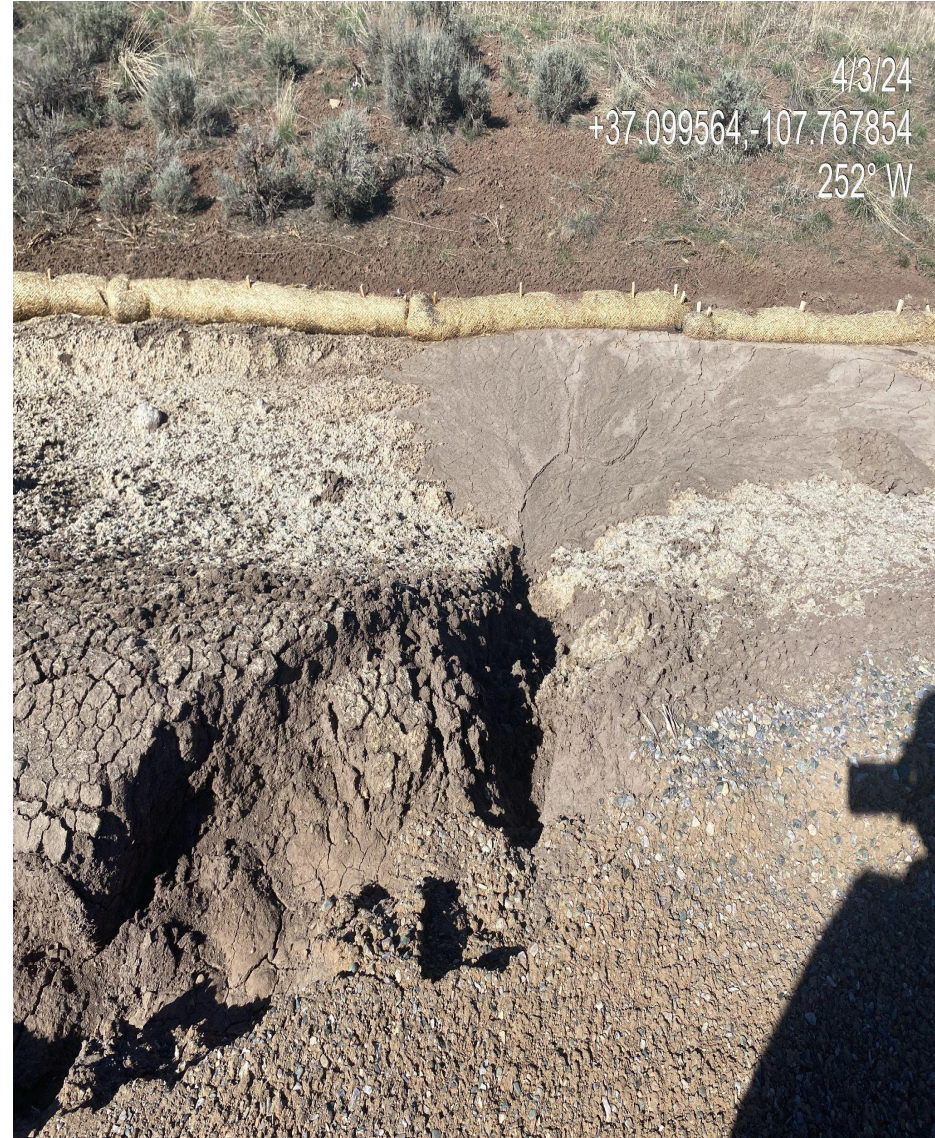
Photo 14. Gully erosion observed forming on the western edge of the southern tank pad disturbance. Maintenance is needed in this area.
