## Inspection Photos

Location Name: TEP ROCKY MOUNTAIN LLC, GM-66S96W/23SWSW

Location ID: 335388

Date: 4/9/2024

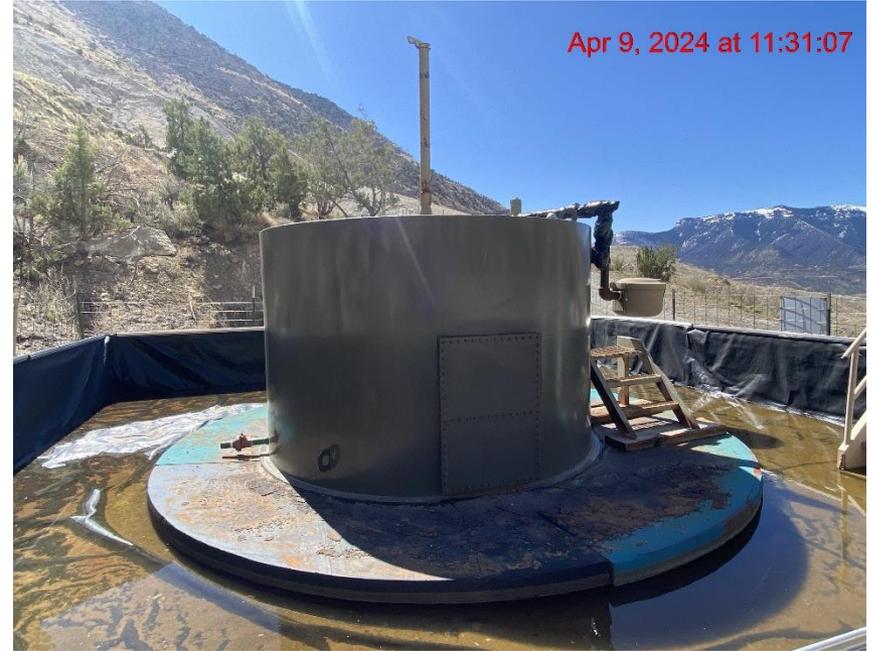
**Tank Label not Posted – Photo #00469**

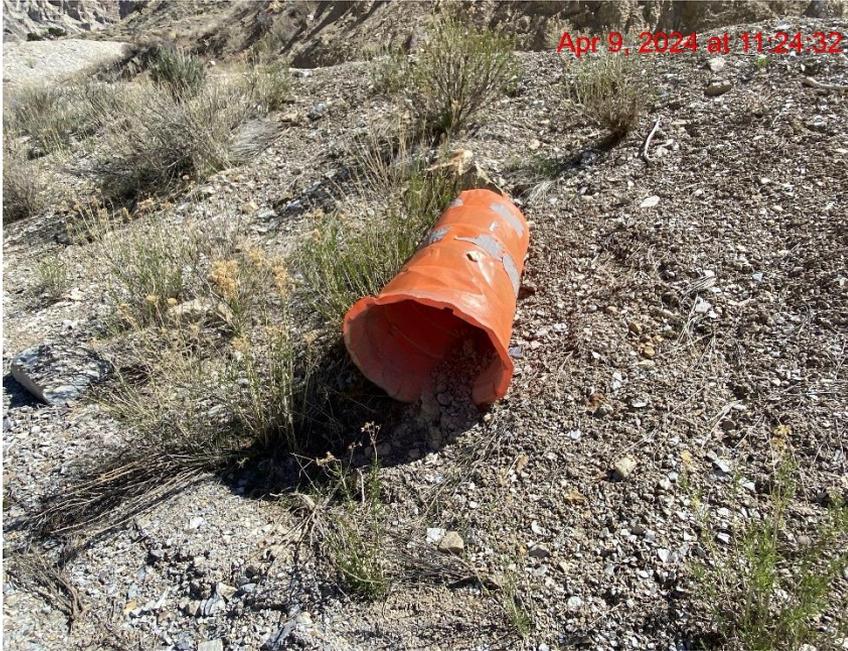
**Debris – Photo #00460**

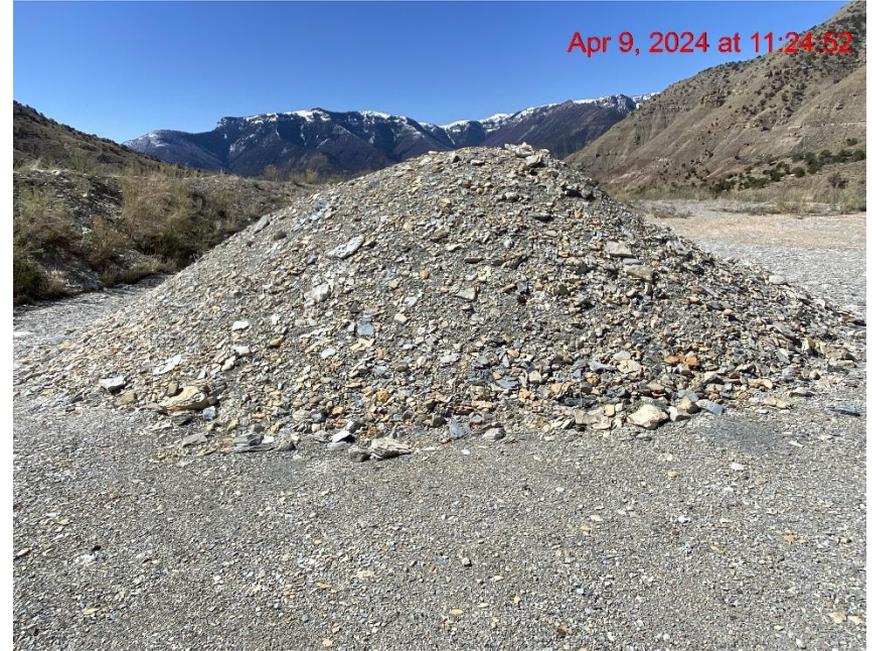
**Unprotected Soil Stockpile – Photo #00461**

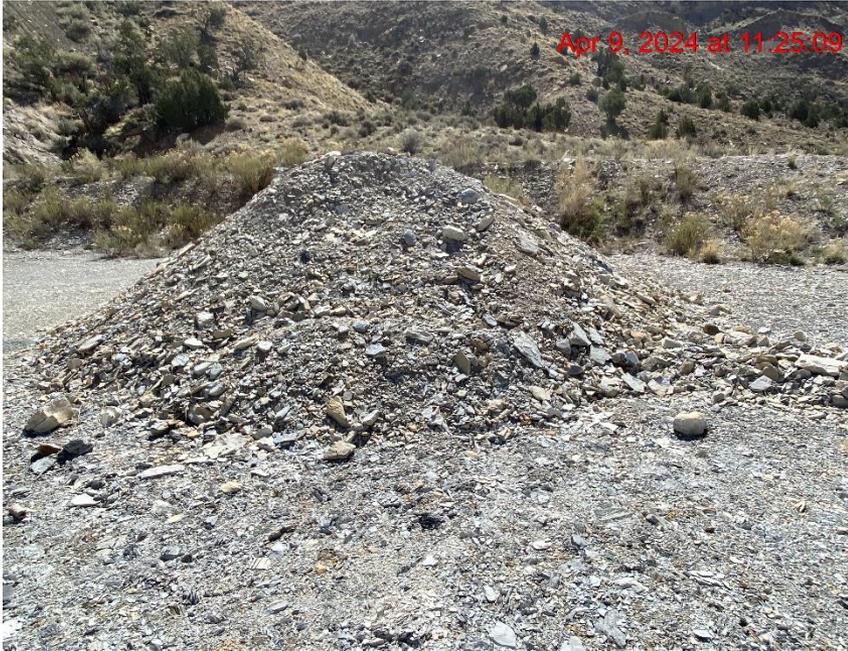
**Unprotected Soil Stockpile – Photo #00462**

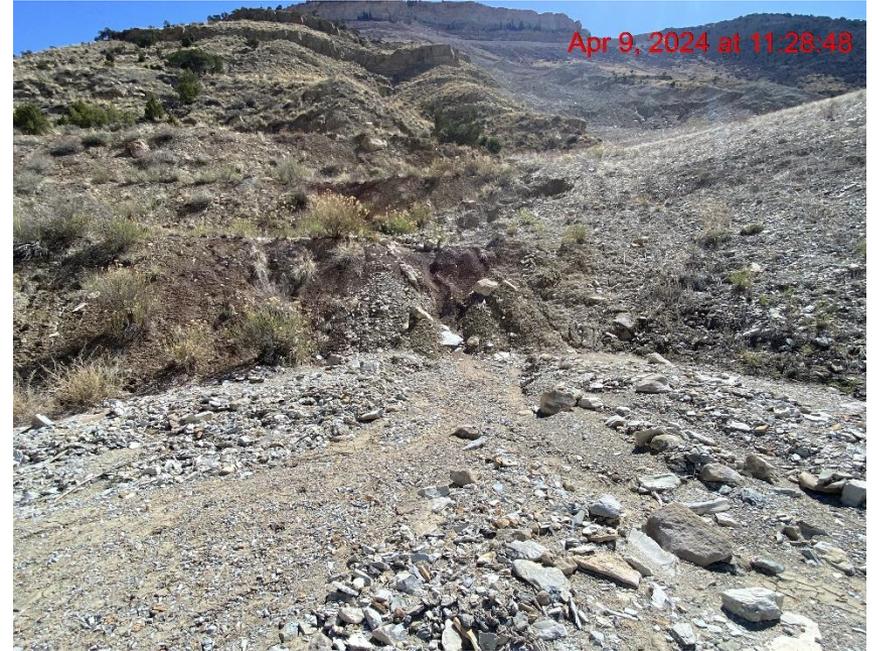
**Insufficient Erosion Control/Sediment Run-on to Location – Photo #00464**

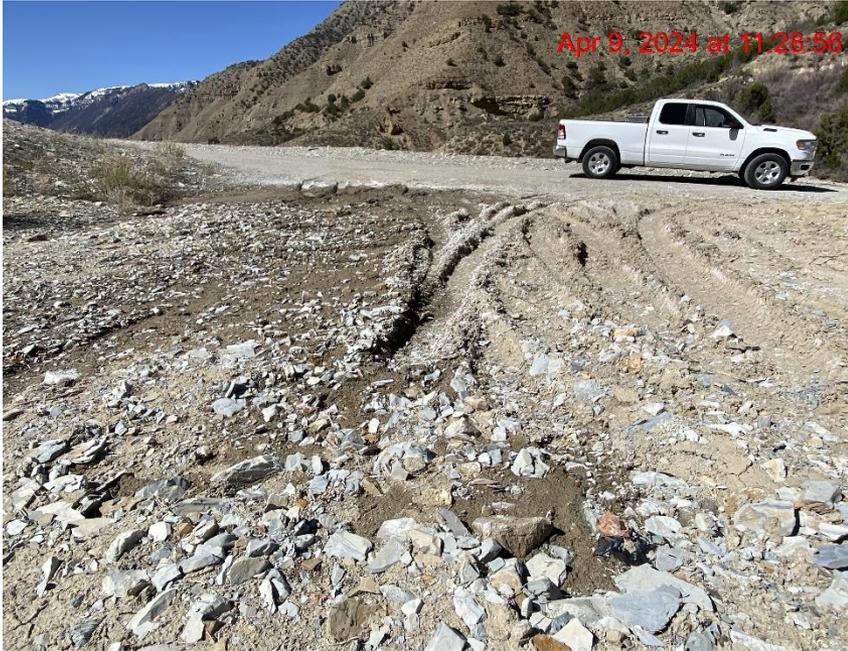
**Sediment Run-on to Location/Lack of Stabilization – Photo #00465**

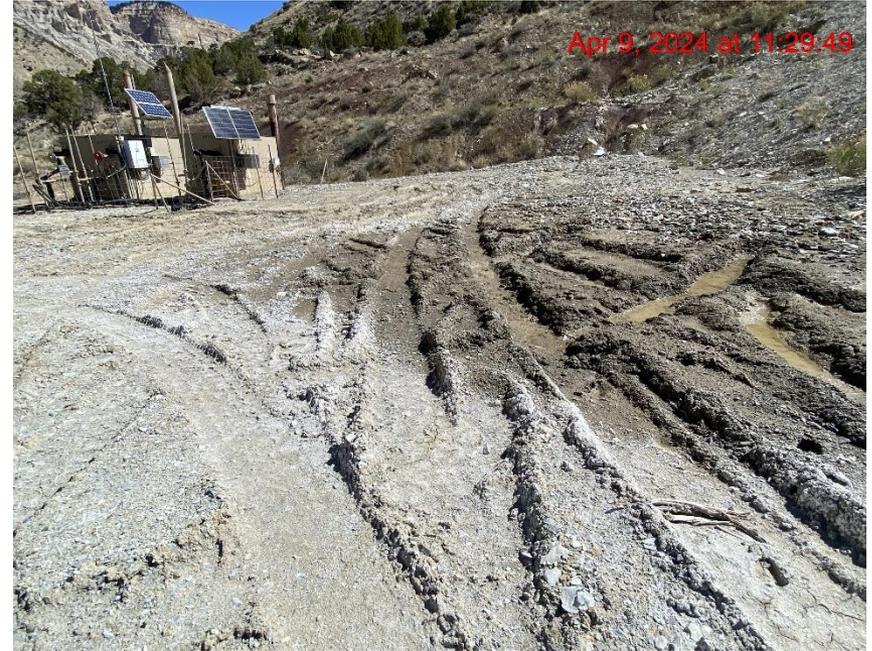
**Sediment Run-on to Location/Lack of Stabilization – Photo #00467**

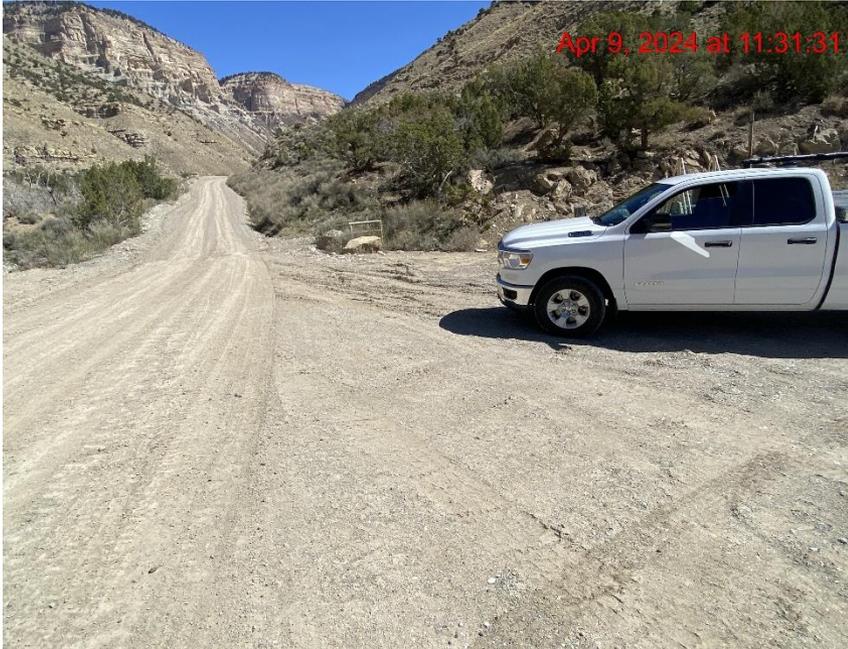
**Insufficient Vehicle Tracking BMPs at Location Entrance/Exit**  
– Photo #00470
