**Inspection Photos**  
**Location Name: Elaine 43-28**  
**Location ID: 336320**

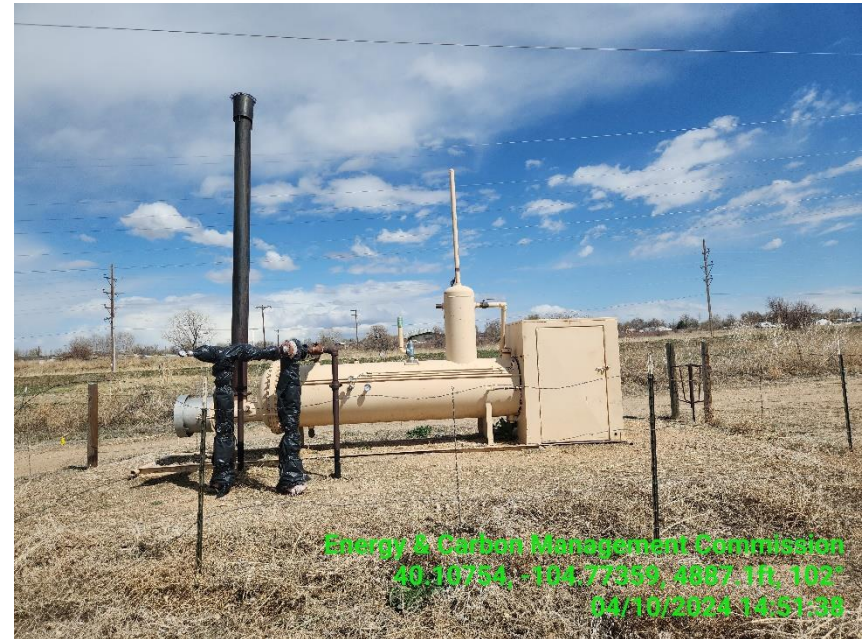
**Photo 2 Horizontal heated Separator.**

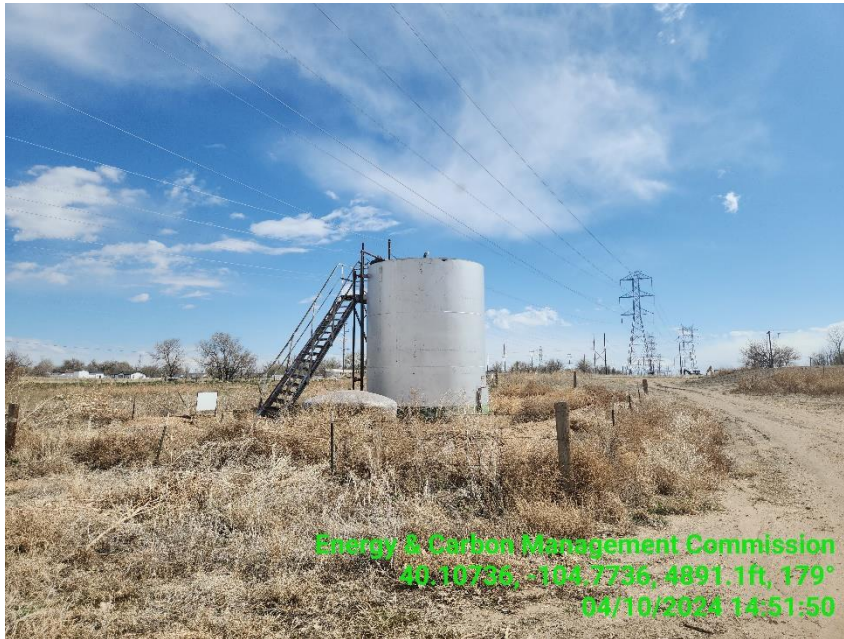
Photo 3 TB berm is over run with debris (dead vegetation).

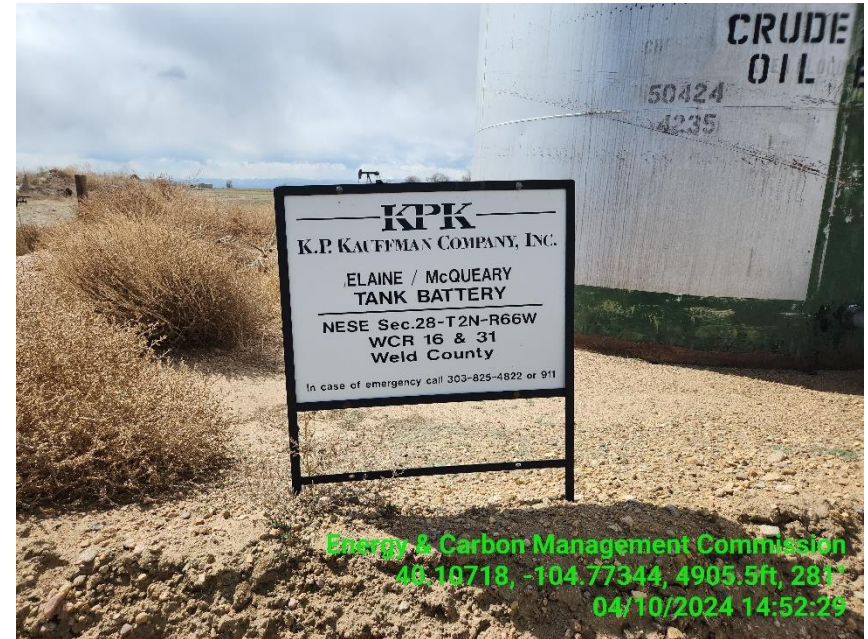
Photo 4 TB sign.

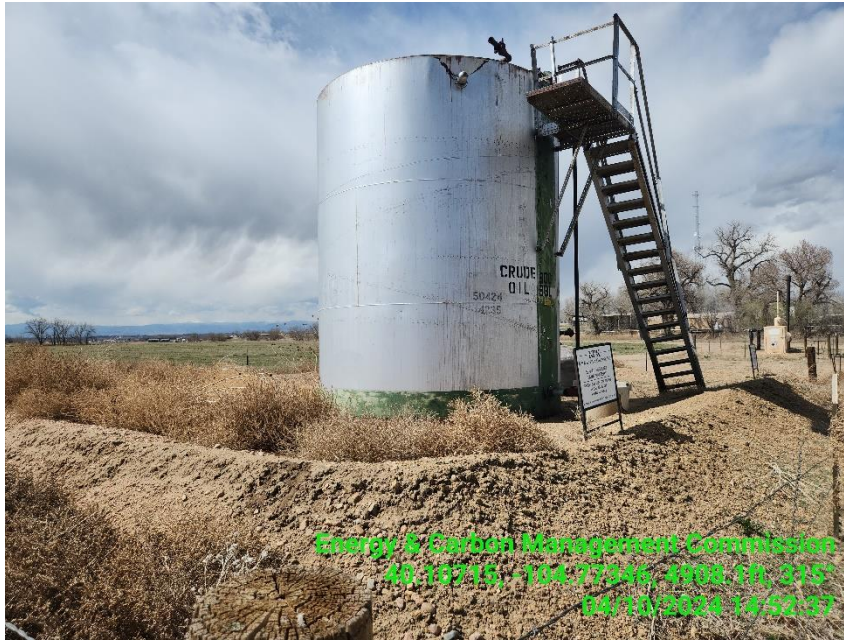
Photo 5 TB berm over run with debris (dead vegetation).

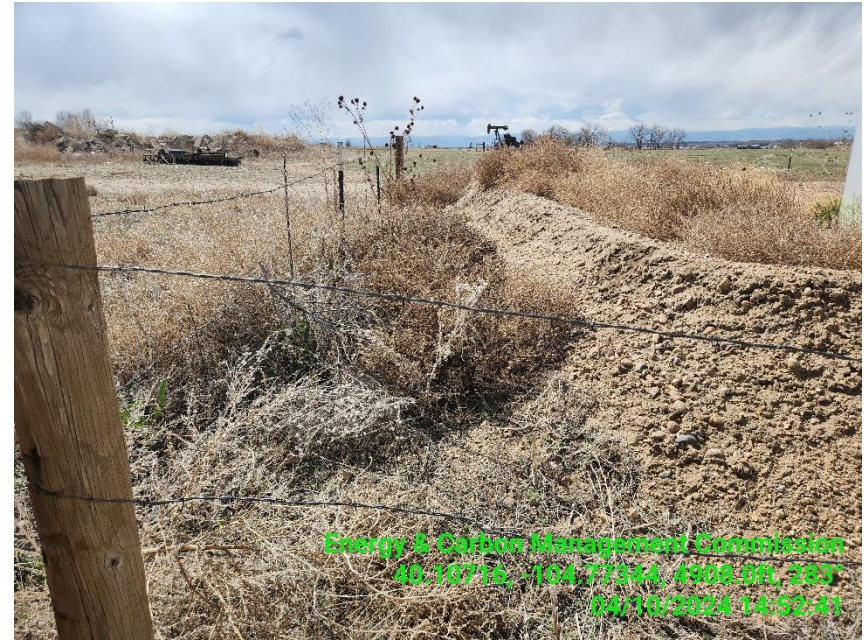
Photo 6 TB berm over run with debris (dead vegetation).

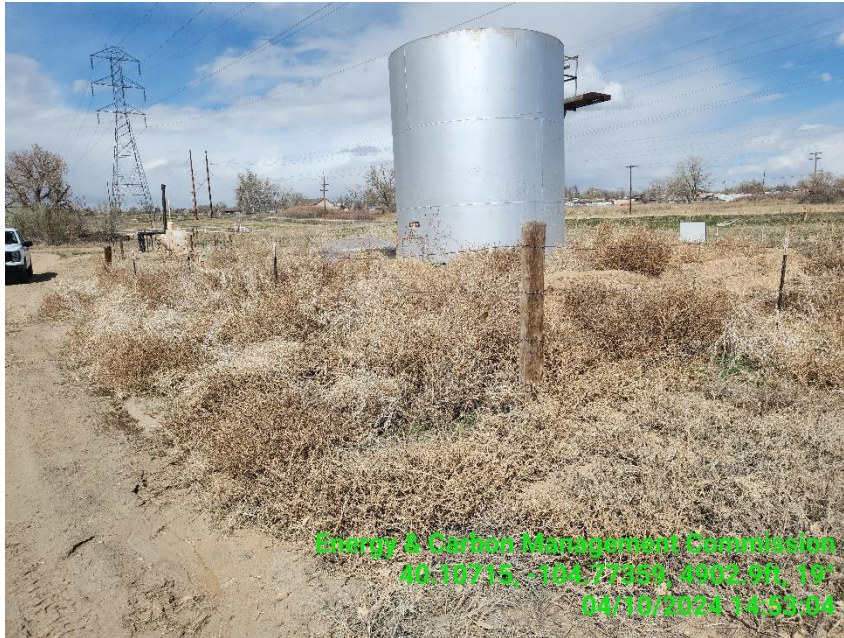
**Photo 7 TB berm over run with debris (dead vegetation).**

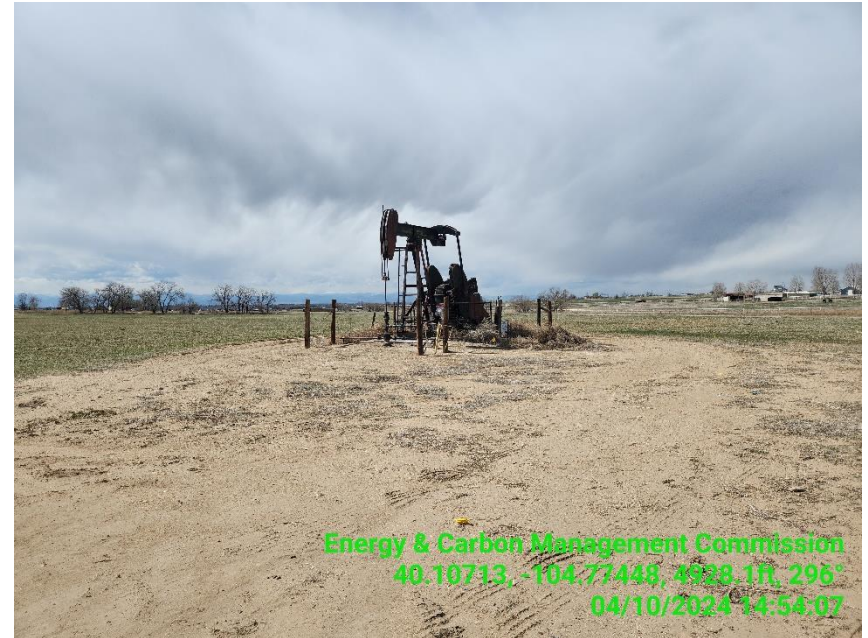
**Photo 8 Well site location.**

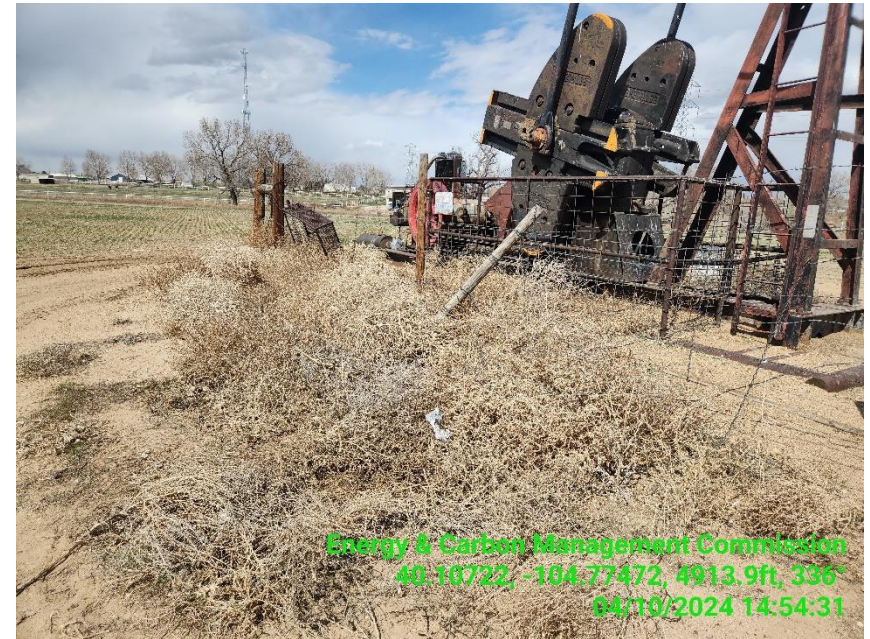
Photo 10 Pump jack base is over run with debris (dead vegetation)..

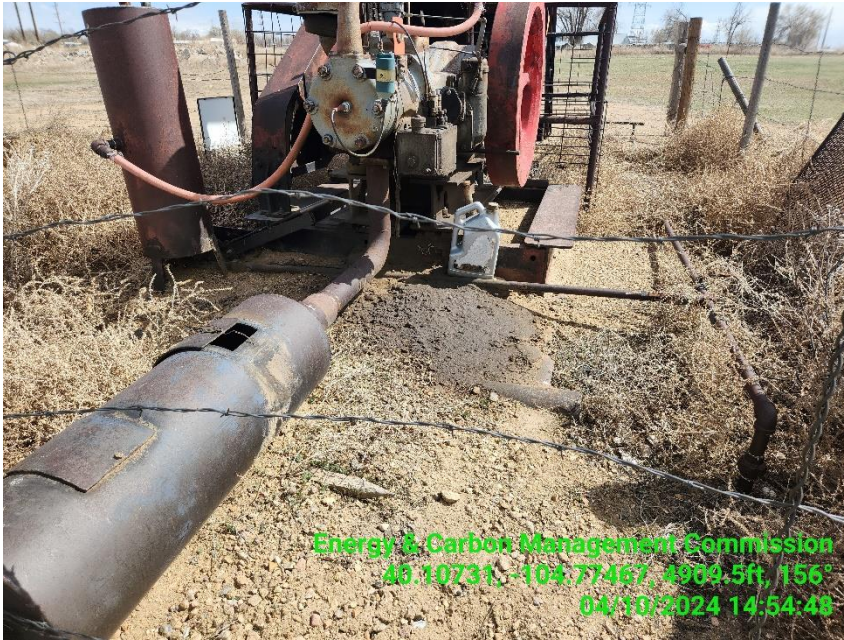
**Photo 11 Dead vegetation/Stained soil by the prime mover (gas engine).**

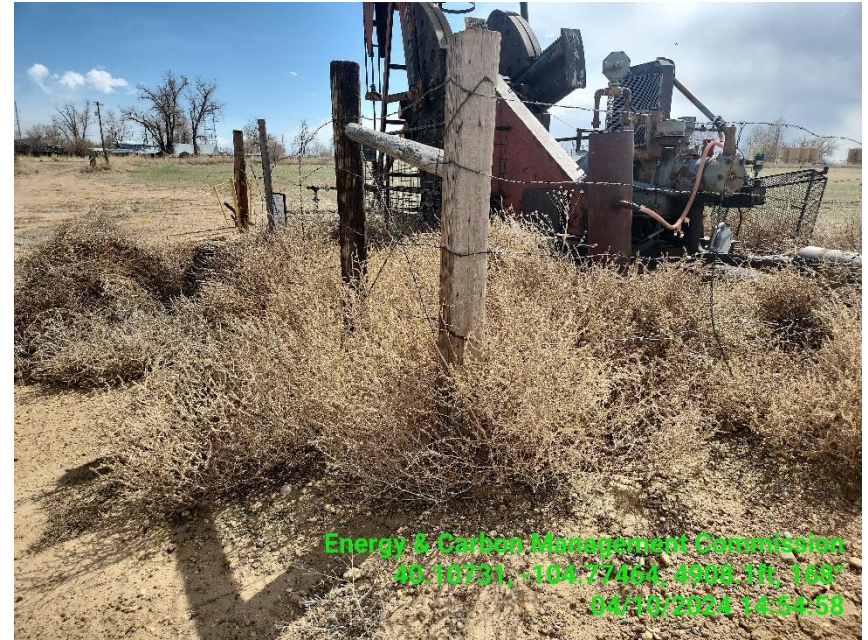
**Photo 12 Pump jack base is over run with debris (dead vegetation)..**

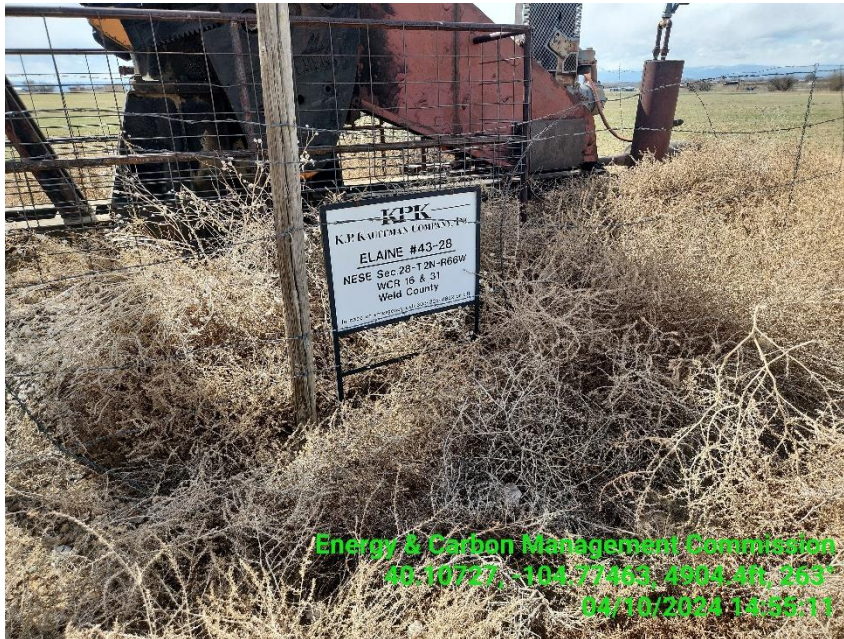
Photo 13 Dead vegetation around the WH sign

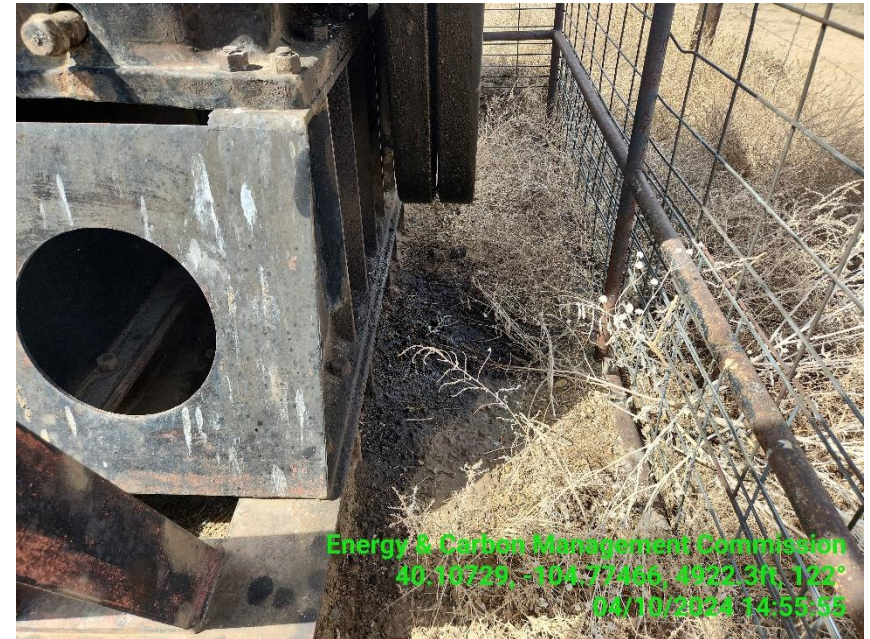
Photo 14 PJ base is over run with debris (dead vegetation) & the PJ gear box is leaking oil onto the ground.

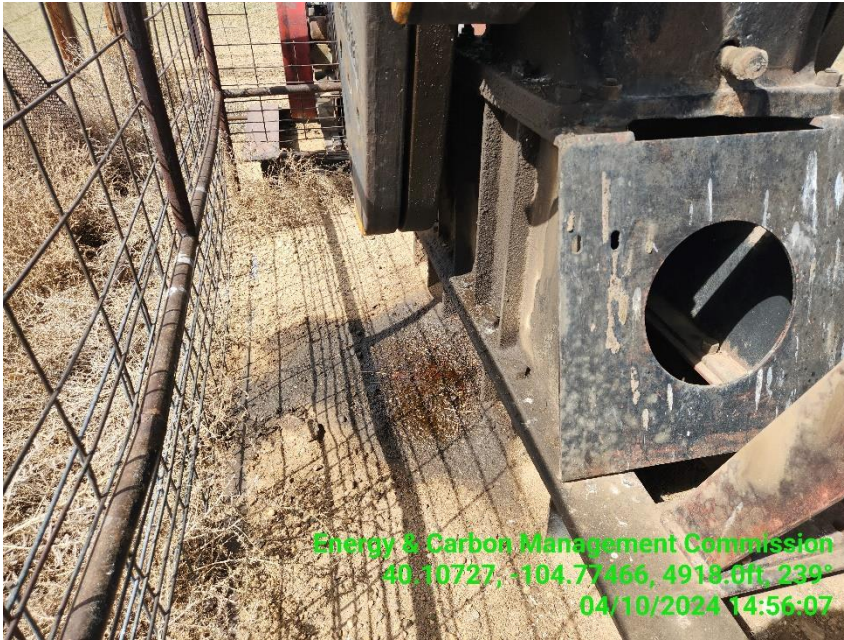
**Photo 15 PJ gear box is leaking oil onto the ground.**
