# Construction and Stormwater Inspection

Operator: PDC ENERGY INC - 69175

Location ID: 485098

Inspection Photos  
Location Name: Denali State 5N67W13 1-23  
Location ID: 485098

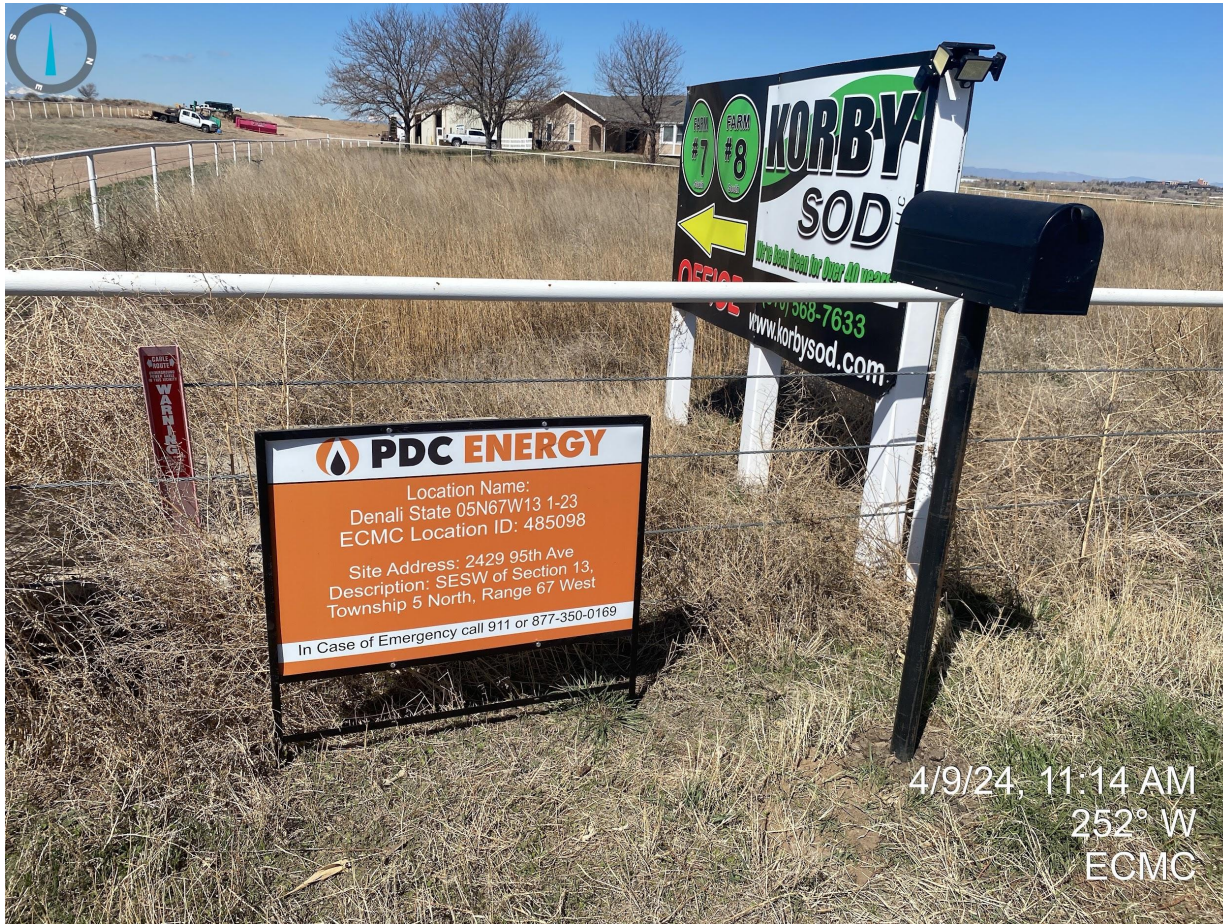
Photo 1. Form 2A posted at the location entrance.

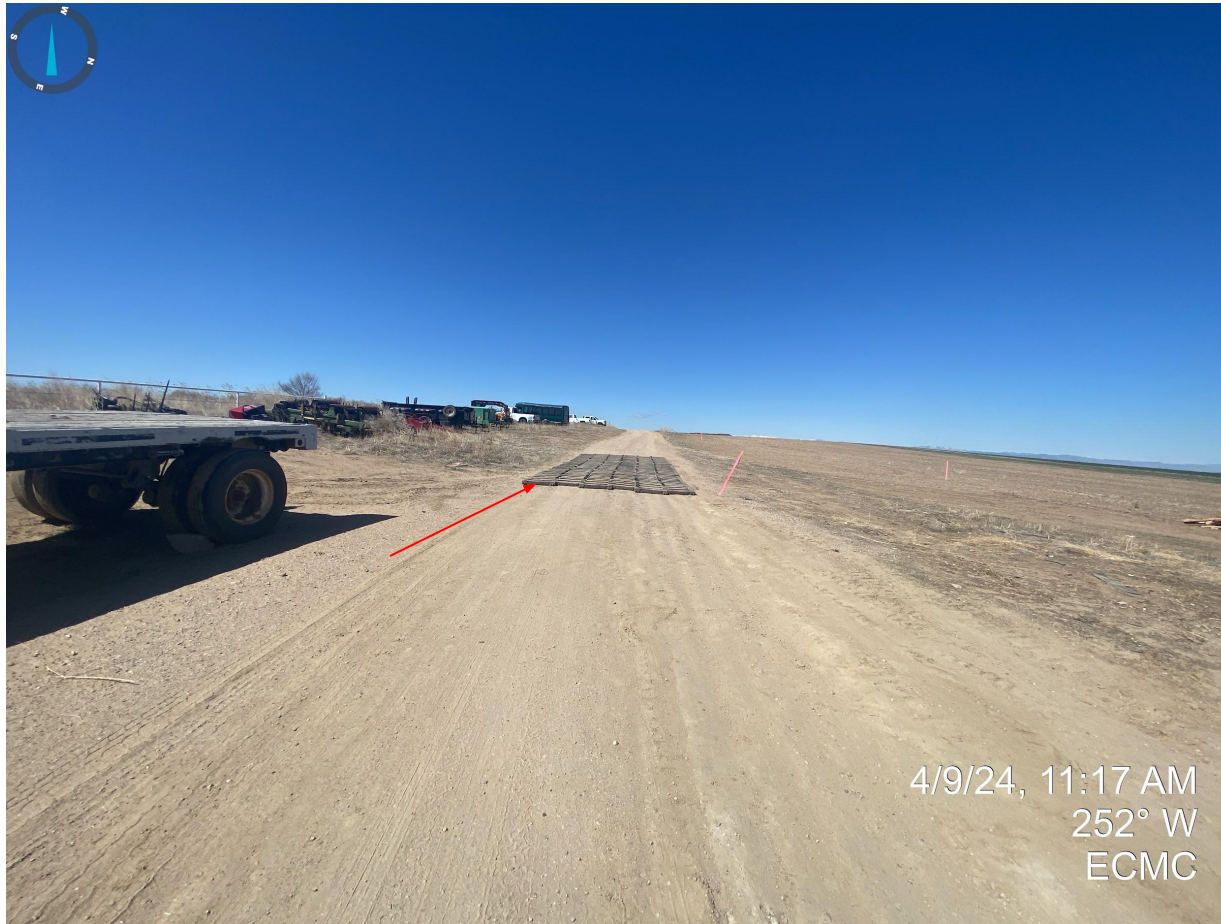
**Photo 2.** Vehicle track out pad installed along the access road.

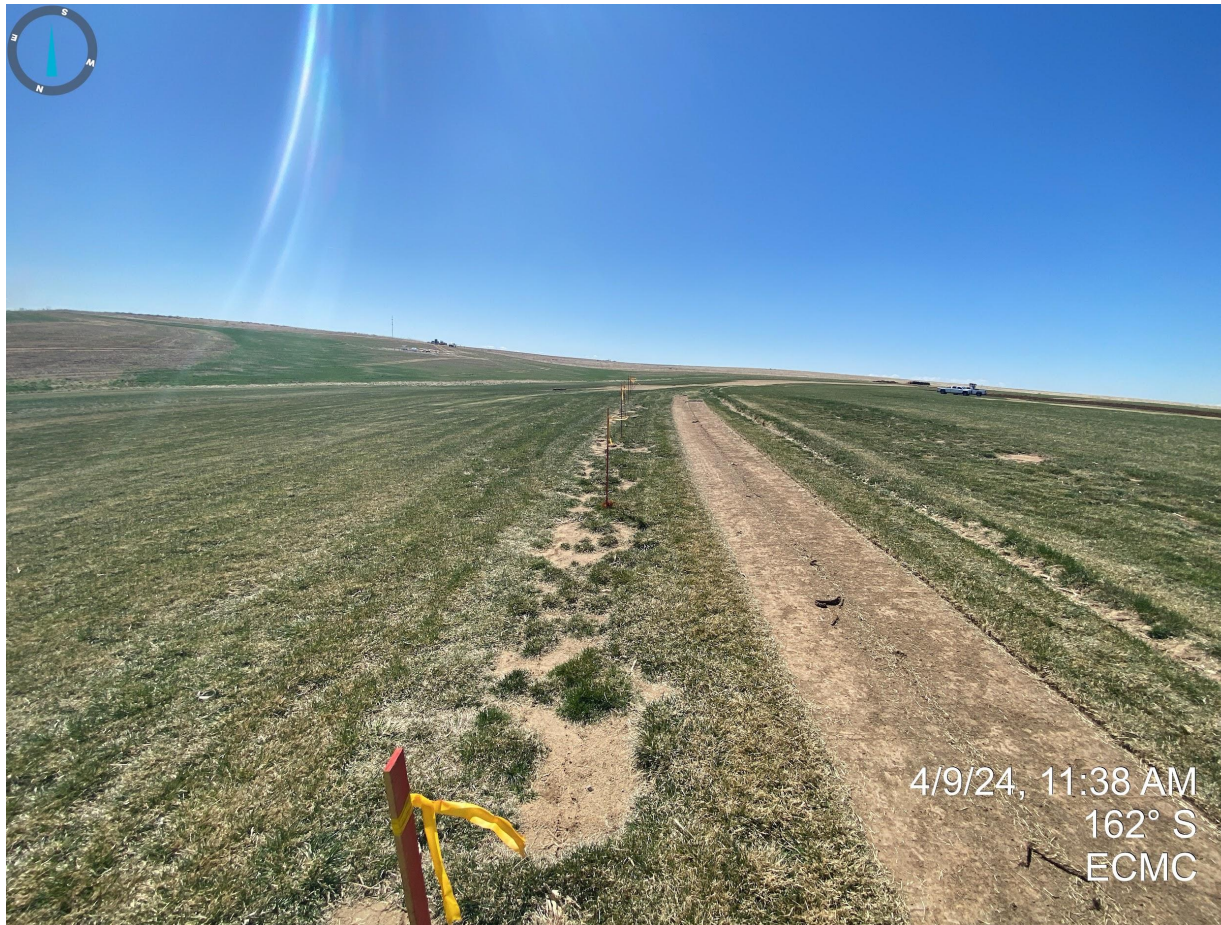
**Photo 3.** Taken near the proposed well locations. Topsoil salvage operations had not commenced at the time of this inspection. The Operator shall ensure that all topsoil is salvaged for the location and access road, in compliance with Rule 1002.b.

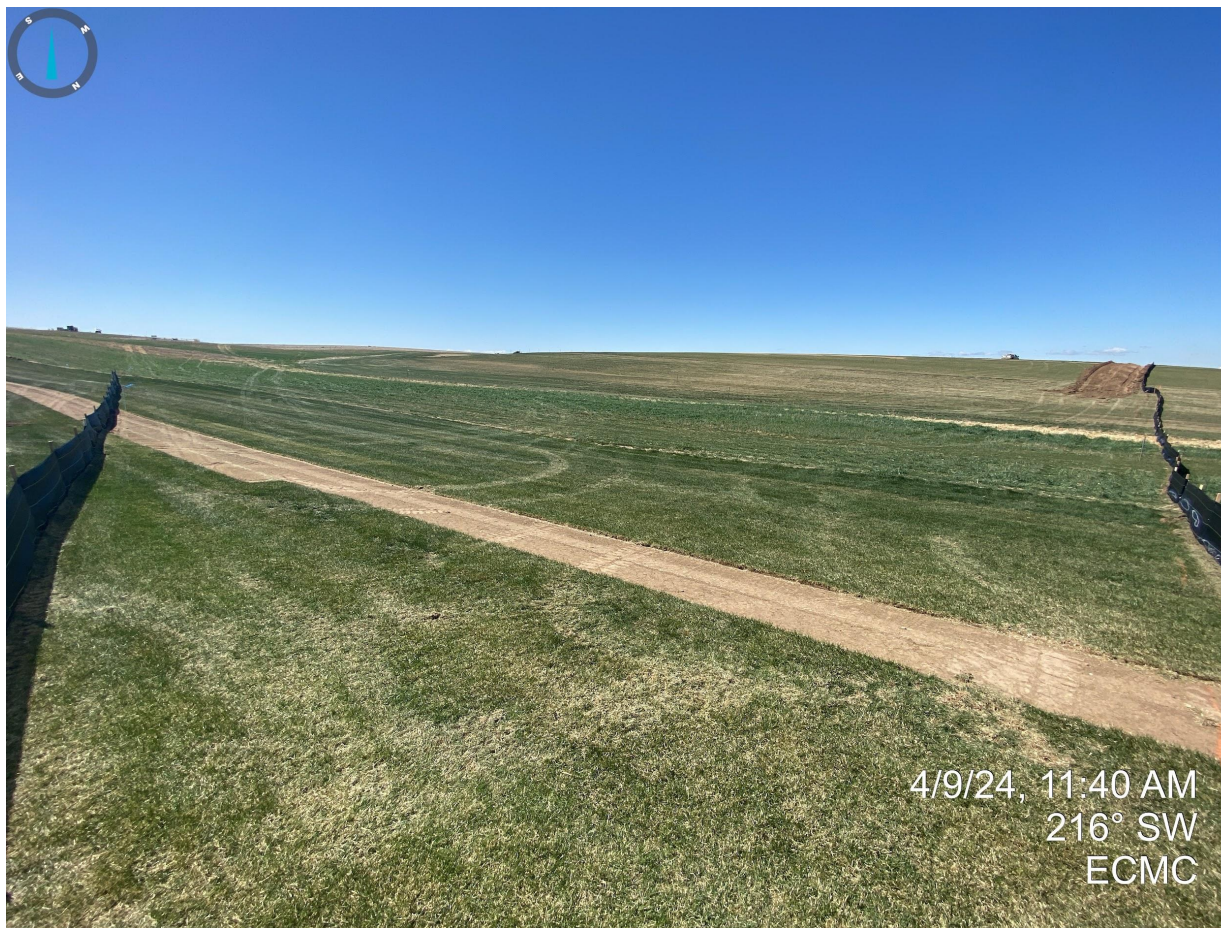
**Photo 4.** Taken near the northeast corner of the disturbance area. Topsoil salvage operations had not commenced at the time of this inspection; onsite crews were in the process of installing a perimeter stormwater control BMP (ditch and berm). Additionally, silt fence has been installed along the northern portion of the disturbance area.

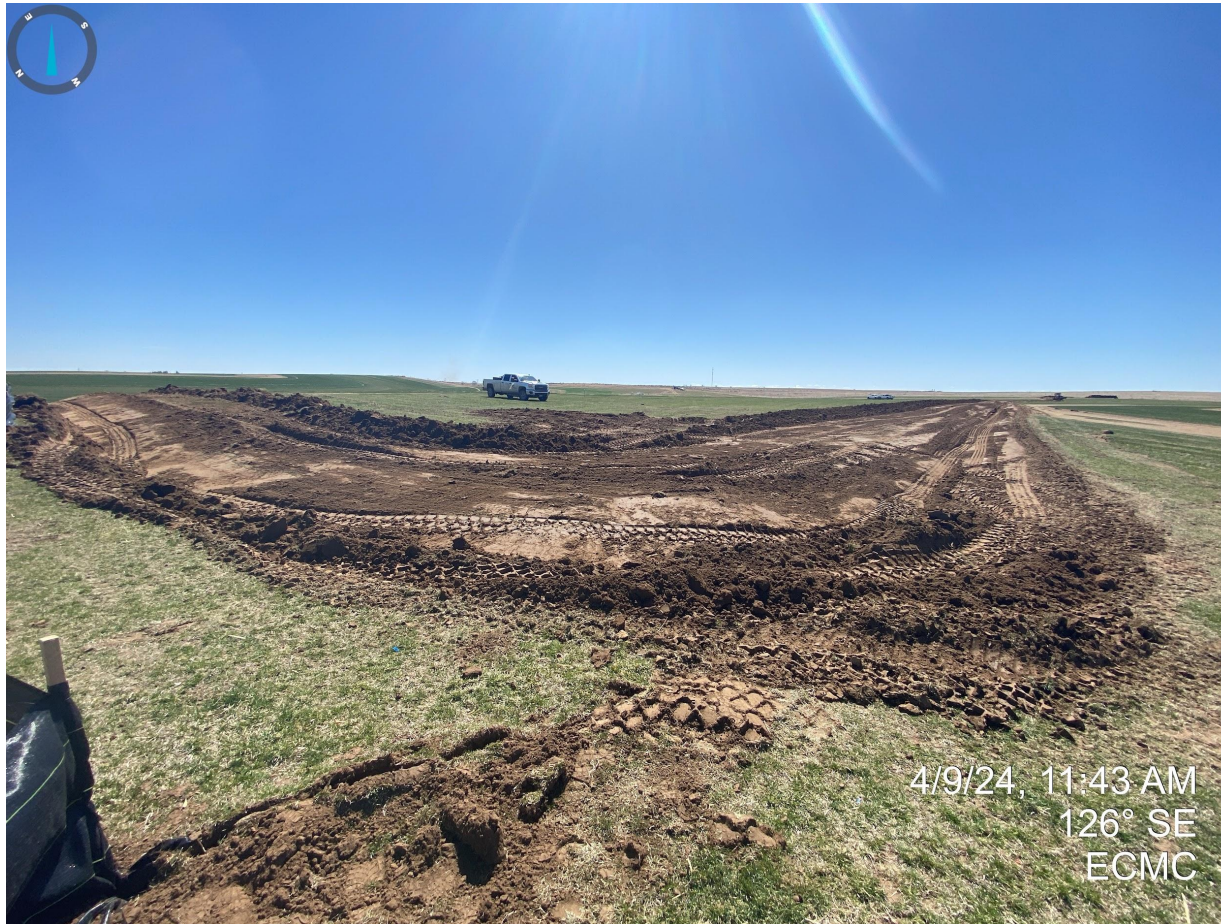
**Photo 5.** Taken near the northwest corner of the disturbance area. Topsoil salvage operations had not commenced at the time of this inspection; onsite crews were in the process of installing a perimeter stormwater control BMP (ditch and berm).

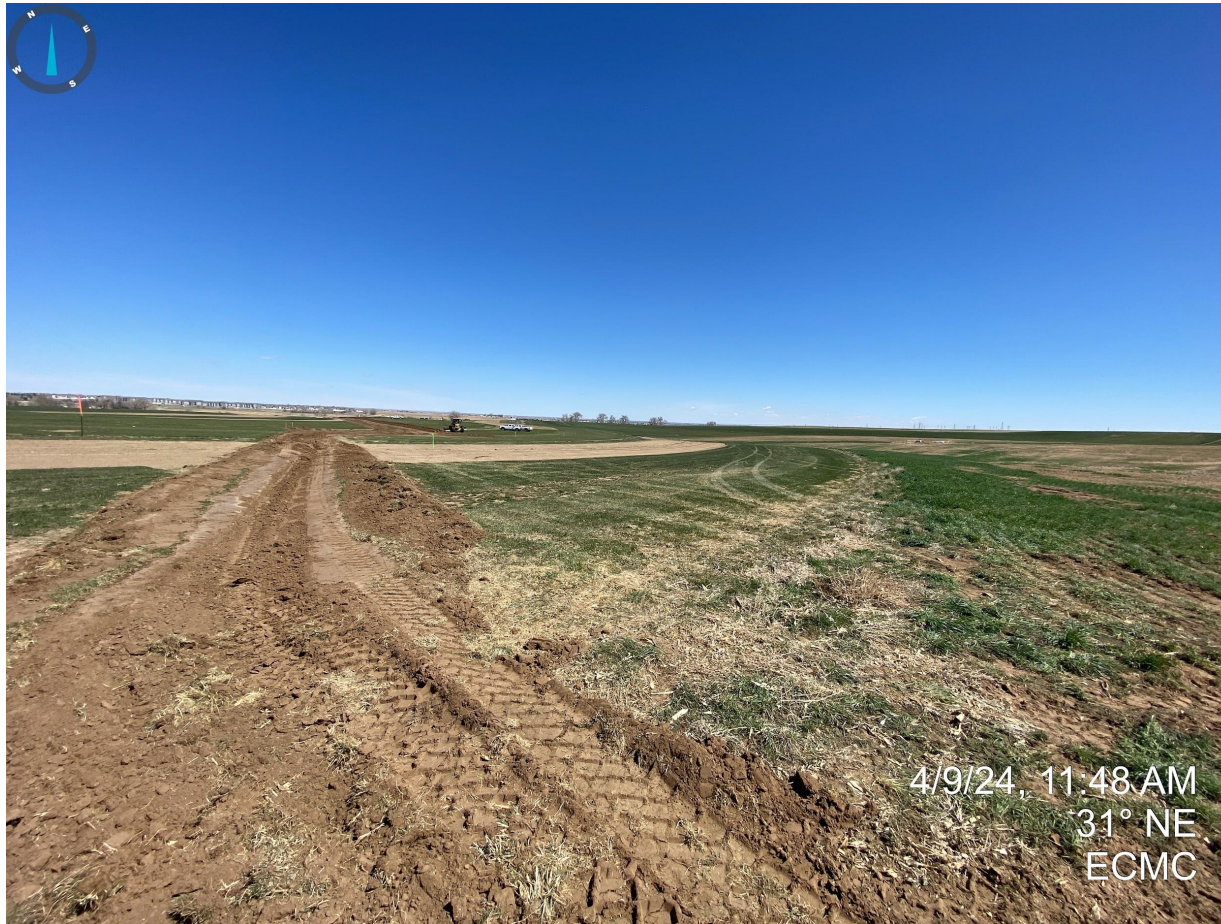
**Photo 6.** Taken near the southwest corner of the disturbance area. Topsoil salvage operations had not commenced at the time of this inspection; onsite crews were in the process of installing a perimeter stormwater control BMP (ditch and berm).

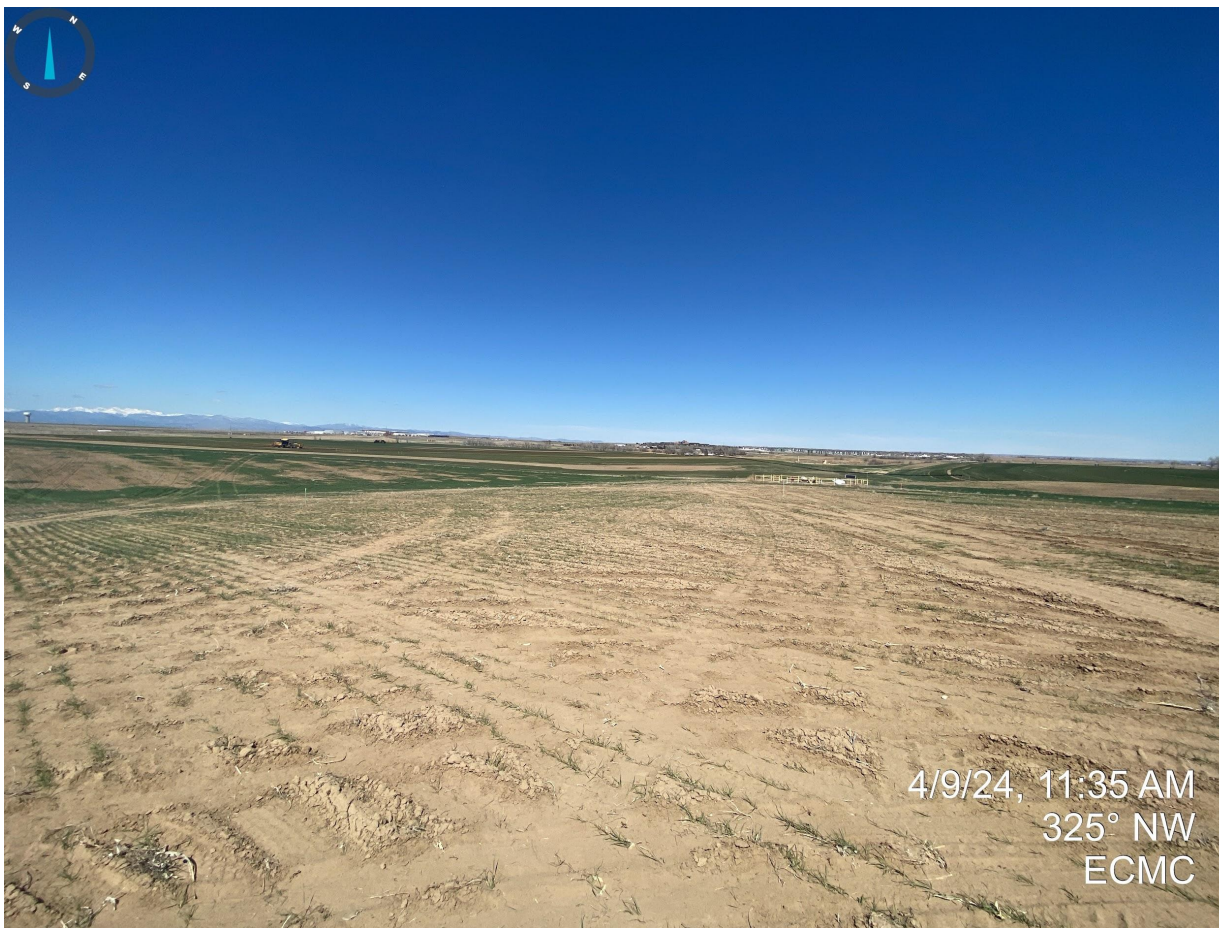
**Photo 7.** Taken near the southeast corner of the disturbance area. Topsoil salvage operations had not commenced at the time of this inspection; onsite crews were in the process of installing a perimeter stormwater control BMP (ditch and berm).
