WELL NAME: LORENCITO 10-2, API #: 071-07123, INSP. # 695109419

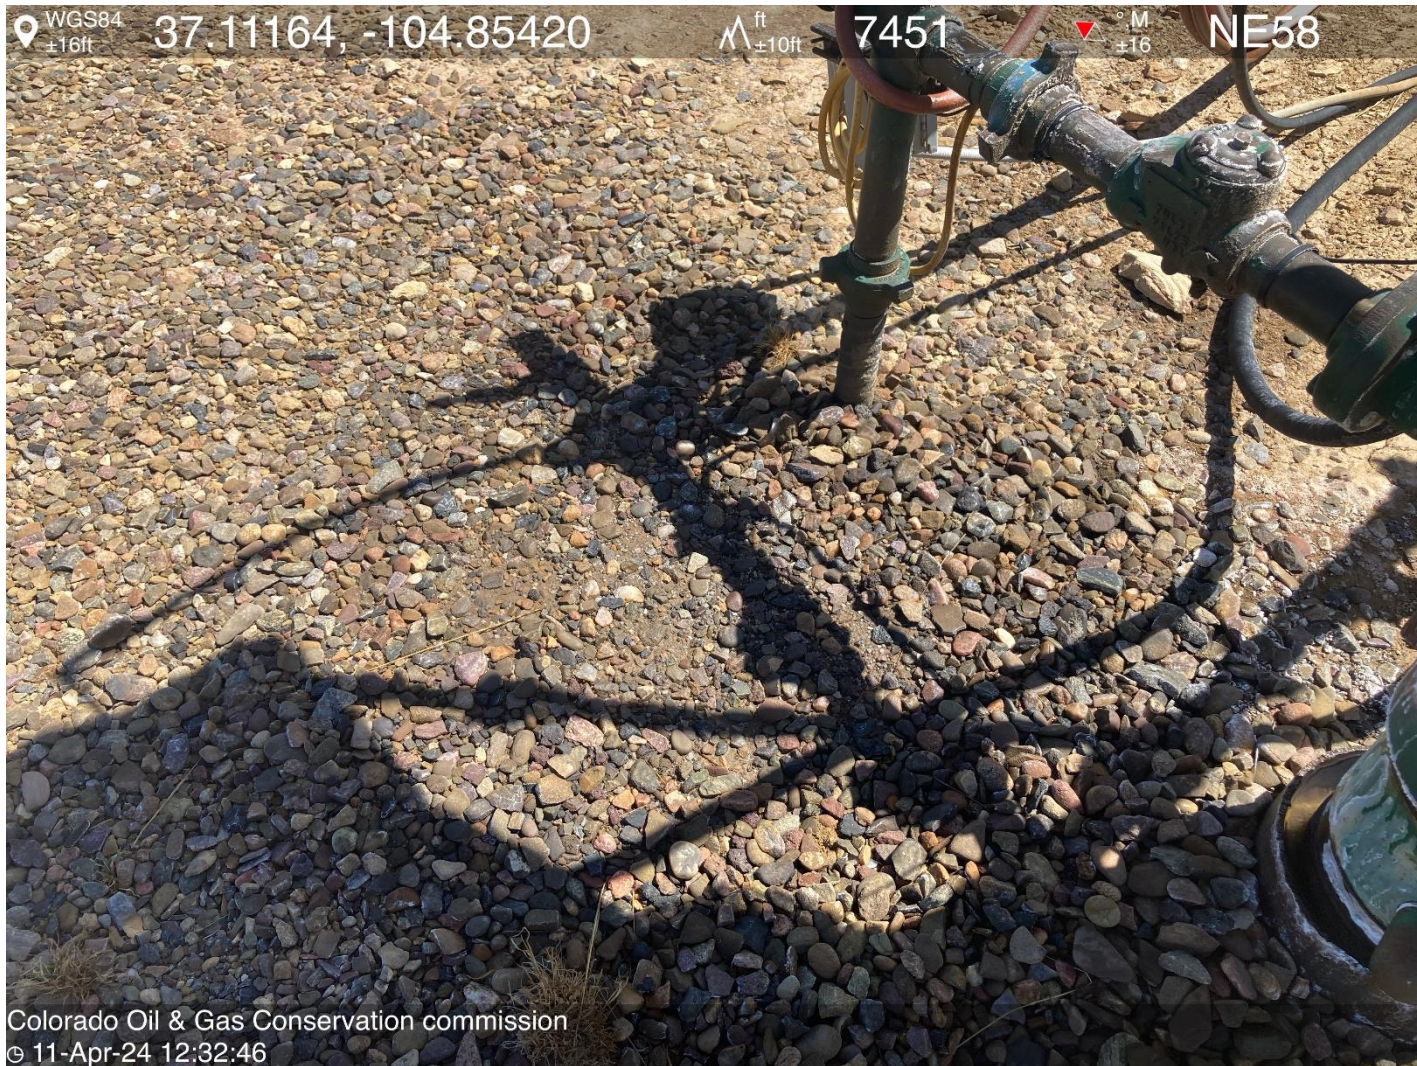
PHOTO 3: WELLHEAD AND EQUIPMENT

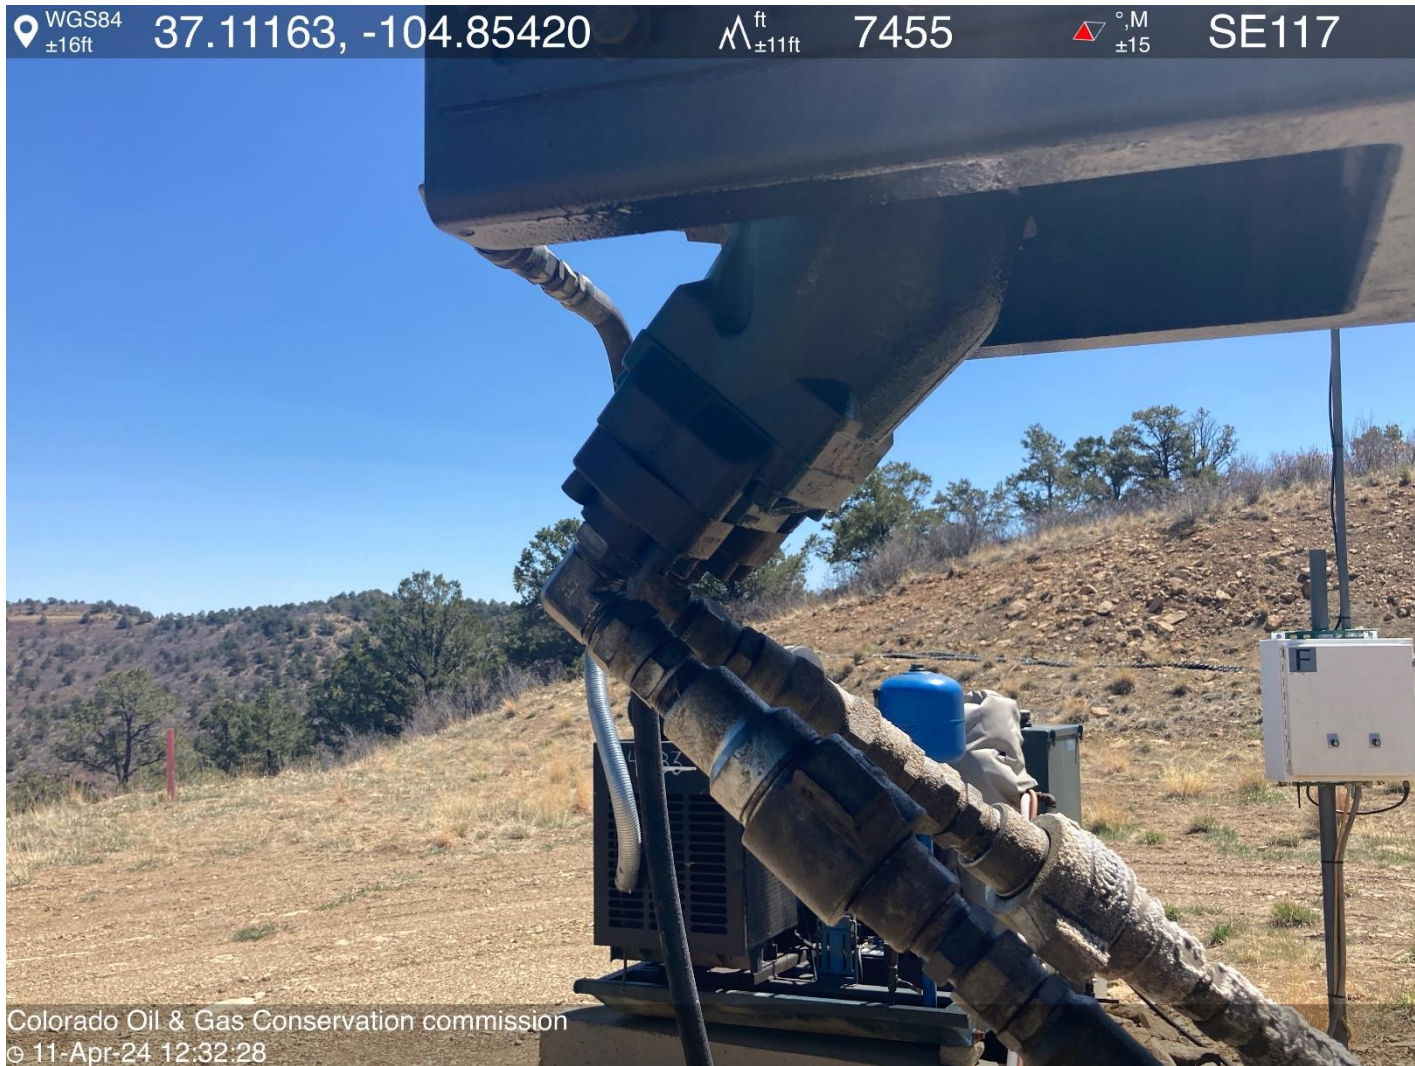
PHOTO 4: AREA OF IMPACTED SOIL NEAR DRIVEHEAD (HYDRAULIC OIL IS LEAKING FROM DRIVE MOTOR). Conduct maintenance on equipment, cleanup stained material and review self inspection processes. COMPLY WITH RULE 1002,.(2).D. CA DATE 4-18-2024.
