# DP402/Hullabaloo

## Photo Log

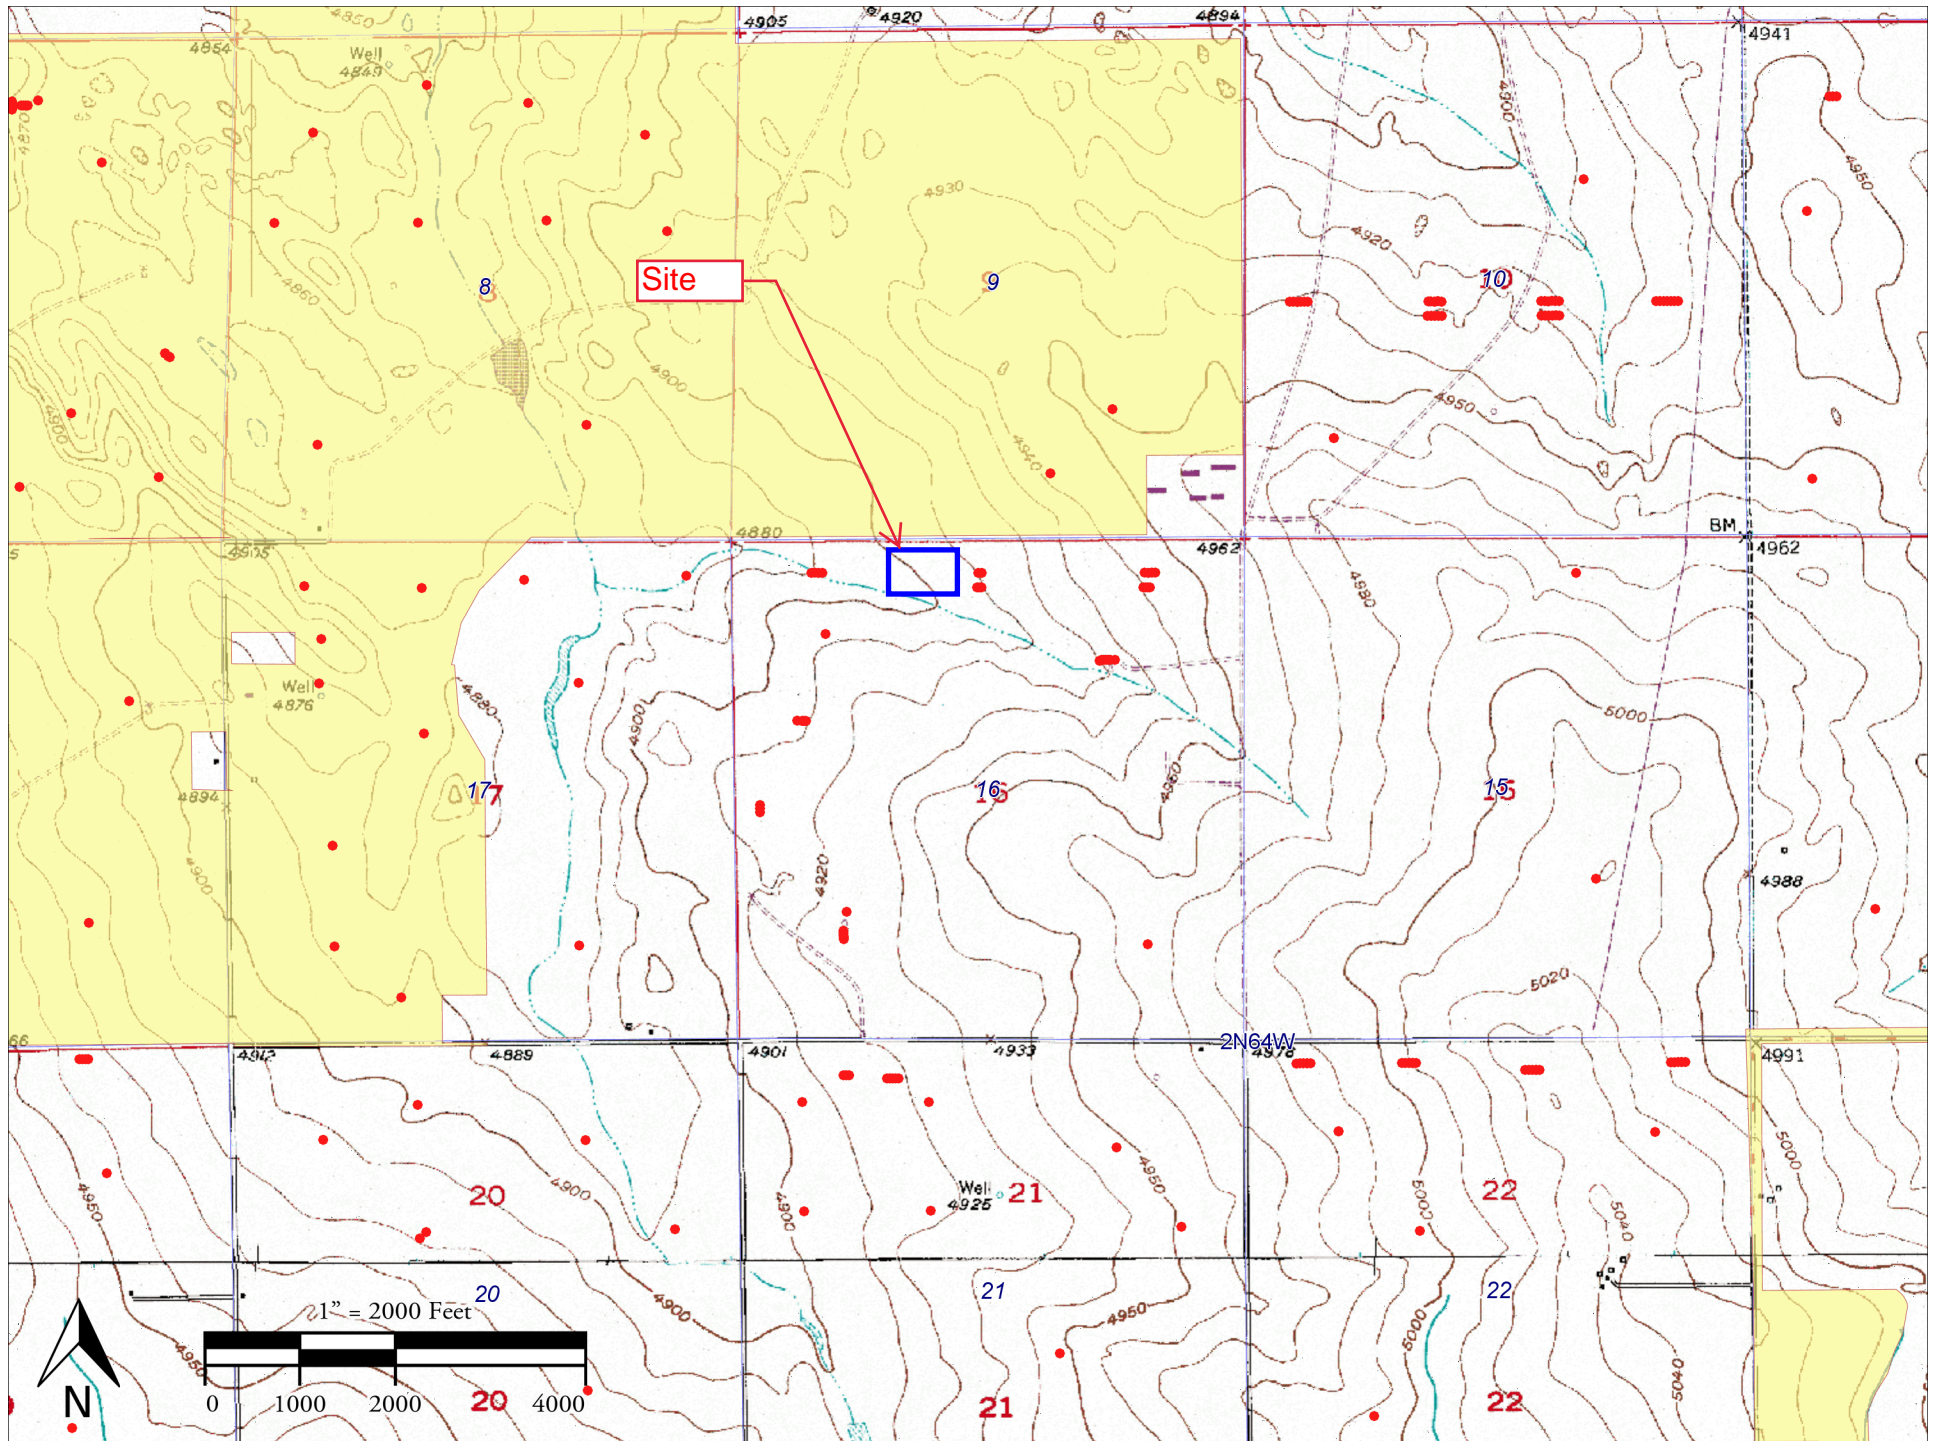
Impacted Area 15' x 22' x 1' deep

Release Point

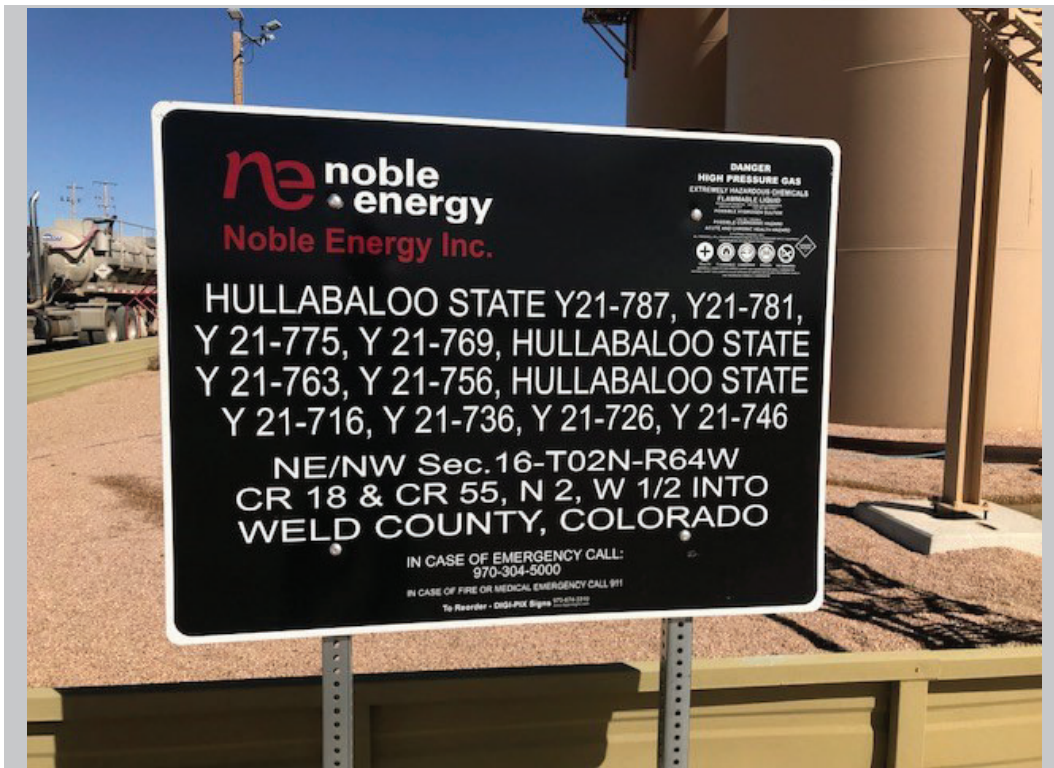
#1 - DP402/Hullabaloo Facility

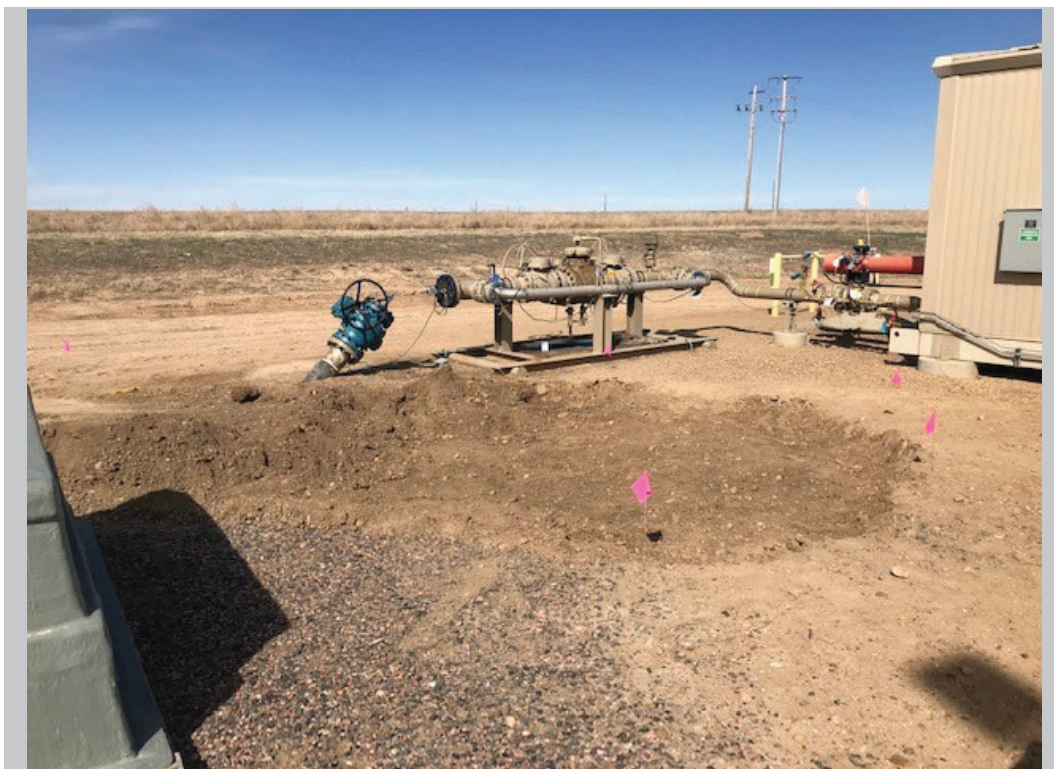
#2 - Looking northeast at pig launcher where release occurred

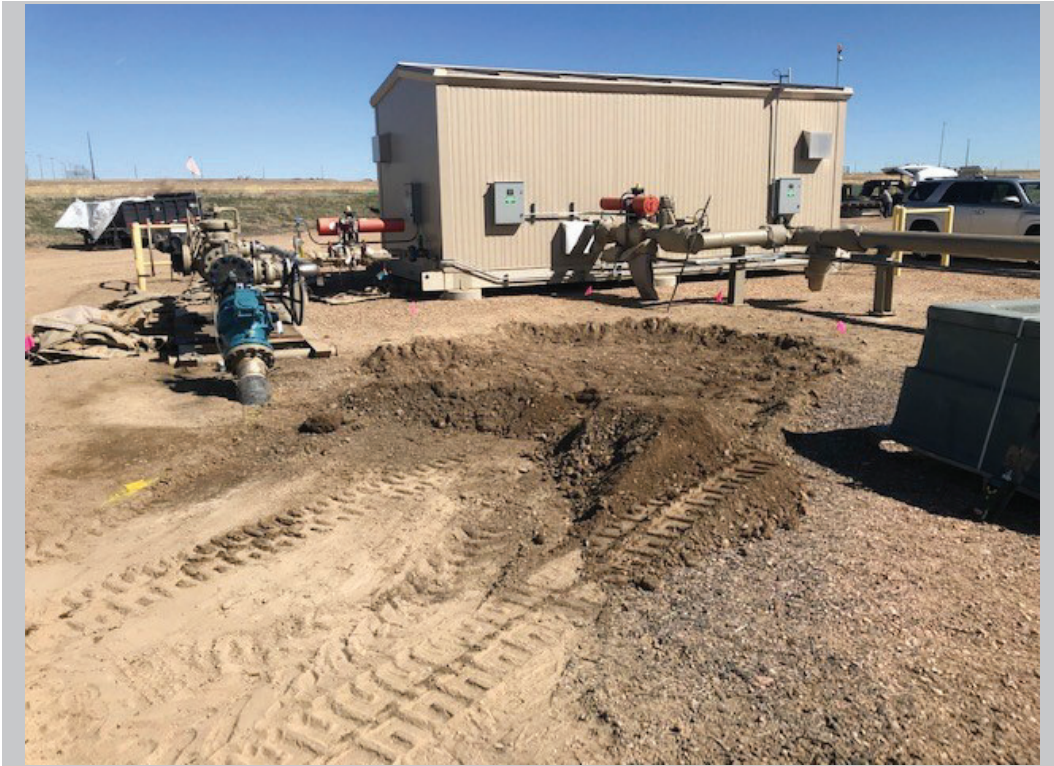
#3 - Looking southeast at impacted soil area that has been partially excavated. Note LACT building in background.

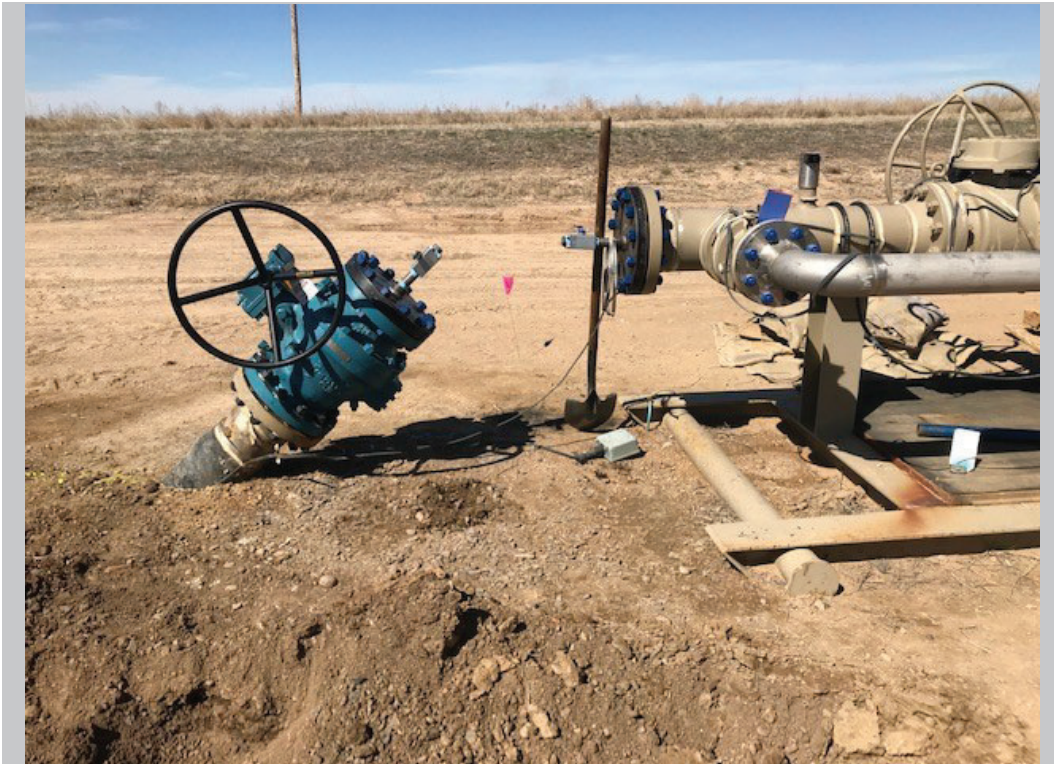
#4 - Looking north at failure location; failed section has been removed from system.

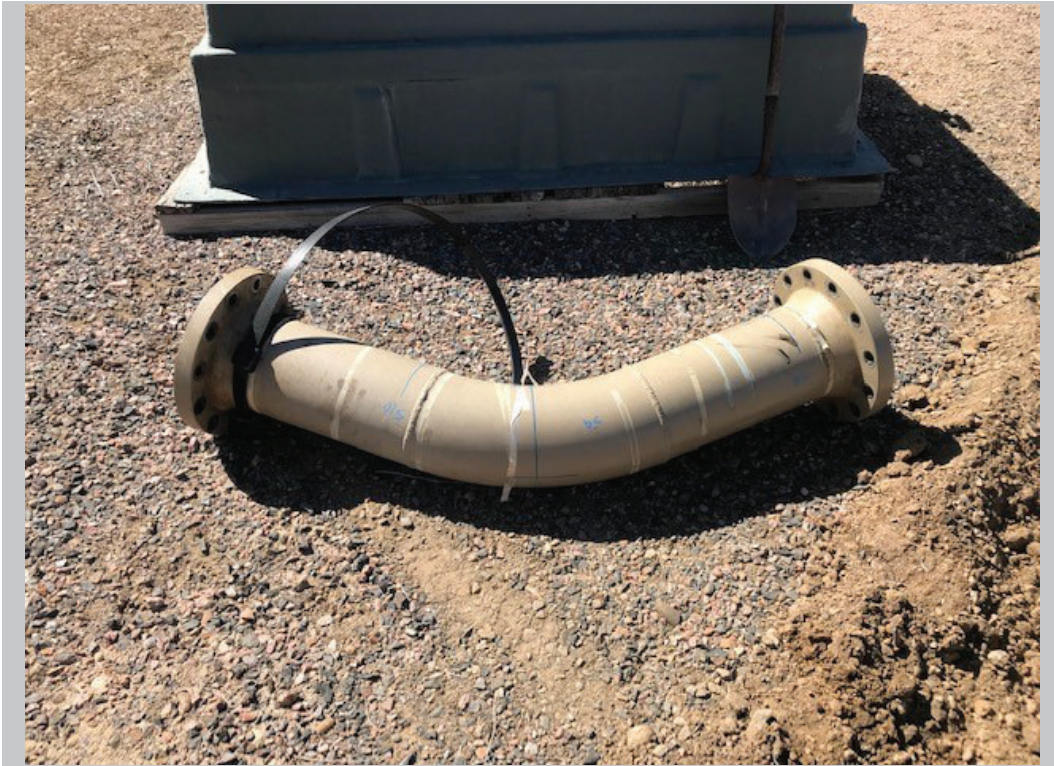
#5 - Failed section of pipe. Band on the left side of pipe was used as a leak clamp.

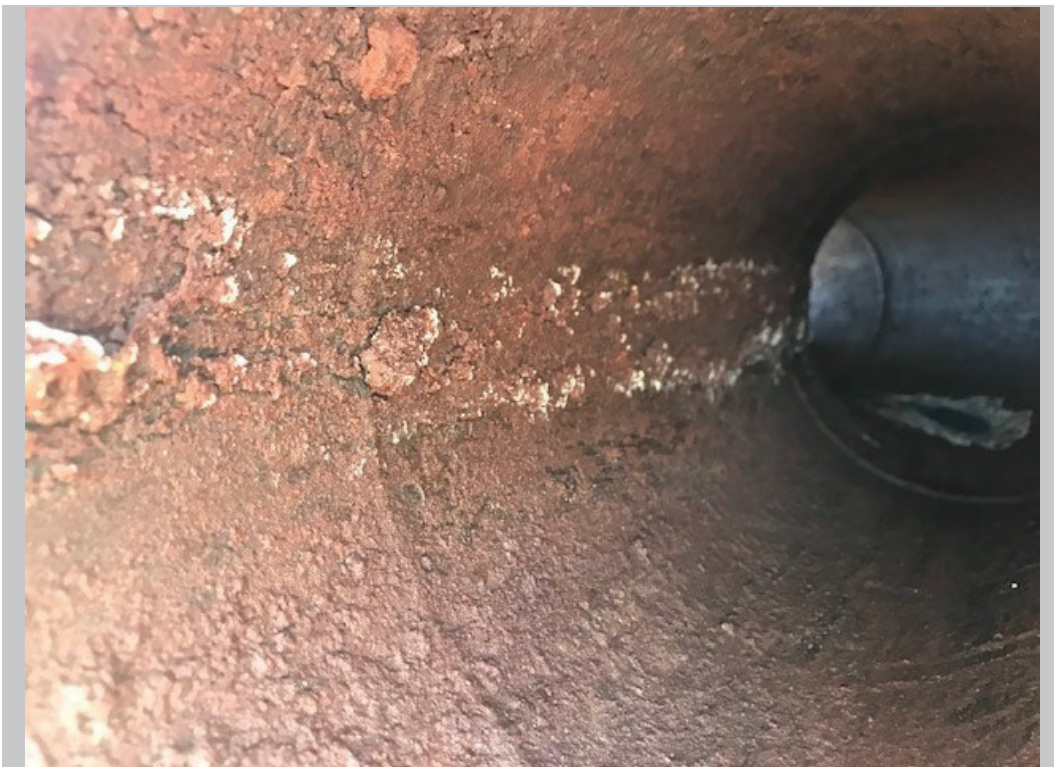
#6 - Inside of failed pipe section.
