## Inspection Photos

Location Name: CAERUS PICEANCE LLC MILLER 14-2 (B14W) Pad

Location ID: 334742

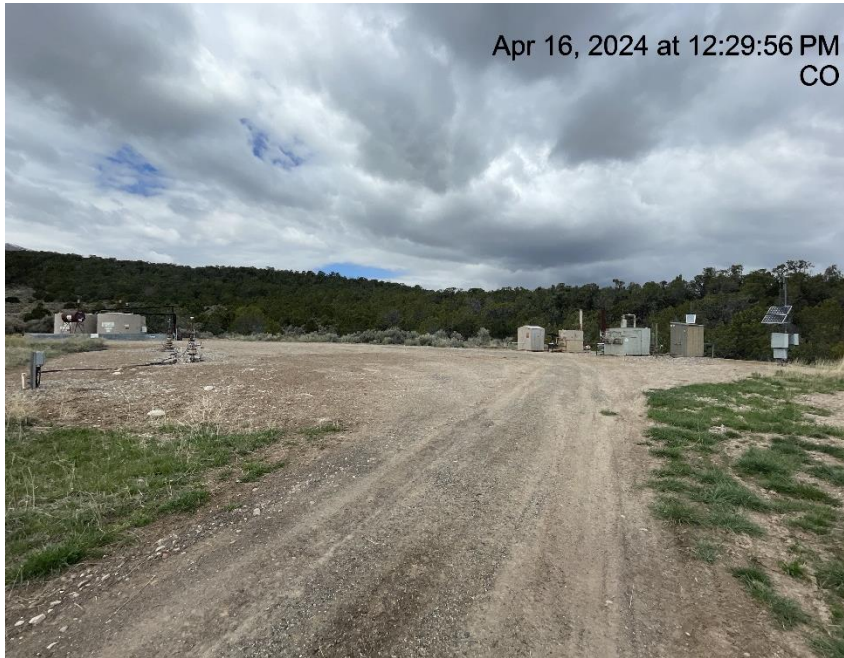
Photo # 4183 From entrance to location

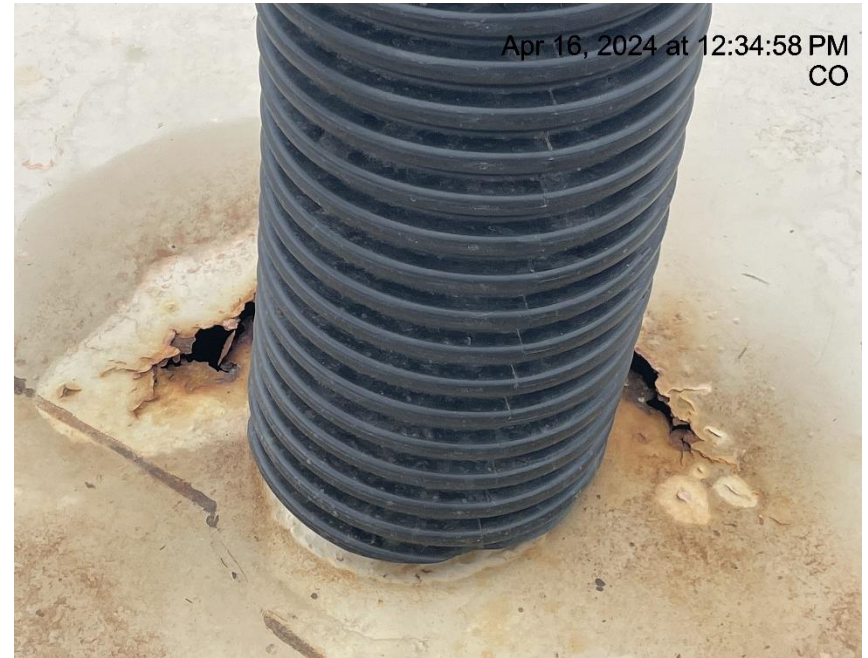
**Photo # 4188 Possible tank failure – tank appears to be compromised, holes & corrosion on the top of production tank**

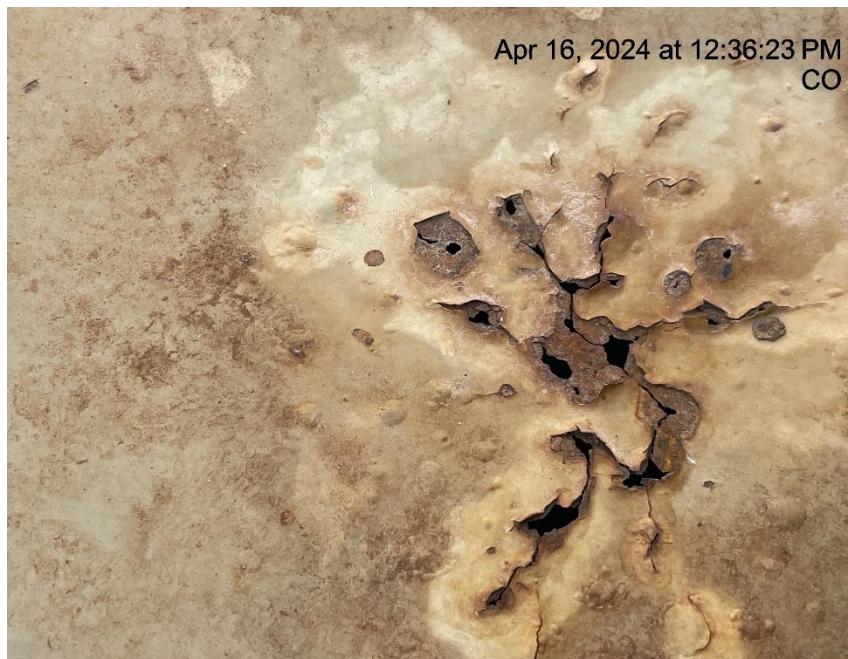
**Photo # 4189 Possible tank failure – tank appears to be compromised, holes & corrosion on the top of tank**

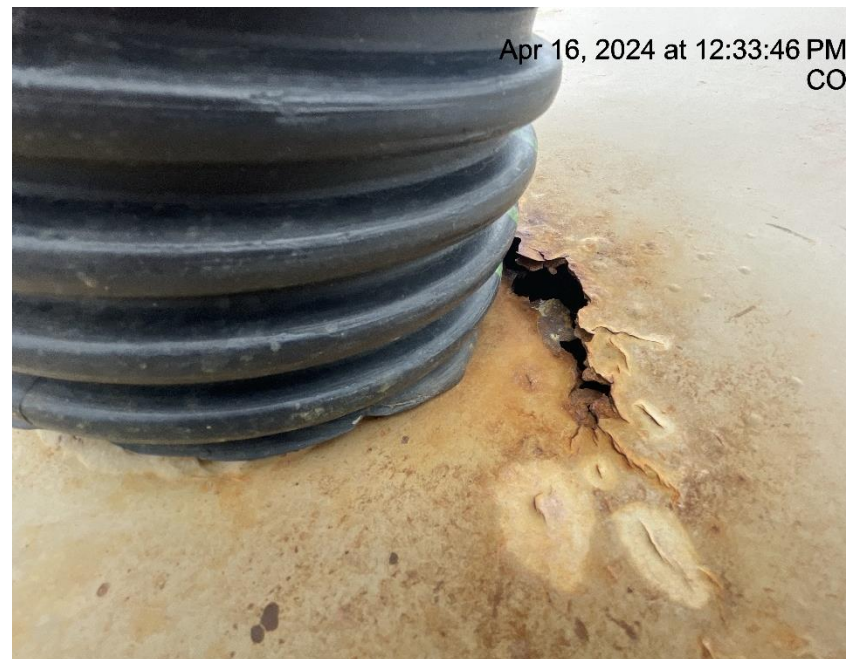
**Photo # 4190 Possible tank failure – tank appears to be compromised, holes & corrosion on the top of tank**

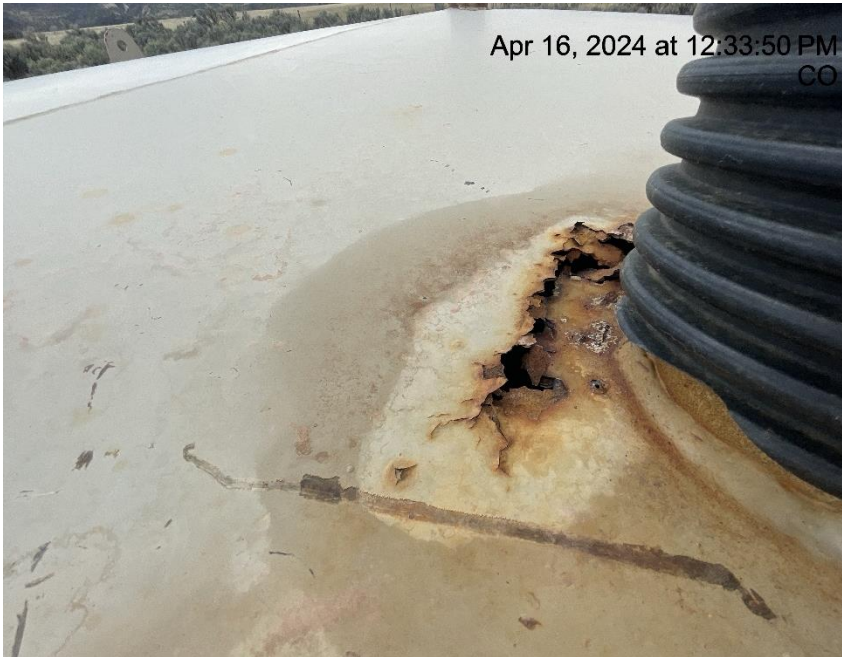
**Photo # 4191 Possible tank failure – tank appears to be compromised, holes & corrosion on the top of tank**

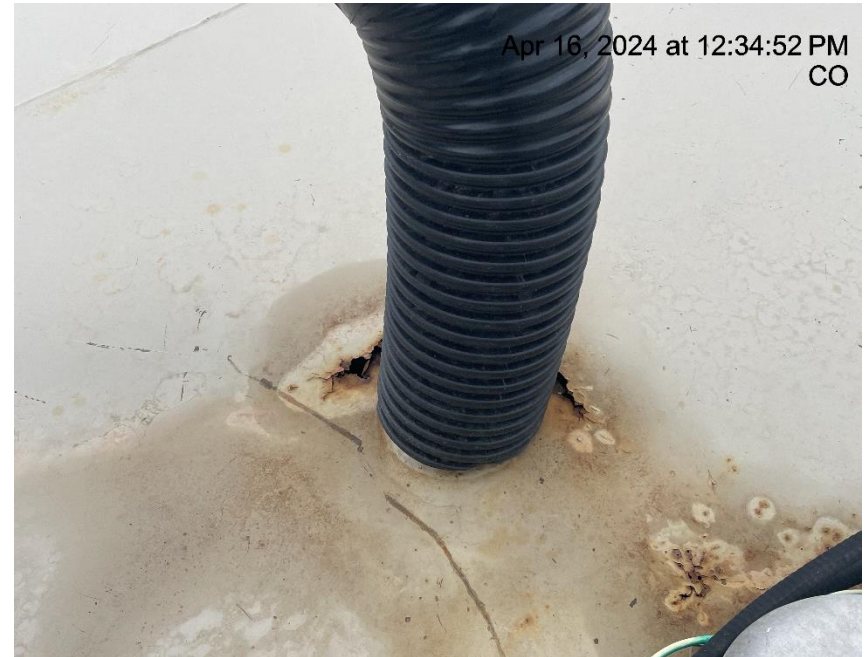
**Photo # 4192 Possible tank failure – tank appears to be compromised, holes & corrosion on the top of tank**

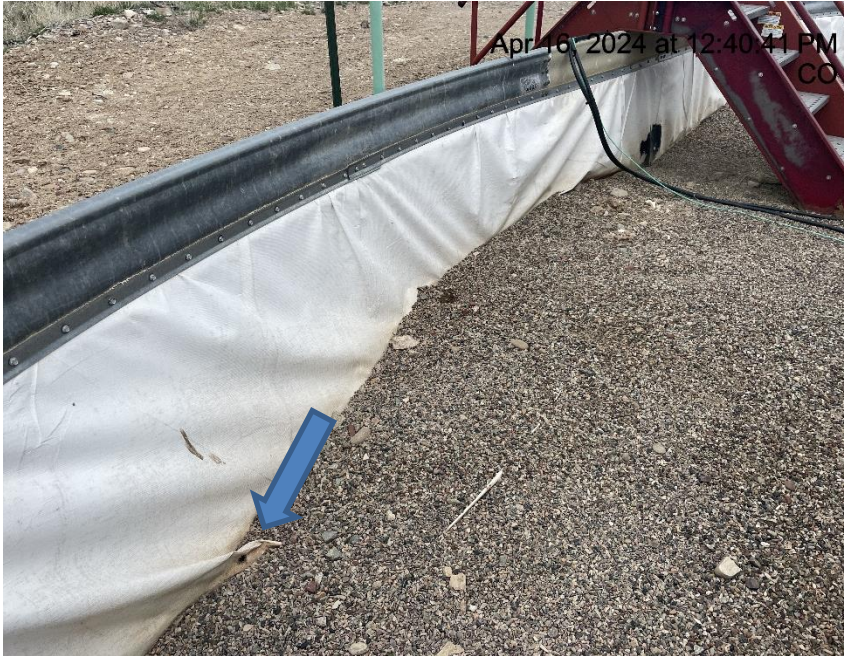
**Photo # 4193 Hole in liner/liner needs maintenance**

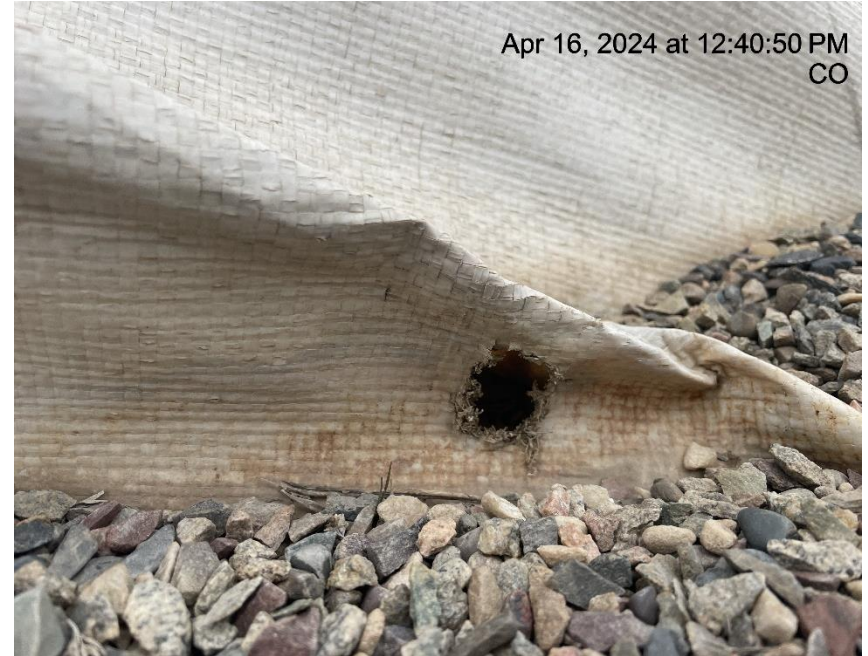
**Photo # 4194 Hole in liner/liner needs maintenance**

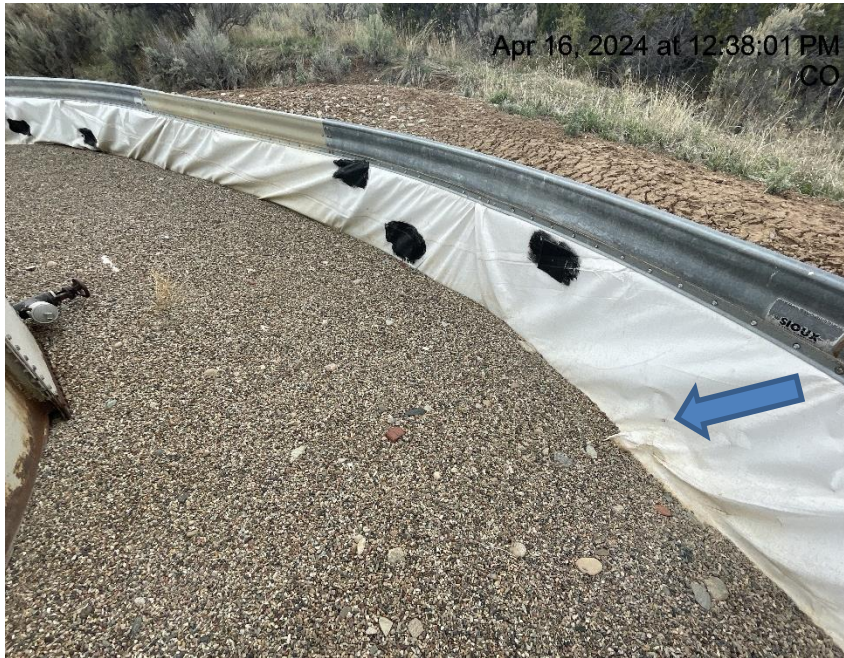
**Photo # 4195 Hole in liner/liner needs maintenance**

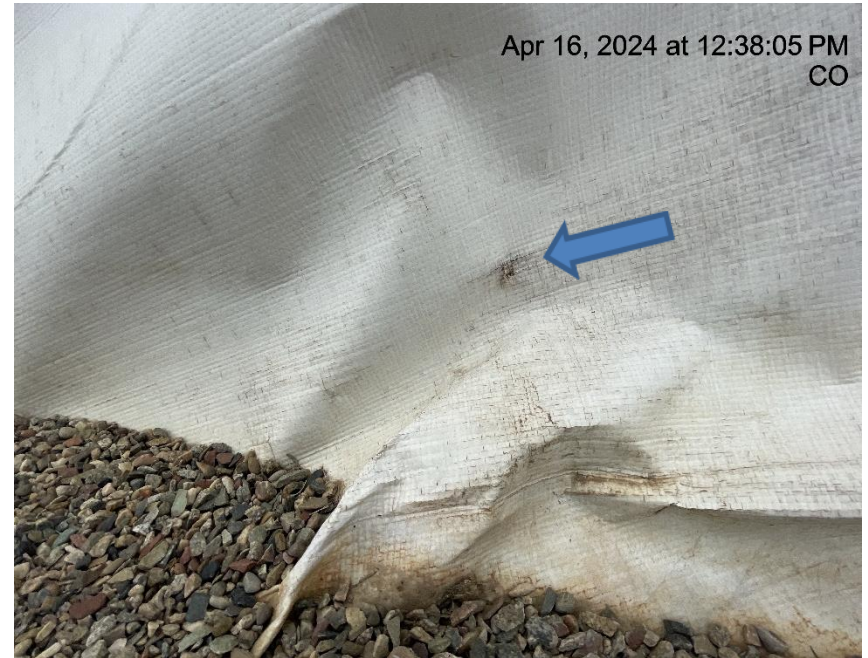
**Photo # 4196 Hole in liner/liner needs maintenance**
