Inspection Photos

Operator: MorningStar Operating LLC - 10755

Location ID: 334049

Inspection Photos
Location Name: Chapin 32-06 23-3, 4
Location ID: 334049

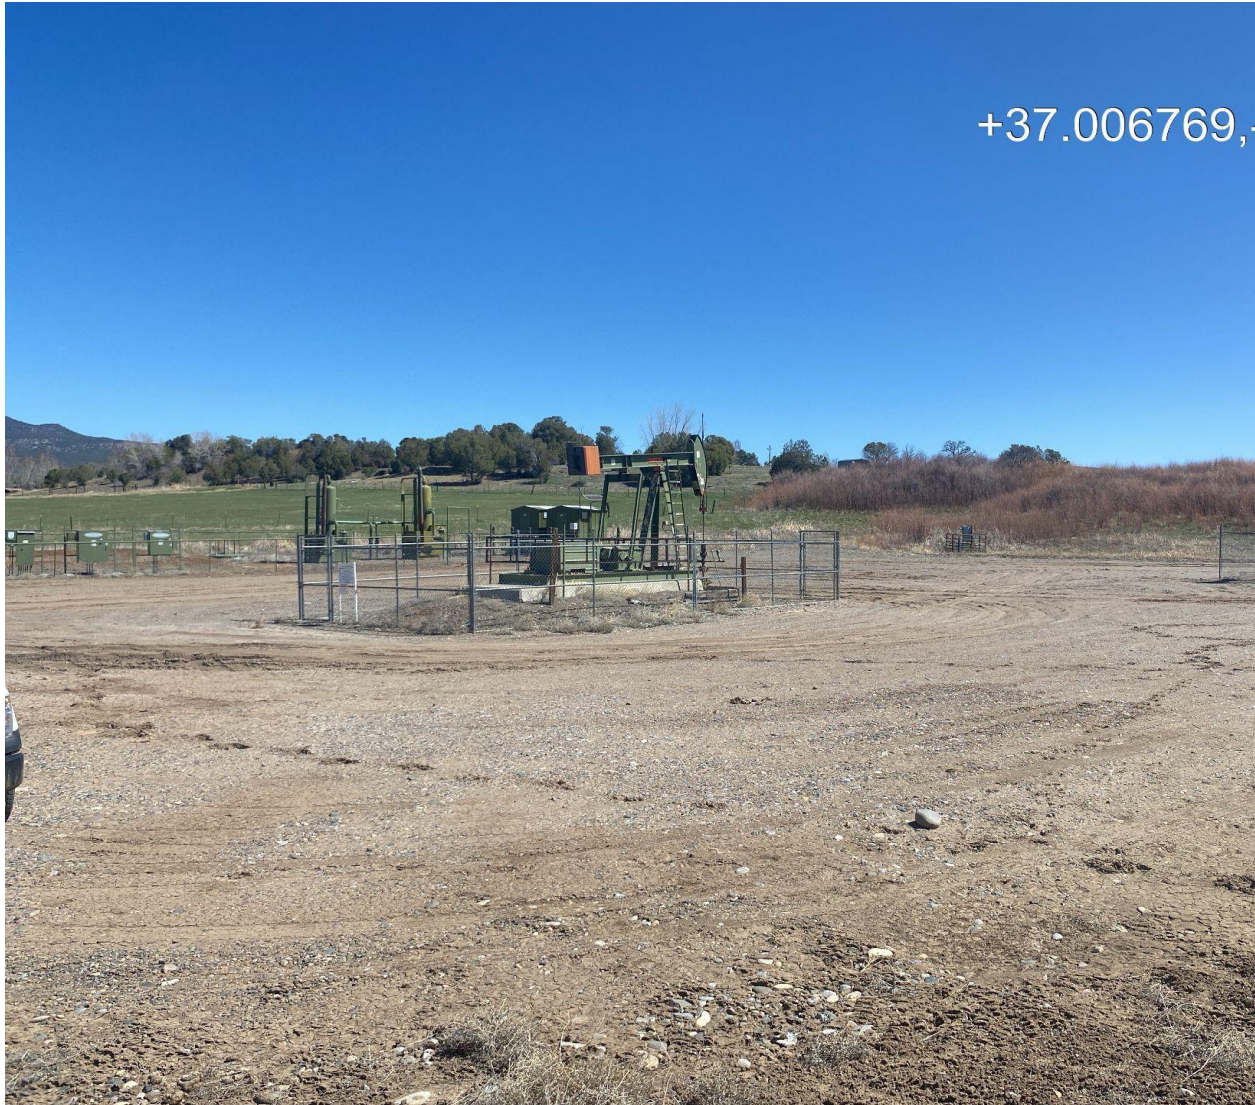
Photo 1. View of the well disturbance from the access point facing center.

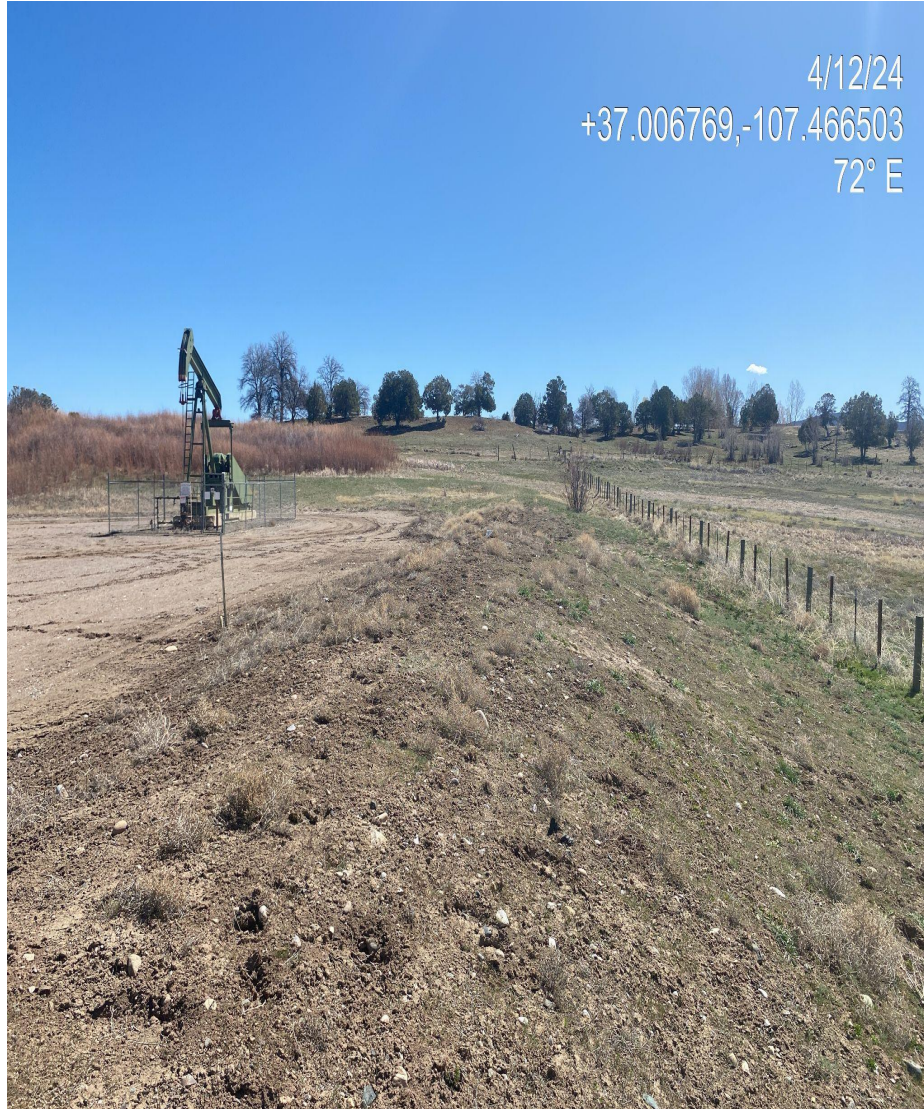
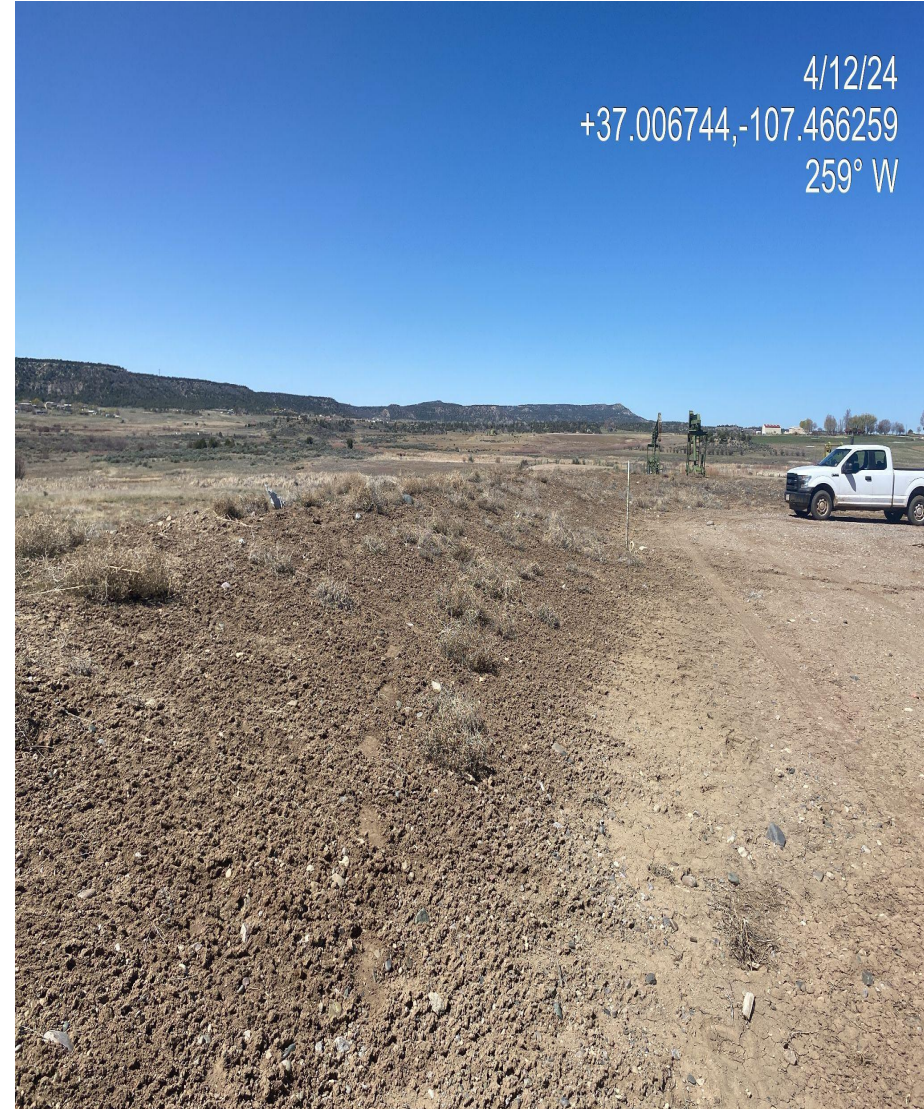
Photo 2. southern fill slope/interim reclamation areas dominated by kochia/russian thistle debris and lacking vegetation. Stormwater BMPs/soil stabilization is needed until long term stabilization is achieved with perennial vegetation.

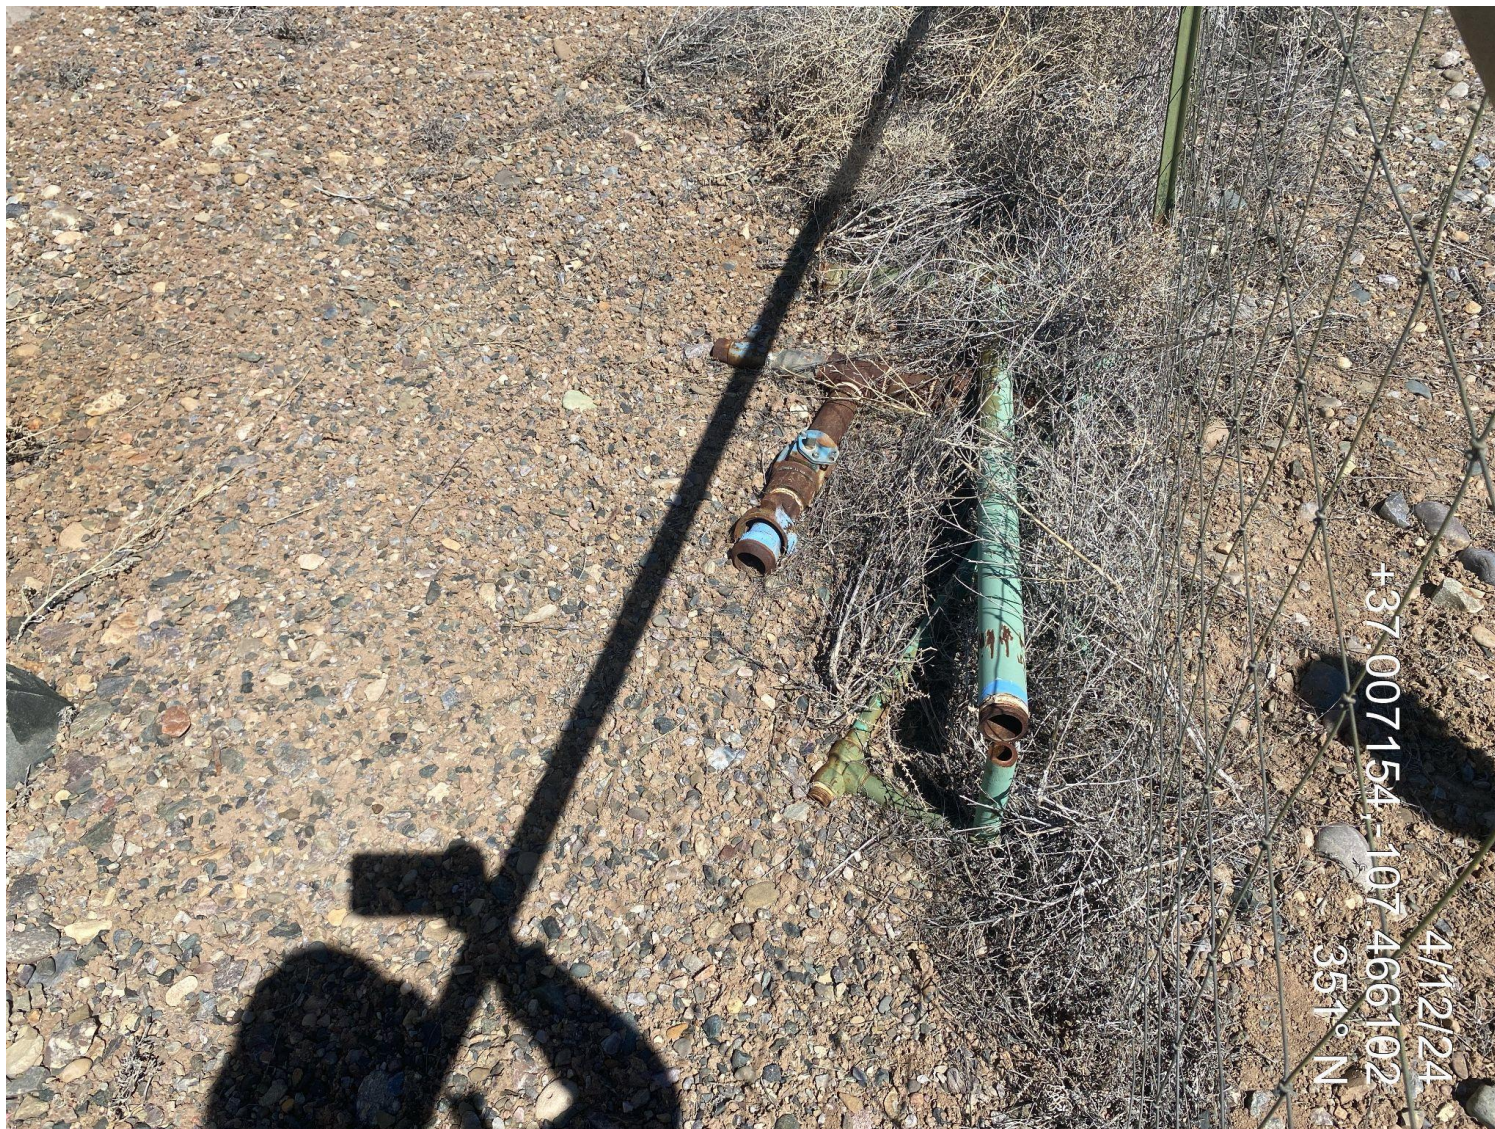
Photo 3. Unused oil and gas fitting/piping equipment observed on location.

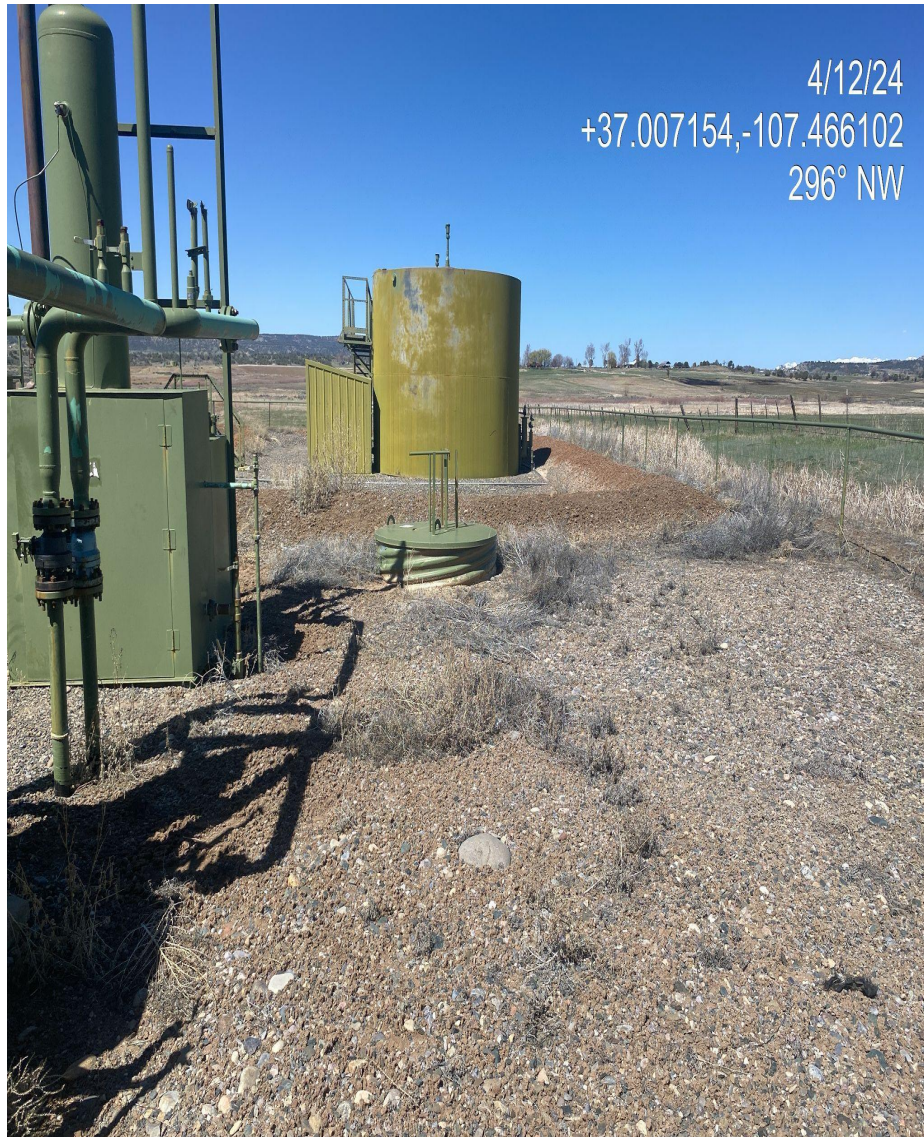
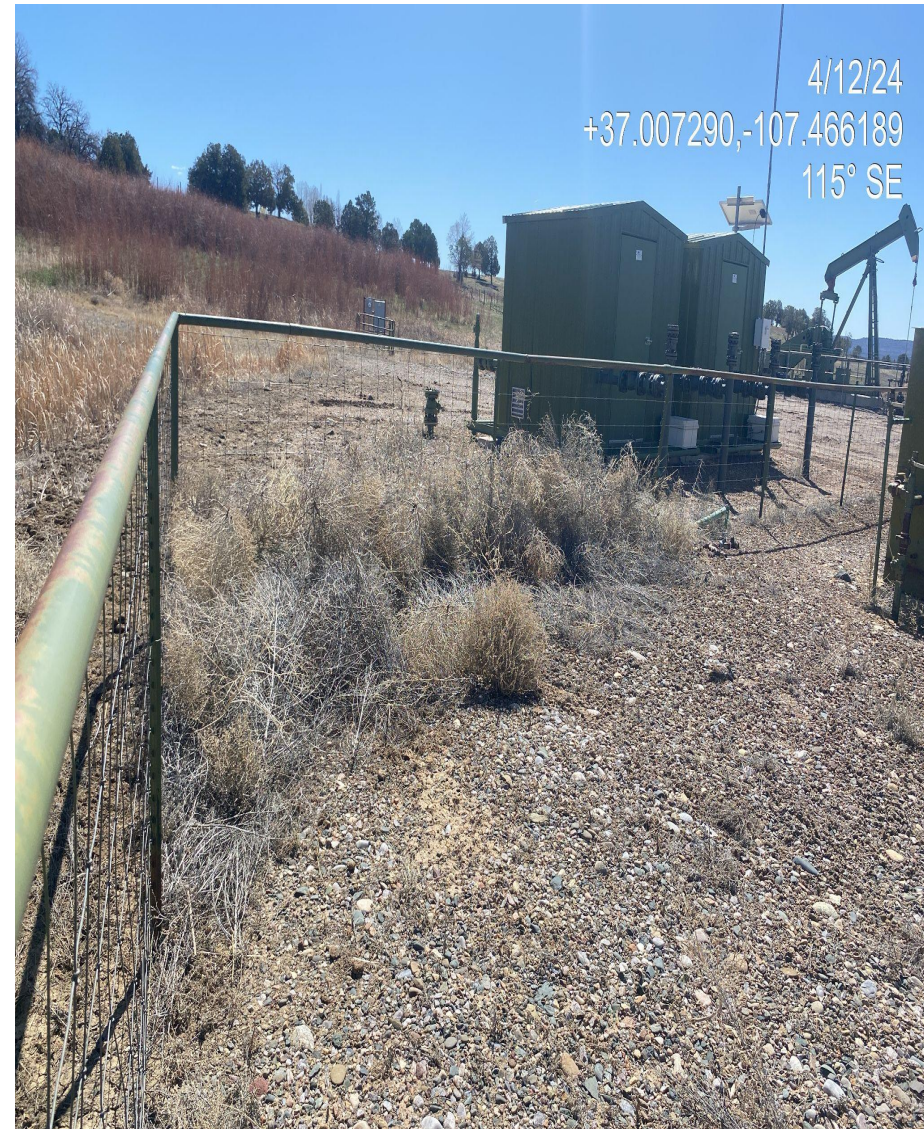
Photo 4. View of weedy kochia and russian thistle debris dominating the entire disturbance.

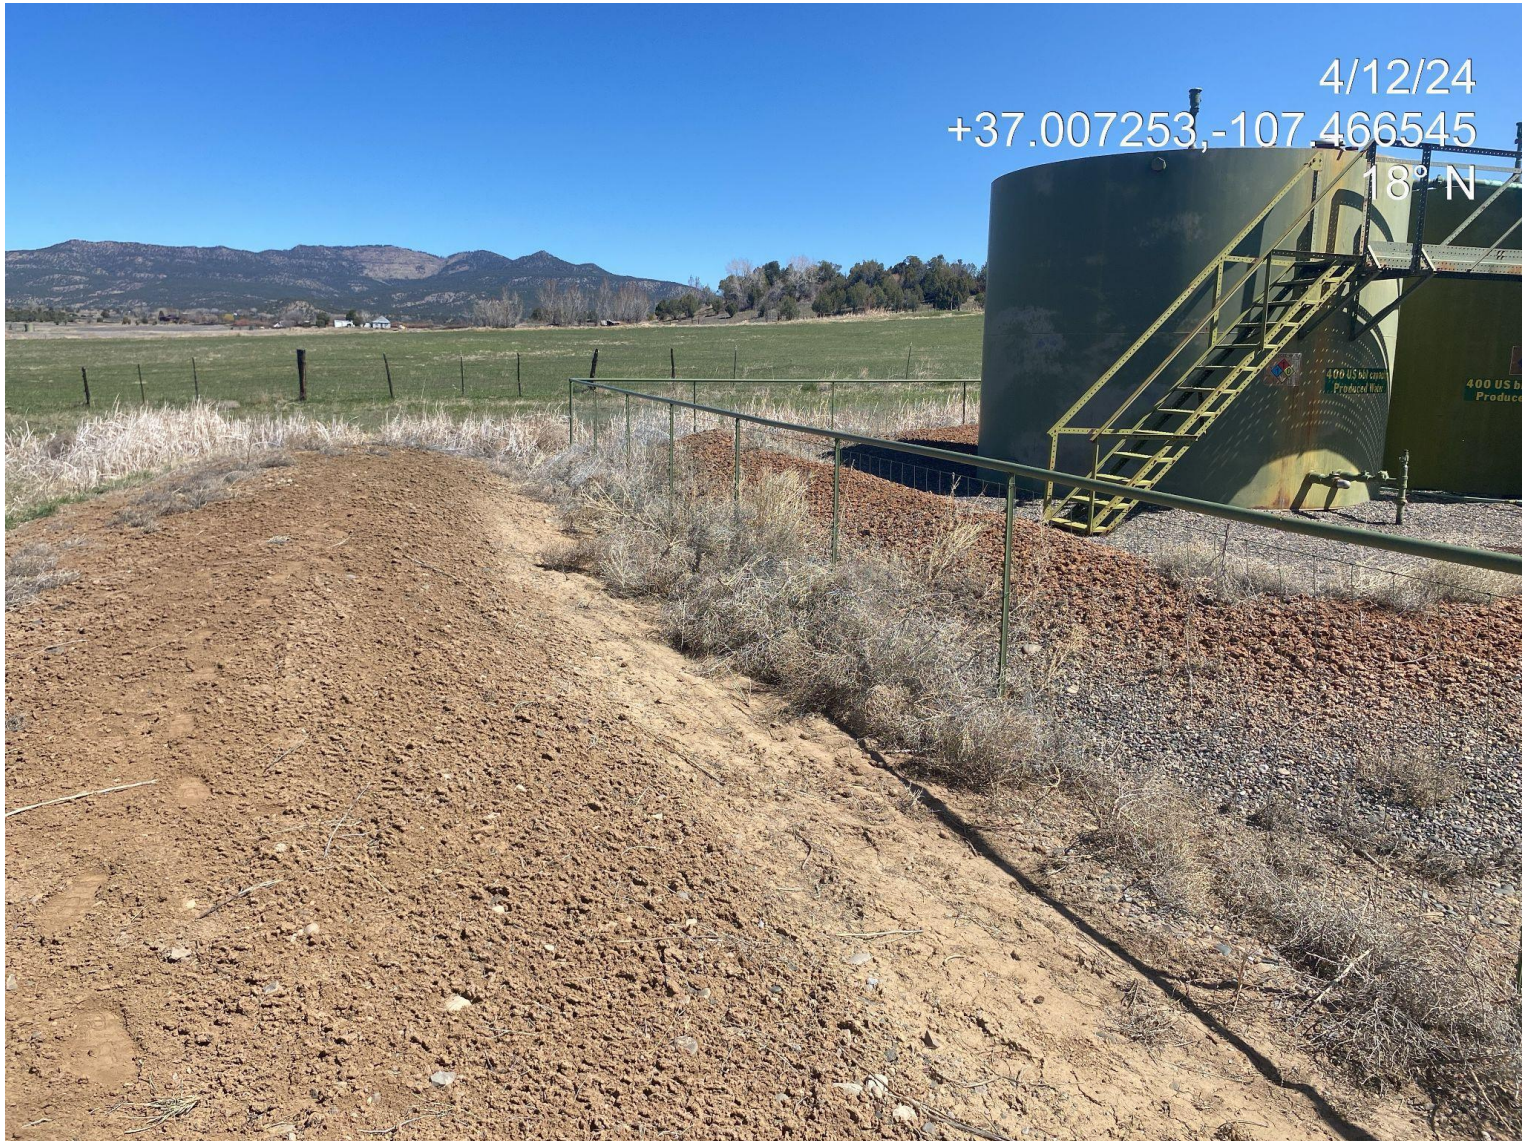
Photo 5. View of weedy kochia/russian thistle debris on location.

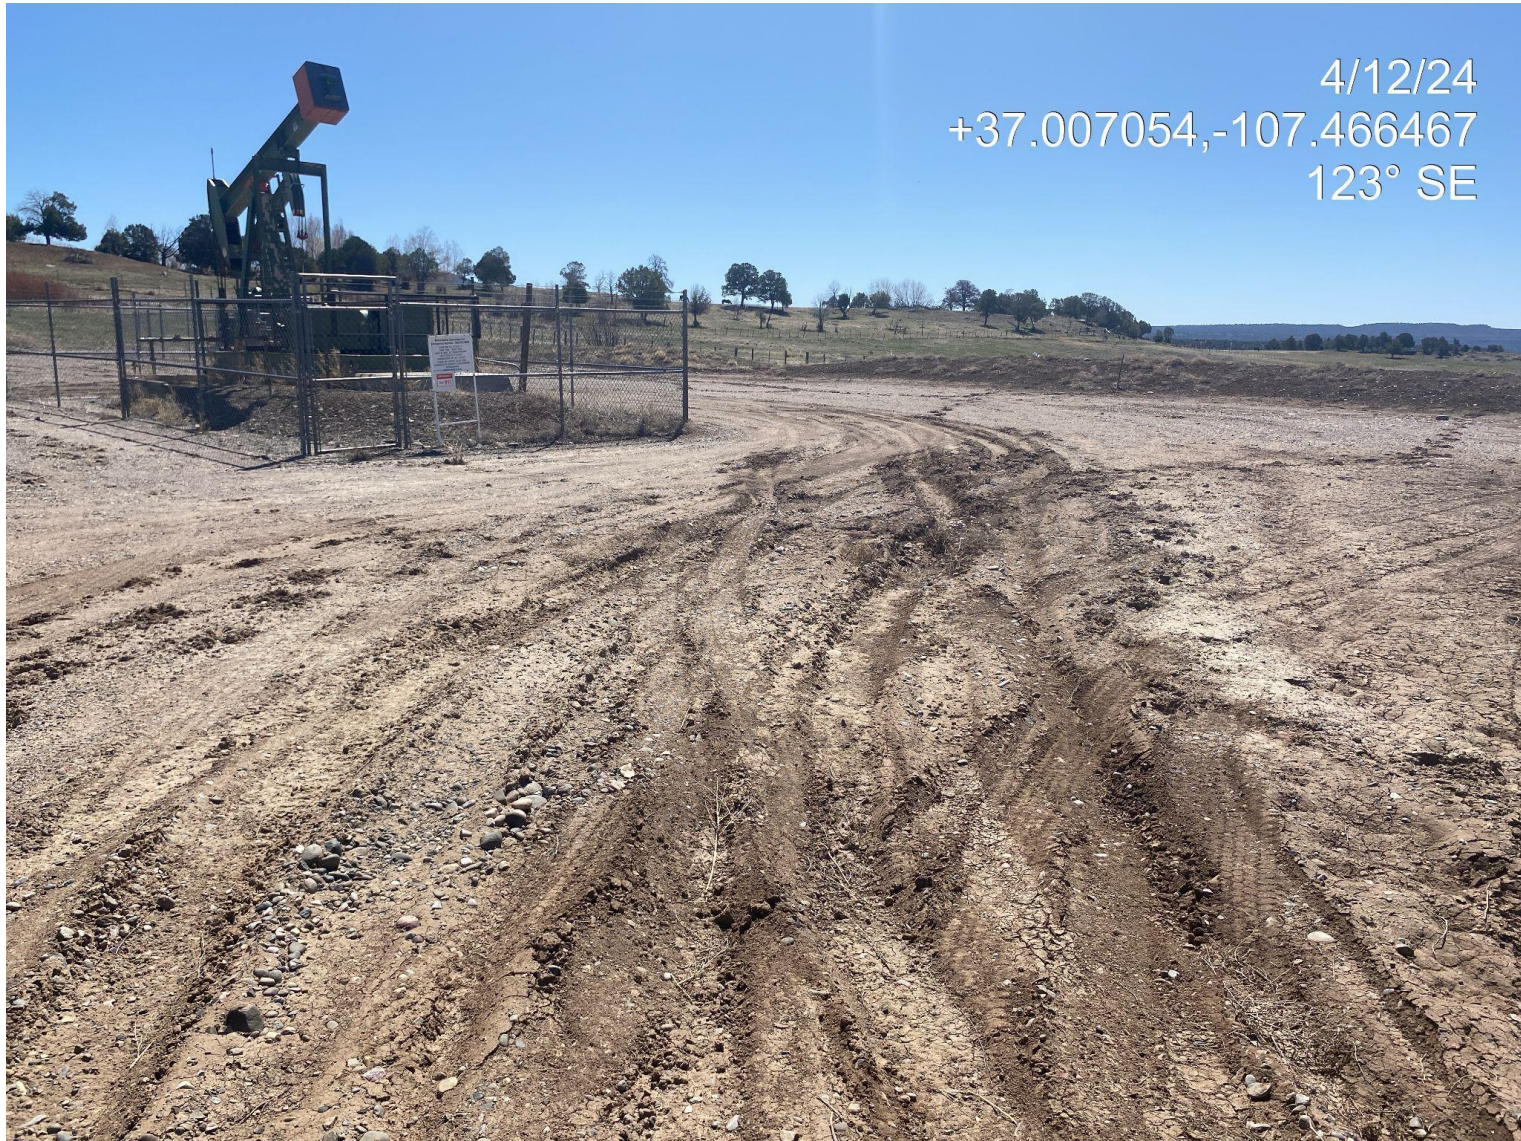
Photo 6. Rutting observed on location, additional stabilization is needed to minimize site degradation.

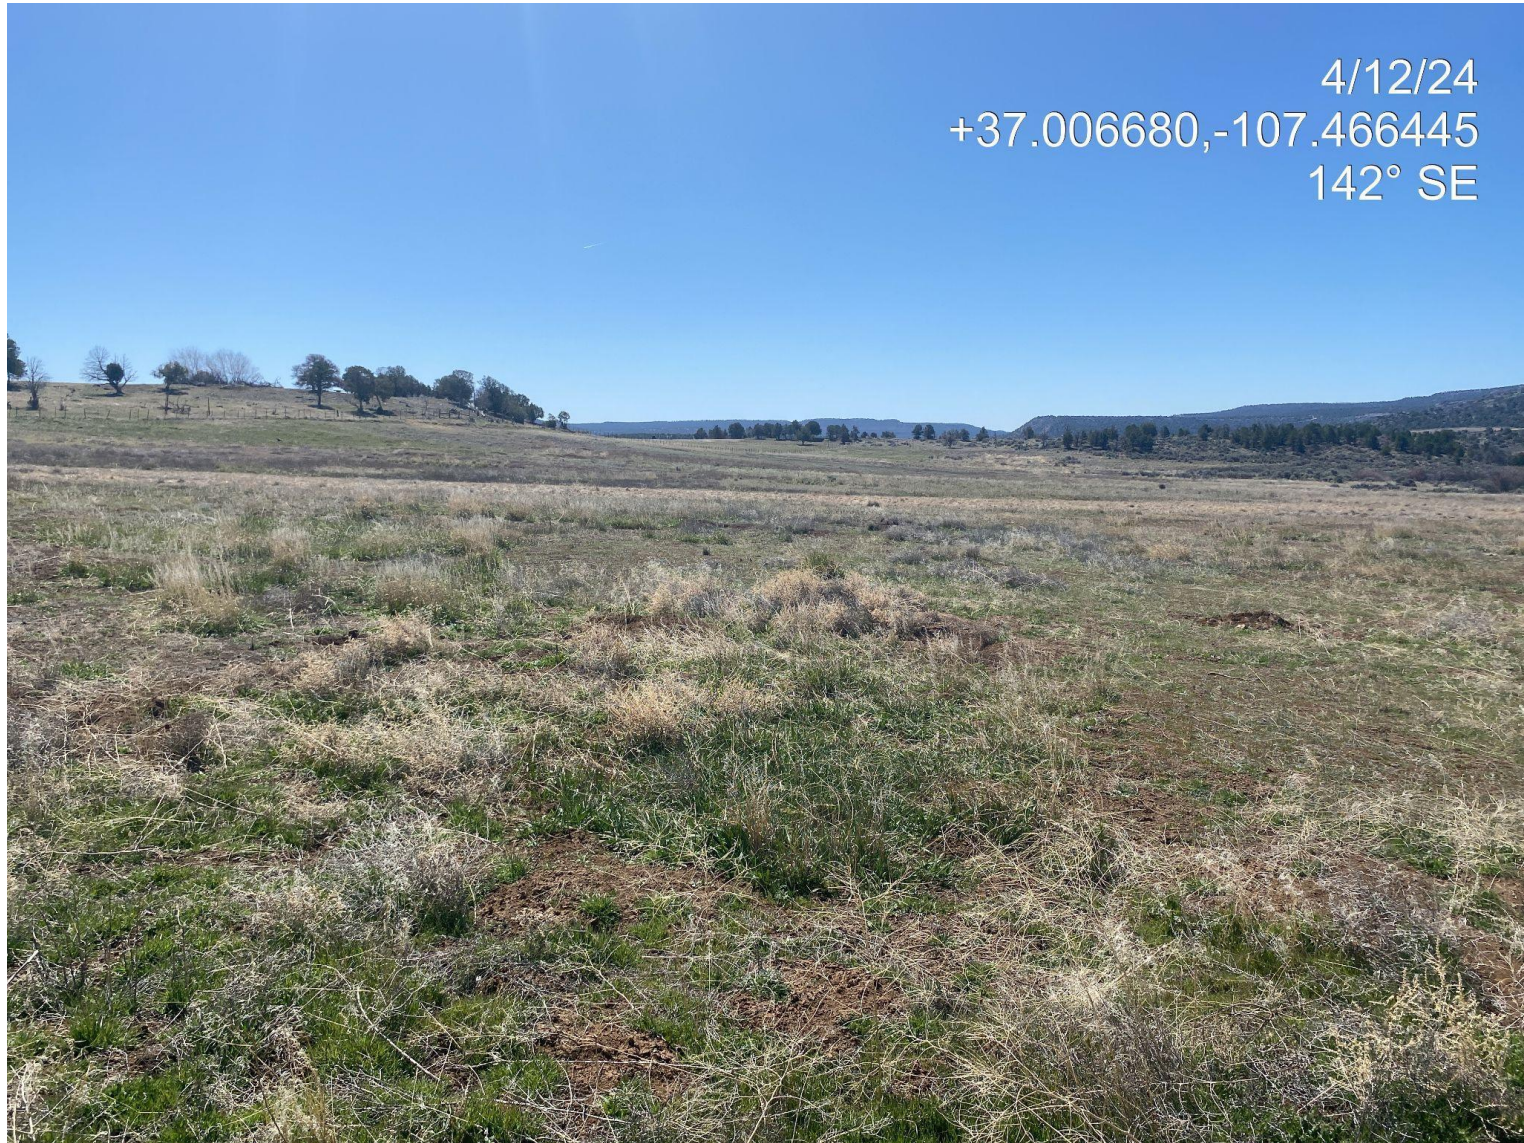
Photo 7. Reference area comprised of smooth brome and intermediate wheatgrass.
