# Inspection Photos

Operator: MorningStar Operating LLC - 10755

Location ID: 334035

Inspection Photos  
Location Name: Quintana 32-6 15-2, 4  
Location ID: 334035

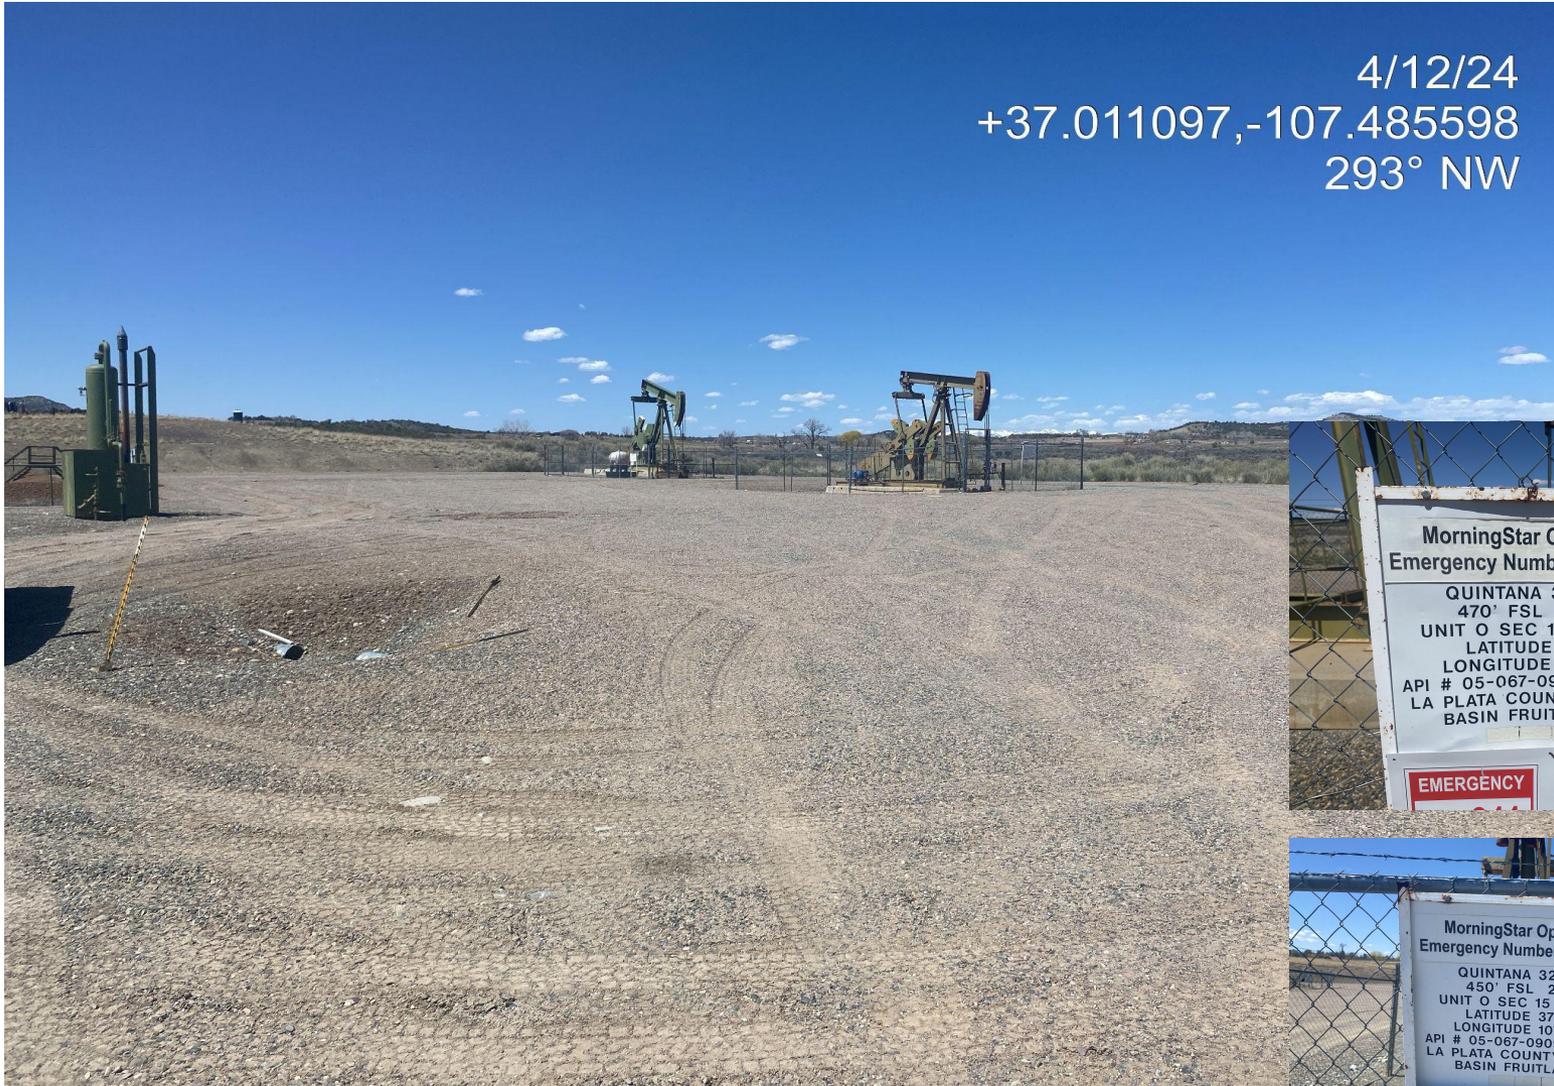
Photo 1. View of the well disturbance taken from the access point facing center.

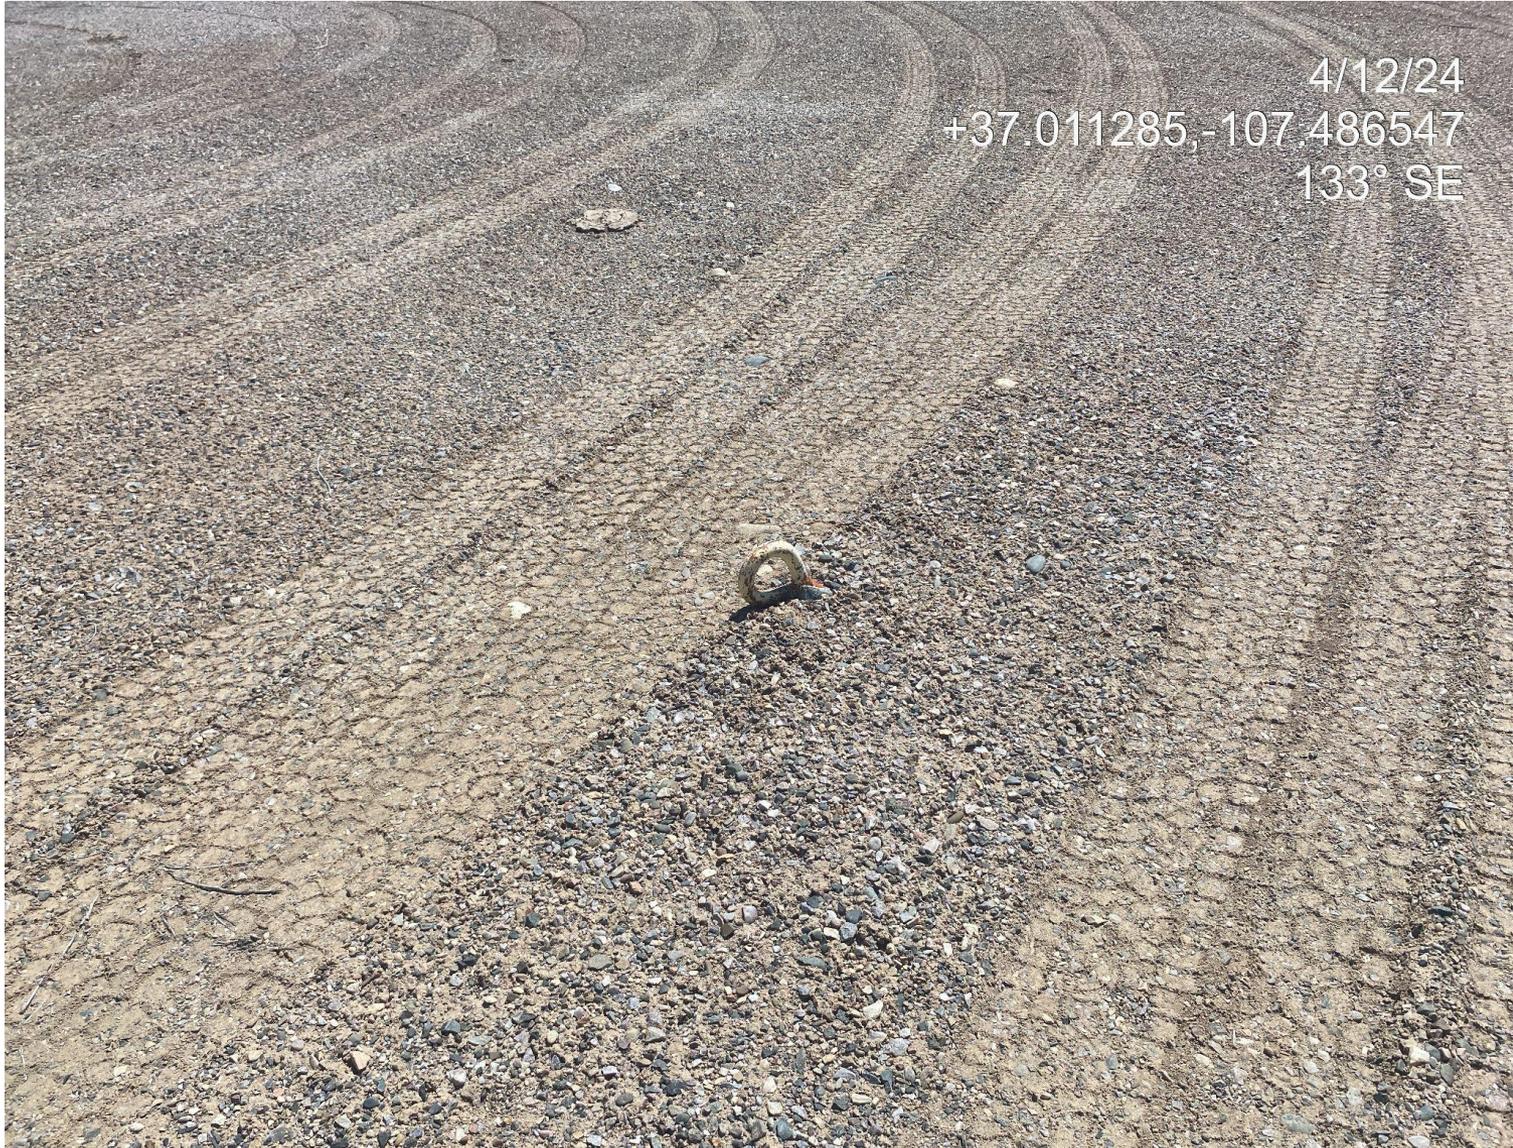
Photo 2. View of unmarked guy line anchor on location.

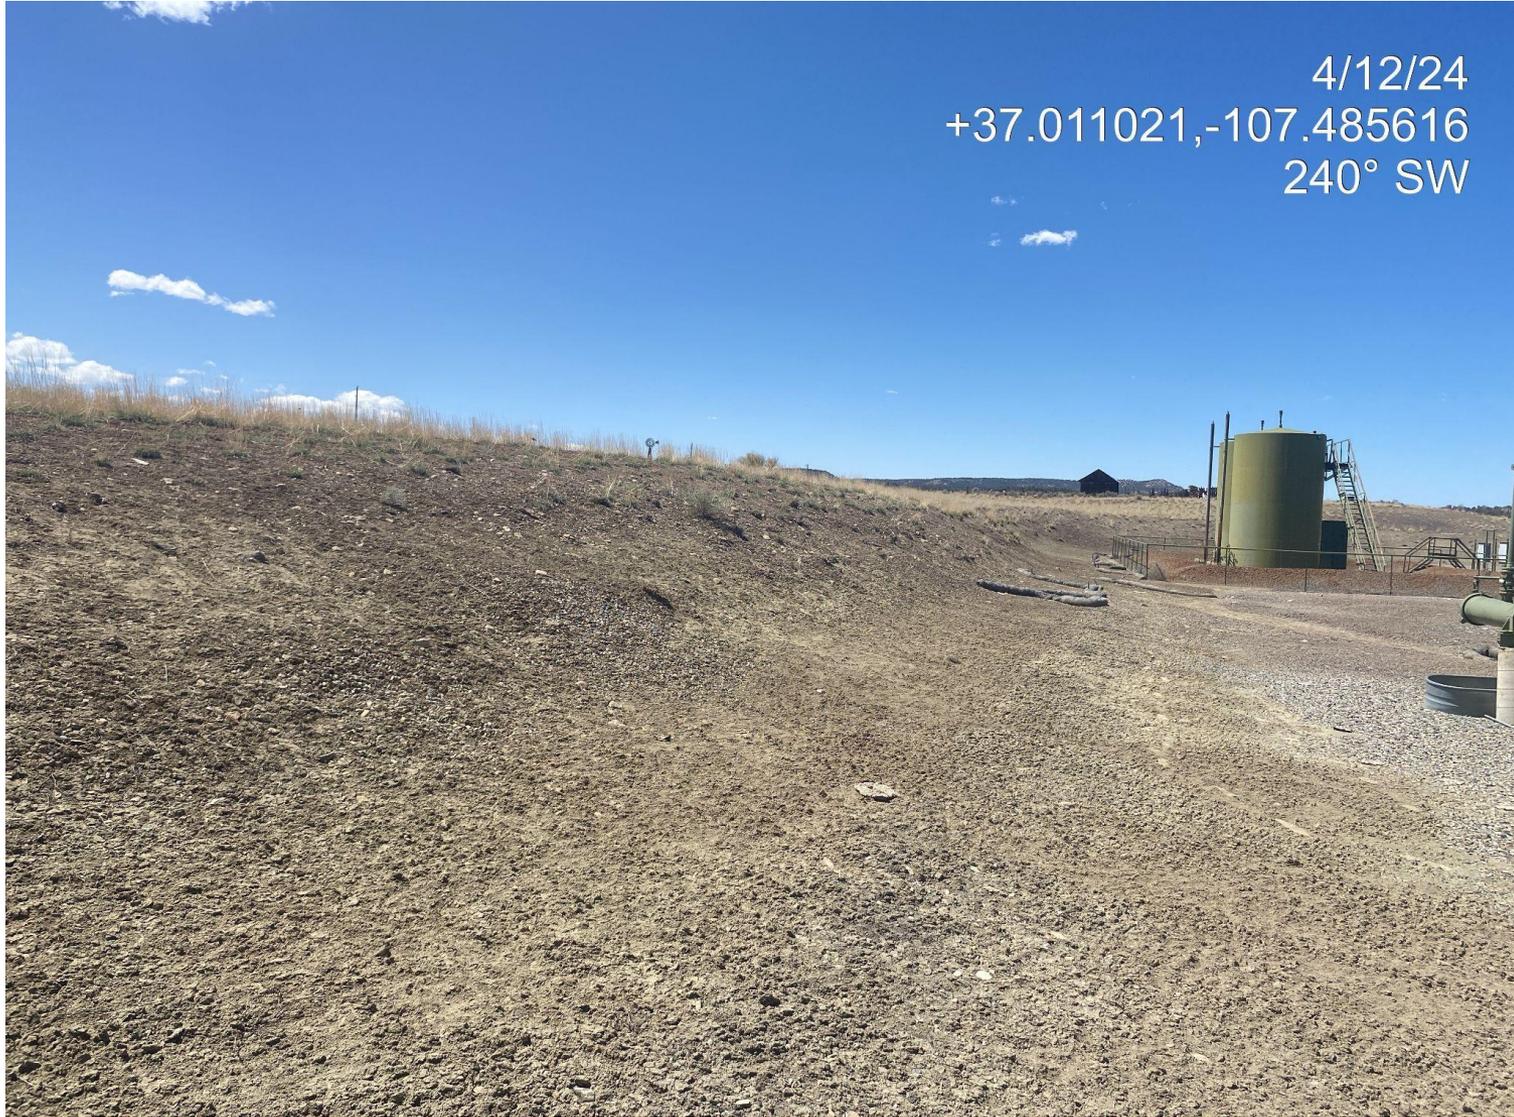
**Photo 3.** View of an un stabilized southern cut slope/interim reclamation area. Erosion controls need to be installed until area is stabilized with perennial vegetation.

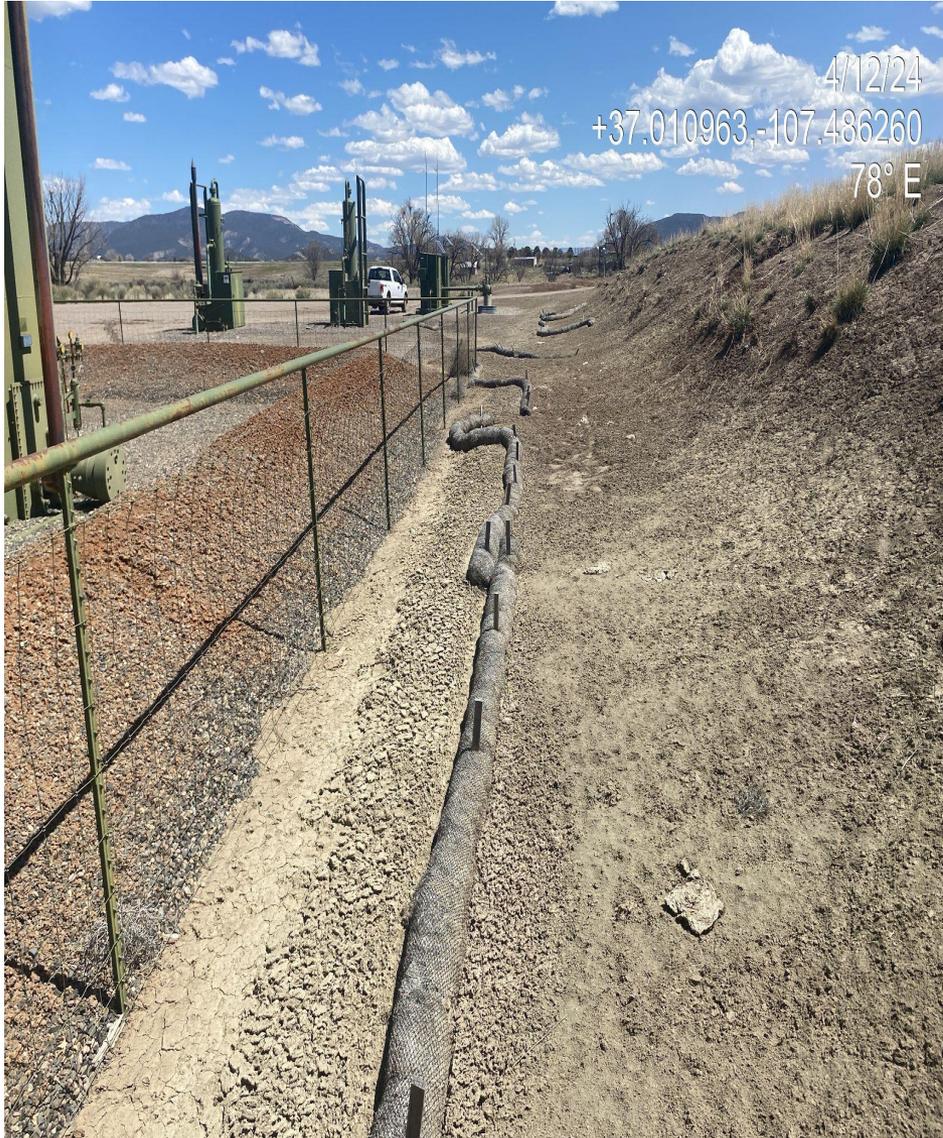
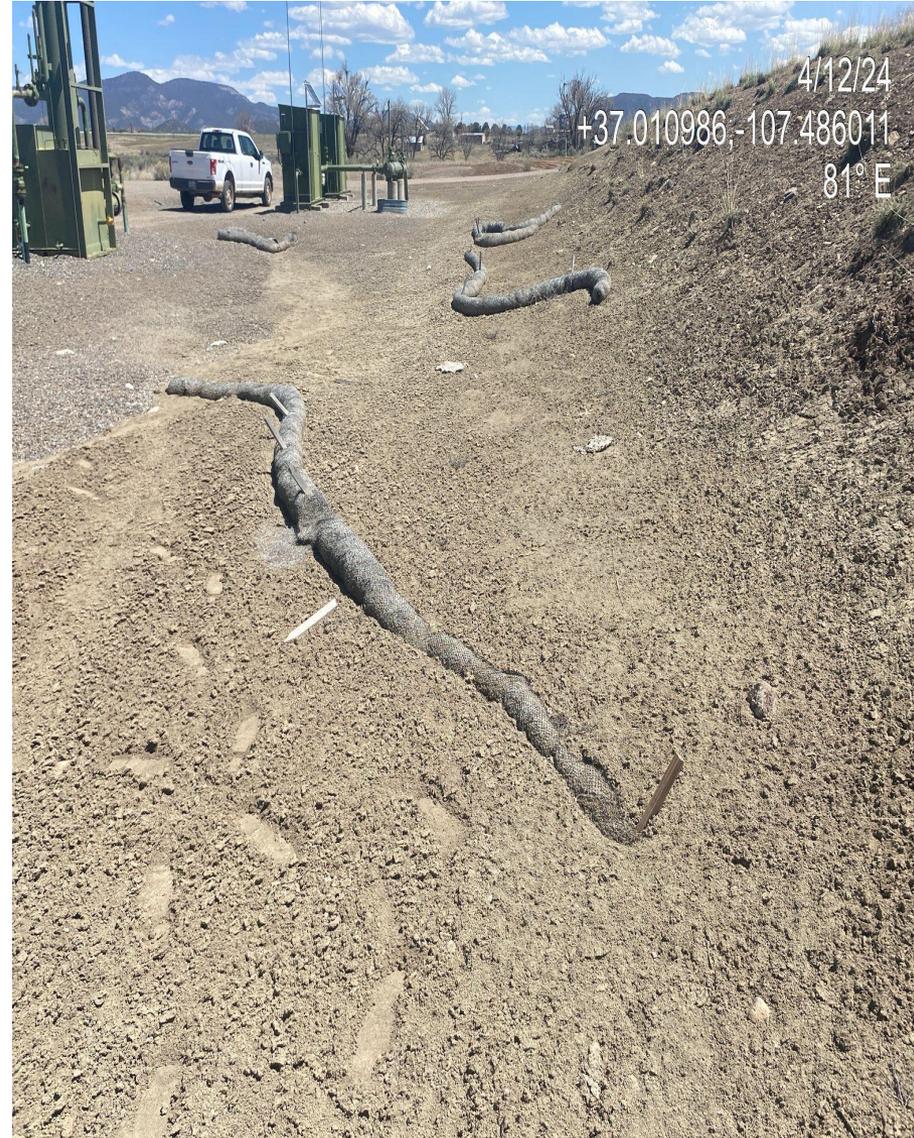
**Photo 4.** View of various piles of wattles in the southern portion of the disturbance that are no longer functioning and are considered debris.

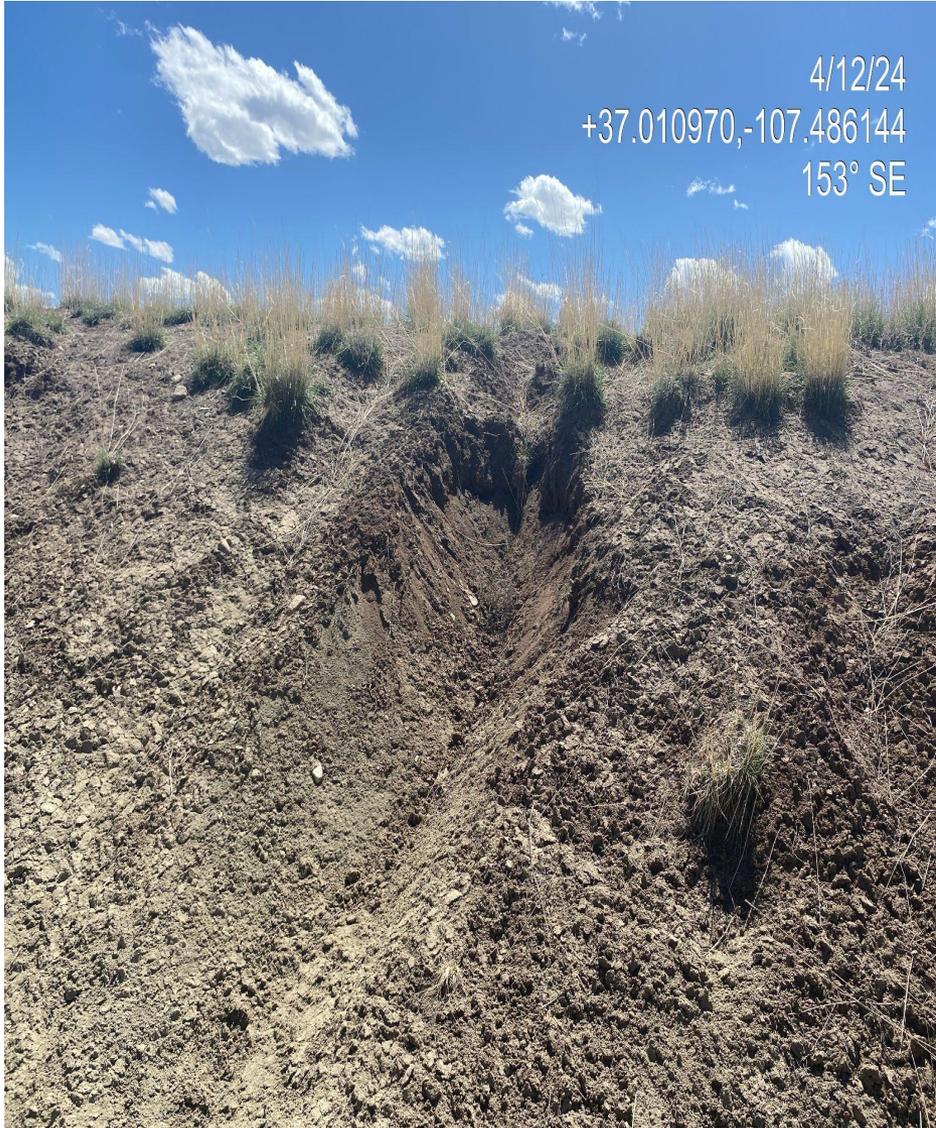
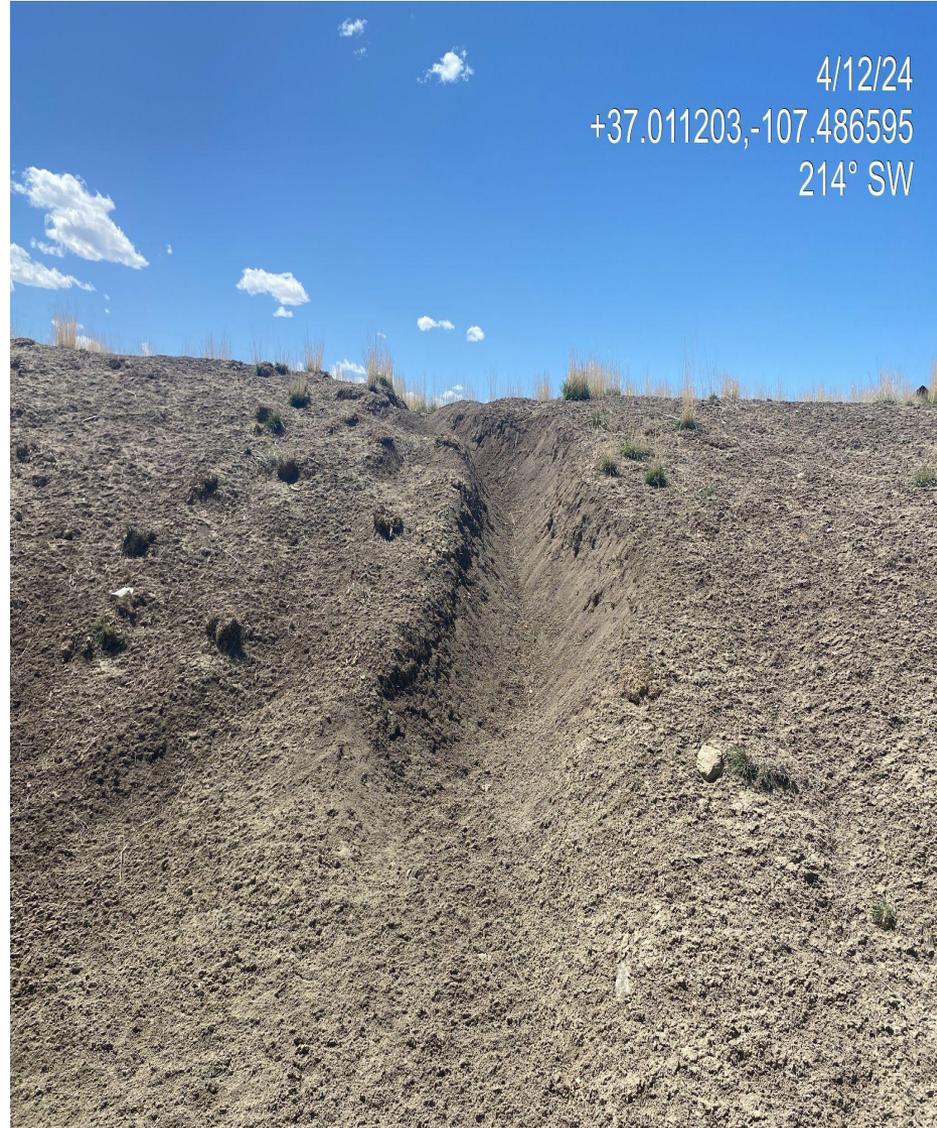
**Photo 5.** Gully erosion observed forming in the southern cut slope where soils remain unstabilized.

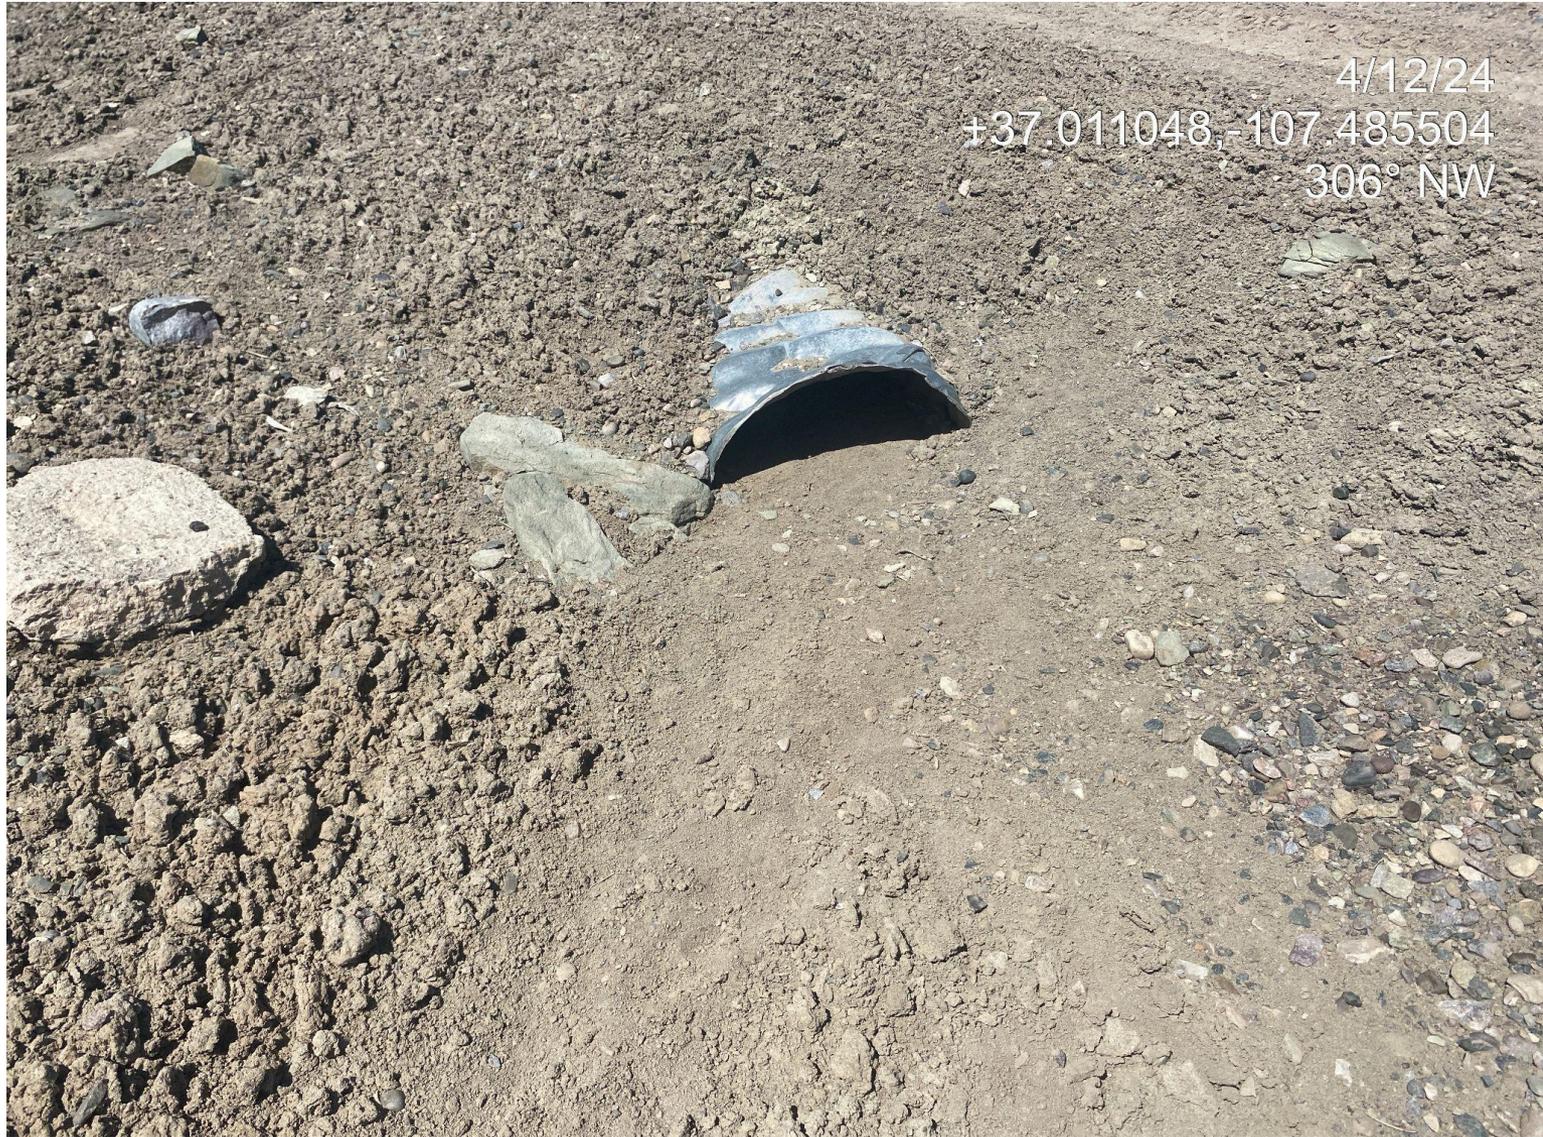
**Photo 6.** View of storm water culvert on location that is full of sediment and no longer functioning.

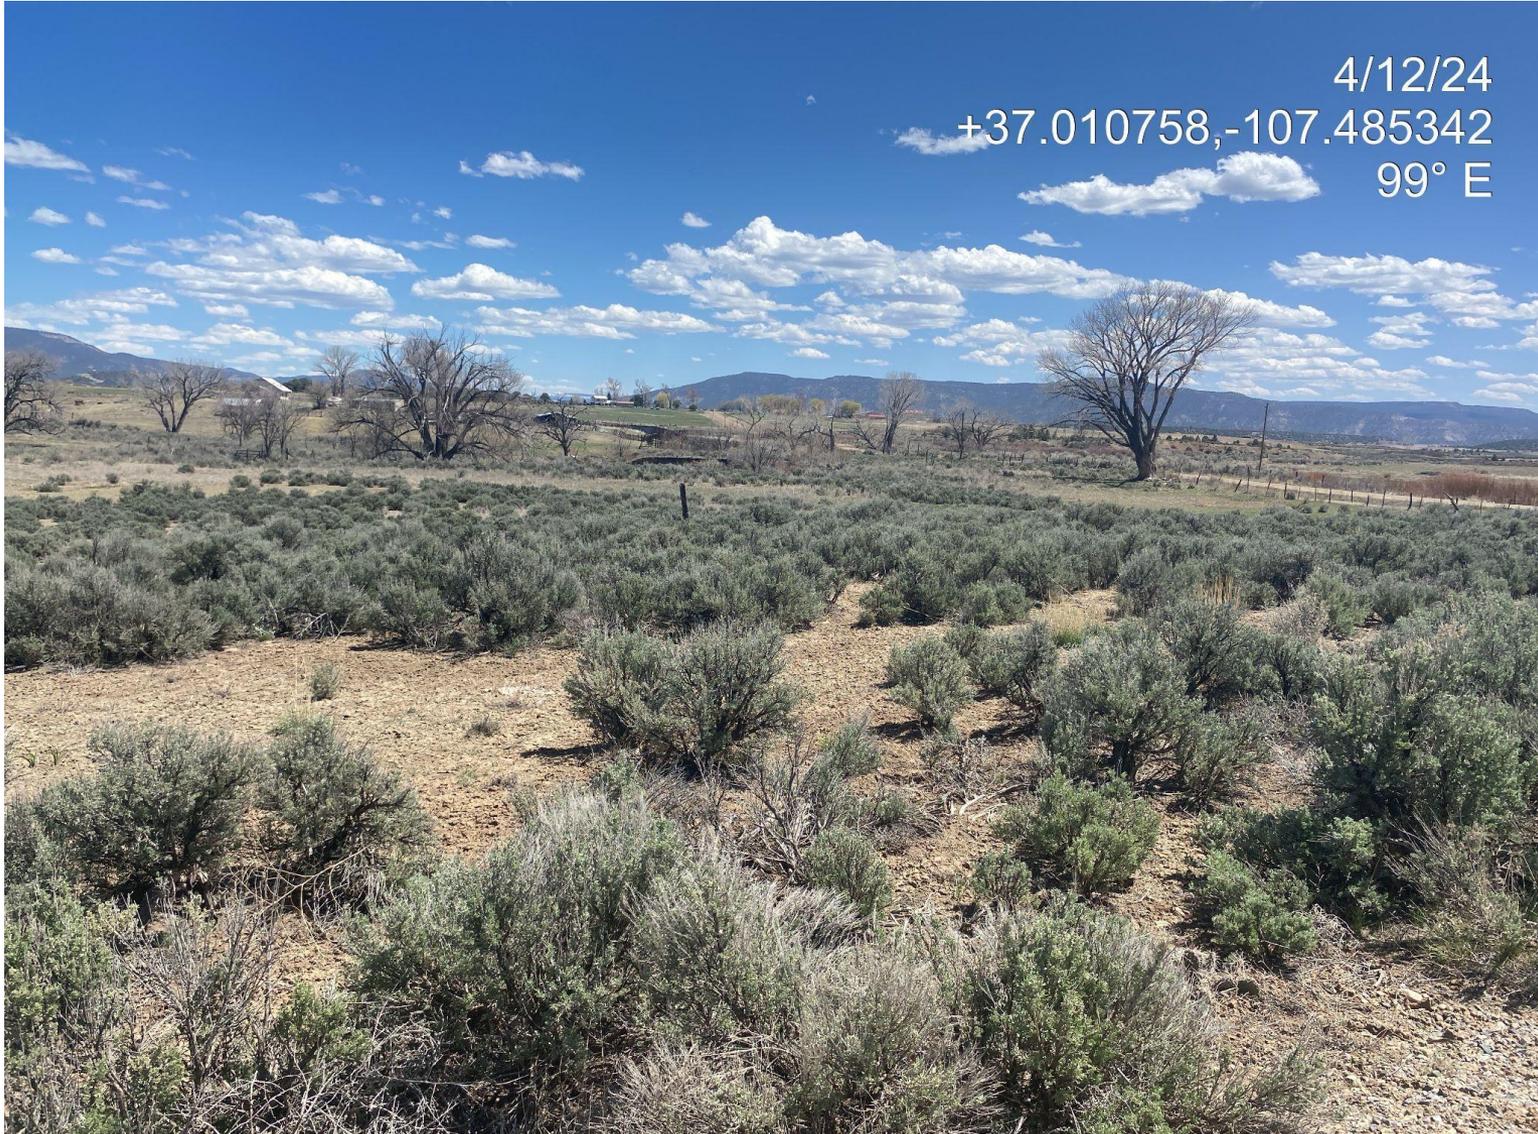
**Photo 7.** Reference area comprised of sage brush, intermediate wheatgrass and rabbit brush.
