Inspection Photos

Operator: TEP ROCKY MOUNTAIN LLC - 96850

Location ID: 335052

Inspection Doc: 696205759

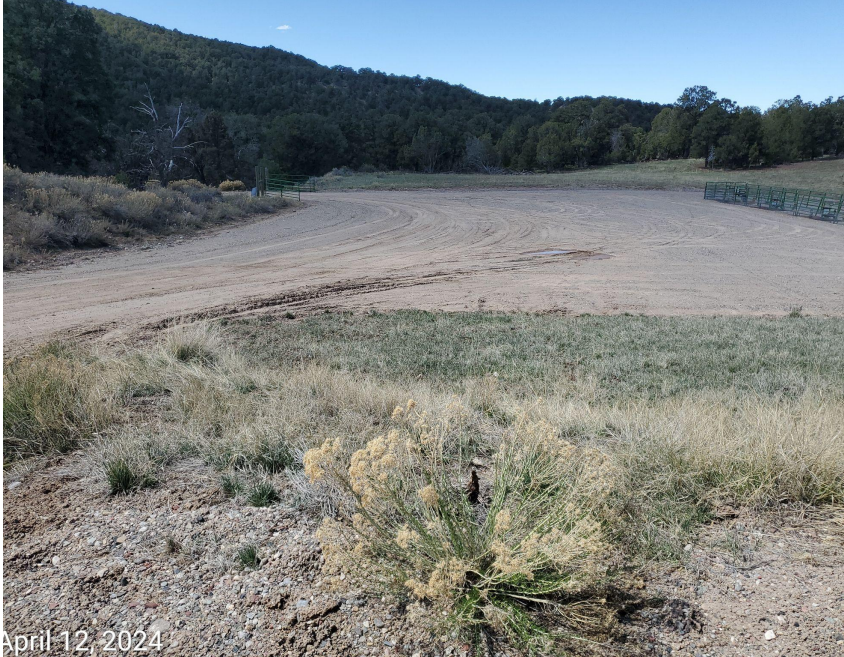
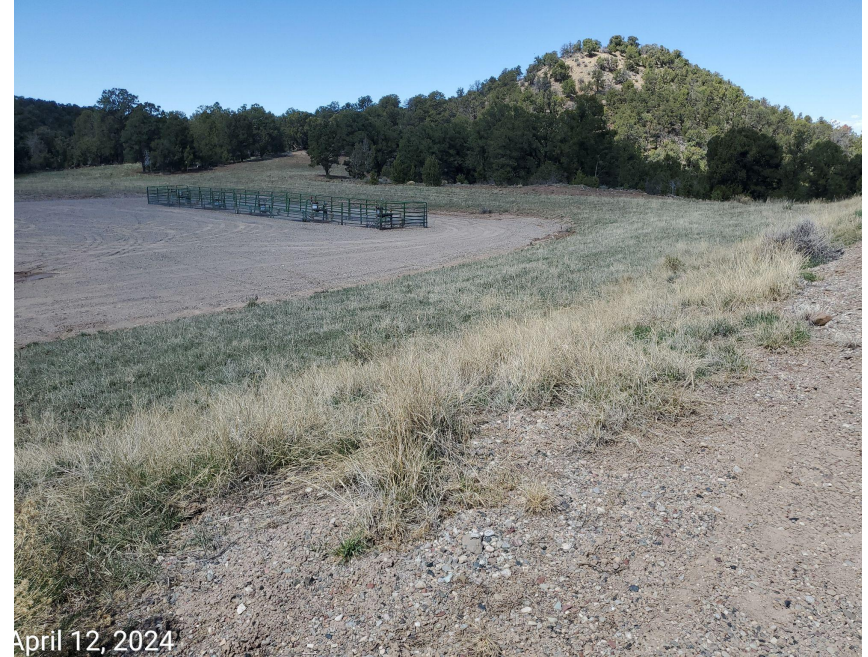
Photo 1: Photos taken from the south end of the Location. Photo provides an overview of the Location from west, northwest, northeast to east.

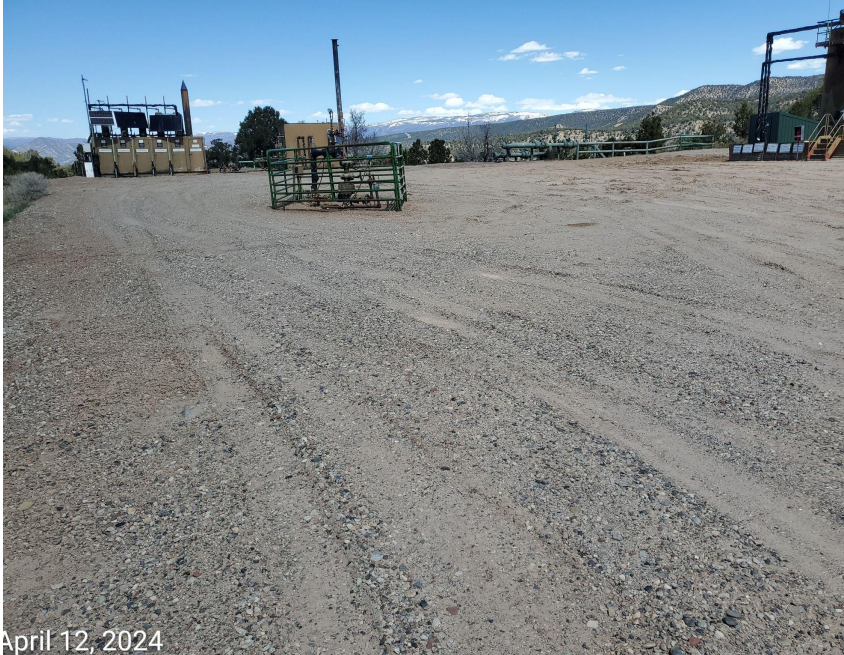
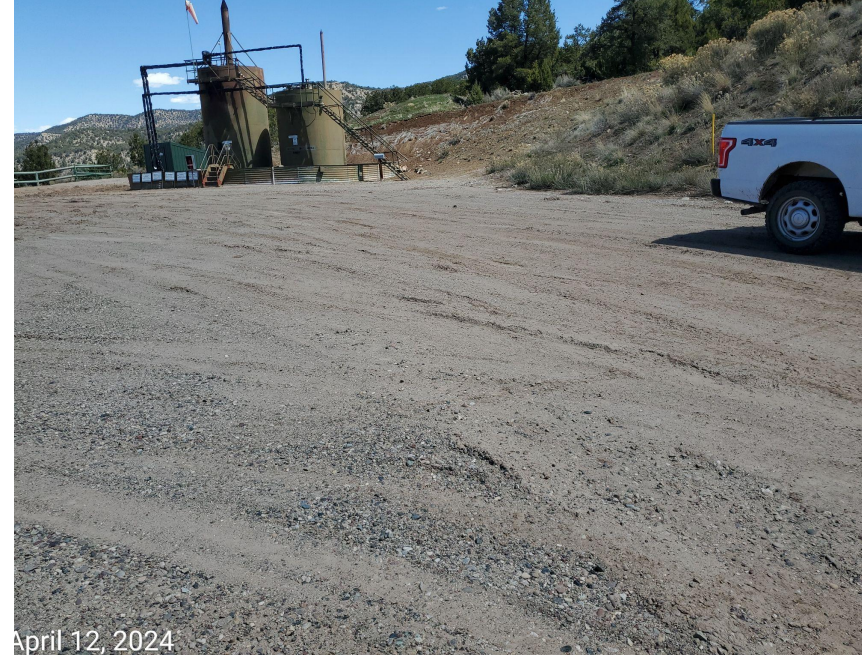
Photo 2: See comments under photo 1.

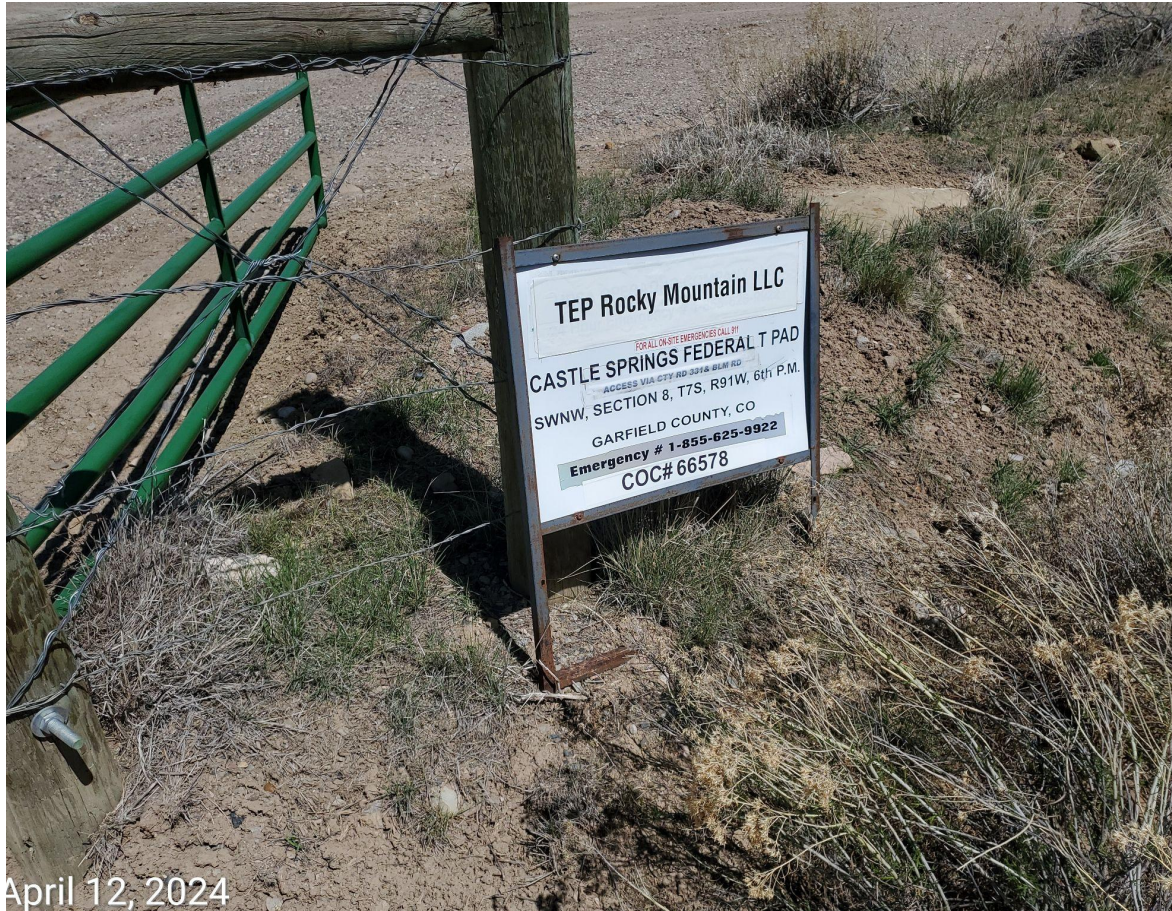
Photo 3: Location signage, southwestern entrance. Emergency contact number no longer works, and appears to be for the previous operator.

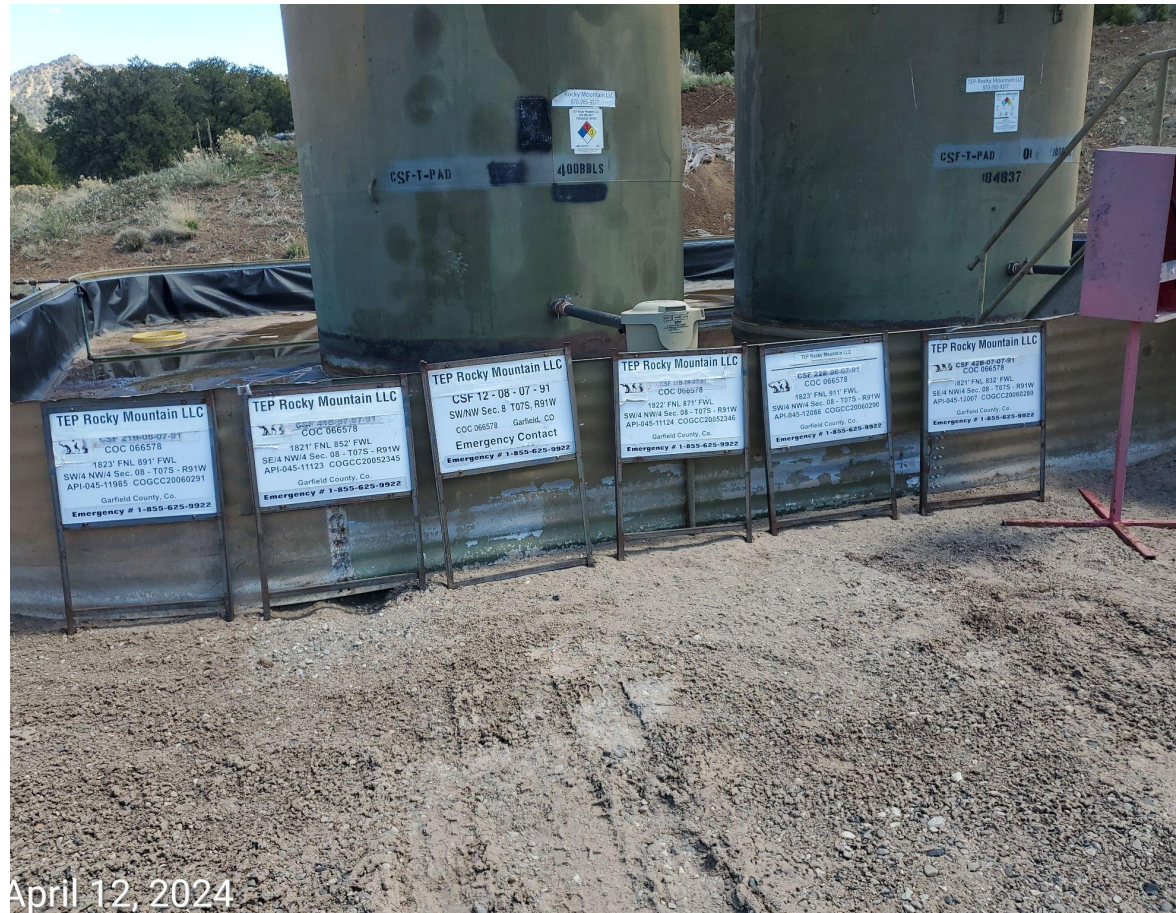
Photo 4: Photo shows signage at tank battery facility. Emergency contact number no longer works, and appears to be for the previous operator.

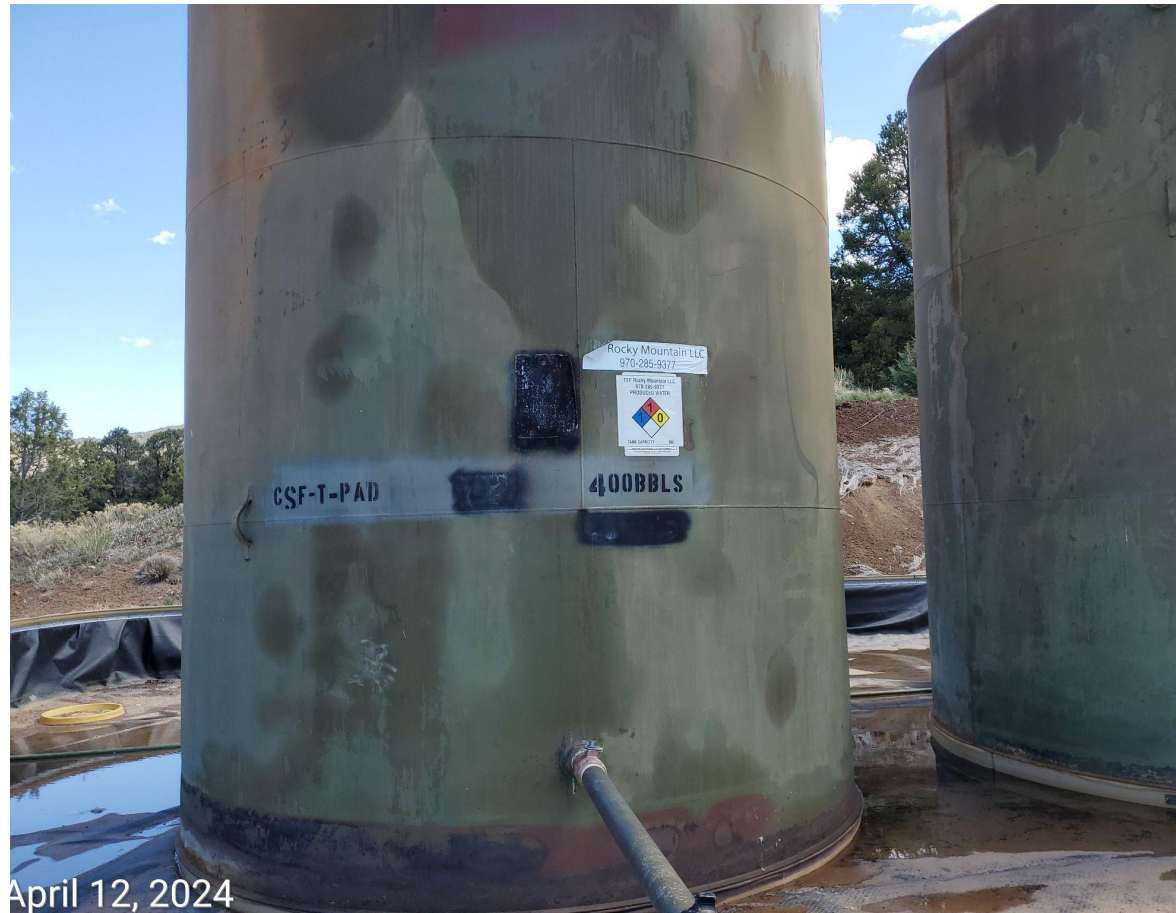
Photo 5: Tank label peeling. Maintenance advised.

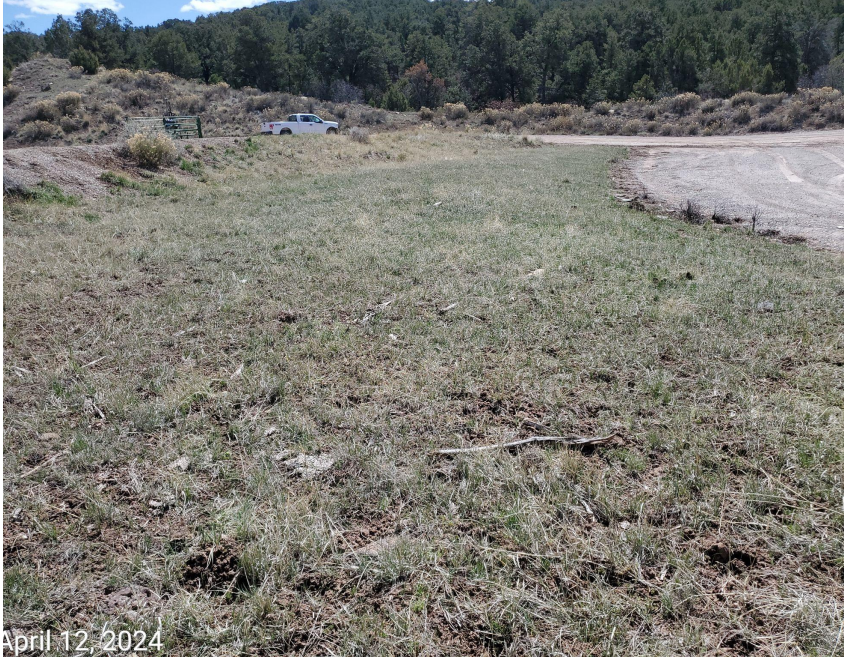
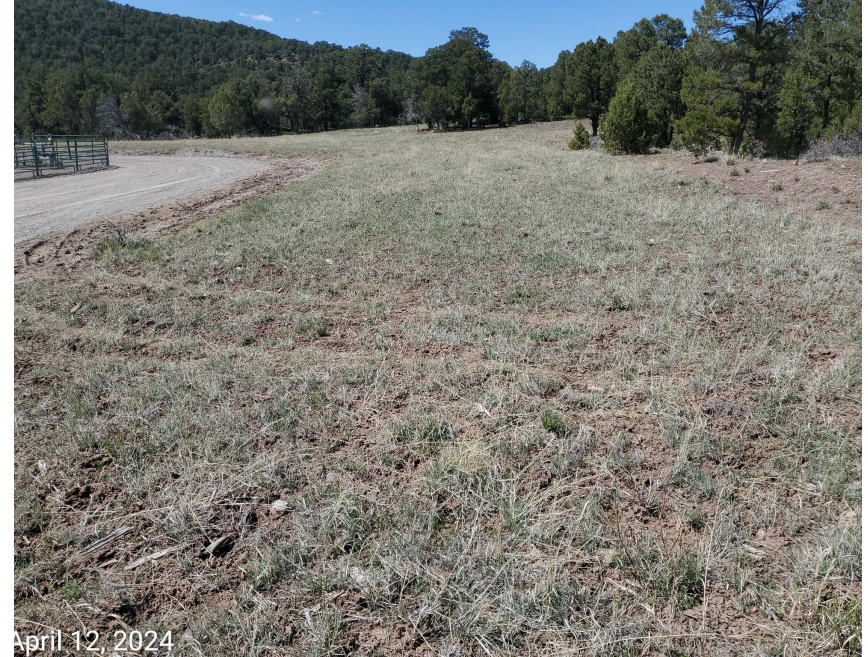
Photo 6: Photos taken from the interim areas on the west end of the Location. Reclamation within these areas appears to be progressing towards 1003 standards.

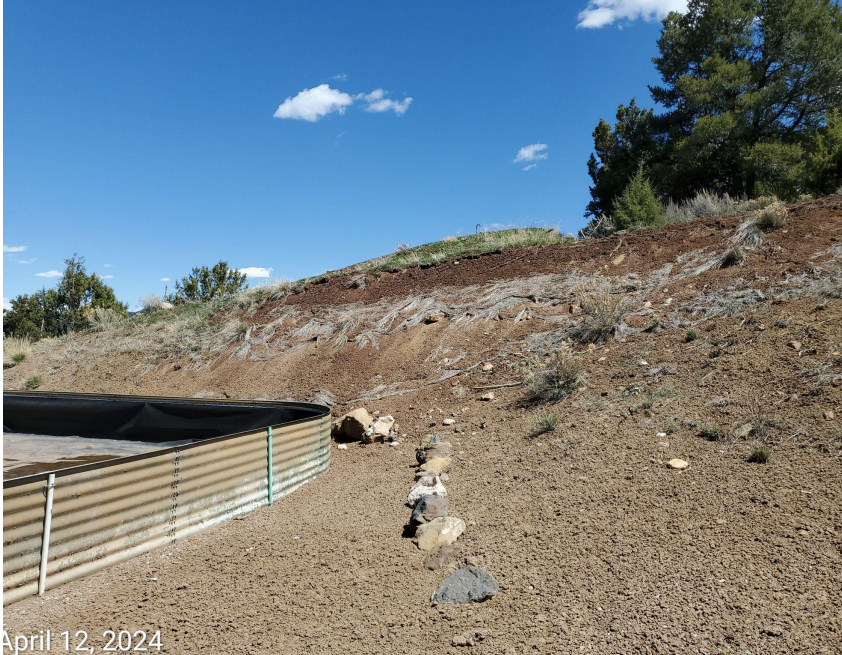
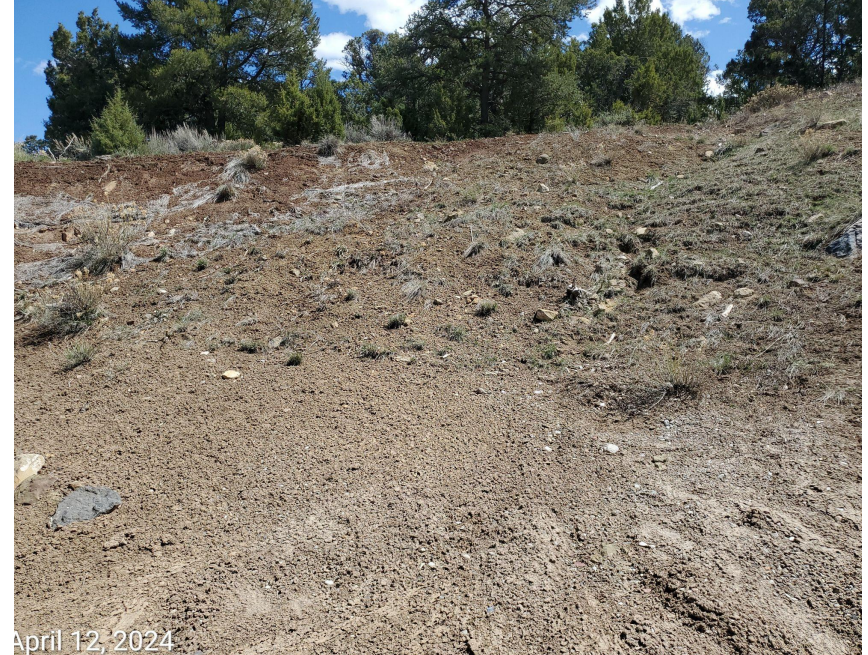
Photo 7: Photos taken from the east end of the Location. Photos show areas of the Location not progressing towards 1003 standards. Slopes predominantly bare and exposed soils. Stormwater and erosion control BMPs no longer in proper functioning condition.

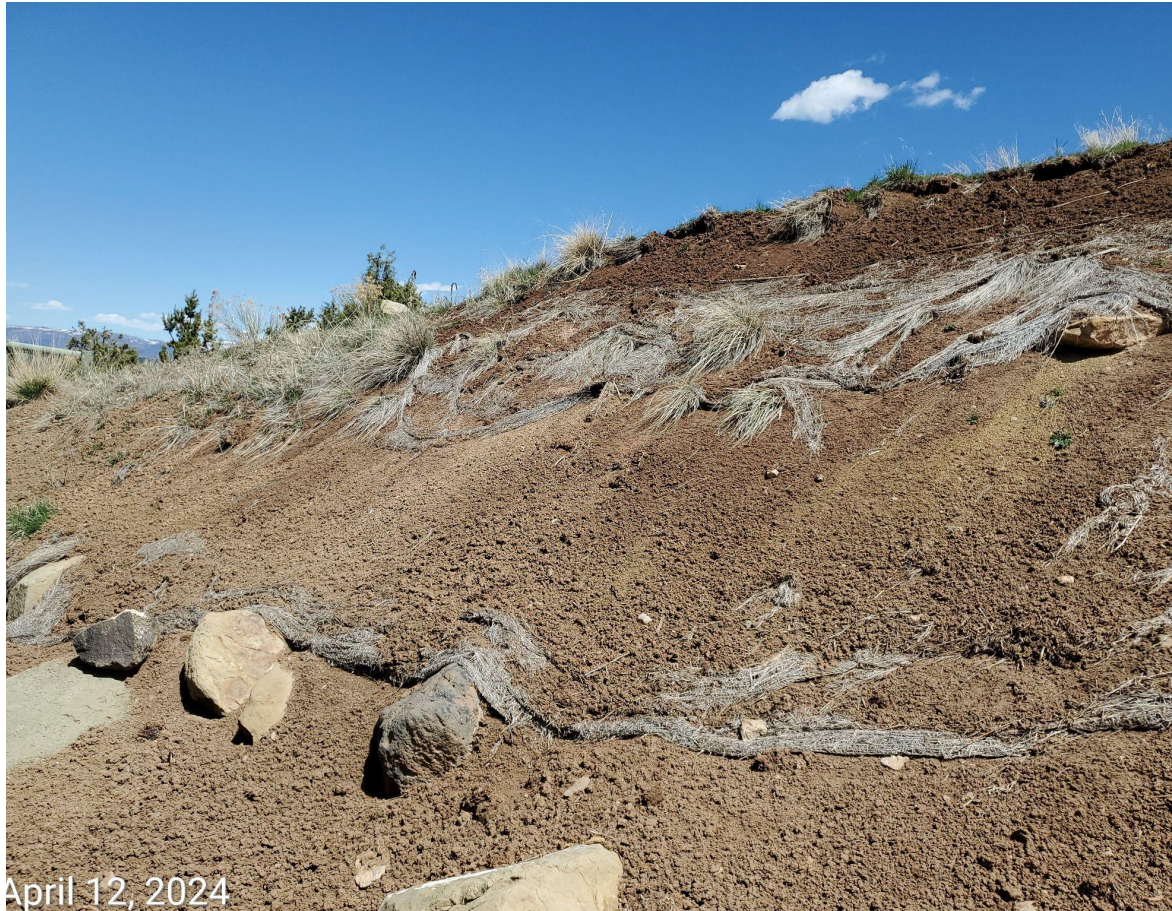
Photo 8: Continued from photo 7. Erosion blankets no longer in proper functioning condition. Stormwater and erosion control BMPs missing or insufficient.

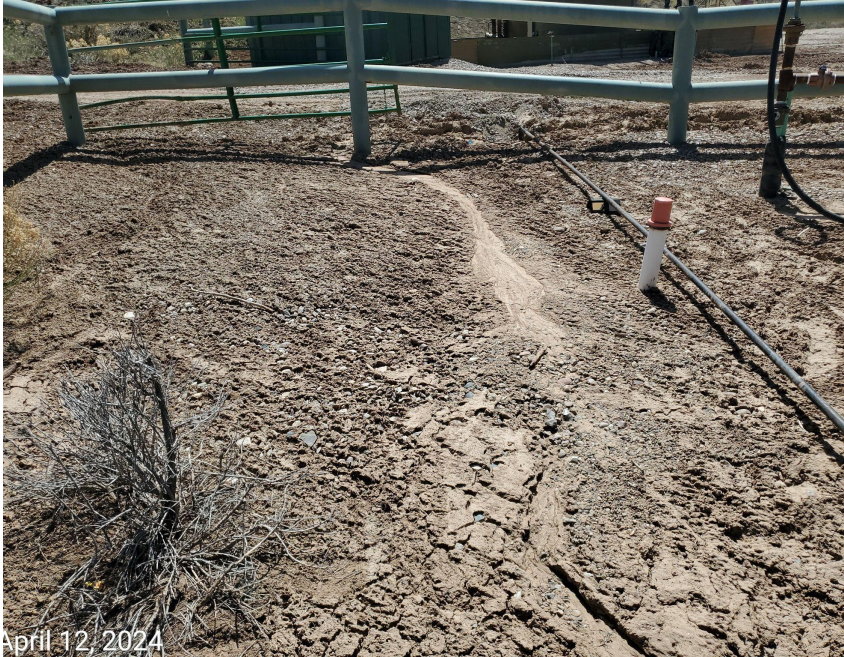
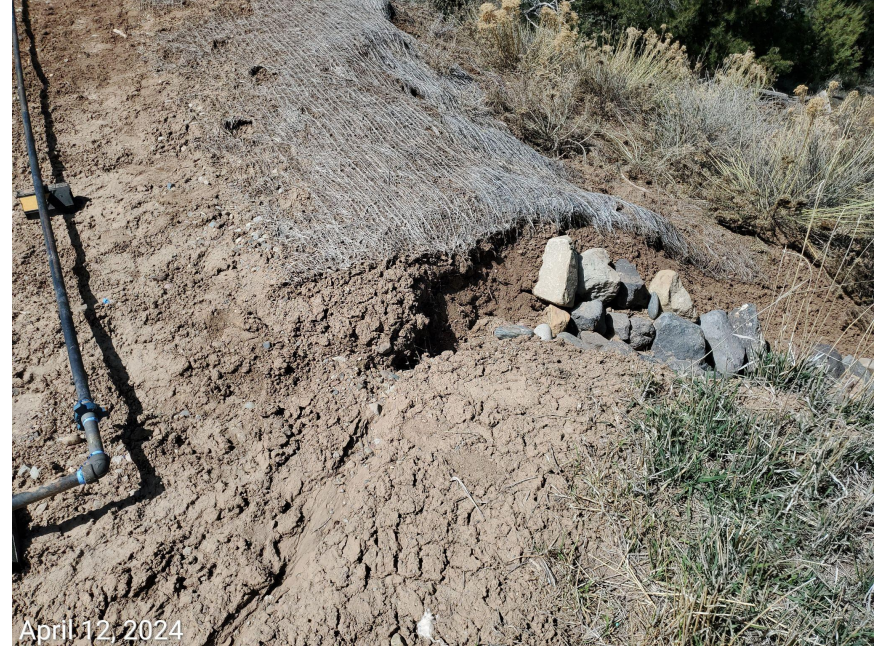
Photo 9: Photos taken from the northeast end of the Location. Stormwater runoff resulting in erosion, degradation and sediment transport. Gully erosion evident- Operator appears to have placed rip-rap material within the gully in an attempt to stabilize the erosion. Erosion blankets are also evident next to gully and on remaining slopes. Outlet has not been designed/constructed per good engineering practice and degradation to the slopes have persisted. Erosion blankets appears to have only been implemented on sections of the slopes, and appears insufficient and/or no longer in proper functioning condition.

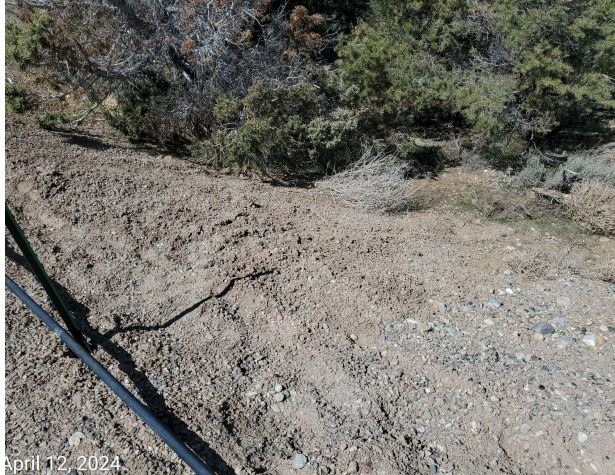
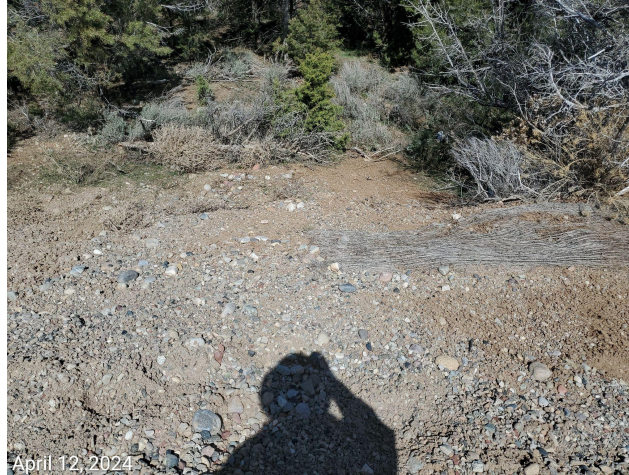
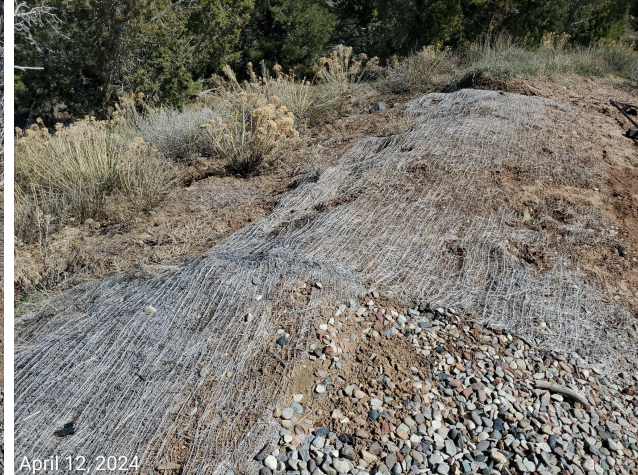
Photo 10: Photos taken from the north end of the Location. Erosion blankets have only been implemented on a portions of the slope, and appears insufficient and/or no longer in proper functioning condition.

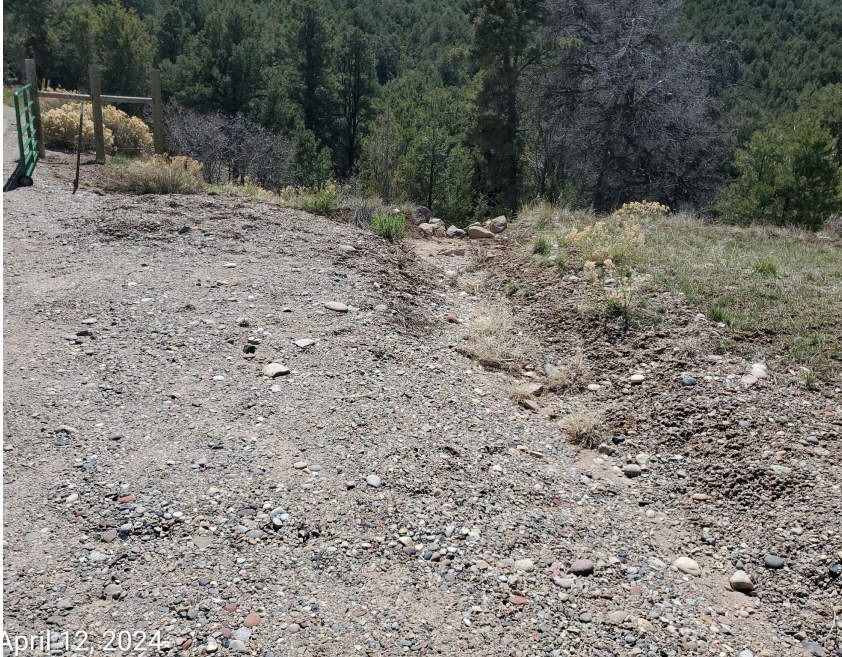
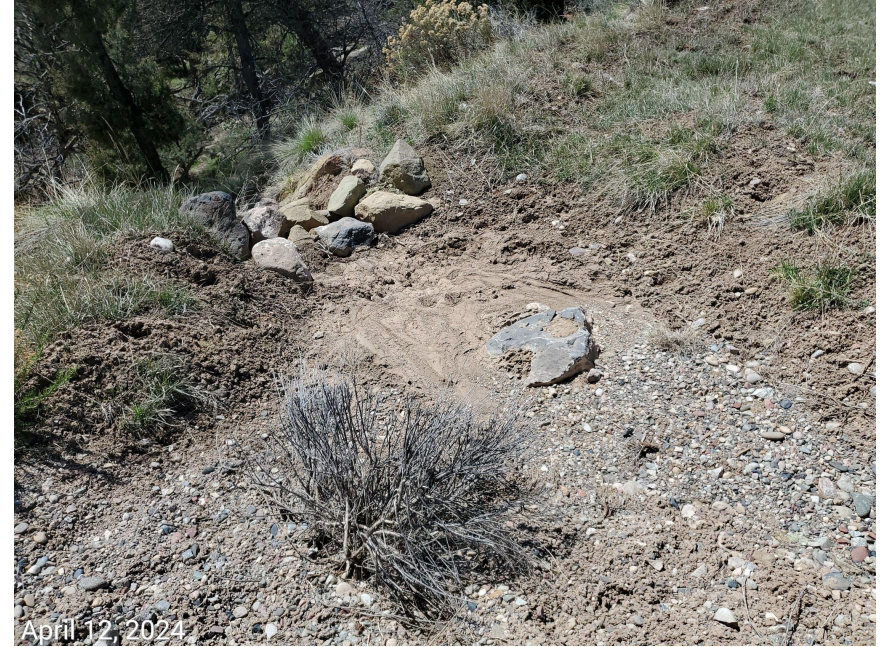
Photo 11: Photos show the sediment trap on the southwest end of the Location.

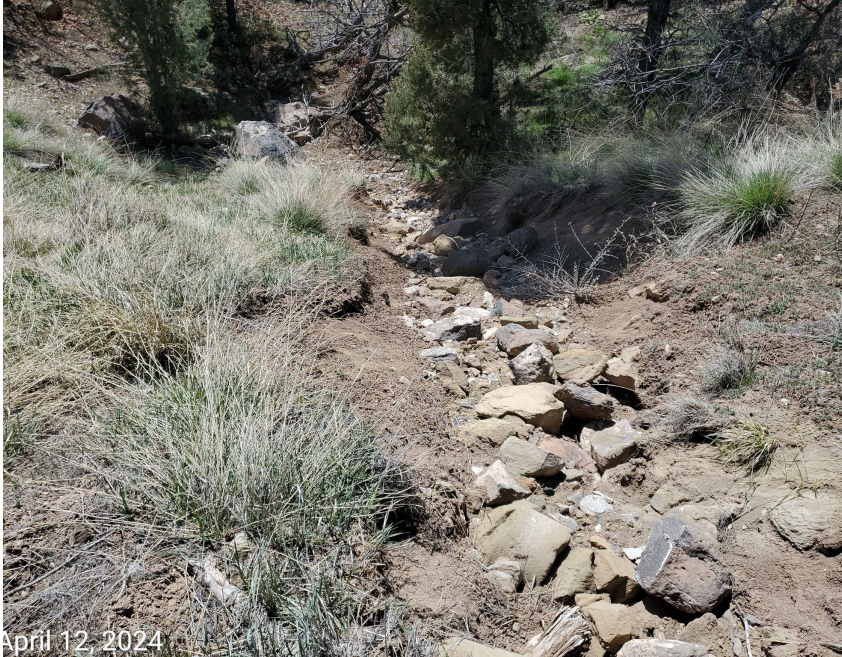
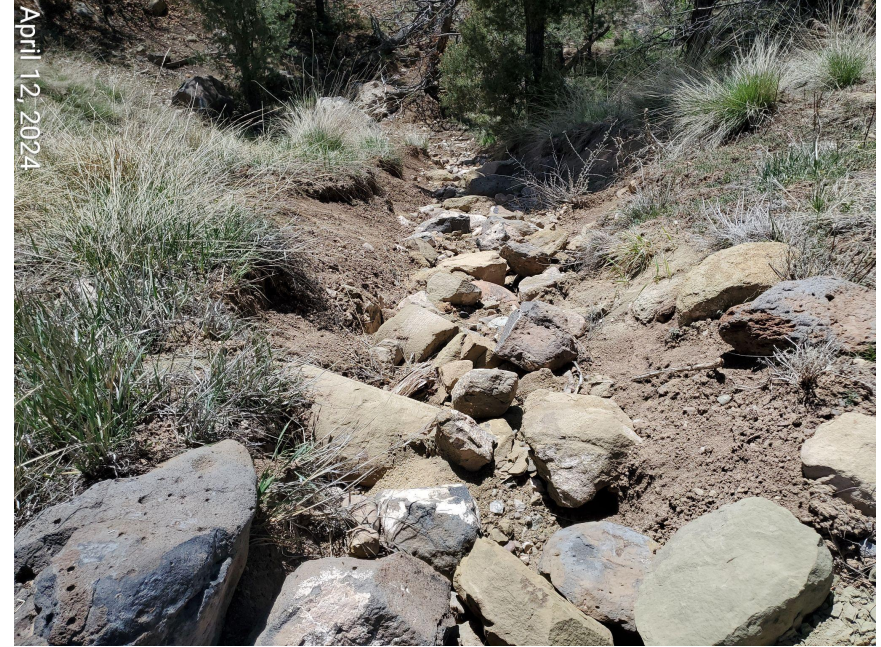
Photo 12: Continued from photo 11. Sediment trap on the southwest end of the Location has not been installed with a properly engineered outlet; geotextile lining in conjunction with the rip-rap material not observed; slopes within outlet lacks stabilization and erosion degradation / sediment transport is evident.

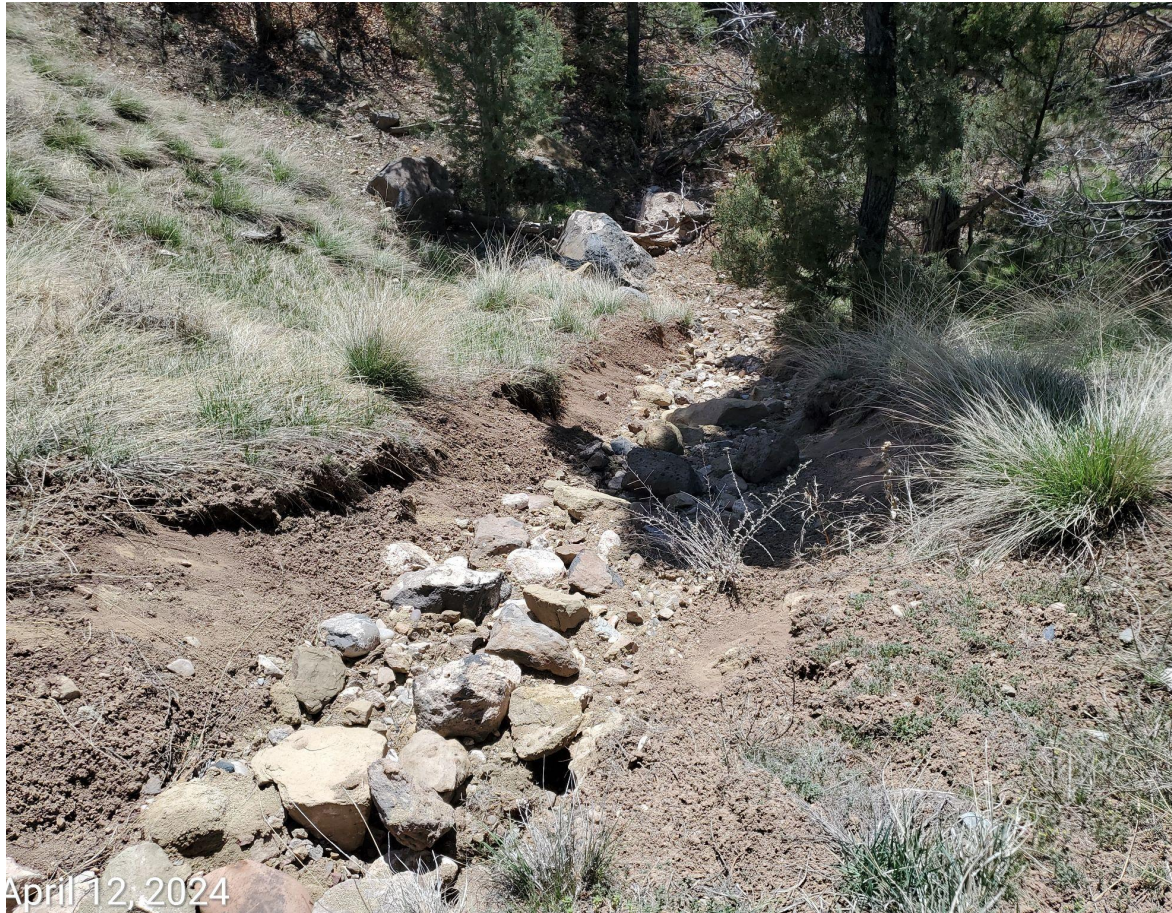
Photo 13: See comments under photo 12.

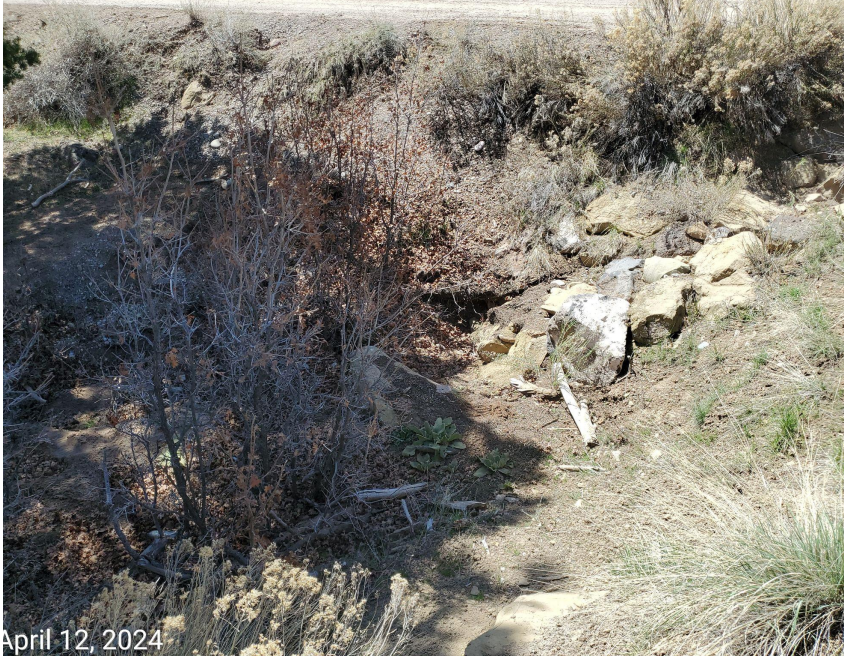
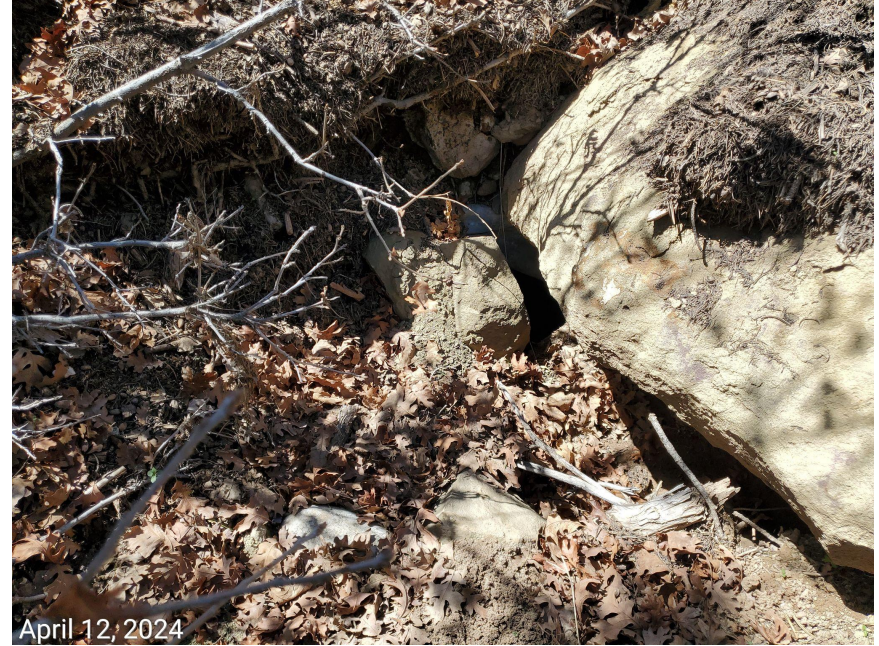
Photo 14: Photos taken from the inlet of the culvert on the southwestern Location entrance. Culvert appears to be filled at the inlet/outlet.

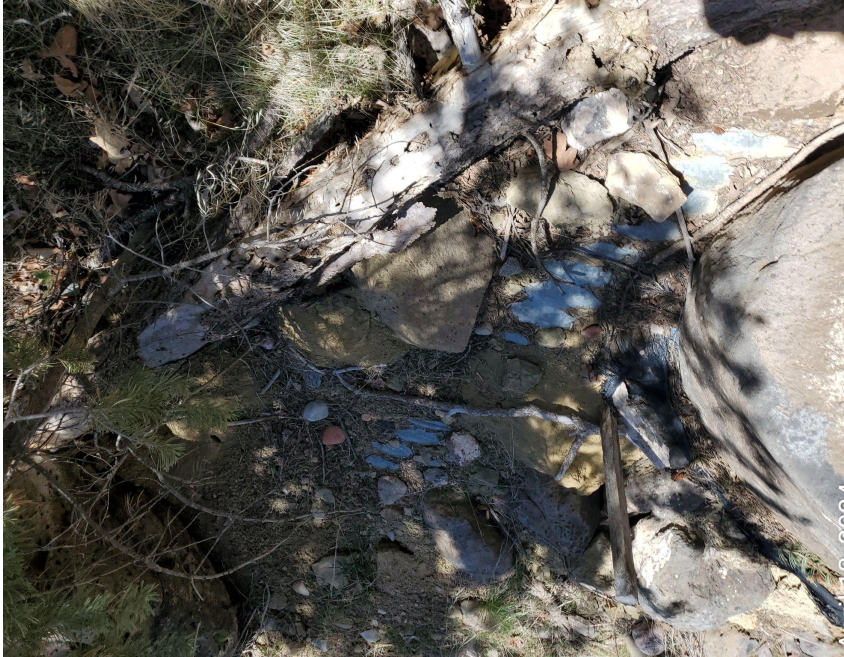
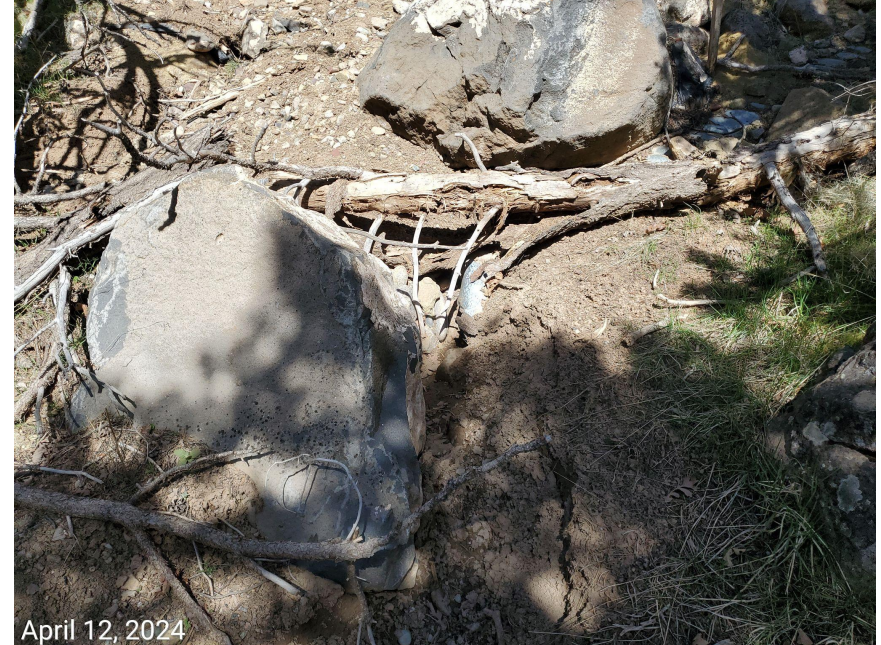
Photo 15: Photos taken from the outlet of the culvert on the southwestern Location entrance. Culvert appears to be filled at the inlet/outlet.
