Inspection Photos

Loc: 324494

Operator: **OXY USA INC**

Inspection Date: 4/16/2024

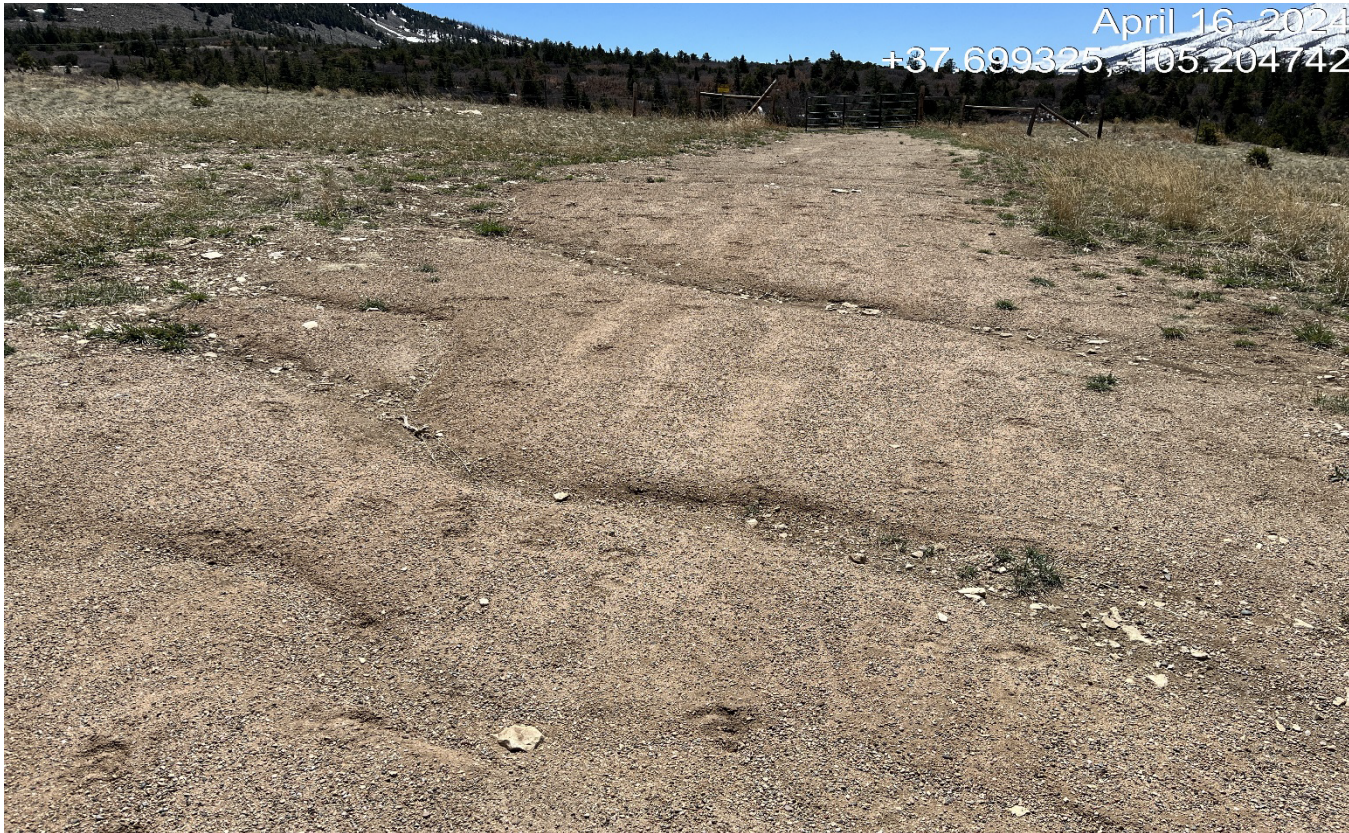
Photo 1. Facing south toward the access road. There is erosion occurring across the road and no BMP's were installed. The access road will need to be decompacted and reclaimed. Previous corrective action has not been completed.

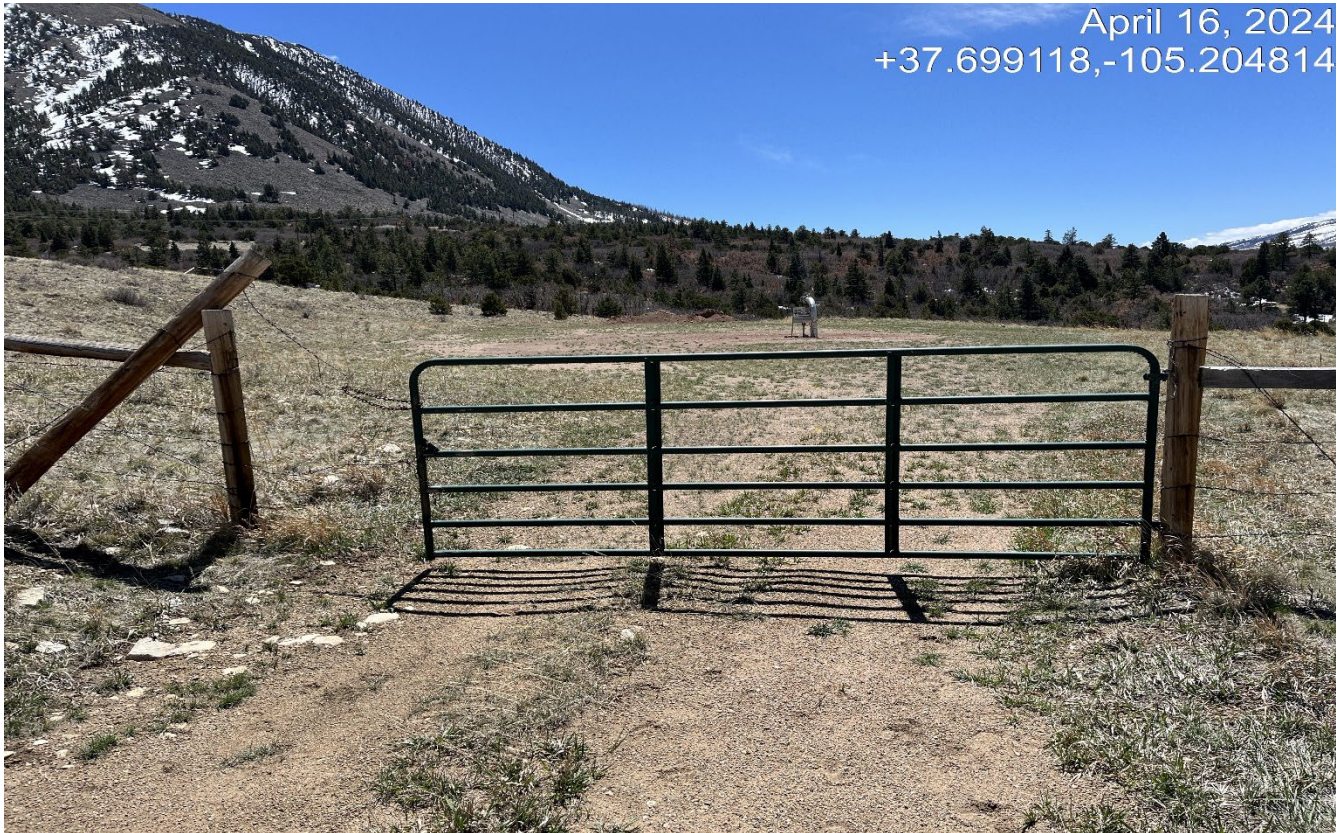
Photo 2. Facing south toward the location. The well has been plugged and abandoned . The location will need to be recontoured back to the original contours and reclaimed. This gate does not prevent livestock entry.

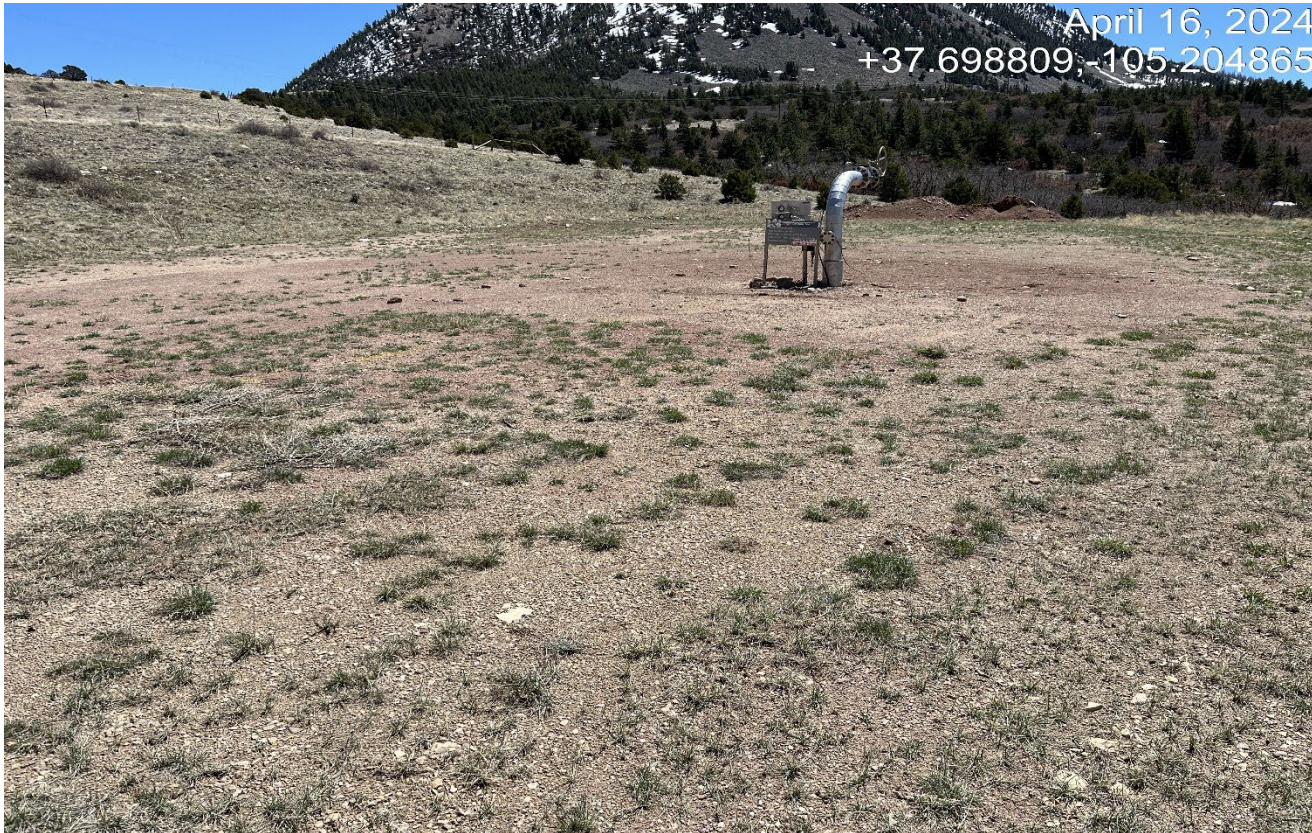
Photo 3. Facing toward the wellsite. The wellhead has been covered up and backfilled. This pipe riser must be removed. All equipment must be removed with 3 months of abandonment.

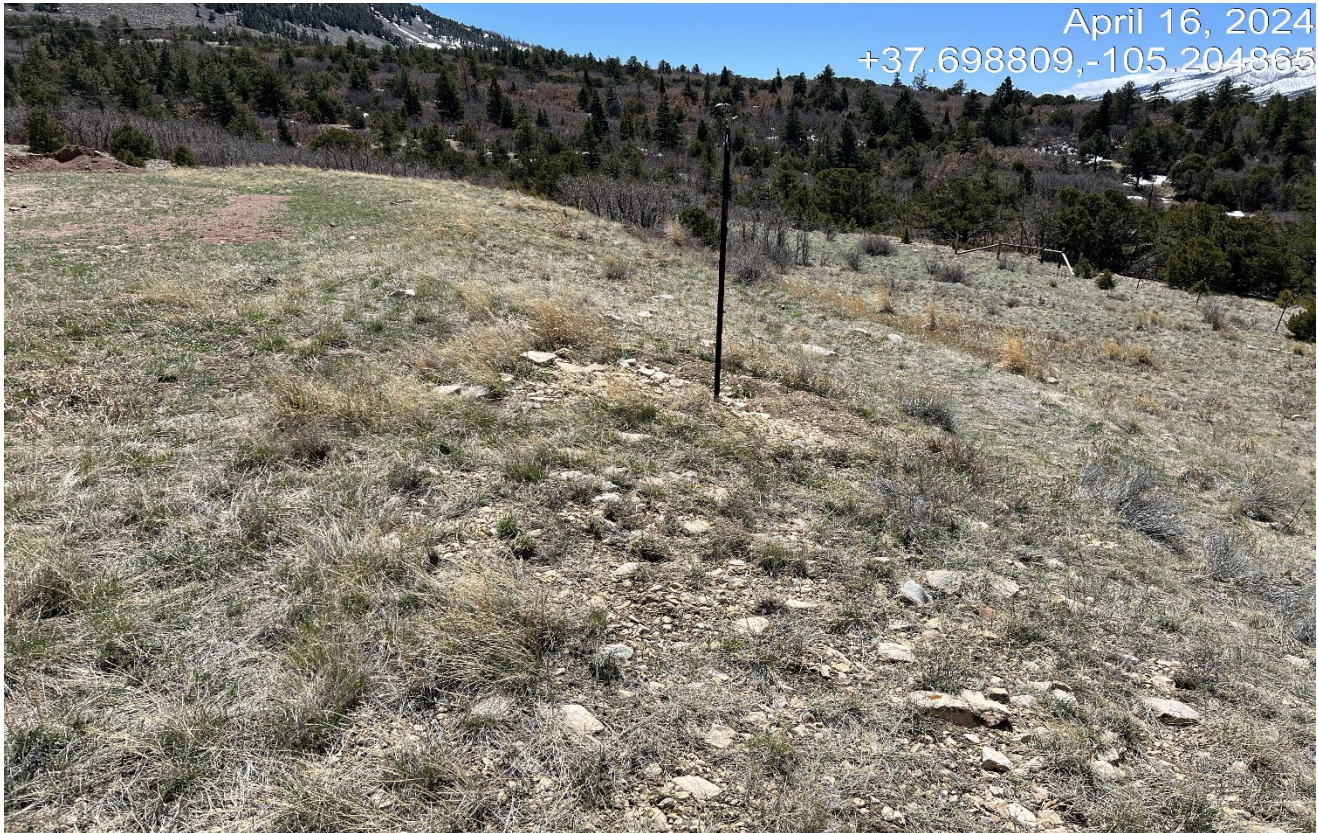
Photo 4. Facing south toward the fill slope which must be recontoured back to the original condition.

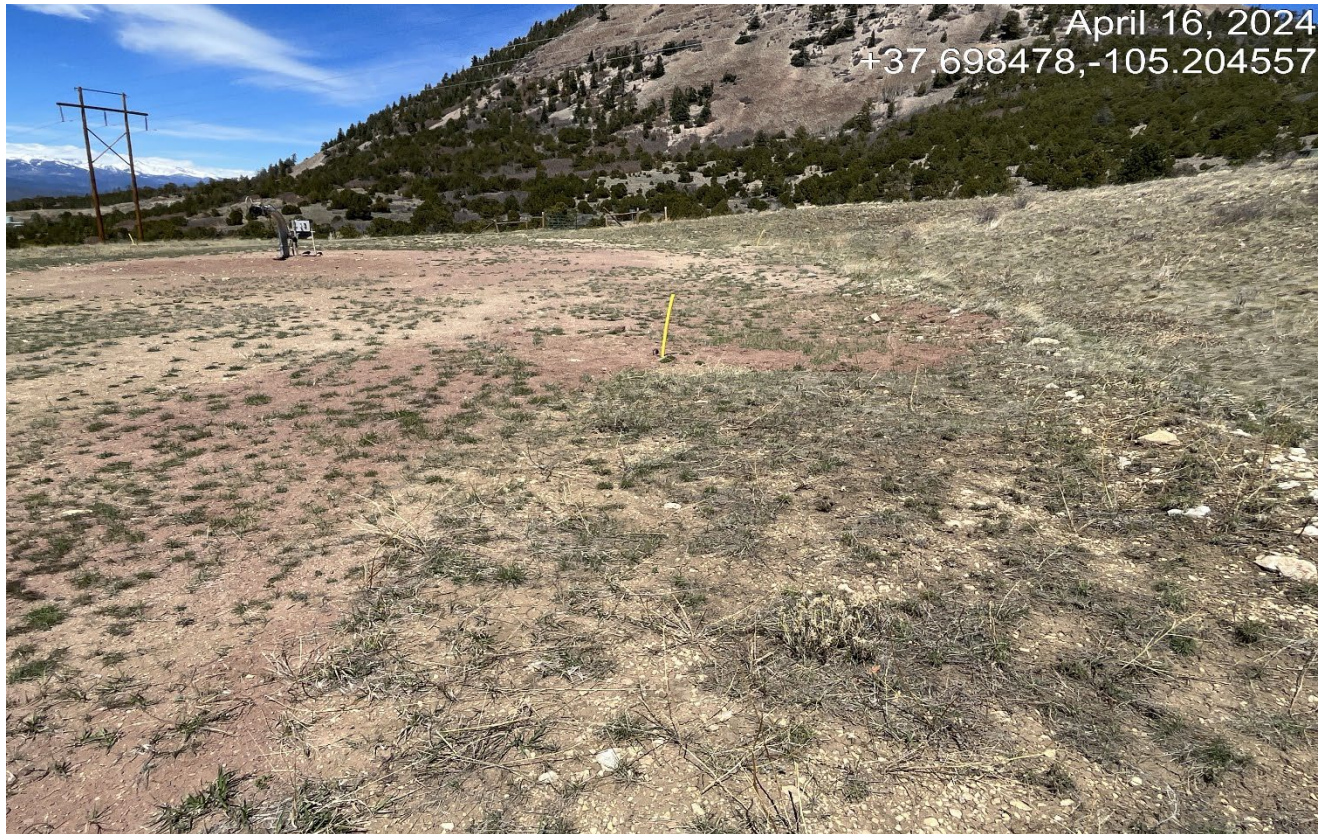
Photo 5. Facing northwest at the location. The four guyline anchors have not been removed.
