Final Reclamation and Stormwater Inspection

Operator: BONANZA CREEK ENERGY OPERATING
COMPANY LLC - 8960

Location ID: 302895

Inspection Photos
Location Name: Pronghorn 31-21
Location ID: 302895

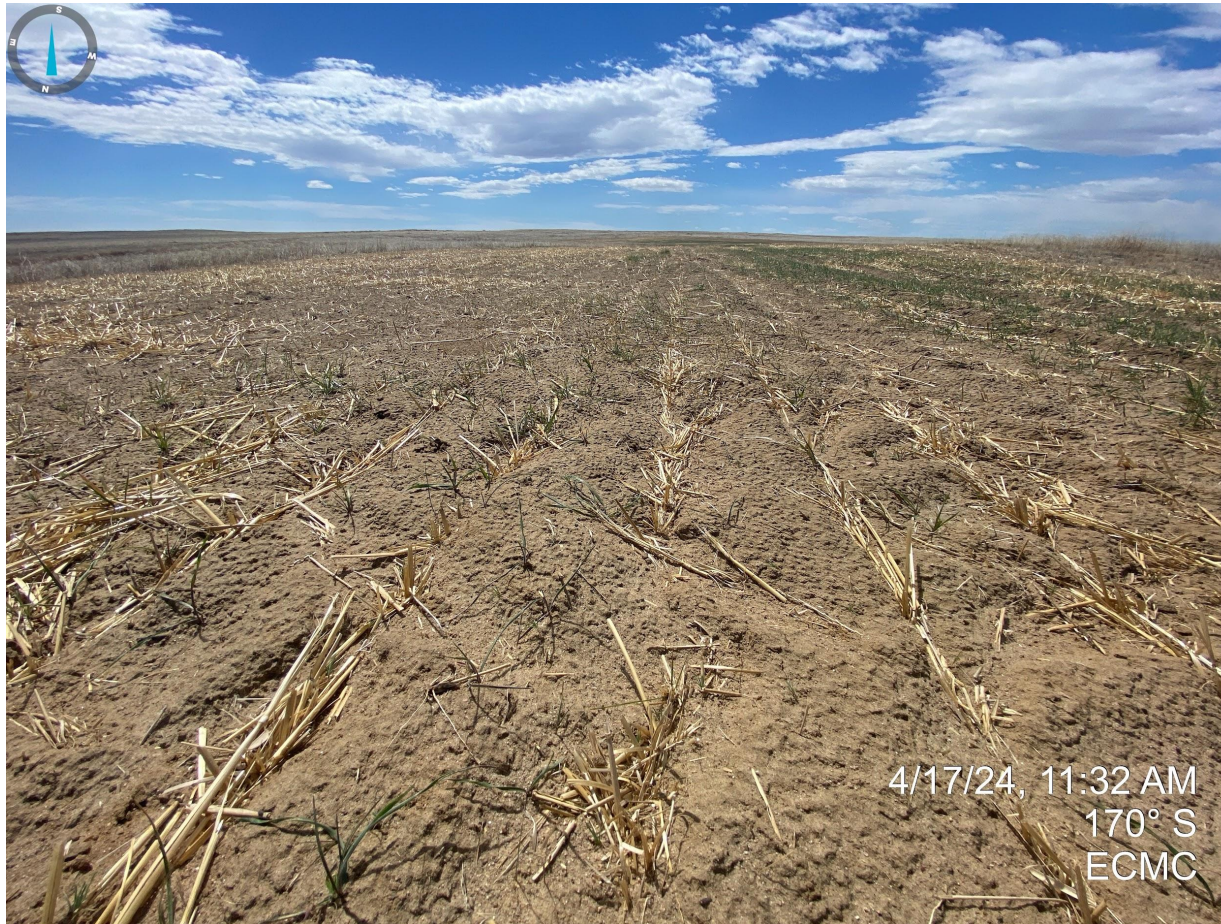
Photo 1. It appears the location has been recently reclaimed with evidence of straw mulch and germination observed during this inspection. A follow-up inspection will be conducted at a later date to verify vegetative compliance with Rule 1004.

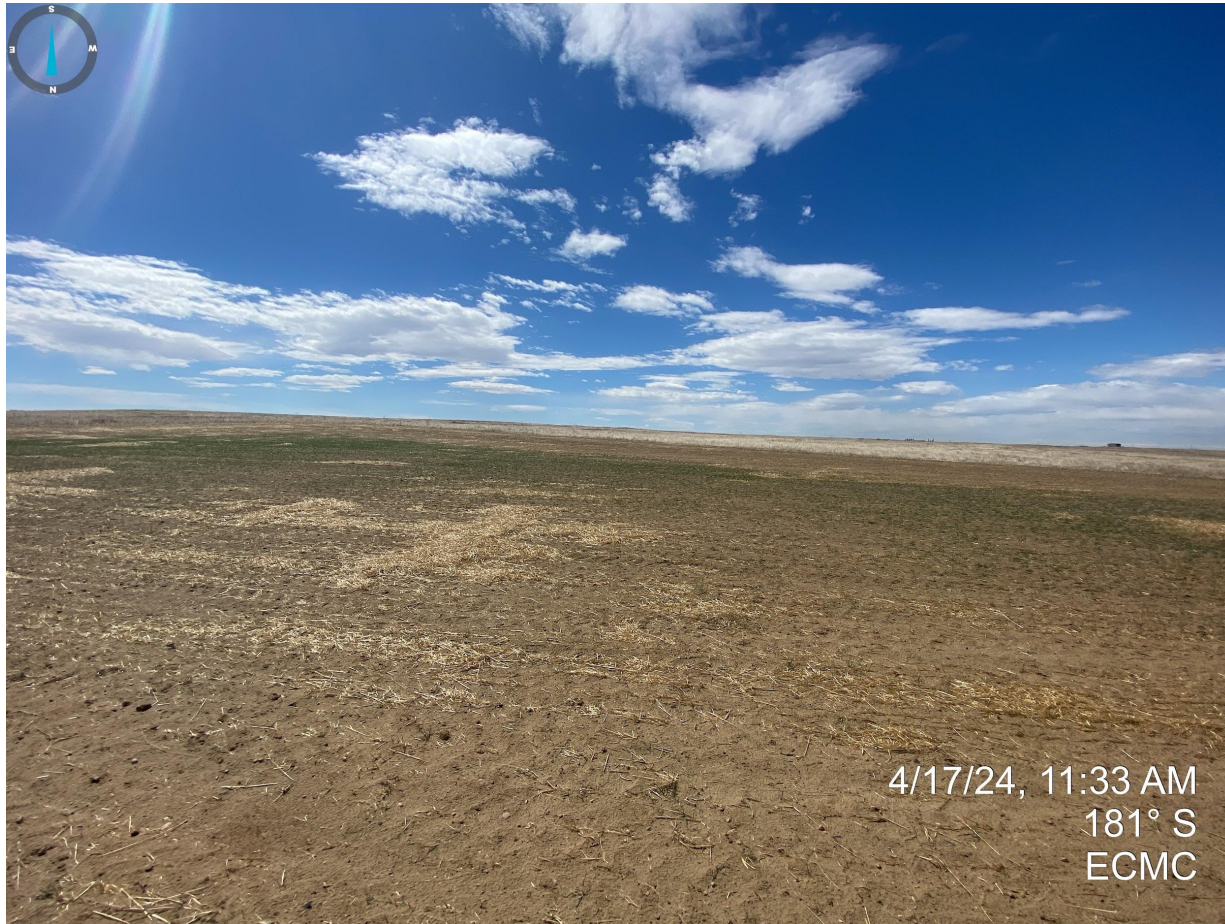
Photo 2. Taken near the northern portion of the location, facing south. See comments in Photo 1.

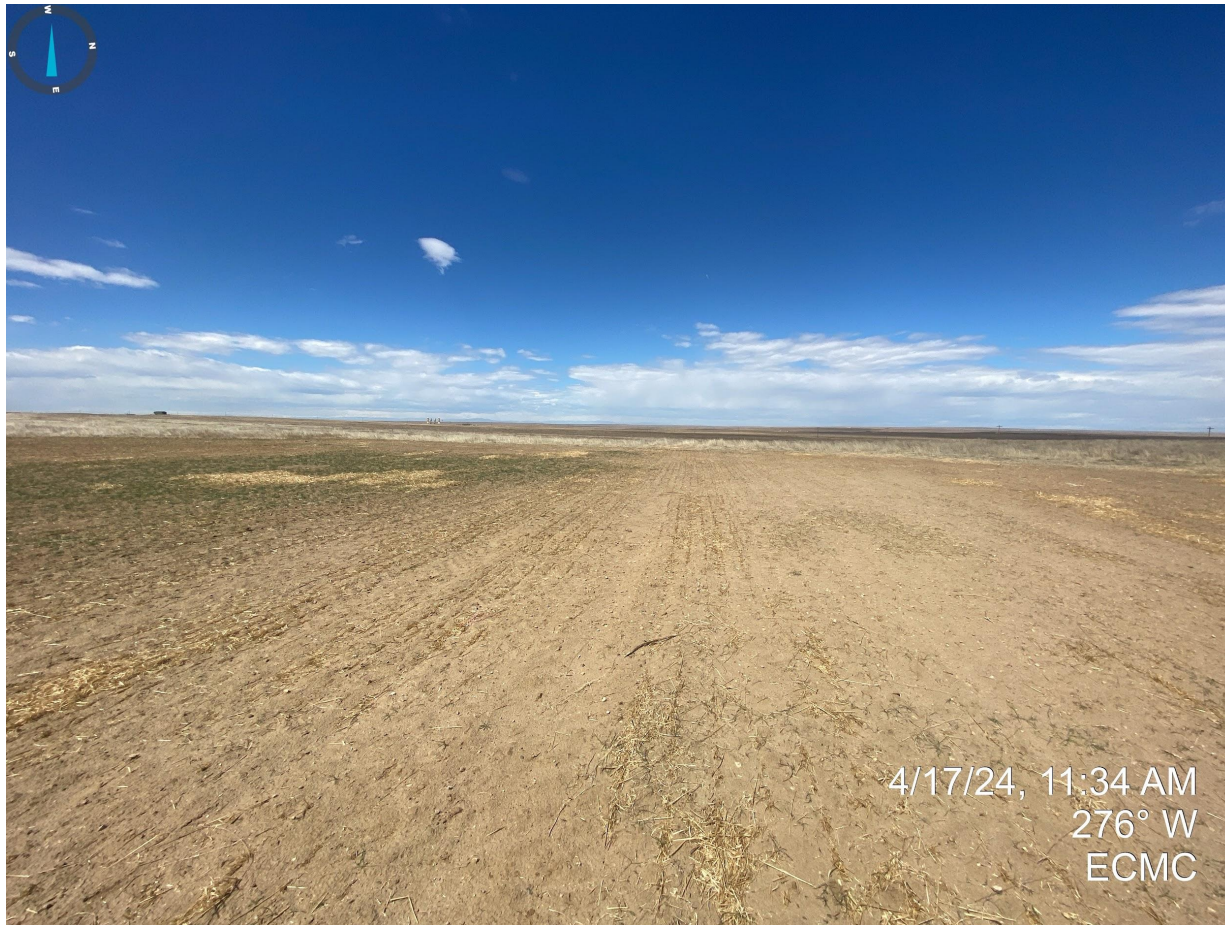
Photo 3. Taken near the center portion of the location, facing west. See comments in Photo 1.

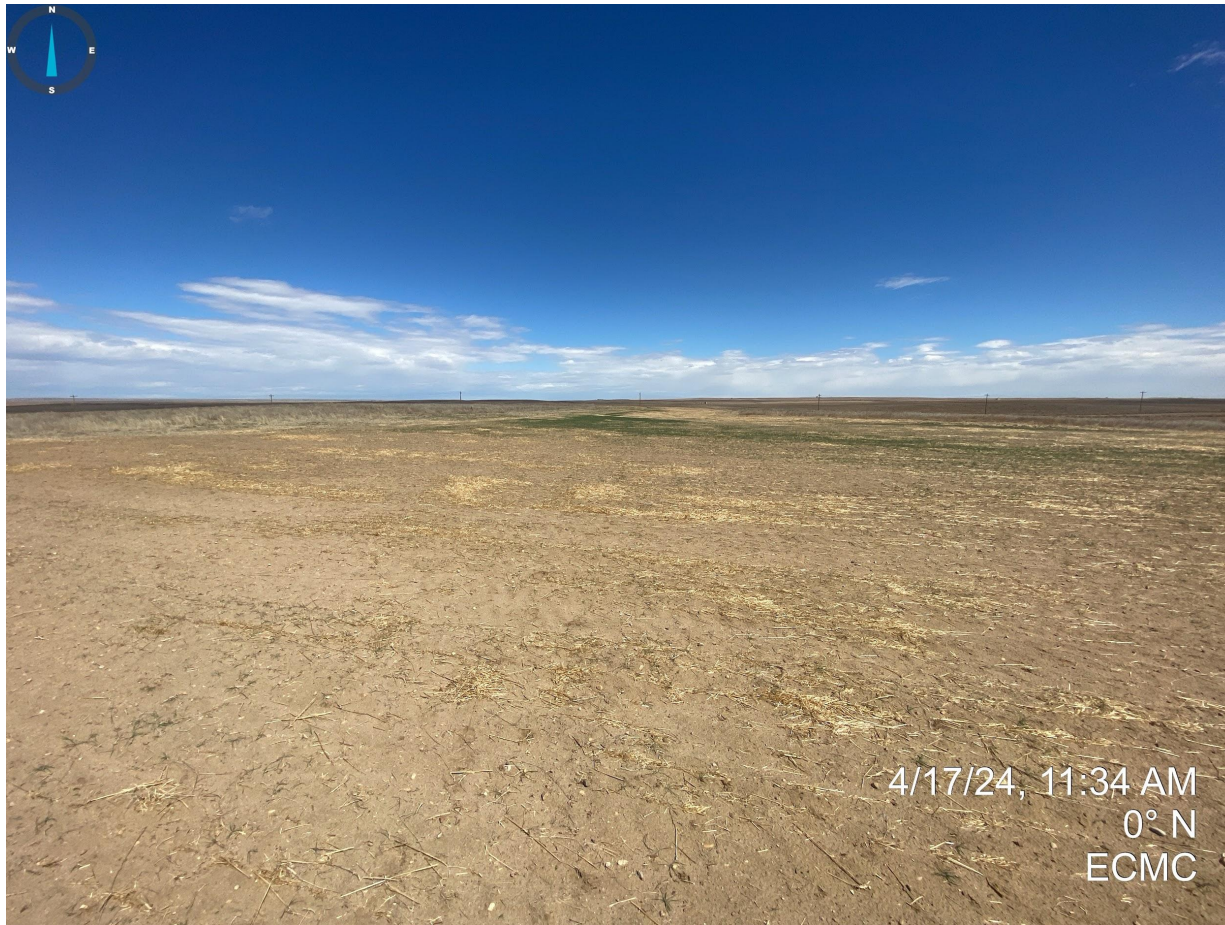
Photo 4. Taken near the center portion of the location, facing north. See comments in Photo 1.

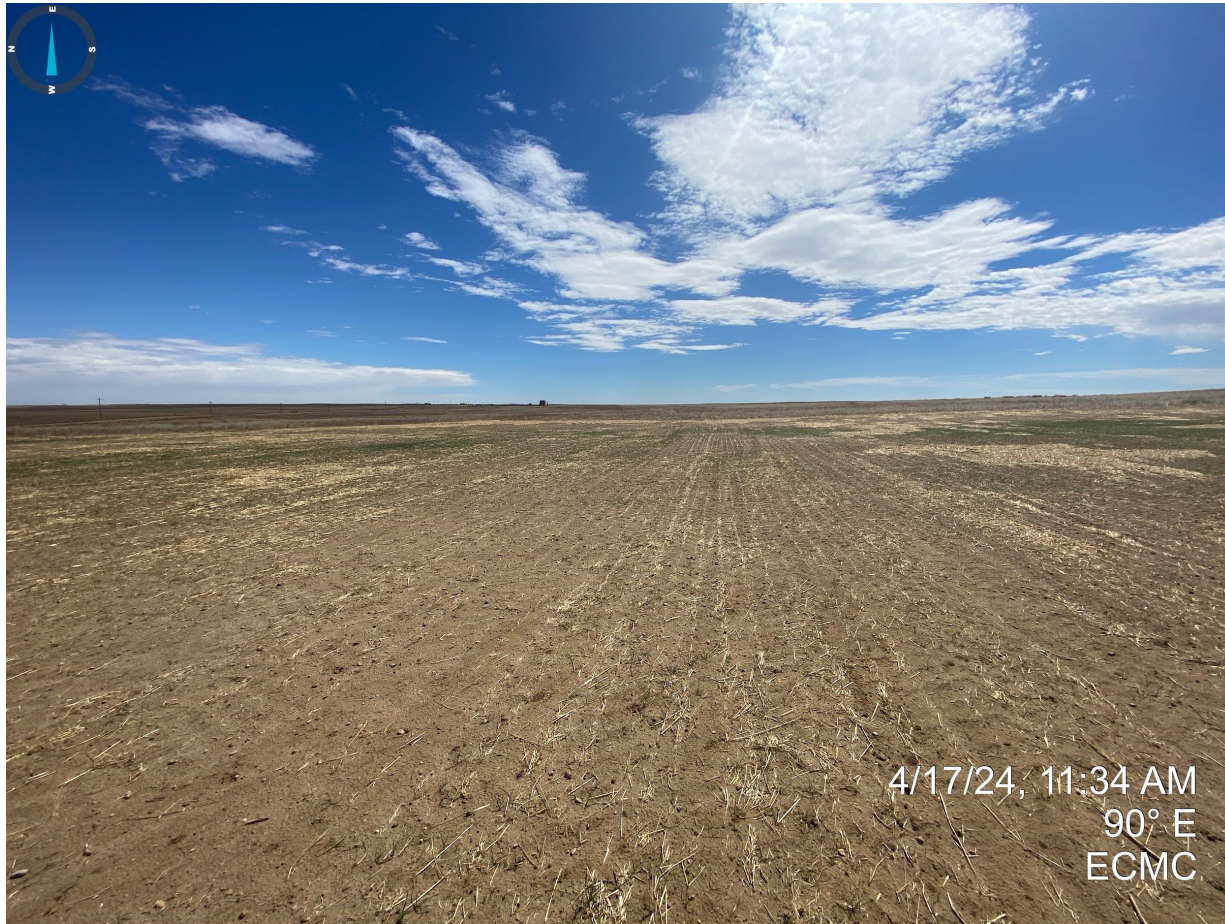
Photo 5. Taken near the center portion of the location, facing east. See comments in Photo 1.

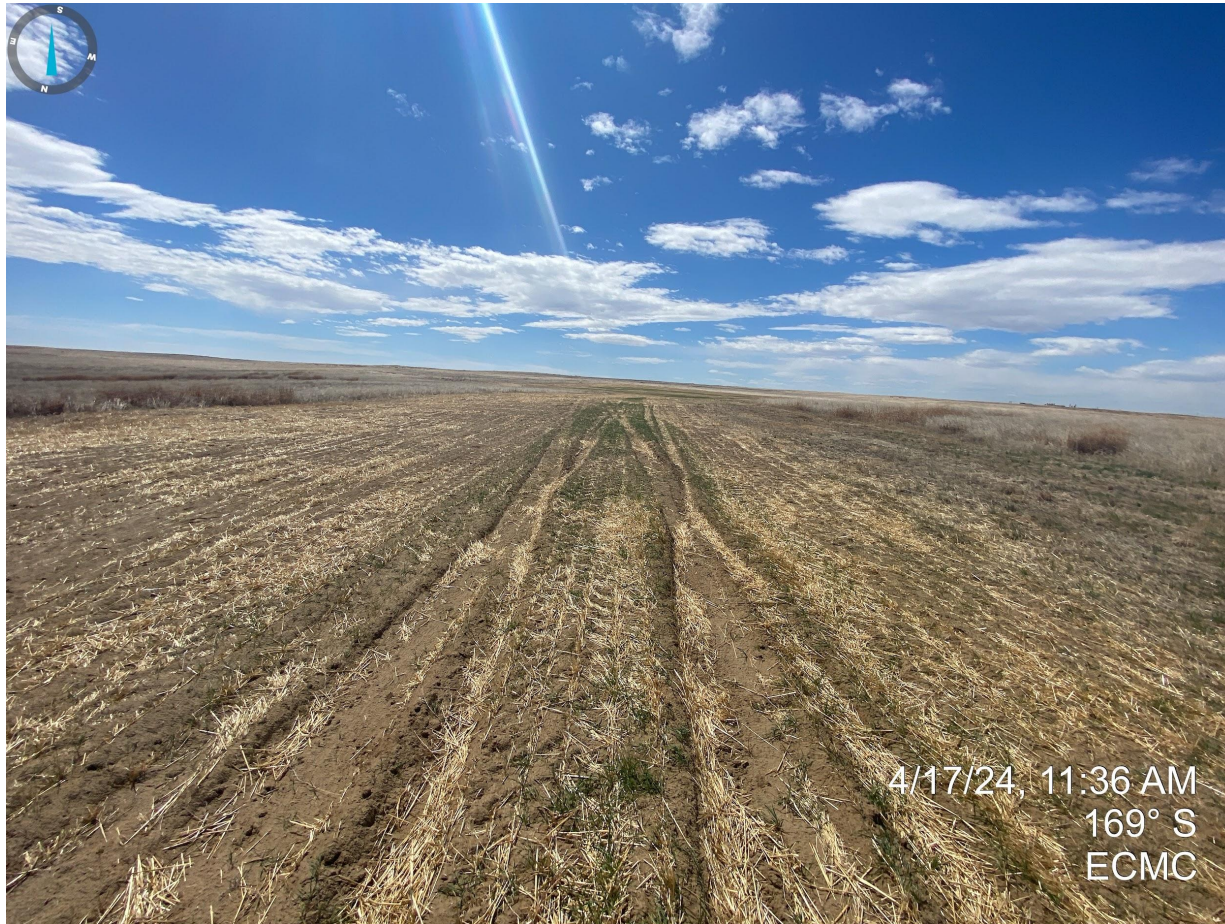
Photo 6. Taken along the access road, facing south. See comments in Photo 1.
