Inspection Photos

API: 055-06037

Operator: OXY USA INC

Inspection Date: 4/16/2024

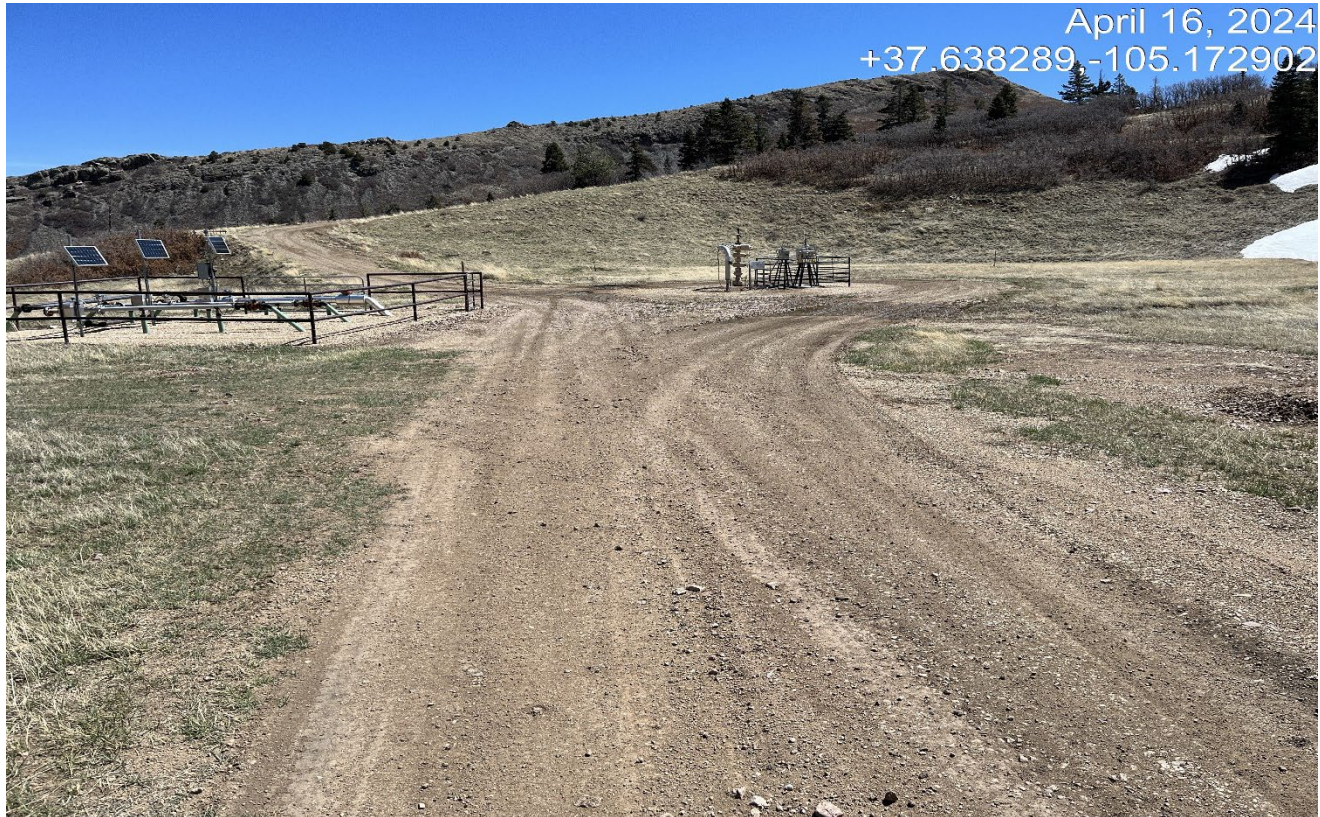
Photo 1. Facing east toward the wellsite.

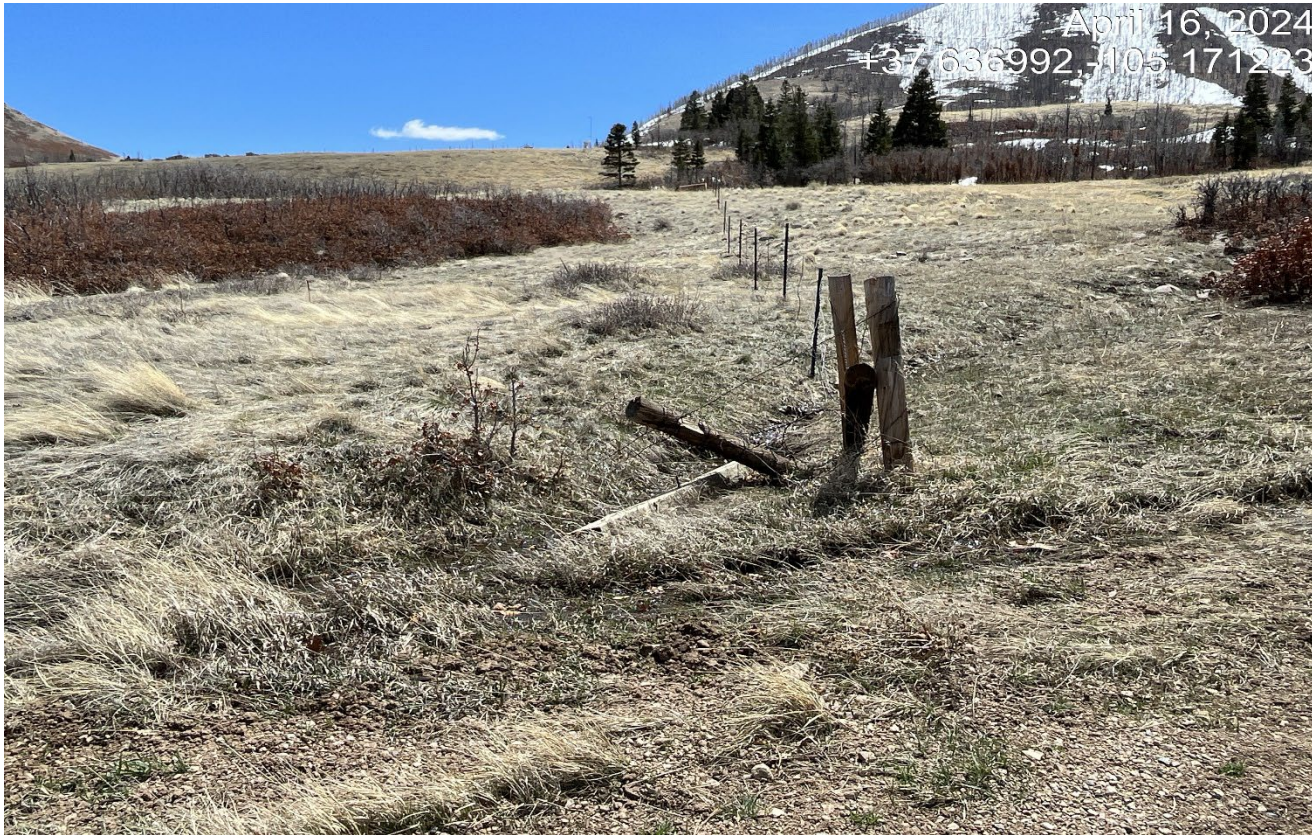
Photo 2. The perimeter fence around the location is not maintained and there are posts and wire laying on the ground.

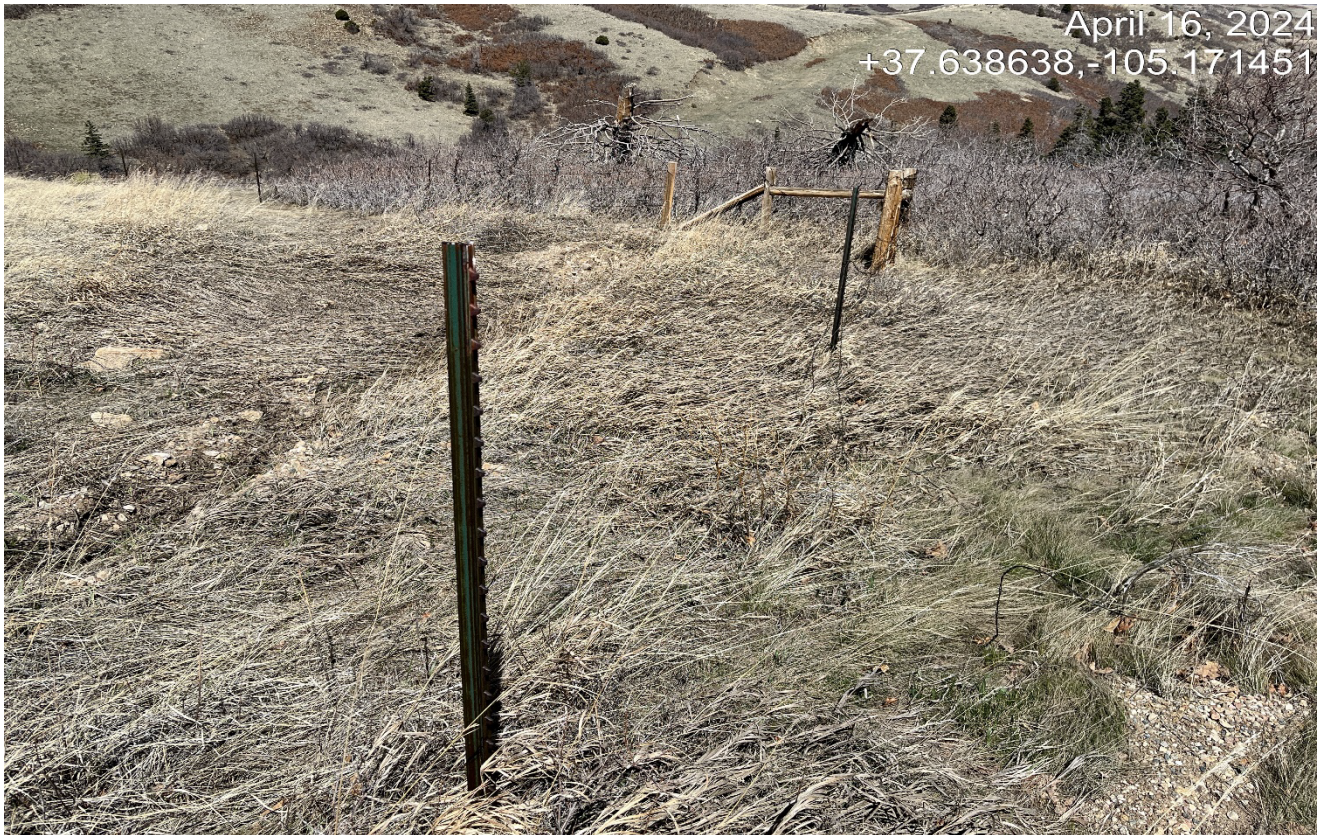
Photo 3. The perimeter fence around the location is not maintained and there is wire laying on the ground.

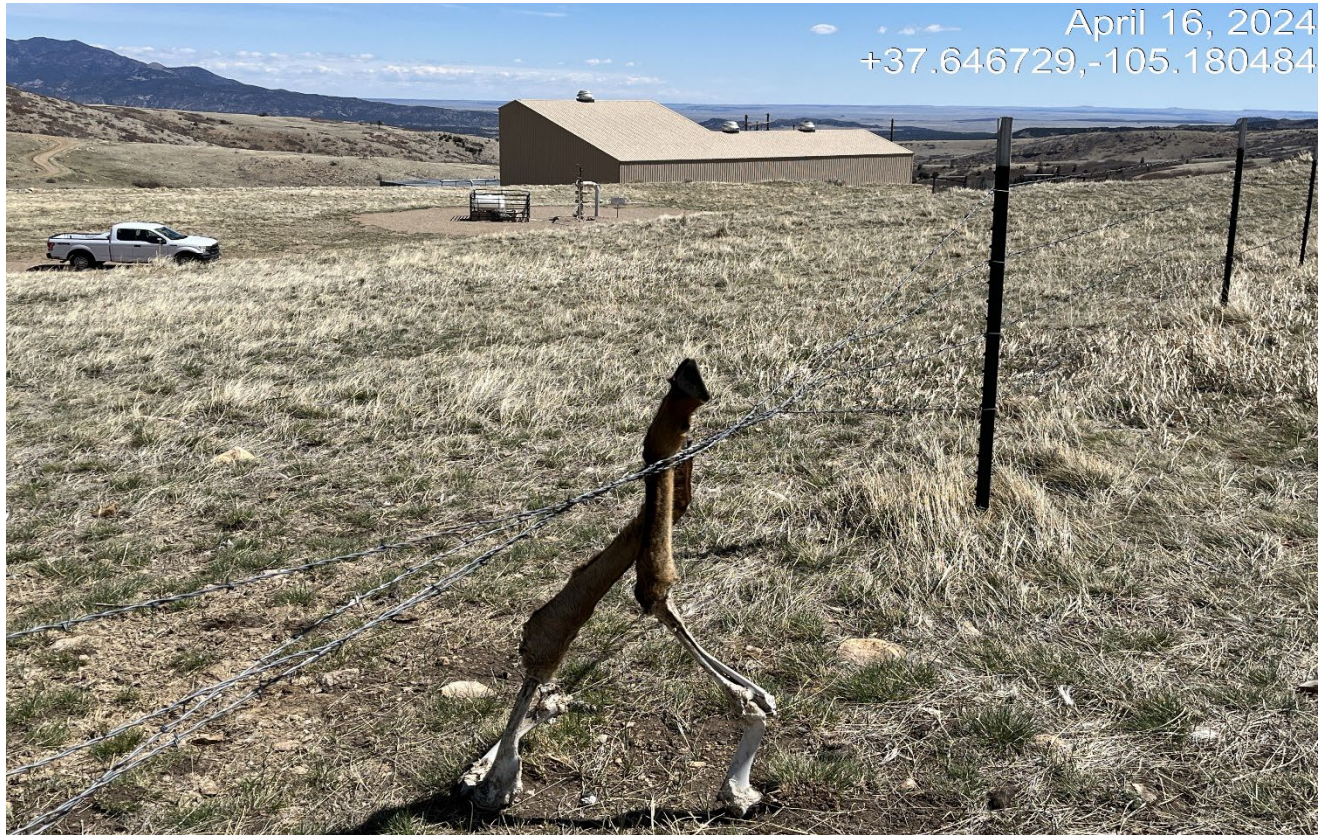
Photo 4. This is an example at a nearby fenceline and the importance to either maintain or remove fences. CPW wildlife friendly fencing is encouraged.
