Interim Reclamation and Stormwater Inspection

Operator: Highpoint Operating Corporation - 10071

Inspection Document #: 713900536

Location Name: Anschutz Equus Farms 4-62-33

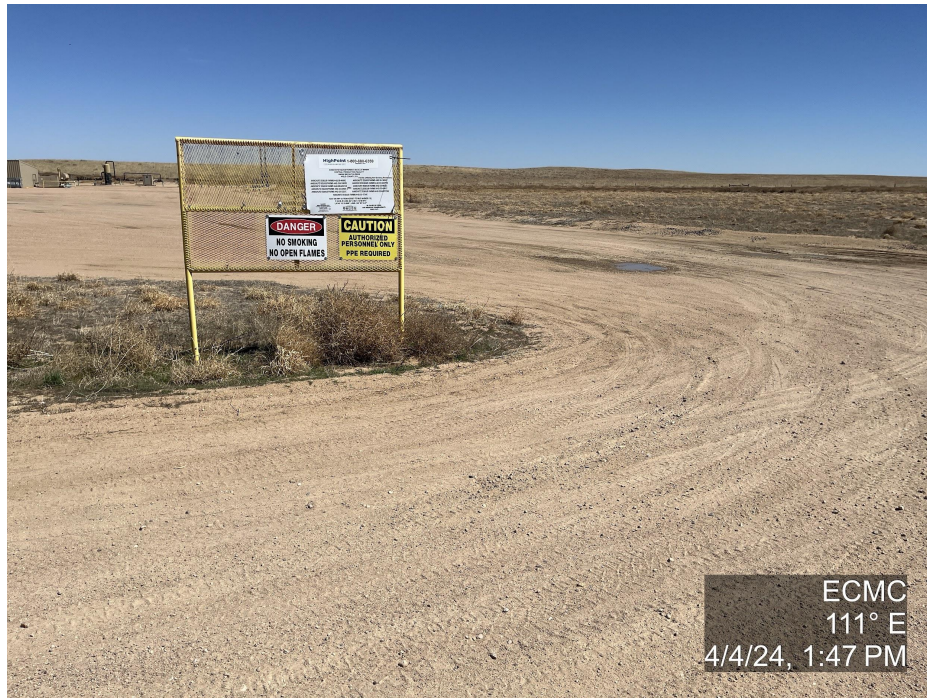
ECMC
111° E
4/4/24, 1:47 PM

Photo 1. The photo was taken at the entrance to the well location facing East. The photo illustrates the entrance and operator signage.

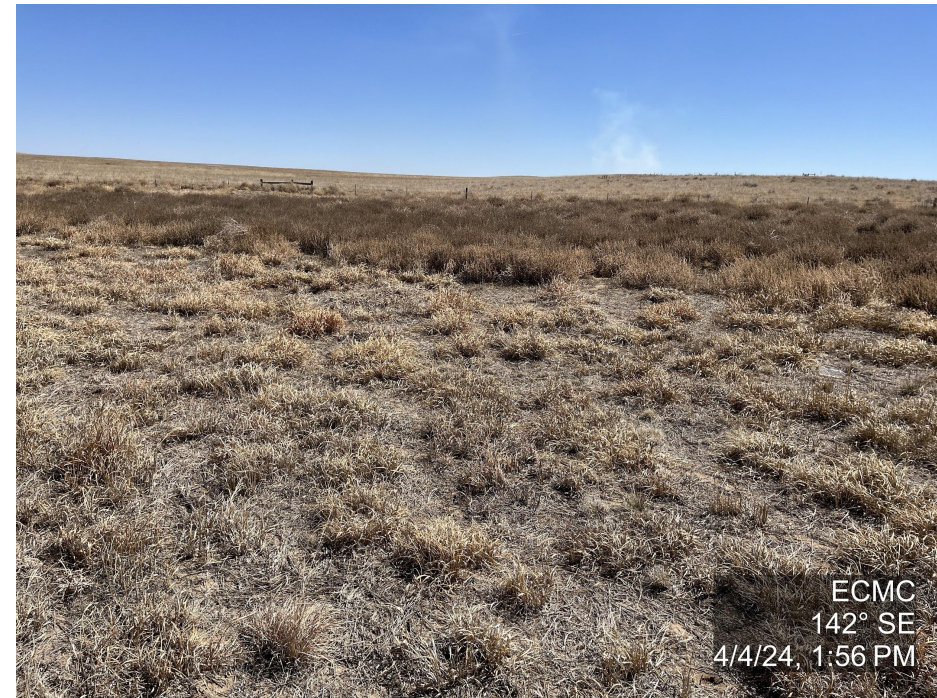
ECMC
142° SE
4/4/24, 1:56 PM

Photo 2. The photo was taken at the well location facing Southeast. The photo illustrates the portions of the interim reclamation areas are dominated by Russian thistles.

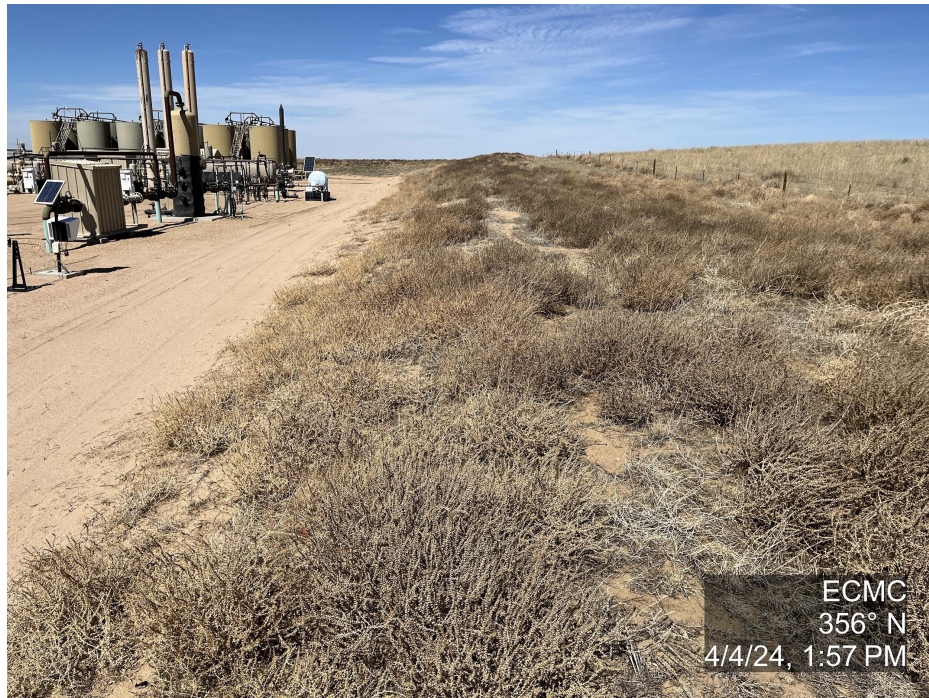
Photo 3. The photo was taken at the well location facing North. The photo illustrates the interim area to the East is primarily dominated by Russian thistle.

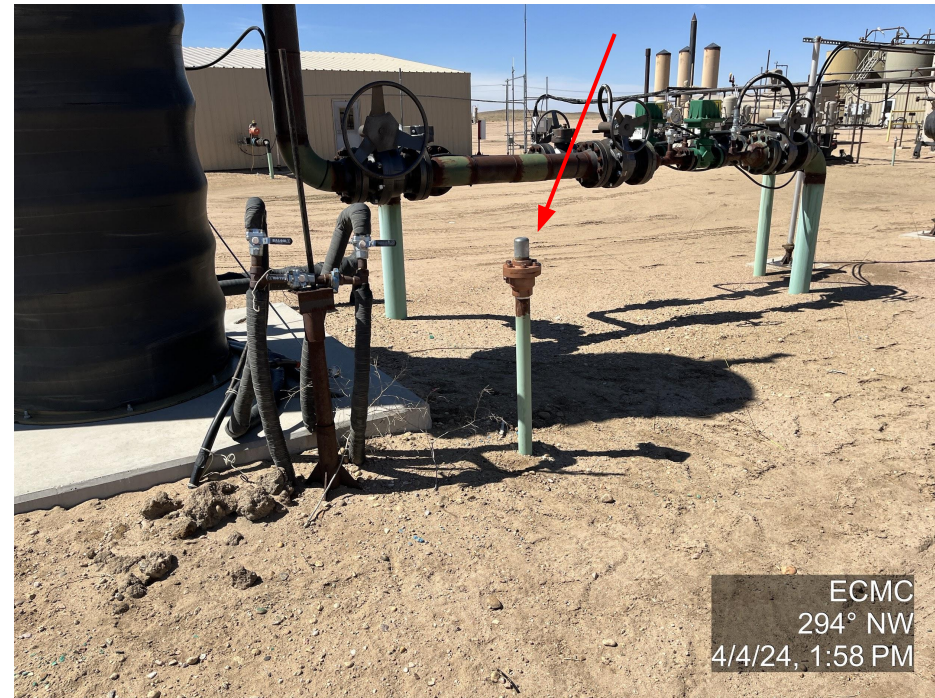
Photo 4. The photo was taken at the well location facing Northwest. The photo illustrates an unmarked un-tagged riser.

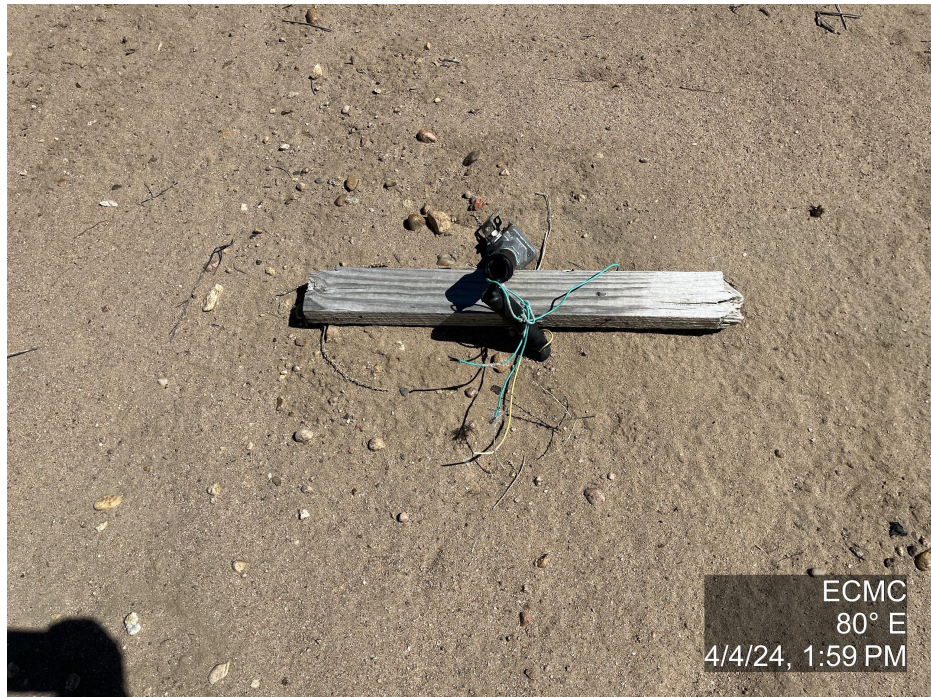
Photo 5. The photo was taken at the well location facing East. The photo illustrates debris consisting of electrical wires on the production pad.

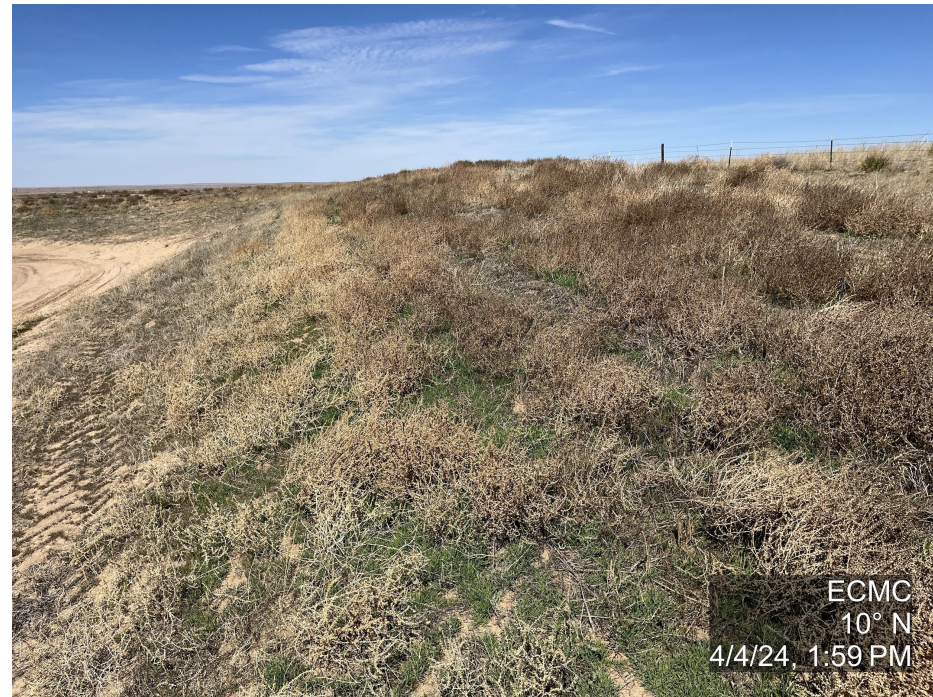
Photo 6. The photo was taken at the well location facing North. The photo illustrates interim areas in the Northeast of the disturbance are dominated by Russian thistle.

Note - Newly germinating vegetation appears to also be dominated by Russian thistle.

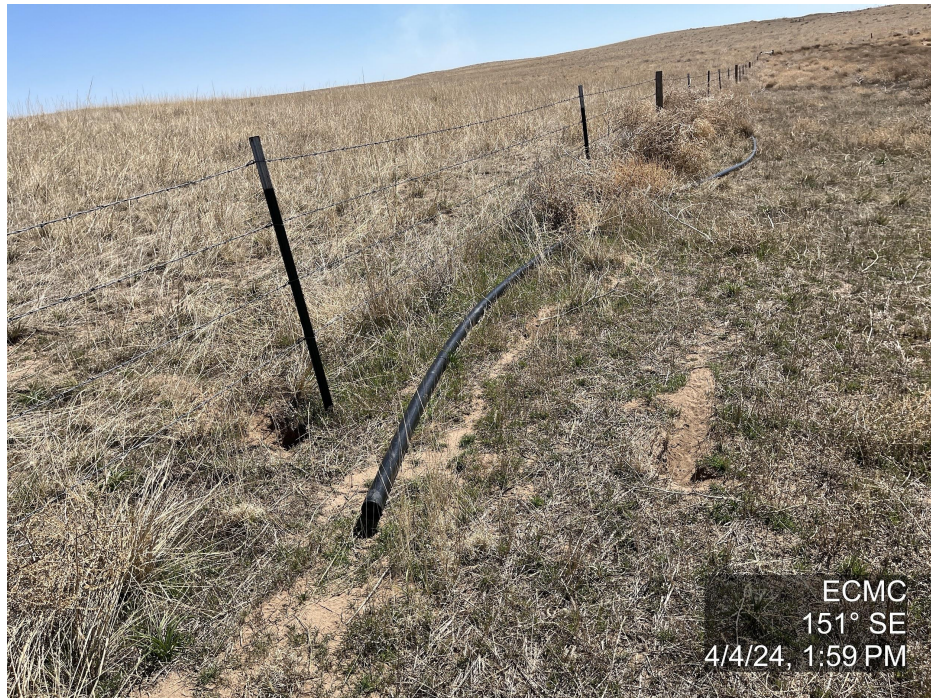
Photo 5. The photo was taken at the well location facing Southeast. The photo illustrates piping being stored in the interim areas on the East side of the location.

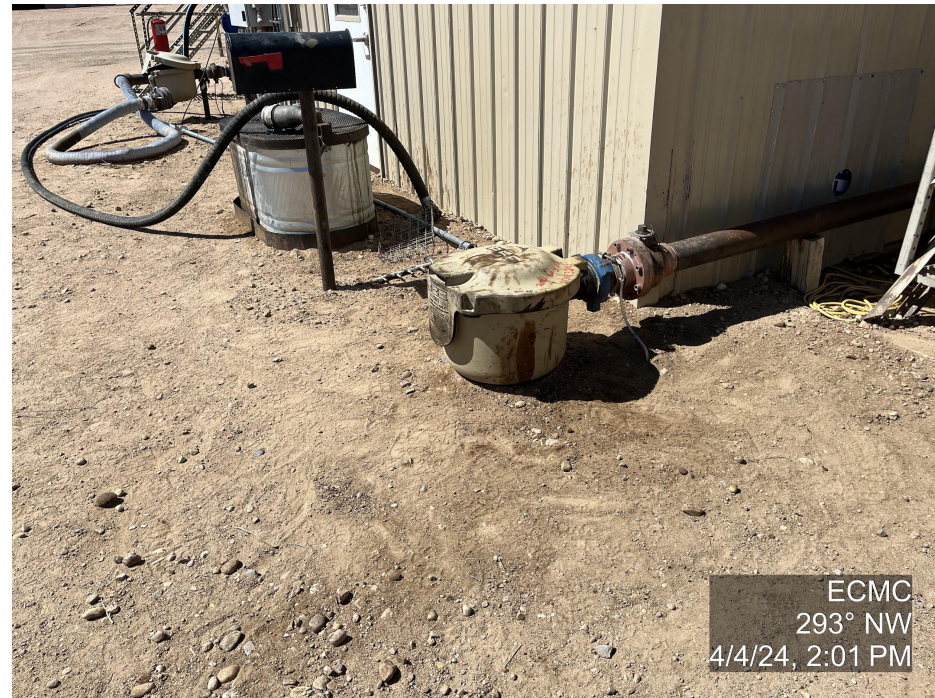
Photo 6. The photo was taken at the well location facing Northwest. The photo illustrates stained soil as well as loadout hoses being stored without any containment.

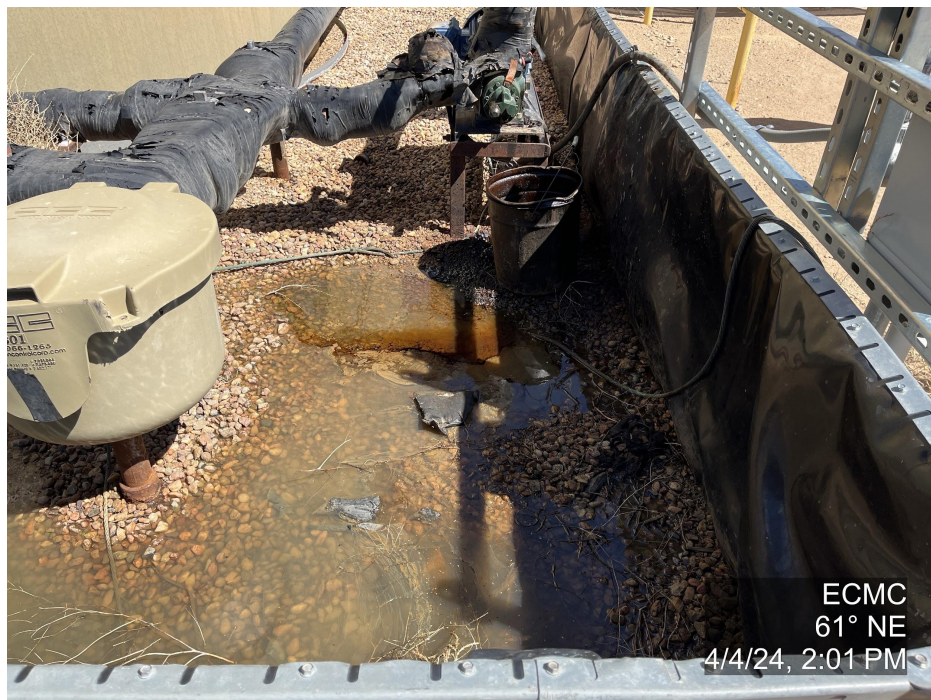
Photo 5. The photo was taken at the well location facing Northeast. The photo illustrates stained soil within the secondary containment.

Note - Recent precipitation has occurred as well.

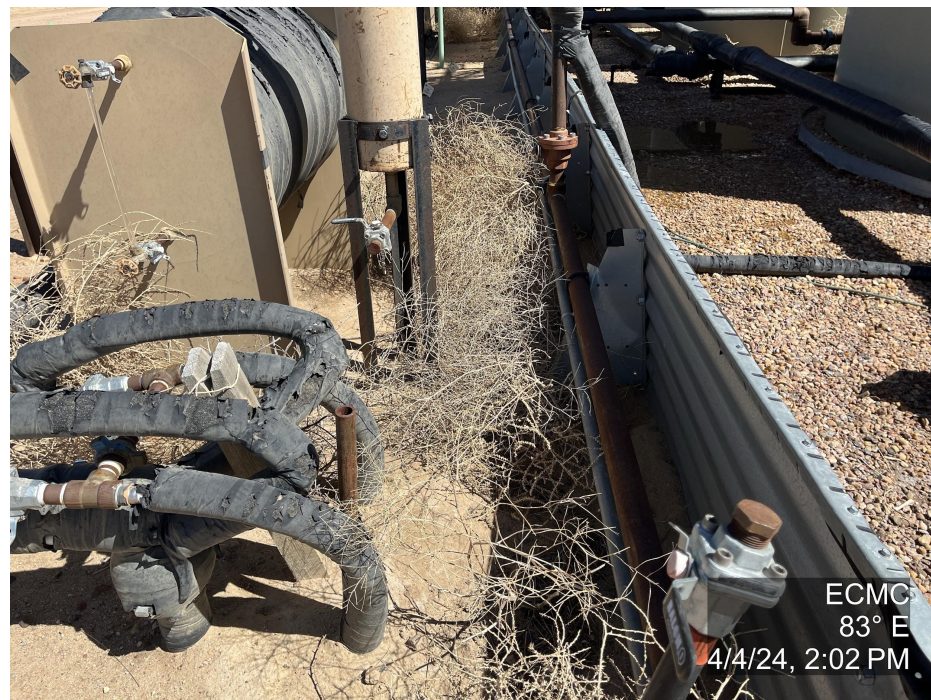
Photo 6. The photo was taken at the well location facing East. The photo illustrates tumbleweeds stuck within equipment.

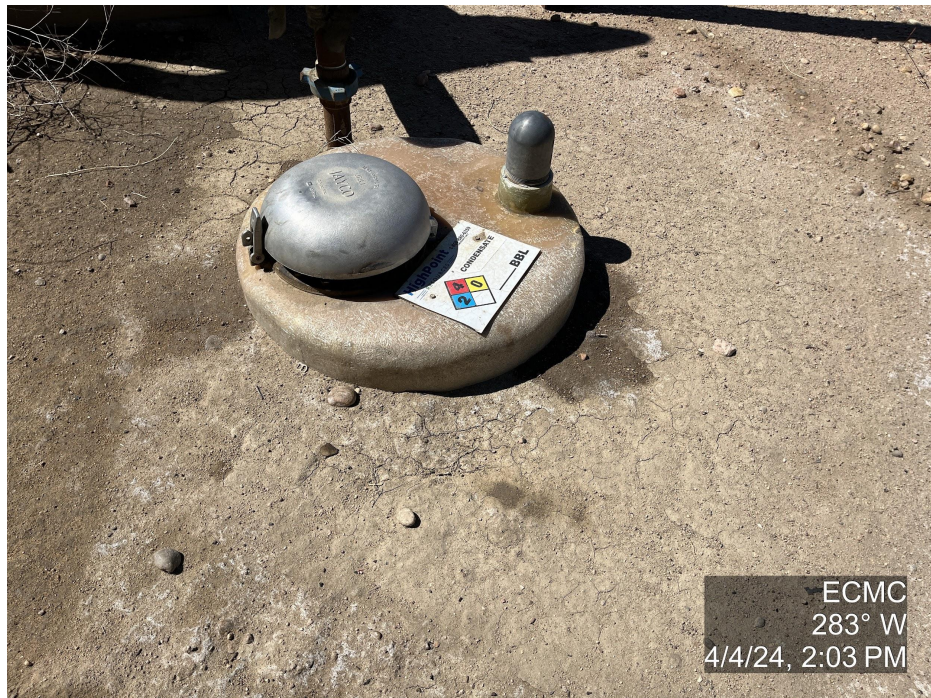
Photo 5. The photo was taken at the well location facing West. The photo illustrates stained soil around a buried condensate container.

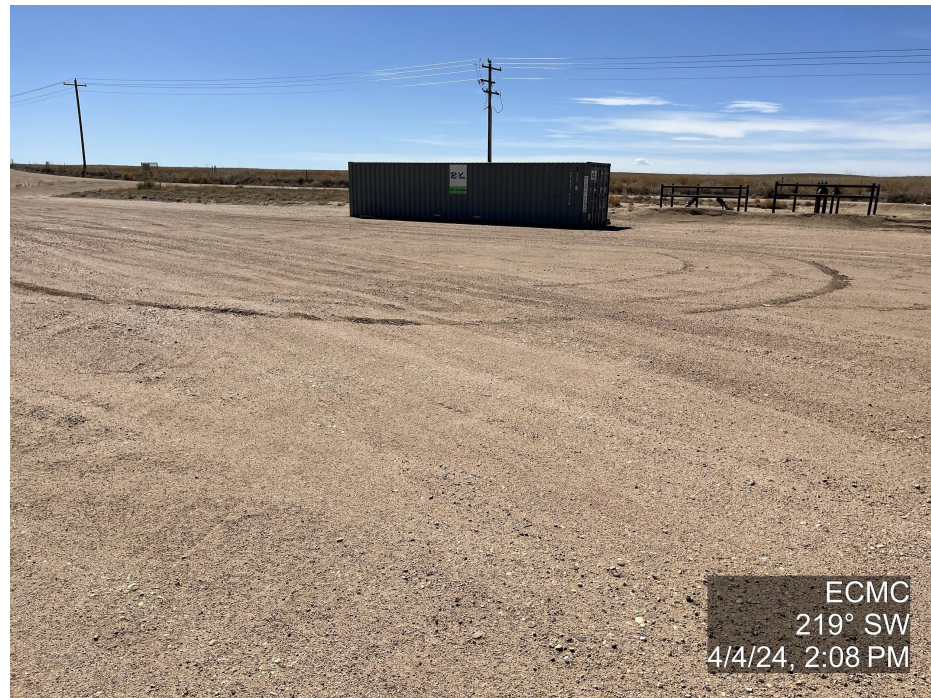
Photo 6. The photo was taken at the well location facing Southwest. The photo illustrates a shipping container being stored on the production pad.

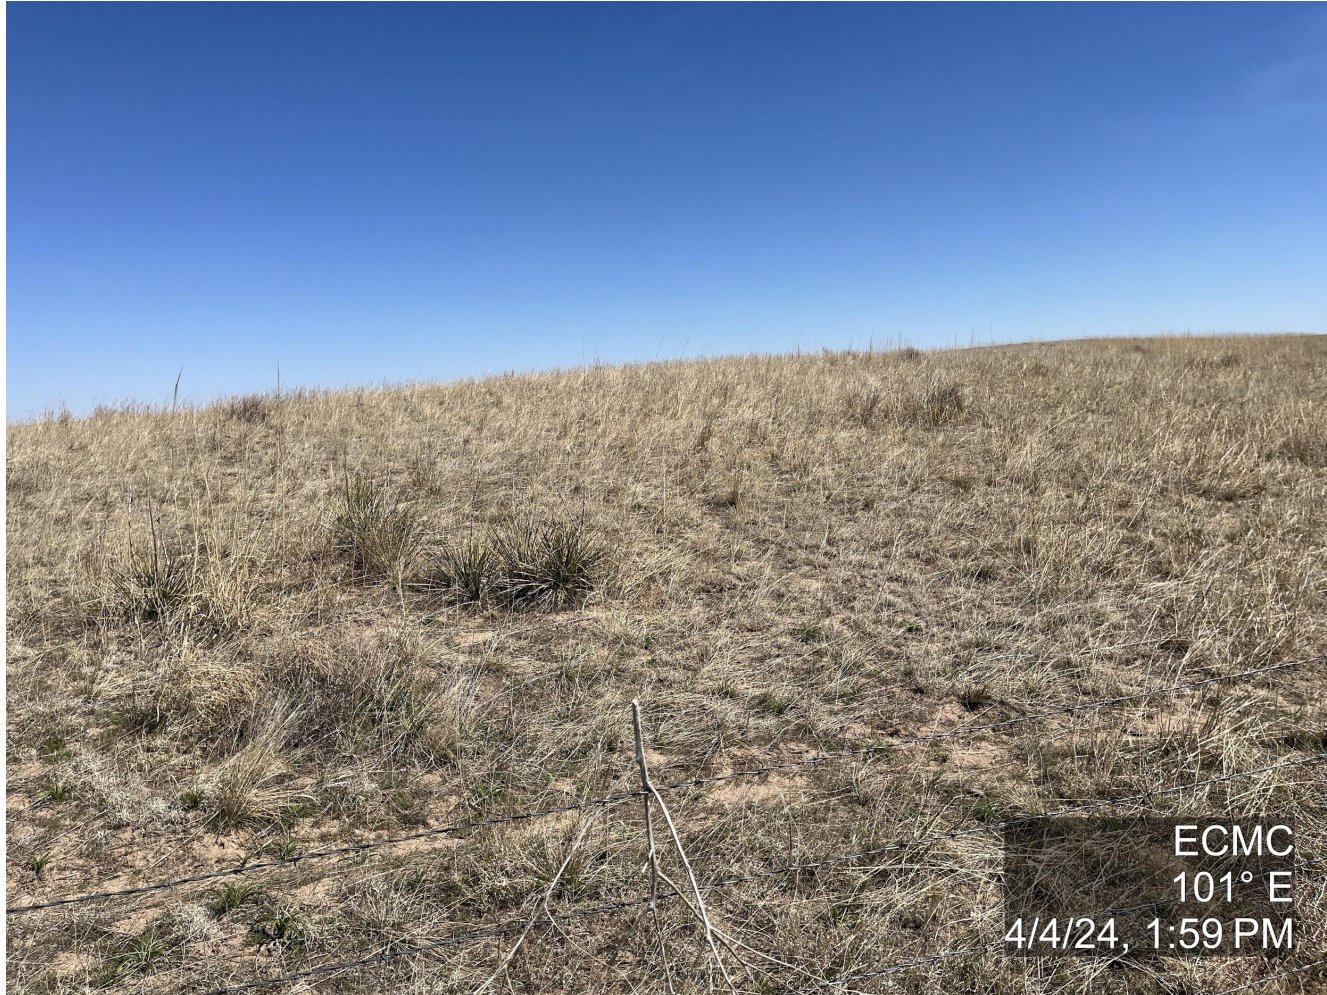
Photo 5. The reference photo was taken at the edge of the well location facing East. The photo illustrates that reference areas are dominated by Sand dropseed and Yucca.
