# Inspection Photos

Operator: Hilcorp Energy Company - 10133

Location ID: 325959

Inspection Document #: 714000688

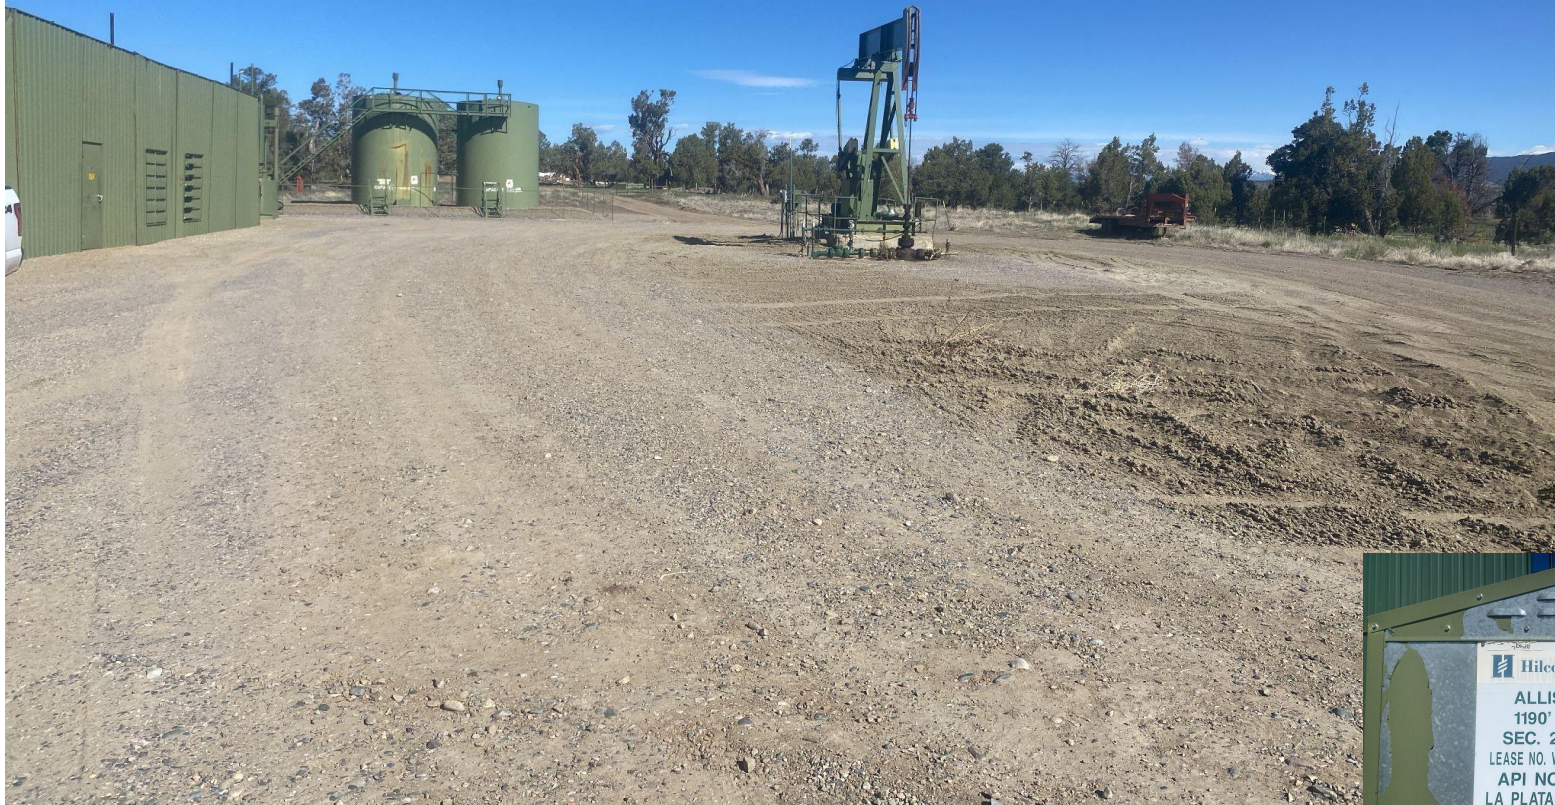
**Photo 1.** View of the well disturbance taken from the access point facing center.

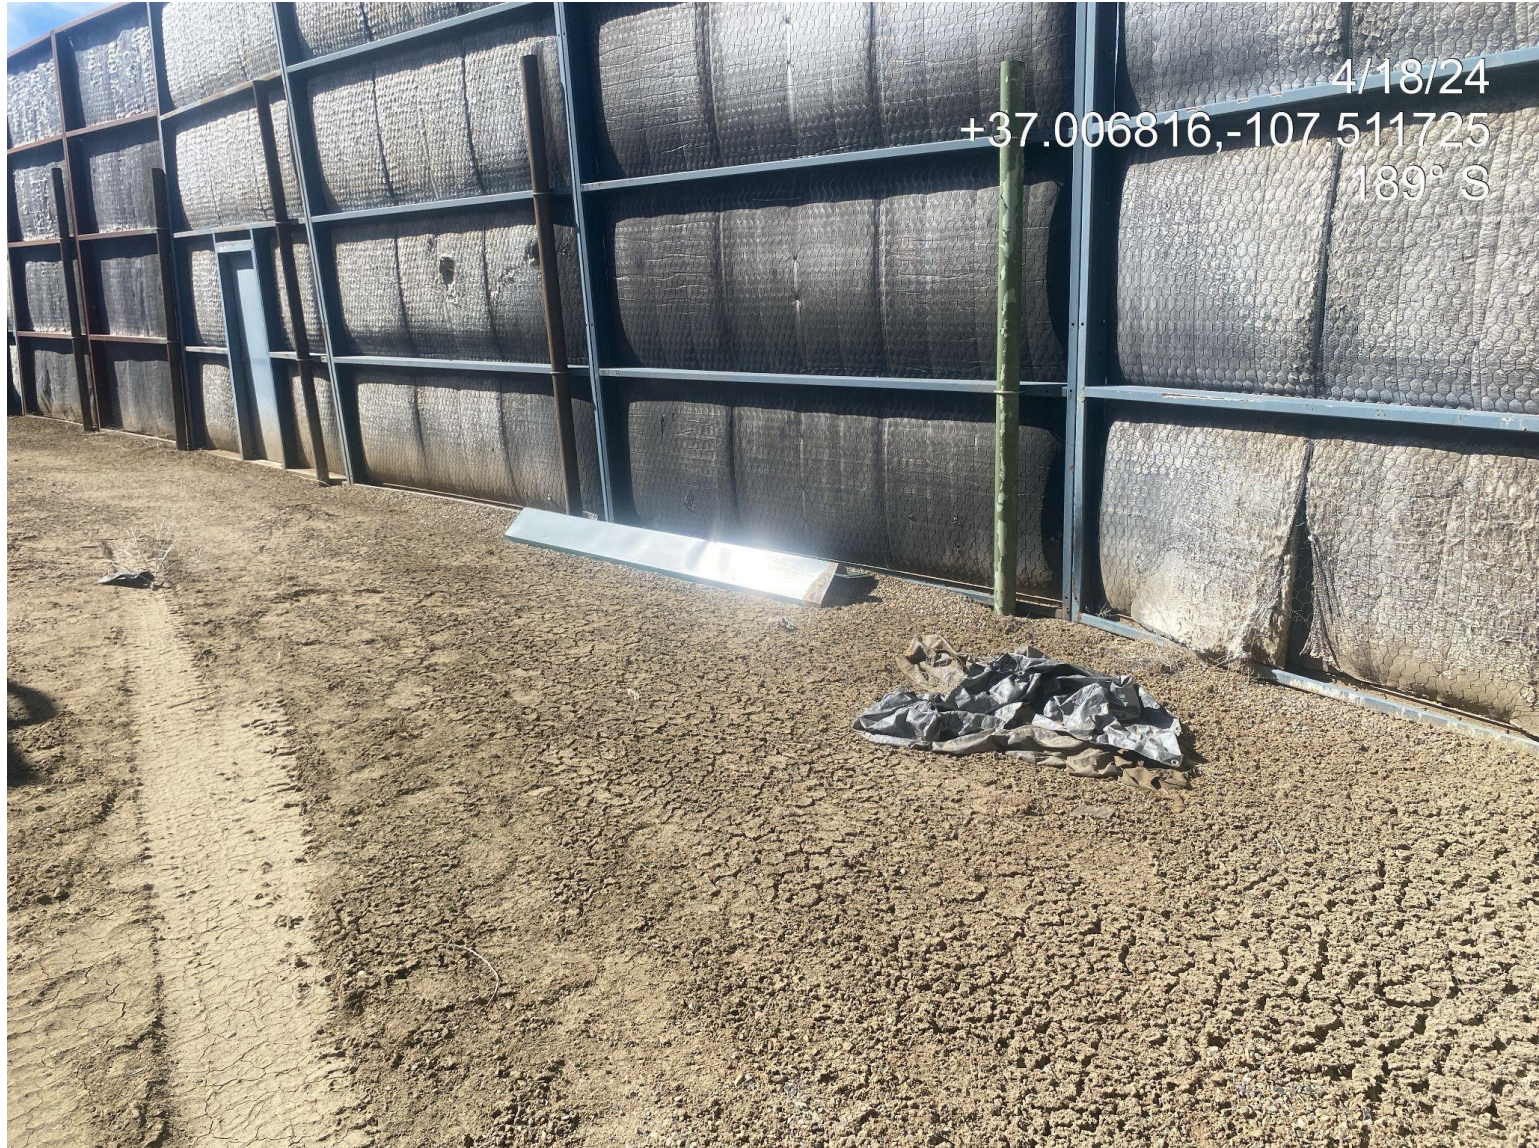
**Photo 2.** Plastic/metal trash observed within the sounds walls on location.

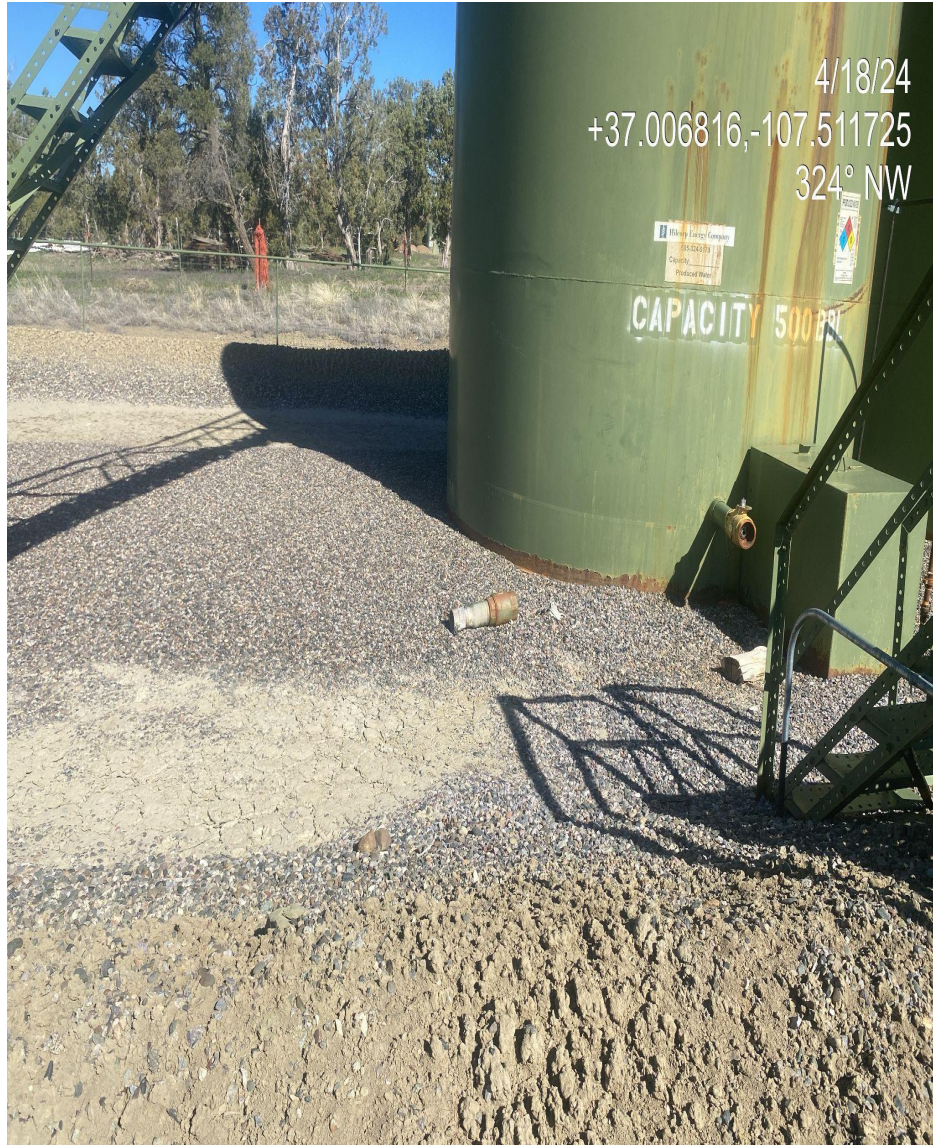
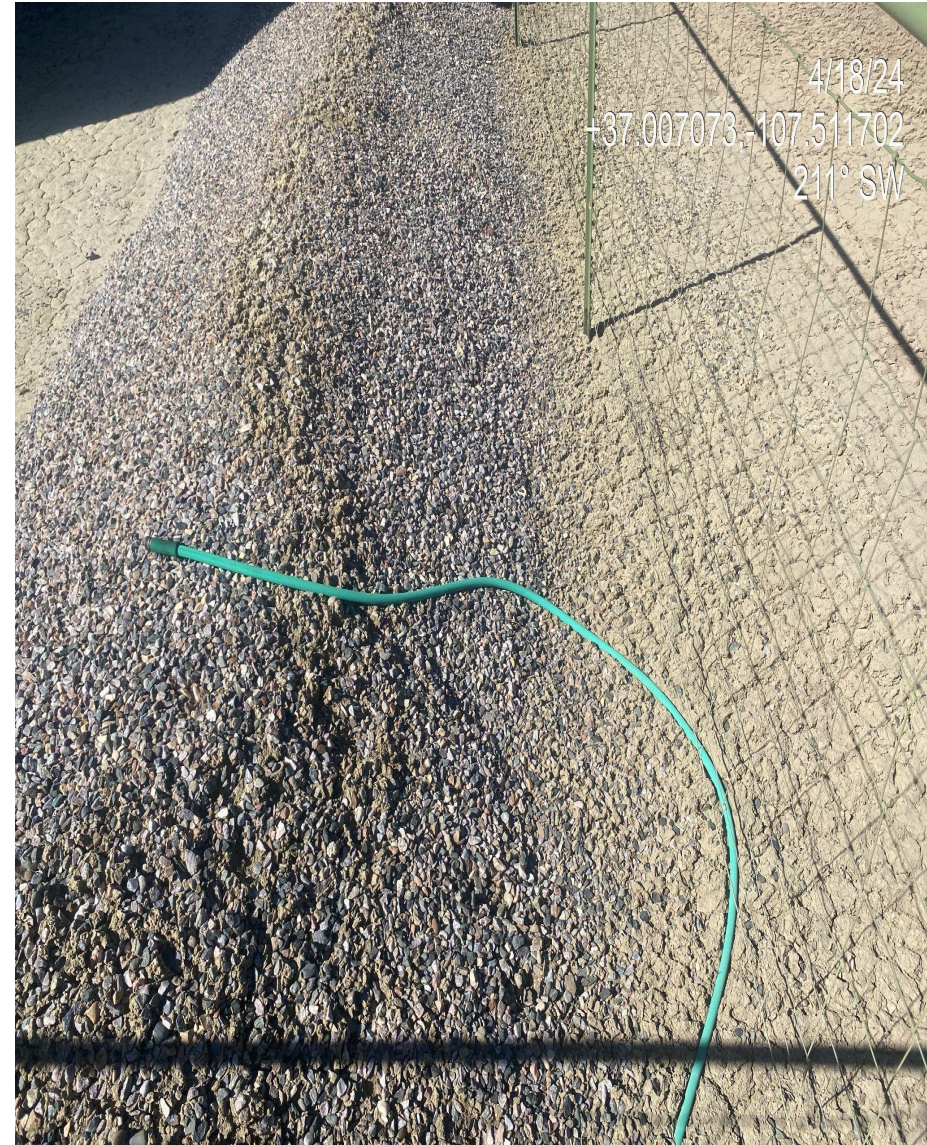
**Photo 3.** Unused fitting and tubing equipment observed within the produced water tank berm on location.

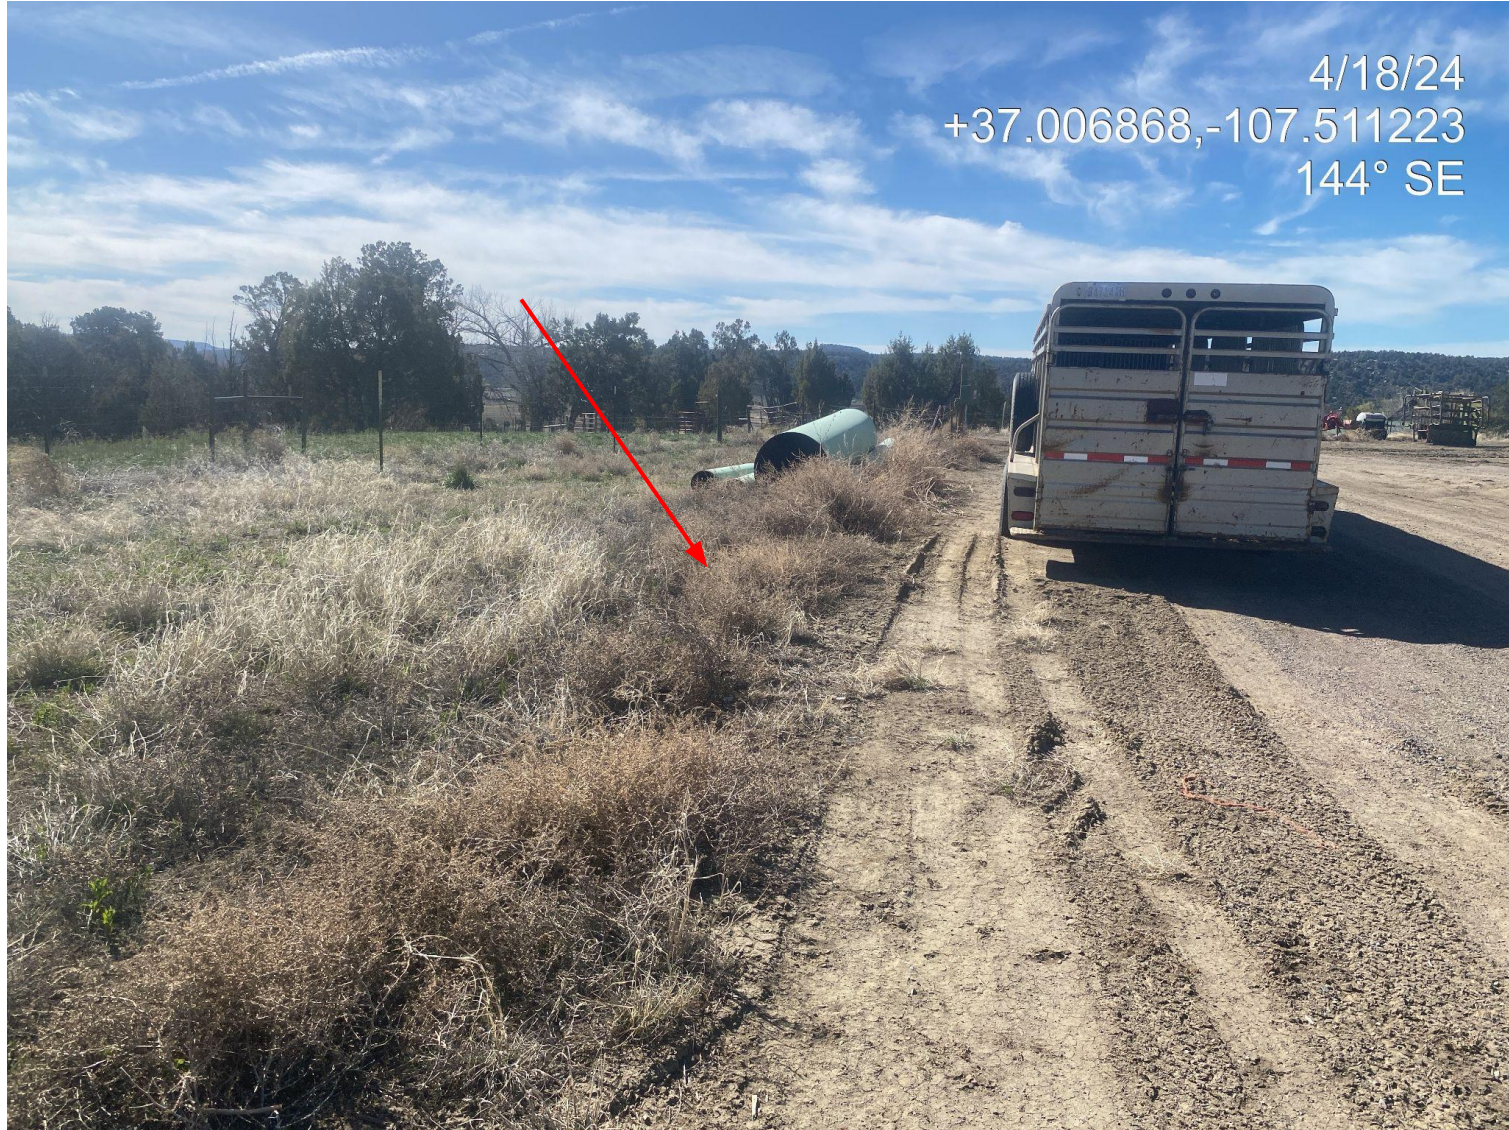
**Photo 4.** View of weedy russian thistle debris lining the eastern edge of the disturbance.

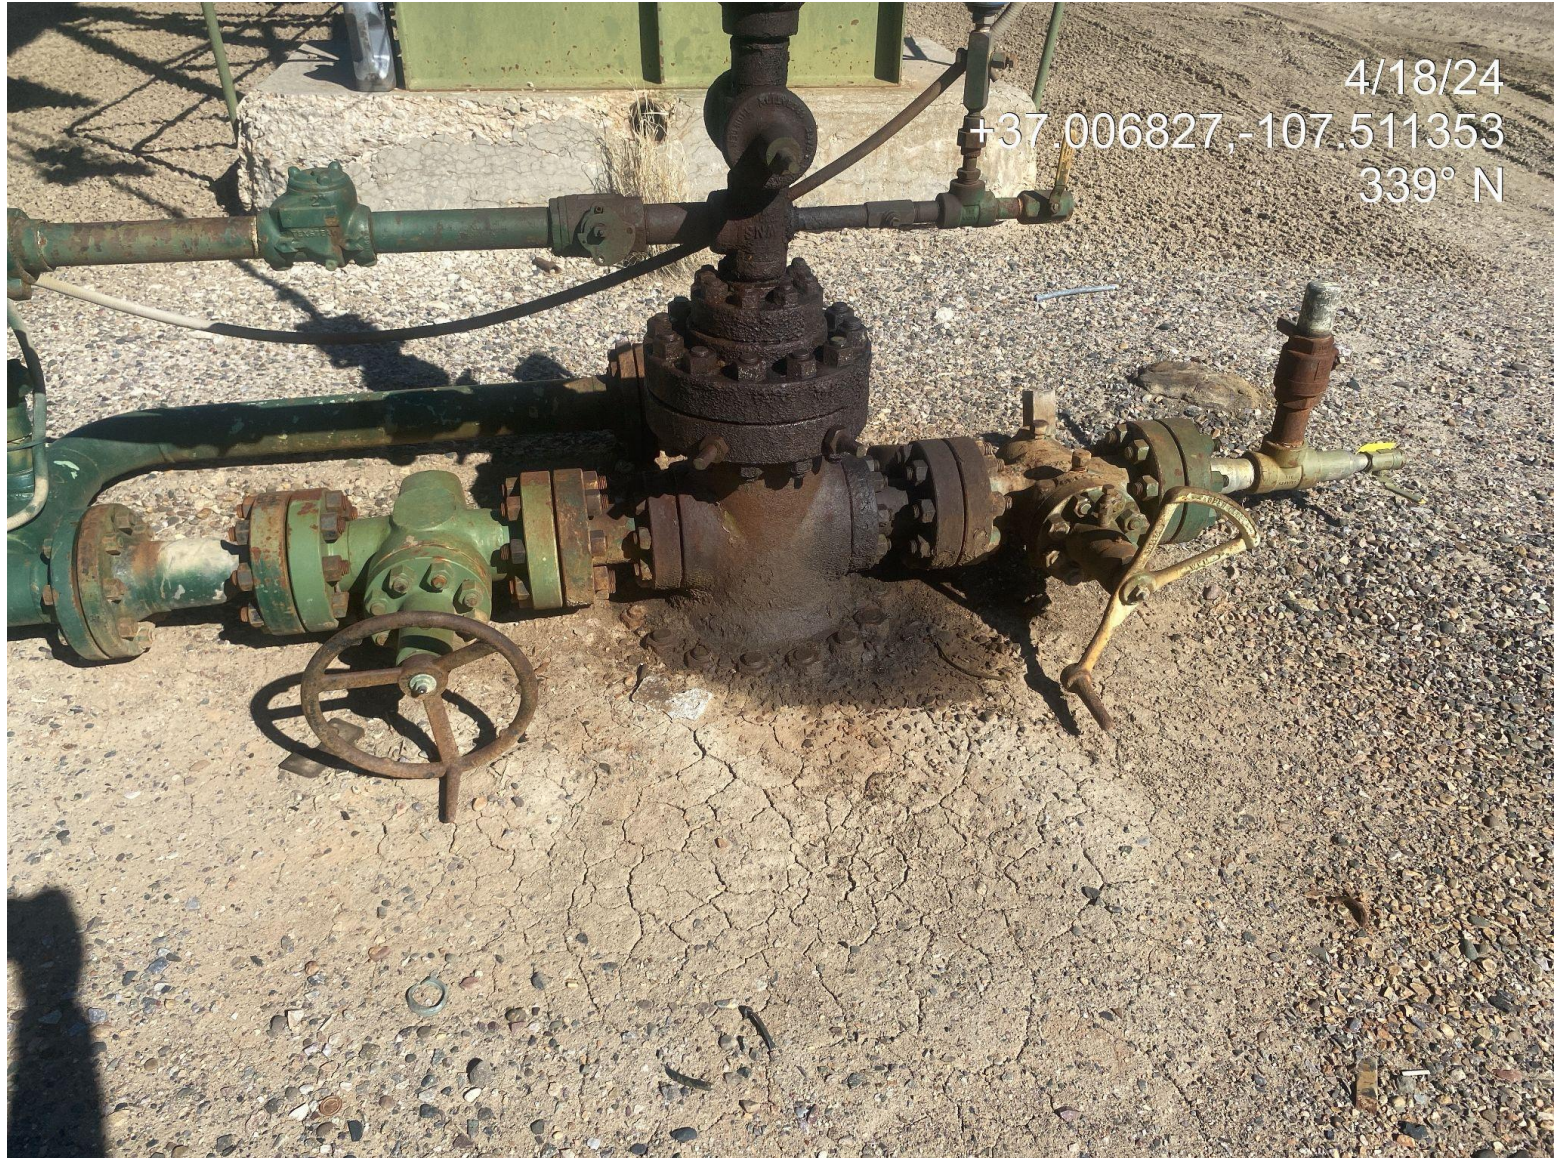
**Photo 6.** Impacted surface material observed at the well head.

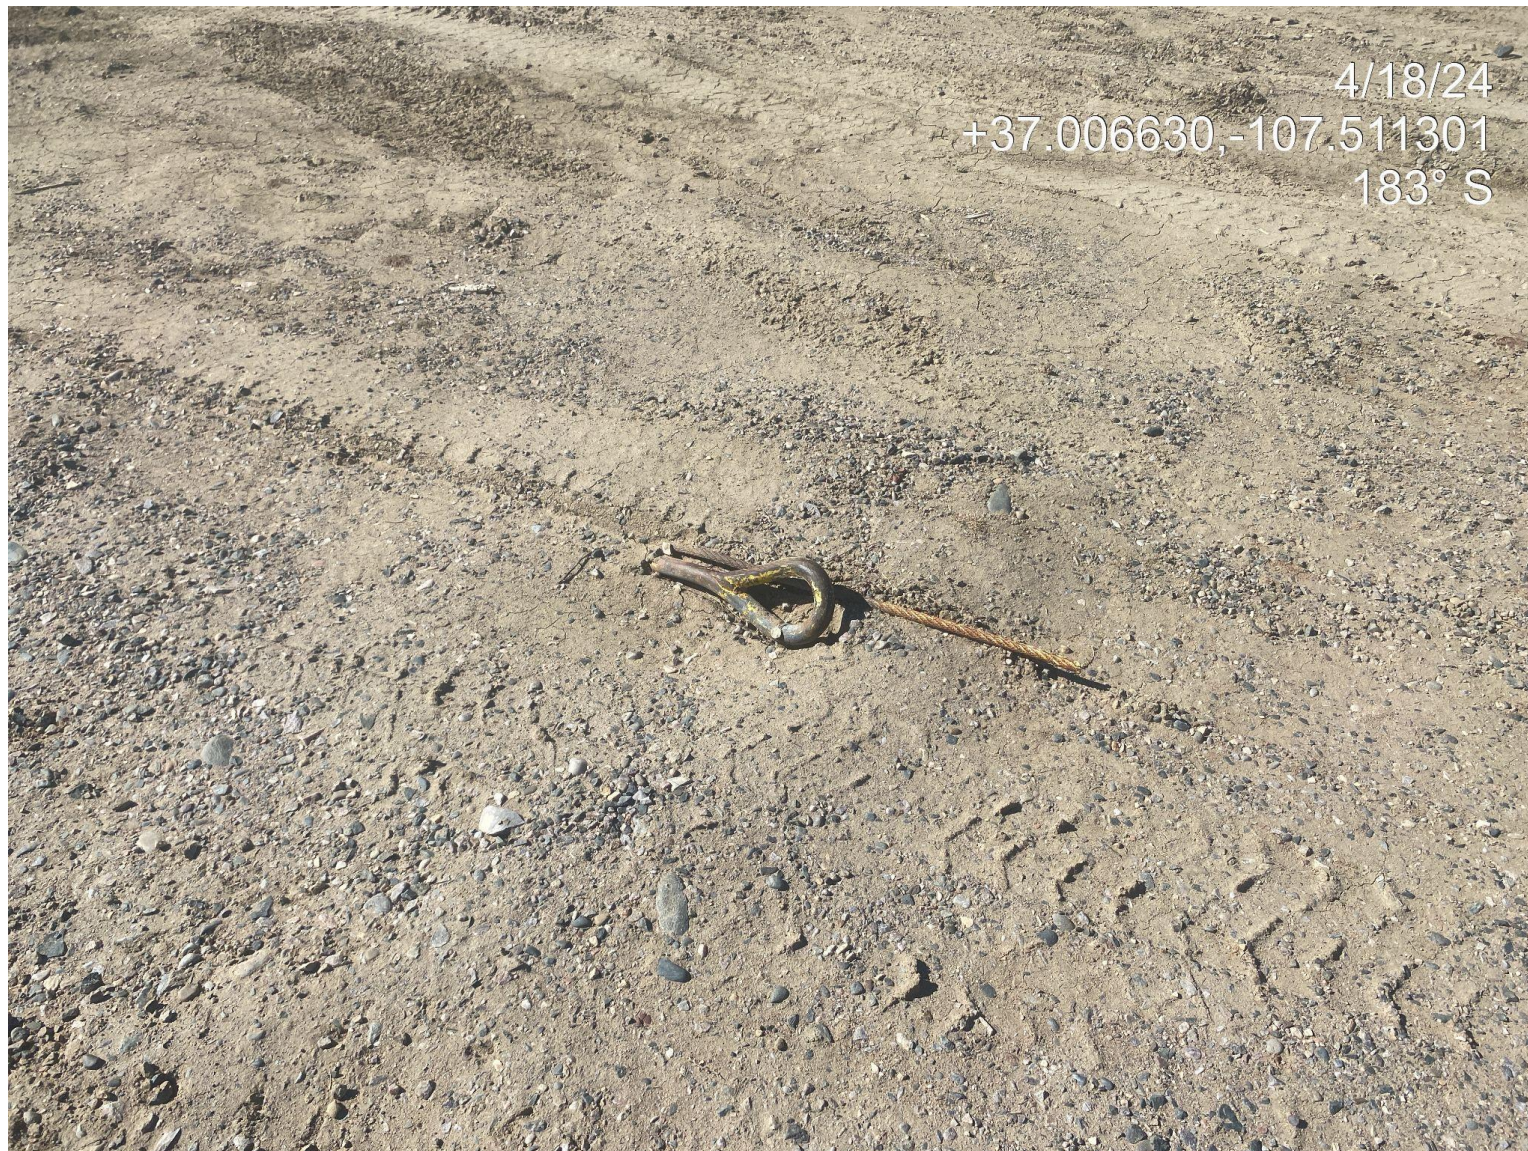
**Photo 7.** Unmarked guy line anchor on location.
